Extensive renovation the pathology of heritage buildings

Rasmussen, Torben Valdbjørn

Published in: ISBP2015 - 1st International Symposium on Building Pathology

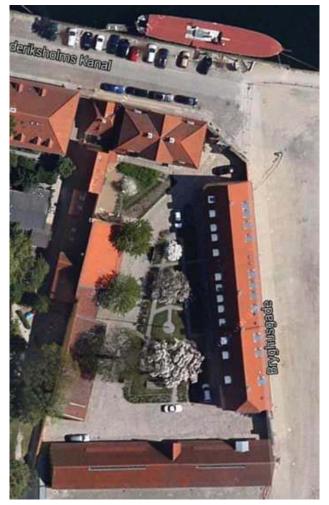
Figure 1. Google maps, photo showing the plan of the listed complex

The listed complex consists of four individual listed buildings. The buildings form a single complex surrounding a courtyard, see Fig. 1.
