Extensive Renovation of Heritage Buildings

Rasmussen, Torben Valdbjørn; Møller, Eva B.; Buch-Hansen, Thomas Cornelius

Published in: **Open Construction & Building Technology Journal**

Publication date: 2015

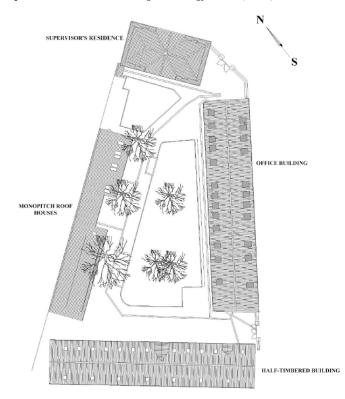
Fig. (1). Site plan of the listed complex, Fæstningens Materialgård.

The listed complex, *Fæstningens Materialgård*, located in the western part of downtown Copenhagen, was used as case for the study. The history of the listed complex goes back to the 17th and 18th centuries when the old royal materials yard had to be replaced by a new one. Construction of the complex begun in 1740 with a new, very distinguished residence for the supervisor. The complex consists of four individual listed buildings. The buildings form a single complex surrounding a courtyard, see Fig. (1) and consist of 1 to 3 storey brick buildings with red tile roofs, yellow limewashed facades, green-painted doors and gates and whitepainted windows. Only the original warehouse building of the complex is built as a half-timbered structure.

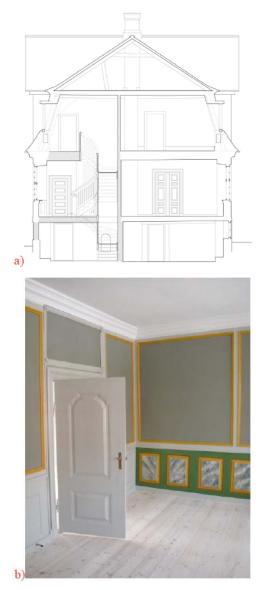
Fig. (2). The building containing the supervisor's residence. a) The structural section, b) a photo of the supervisor's residence after renovation.

The supervisor's residence, see Fig. (**2a & 2b**), is recognised by its representative character and position in the hierarchy of the complex, the hierarchy between the storeys, the rooms and interiors with a mix of historic styles and joinery details. The supervisor's residence is characterised as the 'grandest' building in the complex, and there is a desire to expose and enhance the fine, richly decorated interiors.

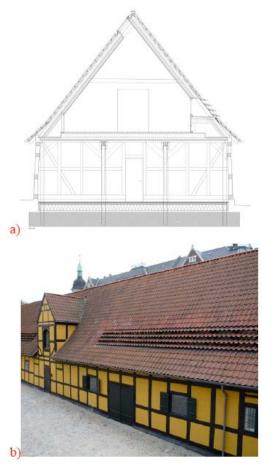
Fig. (3). The half-timbered building. **a)** The structural section, **b)** a photo of the half-timbered building after renovation.

The still-preserved half-timbered building, see Fig. (**3a** & **3b**), retains its warehouse character and clearly shows the longitudinal beam structure and rough, simple detailing. The character of the half-timbered warehouse with its clear structures and rough simple detailing, as well as its close relation-

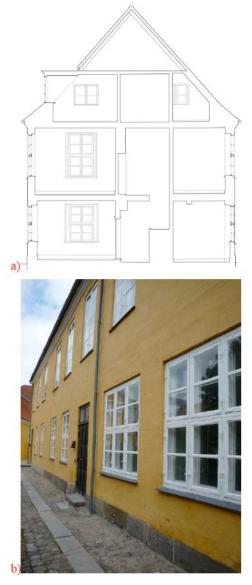
Fig. (4). The office building. **a)** The structural section, **b)** a photo of the office building after renovation.

The office building is recognised for its longitudinal partition walls, the distinction between the northern and southern parts of the building, its room plan layout and joinery details, see Fig. (4a & 4b). The renovation of the office building was undertaken to re-establish valuable elements from different periods and to restore the old room structures.

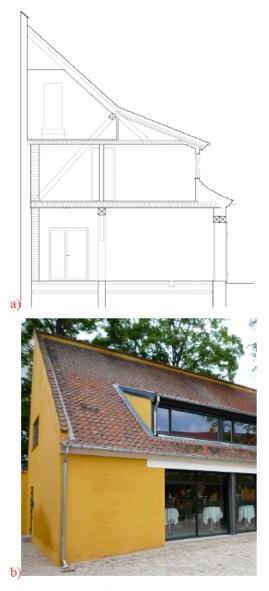
Fig. (5). The monopitch roof building. **a)** The structural section, **b)** a photo of the monopitch roof building after renovation.

The monopitch roof building, shown in Fig. (**5a & 5b**), shows the original timber structure with very large dimensions. Renovation of the monopitch roof building was undertaken to re-establish the characteristics of the buildings as more or less open 'sheds' with clear structures, few simple details and a close relationship to the courtyard.

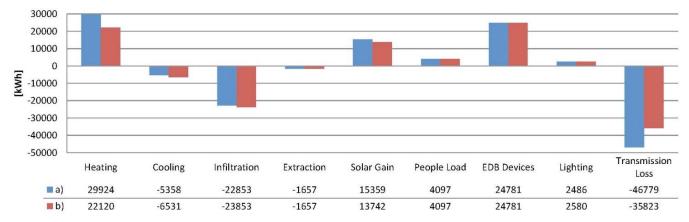
Fig. (6). Breakdown of the energy balance in the building that holds the supervisor's residence with; a) original secondary glazing; and b) where the existing secondary glazing was changed to low-energy glazing. The heat balance is based on the future interior layout with the future occupant loads and expected use of IT equipment. The thermal environment was maintained at a Category C level by means of cooling.
