Luterbacher, R, Coope, TS, Trask, RS & Bond, IP 2016, 'Vascular self-healing within carbon fibre reinforced polymer stringer run-out configurations', *Composites Science and Technology*, vol. 136, pp. 67-75.  
<https://doi.org/10.1016/j.compscitech.2016.10.007>

# ***Title: Vascular self-healing within carbon fibre reinforced polymer stringer run-out configurations***

Authors: R. Luterbacher, T.S. Coope, R.S. Trask, I.P. Bond

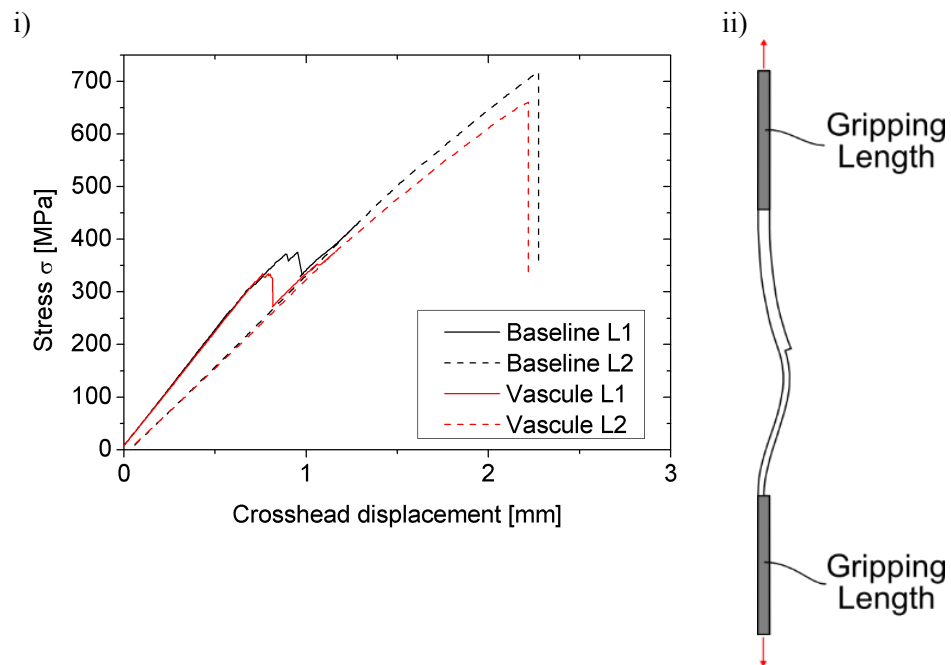
**Figure 3. i) Representative stress-displacement curves for the baseline and the vascularised specimen and ii) Schematic out of plane deformation of the specimen.**

Figure 3 (i) shows representative stress-displacement curves and Table 1 summarises the test results.

Due to the offset between the loading axis and the neutral axis, the specimen deforms through the thickness as shown in Figure 3 (ii), causing through thickness stresses at the tip of the flange and delamination at the tip of the flange.

Initially, the baseline and vascularised specimens behaved similarly and exhibited linear-elastic behaviour. A similar stiffness was observed, which was in accordance with observations made previously, in that small diameter vasculature had little effect on the overall stiffness [28,29]. In the case studied, the vasculature corresponded to approximately 0.6% of the cross section area of the lap without removing any plies oriented in the loading direction. However, the vasculature did have an effect on the initiation load of the delamination with a reduction of 15%. This was due to the fact that the vasculature acted as a free surface, as the  $-45^\circ$  and  $90^\circ$  plies are terminated in order to accommodate the vasculature. The damage initiation at the cut plies was observed on the fracture surface of the vascularised laminate in Figure 4. Upon damage the apparent stiffness was reduced by approximately 23% due to the delamination of the strap. The failure load of the strap lap specimen was reduced by 10% due to the introduction of the vasculatures.

In contrast to the lap strap specimen, where the debonding of the strap occurred immediately (refer to Figure 3 (i)), a more progressive damage was observed for the stringer run-out specimen. Damage progression was only observed visually during testing, however, the following observations were noted. For the baseline and vascularised specimen (Figure 7 (i)) at ca. 60 kN the initial debonding of the stringer was observed. However, the load bearing behaviour of the vascularised specimen was higher (up to 7%) than for the baseline configuration. Therefore, one potential interpretation could be that the vasculae acted as delamination arrestors. As only one specimen was tested no definitive conclusion can be drawn as to whether the improved behaviour of the vascularised specimen was due to material and manufacturing variability or if the vasculae acted as delamination arrestors, thereby effectively compartmentalising the propagating debonding damage [25]

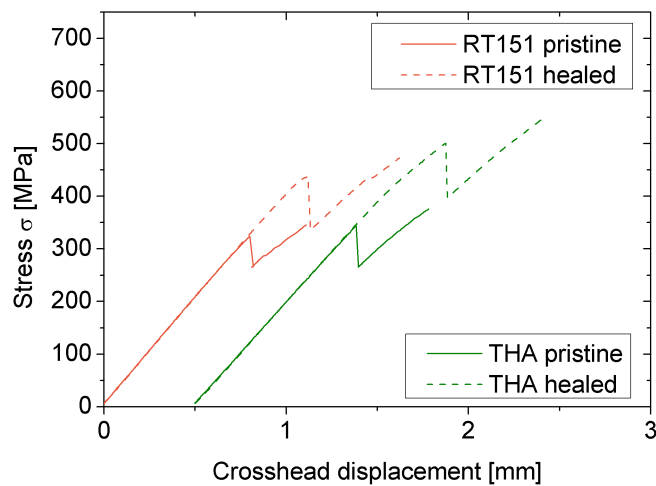
**Figure 5. Representative healing curves for the strap lap specimen healed with RT151 and THA. Curves are off-set for improved visualisation**

Figure 5 shows representative stress-displacement curves for the pristine and healed vascularised specimen and Table 2 summarises the healing results.

After healing, the stress-displacement response was similar to that of the pristine specimen with both healing agents successfully demonstrating a recovery in performance. The stiffness was fully recovered and the stress level at which the delaminations initiated was increased, leading to a healing efficiency,  $\eta_{\sigma}$ , ranging between 137-145%. It is expected that under fatigue loading the THA healed specimen will perform better due to its inherent toughness [29]. The reason for this increase in stress level at which the delaminations were initiated can be explained by the increase in the thickness of the resin rich interlayer ( $\sim 350 \mu\text{m}$ , Figure 6 (i)) leading to locally higher fracture toughness values [31]. Therefore, due to the fact that additional resin is injected into the crack plane, the thickness increases marginally. In addition, the RT151 resin has a brittle behaviour, whereas the THA is ductile and as healing efficiencies in the same order of magnitude are observed, the main mechanism is likely to be attributed to the increase of fracture toughness due to the thicker resin rich interlayer [31]. The damage propagated along a similar path as in the pristine case failing the healing agent in both cases in a cohesive way (Figure 6 (iii), (iv)).
