Marquette Interchange Installation Report

Marquette University, Transportation Research Center

Marquette Interchange Perpetual Pavement Instrumentation
Project: Installation Report

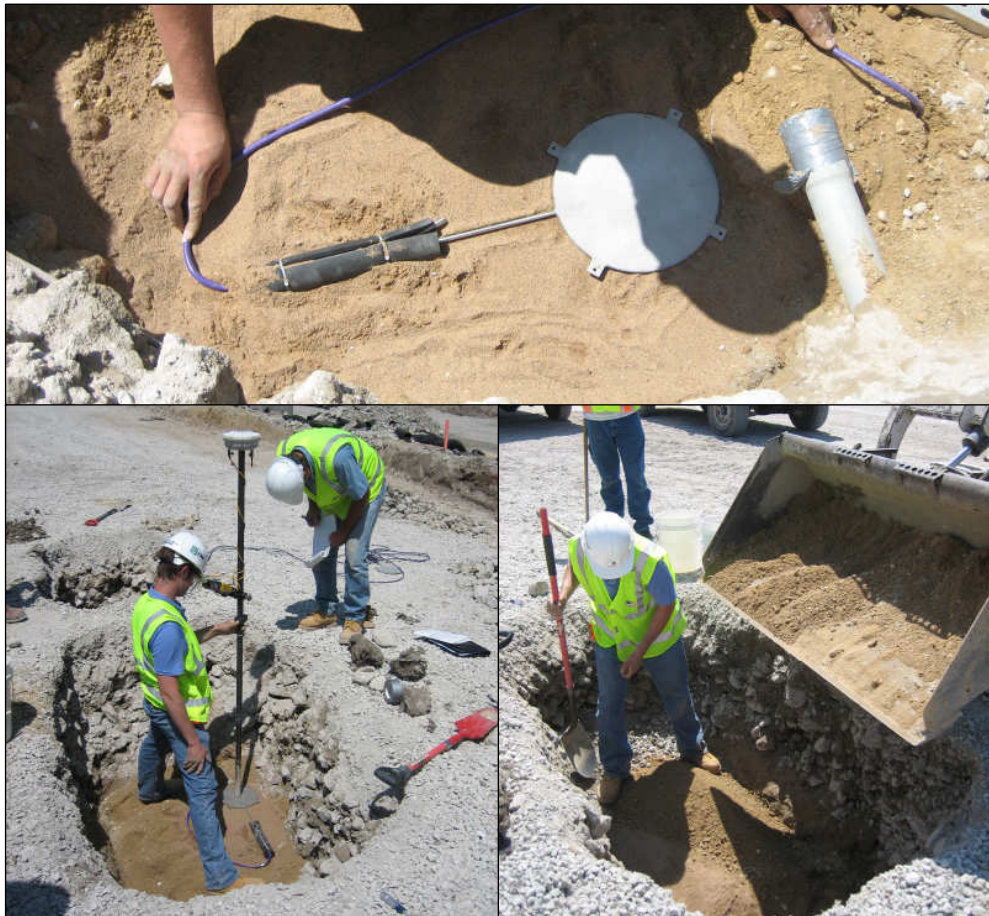
Figure 2-3 –Top: Placing EPC in a bed of fine sand and routing sensor cable carefully. Bottom left: Measuring and recording the final location of the EPC with a GPS based measuring device. Bottom right: Backfilling against the EPC with sand.

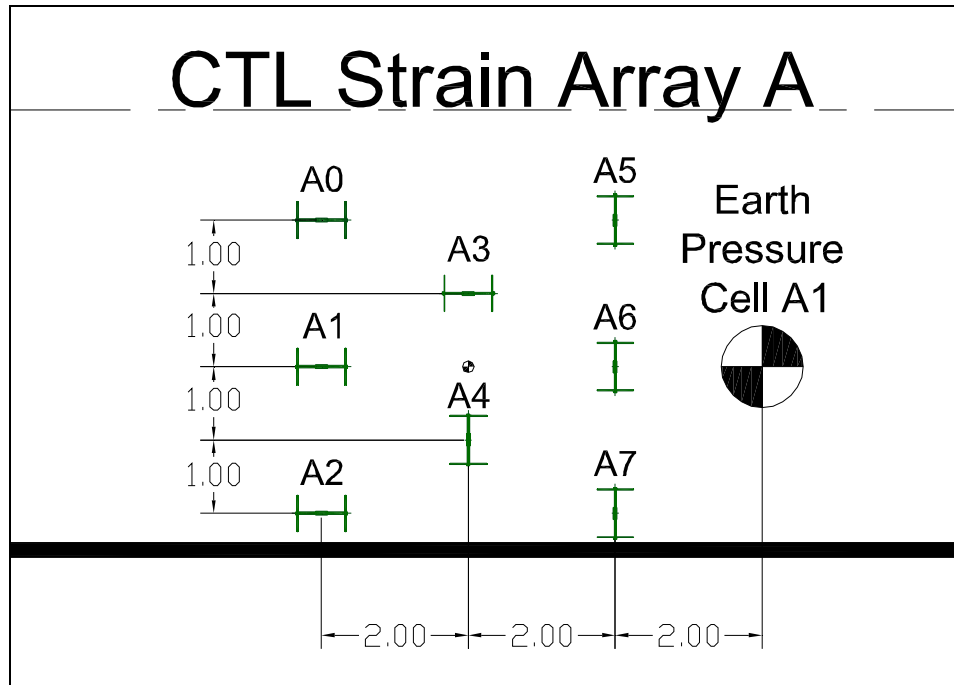
Figure 2-5 - Spacing of the strain gauges and earth pressure cells are shown above. All units are in feet. Note that the orientation of the two gauges in the middle of the array alternate rotation angles (transverse vs. longitudinal) for the two CTL arrays as shown in Figure 2-6.

The first step for installation of the ASGs involved finding the previously installed conduits and exposing them. The proposed locations and spacing (see Figure 2-5 and Figure 2-6 below) of each strain gauge was marked on the open graded base layer with paint. The leads on the ASGs were unwound and readied for pulling into the conduits. One team would work on pulling the leads to the bottom pull-box and screwing them into the terminals on the data acquisition system while another worked on preparing the gauges for placement into the asphalt layer.

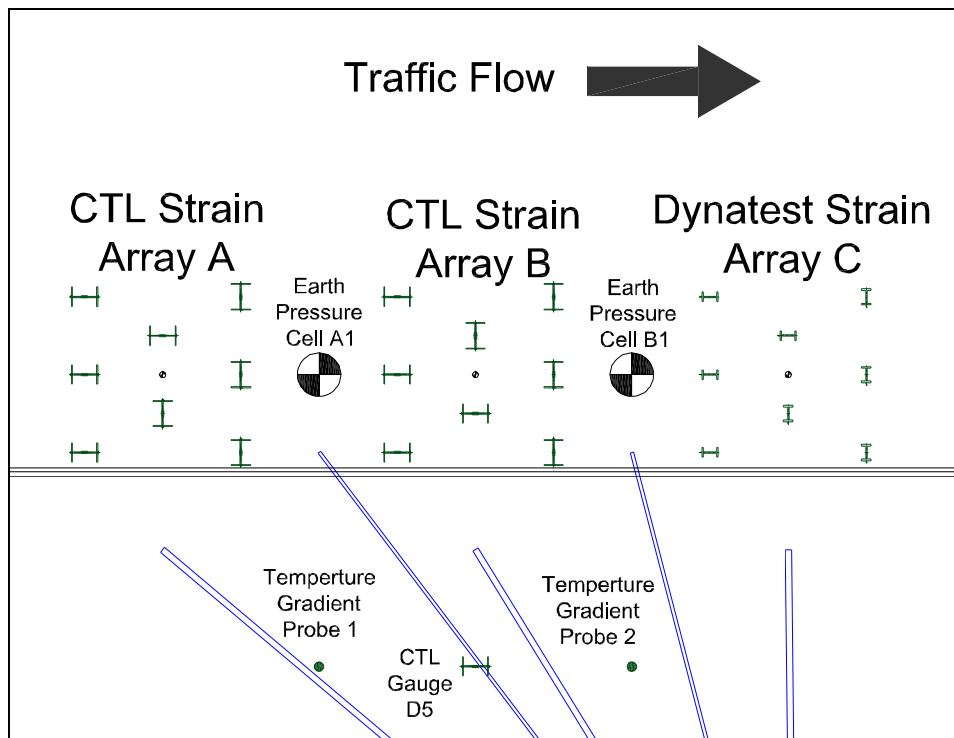
Figure 2-6 - Final configuration of strain gauges, earth pressure cells, and pavement temperature gradient probes.

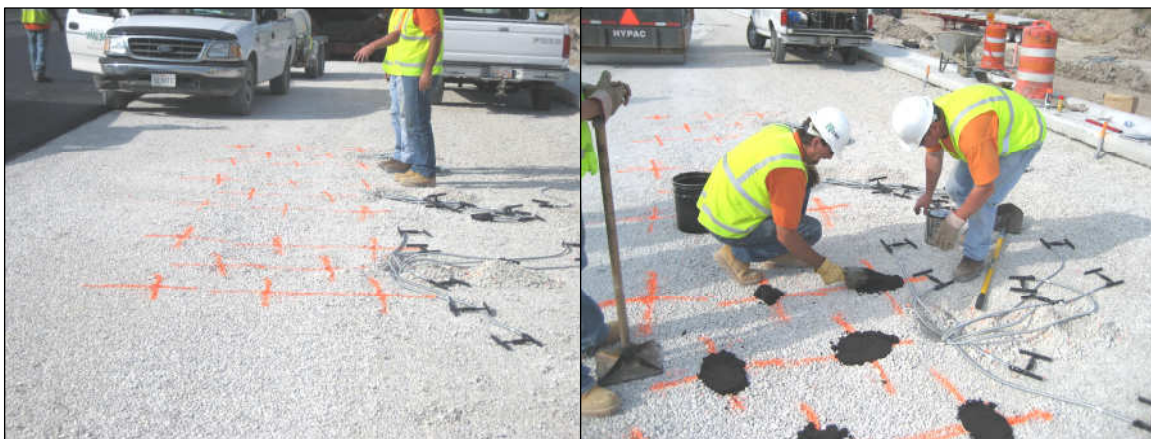
Figure 2-7 - Left: Marking the proposed locations of the gauges. Right: Placing sand/binder pad and fitting gauges.

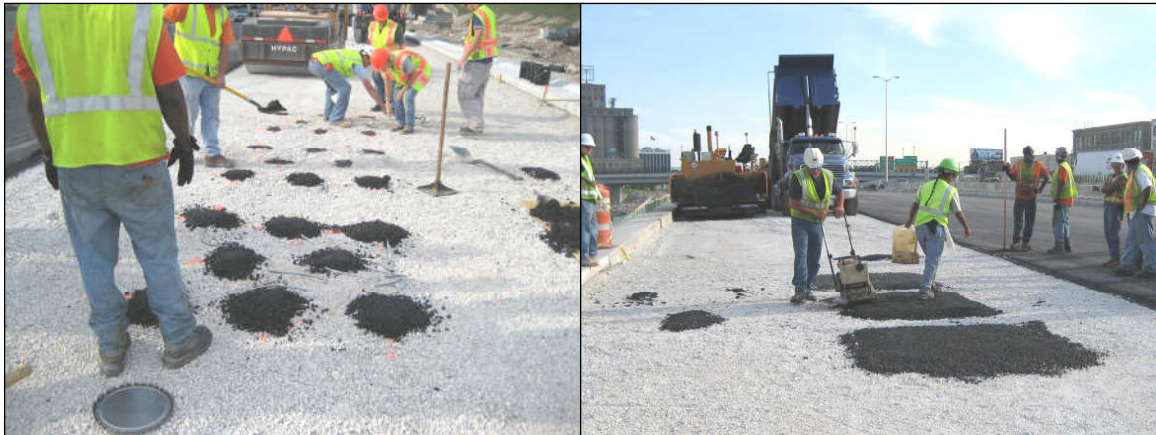
Figure 2-8 - Left: Placing screened asphalt on top of gauges and carefully compacting. Right: Compacting the unscreened asphalt over the gauge arrays with the paving crew approaching.

Just before the paver was about to arrive at the gauges, asphalt material from the paver hopper was screened off on the 3/8" sieve and placed on the gauges, roughly 1 inch thick. The material was compacted using mild compaction force using a hand tamper. Once all of the gauges were covered with screened asphalt, the gauges were checked once more for sensor leads that were misplaced. A layer of unscreened asphalt (about 2 inches thick), was placed on top of the gauge arrays and compacted using a gas powered plate tamper shown below in Figure 2-8.

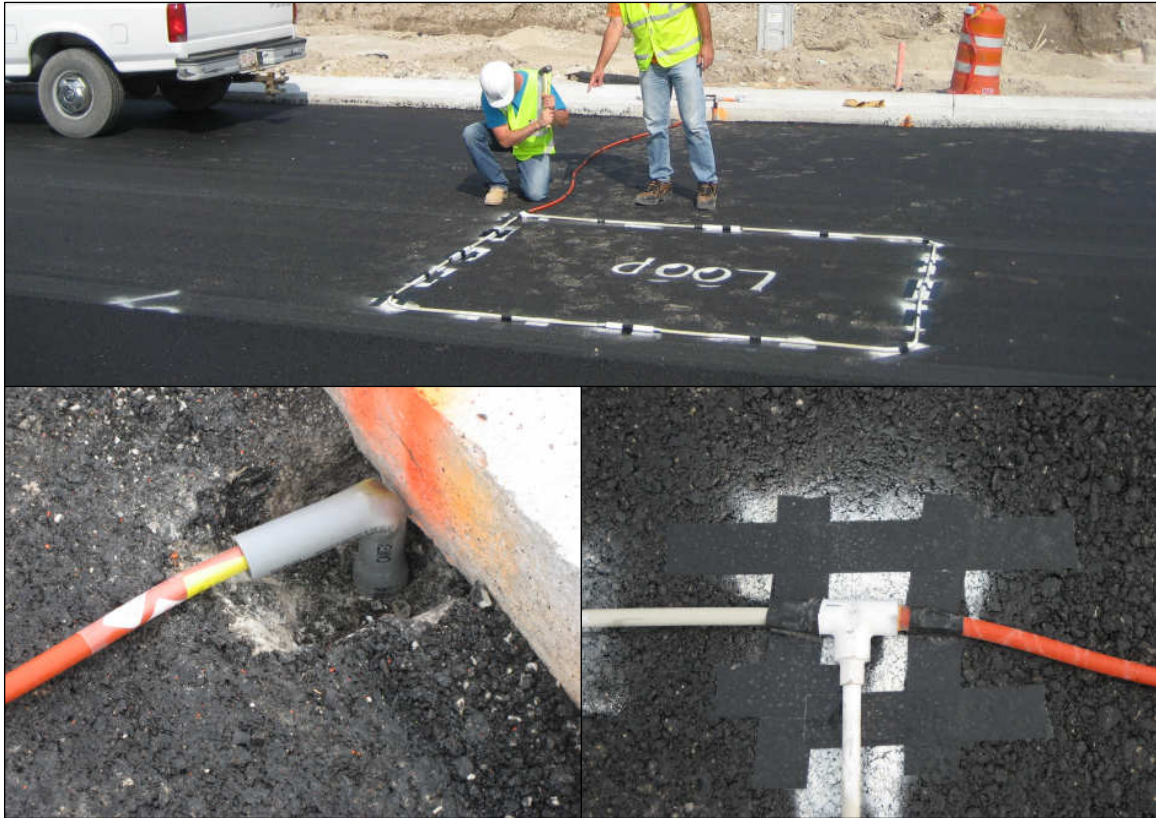
Figure 2-10 - Pictures showing various parts of the loop detector installation. Top: The fiberglass tape was hammered lightly to create a good bond to pavement. Bottom left: The asphalt around the conduit was removed with a cold chisel and hammer to expose enough conduit to install a “homemade” 90° elbow. The rather thick looking orange cable actually ends just inside this elbow and only two small wires actually pass through the elbow. Bottom right: A close up showing how the corner was adhered to the pavement and also the construction of the Never Fail Loop.

The inductance loop was secured to the pavement using a fiberglass adhesive-backed tape (known as “Gorilla Tape” manufactured by the Gorilla Glue Company) shown in Figure 2-10. The tape is similar in appearance to standard duct tape, but much stronger and has much more adhesive strength (it should noted that metal should not be used in close proximity to the loop detector as it may deteriorate its sensitivity). Sections of the loop were secured in multiple locations and the wires were pulled to the conduits and secured. A simple resistance and continuity check of the loop after placement showed that the wires had not been broken and the sensor should be operational.

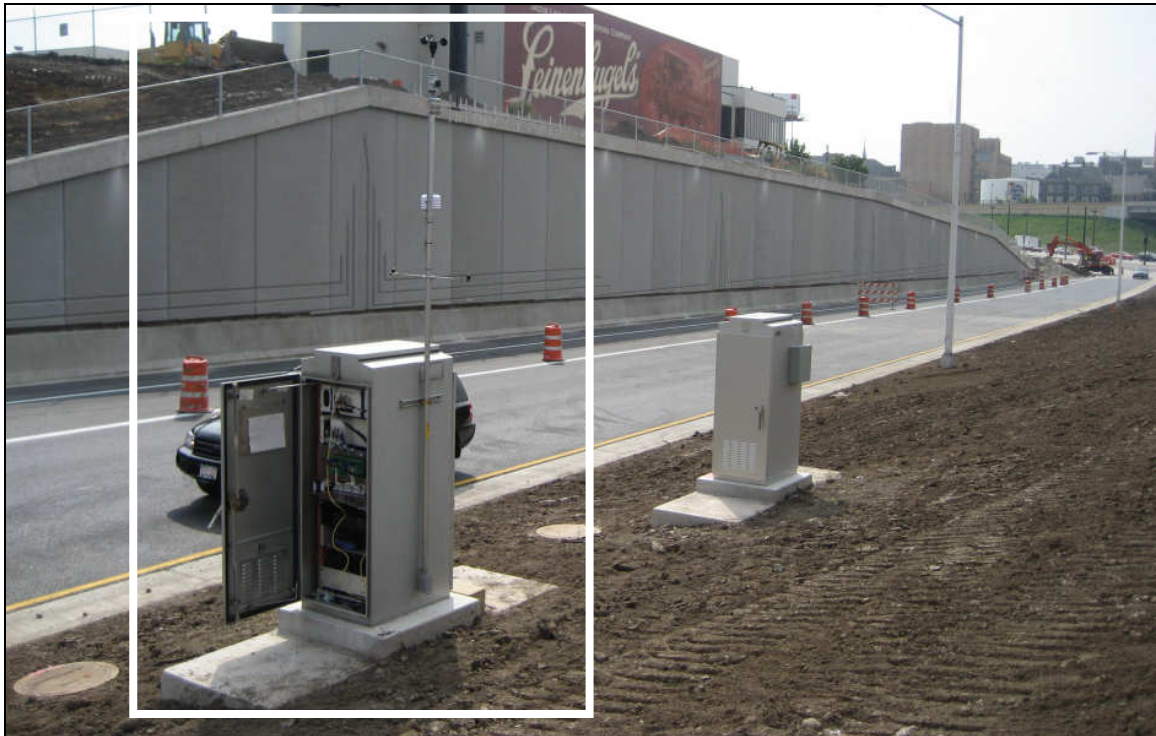
Figure 2-11 - The highlighted cabinet is occupied by the equipment for this project. The mast connected to the cabinet holds environmental sensors as well as the wireless communications antenna. The cabinet in the background houses various traffic control devices for WisDOT. The two cabinets are connected by a limited number of conduits.

The roadside cabinet had been installed on its concrete pad (Figure 2-11 shows the project cabinet in place) by Outdoor Lighting and since the system was close to being complete, most of the equipment was prepared to be installed into the cabinet. This work was done while waiting for the paving crews to reach the test section with the final SMA surface layer so the temperature probes could be installed. Many of the sensor leads (including moisture probes, temperature probes, strain gauges, etc) needed to be extended to reach the inside the cabinet (a “comfortable” distance from the lower pull-box into the cabinet is about 20 feet). The data acquisition system, din-rails, power supplies, wireless radio, weather/antenna mast, and pavement temperature/camera mast were installed during this time period.

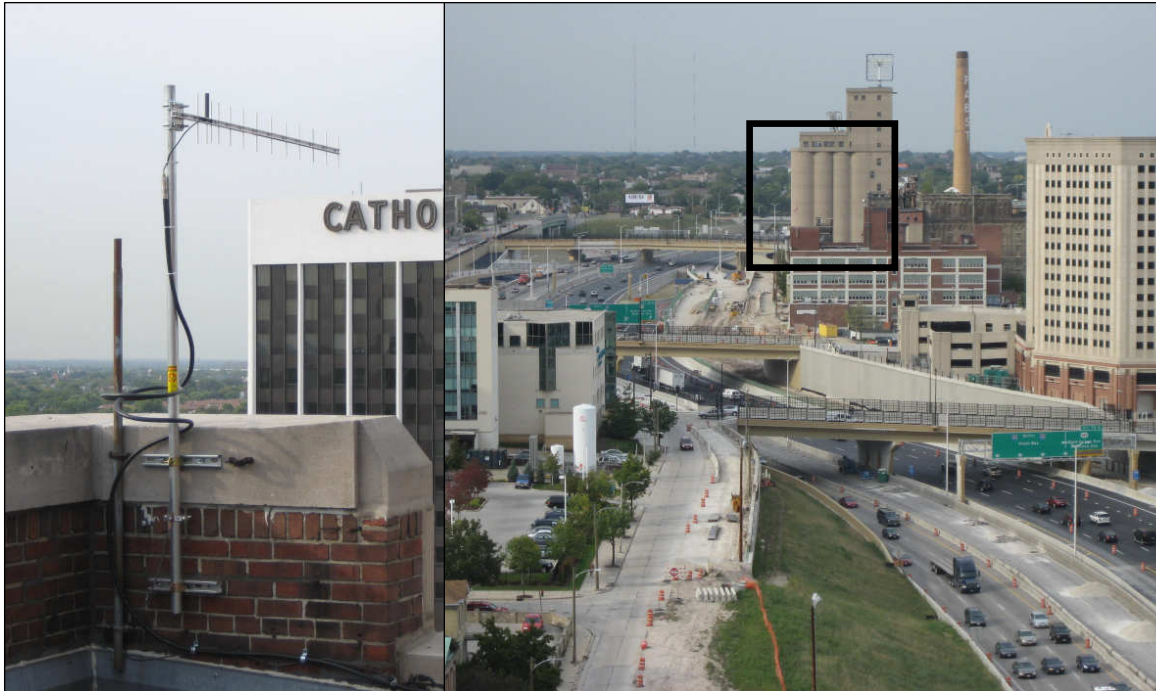
Figure 2-12 - Left: The wireless antenna mounted on the corner of Carpenter Tower Hall at Marquette. Right: View from the antenna location at Carpenter Tower. The test section is located just behind the grain elevators in the highlighted area.

The coaxial cable that the antennas used for signal transmission required that special connector be installed. Service personnel from TAPCO Inc. installed the terminals on the cables on September 21 and the cable modems were powered up and checked for connectivity. The results showed that the connection was excellent even though the line of sight from Carpenter Tower Hall to the test section is blocked by grain elevators from the now defunct Pabst Breweries. The line of sight is visually shown in the right photograph in Figure 2-12.

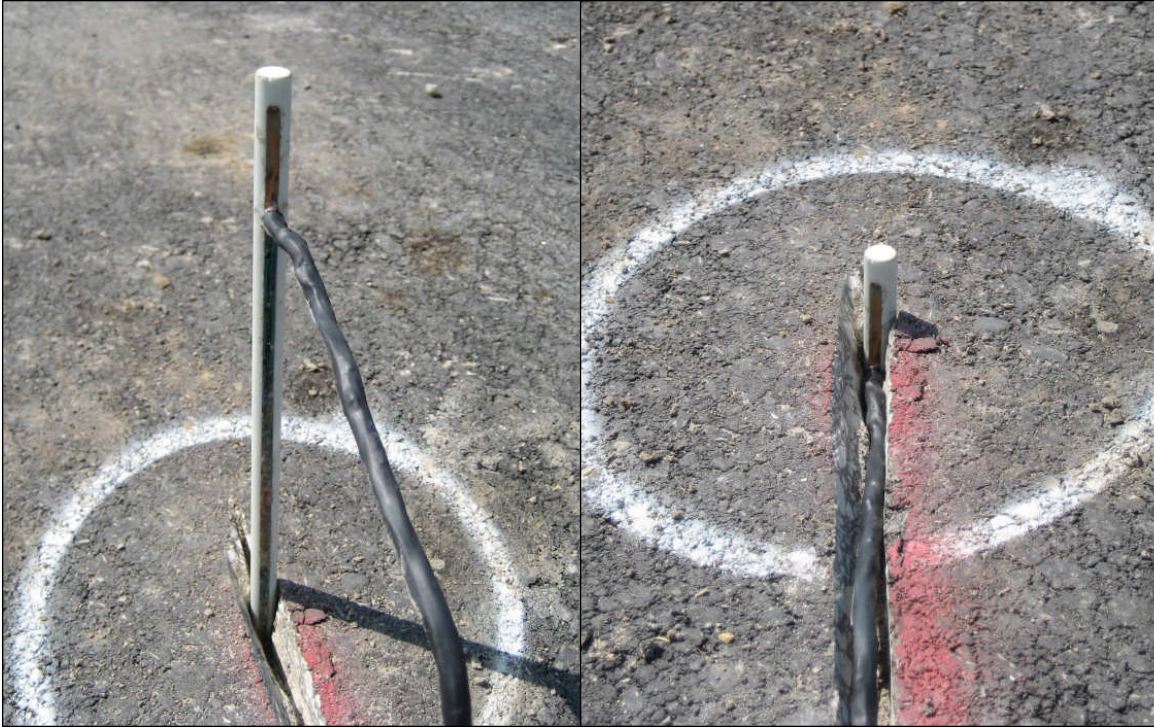
Figure 2-13 - The photograph on the left shows almost the entire length of the temperature probe. The photograph on the right shows the temperature probe fully inserted to its final position. Note that the sensor lead is fitted into its channel, but has not been sealed yet.

The sensor leads were pulled almost all of the way into the conduit. Since the conduit opening was close to the curb, the sensors were pulled off to the side of the roadway until the time approached to pave over the sensors. When paving crews approached, the temperature probes were pushed in the drilled hole until they bottomed out. The protruding end of the probe was re-measured to ensure that the probe would not be higher than the final pavement elevation and actually was designed to be one-half to one inch below the surface of the SMA as shown in Figure 2-13. After this check the sensor leads were fitted into the channels and the excess wire was pulled into the pull box. Sealant was then placed in the channel to secure the wire into the channel and also protecting it from the approaching paving equipment.

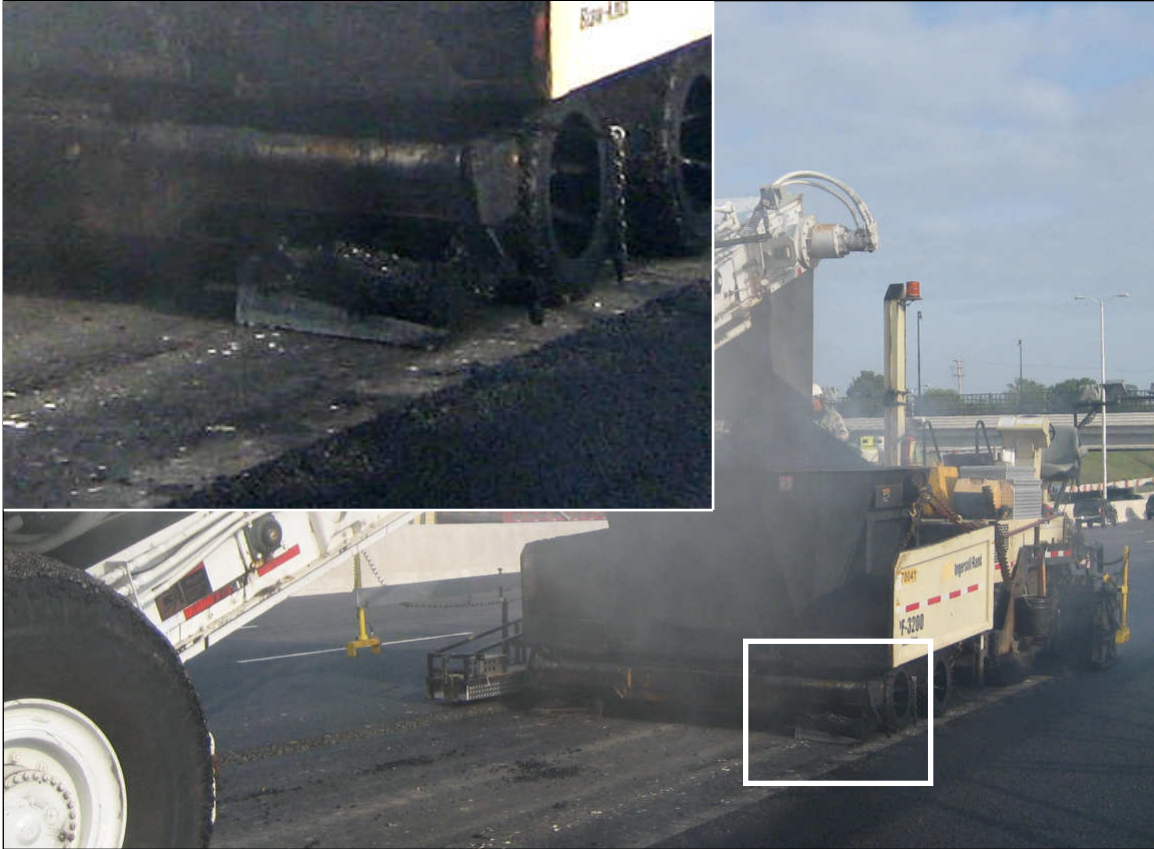
Figure 2-14 – The scraper in the wheel paths of the pavers should be lifted off the pavement surface to avoid destroying sensors and their wiring. The inset picture is a close-up of the scraper which is in the down position, resting on the pavement surface.

raised out of the way when dealing with any instrument leads crossing the path of this scraper. Failure to do so will result in damage to the instruments.

The next step consisted of watching the paving equipment pass over the sensor. Because of the location of the sensor on the pavement and the procedure used to place the SMA, the protruding temperature probes fell within the wheel base of the trucks charging the paving equipment. Again, it is warned to pay close attention to the scrapers in front of the paver's wheel path (see Figure 2-14) because it has the potential to destroy the sensor leads. They can be (typically) easily lifted up and secured with chains (usually welded right to the paver).

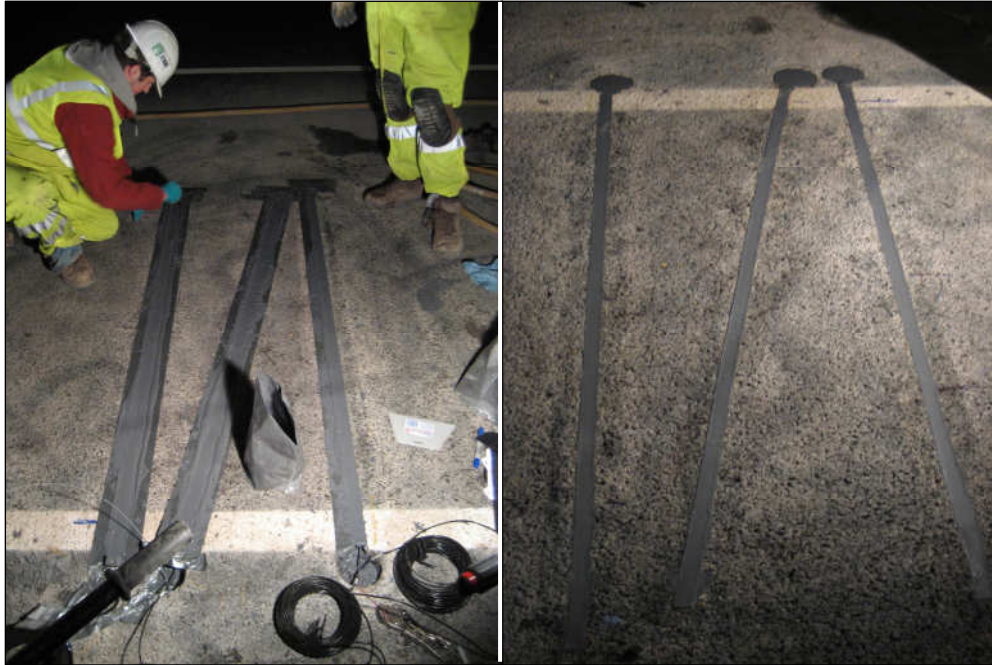
Figure 2-16 - Left: All three wheel-wander sensors have been installed and the grout on the final sensor is being leveled with the pavement surface before hardening. Right: All three sensors installed with the tape removed.

One bag of grout was thoroughly mixed using a cordless drill and mixing paddle. The hardener was introduced and the grout was mixed again for three to five minutes. The slot was filled about half full with grout. The sensor was carefully lowered into grout being cautious that no voids would form between the sensor and grout. A supplied depth tool was used to further set the sensor to the proper depth within the slot. More grout was added as needed to fill the slot. Any excess grout was struck off with a trowel, finished flush with the surrounding pavement, and the grout was allowed to set and harden as shown on the left in Figure 2-16.

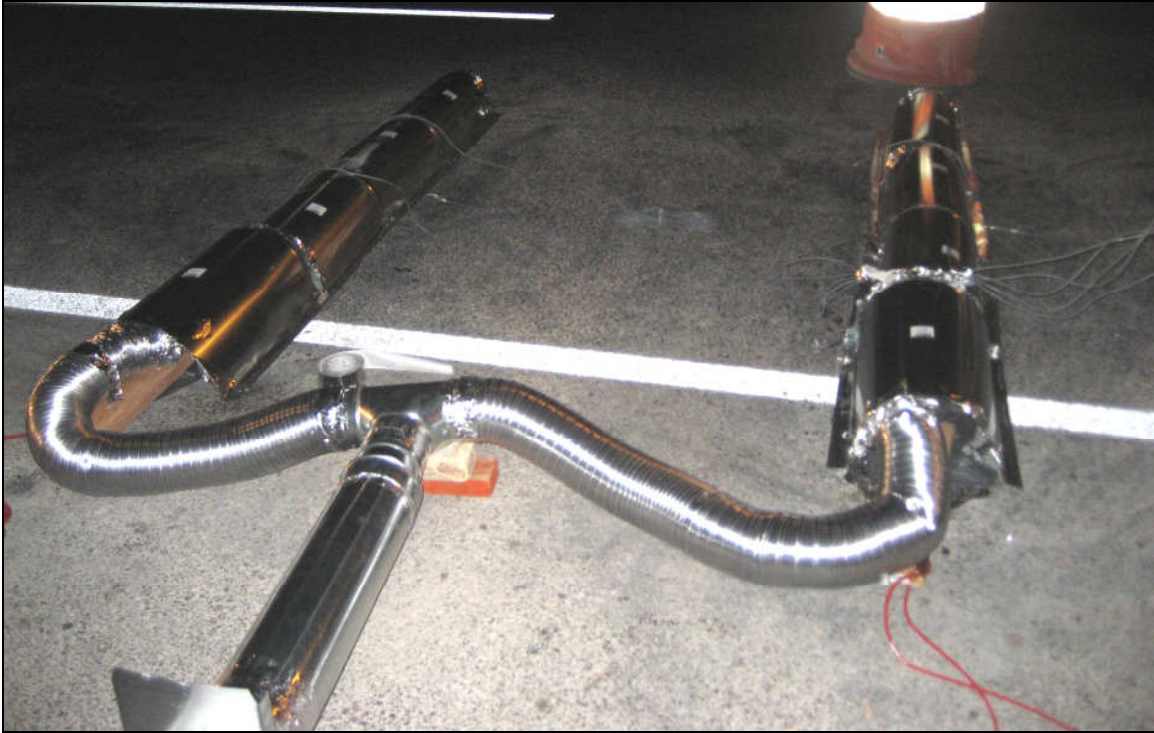
Figure 2-17 - The heating assembly was placed over the two slots cut for the WIM sensors. Heat was supplied by a forced-air kerosene fueled heater (not pictured). The sections of the assembly were sealed with aluminum ducting tape to minimize heat loss. Multiple temperature probes were in place to accurately measure pavement temperatures.

A special heating assembly was placed over the strips to initiate the heating process which is depicted in Figure 2-17. The heating assembly consisted of a series of HVAC ducting and a kerosene force air heater. Round sections of standard ducting from a home improvement store were bent to form a half circle and connected with other pieces of ducting that all came together at one junction. The forced air heater was then placed at this junction and blew hot air through ducting and over the slots in the pavement.

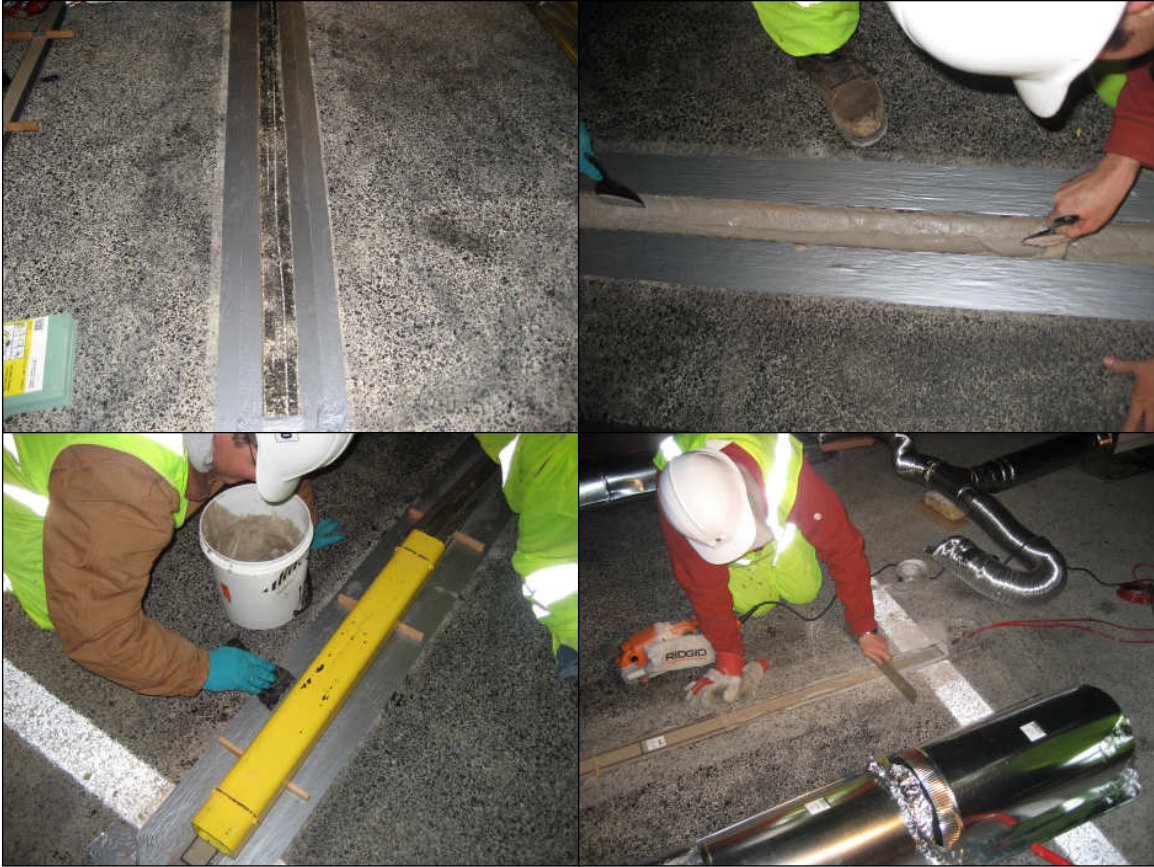
Figure 2-18 - Upper left: Channel for the WIM sensor ready for installation. Upper right: Grout for the sensor being distributed into the channel. Lower left: Sensor in place with pieces of steel placed across the leveling beams to keep sensor from floating out of the grout. Touch up work to the grout was done before its initial set. Lower right: The sensors were ground flush with the surrounding pavement and checked using an 18-inch long straight edge.

Once the hardener and resin had been combined, the grout was mixed for about five minutes or until well mixed. Half of the grout was poured into the channel and was spread around evenly using disposable plastic trowels depicted in Figure 2-18. Some of the grout was pushed up against the walls of the pavement channel making a “V” shape which helps the grout get around the sensor body and also works the grout into the pores of the asphalt surface. The sensor was then carefully lowered into the pavement until the leveling beams sat on the pavement surface. Immediately following, heavy pieces of steel were placed on the leveling beams to keep the sensors from floating out of the grout until it had cured. Plastic trowels were used to smooth out the surface of the grout left between the pavement and the top of the sensor. Because of the cohesive consistency of the grout getting a nice flat finish was difficult, especially after it began setting up. Some parts of the grout were left high and would be knocked down flat with the pavement during grinding.

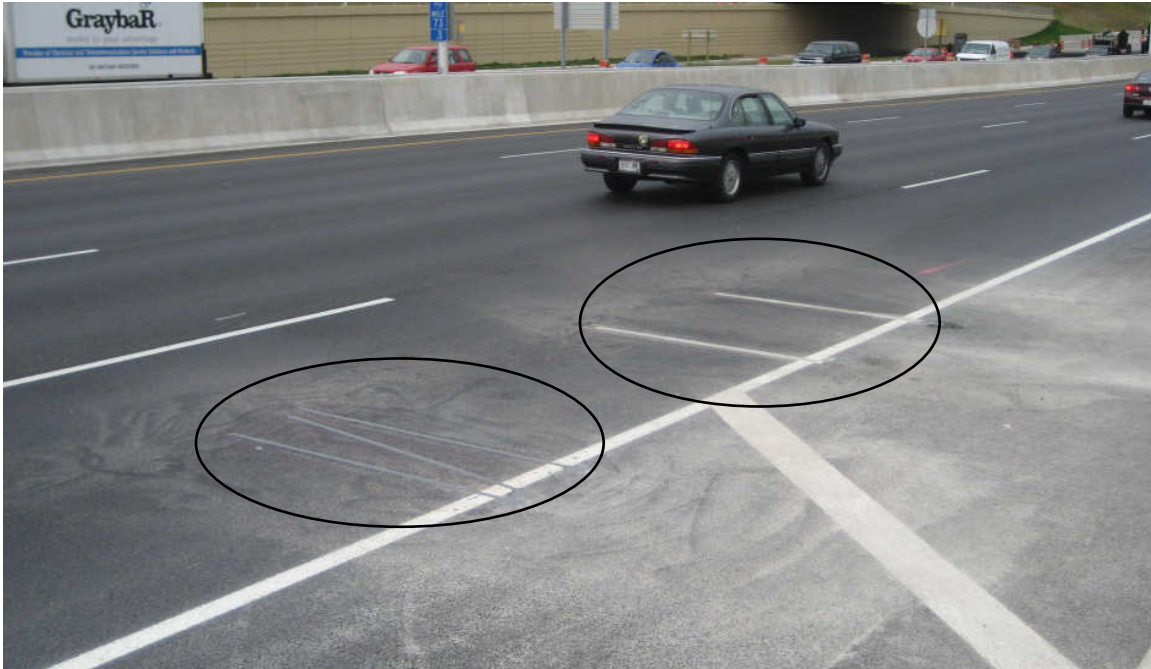
Figure 2-19 – Test section opened to traffic with the wheel-wander and WIM sensors installed (circled areas).

Once the grinding had been completed, holes in the pavement exposing the conduits needed to be filled. Sealant was placed around the wire leads to prevent grout from entering the conduit and the foam placed at the ends of the sensors was also removed. Fast setting grout (leftover grout used for the wheel-wander sensors) was then poured into the holes up to the level of the pavement surface. Voids left in the pavement by over-cutting were also filled. Once the grout was nearing its full strength, the pavement was cleaned up and the highway was reopened to traffic. The finished products (including the wheel wander grid) are shown below in Figure 2-19

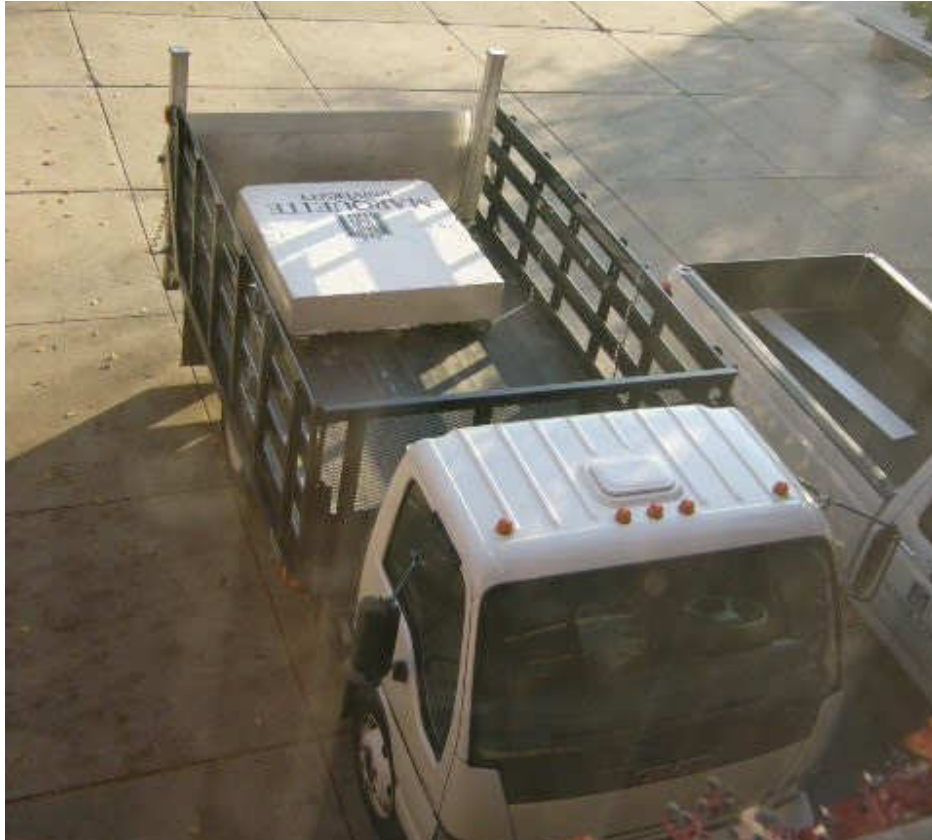
Figure 2-20 - Vehicle used to calibrate the WIM system. Note the concrete slab placed in the bed of the truck over the rear axle.

To calibrate the WIM a flat bed truck was used with a large weight placed in the back as shown in Figure 2-20. The total truck weights were obtained by driving the entire truck onto a static scale and recording the weight and then advancing the truck forward so that only the rear axle was measured. The scale platform was very flat, so this method should be accurate. To obtain individual wheel loads the axle weights were divided in two.

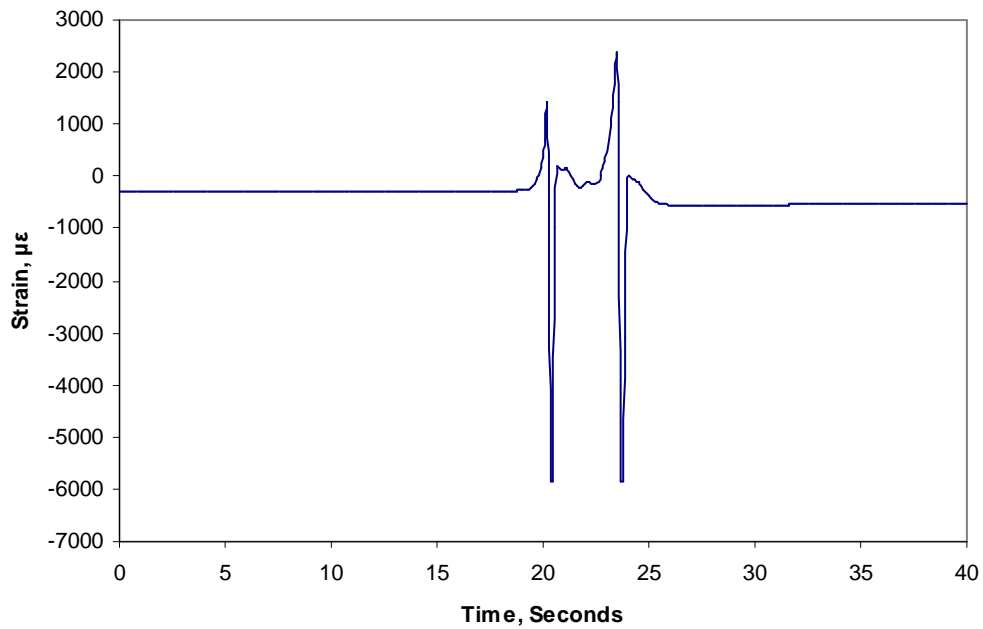
Figure 3-2 – CTL ASG gauge B0 response to roller pass.

The following plots were generated from the rolling operations. Figure 3-1 and Figure 3-2 are examples of gauges that are functioning properly. They both show significant induced strain values, with two peaks indicating the time at which the steel wheel roller passed over the gauges. Figure 3-3 shows the output from the Dynatest C7 gauge which was showing a substantial amount of signal noise.

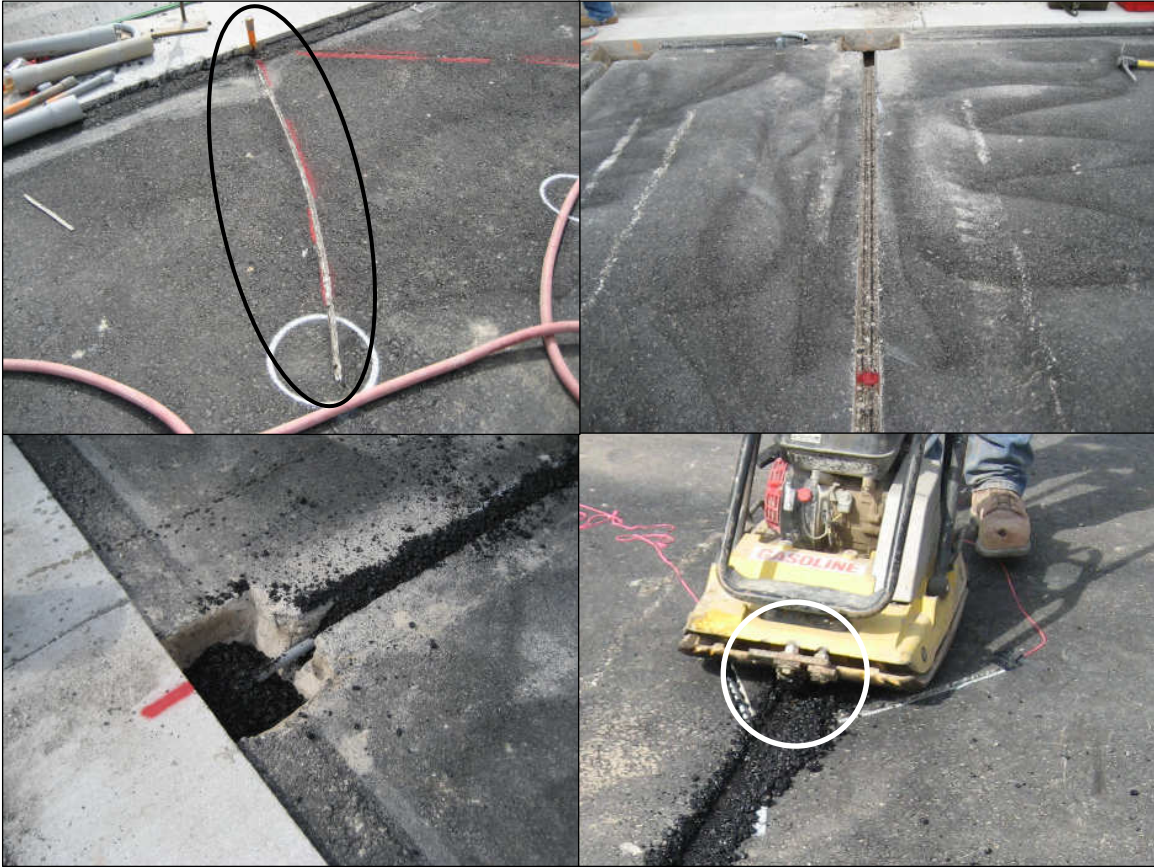
Figure 4-3 - Installation of the WIM, wheel wander, and temperature sensor conduits. Top left: Grooves were cut with a saw for the sensor leads for the pavement temperature gradient probes. Top right and bottom left: Groove cut with conduit in place for a WIM sensor. Bottom right: Asphalt being re-compacted into groove cut for the wheel-wander sensors. The plate tamper had a bolt-on bar (circled) mounted on the bottom to fit into the cut to increase compaction efficiency.

For the two temperature sensors, grooves were cut from the stubbed up conduit at the curb line to the proposed sensor locations. The grooves were cut with a gas powered saw with an abrasive bladed mounted (Figure 4-3 - top left). The grooves were about $\frac{3}{4}$ inch wide and about $\frac{3}{4}$ inch deep, just large enough to accommodate the large diameter sensor leads that would be installed into it plus extra room for sealant to be used to secure the wire. One conduit would house both sensor leads. The holes for the temperature probes were not drilled until they were ready to be installed.

For the WIM and wheel-wander sensors, a much larger groove was needed to house the one-inch diameter conduits. A two-inch wide milling wheel mounted on a skid-loader was used to cut the pavement from the conduits to a location just short of the proposed sensor locations (Figure 4-3 - top right). The pavement around the conduits had

Fresh asphalt was then replaced into the grooves in the pavement as seen in the bottom photographs in Figure 4-3 above. Some areas were compacted by hand using a hand tamper, while most the longitudinal portions of the groove were compacted with a

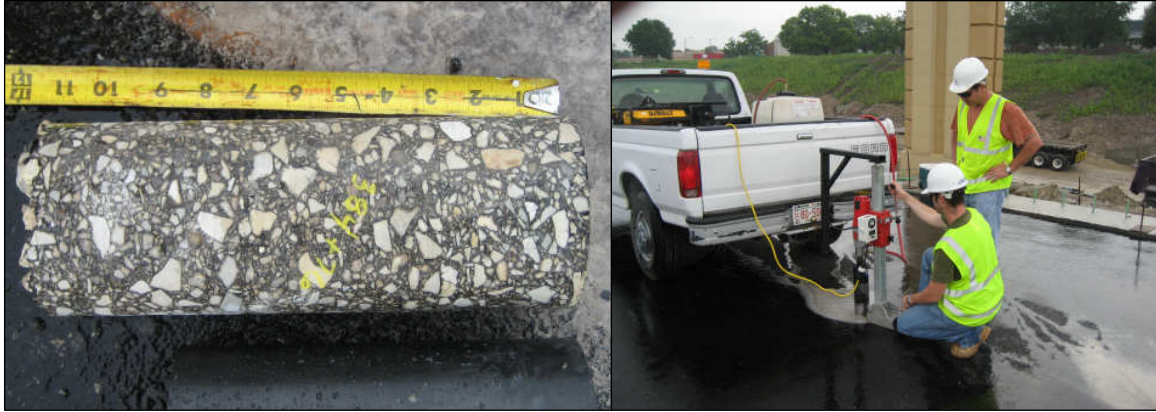
Figure 5-2 – Left: Core sample removed from the pavement. Right: The core-drill was secured against the weight of a vehicle to produce samples with very smooth side walls for possible future testing.

Permission was granted from the guarantor of the pavement to take four four-inch-diameter cores samples, just prior to final of the SMA layer, for future testing and other uses (see Figure 5-2 below). They were taken a substantial distance away from the test section; two taken south of the test section and another two north of the section. Upon removal of one core, the upper pavement layer (upper lift of E30 mix, the SMA layer had yet to be paved) fell away from the rest of the layers. The bond between layers has not been investigated, so the only action taken was to take note of the observation. The core samples were taken back to the lab at Marquette University, preserved by packaging them appropriately, and are currently in storage.

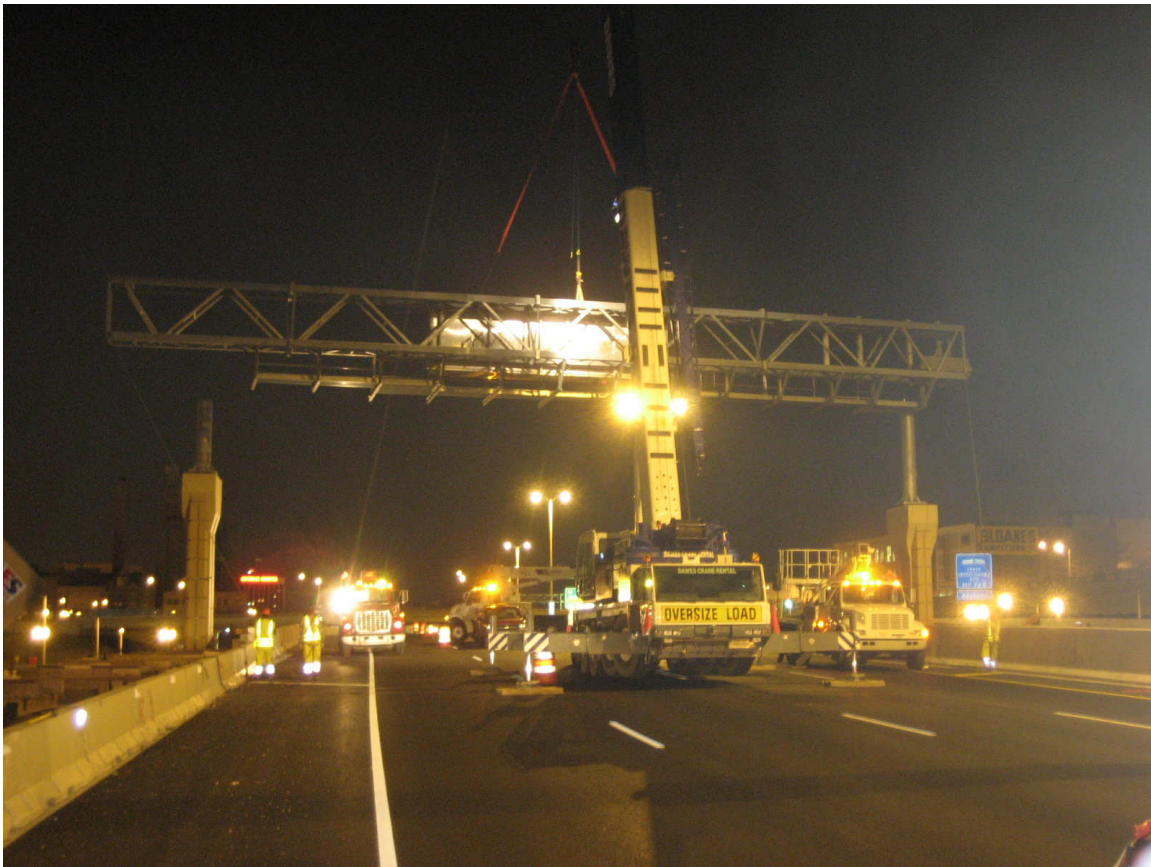
Figure 5-3 - Heavy lift crane lowering the sign bridge into its final resting position. Note that the outriggers for the crane came close to the sensor locations.

shown in Figure 5-3 **Error! Reference source not found.** The physical positioning of the crane and its outriggers on the pavement was unknown, but it was understood that this could potentially damage the surface mounted instruments. The operation was monitored throughout equipment set-up and lifting. The crews were notified of the sensitive pavement and were very cooperative with avoiding the area.
