**LASER INDUCED FLUORESCENCE IMAGING OF
THERMAL DAMAGE IN POLYMER MATRIX COMPOSITES***

E.A. Wachter, W.G. Fisher, and K.E. Meyer
Oak Ridge National Laboratory, Oak Ridge, TN 37831-6113

ABSTRACT

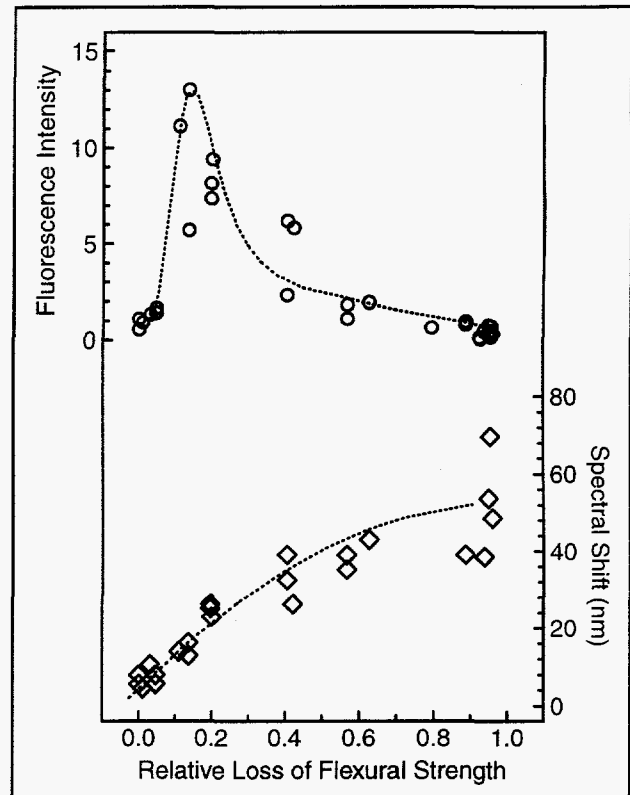
Figure 1. Relationship between damage and LIF response for thermally-damaged PMC coupons (fabricated from DDS-TGDDM epoxy-resin) excited using laser radiation at 633 nm. Upper curve, fluorescence intensity as a function of thermal damage. Lower curve, wavelength of peak fluorescence intensity as a function of damage. Damage was independently quantified using standard ASTM flexure tests.

To quantify the relationship between thermally-induced damage and key spectroscopic parameters, we collected fluorescence spectra from a series of 29 PMC coupons (prepared from Hercules IM6/3501-6 pre-preg tape, each of which were $2.5 \text{ cm} \times 7.6 \text{ cm} \times 0.3 \text{ cm}$ thick) that had been exposed to elevated temperatures for various durations. Wet and dry pre-treatments were used for subsets of these samples. Damage was independently quantified in terms of loss of flexural strength using standard ASTM flexure tests. When spectral properties of this test set are plotted relative to mechanical properties, several interesting correlations are noted (Figure 1). First, fluorescence intensity is found to increase sharply at the onset of thermal damage, reach a maximum value, and finally to drop off with further increases in damage. This sharp increase in fluorescence intensity can be useful for identifying the boundaries of a damaged area. Second, a dramatic monotonic shift occurs in the wavelength of peak fluorescence intensity, which moves towards longer wavelengths with increasing damage. This second factor may be useful in quantifying the degree of damage within a damage zone. This basic trend was observed for all excitation wavelengths and did not depend on the sample pre-treatment.

The results shown in Figure 1 raise a fundamental question – what is being measured in the LIF method? We believe that laser-induced fluorescence provides a sensitive means for probing the structure of the epoxy-resin polymer at a molecular level. When cured at 175°C , three parallel reactions take place in the DDS-TGDDM epoxy-resin system that result in inter-molecular cross-linking and the formation of intra-molecular ring matrices. These complex macro-molecular structures exhibit optical absorption and fluorescence emission over an extremely wide range of wavelengths, spanning ultraviolet to near infrared optical wavelengths. But if this material is heated to temperatures above the service limit, the matrix degrades as a consequence of various oxidation, hydrolysis, and dehydration reactions. As a consequence, the fluorescence spectrum of a heat-damaged specimen consists of a superposition of fluorescence signatures from the original cure products and features attributable to these degradation products. Changes in this “spectral fingerprint” occur as the polymer is irreversibly heat damaged. These changes include variations in total emission intensity and in wavelength of maximum fluorescence intensity. Monitoring these spectroscopic parameters allows both qualitative identification of damage location as well as quantitative measurement of the severity of damage.

The data in Figure 1 can serve as the basis for interpretation of LIF-based imaging. Two-dimensional LIF imaging of heat-induced damage can be achieved using flood illumination of a sample and photographic or videographic collection of the fluorescence emitted from the surface of the sample (Figure 2). We have found it convenient to couple laser excitation light into a multi-mode optical fiber, the divergent output of which is then positioned so as to evenly illuminate the composite specimen. Fluorescence emission from the surface of the specimen can then be collected using a standard 35-mm SLR camera lens, and detected by a high sensitivity video camera. Optical filters mounted on the front of the camera lens facilitate rejection of scattered excitation light. Images thereby produced are easily captured by a personal computer, which can be used to subsequently process image data to improve contrast or to determine emission wavelength characteristics. Using this general approach, images of areas in excess of 1 m² can be easily acquired in approximately one second.

To obtain quantified measurements of thermally-induced damage it is necessary to collect spectral data at multiple wavelengths so that the wavelength of maximum intensity (λ_{\max}) can be estimated. A calibration curve such as that shown in Figure 1 (lower curve) may then be used to convert λ_{\max} into an estimate of the degree of damage. It should be pointed out that no direct correlation to mechanical strength properties of a component can be made with this analysis, since the fluorescence measurement only evaluates the condition of the surface of the composite material, which may or may not be related to integrity of the underlying material – this is an important point since different damage scenarios, ranging from a short burst of extremely high temperature (fire) to gradual exposure to slightly elevated temperatures (thermal cycling), will determine the ultimate depth of damage. However, the relationship shown in Figure 1 implies that fluorescence response can serve as an accurate predictor of the extent of thermal damage. Imaging based on changes in wavelength of maximum fluorescence (or “wavelength shift imaging”) can be achieved by processing a series of images, such as those shown in the left portion of Figure 3, on a pixel-by-pixel basis to produce an image that plots estimates of λ_{\max} for each pixel. Such an image is shown on the right of Figure 3.

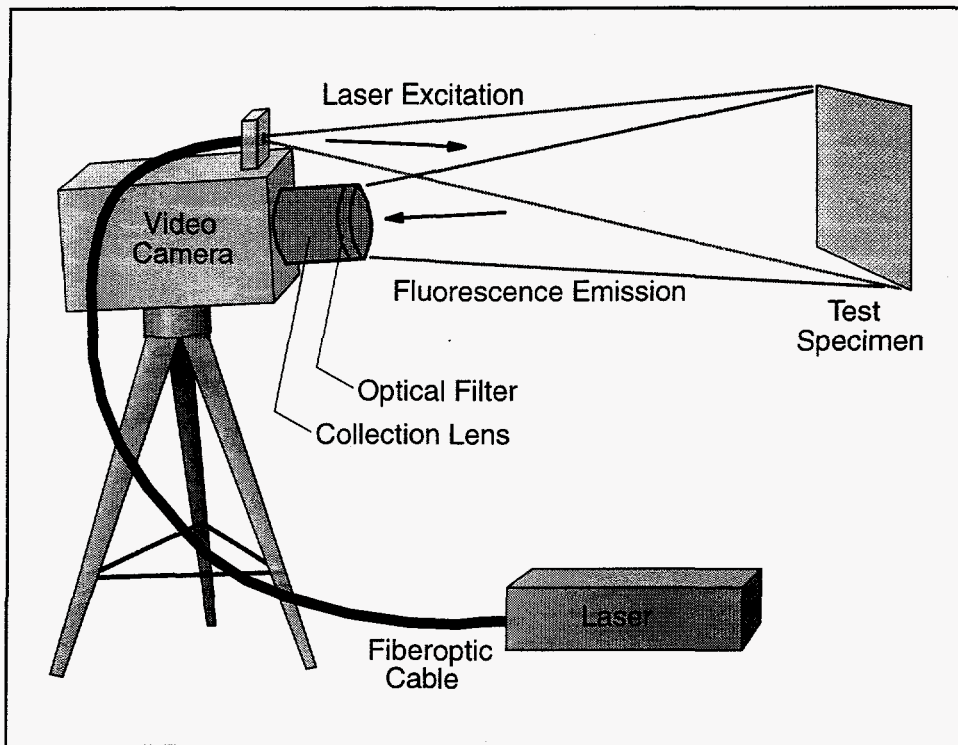
Figure 2. Instrumentation for LIF imaging of PMC's. For intensity imaging, a single image is collected using one bandpass optical filter. For wavelength shift imaging, multiple images are collected using different filters that cover a range of bandpasses.

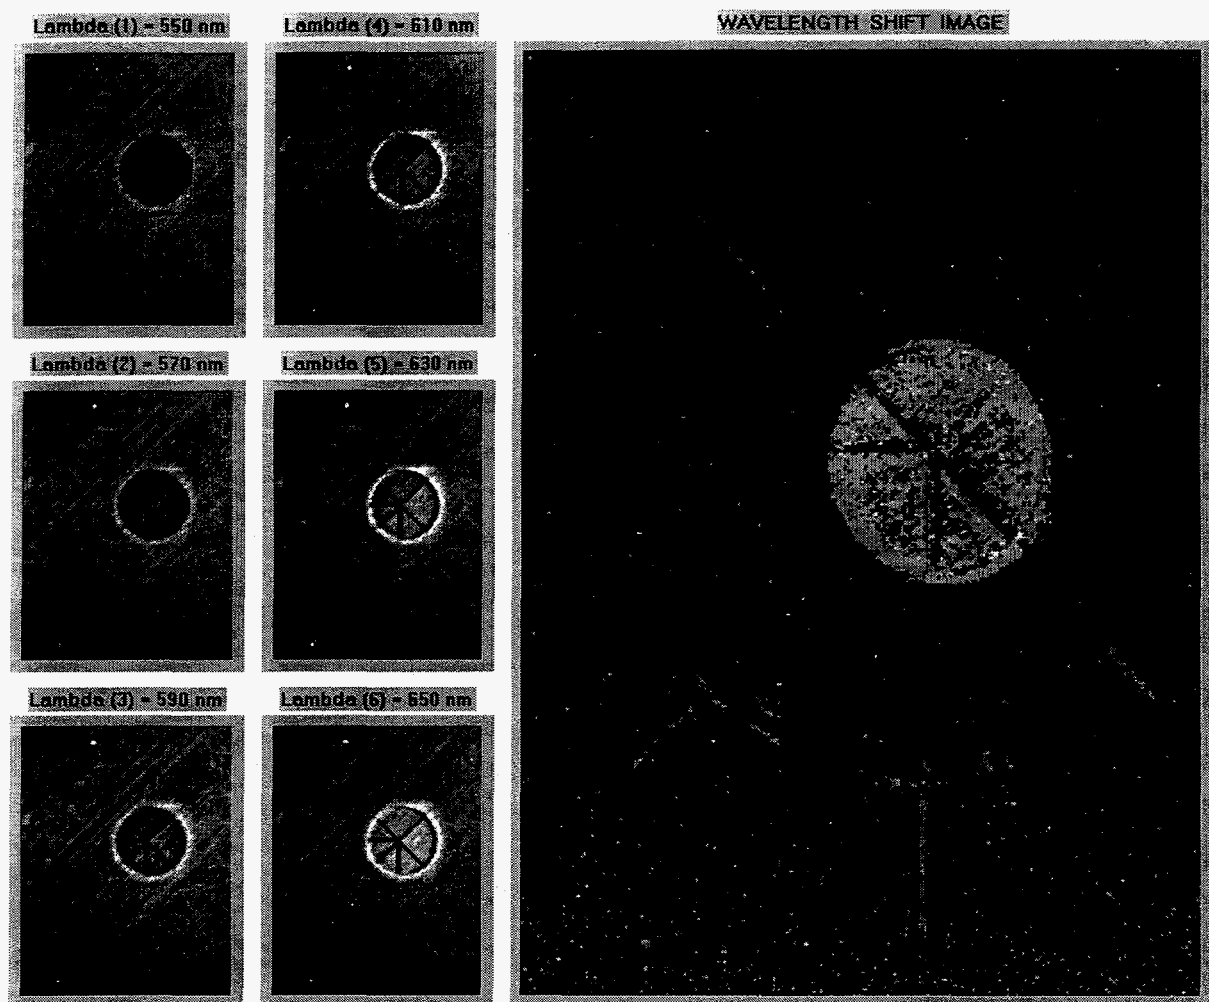
Figure 3. Intensity images (left) and resultant wavelength shift image for a PMC panel exposed to contact heating in the circular zone that is evident in all images.

Typical imaging data is shown in Figure 3, which shows the central region of a panel exposed to 250°C for 30 minutes. The small images on the left show intensity images taken in 10 nm wide bands spaced 20 nm apart (spanning emission wavelength bands from 550 nm to 650 nm, obtained using excitation at 514.5 nm). The large image on the right is a processed image showing wavelength shift (this will be discussed in detail below). Note that each of the individual intensity images in Figure 3 is characterized by a uniform field of resin surrounding a central burn area. Small variations in LIF intensity are observed in this unburned zone (for example, parallel diagonal lines are noted that correspond to the direction of the fiber plies in the top-most layer, while various ink marks on the surface are visible as dark areas). These artifacts are attributable to variations in the amount of resin exposed at the surface, which in turn affects the observed intensity – ink on the surface of the panel masks the exposed resin, producing a dark artifact. In each intensity image, the burn area is surrounded by a ring of bright emission, while the central circle – the area exposed to the highest temperature and presumably experiencing the greatest thermal damage – exhibits a reduced intensity relative to this ring. This unusual pattern can be understood by examining Figure 1. If intensity of fluorescence is measured at a given emission wavelength, the maximum intensity will correspond to lightly damaged material (the condition representative of the maxima in the upper curve of Figure 1), while severely damaged areas will exhibit reduced emission intensity (corresponding to the right side of the upper curve in Figure 1). Since severely damaged areas will always be surrounded by a border of lesser damage (due to the thermal gradient that must exist around the point of thermal exposure), this ring pattern will often be observed in intensity images. Hence the zone of maximum fluorescence intensity can be used to indicate the border between damaged and undamaged material.

The wavelength shift image shown in Figure 3 demonstrates how the various artifacts observed in the individual intensity images are effectively compensated following processing. For example, the intensity artifacts observed in the undamaged zones of the panel essentially disappear in the wavelength image – this is as expected since these features should have no wavelength dependence. In fact, examination of these regions in the six individual intensity images confirms that no significant trends are noted from one emission band to another. The central burn pattern – which shows a progression in relative intensity from 550 nm to 650 nm – produces a uniform, high damage signature in the wavelength image. And the clearly defined ring observed in the intensity images disappears, confirming that this feature is actually indicative of only slightly damaged material relative to the bulk of the panel. Note that the grainy appearance of the wavelength image results from both the small number of wavelength bands used for processing – the small number of possible values for λ_{max} that are plotted (six levels), and that fact that the possible contrast is limited by the wavelength span covered by the intensity image set – to accurately detect extremely damaged material, intensity images further to the red are needed (ie, in the 650-750 nm region). Improved modeling and optimization of filter sets are expected to improve the resolution and accuracy of these wavelength shift images.
