**Metal-Matrix Composites and Thermal Spray Coatings for Earth Moving Machines
Quarter 9 Report**

April 2003

Abstract:

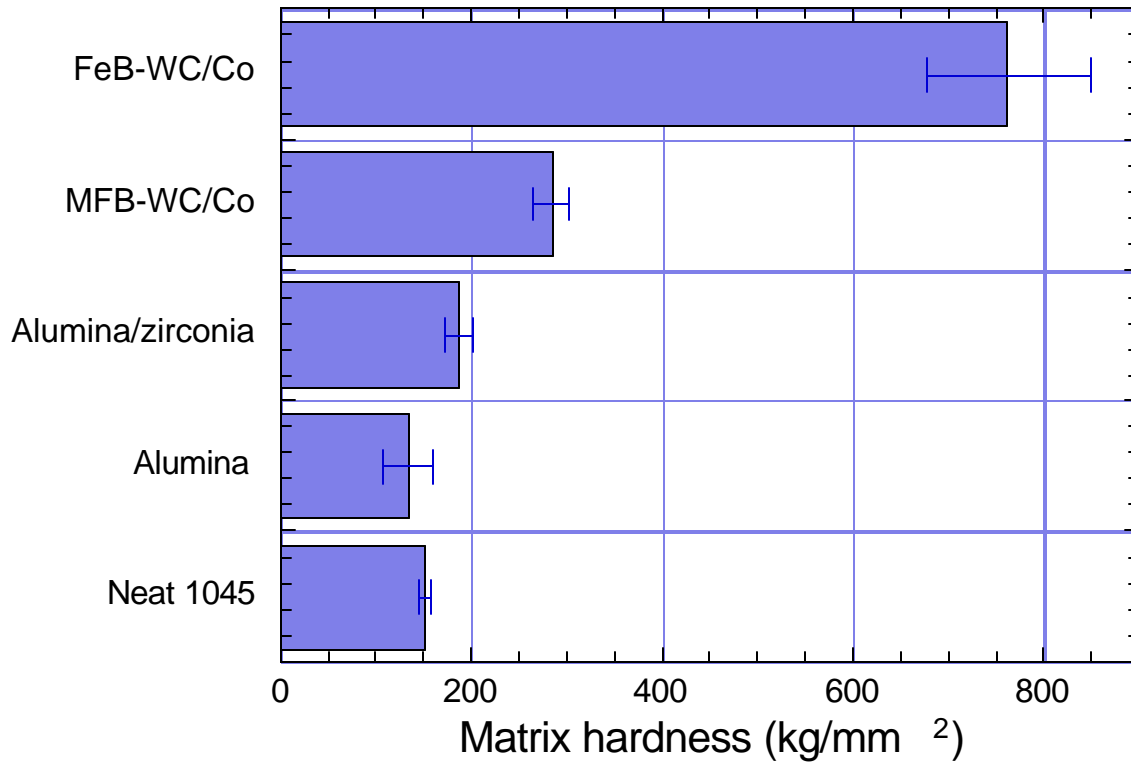
Figure 6 Summary of average matrix hardness within composites and of neat 1045 steel.

The effects of particle dissolution and chemical interactions with the FeB and MFB additions were manifested in significant increases in matrix hardness relative to the neat material (Figure 6). The matrix hardness in the MFB containing materials was about 5 times that of the neat steel; in the FeB material, it was more than twice as high. By contrast, both the alumina and alumina-zirconia containing composites exhibited hardness levels that were the same as that of the neat matrix, within the experimental scatter. This correlation is consistent with the noted similarities in the matrix microstructures.

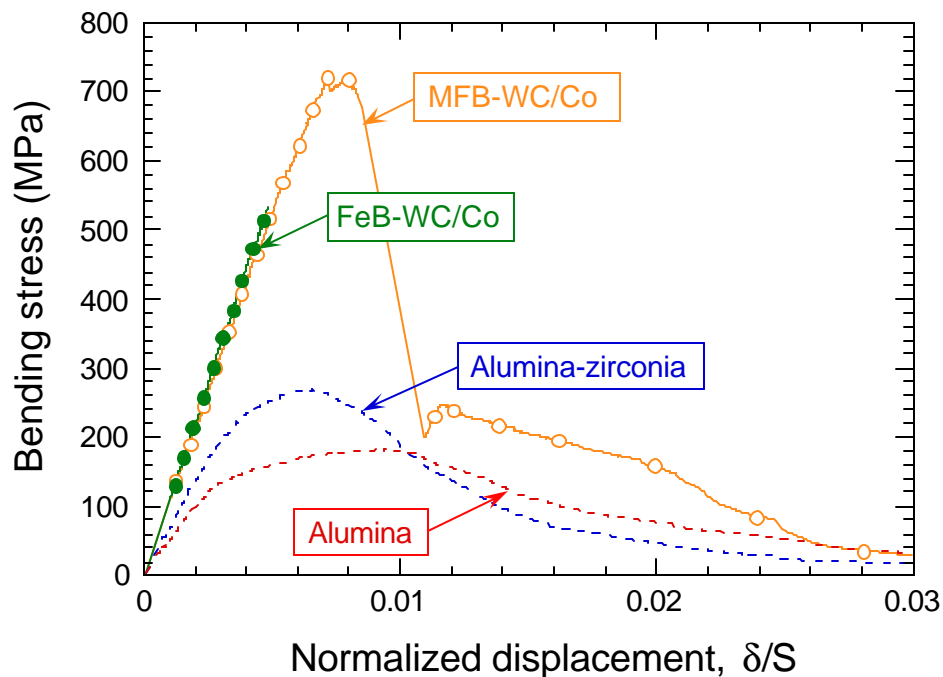
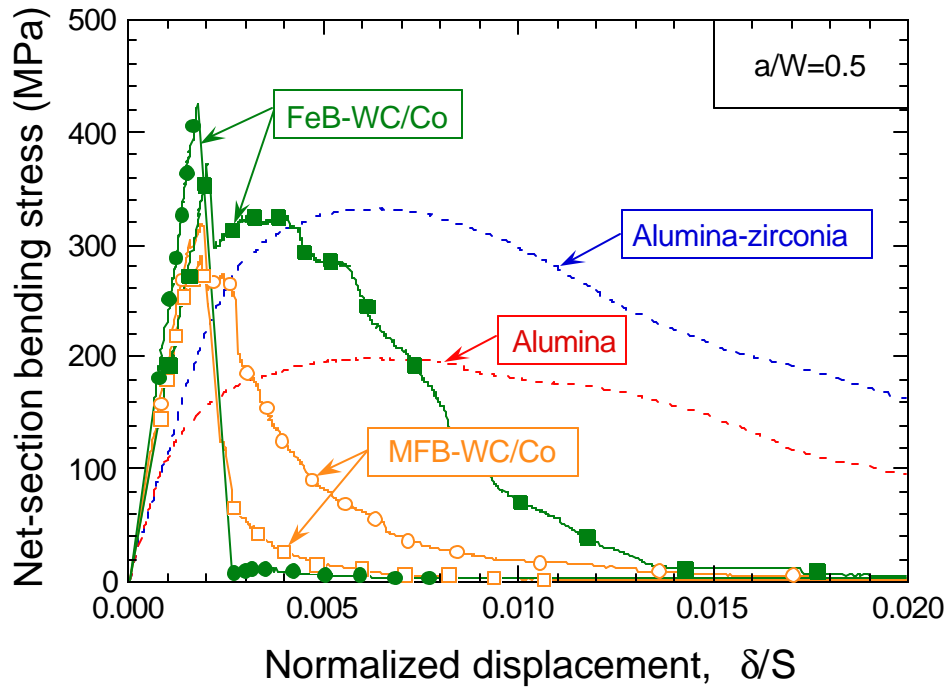
Figure 7 (a) Unnotched and (b) notched bending response of the four composites. (S is span length)

The results from the notched and unnotched bend tests are shown in Figure 7. In the unnotched configuration, the WC/Co composites exhibited high strength (500-700 MPa) (Figure 7(a)). The FeB containing composite fractured catastrophically, whereas the one treated with MFB showed a more significant post load-maximum “tail” in the load-displacement curve. The alumina and alumina-zirconia containing composites exhibited a lower peak stress but a subsequent “graceful” failure.

In the notched condition, the alumina-zirconia material displayed the best performance. Its strength was on par with the two WC/Co composites (300–400 MPa), and higher than that of the alumina composite (about 200 MPa). Furthermore, it exhibited the highest work of fracture: almost an order of magnitude greater than that for the WC/CO materials (Figure 8).

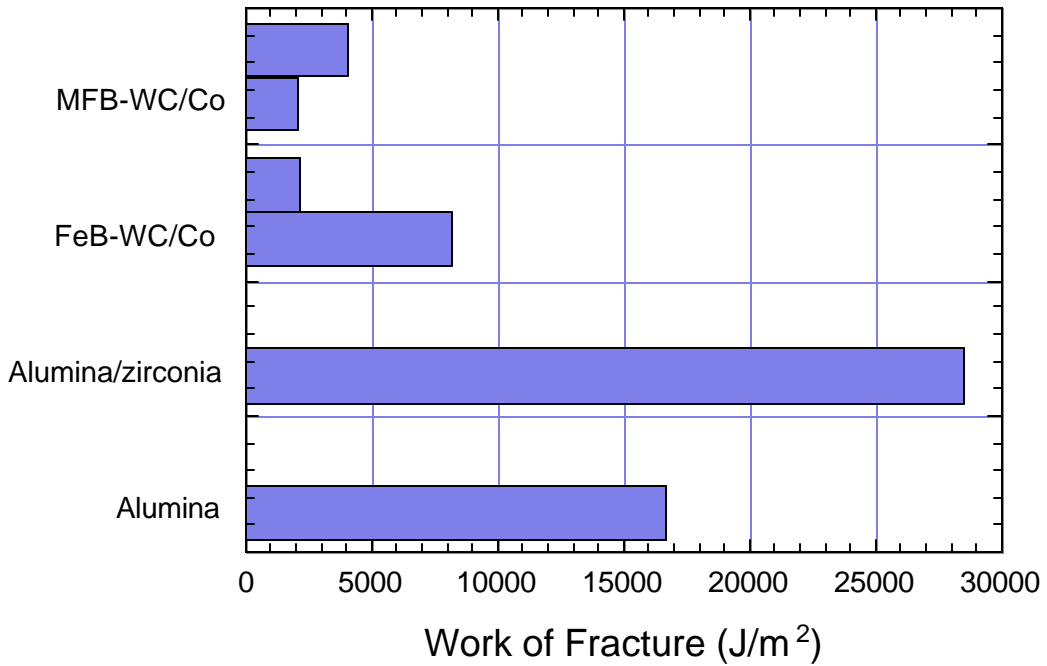
Figure 8 Work of fracture obtained from area under the notched load-displacement curves.

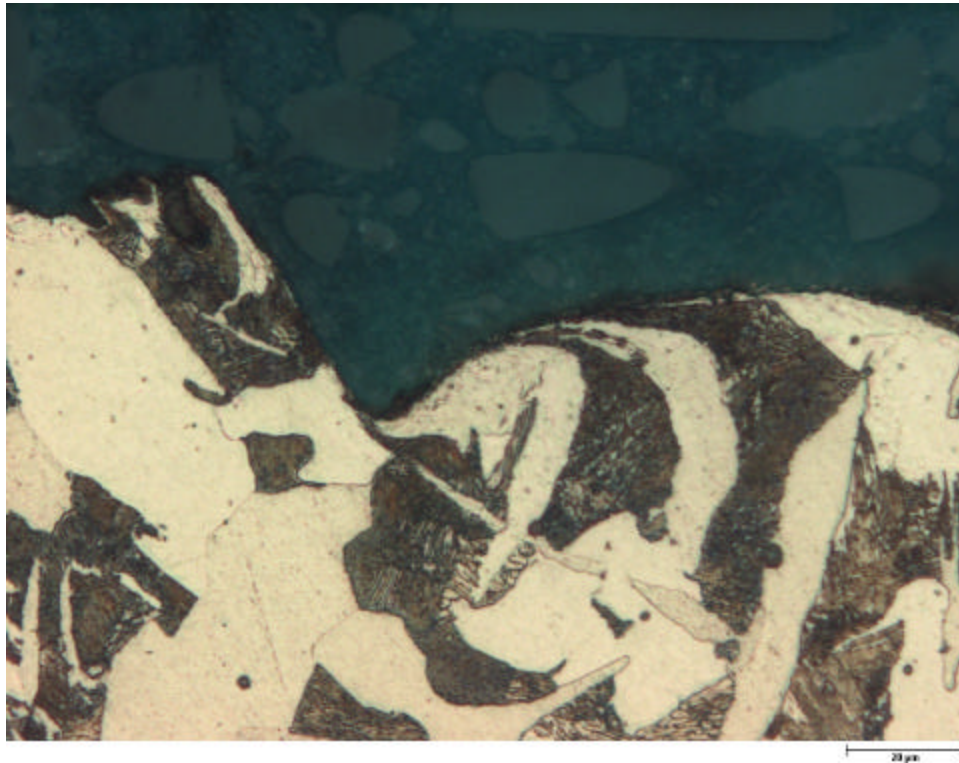
Figure 13 Pin abrasion of neat matrix. (a) SEM image of wear surface showing deep gouges and extensive plastic flow. (b) Optical image of the cross section of a scratch showing localized plastic flow revealed through deformation of pearlite grains.

Abrasive wear results were presented in the Quarter 8 report and a summary of the results is provided again for reference in Figure A3. Figure 13 shows that the neat matrix displayed relatively deep scratches, with material being removed along with the occurrence of a significant amount of plasticity in both the ferrite and pearlite phases (Figure 13(b)).
