Finishing of Precision Generated Metal Optical Components

Phillip C. Baker, John B. Sonderman

August, 1975

This paper was prepared for submission to the
Society of Photo-Optical Instrumentation Engineers
19th Annual Technical Symposium, San Diego, California
August 19-20, 1975

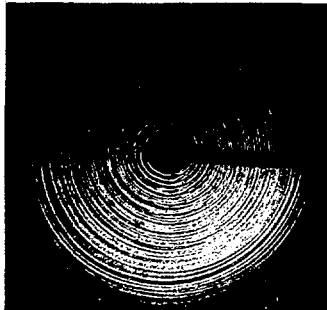
FIG. 5b. Machining marks: By blocking the reference beam the effects of the machining marks present in other interferograms are now more apparent.

The major reason for polishing the copper ellipse was first to remove the effects of the machine marks (Fig. 5a, 5b) which were more pronounced than the marks on diamond turned spheres or flats, then measure the inage and the energy distribution and compare them to the as machined values. (Table 3) (Fig. 6) One of the interesting developments as polishing progressed was that as fringes smoothed out, the wavefront picture became clearer (Fig. 2) indicating the slope errors were hiding the true picture. This finding allowed corrections to be made on the subsequent silver-plated beryllium clamshells.
