Development of a Remote External Repair Tool for Damaged or Defective Polyethylene Pipe

Final Report

Principal Authors:
Kenneth H. Green, Willie E. Rochefort,
Nick Wannemacher, John A. Clark, Kevin Harris

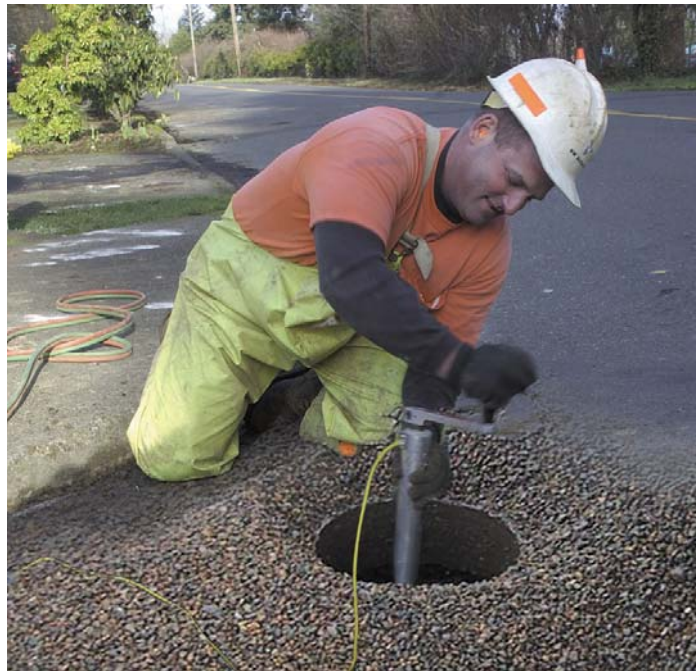
Figure 1: Keyhole Excavation

repair operation and a single excavation. It operates in difficult and keyhole access situations (Figure 1) without the need for pipe squeeze-off.

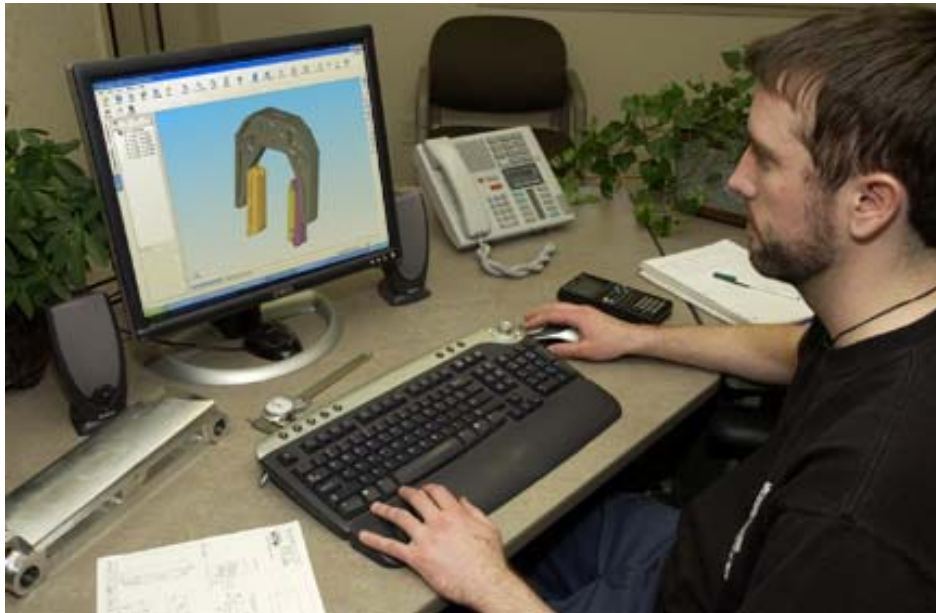
Three mechanical tool configurations were designed. The optimum design was developed using SolidWorks® 3D modeling (Figure 2) to ensure remote operation, keyhole application, and compliance with natural gas industry operating practices.⁶

Figure 2: SolidWorks® 3D modeling of the mechanical tool design

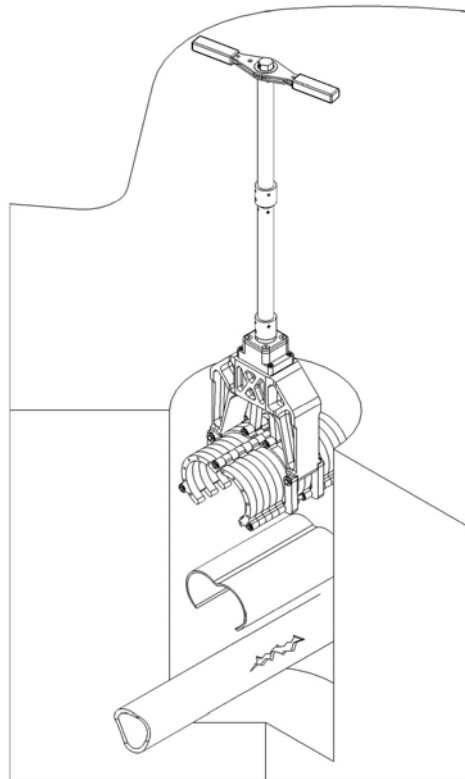
The optimum design concept (Figure 3) was chosen and a test tool was developed and tested in the laboratory to determine functionality, safety and reliability.

Figure 3: Final Test Tool Design

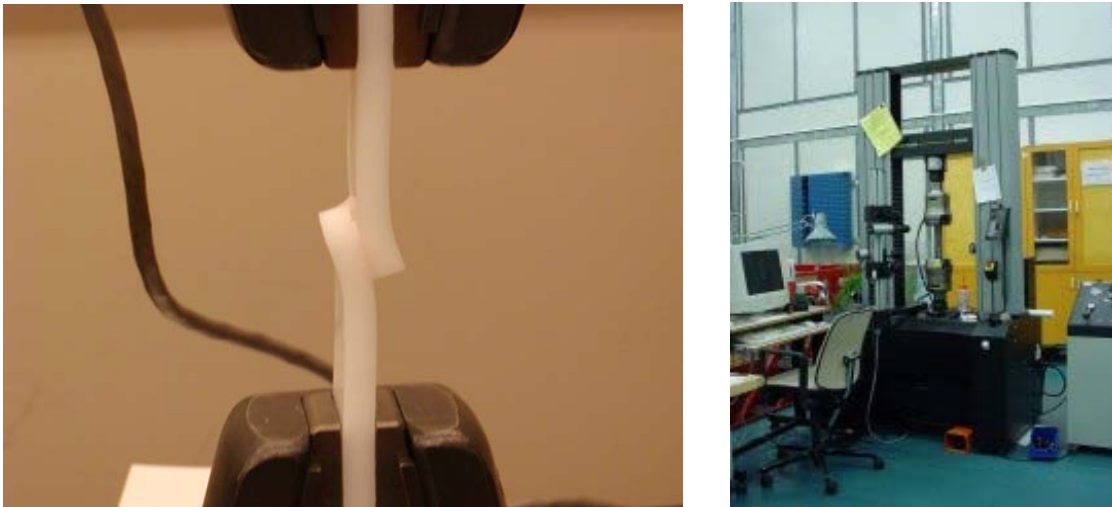
2. PE adhesives: This method utilized structural plastic glues to join the surfaces of the PE patch and the damaged PE pipe. This phase of the research focused on finding an adhesive to bond PE to PE natural gas pipe, which would withstand at least 500 psi (as with the gel concept above). Although many different adhesives were considered, the investigation focused on three structural plastic glues (3M DP8005, 3M DP8010 and Loctite 3030). Glue strength was tested on all three glues with an overlap shear test using an Instron machine (Figure 4).

Figure 4: Overlap Shear Test using an Instron Machine

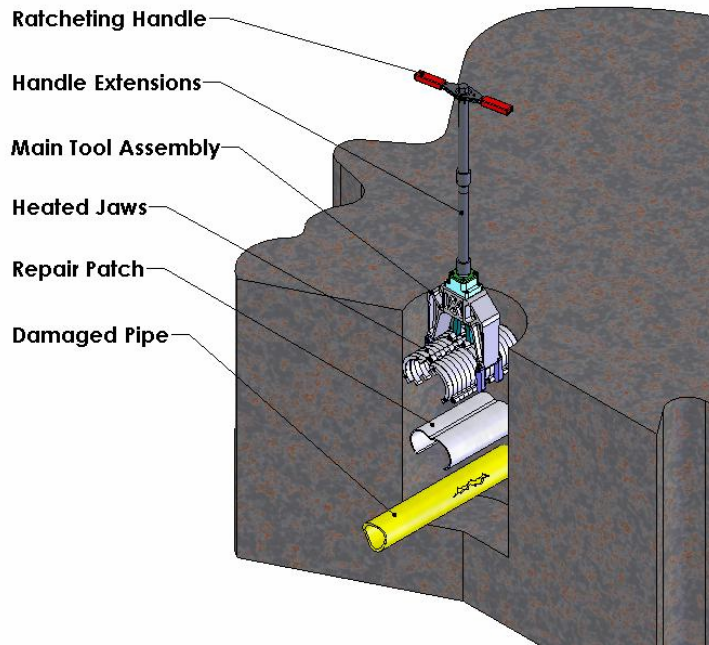
Information from Phase 1 was used to guide the final design of the engineered prototype and the repair patch (Figure 5).

Figure 5: Final design of the engineered prototype for PE pipe repair

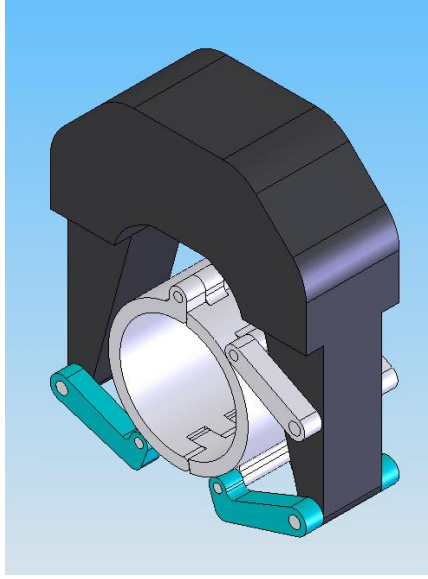
CAD Concept 1 (Figure 8): Solid jaws were incorporated and manipulated by three linkage points. Solid jaws were beneficial in applying constant controlled pressure, but were not favorable for work on more than one pipe size. In order for the tool to apply pressure to the repair patch, a constant downward force and/or the use of loaded springs or cylinders was required. This concept had an asymmetrical closure on the pipe, which could present problems when used in keyhole excavations.

Figure 8: Repair Tool Design Concept 1

This project was performed in two Phases. During Phase 1, various conceptual designs were developed for the mechanical tool to apply the thermo-chemical patch to the compromised area on the PE pipe (Figures 8, 9 & 10). A preferred mechanical tool and repair patch design were selected and laboratory tests (quick-burst tests and sustained pressure tests) were performed on repaired PE pipe sections to determine the overall performance of the test tool, and the quality and adequacy of the repair procedure. In Phase 2, information gained in Phase 1 was used to continue the research on the thermo-chemical repair patch and construct two engineered prototypes. Laboratory tests were performed on repaired PE pipe sections using the same testing protocol and procedures as Phase 1. Specific results and progress are discussed under each task listed below.

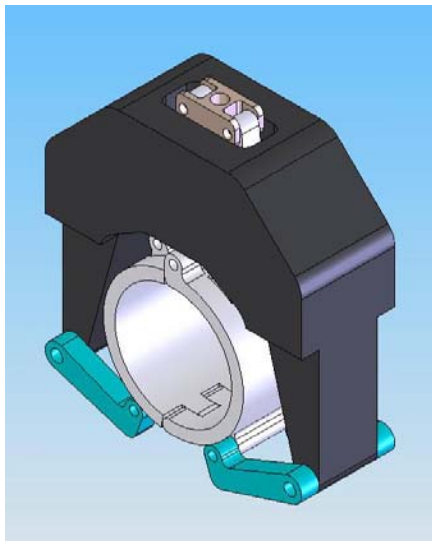
CAD Concept 2 (Figure 9): Solid jaws were incorporated with four linkage points to open and close the jaws. Closure was controlled mechanically by turning a drive thread. This concept provided symmetrical closure on the pipe making it more advantageous than Concept 1, especially for use in keyhole excavations.

Figure 9: Repair Tool Design Concept 2

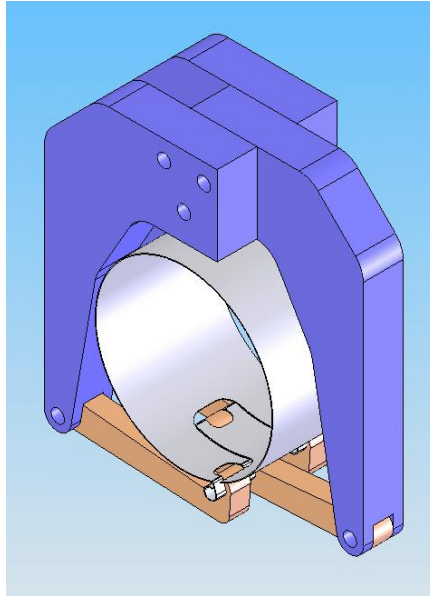
CAD Concept 3 (Figure 10): This concept differed from the other two CAD concepts by utilizing a flexible jaw made from either spring steel or a band heater. Three linkage points wrapped the jaw around the pipe, and with downward force and/or loaded springs applied pressure to the patch. However, the jaw closure did not exhibit as much control as CAD Concept 1 or 2.

Figure 10: Repair Tool Design Concept 3

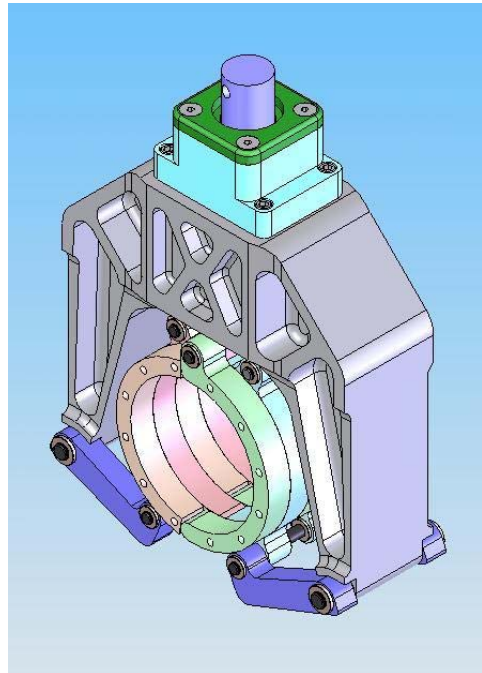
The technical objective of this subtask was to refine the design selected for implementation in Subtask 3.2, and create mechanical drawings needed to manufacture the test tool. The design of the tool (Figure 11) was refined utilizing FEA and CAD, with the following enhancements made to the final tool:

- The dynamics of the tool were reviewed and verified.
- Mechanical stops were added to insure the reliability of the tool.
- The weight of the tool was minimized while ensuring structural integrity.
- The design was reviewed to ensure suitability for manufacturing.
- The jaws were redesigned as layered components and cut using the water jet method to simplify the production process.
- The jaw design was improved to accommodate cartridge heaters and a thermocouple.

Figure 11: Final Test Tool Design

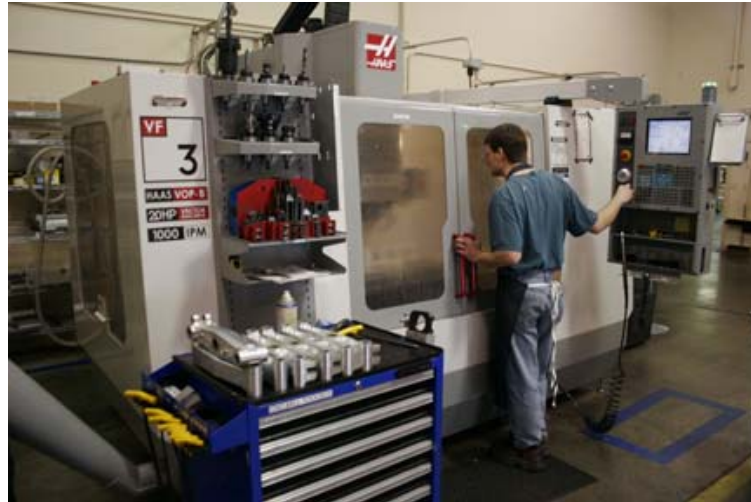
Figure 12: Computer Numerically Controlled (CNC) Machining Center

The preferred design was transferred from SolidWorks® to Computer Aided Machining (CAM) software for virtual machining of each part. The CAM software output a program to manufacture each tool component using Computer Numerically Controlled (CNC) machining centers (Figure 12). The test tool was assembled (Figure 13) based on the mechanical drawings presented in Subtask 3.3. A majority of the mechanical components were fabricated from 6061-T6 aluminum. In-house testing was performed to determine safe and effective operation of the test tool.

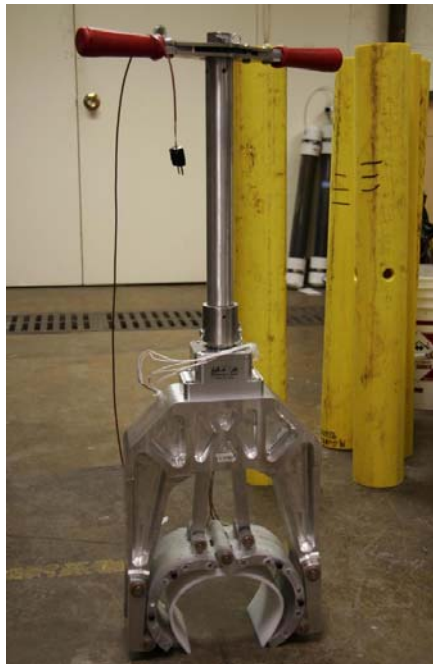
Figure 13: Final Test Tool with Repair Patch

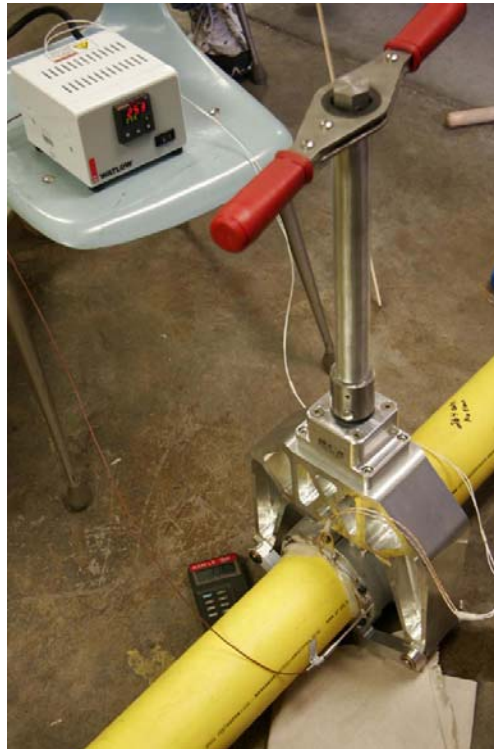
The mechanical design proved successful (Figure 14) during initial functionality testing. A 1-inch hole was drilled into the pipe wall of a 3 ft section of 4-inch IPS SDR 11.5 MDPE pipe to simulate damage produced by a large gouge. This pipe section was used to test the ability of the test tool to successfully apply a thermo-chemical patch over the simulated damage. Little effort was required to fully wrap the PE gel film patch around the damaged area of the pipe. The tool applied adequate constant pressure to the patch. The internally heated (cartridge heaters) jaws heated rapidly and held the temperature at ~257°F/125°C. The repair process was completed in 90 minutes. The initial repaired pipe sample was able to withstand > 450 psig of hydraulic pressure during a quick burst test.

Figure 14: Test tool successful in bonding the repair patch to 4-inch PE pipe

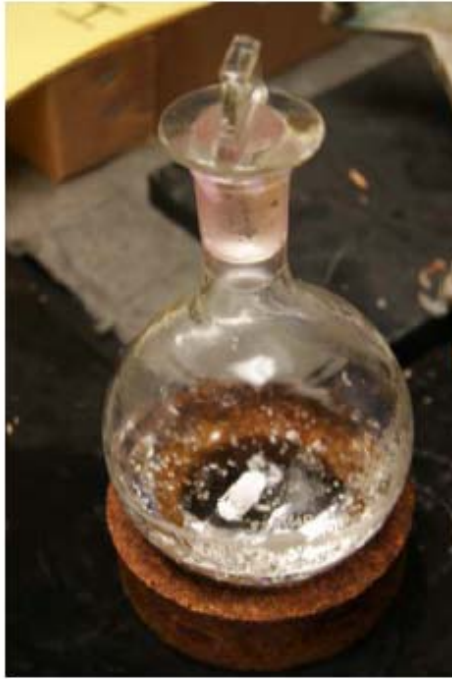
PE gels were researched as a method for adhering PE to PE once the peak strength of the DP8010 was determined. The PE gel produced in this project consisted of an UHMWPE powder dissolved into a solvent (Figure15). Then the resulting mixture

Figure 15: UHMWPE powder dissolved in heated solvent

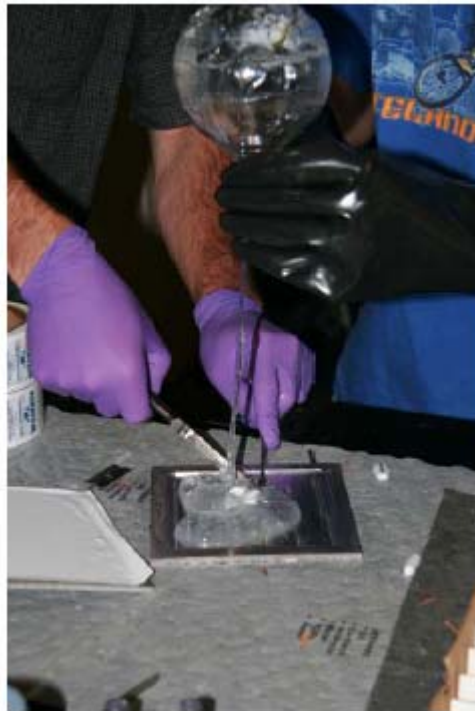
was pressed into a sheet (Figure 16) that consisted of approximately 3-8% of PE (93-98% solvent). This pressed sheet was then dried (Figure 17) to an approximate solvent concentration of 10-20%.

Figure 16: Dissolved UHMWPE pressed into a sheet

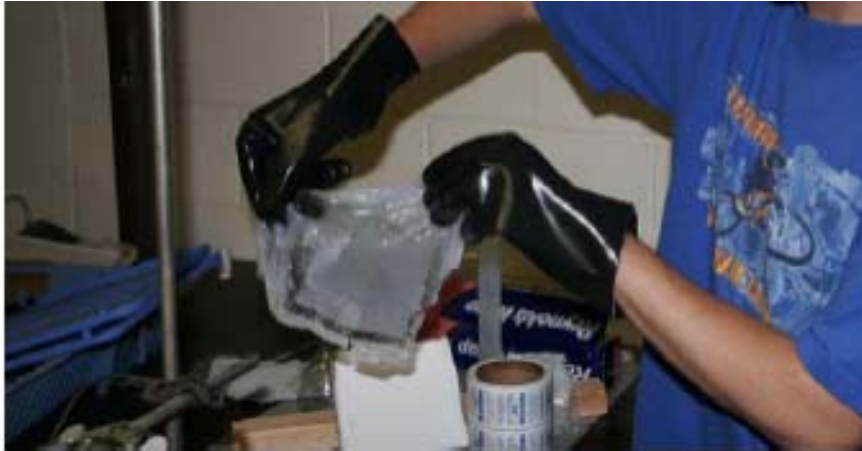
Figure 17: Pressed Gel Sheet

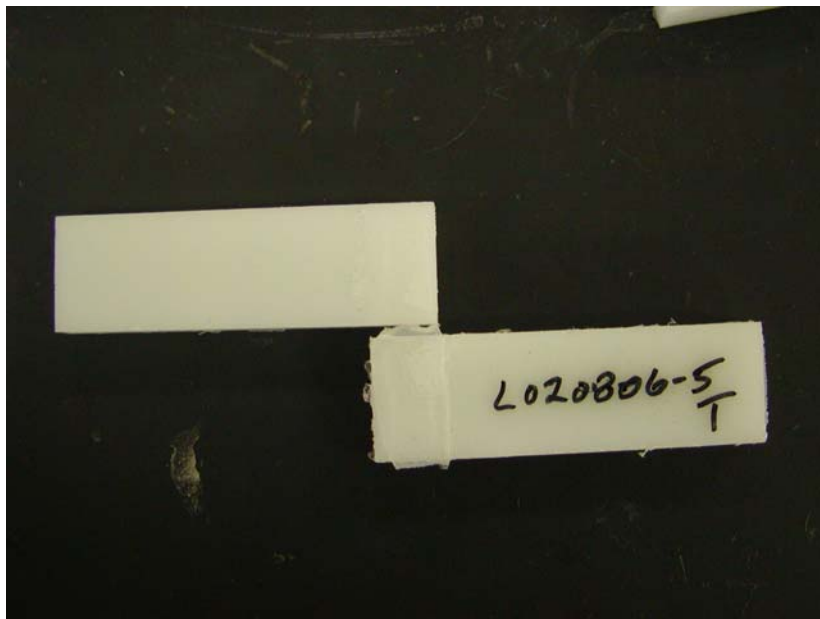
Subsequently, the UHMWPE gel sheet was cut into strips and sandwiched between two pieces of HDPE substrate (Figure 18). The HDPE substrates were bonded using the PE gel in a Carver press (Figure 19) equipped with heated platens. Various scenarios of the lap shear tests were performed varying the test sample thicknesses, pressure of application, and temperature of the platens. All the samples were prepared using a modified version of the ASTM standards D3163, D3165, and D5868.

Figure 18: UHMWPE gel sheet prior to being sandwiched between HDPE substrates

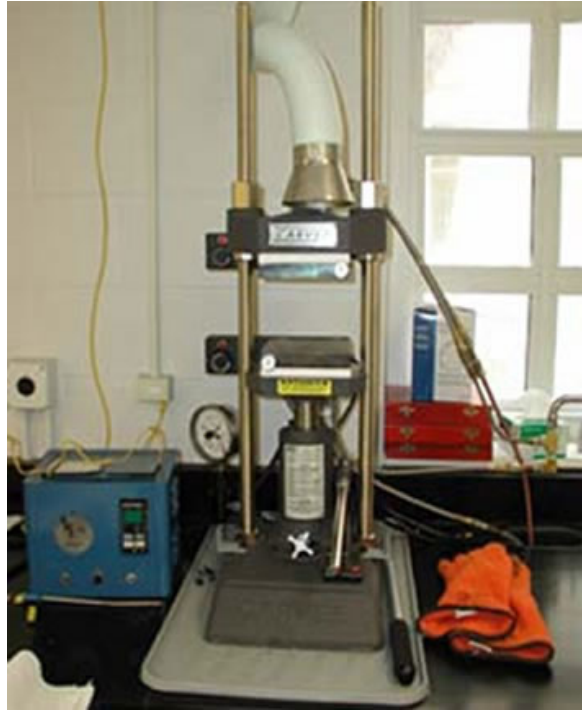
Figure 19: Carver press equipped with heated platens

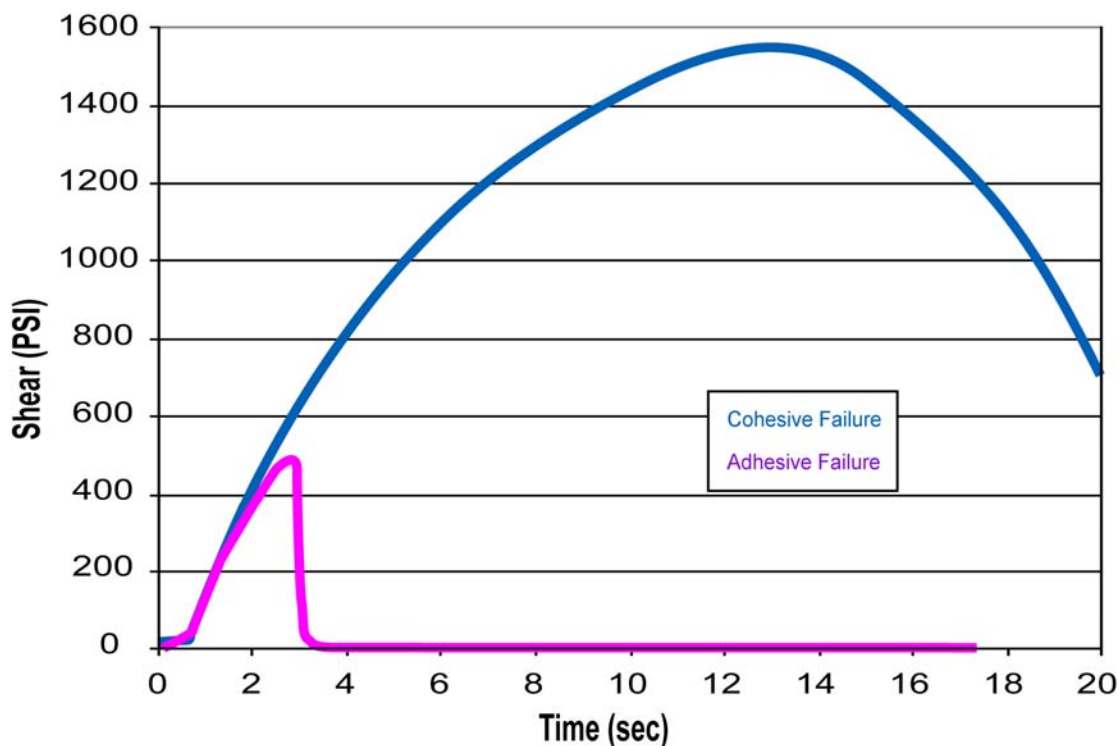
When these PE gel lap shears were tested in an Instron, they exhibited cohesive failures (i.e., the substrate (PE) failed) as opposed to the adhesive failures seen with the DP8010 bonds. A graph showing adhesive vs. cohesive failures during a lap shear test is shown in Figure 20.

Figure 20: Graph of cohesive vs. adhesive failures during lap shear tests

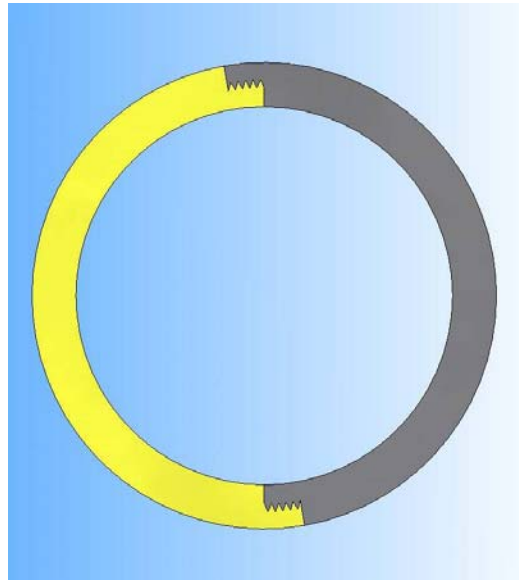
Figure 21: Overlapping half-wrap patch design concept

- d. Overlapping Half-Wrap Patch – a broad category of patches in which two half section patches were placed on opposite sides of the pipe and overlapped on both ends to provide support for the hoop stress (Figure 21). Several potential configurations were investigated:

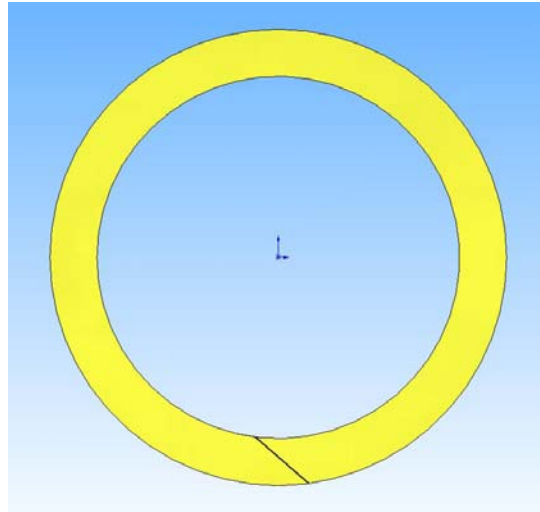
- e. Overlapping Full-Wrap Patch – a hybrid of the above concepts in which a single full-wrap patch was placed around the pipe and overlapped on the

ends (Figure 22). A full-wrap patch substrate was pre-formed to fit inside the open jaws of the repair tool (see Figure 23). Once the tool was placed over the pipe, the patch assembly was molded to tightly wrap around the pipe and overlap at the tapered joint.

Figure 22: Overlapping full-wrap patch design concept

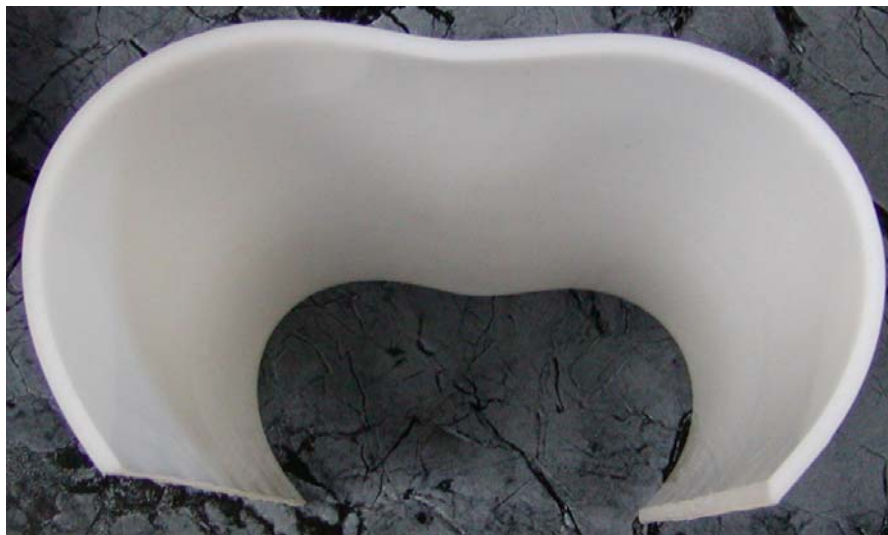
Figure 23: Preformed overlapping full-wrap patch

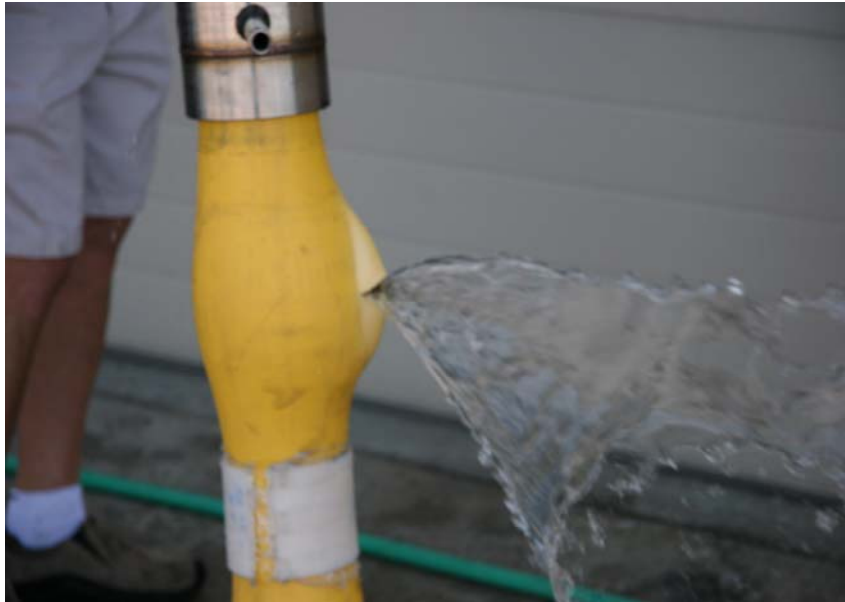
Pressure tests were performed on repaired 4-inch MDPE pipe samples obtained during the test tool performance tests in Task 4.4 to determine how well the PE adhesive, PE gel and PE gel film patches adhered to the pipe surface. The initial pressure tests conducted were quick burst tests performed by raising the hydrostatic pressure in the patched pipe to 600 psi over a short time period (1-5 min) and held until the repaired pipe failed (Figure 24).

Figure 24: Successful bond of PE gel patch to 4" MDPE pipe at 600 psi during quick burst testing

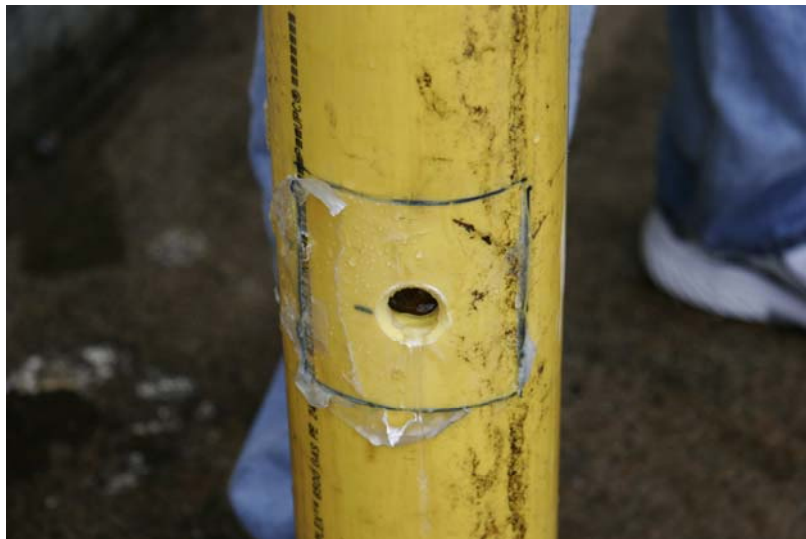
Figure 25: Failure of adhesive patch during quick burst testing at 450 psi

All the quick burst tests performed on the repaired PE pipe samples using DP8010 commercial adhesive patches resulted in patch bond failures between 250 psi and 450 psi (Figure 25). The PE gel and PE gel film patches, however, resulted in many successful quick burst tests where the pipe failed at locations away from the patch (Figure 26).

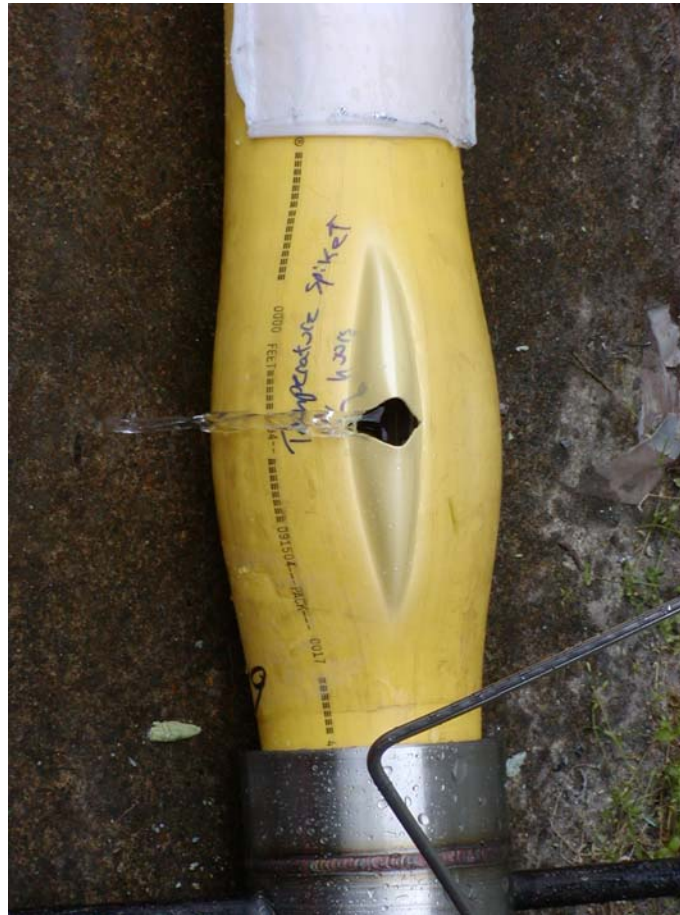
Figure 26: Quick burst test shows pipe failure below PE gel film patch – Indicative of successful bonding

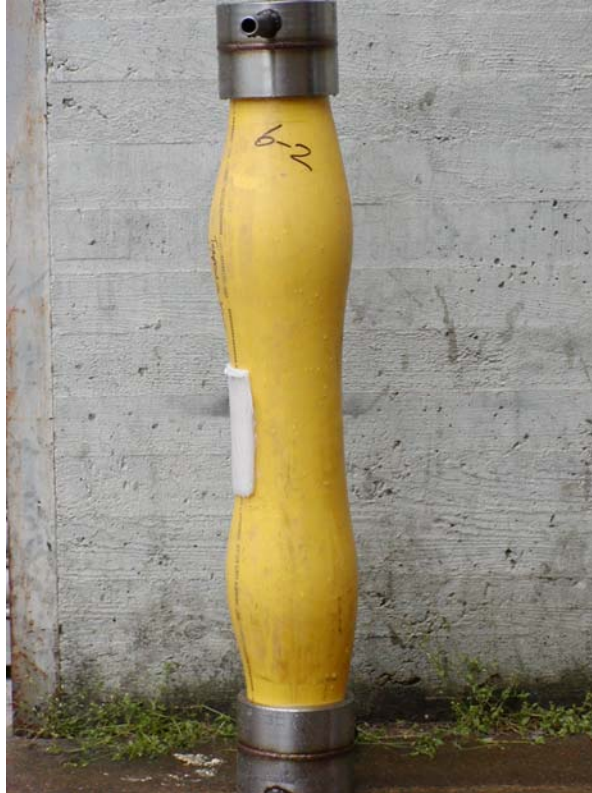
During initial quick burst tests, it was observed that the pipe seemed to be reinforced for hoop stress in the vicinity of the patch, even if only a half patch was applied (Figure 27).

Figure 27: Pipe sample repaired with half patch showing hoop stress reinforcement

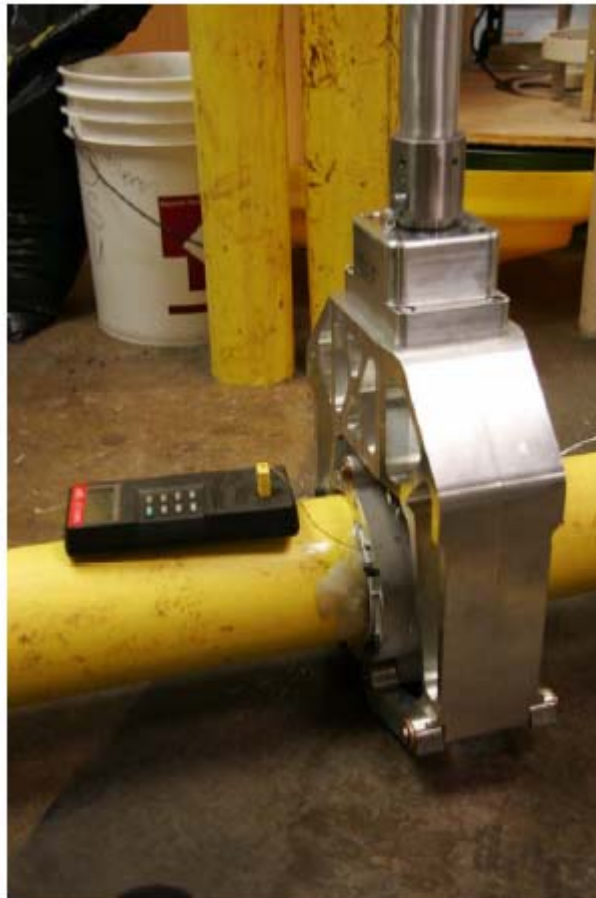
At demonstrations performed for Northwest Natural Gas field crews in Portland, Oregon on February 25, 2005 (Figures 28 & 29), a thermo-chemical PE gel film repair patch (developed in Task 4.1) was applied over a 1-inch diameter hole drilled into the wall of one 4 ft section of 4-inch IPS (SDR 11.5) MDPE pipe pressurized to 45 psig. The repair patch was applied using the test tool developed during Phase 1. The repair patch successfully bonded to the pipe under pressure. Subsequently, the repaired pipe sample was sent to OSU for quick burst testing as reported in Subtask 5.1. The test tool was also successfully demonstrated to DOE/NETL project managers at Timberline Tool facilities in Kalispell, Montana on July 13-14, 2005 (Figures 30 & 31).

Figure 28: Overlapping full-wrap patch applied to 4-inch MDPE pipe during demonstration for Northwest Natural

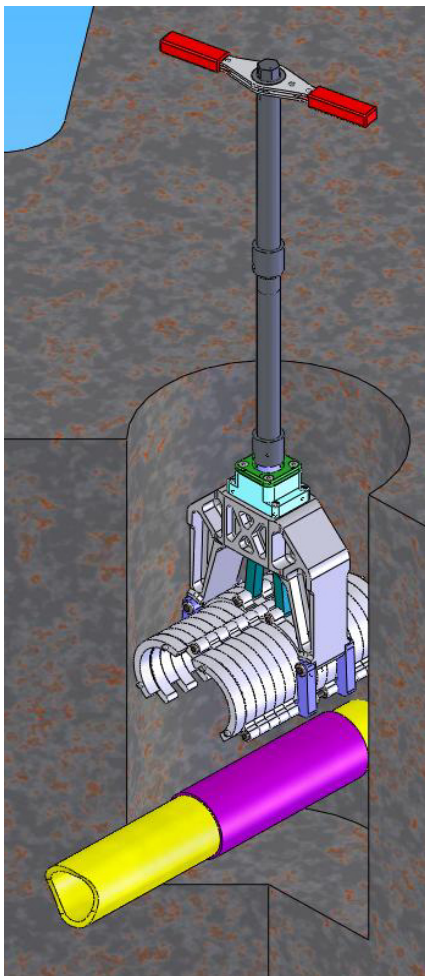
Figure 32: Engineered prototype design shown with 12-inch jaws

- The jaw components were redesigned to cover a section of pipe 12 inches long in order to repair the majority of damaged pipe (small nicks as well as large gouges), (Figure 32).
- The internal cartridge heaters were redesigned to accommodate the extension of the jaws.

The preferred design concept of the engineered prototype was 3-D modeled and a prototype was constructed of 6061 T6 aluminum. A series of functionality tests were performed to validate the design changes detailed above. The engineered prototype applied a full wrap PE gel film patch to 4 damaged sections of 4-inch MDPE pipe samples. The pipe samples had simulated damage as follows: (1) Three 1" holes drilled into the pipe; (2) 1/2" x 6" cut in the pipe; (3) 1/16" x 6" slit to simulate SCG; and (4) 3" x 6" rupture. Results of these functionality tests validated the design changes that were incorporated in the engineered prototype. The engineered prototype utilizing heated jaws was successful in applying a full wrap PE gel film patch to all pipe samples tested.

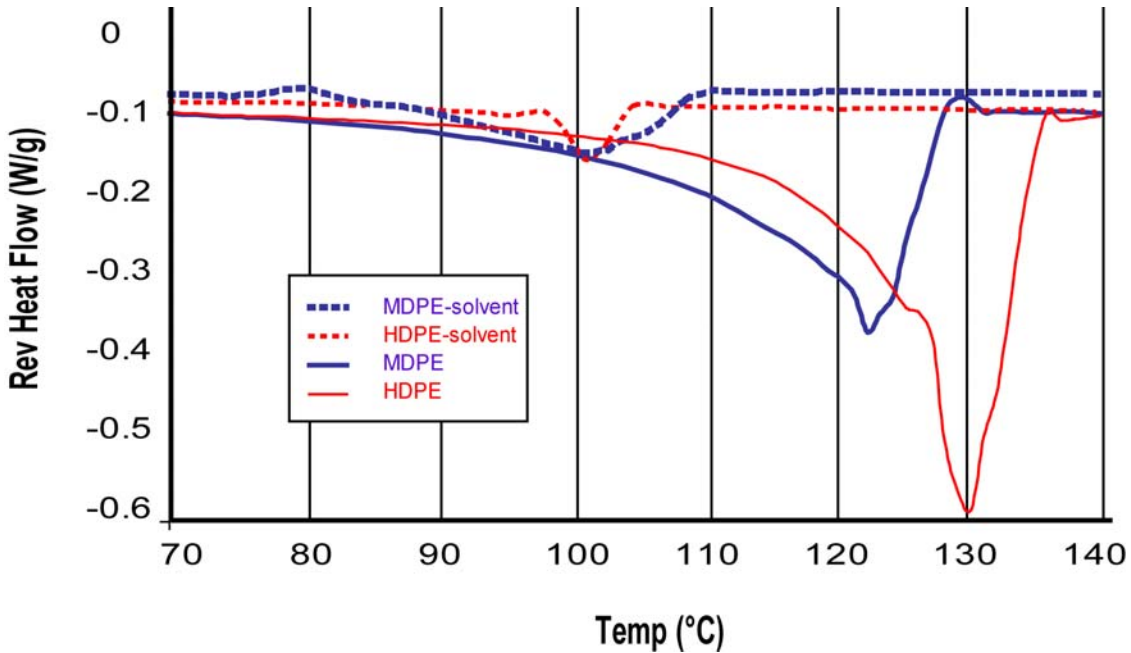
Figure 33: Differential scanning calorimetry curves of virgin PE vs. PE with solvent shows the effect of solvent on lowering the melting point of PE

Differential Scanning Calorimetry (DSC) of PE, in the presence of the solvent, showed an effective lowering of the melting point of both MDPE and HDPE (Figure 33). Lowering the melting point allowed for fusion welding to take place at the substrate-film-substrate interface without significantly diminishing the overall strength of the bulk of the substrate polymers during the bonding process. PE gel films reached their peak strength with a cure temperature of 230°-248°F/110°-120°C. It was vital, however, to have enough solvent in the PE gel film (or PE gel) to allow the solvent to affect both substrate surfaces during the cure process.

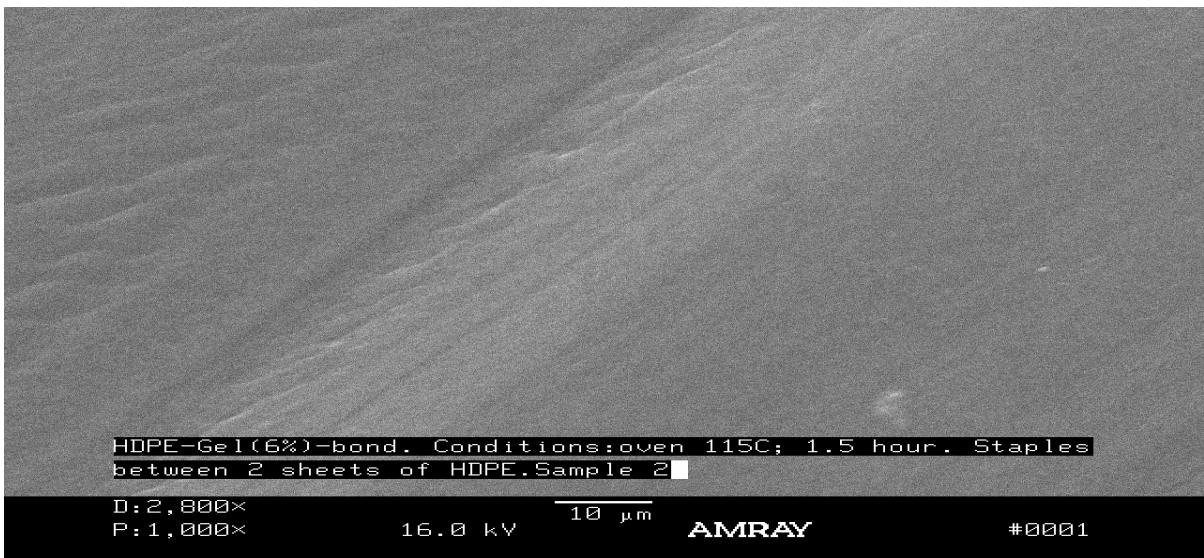
Figure 34: SEM micrograph showing uniform PE bond interface

Another indication that the bonding mechanism was successful is shown by a scanning electron microscopy (SEM) micrograph of the bonded area (Figure 34). From this SEM micrograph, a uniform area was seen with no defined layers. This uniform bond area indicated a seamless fusion of the two substrates.

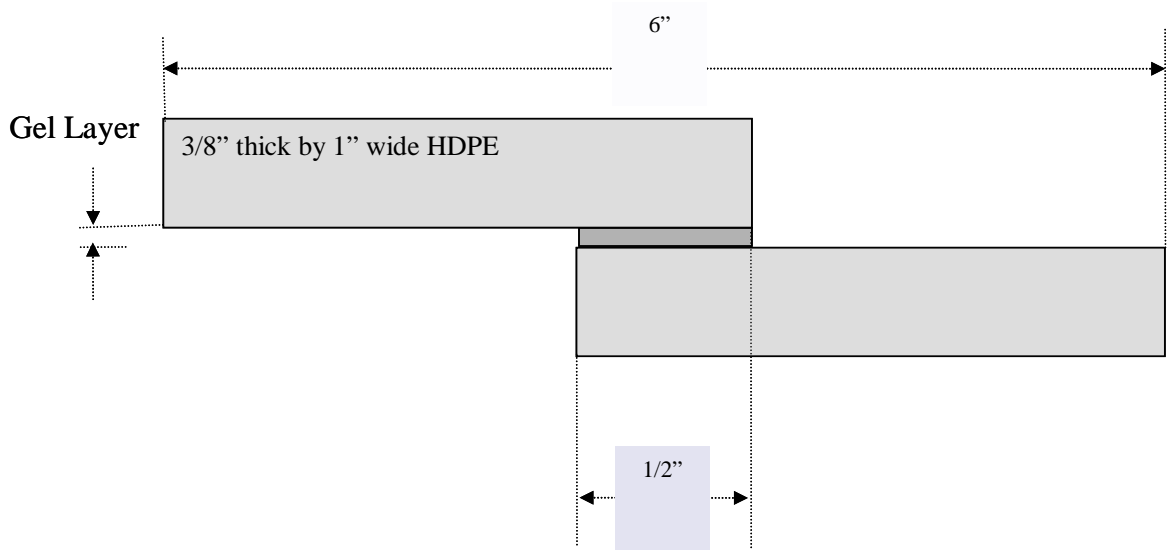
Figure 35: Diagram of lap shear sample design

Lap shear samples were designed to test the bond strength of the PE gel or PE gel film bonds (Figure 35). The lap shear samples were then pulled at a rate of 1-inch per minute to test the strength of the bonds (early work samples were pulled at 1/2-inch per minute). The major variables affecting bond strength were time, temperature, and pressure. For these tests, the platen pressure was maintained at 20 psi. The polymer fusion process required just enough pressure to keep the substrate-film-substrate in firm contact since lower pressures resulted in air gaps, and higher pressures squeezed out the gel layer, both of which resulted in inferior bonds.

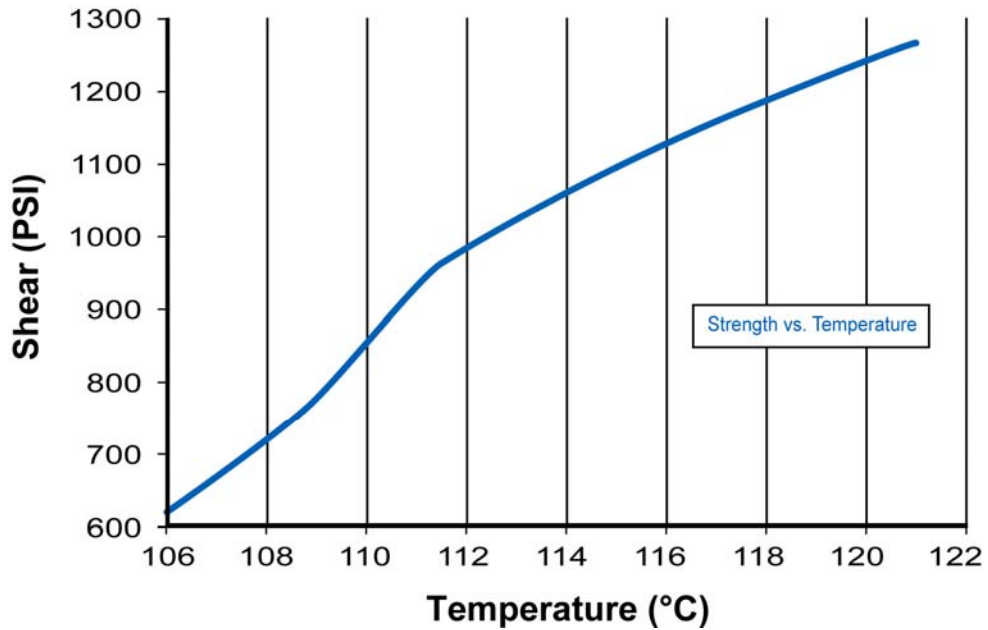
Figure 36: Graph of bond strength as a function of bonding temperature

Temperature experiments were performed with a total cure time of 90 min. For these tests, the lap shear samples were produced at a temperature range of 223°-248°F/106°-120°C. The curve of these points is shown in Figure 36. As expected, in this temperature range, the strength of the bond increased almost linearly as the temperature increased.

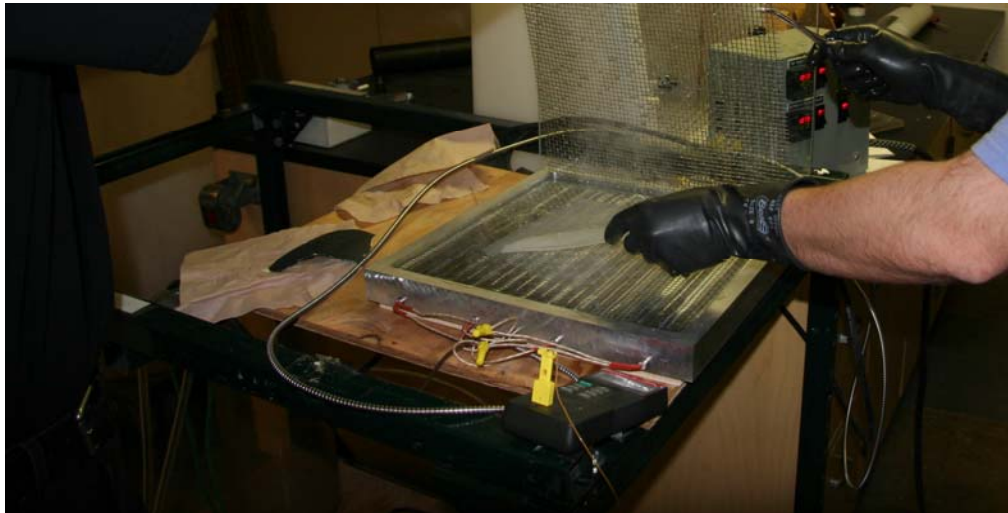
Figure 37: Swelling process used to fabricate a large PE gel film patch

The large PE gel film patches were made by swelling (Figure 37) 8" X 8" UHMWPE films in solvent until they were larger (Figure 38) than a 14" X 14" swollen film. This PE gel film was then placed between a pre-formed sheet of HDPE substrate (the patch) and a very thin sheet of HDPE (0.001"-0.003") (the packaging material) in a sandwich-like configuration (Figure 39).

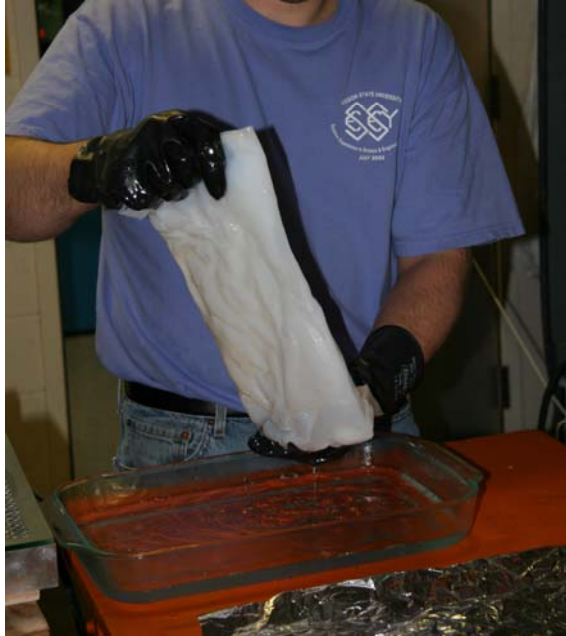
Figure 38: Photo of the final large PE gel film patch after the swelling process

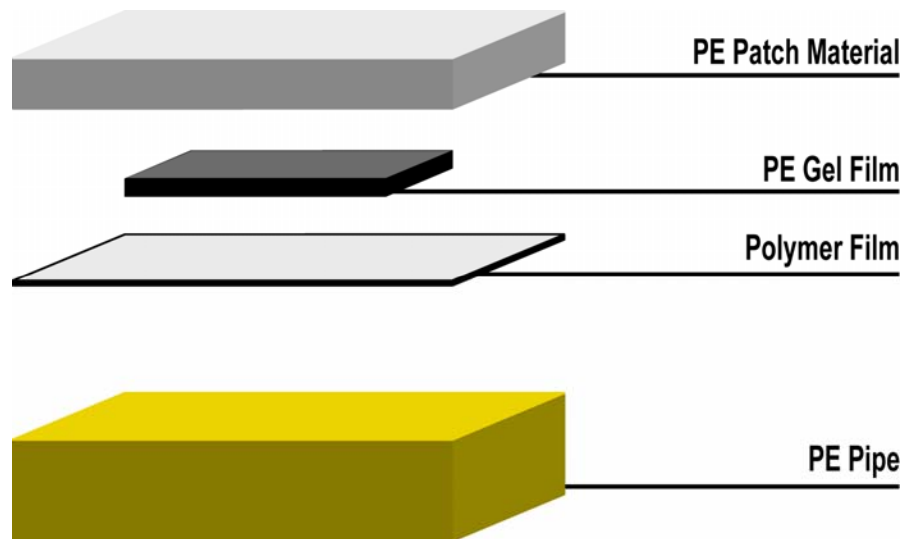
Figure 39: Diagram of PE gel film patch design

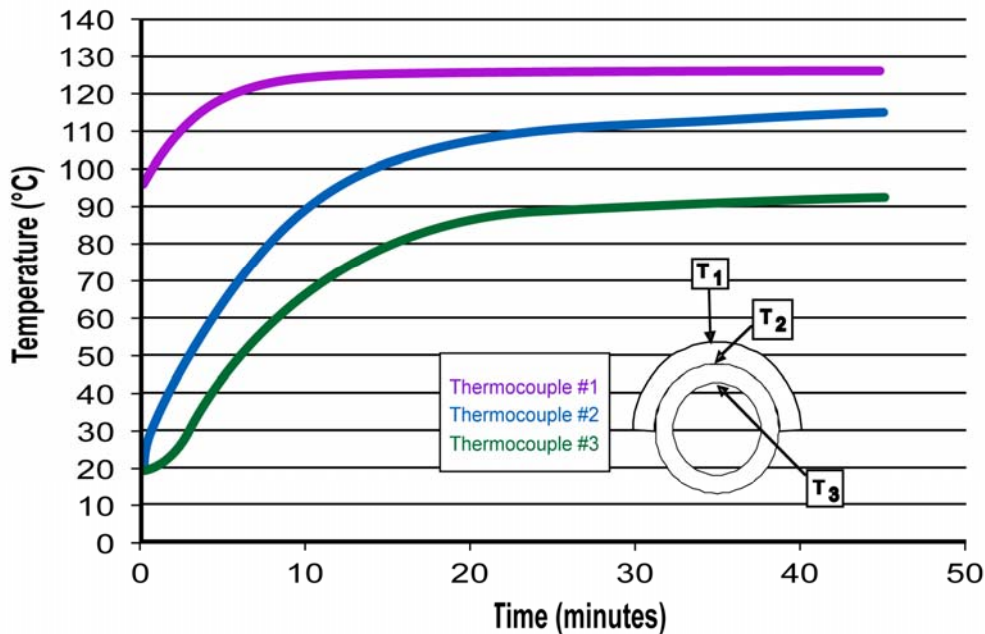
Figure 40: Temperature vs. heating time for 257°F/125°C platen temperature

temperature on an actual pipe sample was significantly different due to the one-sided heating and the additional heat losses. For this reason, heating profiles were developed for the engineered prototype tool (Figure 40). These profiles showed that, starting at a temperature of 86°F/30°C, approximately 20 minutes was required for the interface temperature to reach the desired temperature. It also illustrated that the pipe being patched remained well below its natural melting point. As with the lap shears, the pipe patch interface required a minimum of 30-60 minutes at the desired temperature to achieve good bond strength. Therefore, a total cure time of 90 minutes was used when patching pipes with the engineered prototype repair tool. This allowed the bond interface polymers enough time to fuse.

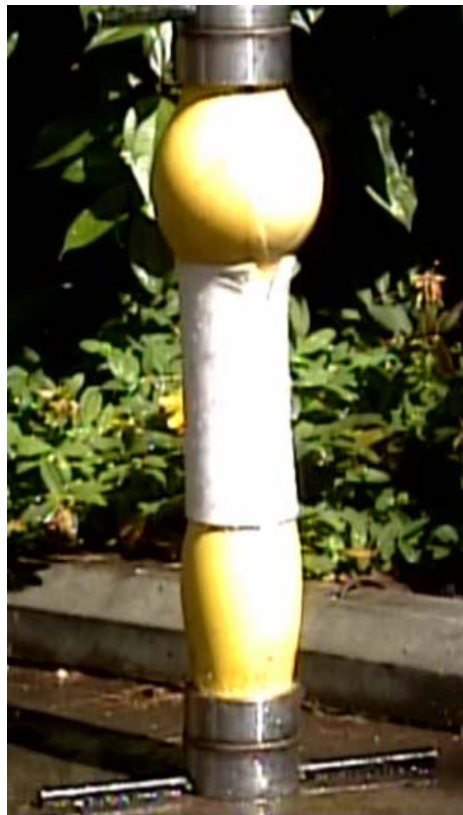
Figure 41: Quick burst test with overlapping full-wrap gel film patch shows successful bond at 500 psi

The technical objective of this subtask was to determine the overall performance of the HDPE repair patch (full wrap-overlapping PE gel film) using quick-burst testing to 600 psi, sustained pressure testing to 200 psi and stress-rupture regression on PE pipe samples repaired by the engineered prototype in Phase 2. Tests were conducted to determine the overall performance of the repair patch (including bonding) with ASTM D1599 quick-burst tests (Figures 41 & 42) at 73°F/23°C and 176°F/80°C; ASTM D1598 sustained pressure tests at 73°F/23°C and 176°F/80°C; and 73°F/23°C stress-rupture regression per ASTM D2837. Results of these tests showed successful bonding of a full wrap patch. Furthermore, a closed system full wrap-overlapping PE gel film patched pipe was held at room temperature and 200 psi for greater than 5 months without any loss in pressure (Figure 43).

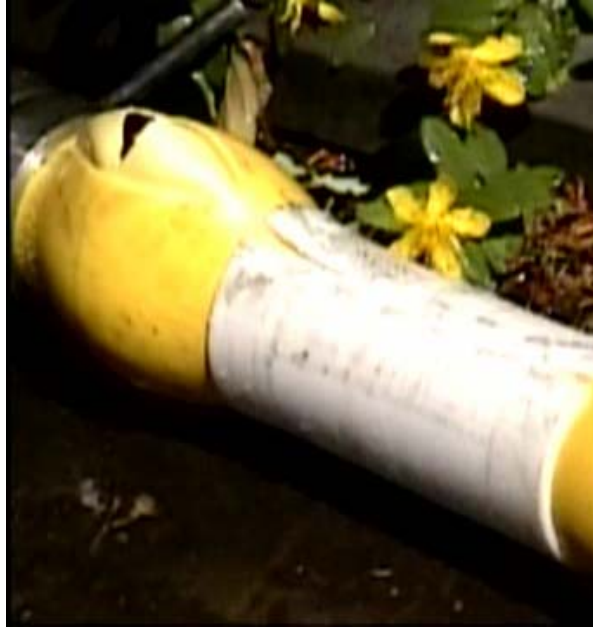
Figure 42: Quick burst test with overlapping full-wrap gel film patch shows successful bond & pipe failure below the patch at 600 psi

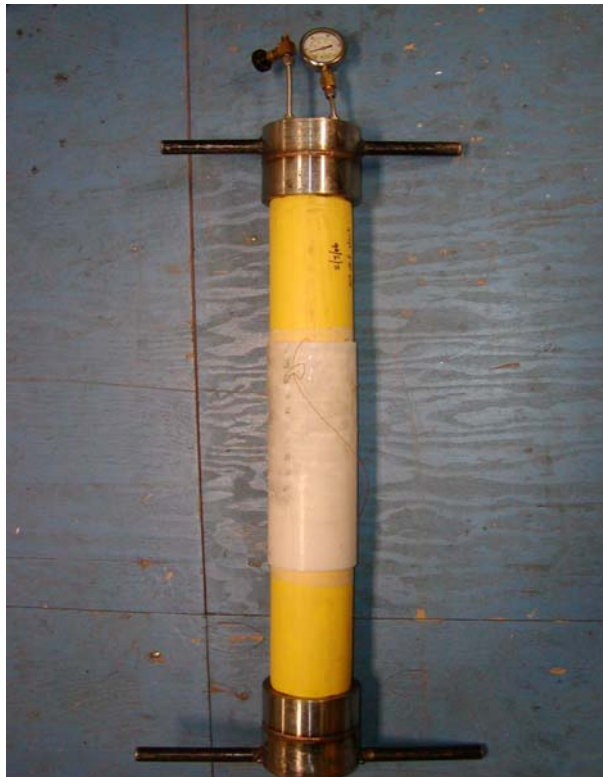
Figure 43: Closed system overlapping full-wrap gel film patch held at room temperature & 200 psi for > 5 months without any loss in pressure

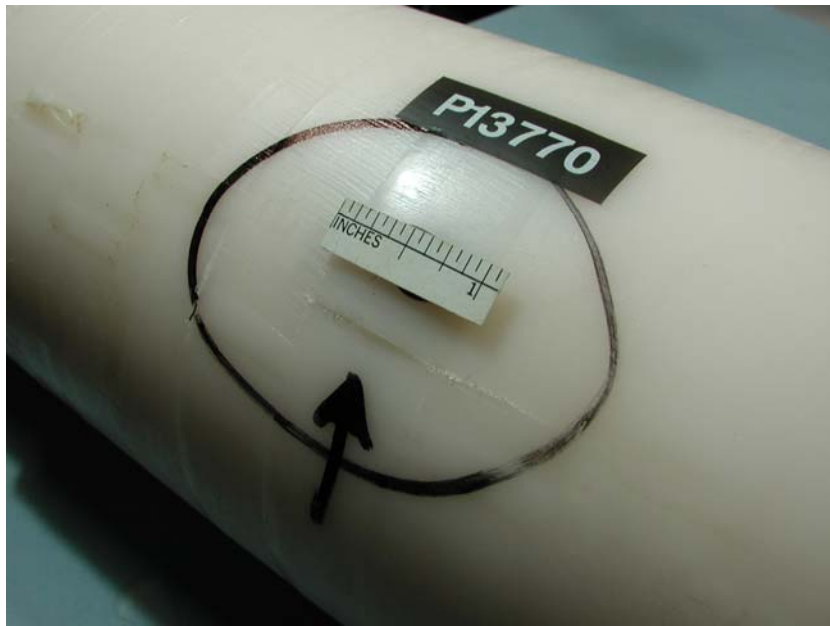
Figure 44: Photo of HDPE patch material failure at the 25-year mark during accelerated age testing

Initial accelerated age testing of repaired pipe sections showed that the applied 3/16" thick HDPE patches developed a small crack in the high-stress areas surrounding the patched hole within the first 48 hours of hot water testing (Figure 44), which indicates the patch material has an approximate 25-year lifespan. Based on these results, the repair patch material will need to be stronger to achieve a satisfactory 50 year patch system. The use of very high molecular weight PE (VHMWPE) or UHMWPE for the patch material is being investigated.

This HDPE repair patch substrate failure was of a brittle nature that was not seen in the room temperature lap shear tests in Task 8.2. In order to find the mechanism associated with these failures, lap shear samples were thermally “aged” in days and then pulled to find what effect thermal aging had on the bonds and substrates. These tests showed that the adhesive bond interfaces retained the majority of their strength, while the HDPE substrates themselves became embrittled and weakened. Figure 45 shows this weakening trend for HDPE as a function of time in 176°F/80°C water. The HDPE lost more than half of its strength within 5-6 days at these conditions.
