Development of a Remote External Repair Tool for Damaged or Defective Polyethylene Pipe

Final Report

Principal Authors:
Kenneth H. Green, Willie E. Rochefort,
Nick Wannemacher, John A. Clark, Kevin Harris

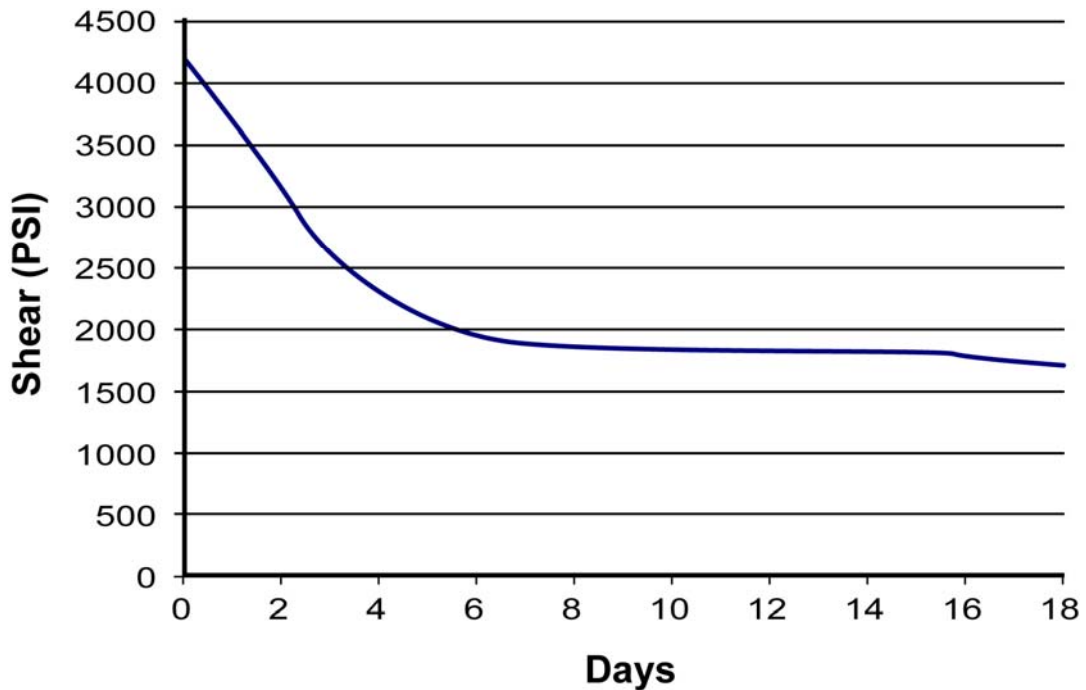
Figure 45: Graph of HDPE patch material strength loss vs. time (days)

This HDPE repair patch substrate failure was of a brittle nature that was not seen in the room temperature lap shear tests in Task 8.2. In order to find the mechanism associated with these failures, lap shear samples were thermally “aged” in days and then pulled to find what effect thermal aging had on the bonds and substrates. These tests showed that the adhesive bond interfaces retained the majority of their strength, while the HDPE substrates themselves became embrittled and weakened. Figure 45 shows this weakening trend for HDPE as a function of time in 176°F/80°C water. The HDPE lost more than half of its strength within 5-6 days at these conditions.

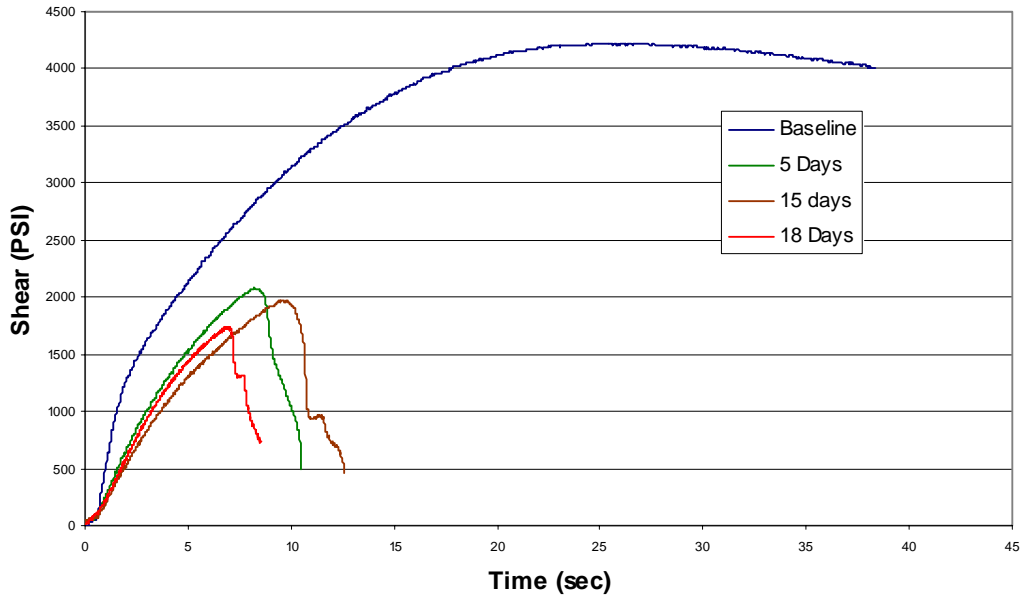
Figure 46: Graph of HDPE patch material strength loss at 5, 15, and 18 days

The same information is presented in Figure 46, where the average pull data (shear) was graphed for 5, 15, and 18 days, compared to non-aged samples (baseline).

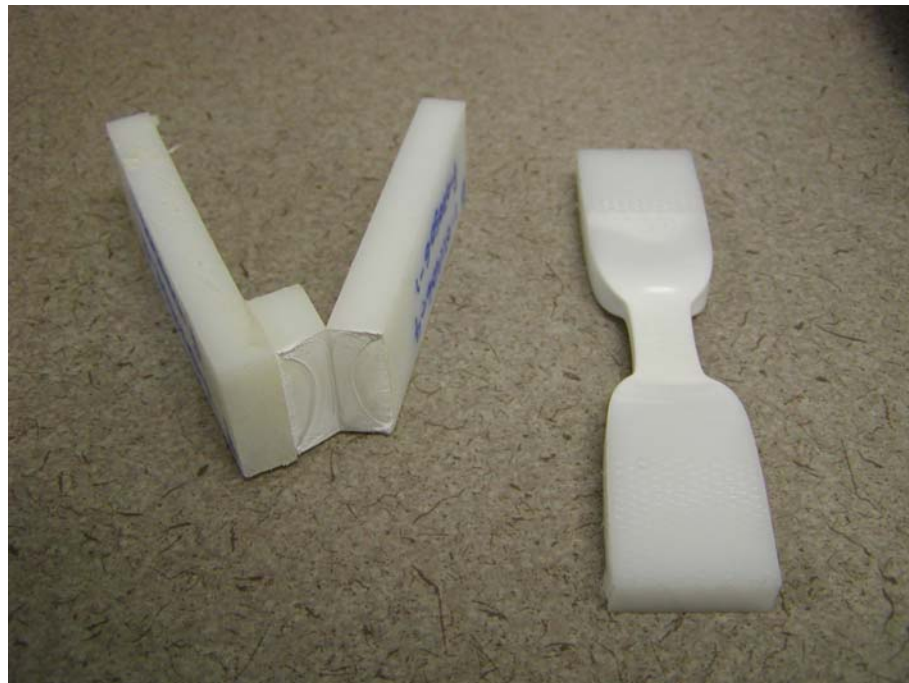
Figure 47: Broken embrittled HDPE material (left) compared to typical necking in HDPE control sample (right)

Figure 47 compares samples of broken embrittled HDPE lapshear samples that were subjected to solvent and the typical necking seen in the control HDPE sample of the same material.

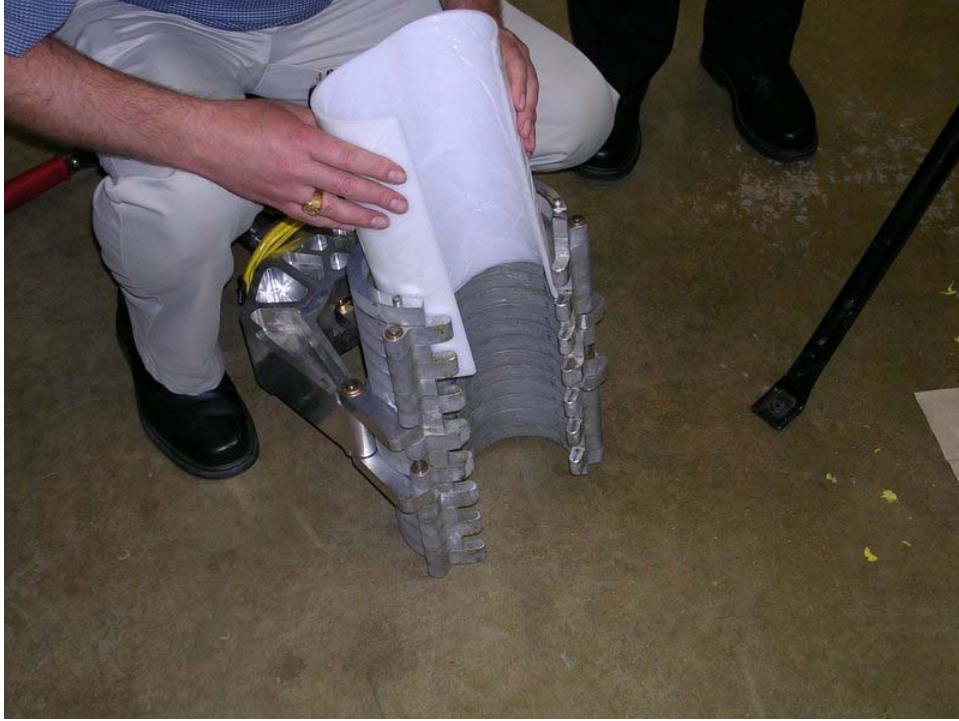
Figure 48: PE gel film repair patch being loaded into the engineered prototype for Nicor Gas demonstration in Naperville, IL

At demonstrations performed for Nicor Gas in Naperville, Illinois on April 19, 2006, a HDPE PE gel film repair patch was applied over a 1-inch hole drilled into the wall of one 4 ft section of 4-inch IPS SDR 11.5 MDPE pipe. A similar repair patch was also applied over a second 4 ft section of pipe with a series of holes drilled through the pipe wall in a pattern that approximated a 2"x 4" hole. Both sections of pipe were pressurized to 65 psi during application. Both repair patches successfully bonded the patch to the pipe. These sections were subsequently subjected to long term testing according to ASTM D1563 at Nicor's facilities. Within 48 hours, the patch material (HDPE) developed a small crack directly over the hole in both pipe samples. However, the bond between the patch and pipe was not affected. These findings were consistent with prior work at OSU (see Figures 48, 49, and 50).

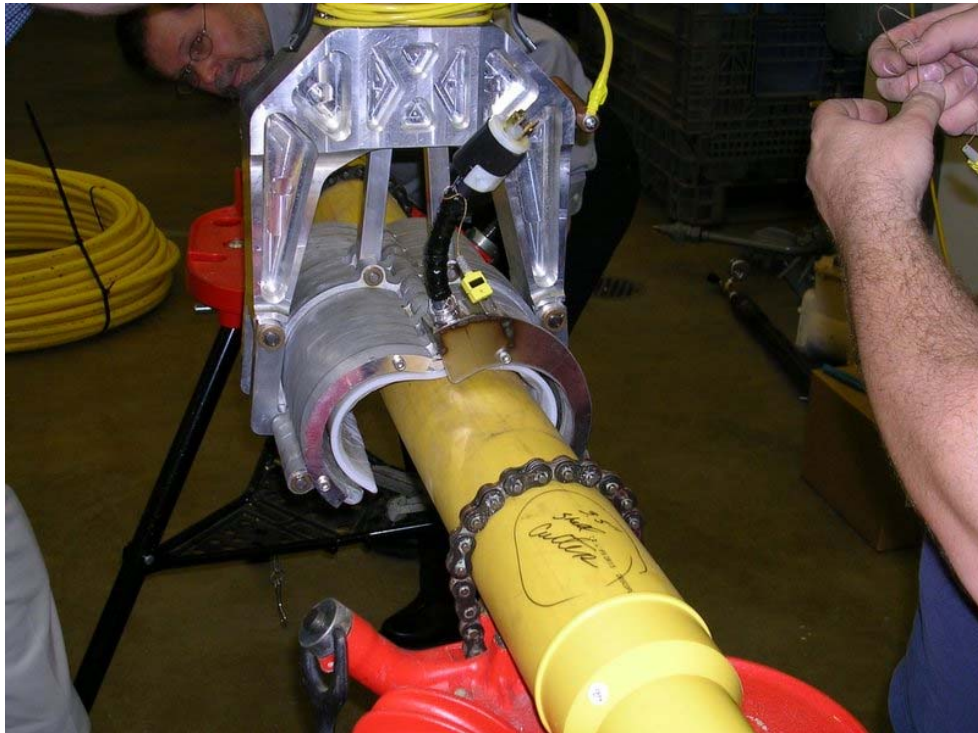
Figure 49: Engineered prototype with PE gel film repair patch being applied to damaged 4-inch MDPE pipe

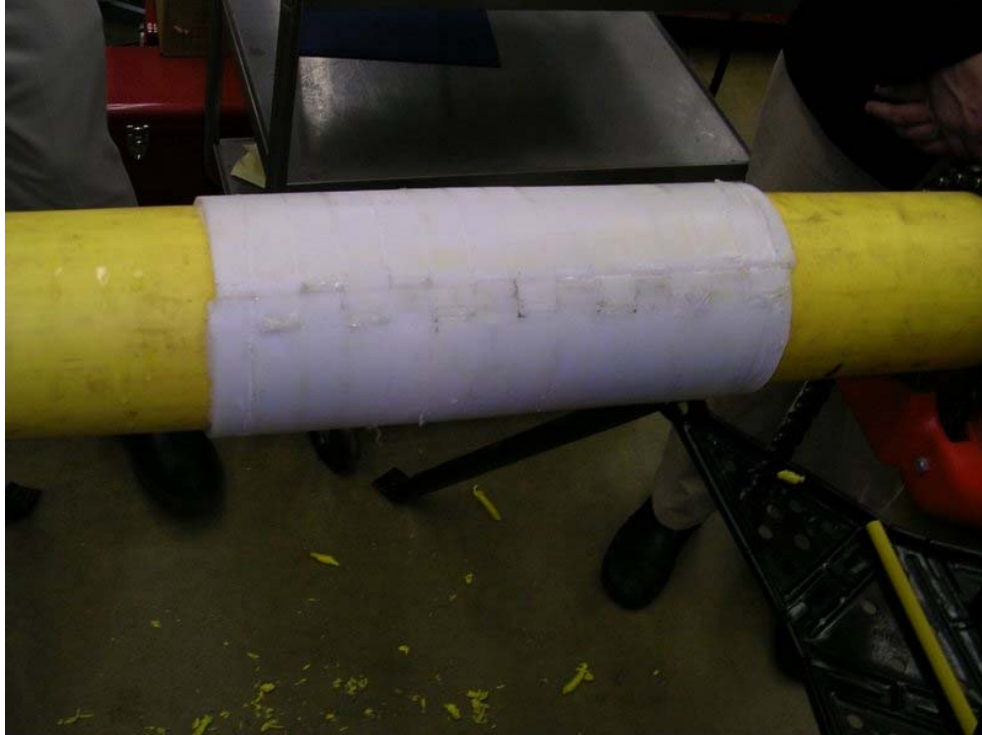
Figure 50: PE gel film patch successfully repaired a damaged 4-inch MDPE pipe

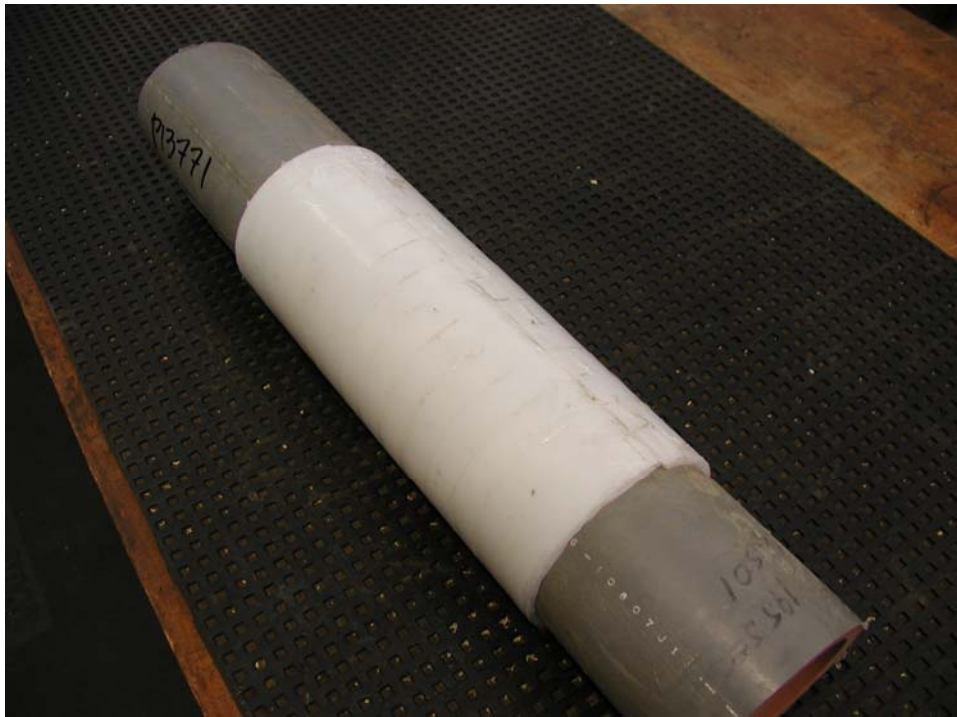
Figure 51: Overlapping full-wrap PE gel film patch successfully bonded to oxidized 4-inch IPS Aldyl-A pipe during demonstration for Sempra Energy

At demonstrations performed at Sempra Energy in Los Angeles, California on May 25, 2006, a HDPE substrate/ UHMWPE swollen PE gel film repair patch was applied over a 1-inch hole drilled into the wall of one 4 ft section of 4-inch IPS SDR 11.5 HDPE pipe. A second identical patch assembly was applied to an oxidized 4 ft section of 4-inch Aldyl-A pipe (Figure 51). This section of pipe had been buried in the ground for 25 years. The HDPE pipe was pressurized to 65 psig. The Aldyl-A pipe was not pressurized. Both repair patches successfully bonded to the pipe. The HDPE pipe section was subjected to 670 psi hoop stress (~107 psig) in 176°F/80°C water for 48 hours. As seen in prior tests at other gas companies, a small crack developed at the area of damage. However, the bond between the pipe and the patch was not affected. The repaired pipe samples were sent to the laboratory at OSU for further SEM tests (as discussed in Task 9.2).

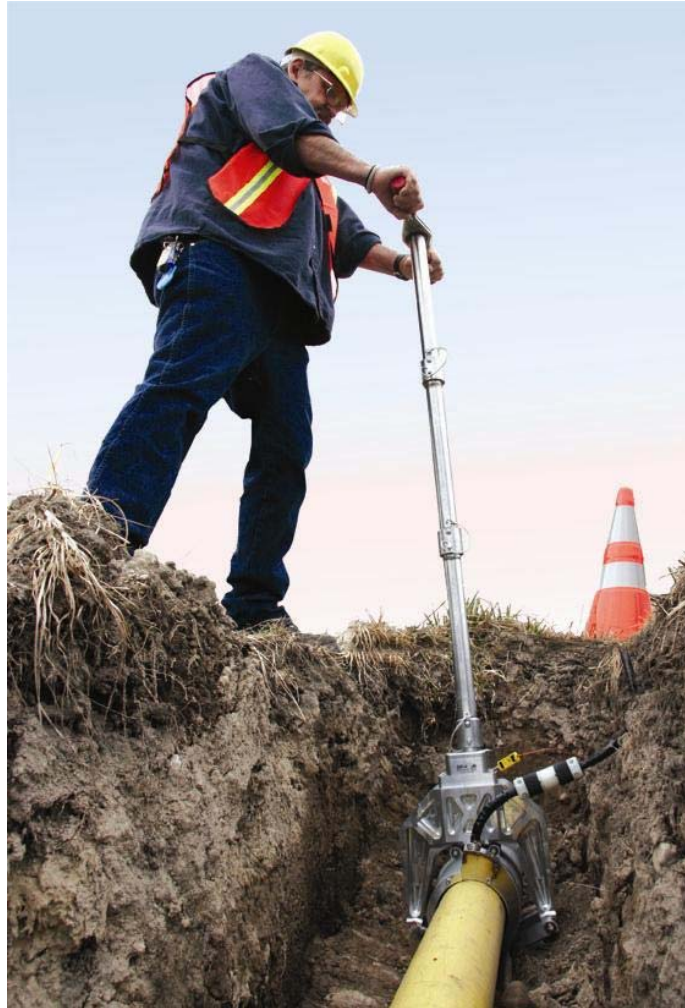
Figure 52: Final engineered prototype applying a PE gel film patch on 4-inch MDPE pipe

The design and performance of the engineered prototype (Figure 52) and the thermo-chemical patch process were successfully evaluated by the project team with critical input from the natural gas utility partners. The engineered prototype was evaluated against the design constraints as originally set forth in the proposal.
