SANDIA REPORT

SAND2003-2923

Aircraft Wire System Laboratory Development: Phase I Progress Report

Mike Dinallo and Chris Lopez

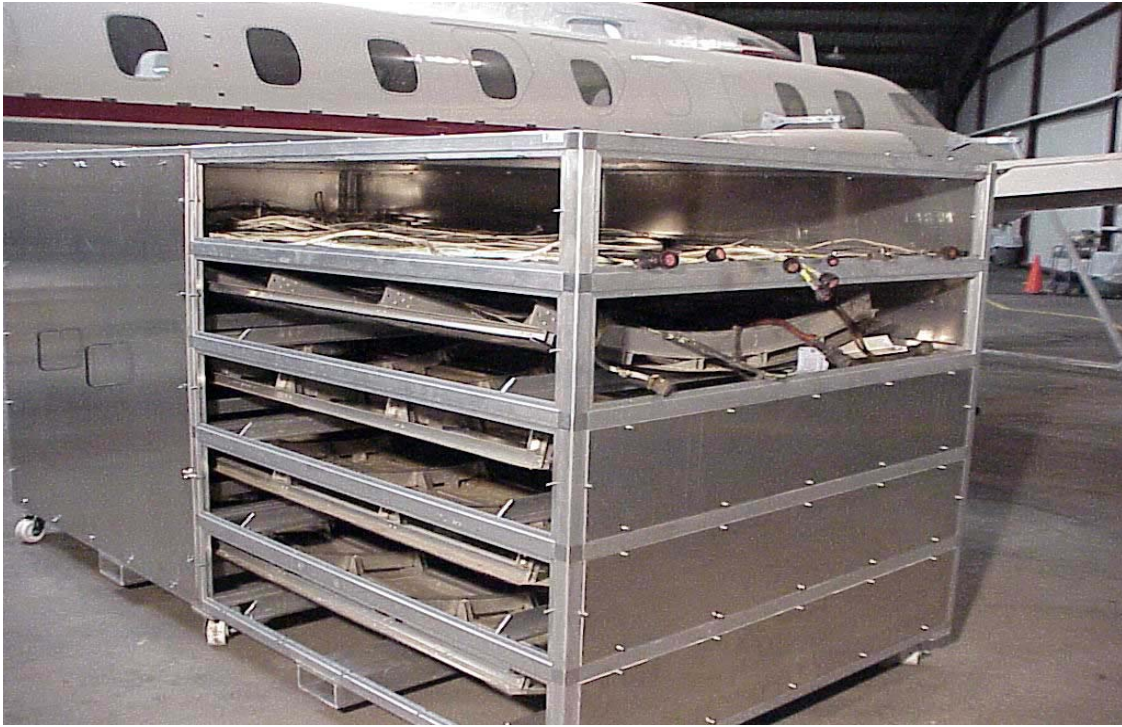
Figure 2. Partially Assembled Wire Harness Enclosure

The enclosure is made of an aluminum strut frame with aluminum flat panels (1/8 inch thick) attaching to all sides. It is 10 feet in length and 5 feet in height. The general dimensions of the side, top and bottom panel(s) will be 5 x 5 sq-ft. The dimensions of the panels at the front and rear (enclosure width) will be 5 feet in width and 1 foot in height. Figure 1 shows a detailed drawing of the enclosure. The strut frame structure support four additional flat panels spaced at a height of 1 foot. Figure 2 is a photograph of the

enclosure at a partial level of assembly. It can be seen in Figure 2 that the lower four cable trays provide a ribbed-structure, metallic ground-plane for harness support and electrical characteristics related to transmission lines. These segments were made by Foster and Miller Metal Works and are used in the test bed. The segments were fabricated to represent Boeing 727 and 737 aircraft ribbed-fuselage structure. Figure 3 is a photograph of a sample segment.

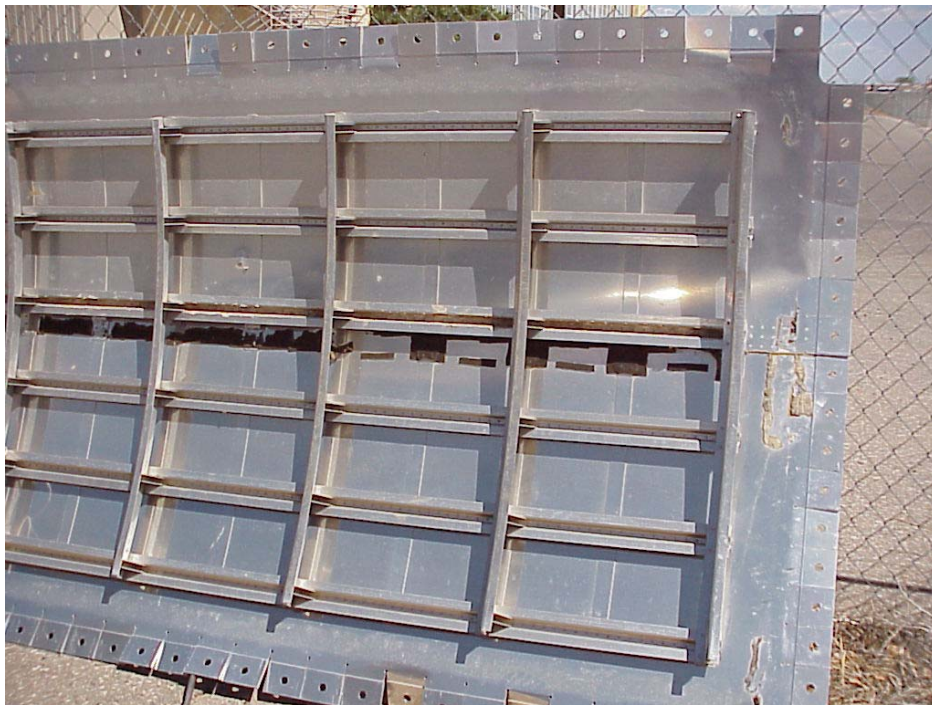
Figure 3. Boeing 727/737 Type Ribbed-Structure Segment Fabricated by Foster-Miller

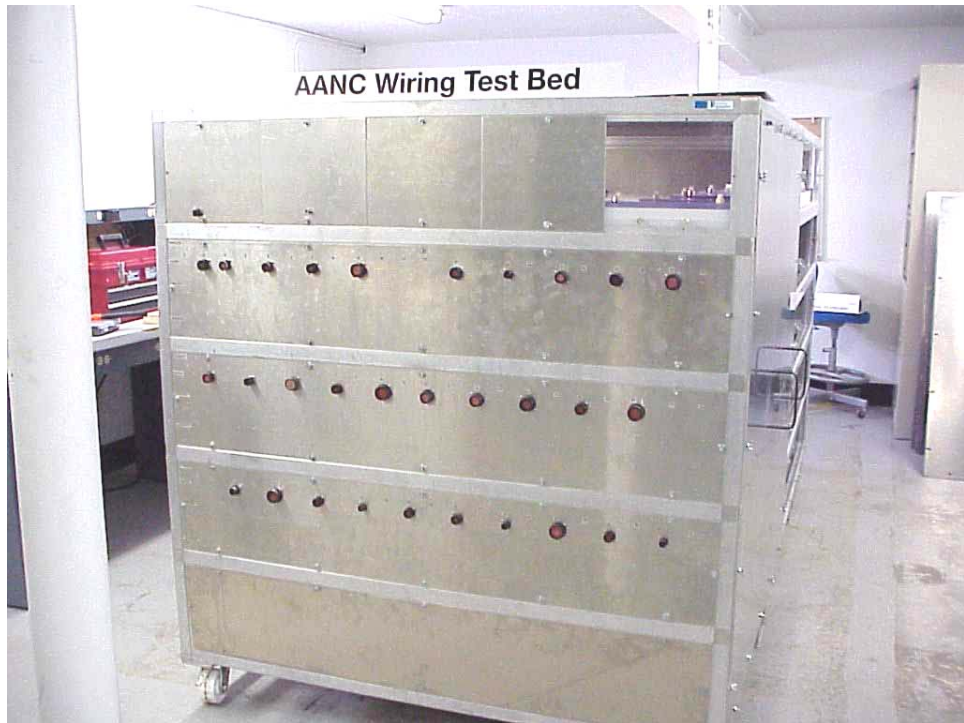
Figure 4. Assembled Wire Harness Enclosure

The removable panels are a quick-connect–disconnect type. The front and rear panels have penetrations to allow harness termination connector panel mounts. The dimensions of these penetrations are in accordance with selection of specific connector types. Lifting portals are welded to the bottom exterior of the enclosure for transportation purposes. The enclosure is mounted on three pairs of neoprene castors for mobility. The fully enclosed test bed is shown in Figure 4. Trays are labeled from 1 to 5, with 3 rows and 22 columns for harness placement per tray.

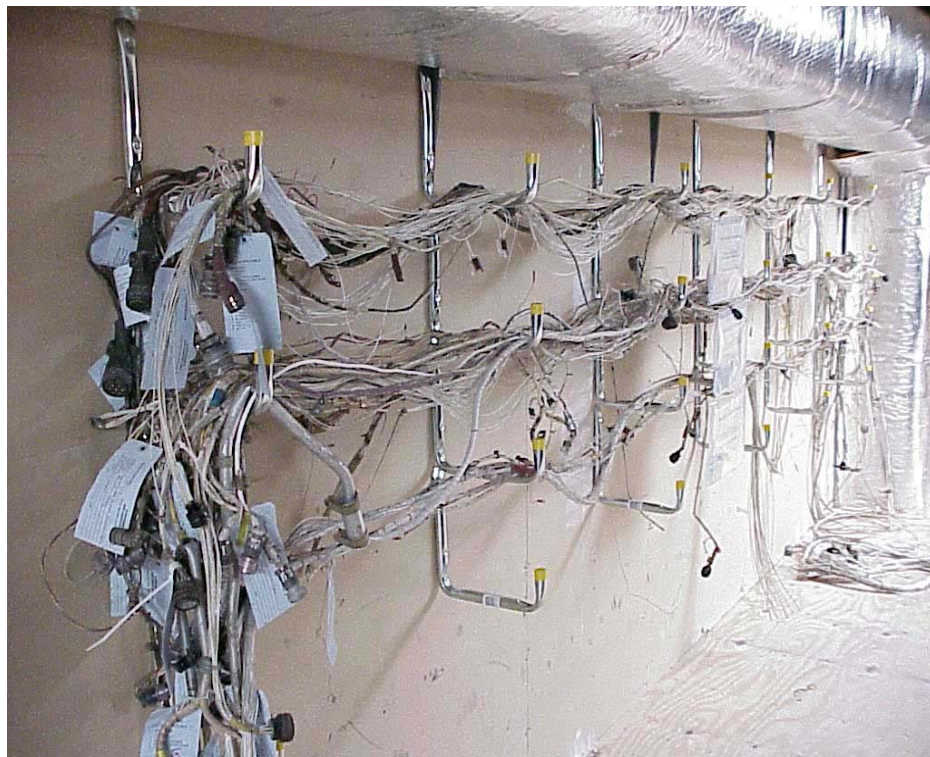
Figure 5. Extracted Harnesses from Retired Aircraft

The test bed has retired and newly fabricated harnesses that include single- and multi-conductor insulated wires that are twisted with and without shielding. Wiring ranges from high-current power cables (awg 8) to small-diameter signal wires (awg 22). Figure 5 is a photograph of inventoried harnesses from Boeing and Douglas retired aircraft. These aged harnesses were obtained from several locations on the aircraft including the EE bay, wheel wells, wing edges, cargo sections, and fuselage. All extracted harnesses are tagged for identification of in-service location and aircraft number, and they were documented on videotape prior to removal. Annex A lists the harnesses acquired.

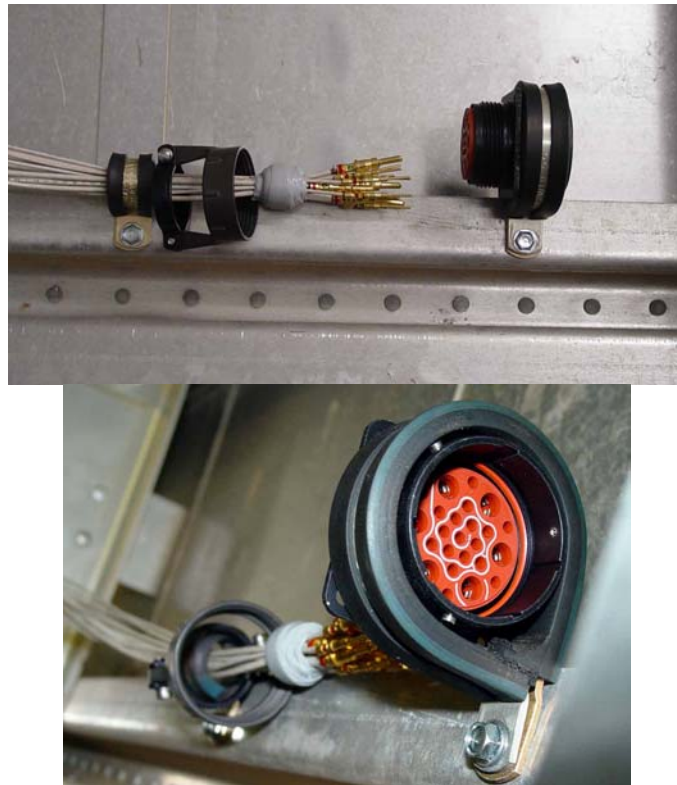
Figure 6. Wire Harness to Connector Assembly Display

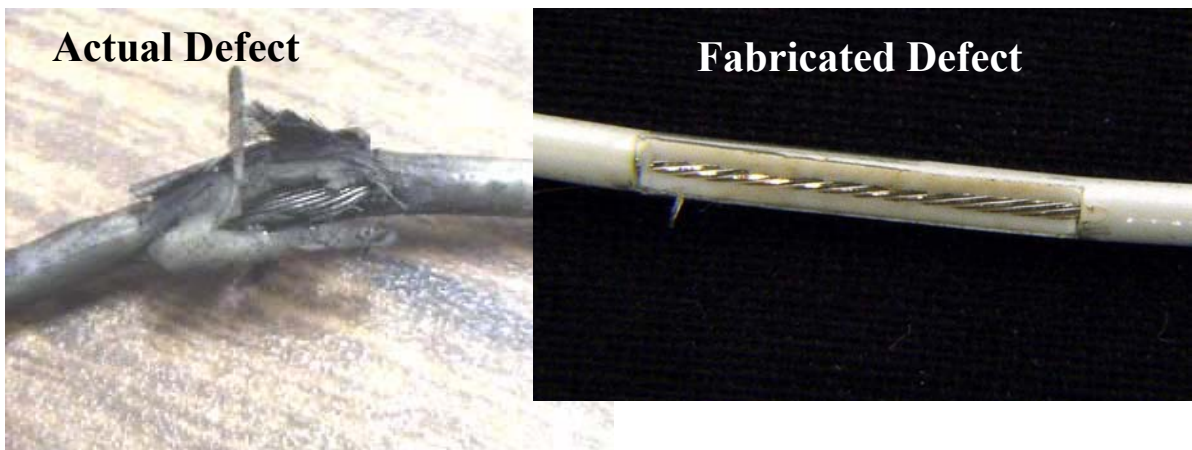
Figure 7. Comparison of Actual and Fabricated Defects Using Annex E Procedures.

For each defect type, a specific fabrication procedure was developed. A defect descriptor chart is provided in Table 1 and describes the defect type and severity. Annex E documents these procedures with illustrative photographs. The procedures were developed and documented in sufficient detail to allow accurate reproducibility. Figure 7 shows a sample using these procedures to fabricate defects. The tools used in these procedures are a standard wire stripper, feeler gauges, and a common knife for insulation cutting. A Dremel tool is also used to produce abraded or chafed wire insulation or metallic shielding. Other defect fabrication tools include a torque wrench for creating over-pressured clamps and a heat gun with a wire-positioning fixture for producing charred insulation. These procedures permit consistency of a given diagnostic method to detect and locate similar as well as different types of defects. Defect procedures, severities, and types are modified based on comments/recommendations made by the

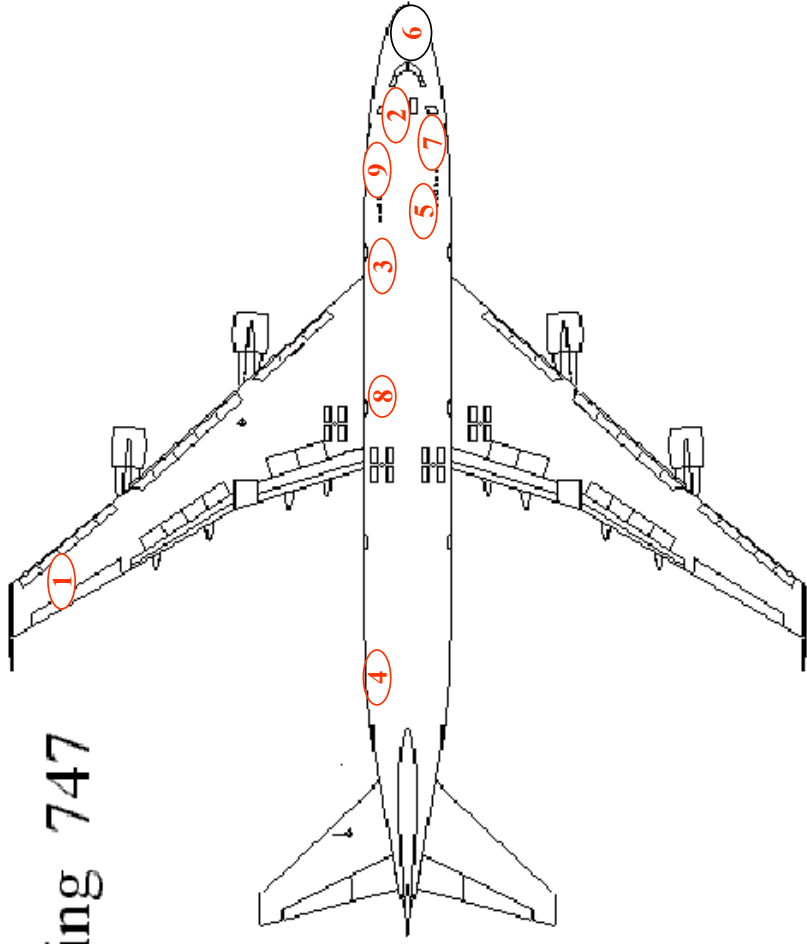
- 1: 61; Left wing clip
- 2: 62; Body STA 560
- 3: 63; Body STA 740
- 4: 64 & 69; Body STA 2220
- 5: 65; Body STA 450
- 6: 66; Body STA 280
- 7: 67; Right Wheel well STA 425
- 8: 68; Body gear STA 1241
- 9: 70; Body STA 400

Figure A.1. Zones Where Harness IDs 61–70 Were Extracted

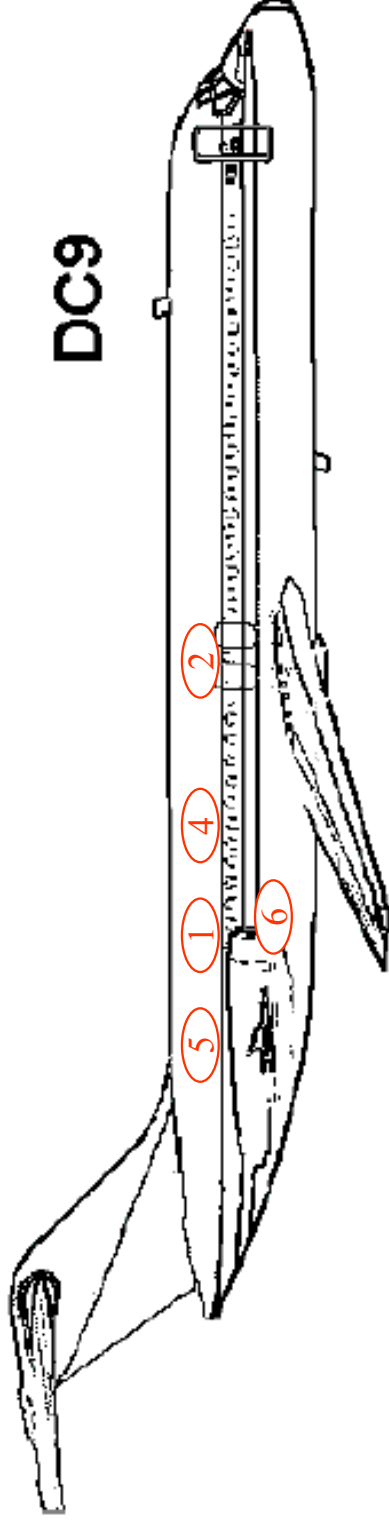
1: 71: Fuselage Station 1087

2: 72: Fuselage Station 617

6: 80: Rear fuselage Station 937

Figure A.2. Zones Where Harness IDs 71–80 Were Extracted

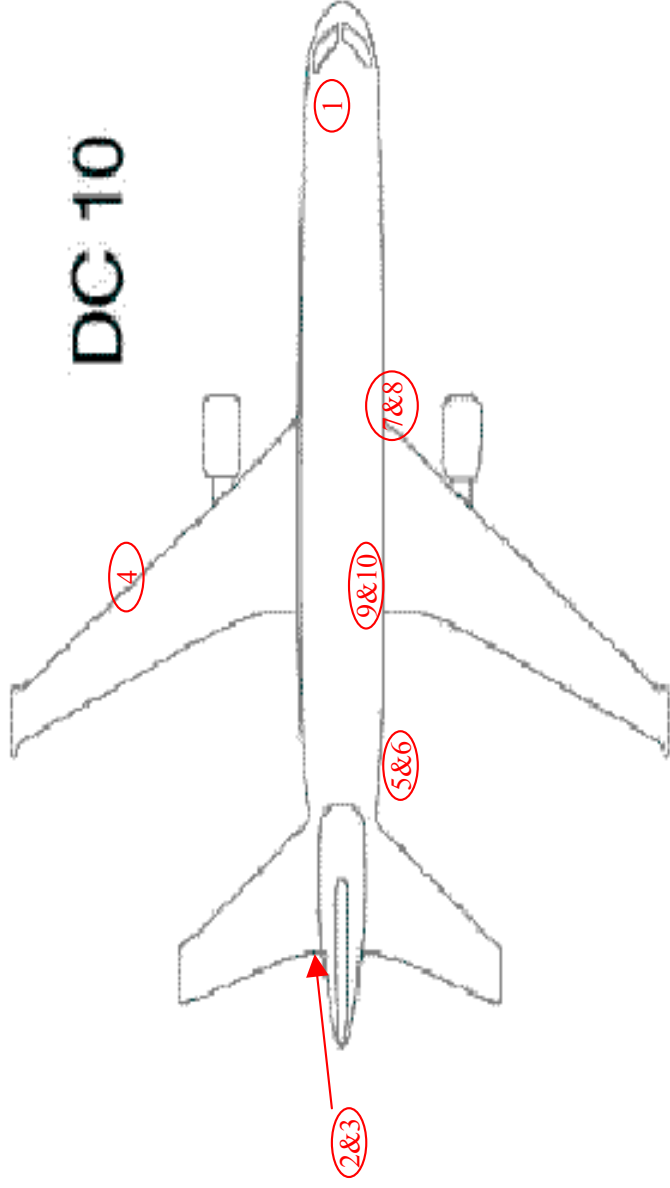
| 1 : 81 : Aft face cockpit panel | 6 : 86 : Bottom cargo section 1850 |

Harness ID	Aircraft Number	Location
81	DC-10 1154 TW	Aft Face of Cocpit Breaker Panel
82	DC-10 1154 TW	Aft Fuselage Compartment (left front side station 1600-1640)
83	DC-10 1154 TW	Aft Fuselage Compartment (left front side station 1599-1585)
84	DC-10 1154 TW	Left Side Trailing Wing Edge (station 772 zone 536)
85	DC-10 1154 TW	Cargo Section (left side to flight recorder) (station 1851)
86	DC-10 1154 TW	Bottom Cargo Section (in bottom) (station 1850)
87	DC-10 1154 TW	Right Wheel Well Gear Zone
88	DC-10 1154 TW	Right Wheel Well Gear Zone
89	DC-10 1154 TW	Electronics Bay (right side aft A and E bay)
90	DC-10 1154 TW	Electronics Bay

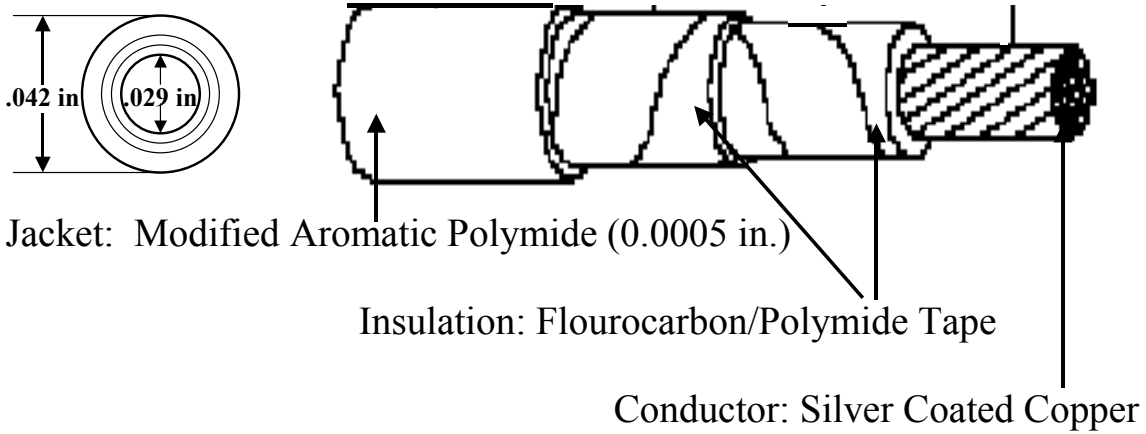
MIL-W-81381/7 - 22 - 8
Mil Spec Gauge Color

Temp Rating: 200° C
600V

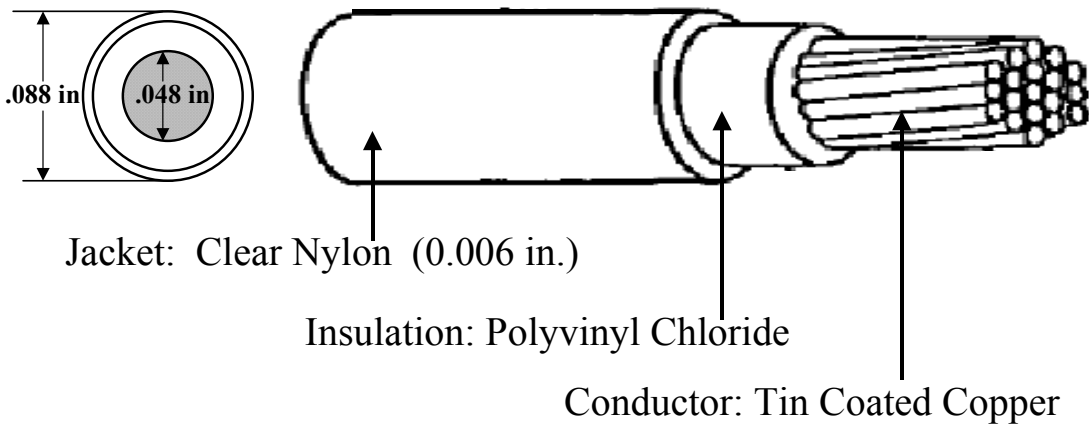
MIL-W-5086/1 - 18 - 9
Mil Spec Gauge Color

Temp Rating: 105° C
600V

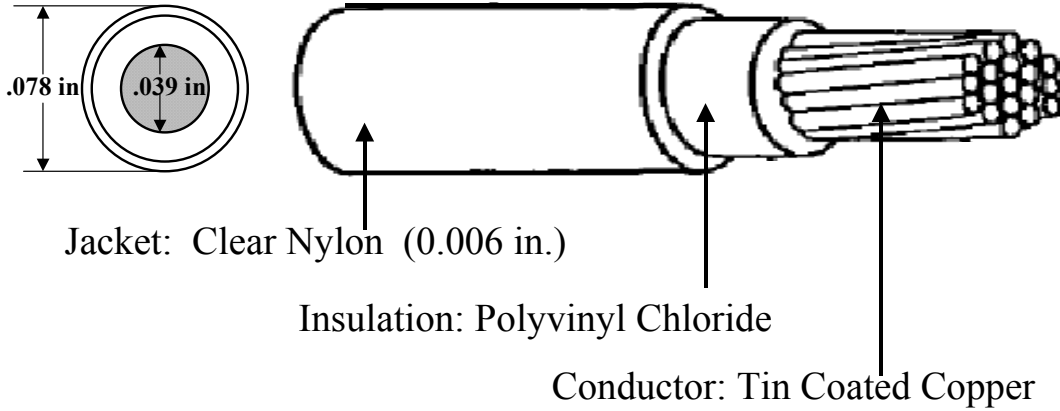
MIL-W-5086/1 - 20 - 9

Temp Rating: 105° C
600V

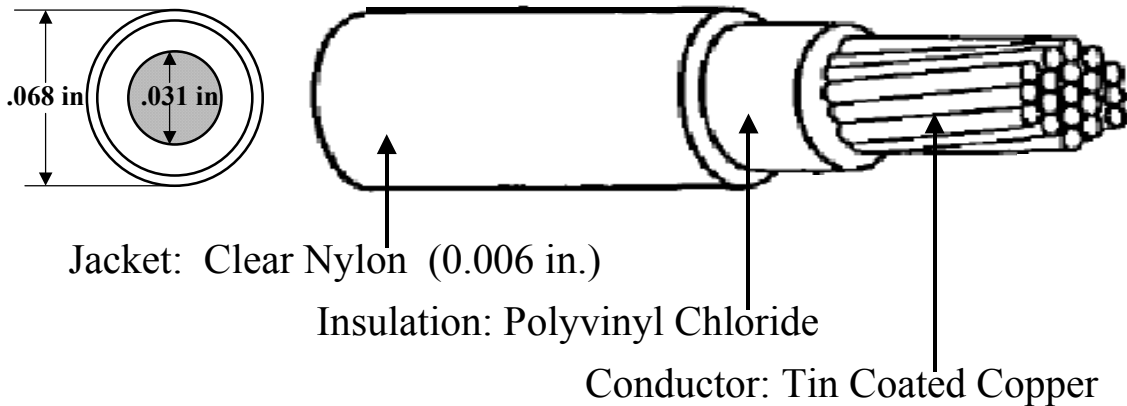
MIL-W-5086/1 - 22 - 9

Temp Rating: 105° C
600V

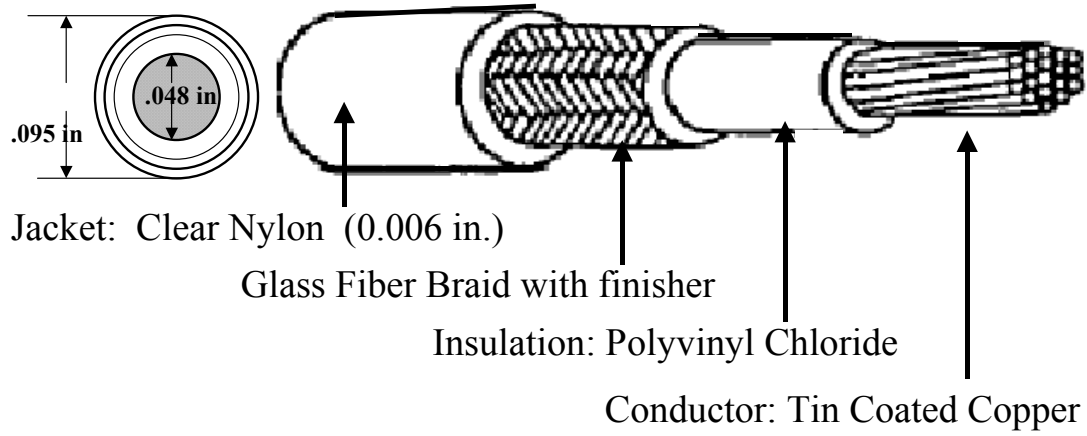
MIL-W-5086/2 - 18 - 9

Temp Rating: 105° C
600V

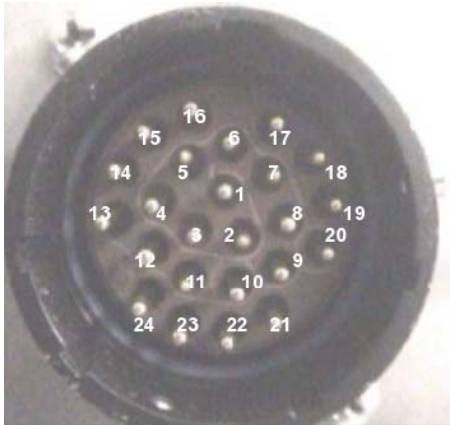
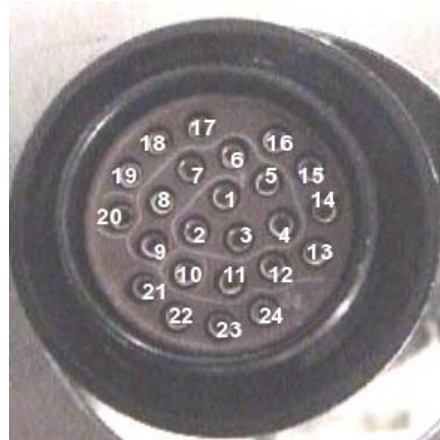
Front: MS24264R16B24PN

Aft: MS24266R16B24SN

Wire Harness Description – Tray 2, Top Row, Column 2

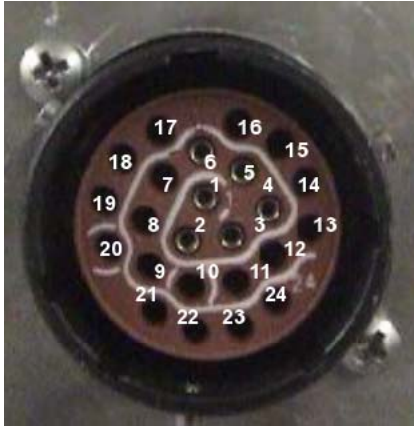
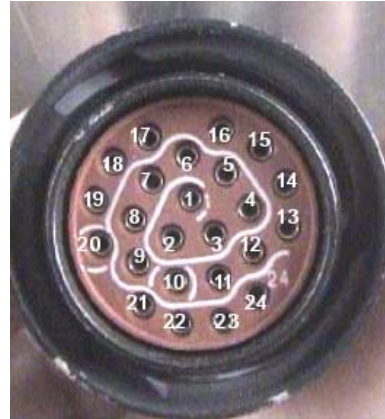
Front: MS24264R16B24PN

Aft: MS24266R16B24SN

Wire Harness Description – Tray 2, Top Row, Column 13

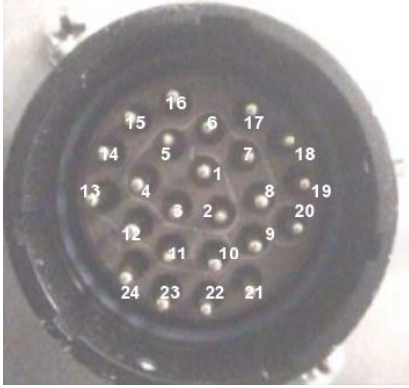
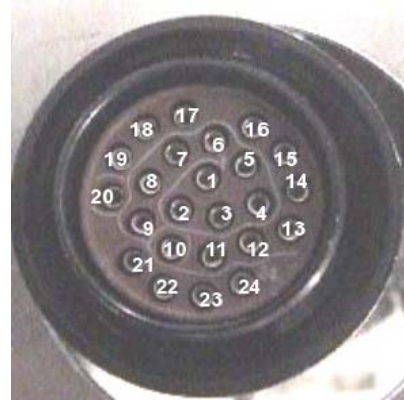
Front: MS24264R16B24PN

Aft: MS24266R16B24SN

Wire Harness Description – Tray 2, Top Row, Column 19

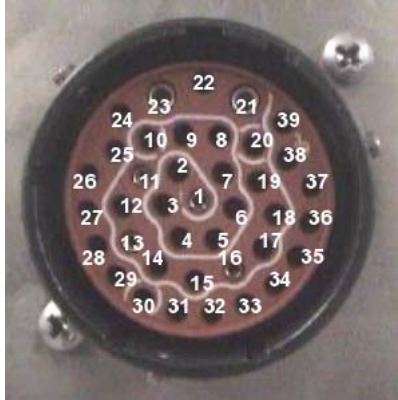
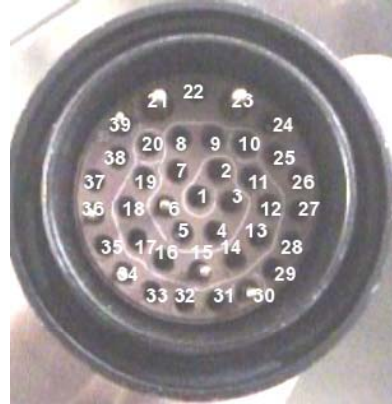
Front: MS24264R20B39S8

Aft: MS24266R20B39P8

Wire Harness Description – Tray 2, Top Row, Column 21

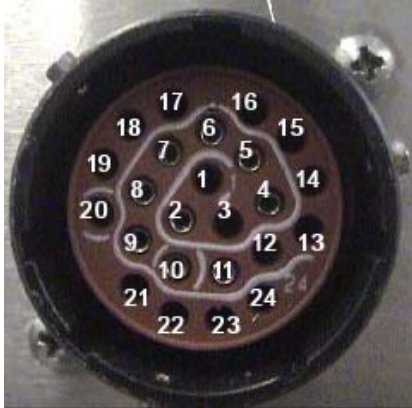
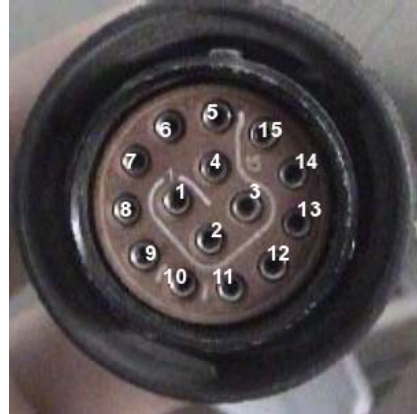
Front: MS24264R16B24SN

Aft: MS24266R14B15SNX

Wire Harness Description – Tray 3, Top Row, Column 2

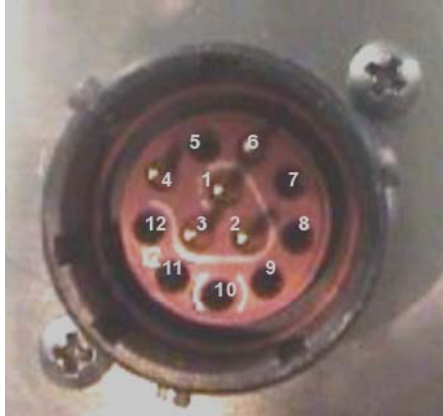
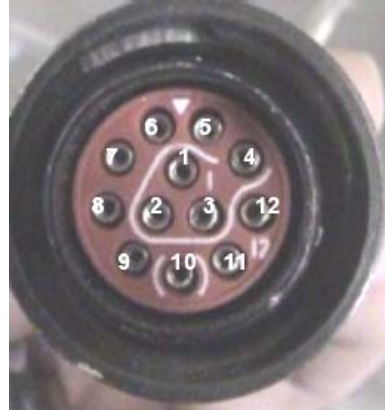
Front: MS24264R12B12PN

Aft: MS24266R12B12SN

Wire Harness Description – Tray 3, Top Row, Column 4

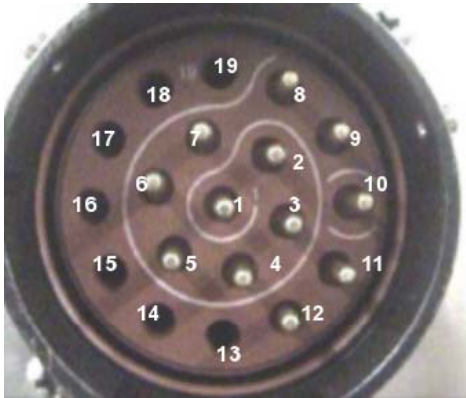
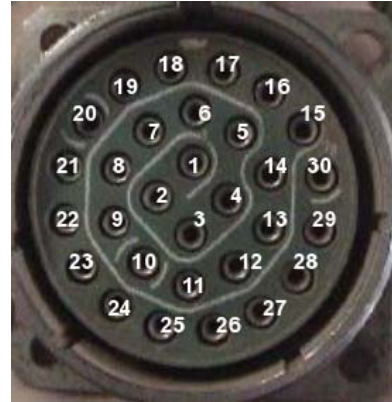
Front: MS24264R22B19P8

Aft: ZZL-R-17 24-3D-S06

Wire Harness Description – Tray 3, Top Row, Column 10

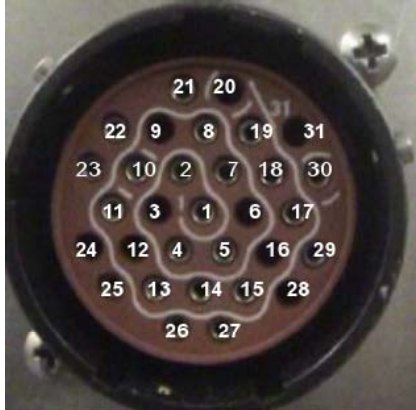
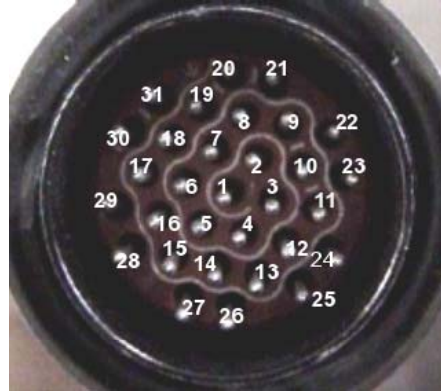
Front: MS24264R18B31S8

Aft: MS24266R18B31P8

Wire Harness Description – Tray 3, Top Row, Column 12

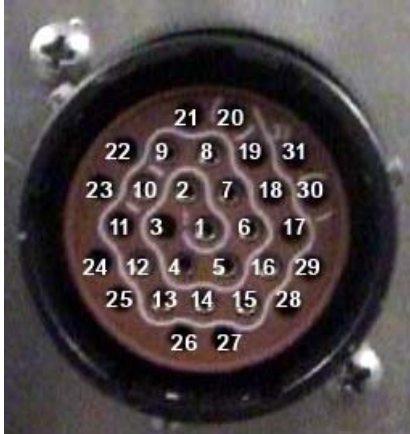
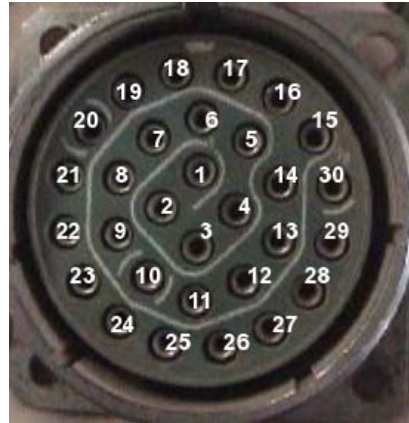
Front: MS24264R18B31S8

Aft: ZZL-R-17 24-3D-S06

Wire Harness Description – Tray 3, Top Row, Column 14

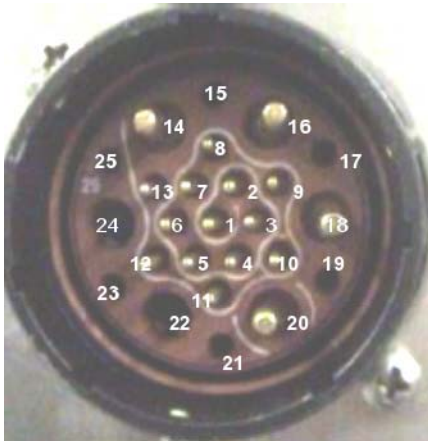
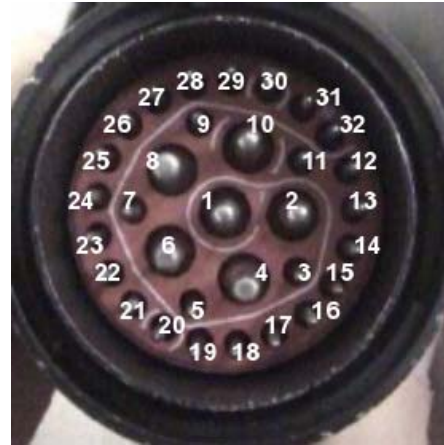
Front: MS24264R20B25PN

Aft: MS24266R22B32PN

Wire Harness Description – Tray 3, Top Row, Column 16

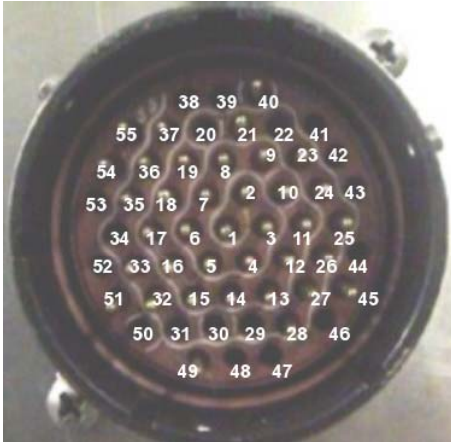
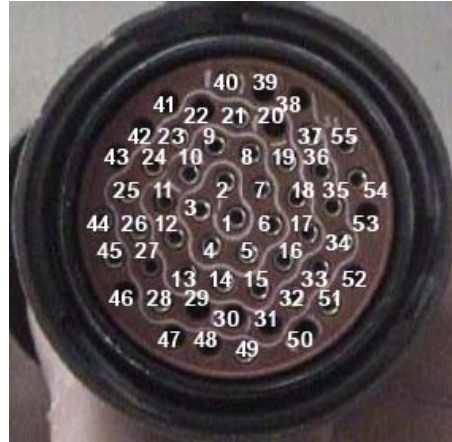
Front: MS24264R22B55P7

Aft: MS24266R22B55S7

Wire Harness Description –Tray 3, Top Row, Column 20

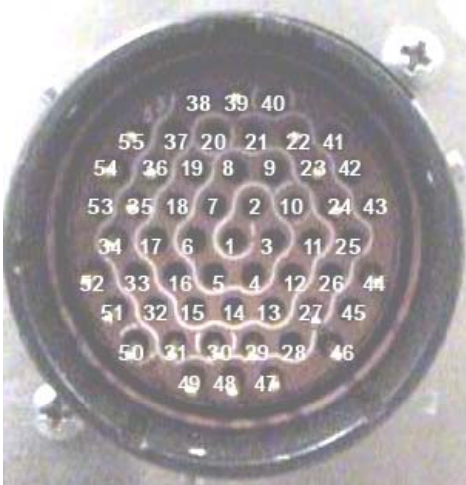
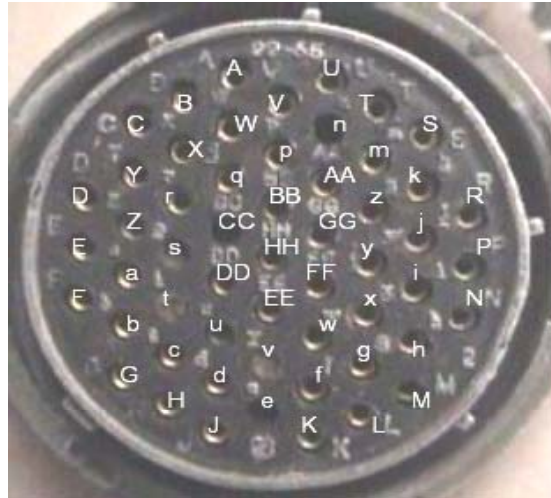
Front: MS24264R22B55P7

Aft: No Visible Number-55 socket

Wire Harness Description – Tray 4, Top Row, Column 5

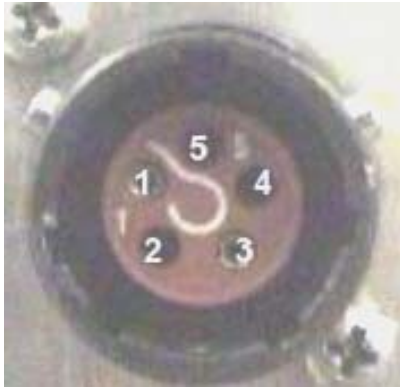
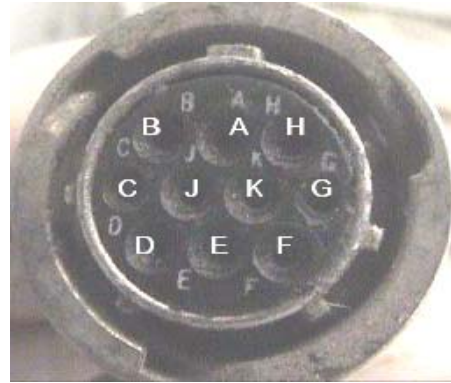
Front: MS24264R10B5SN

Aft: No Visible Number- 10 socket

Wire Harness Description – Tray 4, Top Row, Column 9

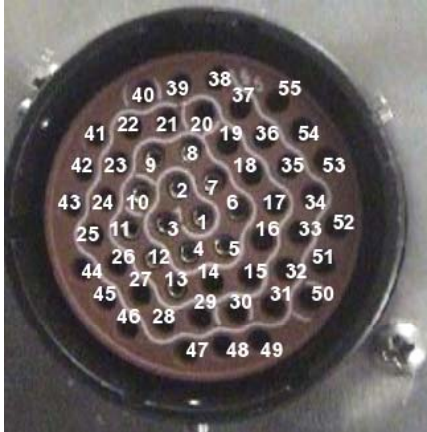
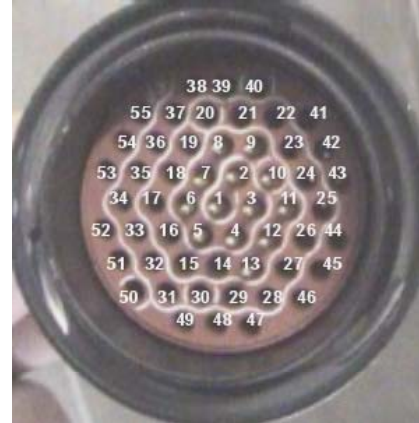
Wire Harness Description – Tray 4, Top Row, Column 17

Front: MS24264R22B55S8

Aft: MS24266R22B55P8

Front Connector: MS24264R22B55S8

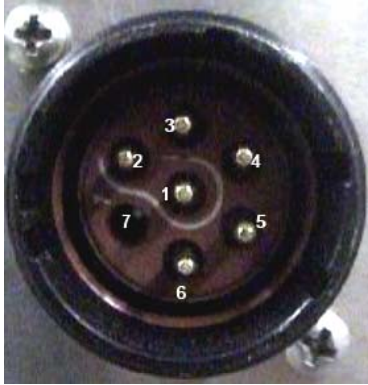
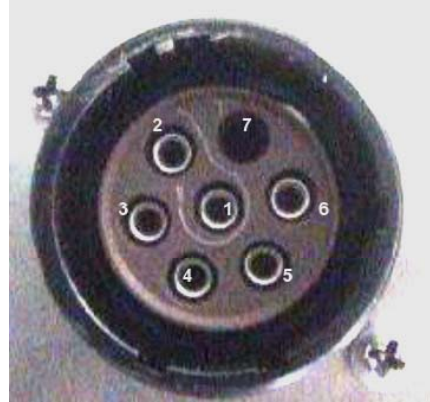
Wire Harness Description – Tray 4, Top Row, Column 19

Front: MS24264R14T7P6

Aft: MS24264R14T7S6

Front Connector: MS24264R14T7P6

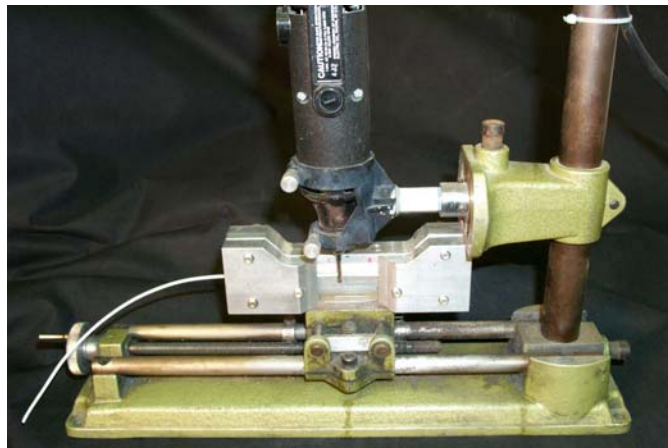
The following procedure describes the methods and tools used to fabricate abrasions into the wire used in the Test-Bed. Abrasions are made with a custom-milling fixture shown in Figure DT1-1 (Dremel Moto-Tool Model # 380-6, Variable Speed).

Figure DT1-1. Dremel Tool Mounted in Custom Mill

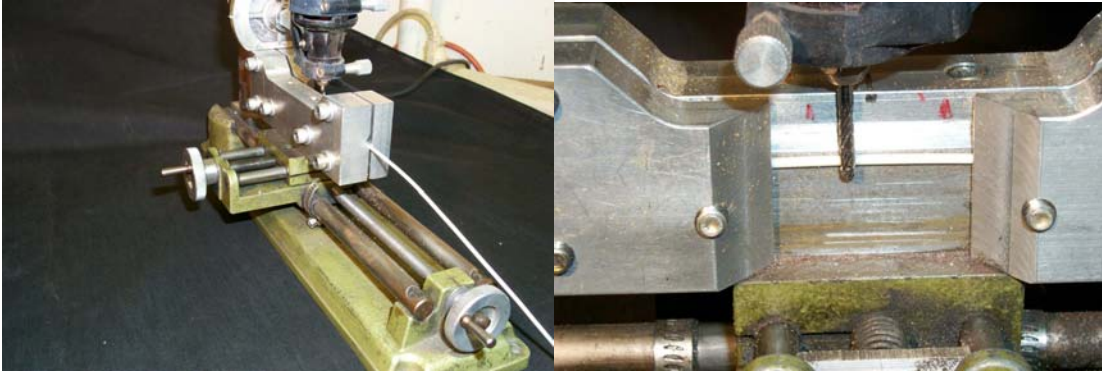
To achieve reproducibility, the same router bit shall be used in all abrasions put into the Test-Bed wiring (Dremel part number 9903, tungsten carbide bit, shown in Figure DT1-2). The Dremel Tool # 380-6 shall be operated at 28,000 RPM for all work. Because of varying dimensions in the insulations of different wire types used in the test bed, there will be differing amounts of feed used on each wire clamped in the mill. Figure DT1-2 shows two views of a wire clamped in the Dremel Mill.

Figure DT1-2. Showing Two Views of a Wire Clamped in Abrasion Test Fixture

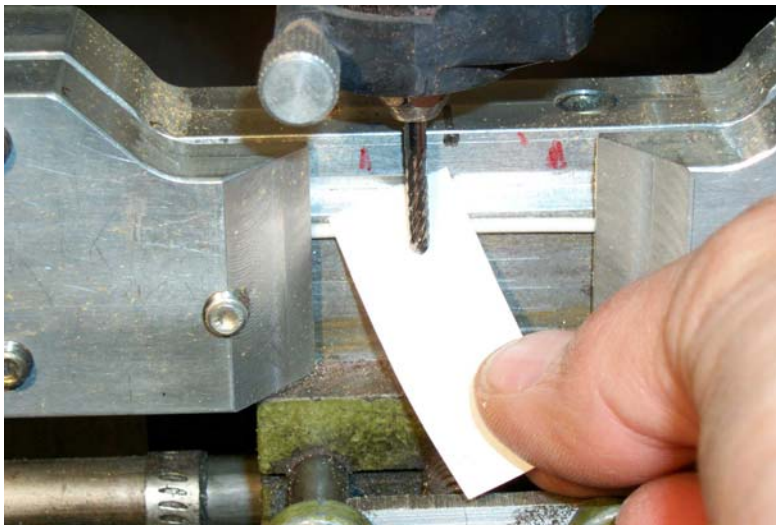
After the wire is clamped into the vise on the mill, the carbide cutter must then be located to within a few mils of the wire insulation. The technique of using a piece of paper (approximately 2 mils thick) between the bit and the insulation will be used. With one hand cranking the X-axis dial and the other hand sliding a small piece of paper between the bit and insulation, move the vise until the paper is just able to be removed from between the bit and wire without tearing (tool is not energized at this time). This technique is shown in Figure DT1-3.

Figure DT1-3. Wire-to-Bit Spacing Adjustment Using Small Piece of Paper

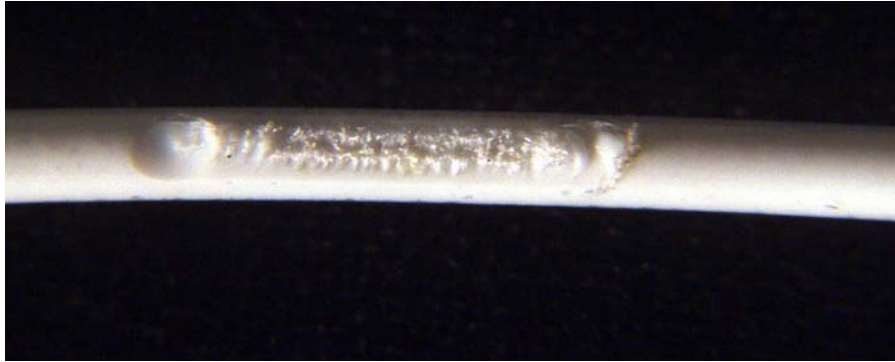
required. The X-axis dial is marked with .0005” increments. Adjust the Y-axis stop to the specified abrasion length. Crank the Y-axis dial clockwise until the stop is encountered. Turn off Dremel tool and remove the wire from the vise. Two examples of wire abrasions are shown in Figures DT1-4 and –5.

Figure DT1-4. Partial Wire Insulation Abrasion

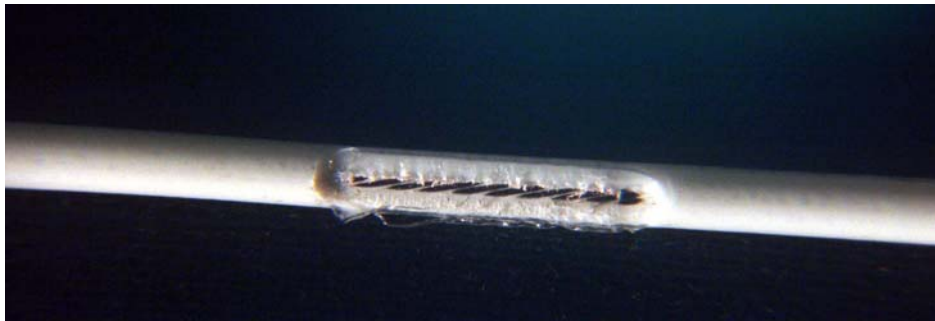
Figure DT1-5. Full Wire Insulation Abrasion Exposing Conductor

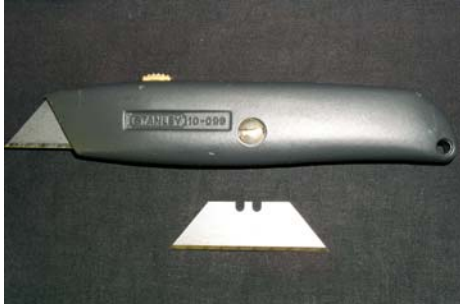
Tools: Stanley 10-099 knife, Stanley 11-921 blade, 25 blade feeler gauge set, measurement calipers, Fixture #1, Allen Screw Driver, Safety Glasses

Figure DT2-1. Stanley Knife and Blade

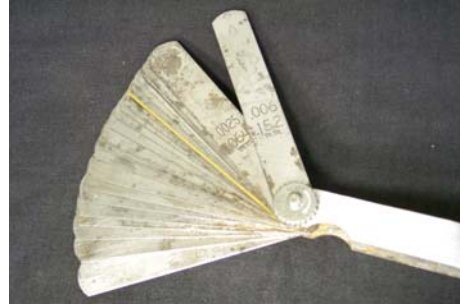
Figure DT2-2. Feeler Gauge Set

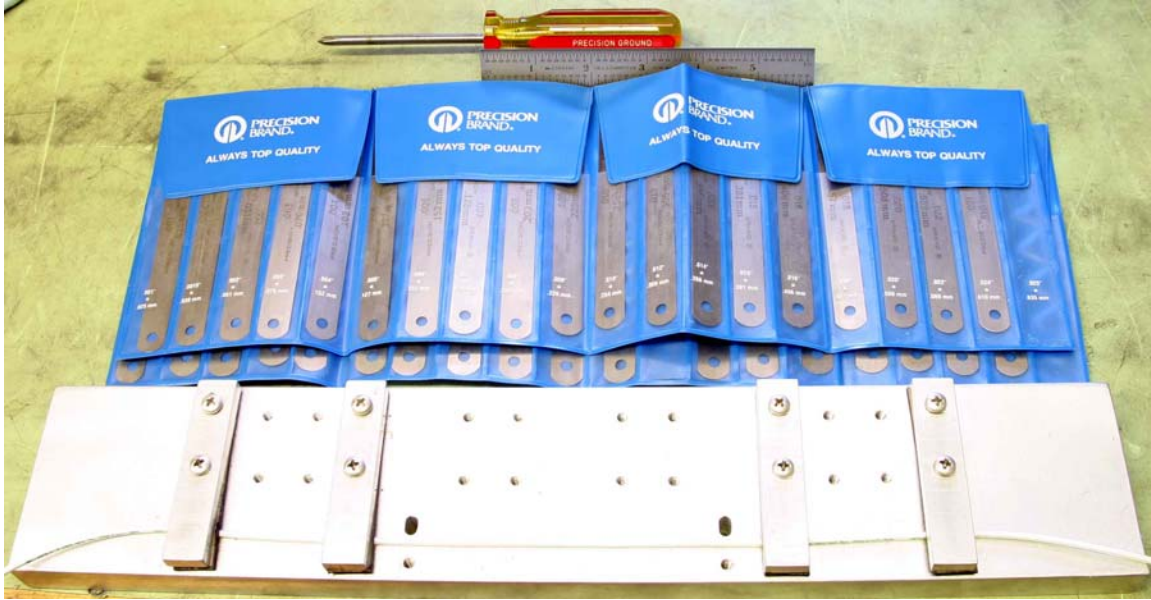
Figure DT2-4. Breach Defect Cutting Fixture and Feeler-Gauges

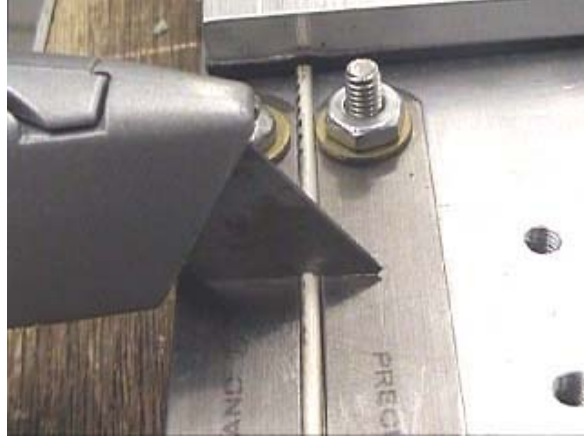
Secure feeler gauges to work surface and lay test wire parallel to the edge of the gauges. Using the Stanley knife press down on the wire insulation until the blade contacts with the top surface of the feeler gauge stack and not going below the top surface of gauges. Figures DT2-5 and DT2-6 show the wire positioned in the cutting fixture and the resulting straight cut. Rotate the wire 90 to 180° and cut again. Repeat the process until a complete 360° circumferential cut through the insulation is achieved. To fabricate a circumferential lateral breach, produce two similar cuts at the desire separation length (e.g., 1 inch away). Make a lateral cut along the separation length, down to the feeler gauge, separate insulation halves, and remove. Figure DT2-7 shows a circumferential lateral breach.

Figure DT2-5. Wire Positioned in Cutting Fixture

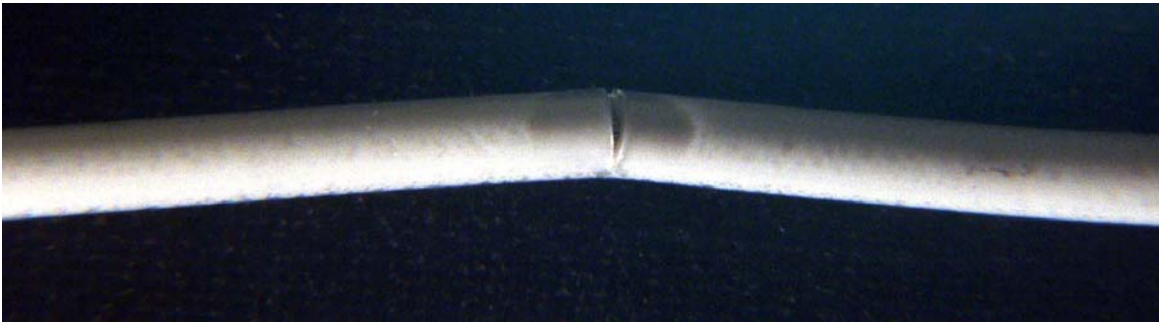
Figure DT2-6. Straight Cut Result

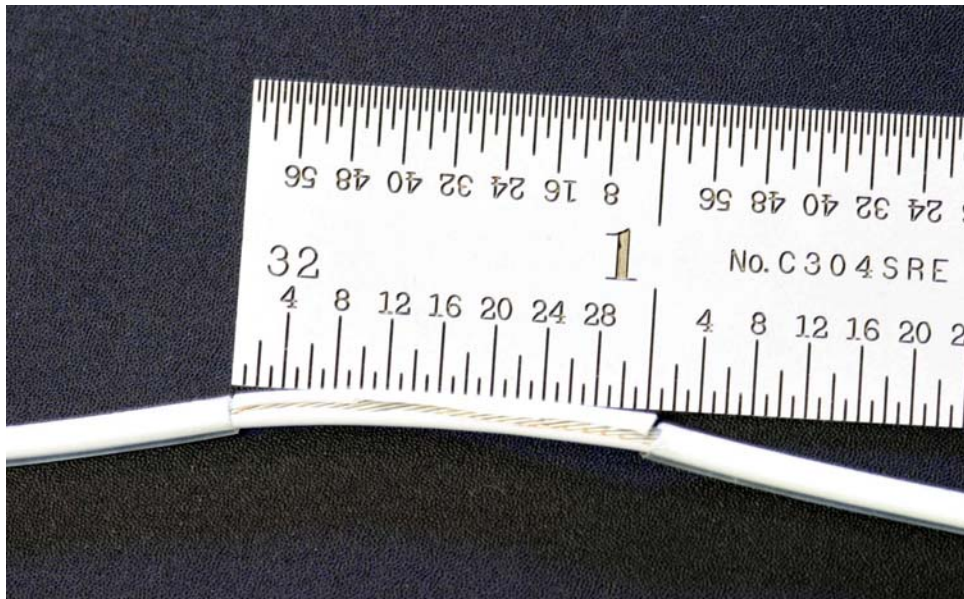
Figure DT2-7. Circumferential Lateral Breach

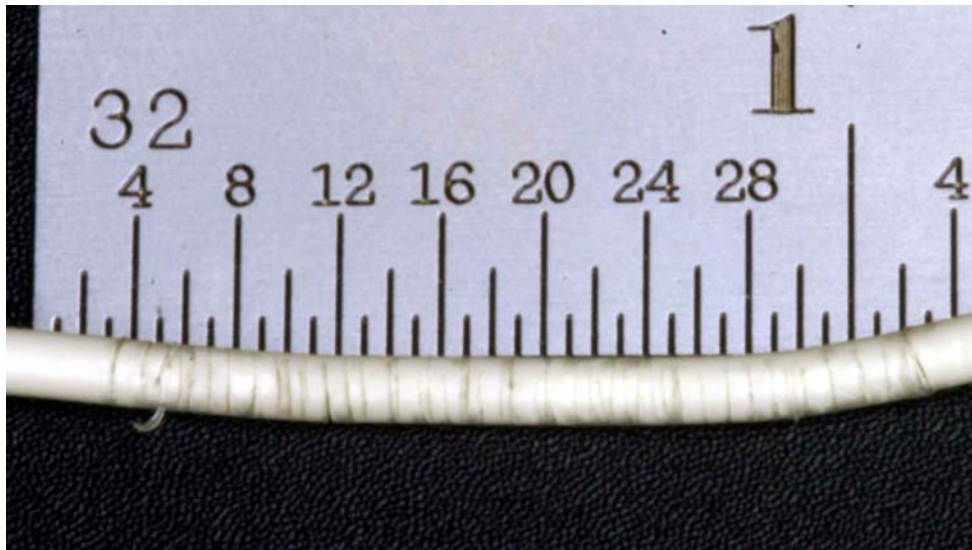
The following procedure will describe a method used to fabricate cracked insulation on wires placed in the test bed. The method introduces a specified number of cracks per inch of wire (density) using the straight knife cut procedure described above in DT-2: Insulation Breach. Determine the proper height of feeler gauge stack by using the measuring steps described in DT2. For cuts that do not go all of the way to the conductor, calculate the additional amount of feeler gauge height by multiplying the percent of remaining insulation desired by the insulation thickness. Figure DT2-1 shows the setup for producing a single cut into the insulation. Figure DT3-1 shows the resulting defect after using this procedure.

DT3-1. Simulated Cracked Insulation Defect from Straight Knife Cuts

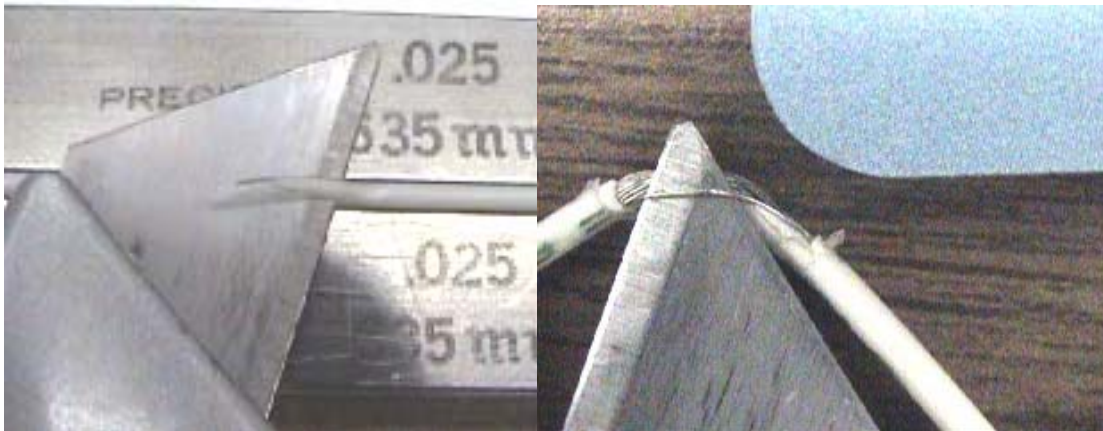
The following procedure will describe the method used to fabricate wire conductor partial strand breakage. Using the procedure described for mounting the wire into the cutting fixture described in section DT-2, secure the specimen wire and feeler gauges on the cutting fixture. Using the Stanley knife, cut into insulation until side of blade is flush with feeler gauges. Make a 360° cut sufficient to expose conductor strands. Remove the wire from the fixture and using the knife select the particular strand. Using a smaller knife, sever the strand. Repeat the procedure until the specified number of strands is severed. After cutting the individual strands, bend each strand backwards (180°), so no contact is made with other strand cuts. Apply heat shrink tubing over defect to hold strands in place and to isolate severed strands. Figure DT4 – 1 shows the wire mounted in the fixture and strand selection and Figure DT4-2 shows the strand folded back.

Figure DT4-1. Two Steps Required for a Partial Conductor Strand Cut

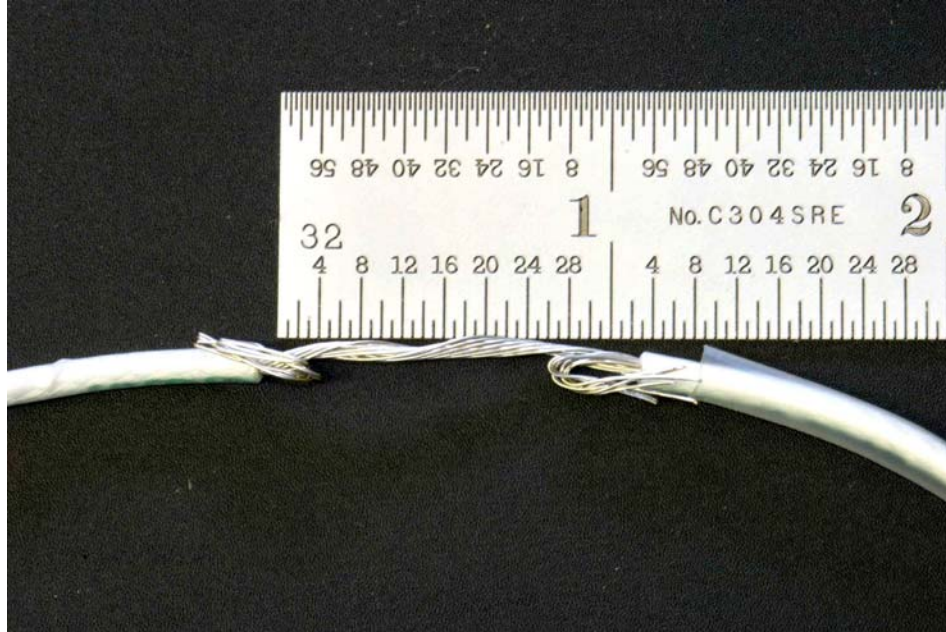
Figure DT4-2. Result of Conductor Strand Cut and Fold-Back
