SANDIA REPORT

SAND2003-2923

Aircraft Wire System Laboratory Development: Phase I Progress Report

Mike Dinallo and Chris Lopez

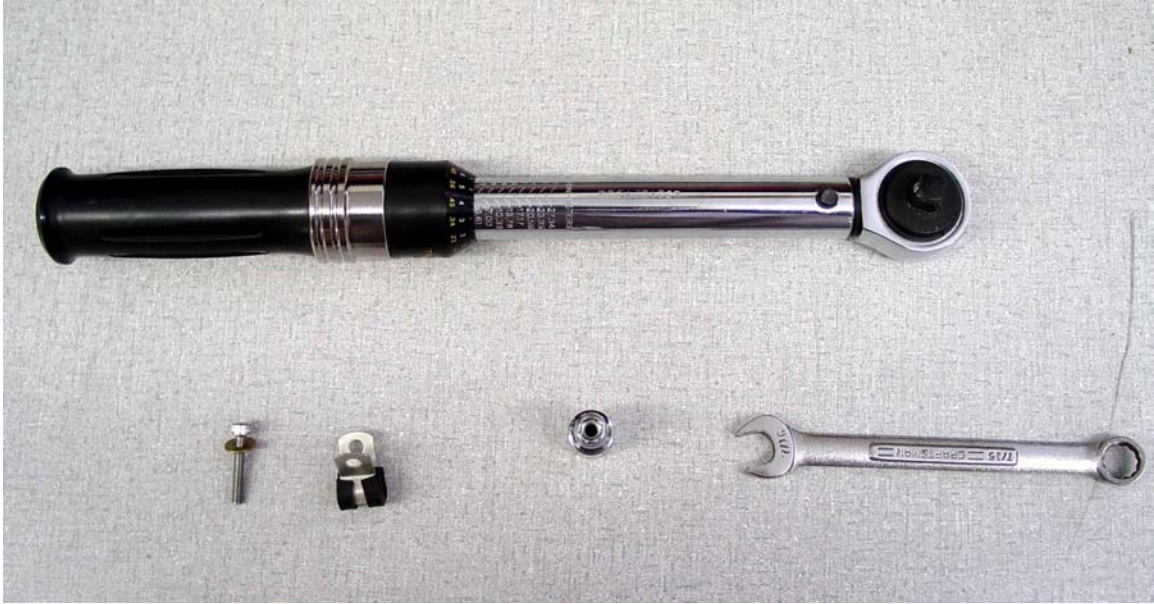
The following procedure describes the two methods used to over-pressure harness clamps. Figure DT5-1 shows the tools that are needed to produce an over-pressured clamp. Using a clamp that is undersized, remove any cushion/padding from the clamp and secure the clamp around the harness at the specified location. The location may correspond to a ribbed structure element of the simulated aircraft fuselage segment location within the enclosure. Using the socket wrench and an appropriately sized ratchet, compress the clamp around harness to a normal (~10 inch-lb) degree of tightness. Next use the torque wrench to the specified value of clamp tightness or compression (units of inch-lb). Another variation of this defect type is to allow one to three wires to be pinched by the hardware section of clamp. Both of these over-pressured clamp defects are shown in Figure DT5-2.

DT5-1. Tools Needed for DT5

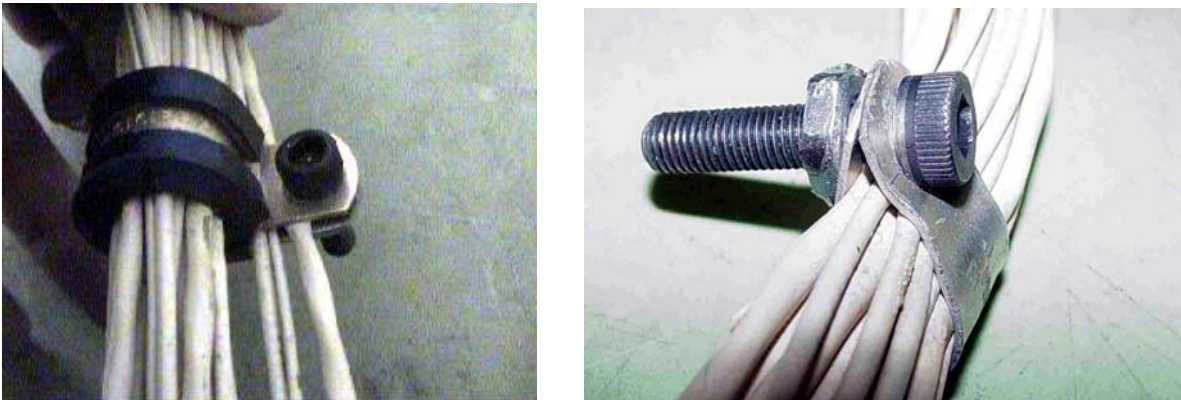
Figure DT5-2. Two Types of Over-Pressured Clamp Defects

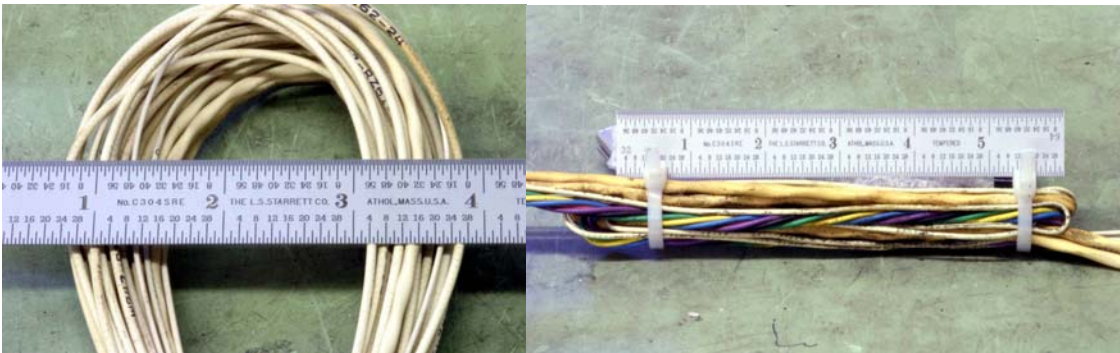
The following procedure will describe the method used to introduce excessive bending radius of harnesses. Ensure that the specimen harness has sufficient length so that when installed into the test bed the connectors are capable of spanning the enclosure length. Bend the harness to a specified radius in multiples of harness diameter. Apply tie band. Repeat the process to orient the harness on the intended path within the enclosure. Figure DT6-1 shows a zero bend-radius defect with two tie bands securing the bends in place and a wire with harness diameter separation of about two diameters.

Figure DT6-1. Illustration of Harness Diameter Separation and Applied Tie-Band

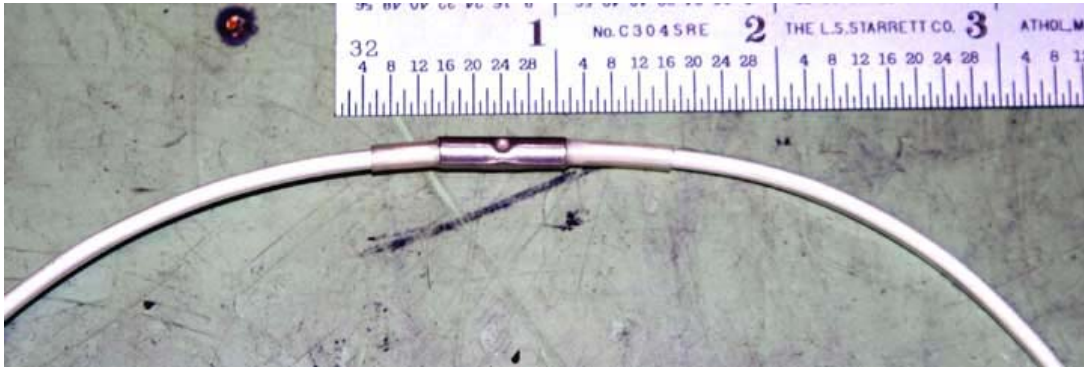
The following procedure will describe three methods used to introduce faulted wire splices. The first method (type I) inserts each end of the wire to be joined into a butt joint but *with no* crimping and *with* heat applied to heat-shrink tubing that is placed about it. This defect is shown in Figure DT7-1. The second method (type II) is a crimped but exposed splice. This defect is shown in the left photograph of Figure DT7-2. The third method (type III) is a crimped splice but excessively over heated. This defect is shown in the right photograph of Figure DT7-2. This type three defect utilizes the charred insulation procedure, exposed for ~ 1 to 1.5 minutes, described in section DT-8 below.

DT7-1. Example of Type I Un-Crimped but Heated Faulted Splice

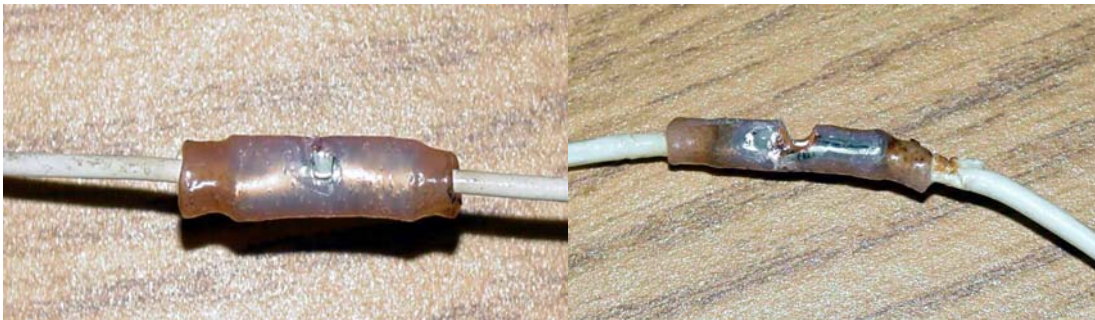
DT7-2. Type II (Left) and Type III (Right) Faulted Splices

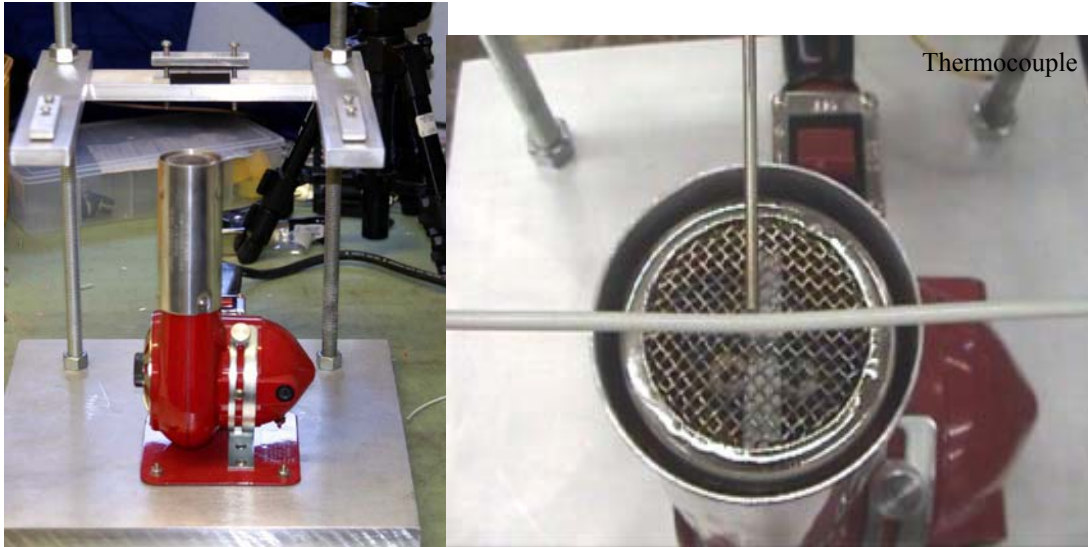
The following procedure describes the method used to fabricate charred wire specimens. Adjust the height of the heat gun wire-mounting fixture so that the wire holder is approximately 1-inch above the heat gun nozzle. The fixture is shown in Figure DT8-1. Turn on the heat gun until the thermometer indicates 500°F. Turn off the heat gun, and quickly place wire specimen on fixture. Turn on the heat gun and expose wire for specified duration. Record exposure time and indicated temperature. Do not allow heat gun to cool down until all desired wires are burned. Figure DT8-2 shows the resulting defects of varying burn severities.

Figure DT8-1. Heat Gun and Wire Mounting Fixture with Close-up View of Wire Positioned Over Heat Gun Nozzle

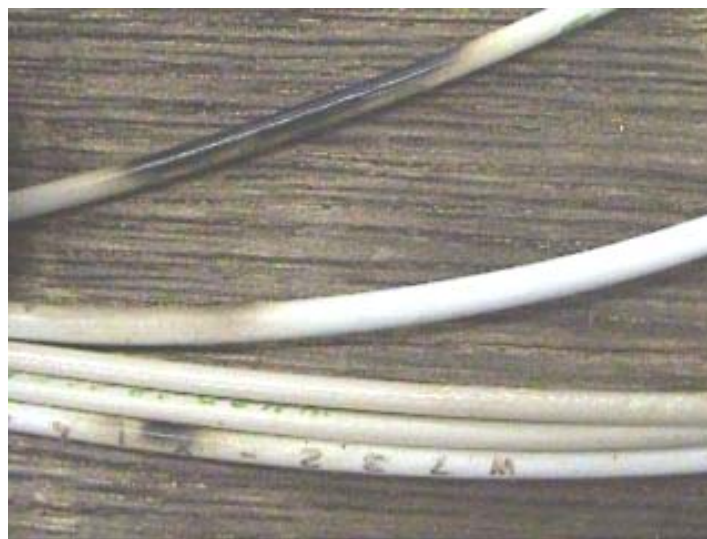
DT8-2. Resulting Severities of Burnt Wires

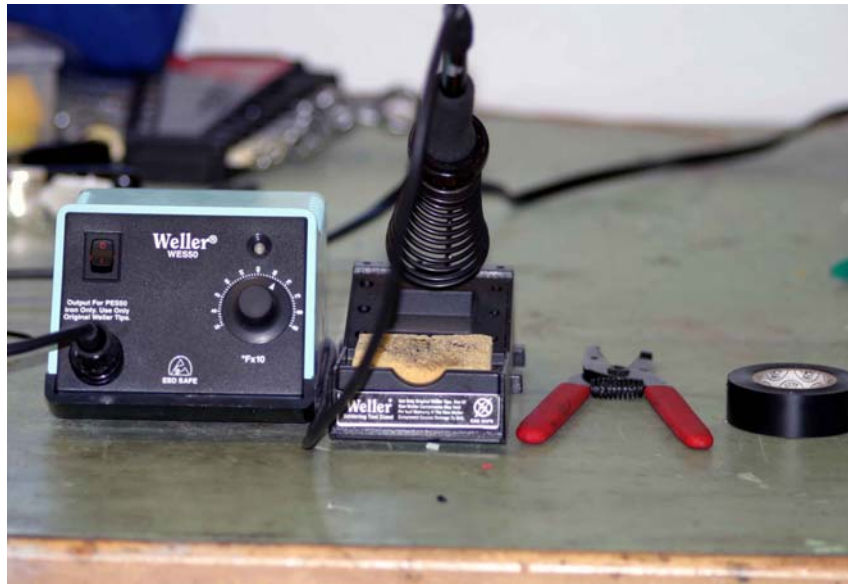
of the wire and cover with electrical tape. If contact is to be maintained between each side of the previously uncut wire, solder together the desired number of strands that correspond to the percentage of contact to be maintained and cover with electrical tape. For example, solder together half of the strands of each end of wire for fifty percent contact. Figure DT9-1 shows the tools needed to do the procedure. Figure DT9-2 shows the soldering together of wire strands and the resulting defects.

Figure DT9-1. Tools Needed for Opened Wire Conductor Defect

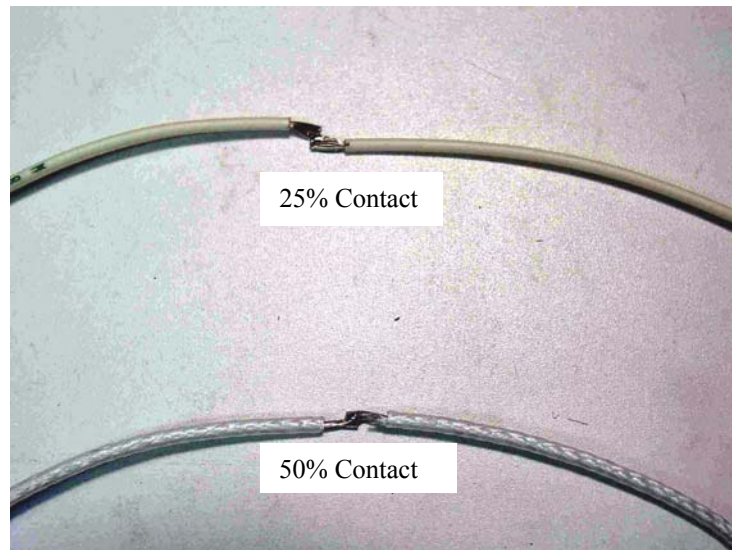
Figure DT9-2. 50 and 25 Percent of Varying Degrees of Contact

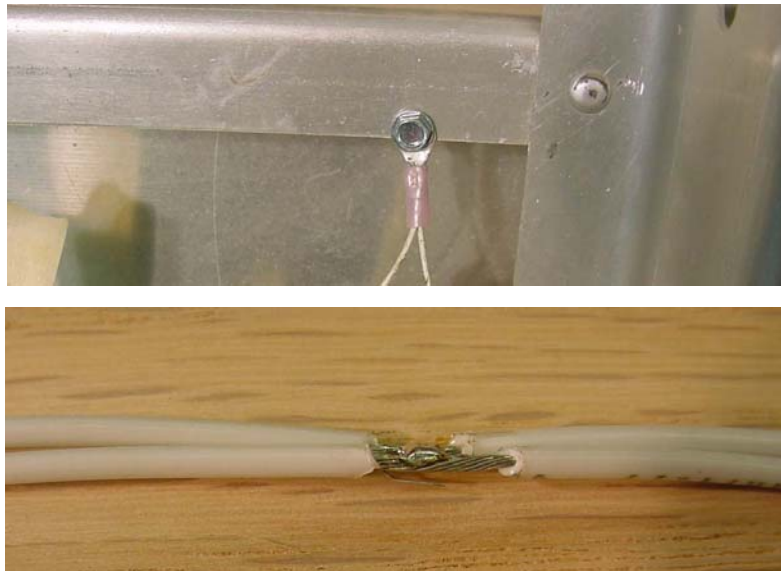
The following procedure will describe two methods used to introduce unintended short-circuited conditions in wire specimens. Select wire specimen and short location. The first method is a wire shorted to the enclosure frame (common mode). Cut wire and crimp on O-lug. Use a sheet metal screw and power drive to attach lug to enclosure frame. The second method uses the lateral breach procedure provided in section DT-2 to remove a segment of insulation of two adjacent wires and then a solder joint to short the two wires together (differential mode). Figure DT10-1 shows both wire short types. The severity of both types of shorts can be varied by soldering resistors of varying ohmic values between the ends of the short. This is shown in Figure DT10-2.

DT10-1. Photographs of Two Short Types

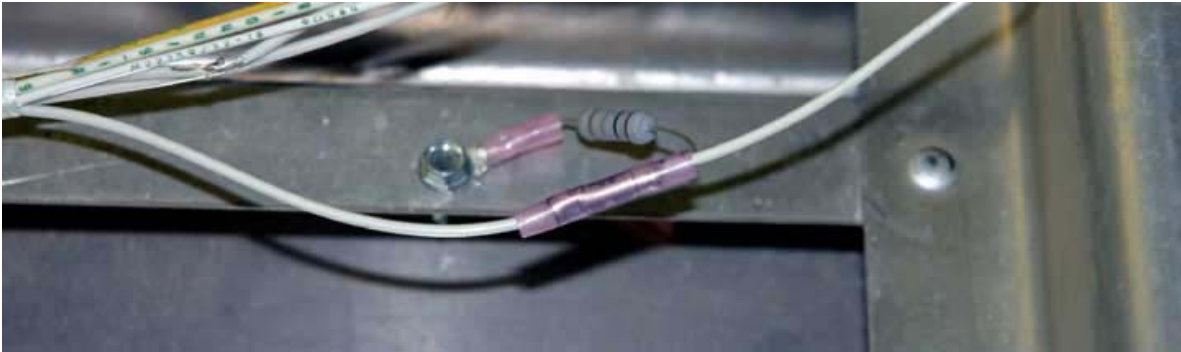
DT10-2. Resistor Used to Simulate a Partial Short

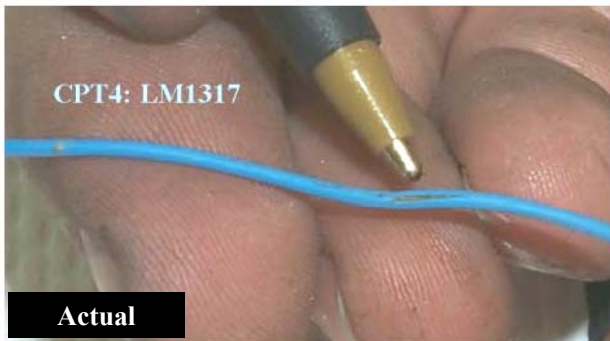
Chaffed Defects (DT-1)

Figure 3.1.7-6. 747 Breach LM1317 – Cockpit Floor.

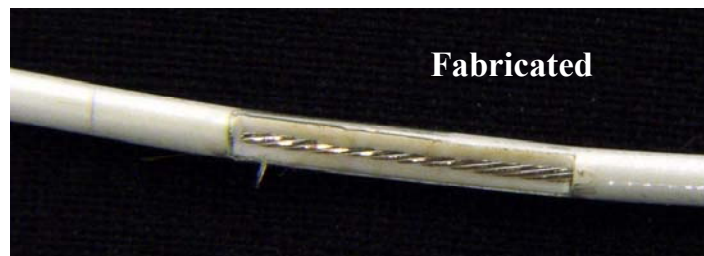
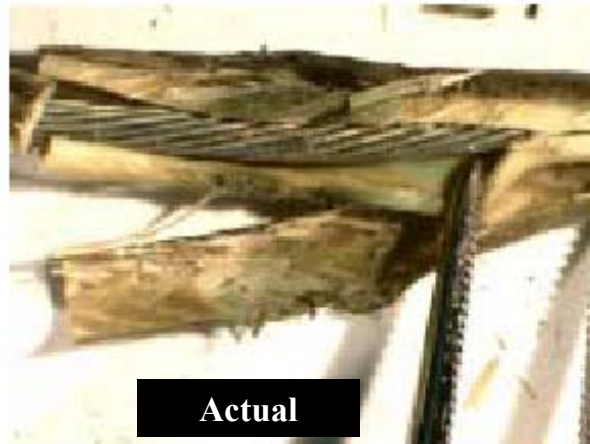
Breach Defects (DT-2)

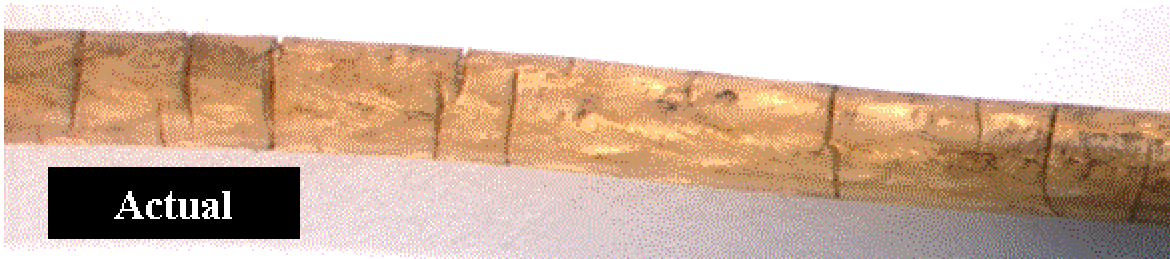
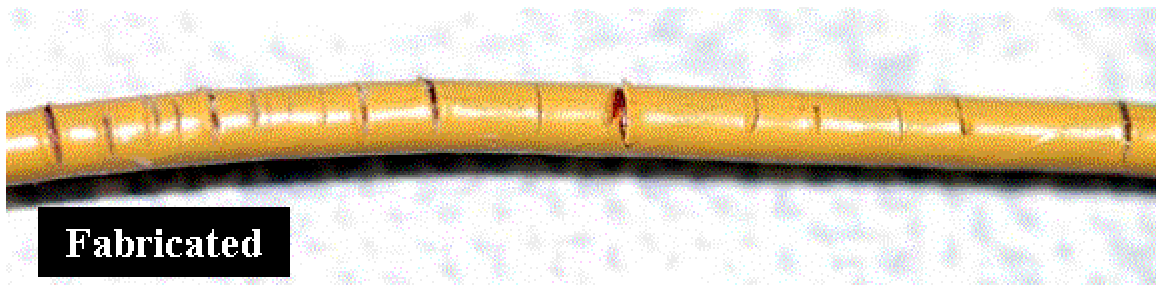
Cracked Defects (DT-3)

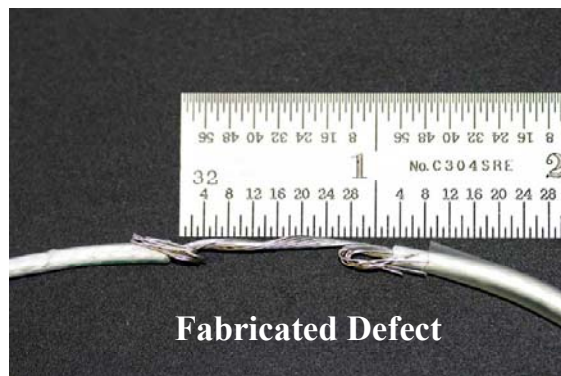
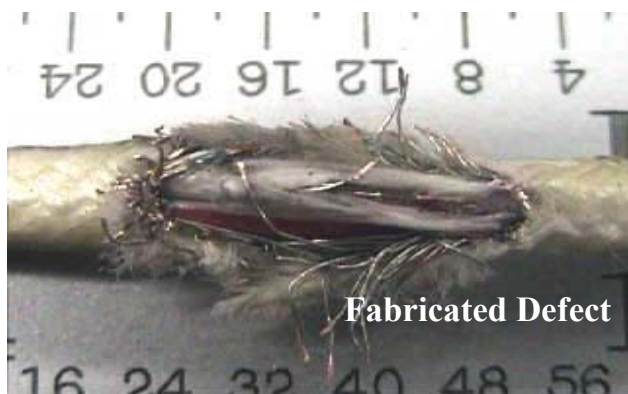
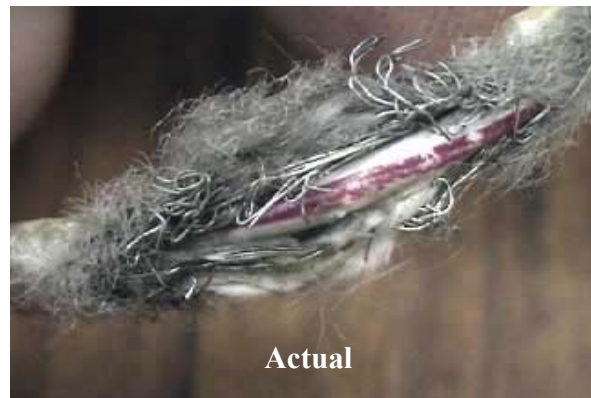
Conductor Strand Break Defects (DT-4)
