Radiographic Inspection of Fueled Clads

**Idaho National Laboratory
Physics Department
Idaho Falls, Idaho 83415**

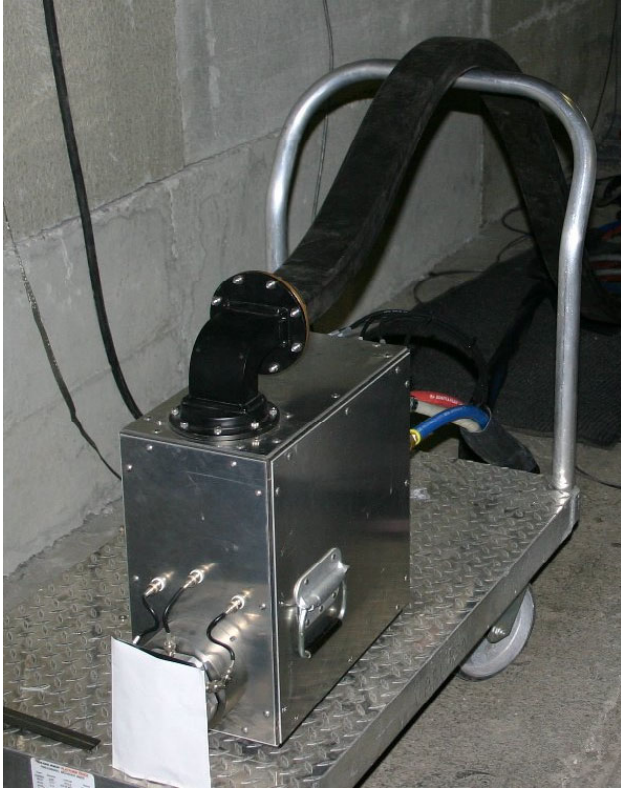
Figure 2. Components used for radiographic testing at the Idaho Accelerator Center Annex in Pocatello, ID. Left: Linear accelerator and waveguide (the paper does not attenuate much radiation!). Right: Rotational stage used for holding and angular positioning fueled clads. A full-scale surrogate is in the clad holder and pieces of another surrogate are at the sides.

Figure 2 shows the business end of the linear accelerator and a photograph of the rotational stage as used in the preliminary tests at the IAC.
