# **OBSERVATIONS ON FAULTS AND ASSOCIATED PERMEABILITY STRUCTURES IN HYDROGEOLOGIC UNITS AT THE NEVADA TEST SITE**

March 2009

U.S. Department of Energy  
National Nuclear Security Administration  
Nevada Site Office

Underground Test Area and Boreholes Programs and Operations  
Environmental Restoration  
National Security Technologies, LLC  
Las Vegas, Nevada

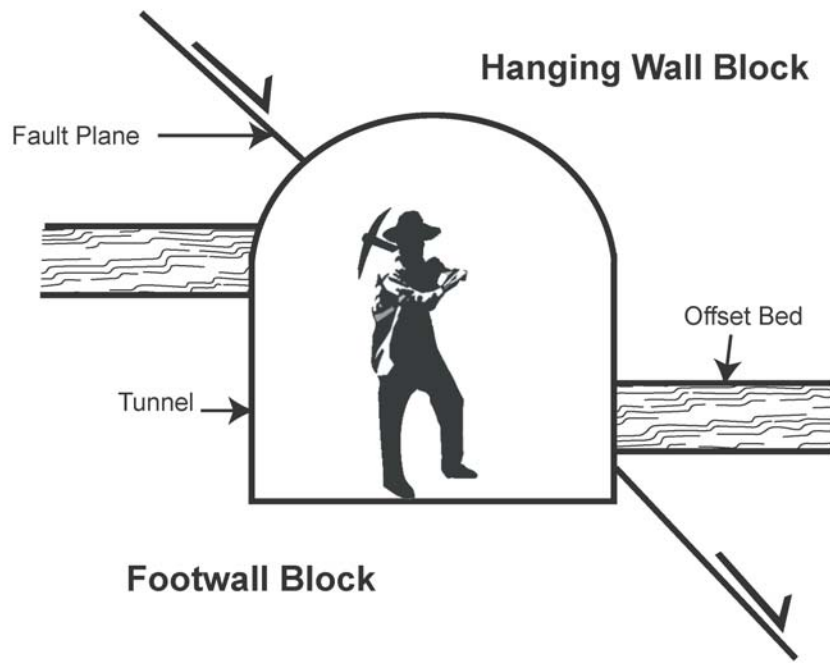
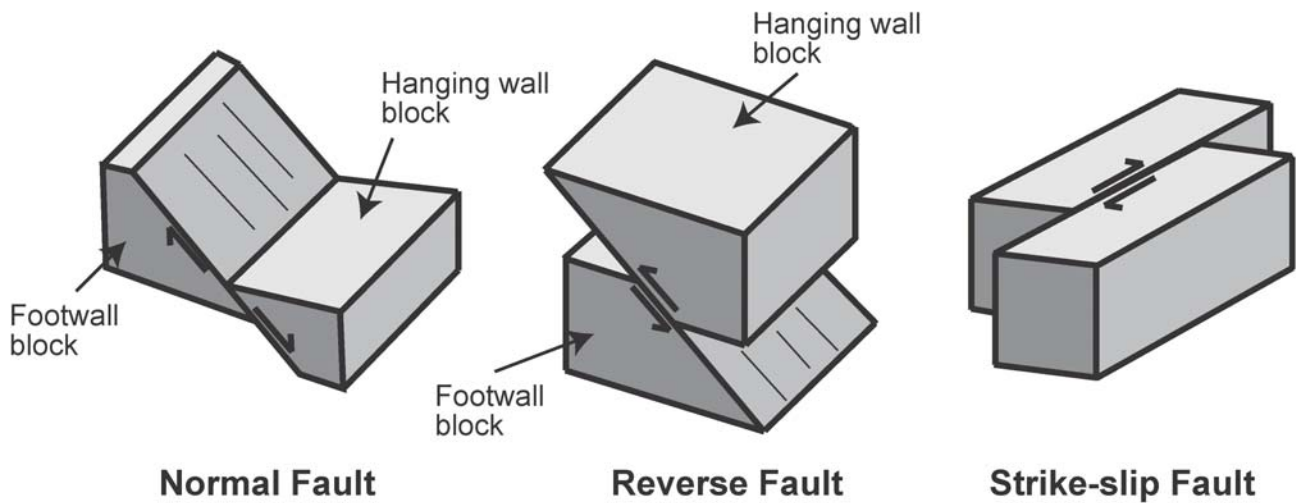
**Figure 1-1**  
**Schematic Diagrams Illustrating Fault Block Relationships**

For an inclined fault, the overlying fault block is referred to as the hanging wall block, and the underlying block as the footwall block. These relationships can be visualized in a simple fashion by a hypothetical tunnel driven along an inclined fault as illustrated in Figure 1-1A. A person in the tunnel will be standing on the footwall and looking up at the hanging wall.

Faults can be classified into three basic types based on the orientation of the fault plane and the relative movement of the adjacent fault blocks (Figure 1-1B). Normal faults are inclined faults where the hanging wall has moved down the fault plane relative to the footwall. By contrast, reverse faults are inclined faults where the hanging wall has moved up the fault plane relative to the footwall. Low-angle (dips less than 45 degrees) reverse faults are typically referred to as thrust faults. Thrust faults can have reverse offset measured in tens of kilometers. Strike-slip faults are typically very high-angle faults where the adjacent fault blocks have moved horizontally relative to each other.

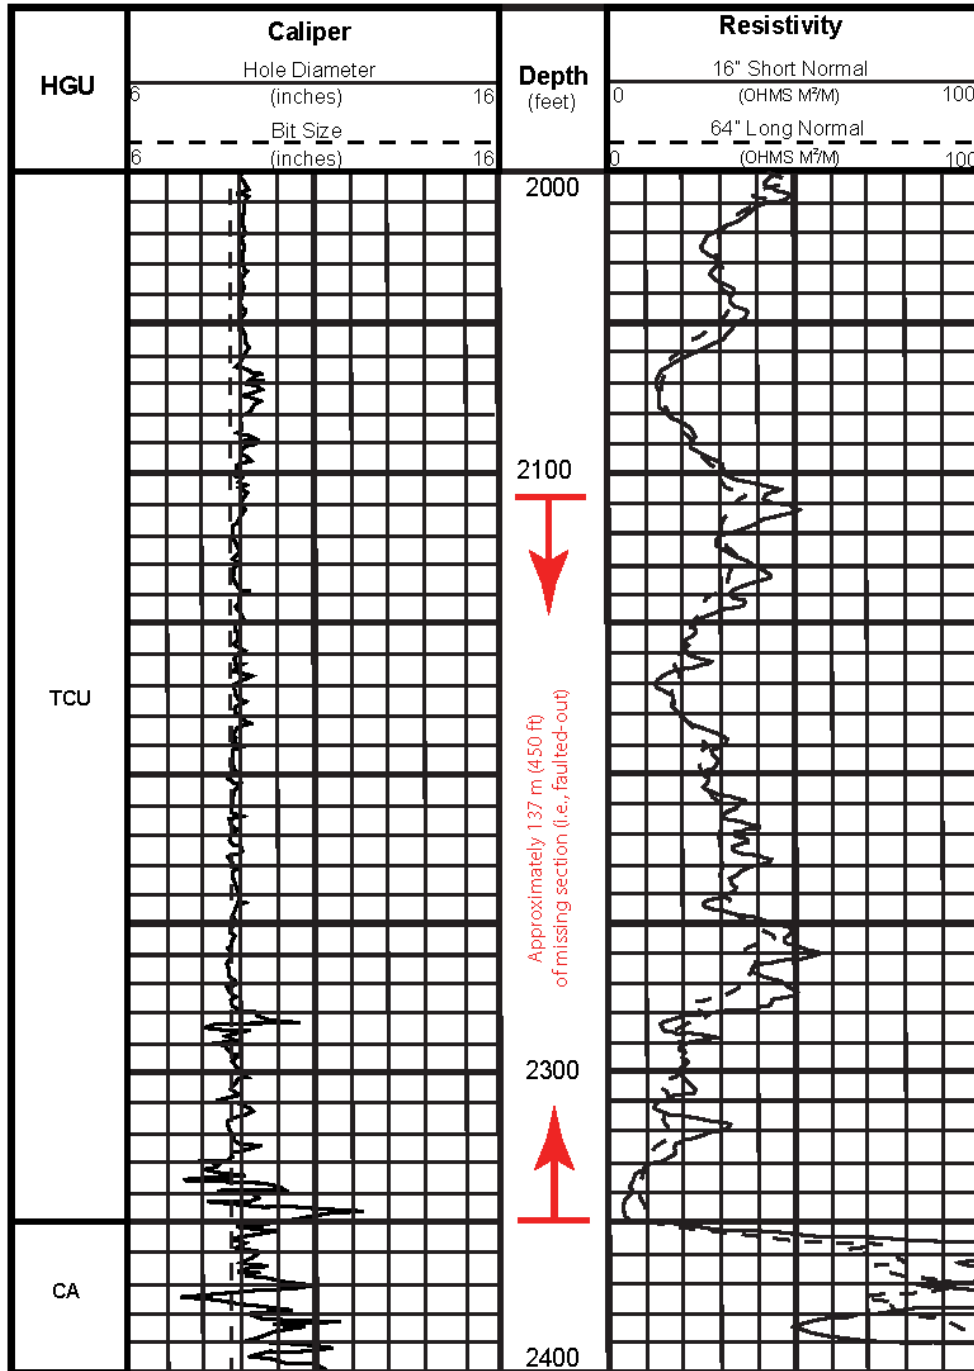
**Figure 2-3**  
**Portions of the Caliper and Resistivity Logs for Drill Hole UE-1q Showing Log Signatures Across the Topgallant Fault in Yucca Flat**

Stratigraphic information indicates that UE-1q intersected the Topgallant fault between the depths of 2110 and 2350 feet (red bracketed interval). Note, however, that the fault is not readily identifiable in the geophysical log data.

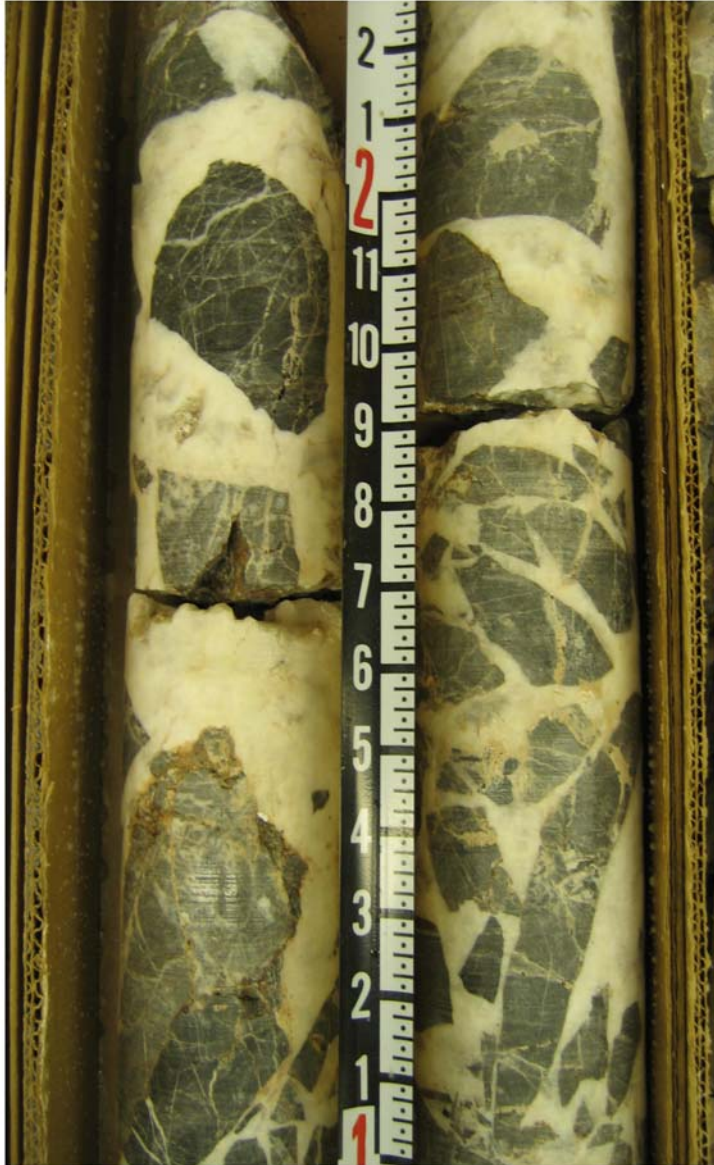
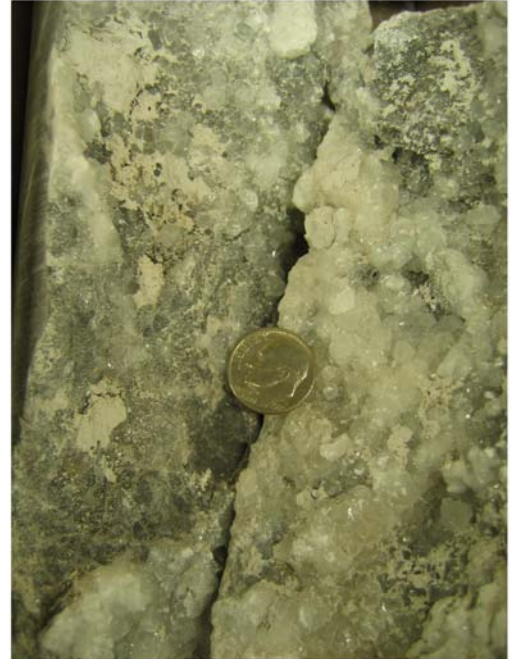
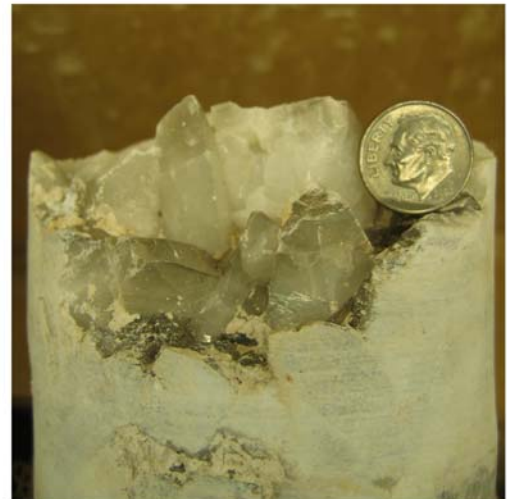
**Figure 4-1**  
**Secondary Calcite in Core Samples from the Hanging Wall of the CP Thrust Fault**  
**in UGTA Well ER-6-2**

Breccia consisting of dolomite clasts within a coarsely crystalline calcite matrix. Tape measure is marked in inches.

Secondary calcite crystals lining fracture in dolomite.

Large secondary calcite crystals lining opening in dolomite.

spectacularly in core samples across the CP thrust fault in Well ER-6-2 that show very coarsely crystalline secondary calcite filling and lining fractures and cementing dolomite breccia (Figure 4-1). It was also observed in this study that calcite-filled fractures were much more abundant in carbonate rocks in the CP Hills, where they occur in the hanging wall of the CP thrust fault, than in carbonate rocks in the Halfpint Range east of Yucca Flat, which are interpreted to generally be un-thrusted (Cole et al., 1997).

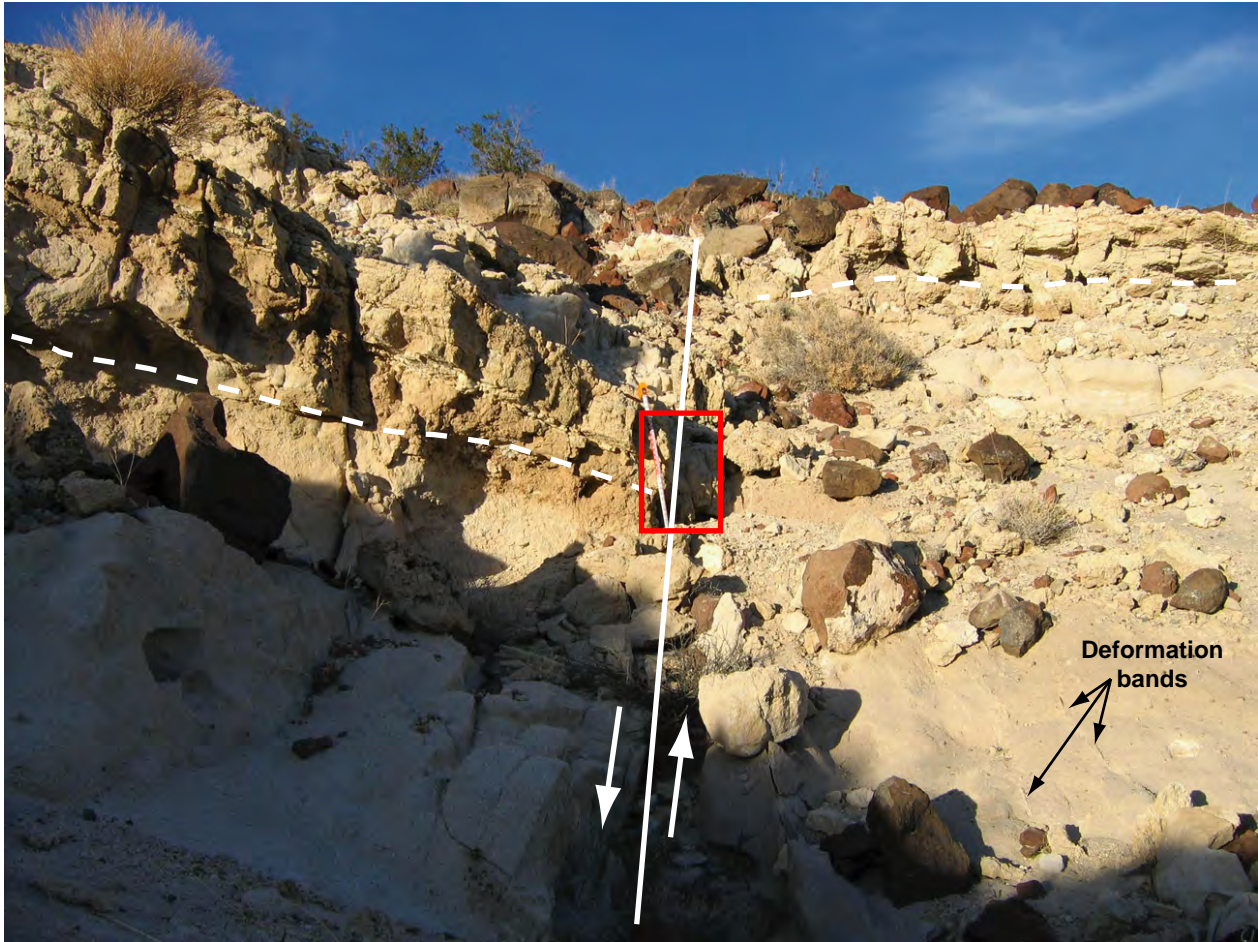
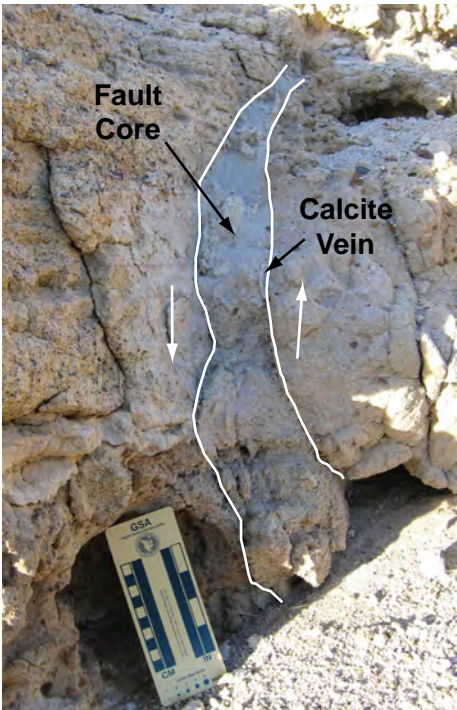
**Figure A-1**  
**Fault Station FF-3**

Normal fault within **vitric-tuff aquifer**. Staff in upper photograph is 1 meter (m) (3 feet [ft]). Red square in upper photograph indicates location of close-up photograph at right.

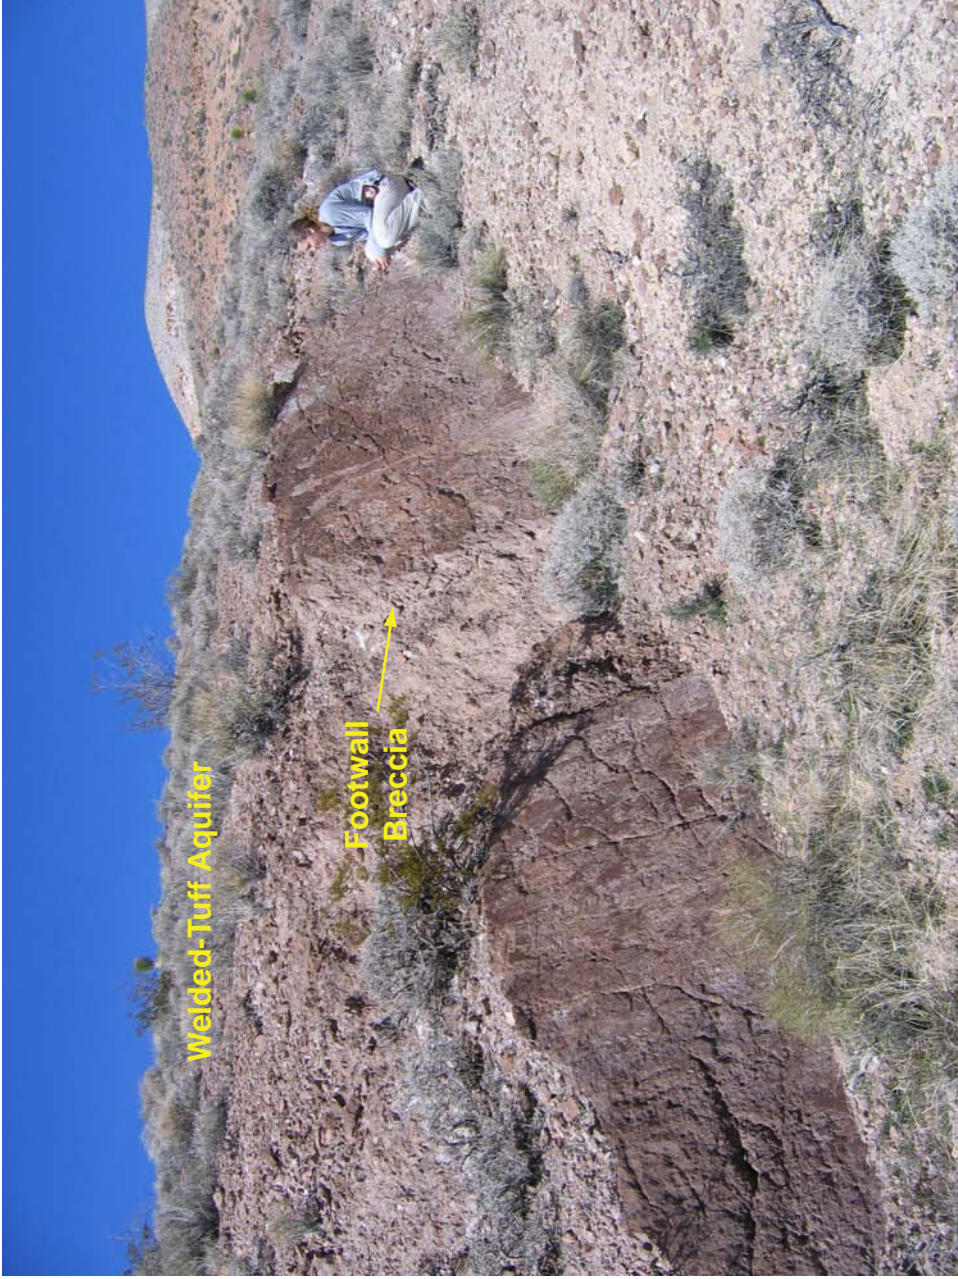
**Figure A-2**  
**Fault Station FP-2**

Footwall scarp in **welded-tuff aquifer**. Fault plane is developed on footwall breccia.

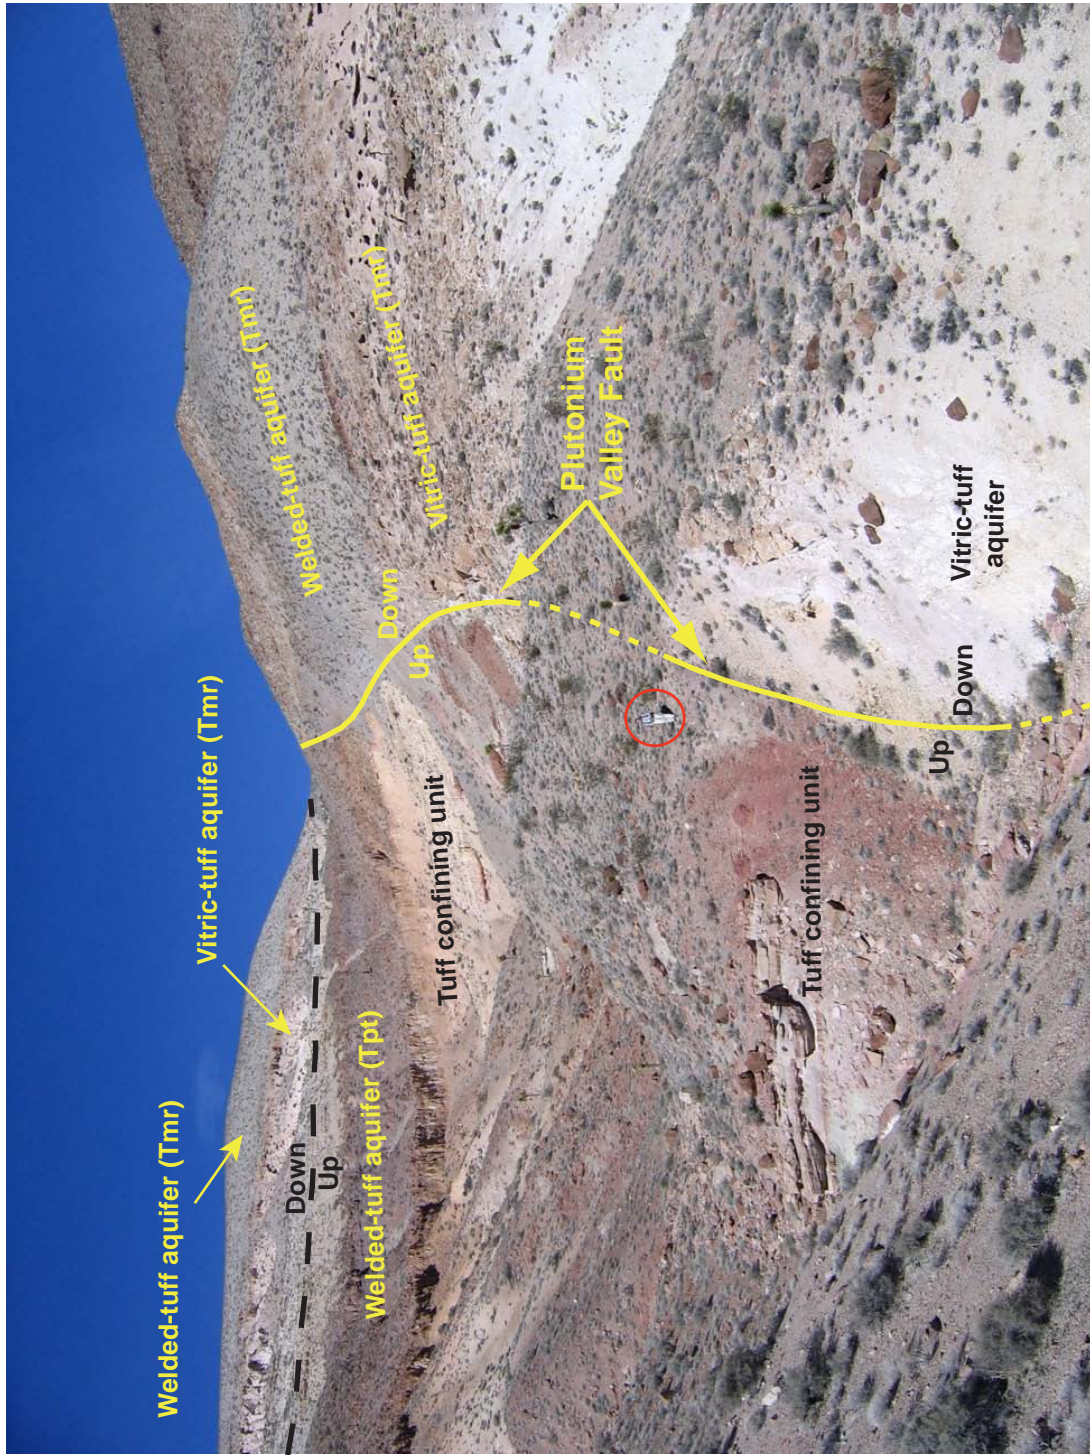
**Figure A-3**  
**Plutonium Valley Fault**

Looking north at the Plutonium Valley fault. The fault dips 70 to 80 degrees to the east and has approximately 120 m (400 ft) of normal offset. The fault juxtaposes **welded-tuff aquifers** and **vitric-tuff aquifers** of the Rainier Mesa Tuff (Tmr) down against **welded-tuff aquifer** and **tuff confining units** of the Topopah Spring Tuff (Tpt) and older volcanic units. Red circle locates geologist for scale.

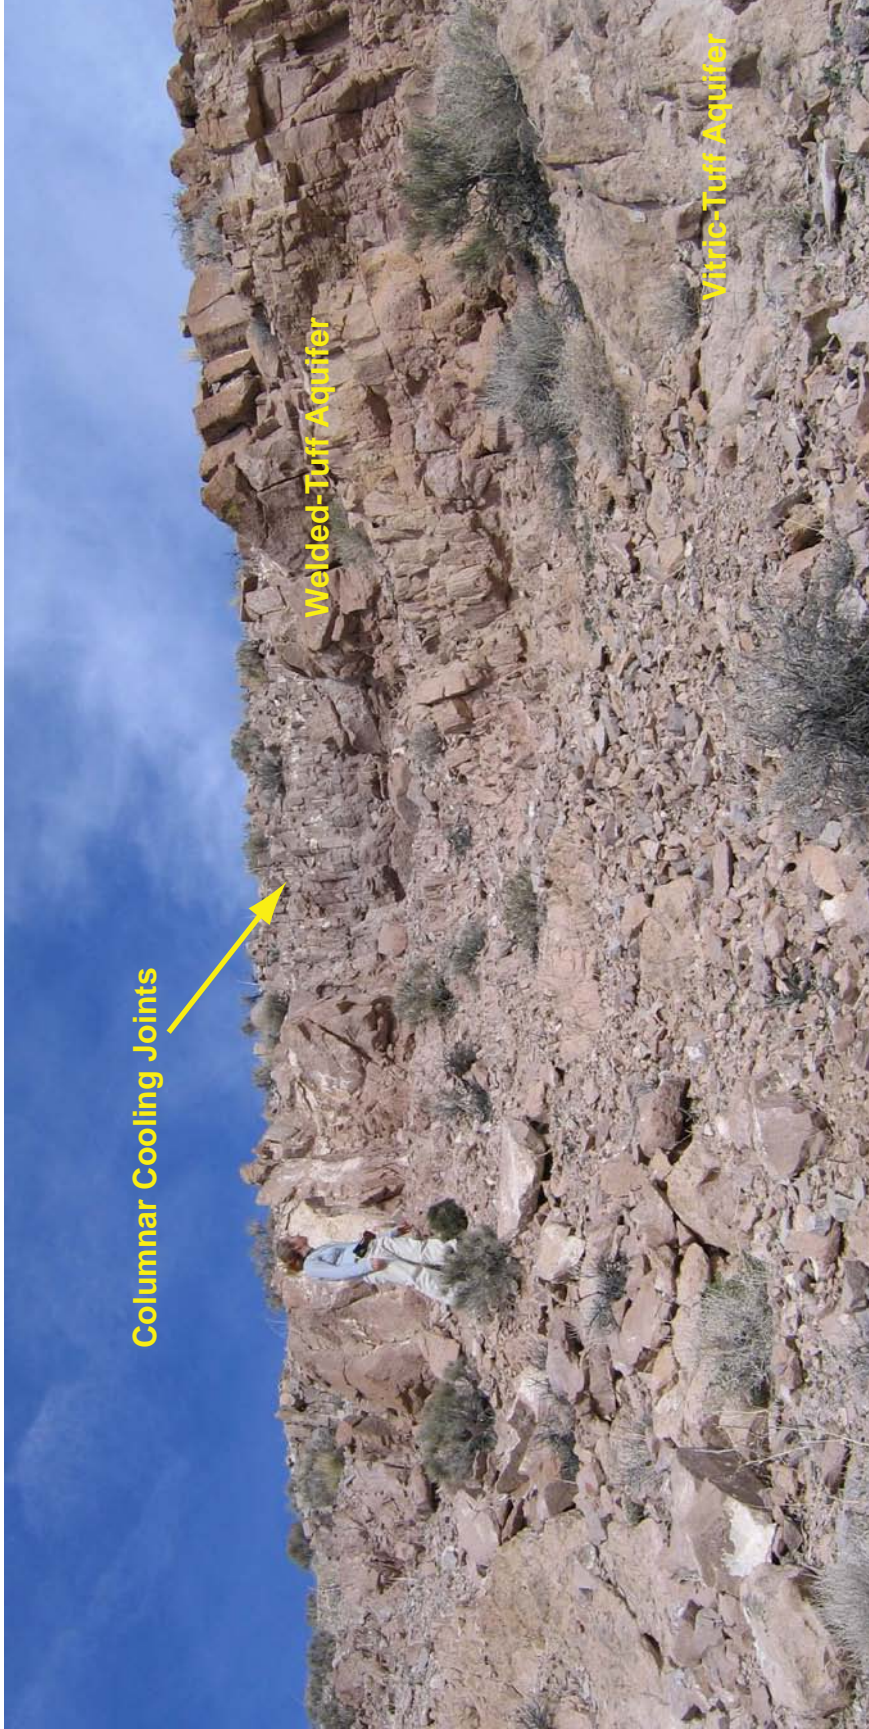
**Figure A-5**  
**Fault Station FP-4 (hanging wall)**

Hanging wall damage zone of the Plutonium Valley Fault. Damage in the **welded-tuff aquifer** consists of intense fracturing. Note, however, that some of the fractures are cooling joints and thus not related to faulting. Note also the general lack of fractures within the underlying **vitric-tuff aquifer**. The trace of the Plutonium Valley fault is just off the left side of the photograph.

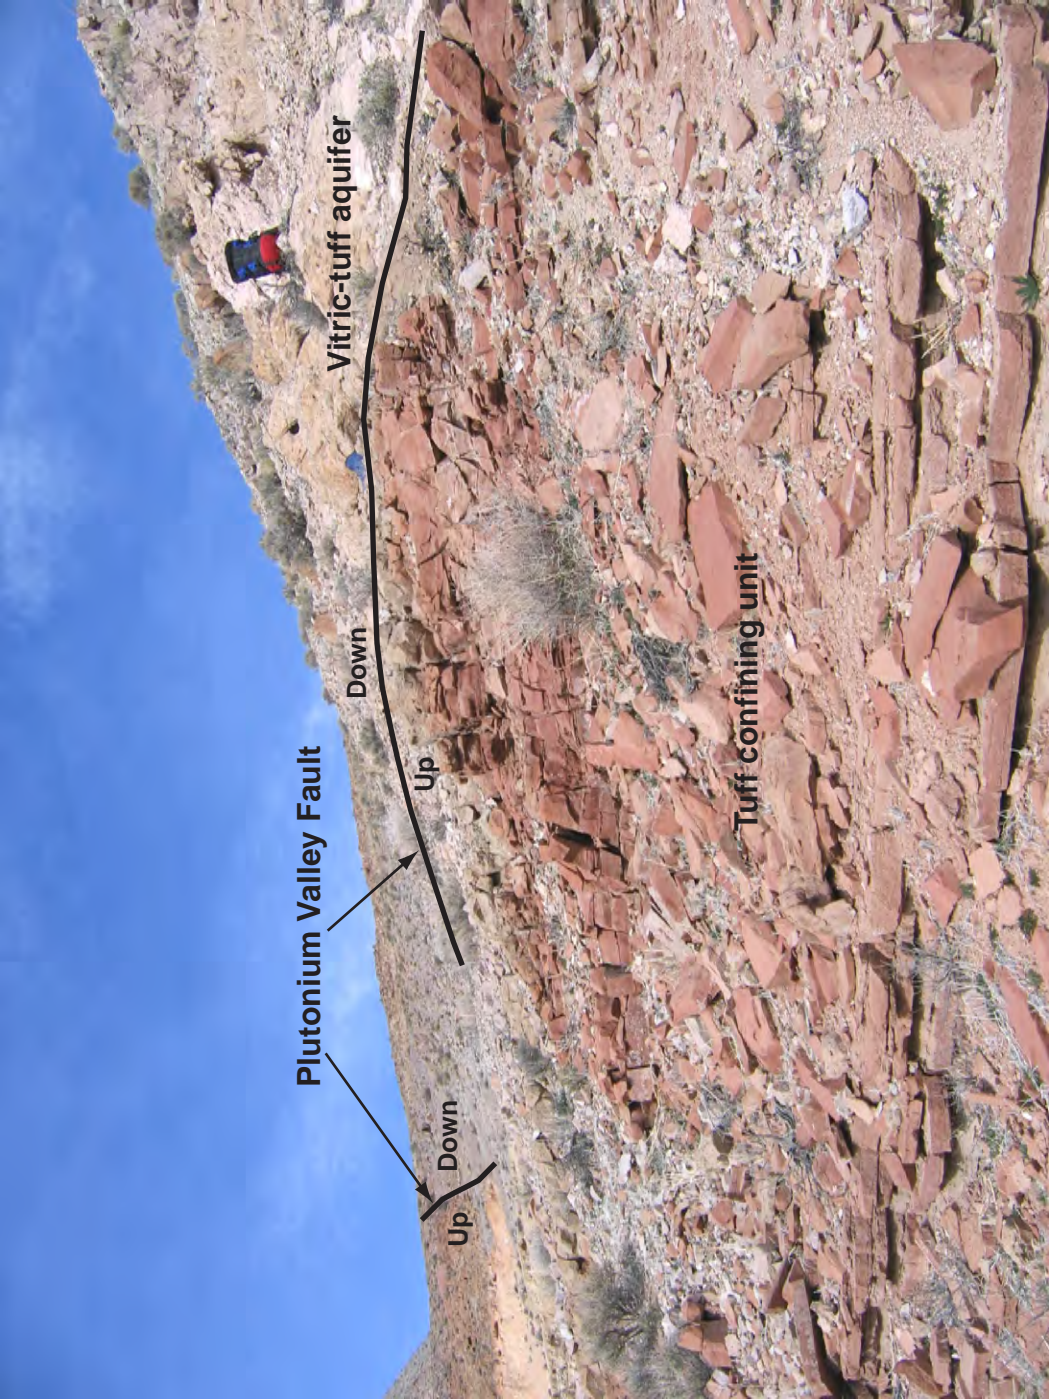
**Figure A-6**  
**Fault Station FP-4 (footwall)**

Footwall damage associated with the Plutonium Valley fault. Thin red tuffaceous siltstone beds are intercalated within an interval of **tuff confining unit** composed mostly of zeolitic to argillic tuff. These more indurated beds show enhanced fracturing adjacent to the Plutonium Valley fault.

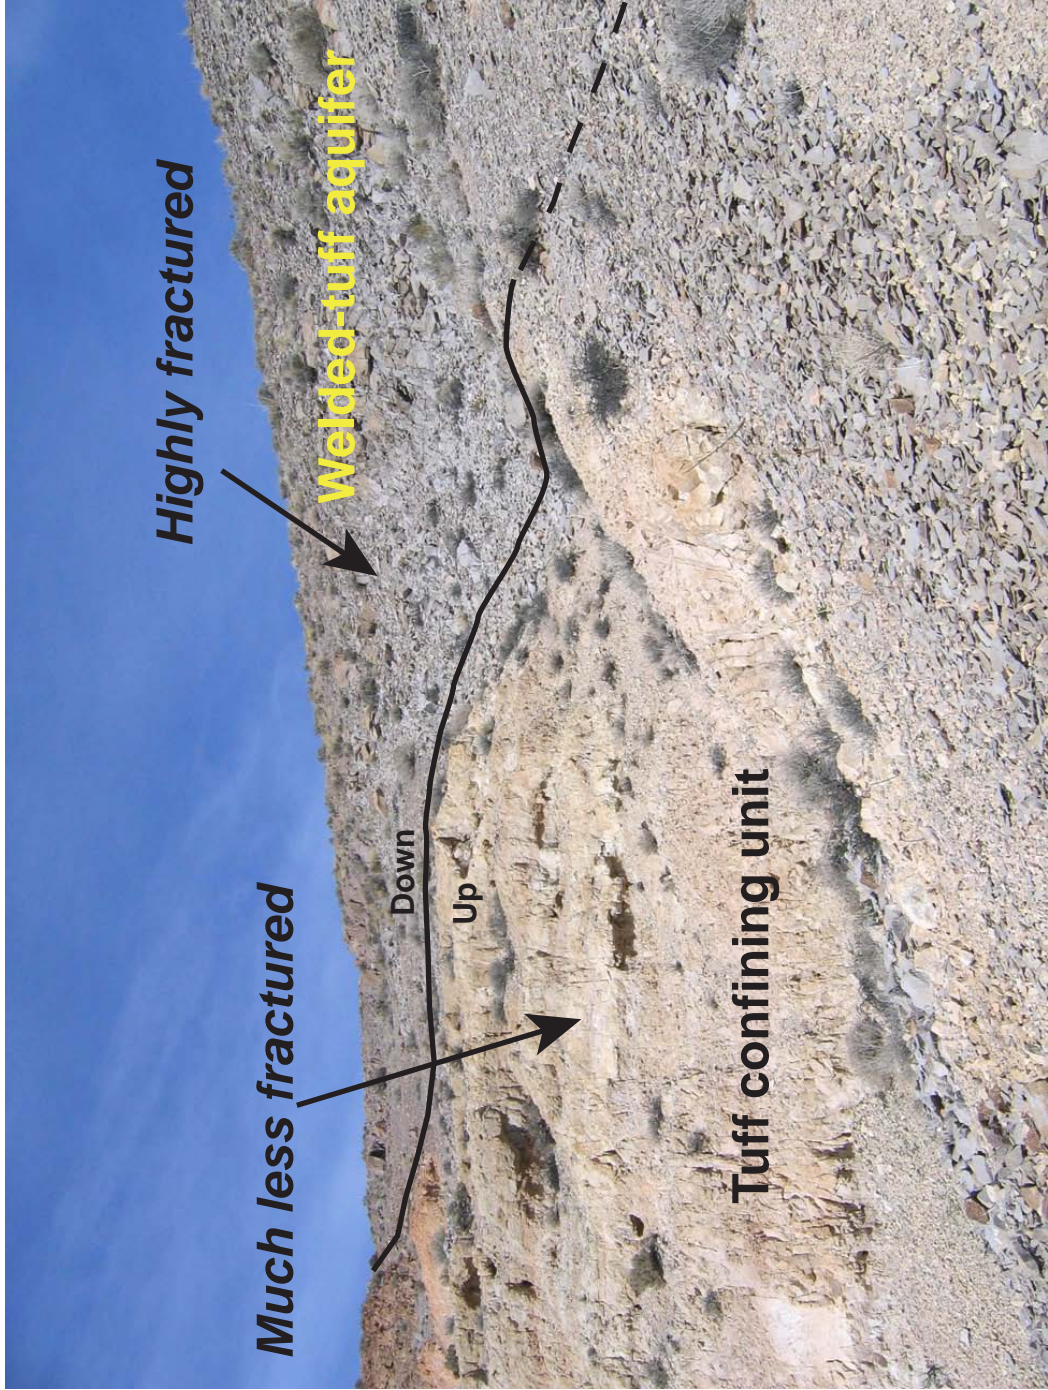
**Figure A-7**  
**Fault Station FP-5**

**Welded-tuff aquifer** faulted down against **tuff confining unit** along the Plutonium Valley fault. The **welded-tuff aquifer** shows intense fracturing that forms scree-covered slopes. The **tuff confining unit** also shows enhanced fracturing adjacent to fault but is much less fractured than the **welded-tuff aquifer**.

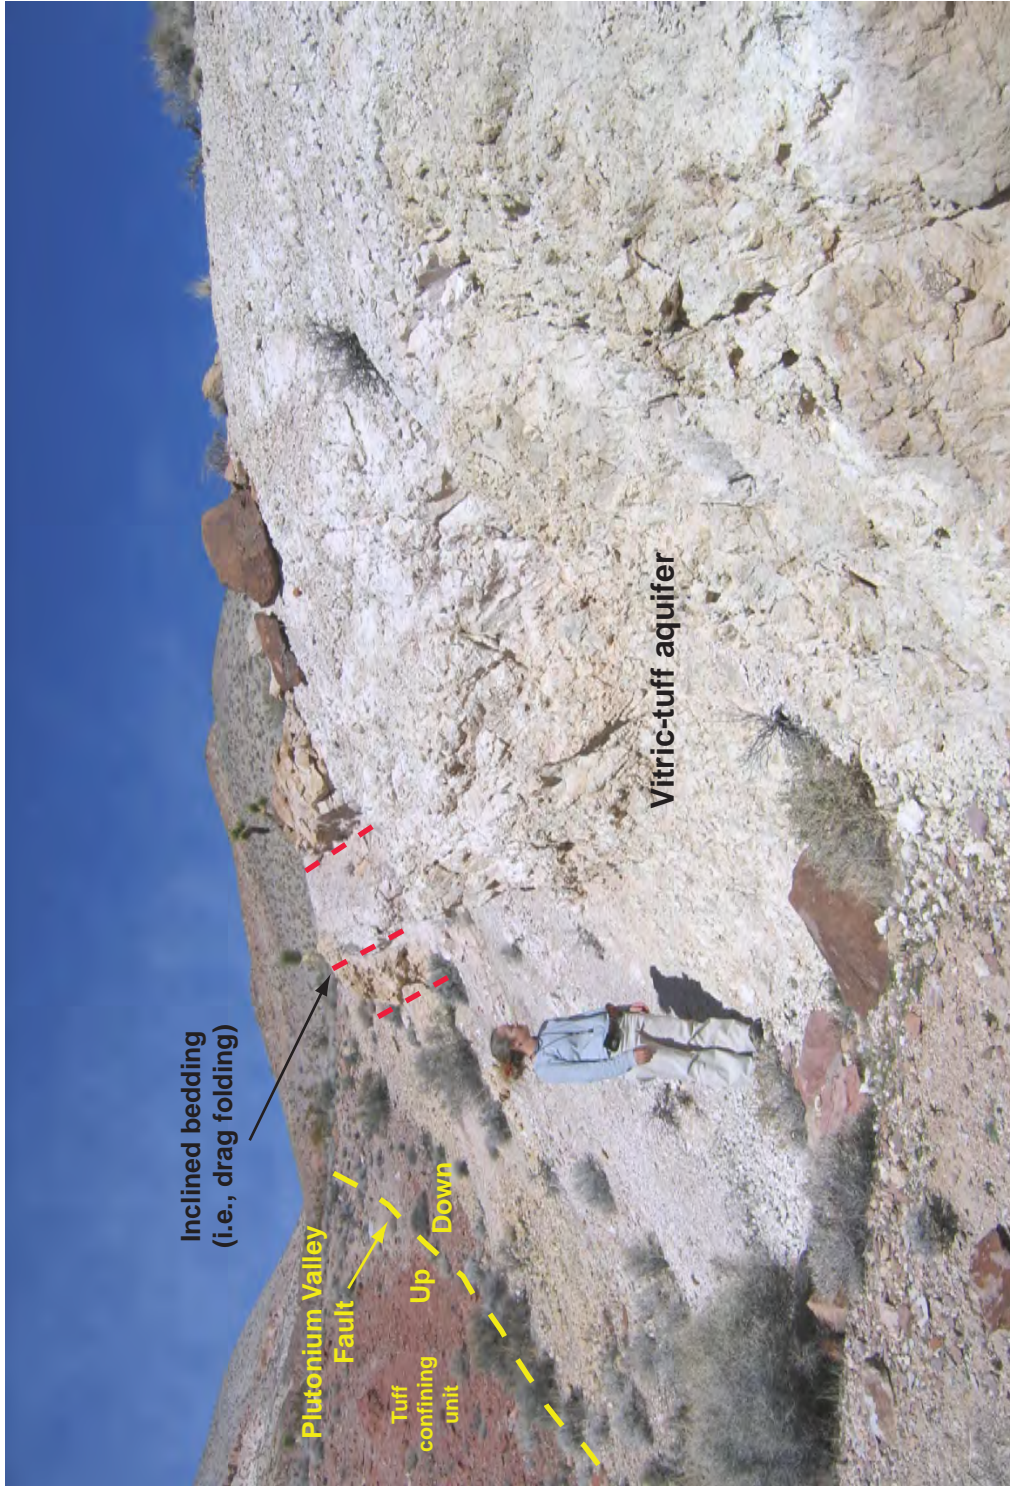
**Figure A-8**  
**Fault Station FP-15 (hanging wall)**

Hanging wall damage within **vitric-tuff aquifer**, Plutonium Valley fault. **Vitric-tuff aquifer** at this location is moderately indurated due to partial silicification. Consequently, damage is similar to that observed in the more indurated HGUs, such as **welded-tuff aquifer**, and includes local shattering and drag folding of the hanging wall rocks.

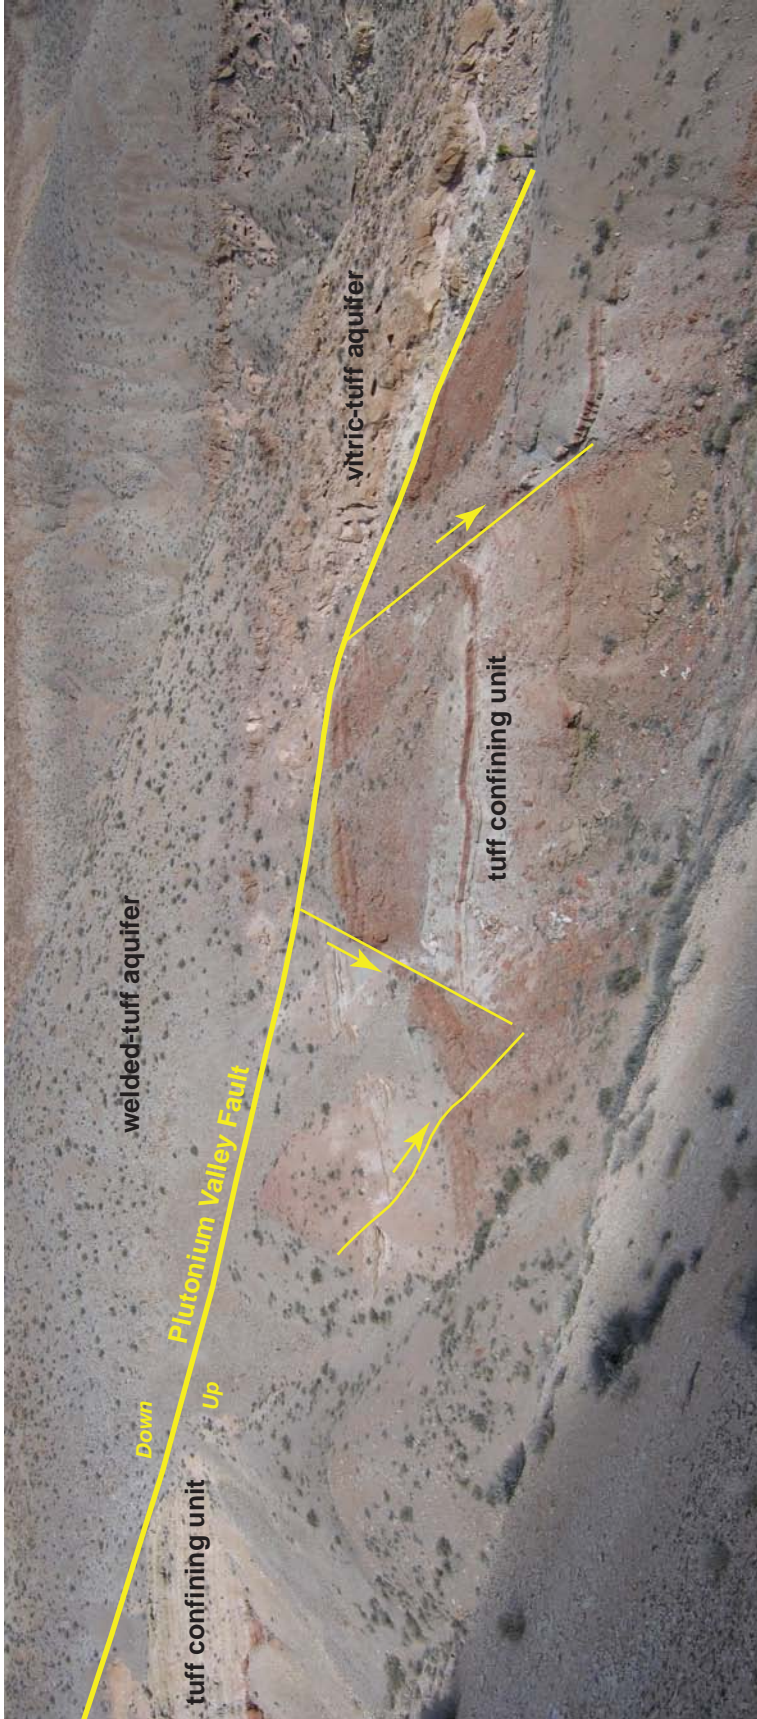
**Figure A-10**  
**Faults in the Footwall of the Plutonium Valley Fault**

Looking east at subsidiary faults within the footwall of the Plutonium Valley fault. In this view, the Plutonium Valley fault dips 70 to 80 degrees away from the reader and has normal offset of approximately 121.9 m (400 ft).

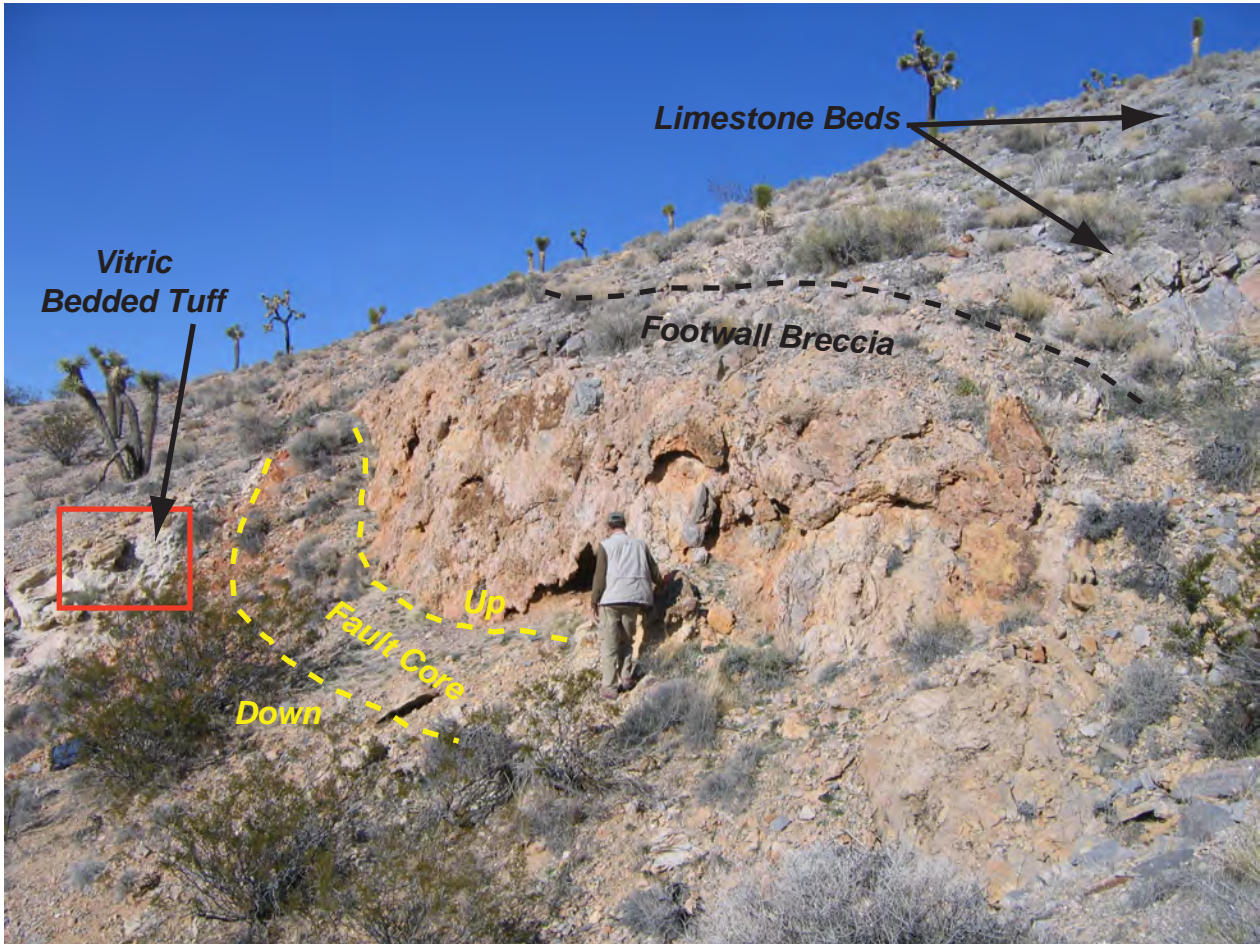
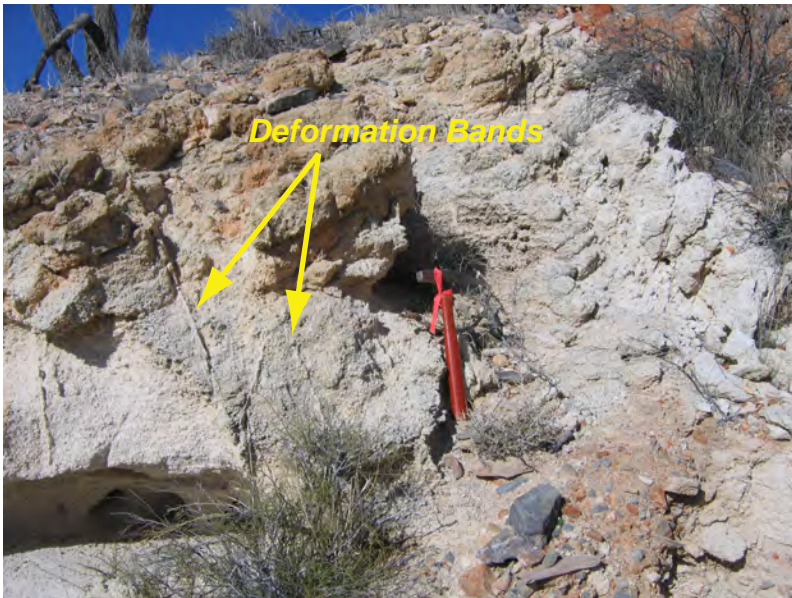
**Figure A-11**  
**Fault Station PR-13**

This fault juxtaposes **vitric-tuff aquifer** and **carbonate aquifer** in the Halfpint Range east of Yucca Flat. The fault forms a prominent footwall scarp within carbonate breccia. Damage was observed to be much more extensive within **carbonate aquifer** than within **vitric-tuff aquifer**. Red square in upper photograph shows location of close-up photograph at left.

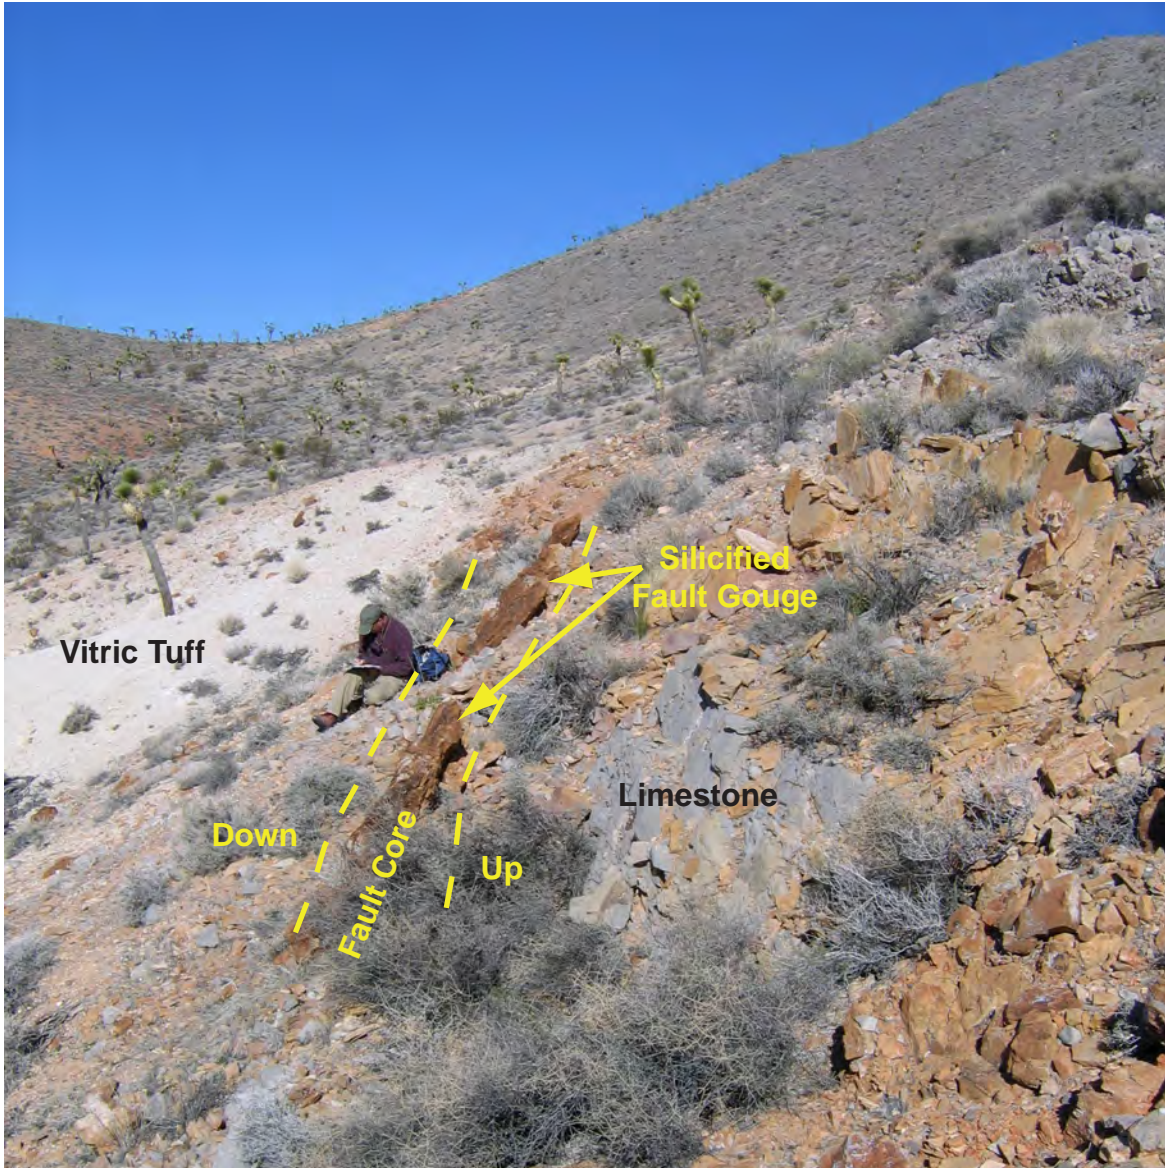
**Figure A-12**  
**Fault Station PR-14**

Looking north at Fault Station PR-14, showing exposure of silicified fault core material.

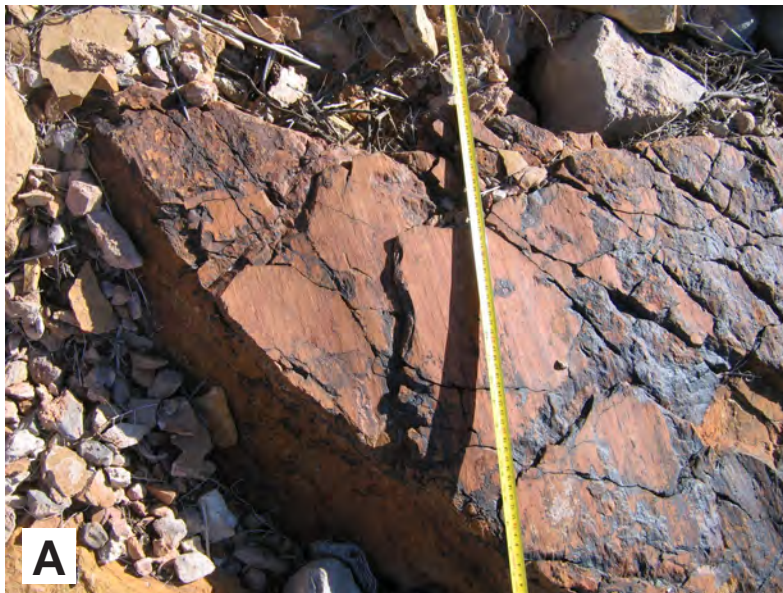
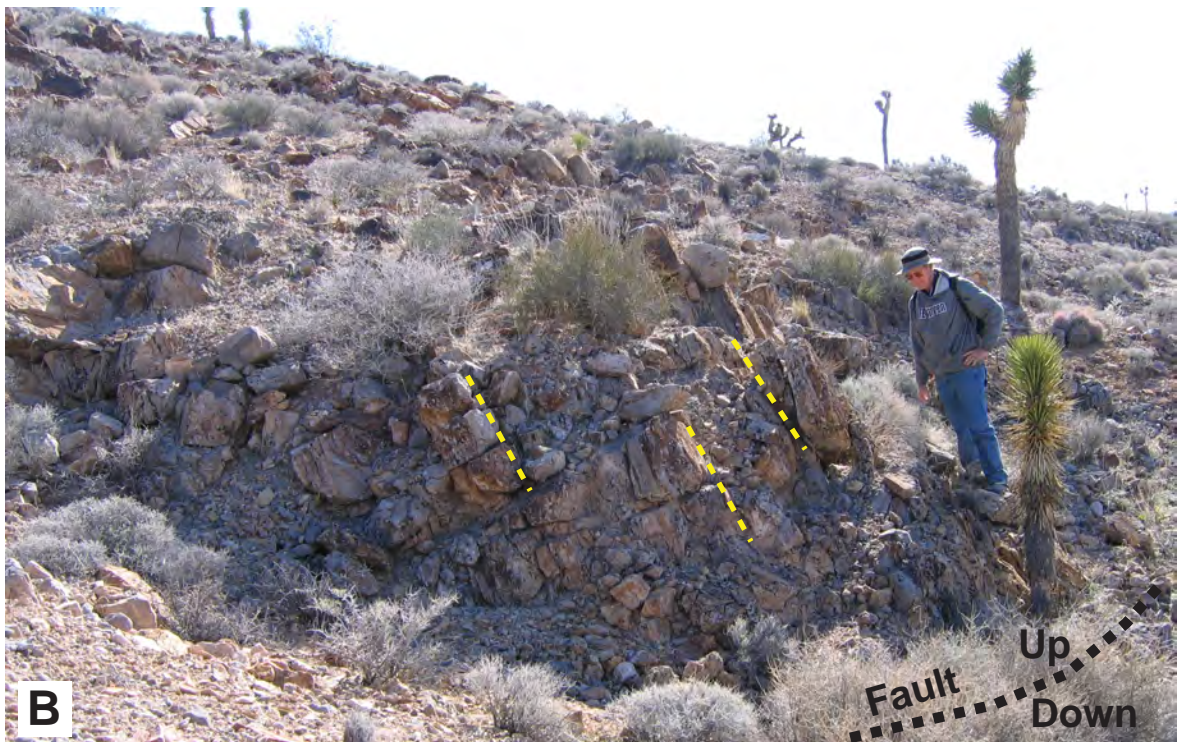
**Figure A-13**  
**Fault Station PR-14**

Close-up of polished and grooved fault surface developed on silicified fault gouge at PR-14.

Exposure of hanging wall damage zone within **carbonate aquifer** just north of PR-14 showing steeply dipping limestone beds (yellow dashed lines) resulting from drag folding along fault.

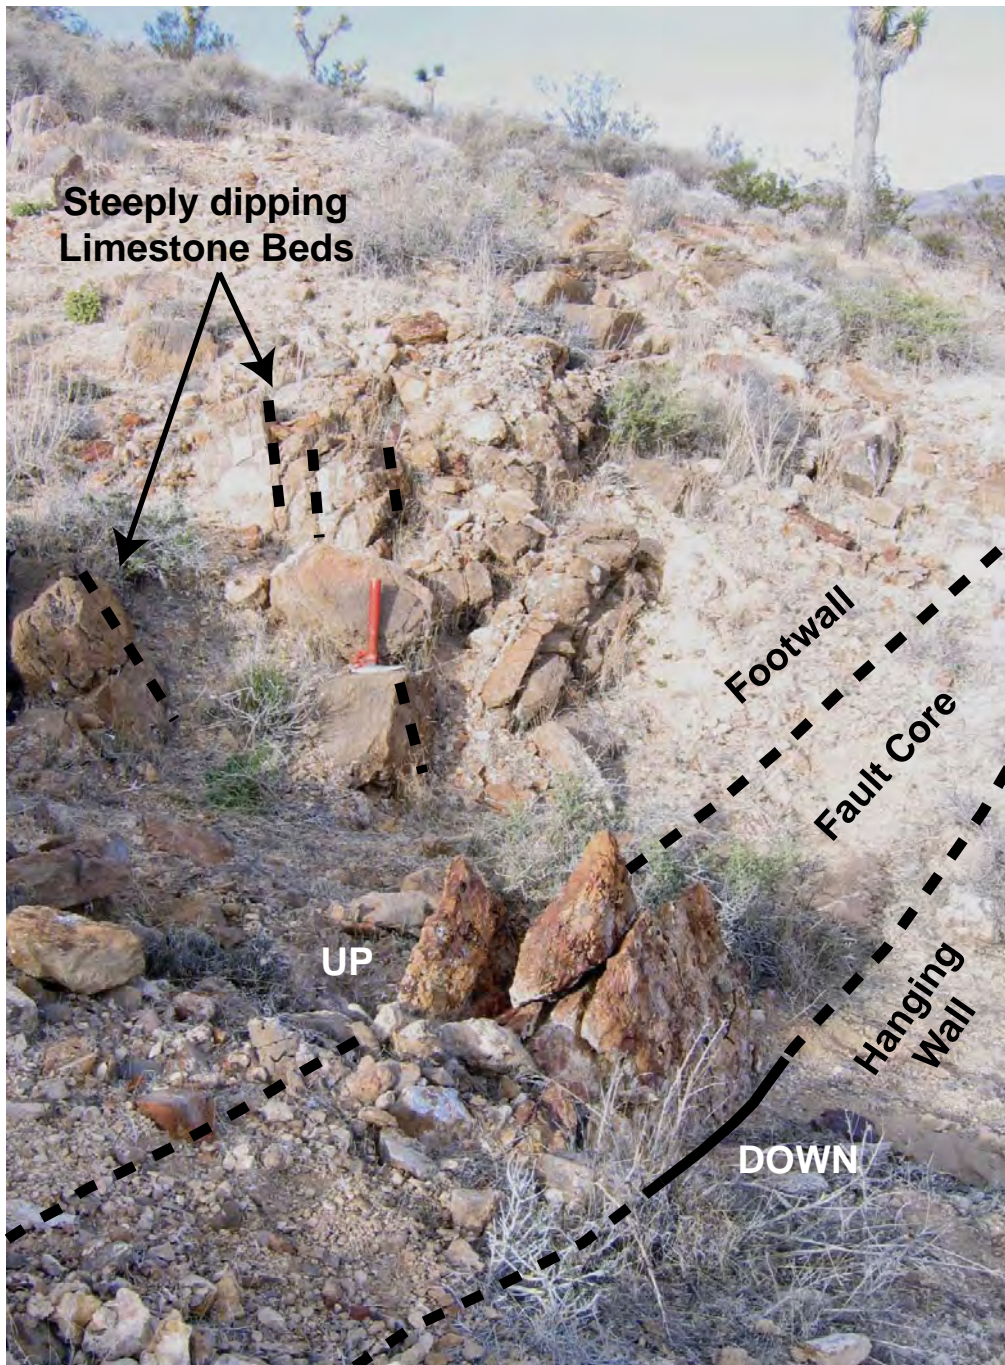
**Figure A-14**  
**Fault Station PR-21**

Photograph at Station PR-21 showing fault core and footwall damage zone within **carbonate aquifer**. Damage includes steeply dipping limestone beds dragged down by movement along fault. Note rock hammer for scale.
