# **OBSERVATIONS ON FAULTS AND ASSOCIATED PERMEABILITY STRUCTURES IN HYDROGEOLOGIC UNITS AT THE NEVADA TEST SITE**

March 2009

U.S. Department of Energy  
National Nuclear Security Administration  
Nevada Site Office

Underground Test Area and Boreholes Programs and Operations  
Environmental Restoration  
National Security Technologies, LLC  
Las Vegas, Nevada

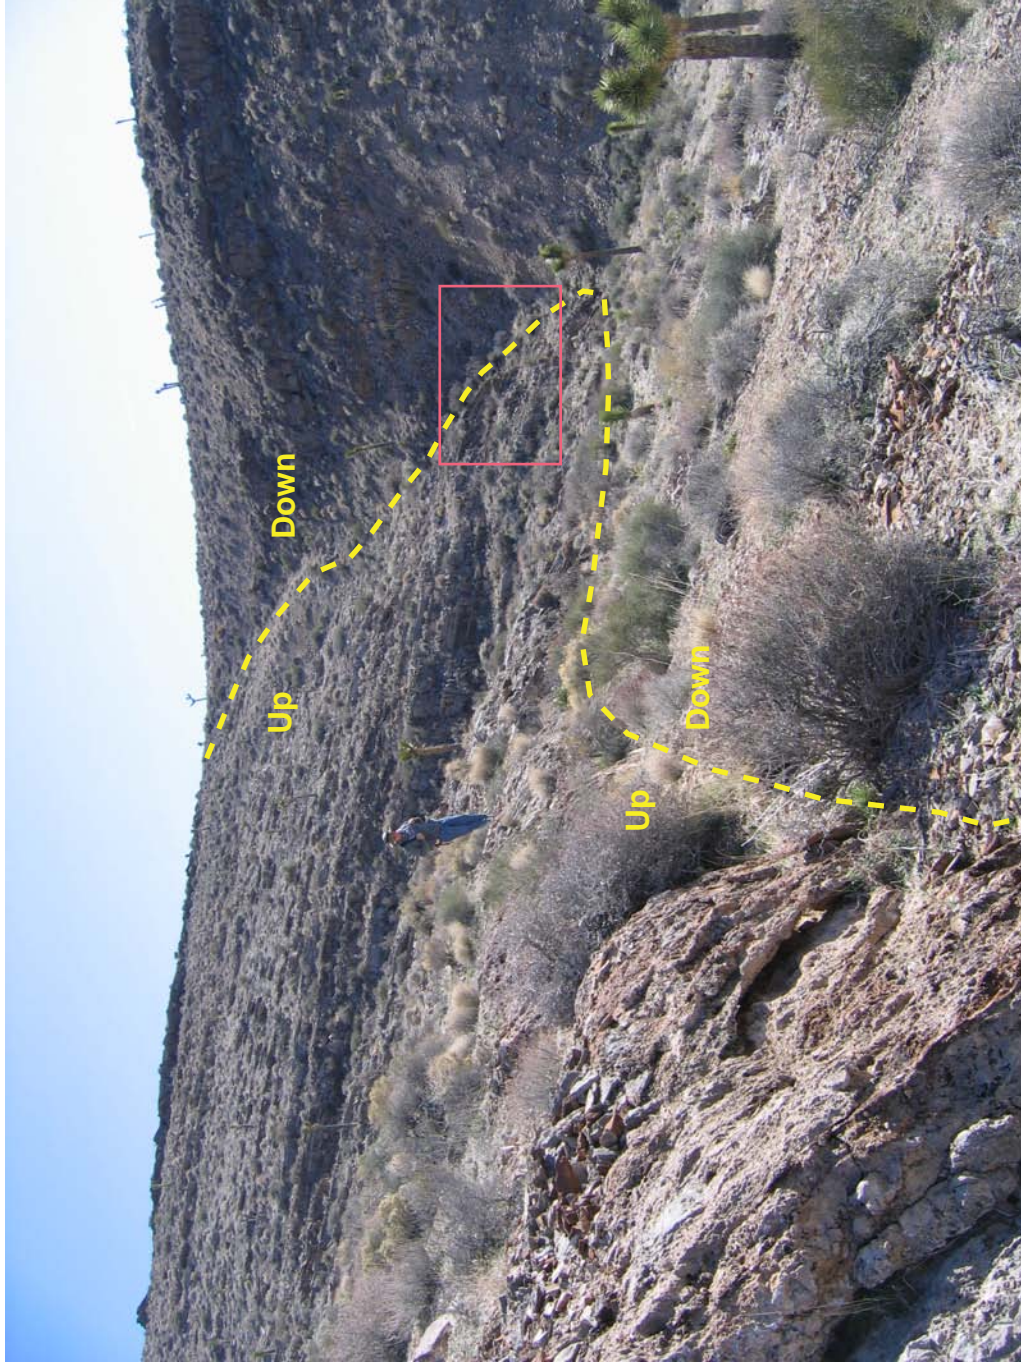
**Figure A-16**  
**Fault Station PR-33**

Looking south along normal fault within **carbonate aquifer**, Halfpint Range. Geologist is standing on footwall scarp. Red square marks approximate location of Figure A-17.

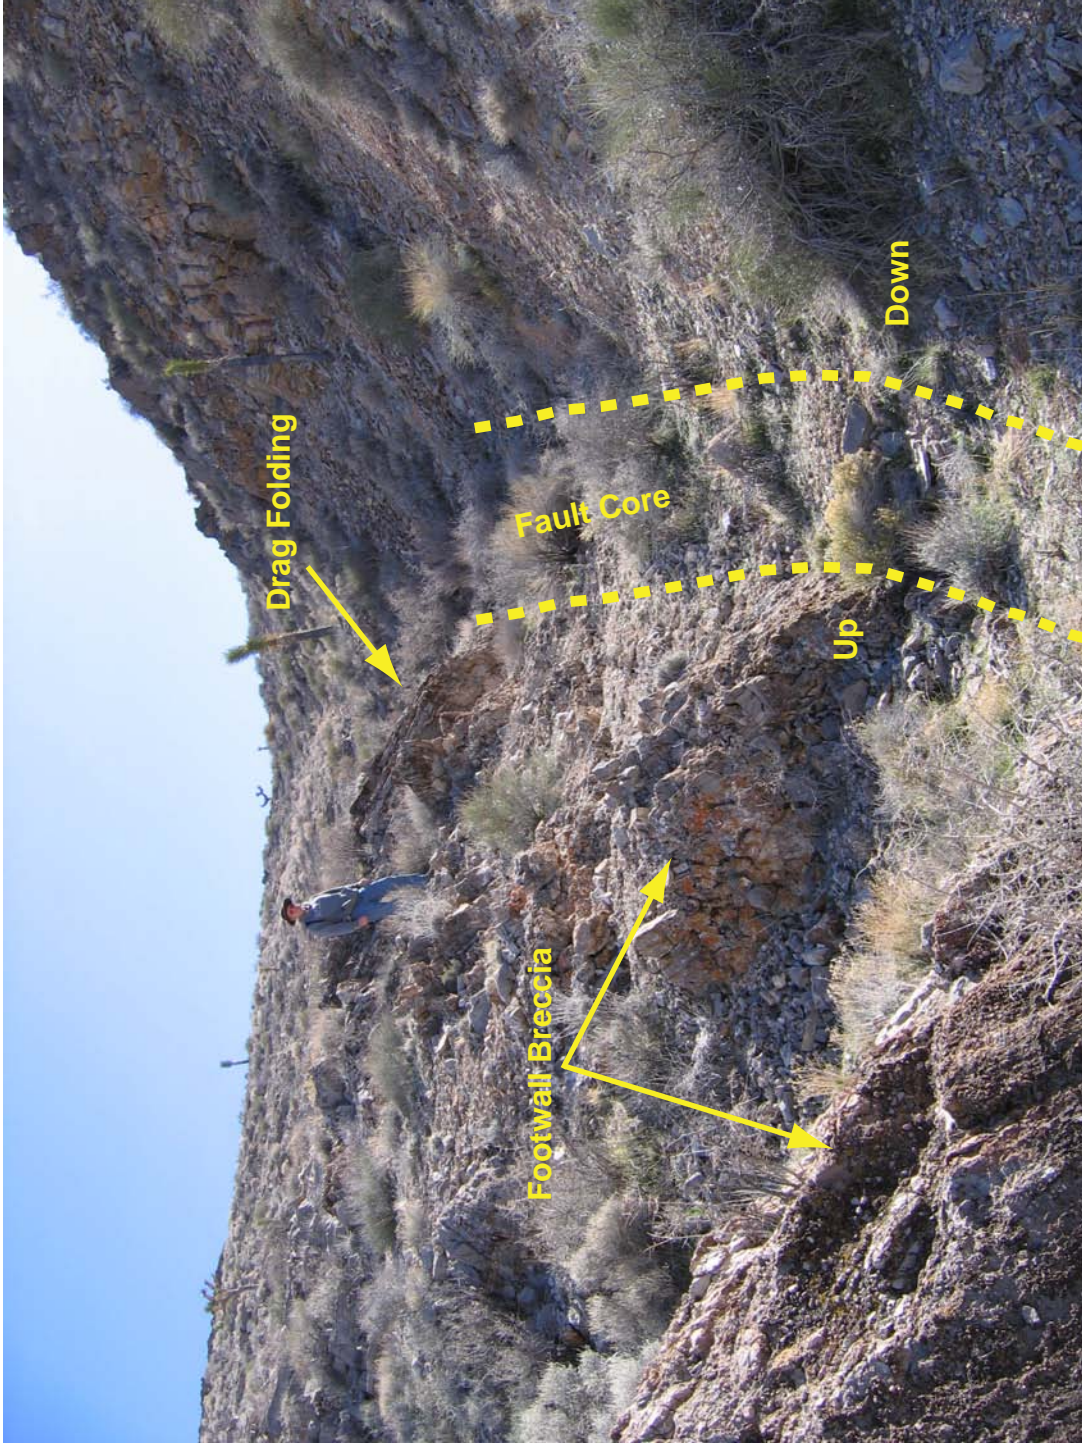
**Figure A-17**  
**Fault Station PR-33 (detail)**

Closer view of normal fault at station PR-33 showing footwall damage features within carbonate aquifer including breccia and drag folding. View is south.

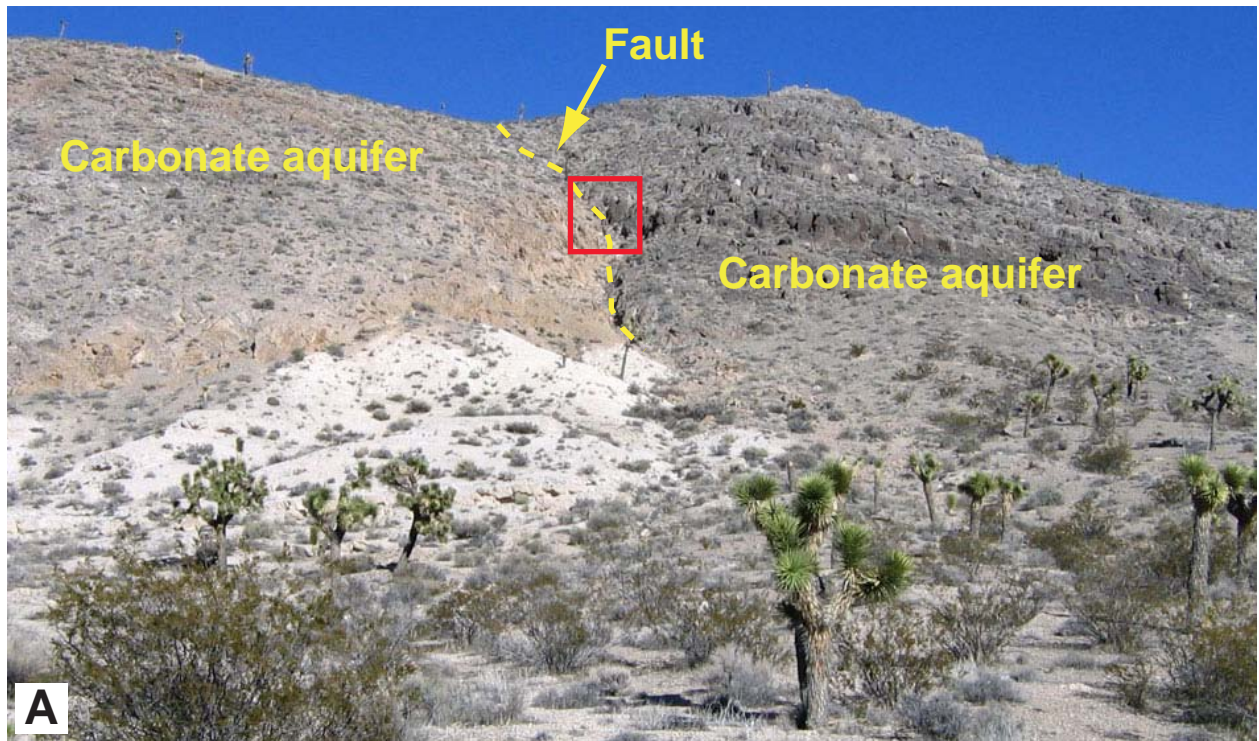
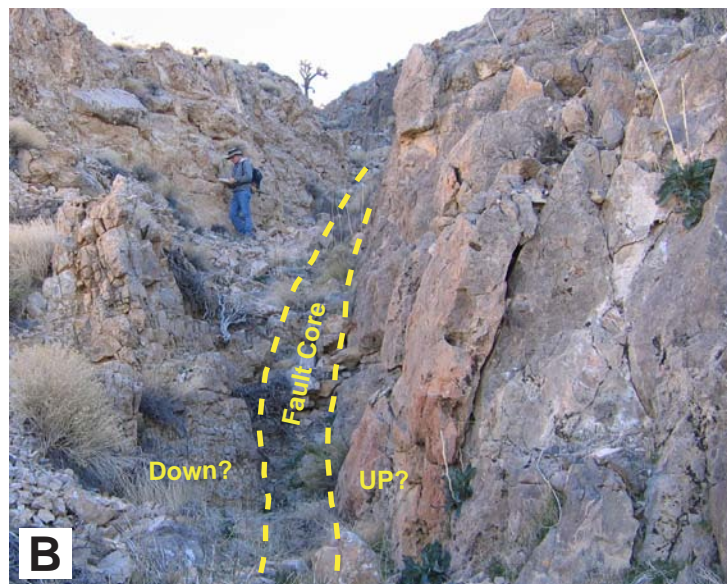
**Figure A-18**  
**Fault Station PR-65 (part one)**

Looking west at fault within **carbonate aquifer**, Halfpint Range. Red square shows location of photographs in Figures A-18B and A-19A and A-19B.

Close view of fault at PR-65 showing the narrow fault core zone.

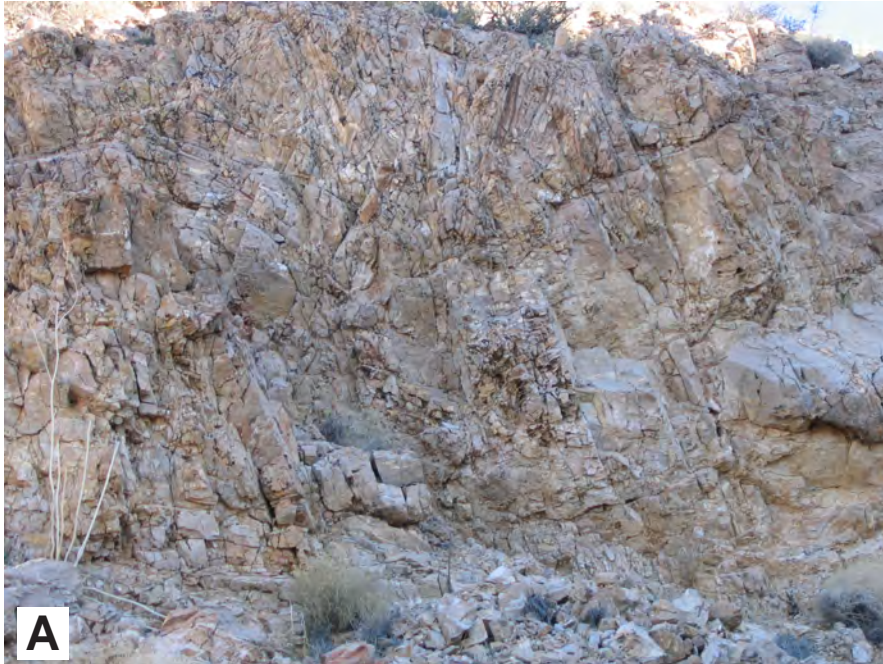
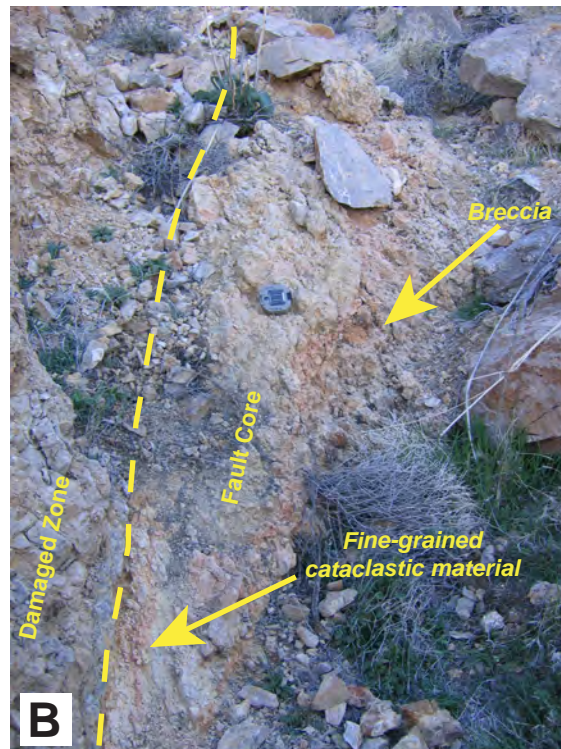
**Figure A-19**  
**Fault Station PR-65 (part two)**

Intense fracturing of **carbonate aquifer** within damage zone on north side of fault at Station PR-65. Exposure is approximately 3.0 m (10 ft) high.

Close-up of exposed fault core material at Station PR-65. Note compass for scale.

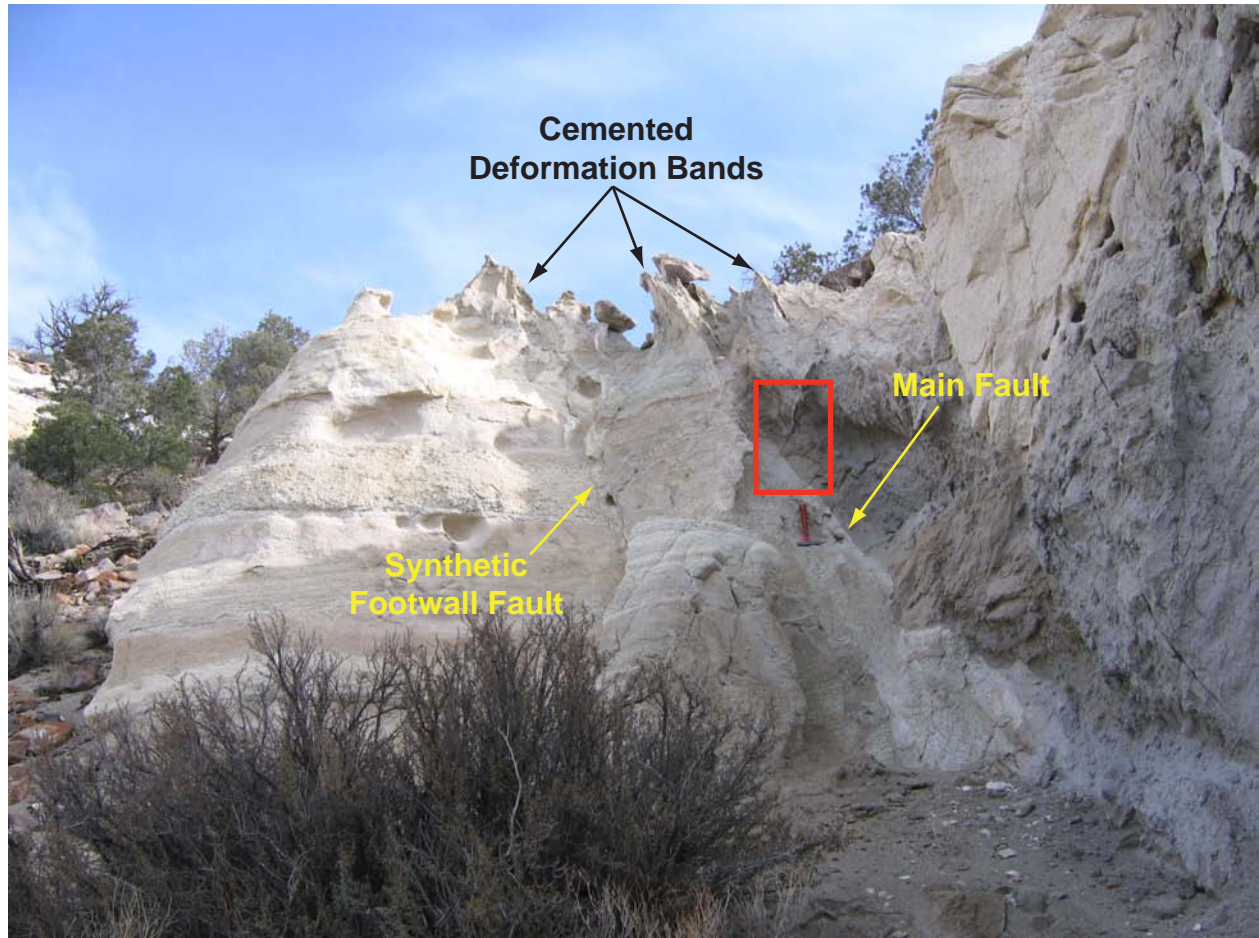
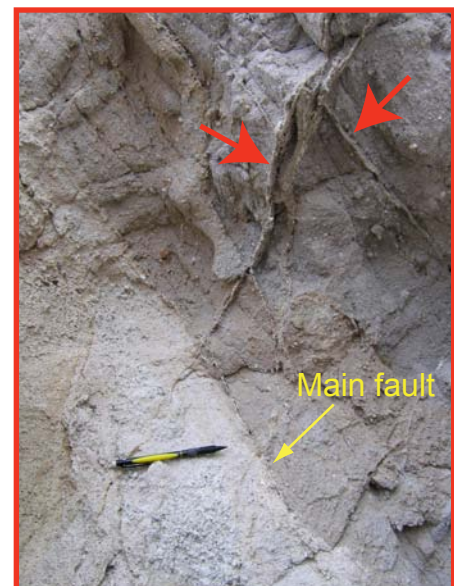
**Figure A-20**  
**Fault Station TP-100**

Normal fault in **vitric-tuff aquifer** showing damage zone features typical of weakly consolidated vitric tuff. Red square indicates location of close-up photograph at right. Note criss-crossing deformation bands (red arrows) adjacent to fault in the hanging wall. Note rock hammer (below red square) for scale in upper photograph.

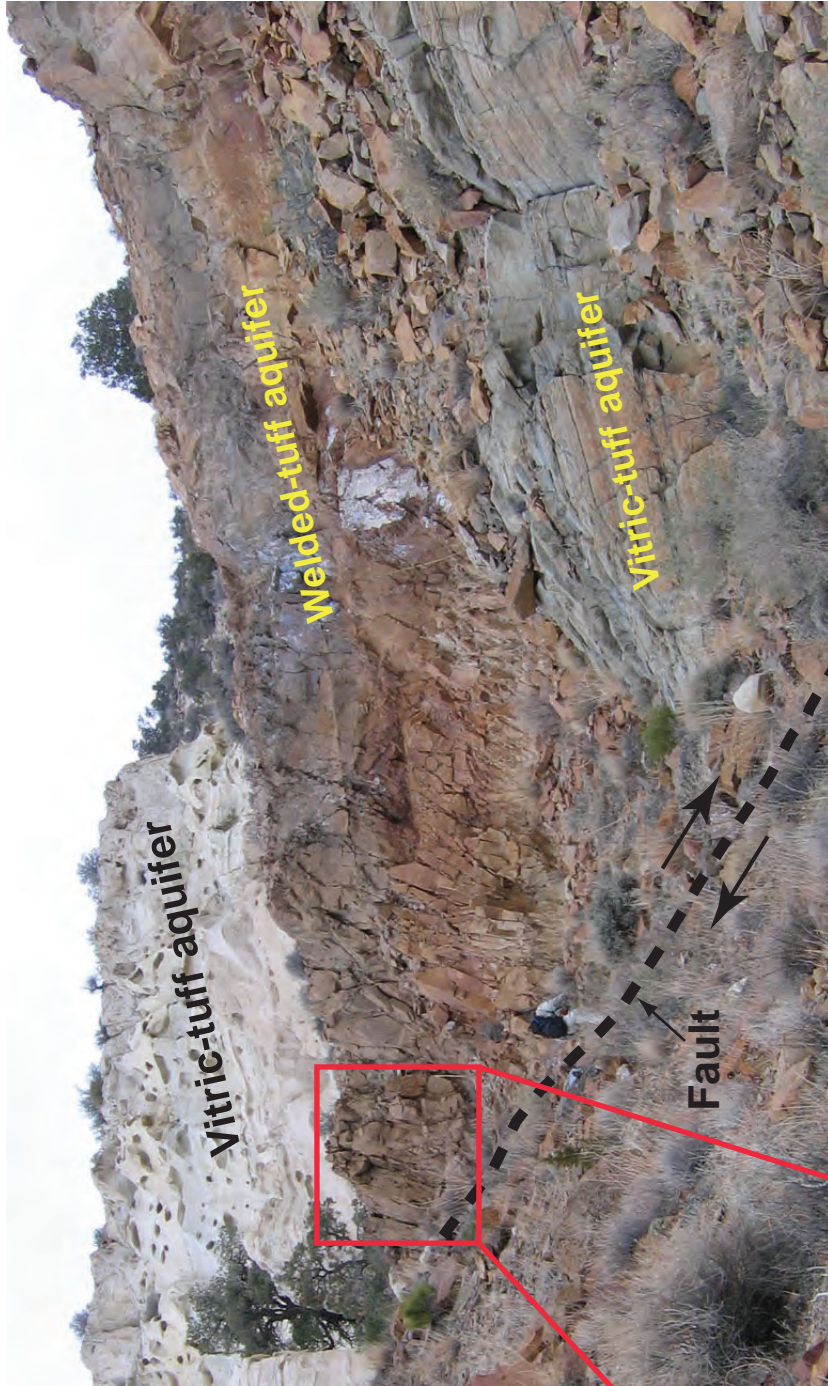
**Figure A-21**  
**Fault Station TP-101**

This fault location shows a well-developed damage zone within **welded-tuff aquifer**. The number of fractures increases from right to left towards the fault within the **welded-tuff aquifer**. Offset along the fault is 6 m, and the hanging wall damage zone within **welded-tuff aquifer** extends out 9 m. Note geologist in lower left of photograph above for scale. Close-up photograph at left shows intense fracturing adjacent to fault.

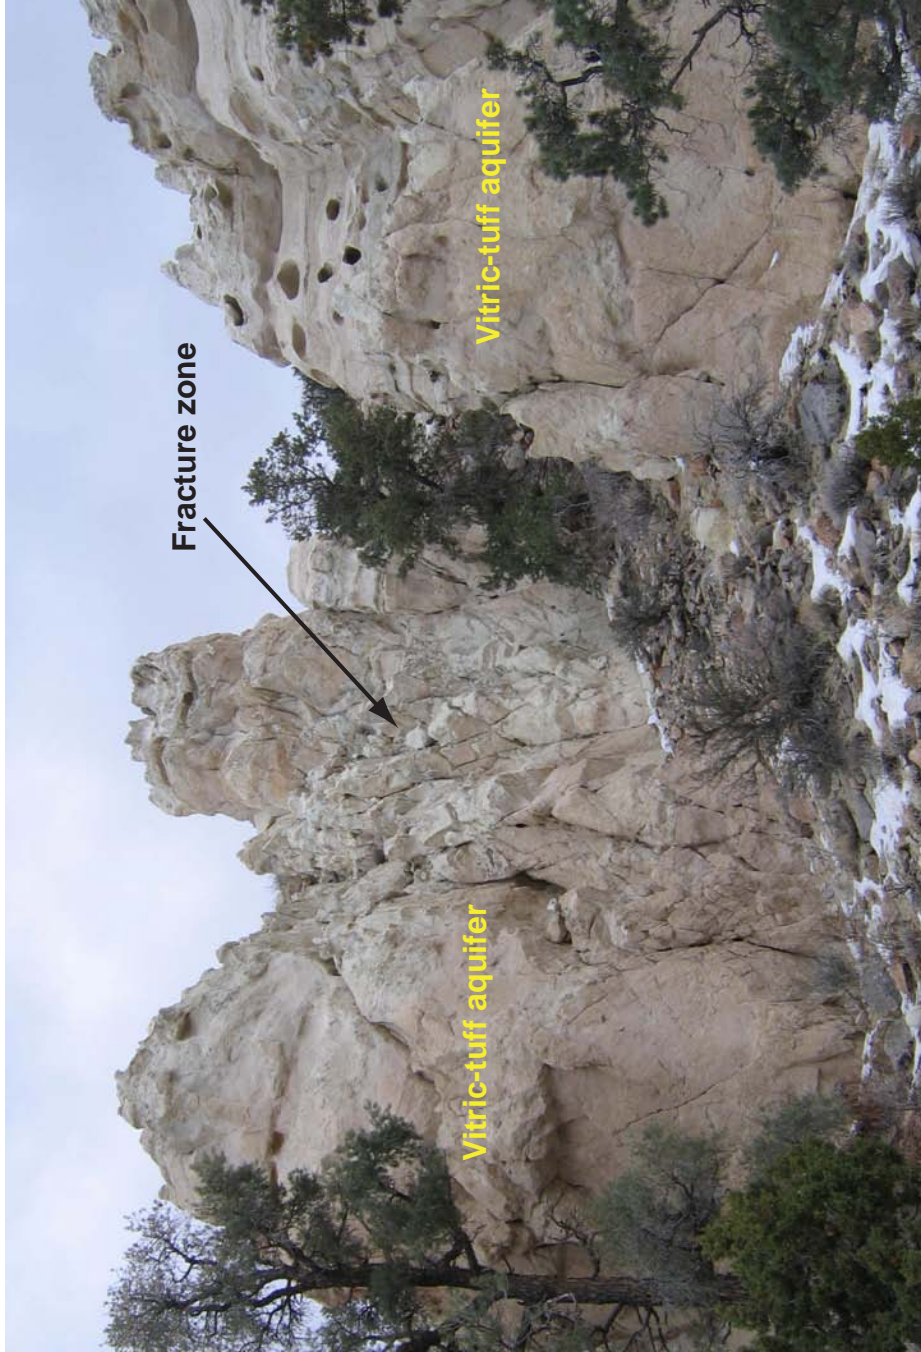
**Figure A-22**  
**Fault Station TP-102**

This exposure of fractured **vitric-tuff aquifer** overlies the **welded-tuff aquifer** in Figure A-13. At this location **vitric-tuff aquifer** is partially altered resulting in a rock that is stronger and more consolidated than typical **vitric-tuff aquifer**. This results in the formation of a fracture zone where the fault in Figure A-13 cuts through the unit. A fault core could not be identified at this location, and thus it is unclear whether the fracture zone represents hanging wall or footwall damage, or both. Height of cliff is approximately 4.6 m (15 ft).

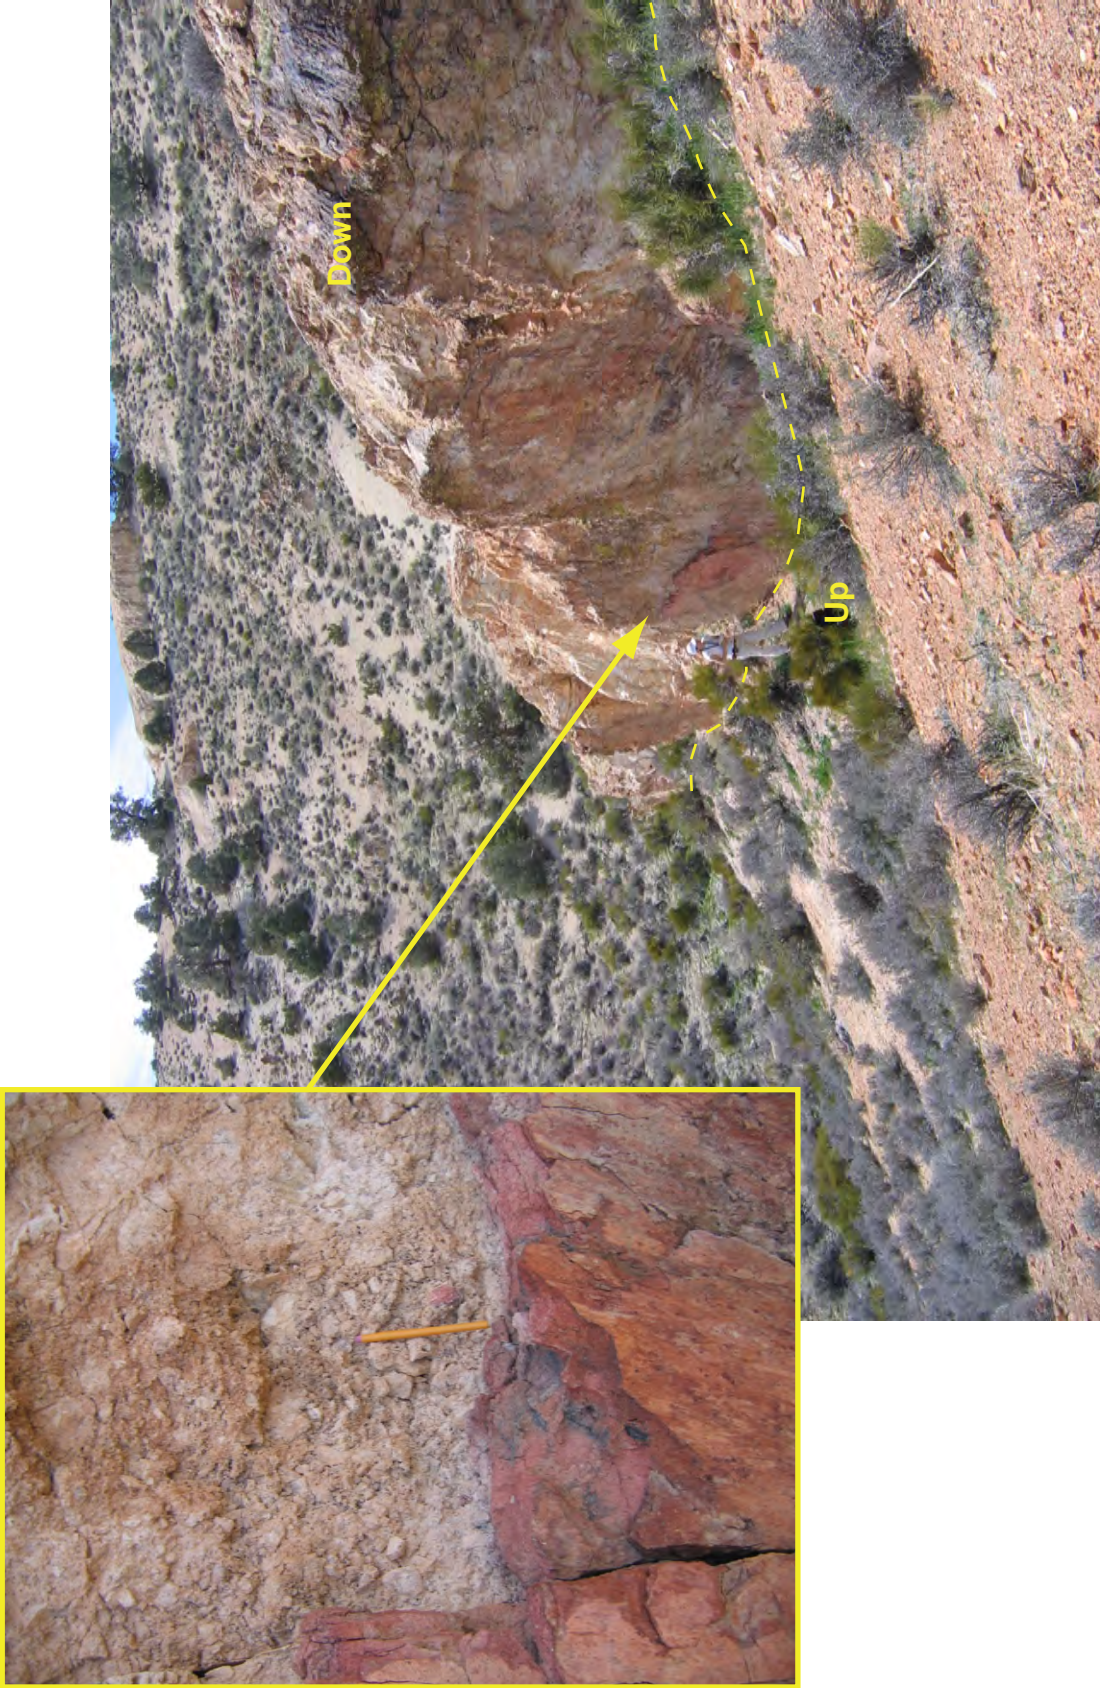
**Figure A-23**  
**Fault Station TS-4**

A hanging wall fault scarp within **tuff confining unit**. The footwall rocks (foreground) consist of Mississippian shale (i.e., **clastic confining unit**) that has been eroded away at this location, leaving a prominent hanging wall scarp composed of more resistant altered tuff. Inset close-up photograph shows crushed material and reddish-orange fault gouge.

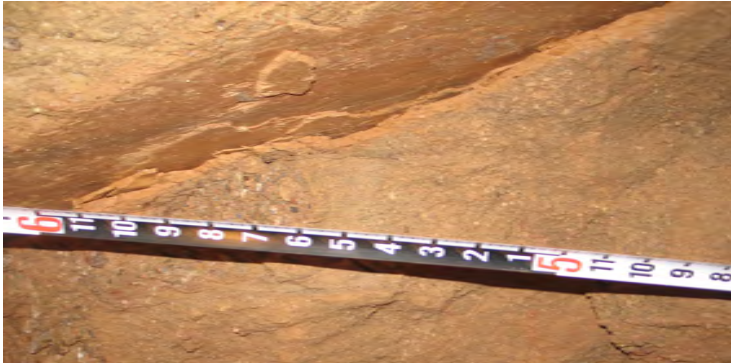
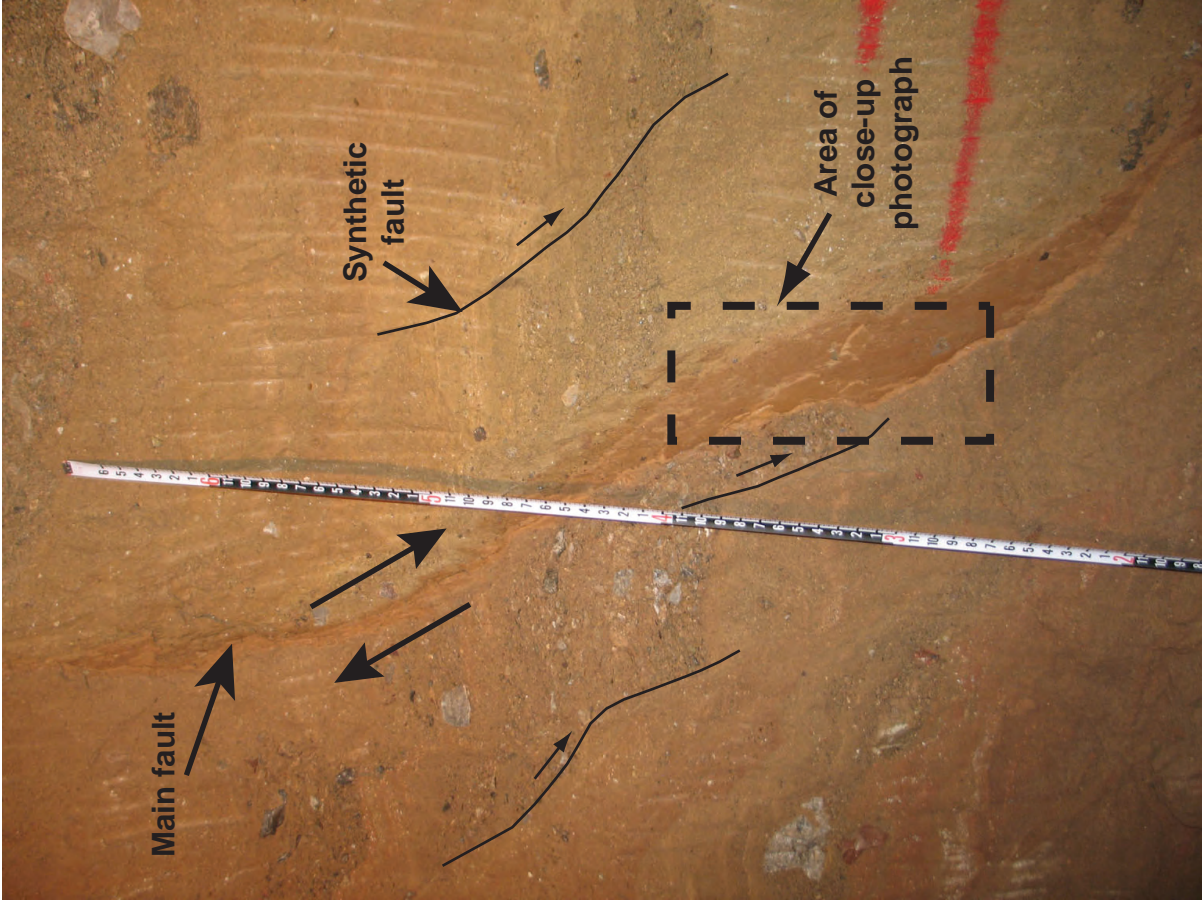
Figure A-24  
Fault Station U1a

Close-up of fault core.

This fault is within **alluvial aquifer** in the U1a tunnel complex located approximately 290 m (960 ft) below the surface in Yucca Flat. The thin fault core is filled with fault gouge (see close-up above). Damage adjacent to the fault is limited to several small synthetic faults. Black and white colored intervals on scale represent 1 ft. Vertical striations in upper right of photograph are teeth marks from the alpine mining machine.

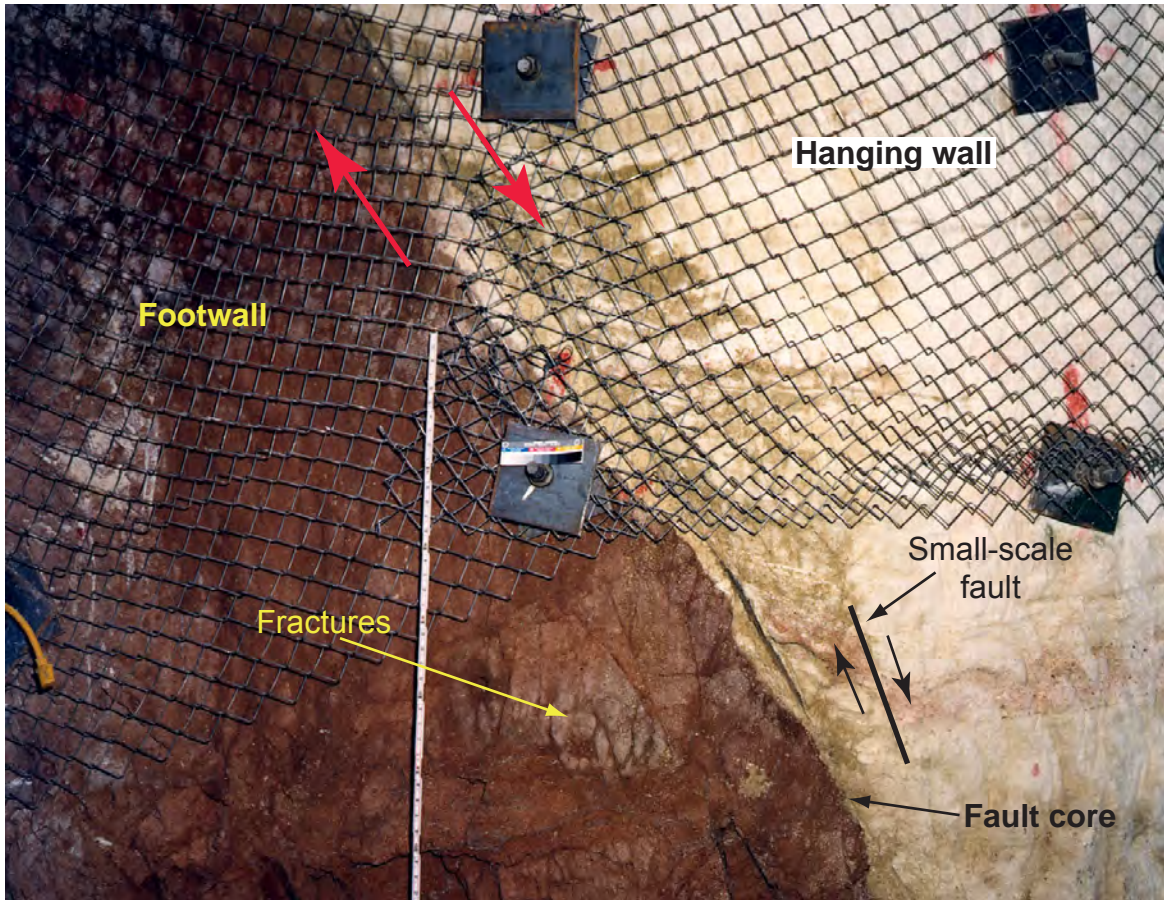
**Figure A-25**  
**Fault Station N-GSD X-Cut**

This normal fault within **tuff confining unit** in N-Tunnel has a very thin fault core. Damage in the footwall consists of numerous mostly tight fractures oriented sub-parallel to the main fault. Hanging wall damage is considerably less than in the footwall. Offset is greater than 6 m (20 ft). Staff is approximately 1.2 m (4 ft) high.

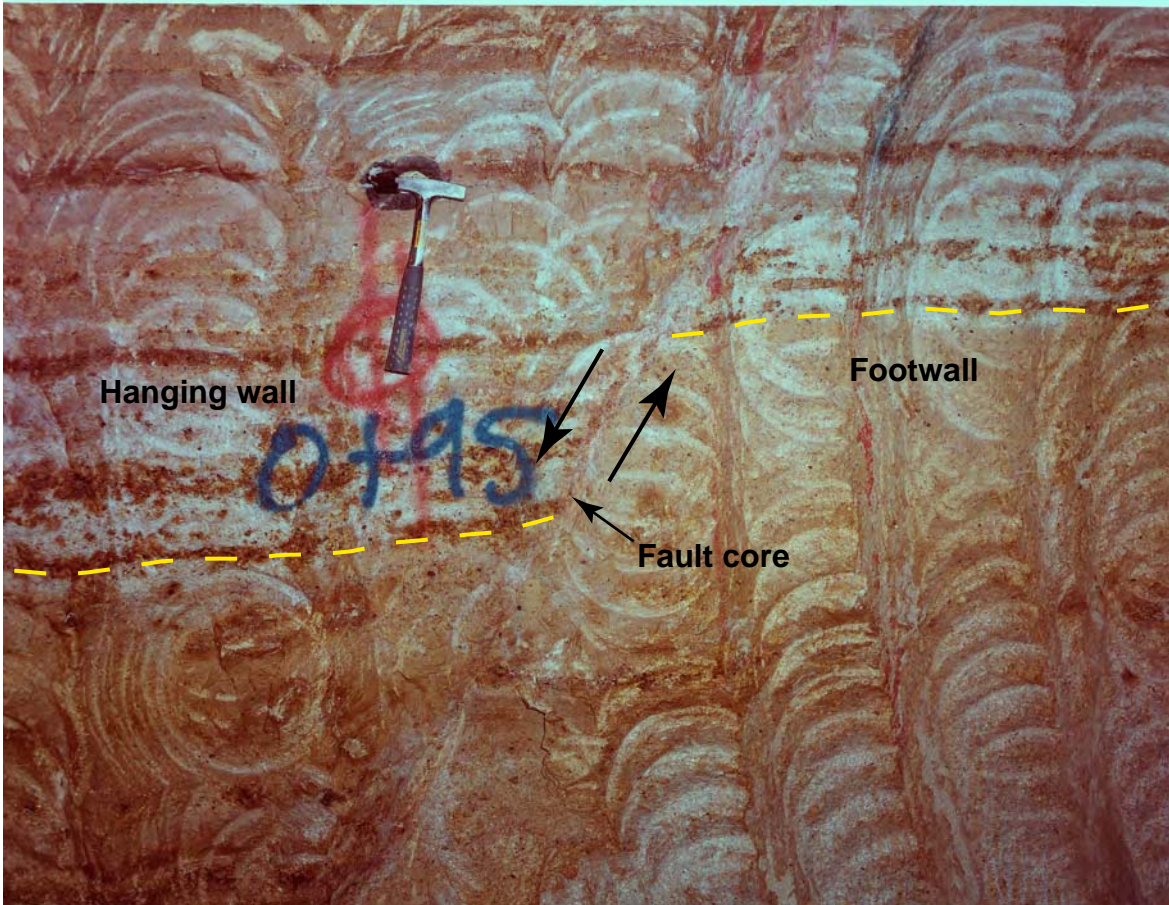
**Figure A-26**  
**Fault Station N-10-A**

This normal fault is within **tuff confining unit** in N-Tunnel. The fault has a thin fault core and shows minimal damage. Circular marks were made by the mining machine. Offset is 0.4 m (1.2 ft). The hammer is 28 centimeters (cm) (0.9 ft) long.

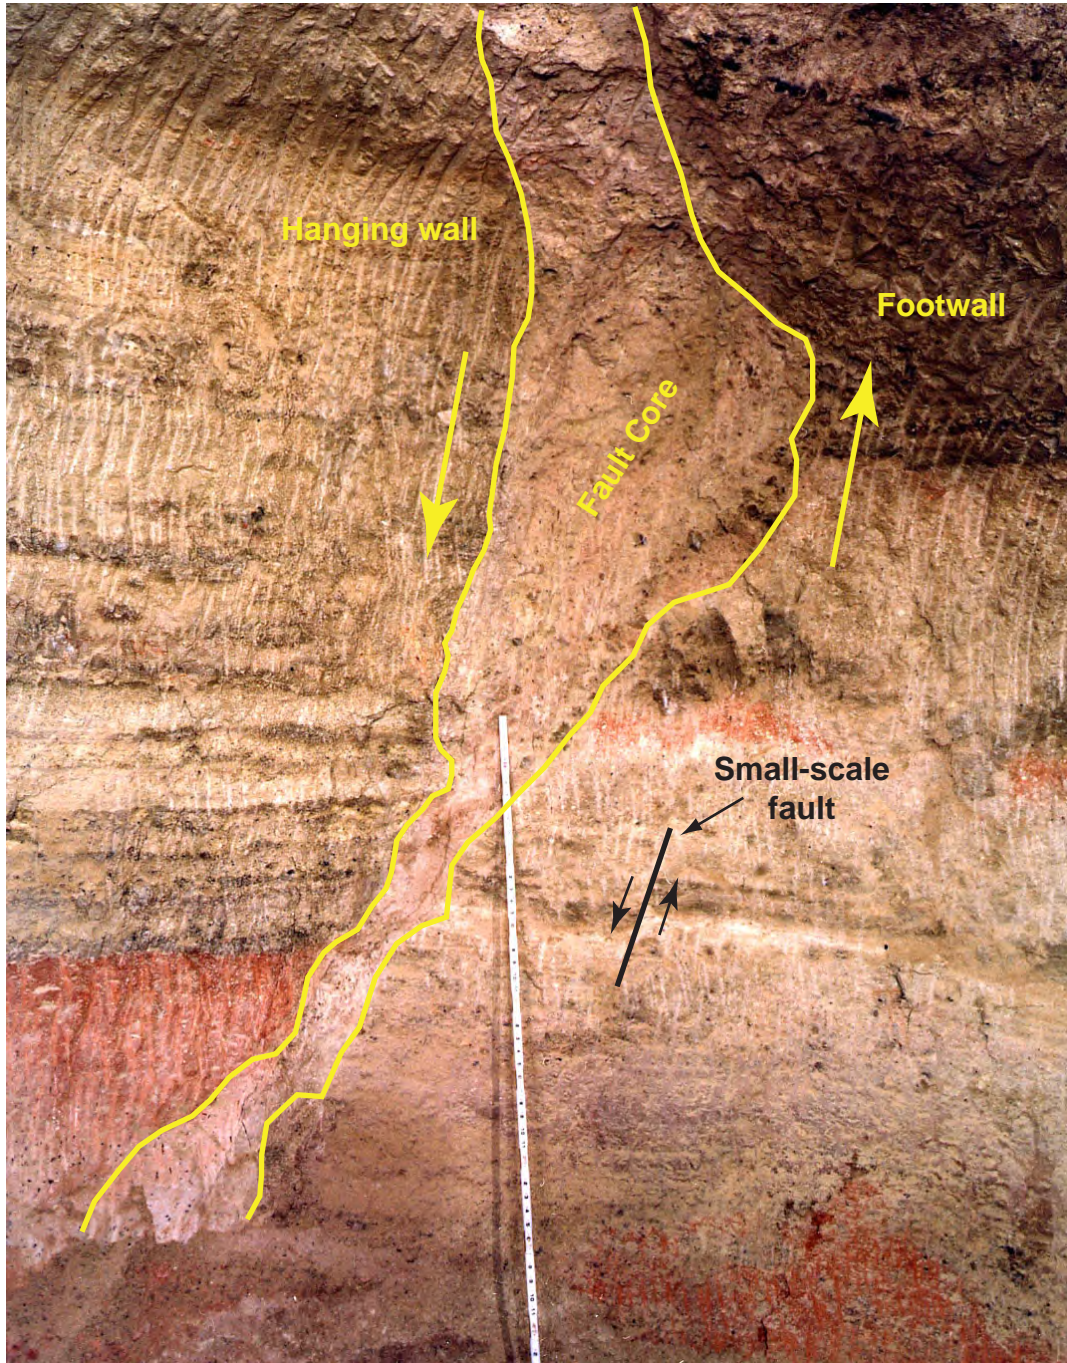
**Figure A-27**  
**Fault Station N-21BP-2**

This normal fault within **tuff confining unit** is exposed in the wall of a drift in N-Tunnel. The drift intersected this fault at a low angle; thus, the fault plane is sub-parallel to this view and extends into the side of the drift from left to right, dipping away from the reader. Amount of offset is greater than 6 m (20 ft). The fault core is less than 15 cm (6 inches [in.]) wide and is composed of clayey fault gouge. Damage in both the footwall and hanging wall is negligible. Staff is 1.2 m (4 ft) high.

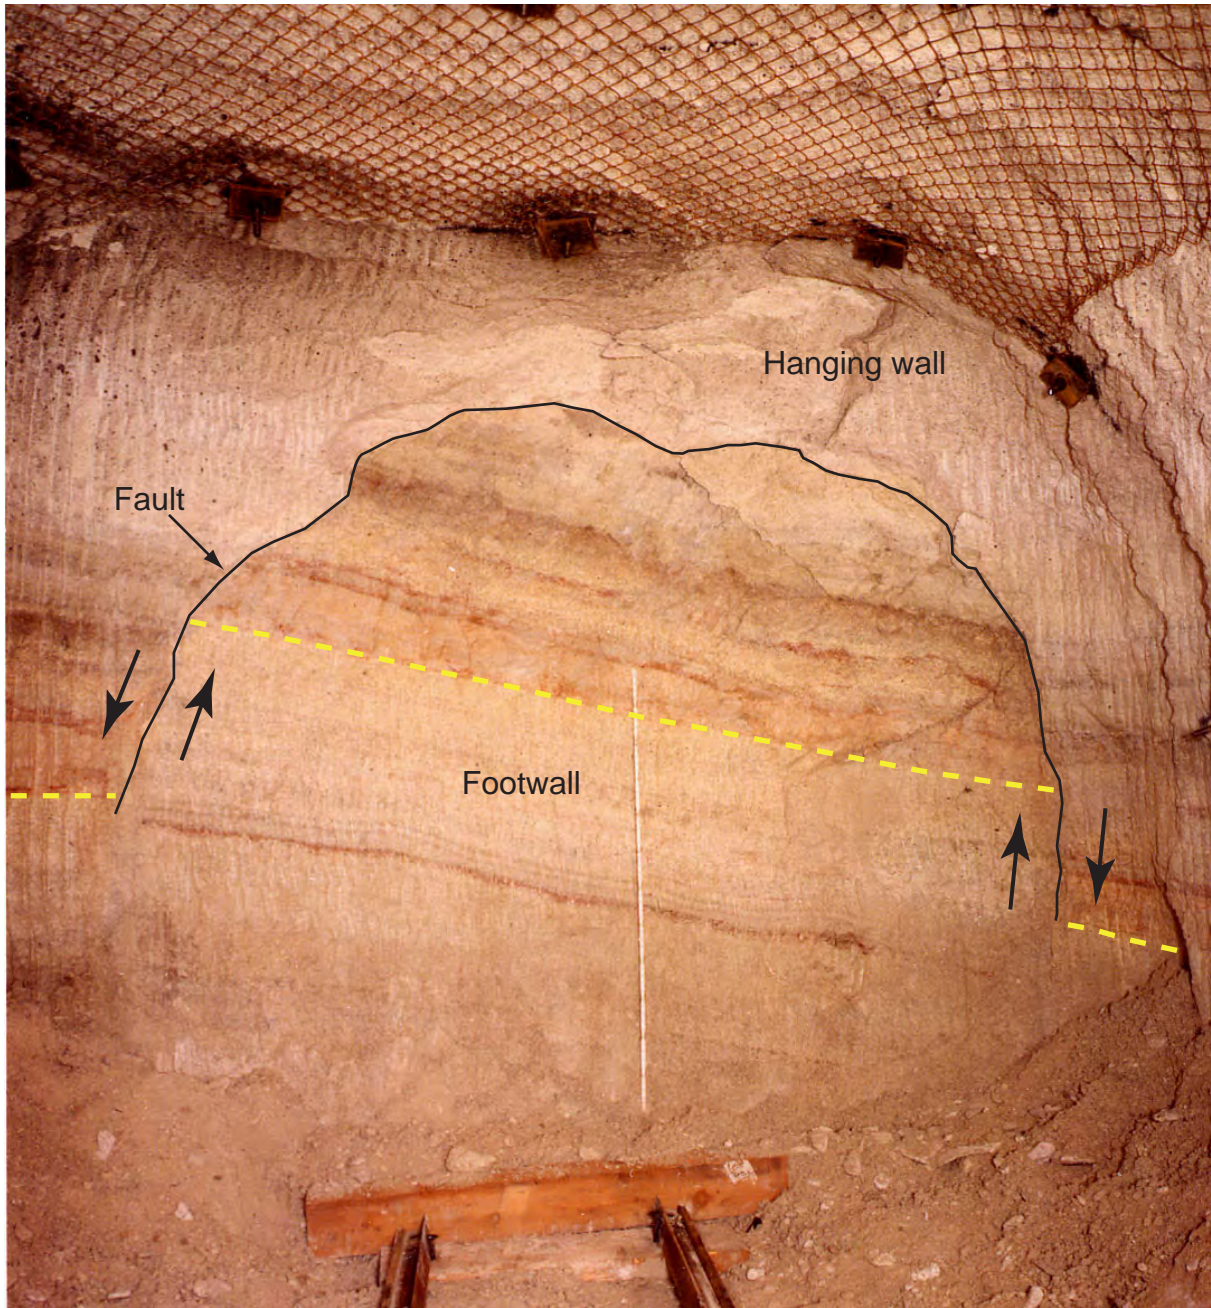
**Figure A-28**  
**Fault Station N-17BP**

This fault exposure is at the end of a drift in N-Tunnel that has been mined perpendicular to a normal fault within **tuff confining unit**. The fault dips toward the reader. Offset is between 0.6 and 0.9 m (2 and 3 ft). Note very thin fault core and lack of damage. Staff is 1.8 m (6 ft) high.

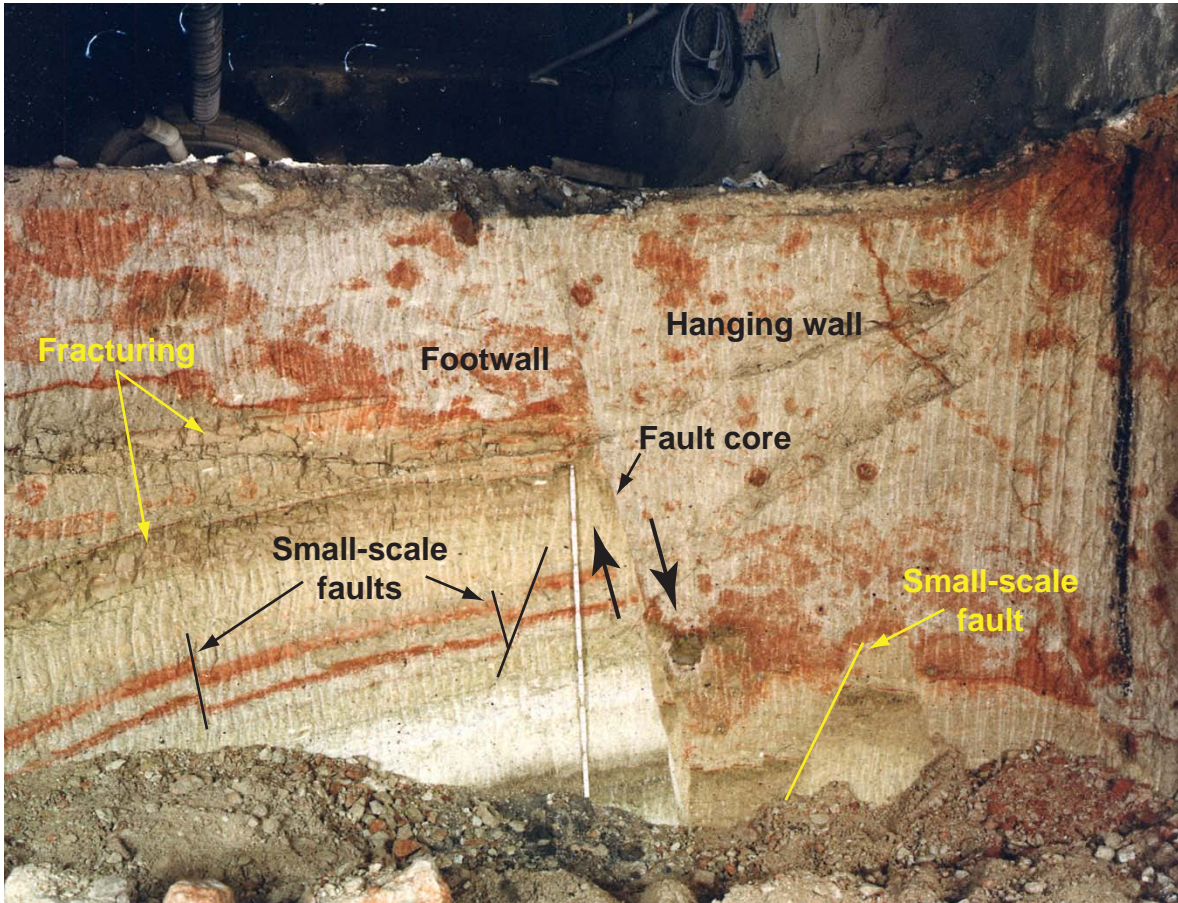
**Figure A-29**  
**Fault Station N-21LOS-1**

This normal fault within **tuff confining unit** in N-Tunnel shows minor damage consisting of fracturing and small-scale faulting. Fracturing is most pronounced in silicified beds in the footwall. The fault core is very narrow, generally less than a few millimeters. Offset is 0.9 m (3 ft). Staff is 1.0 m (3.5 ft) high.

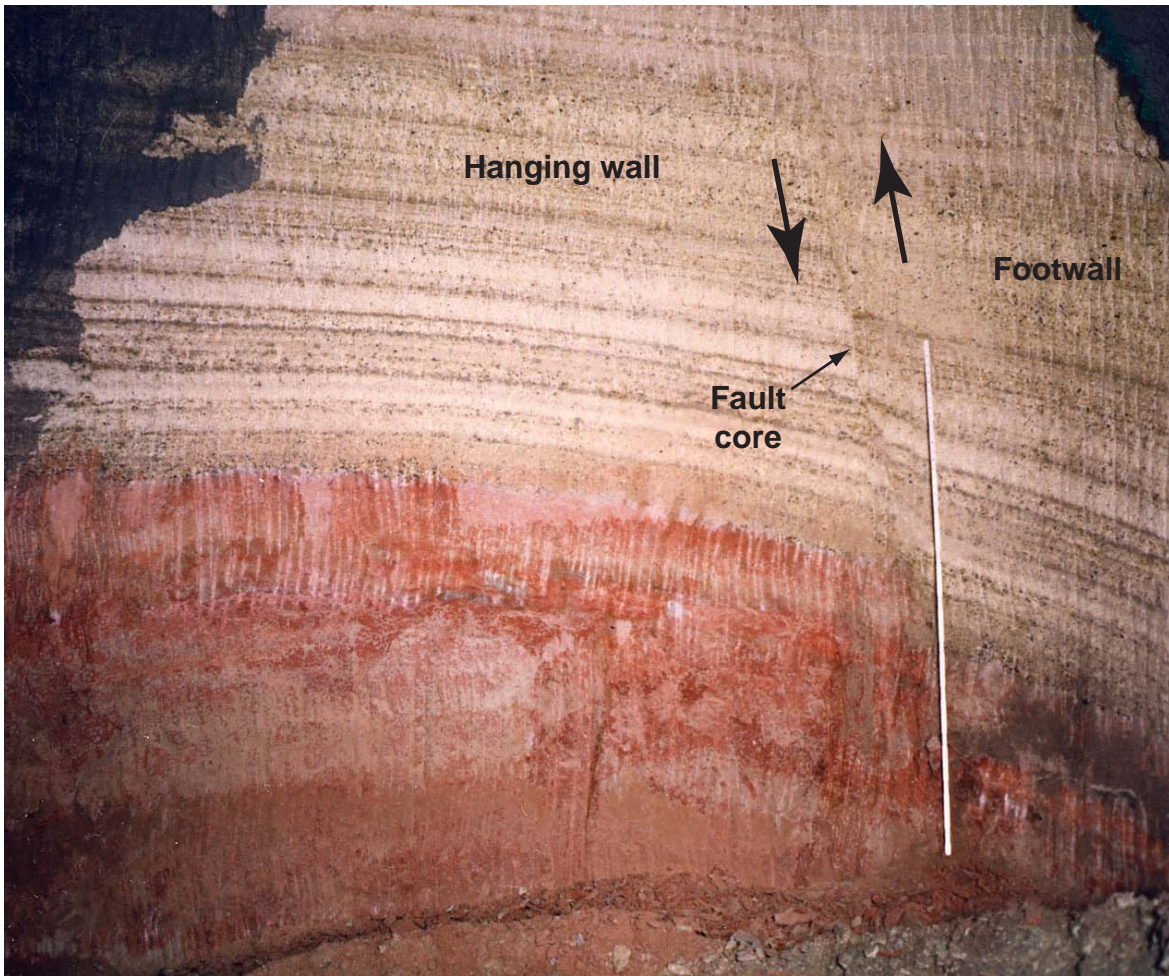
**Figure A-30**  
**Fault Station N-21LOS-2**

This normal fault within **tuff confining unit** in N-Tunnel shows no fault-related damage. The width of the fault core is less than 1 cm (0.4 in). Offset is 0.3 m (1 ft). Staff is 1.8 m (6 ft) high.

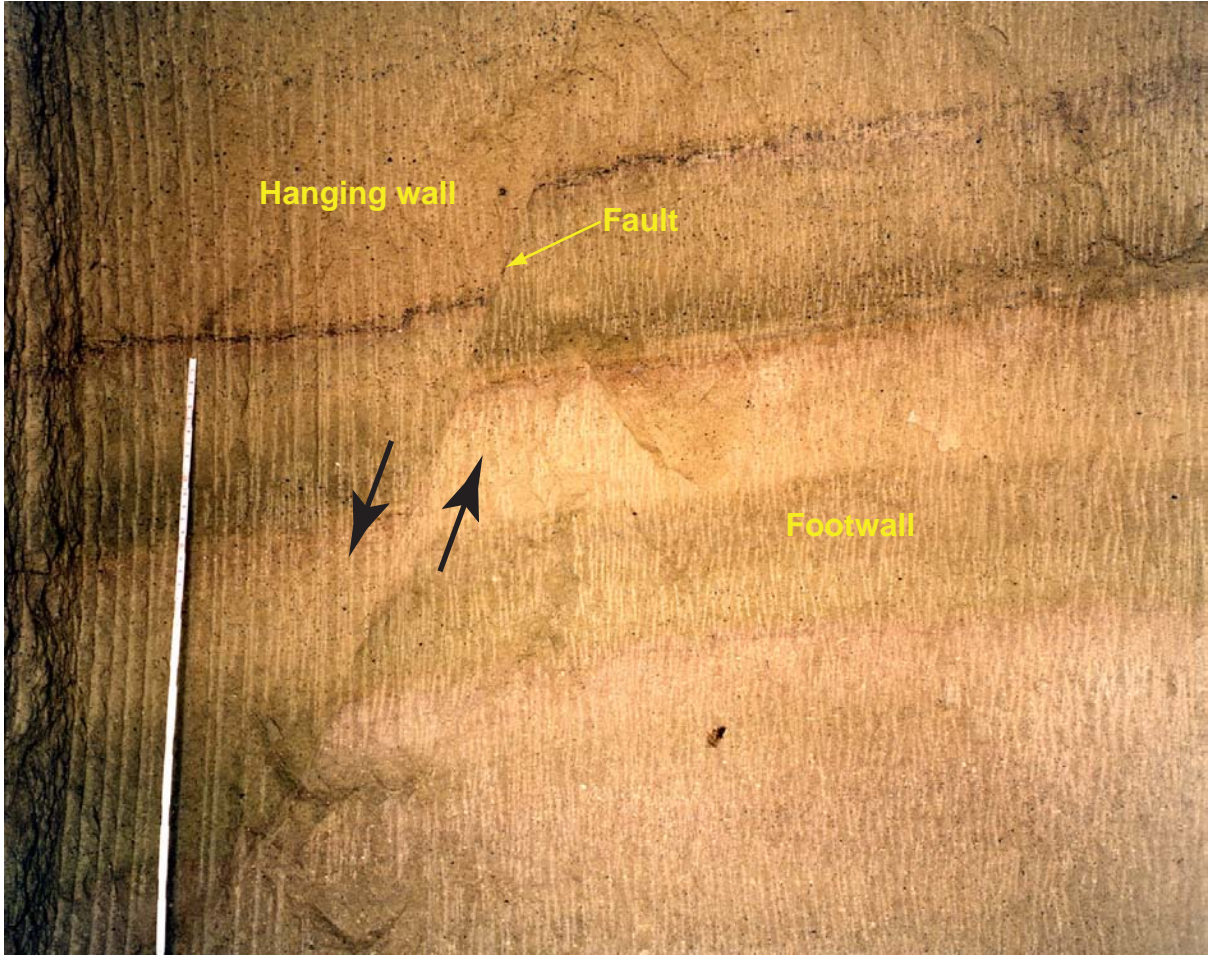
**Figure A-31**  
**Fault Station N-22BP**

This small normal fault within **tuff confining unit** in N-Tunnel shows no fault-related damage. The fault core is less than 1 cm (0.4 in.) wide. Offset is 0.2 m (0.7 ft). Staff is 1.4 m (4.5 ft) high.
