# **OBSERVATIONS ON FAULTS AND ASSOCIATED PERMEABILITY STRUCTURES IN HYDROGEOLOGIC UNITS AT THE NEVADA TEST SITE**

March 2009

U.S. Department of Energy  
National Nuclear Security Administration  
Nevada Site Office

Underground Test Area and Boreholes Programs and Operations  
Environmental Restoration  
National Security Technologies, LLC  
Las Vegas, Nevada

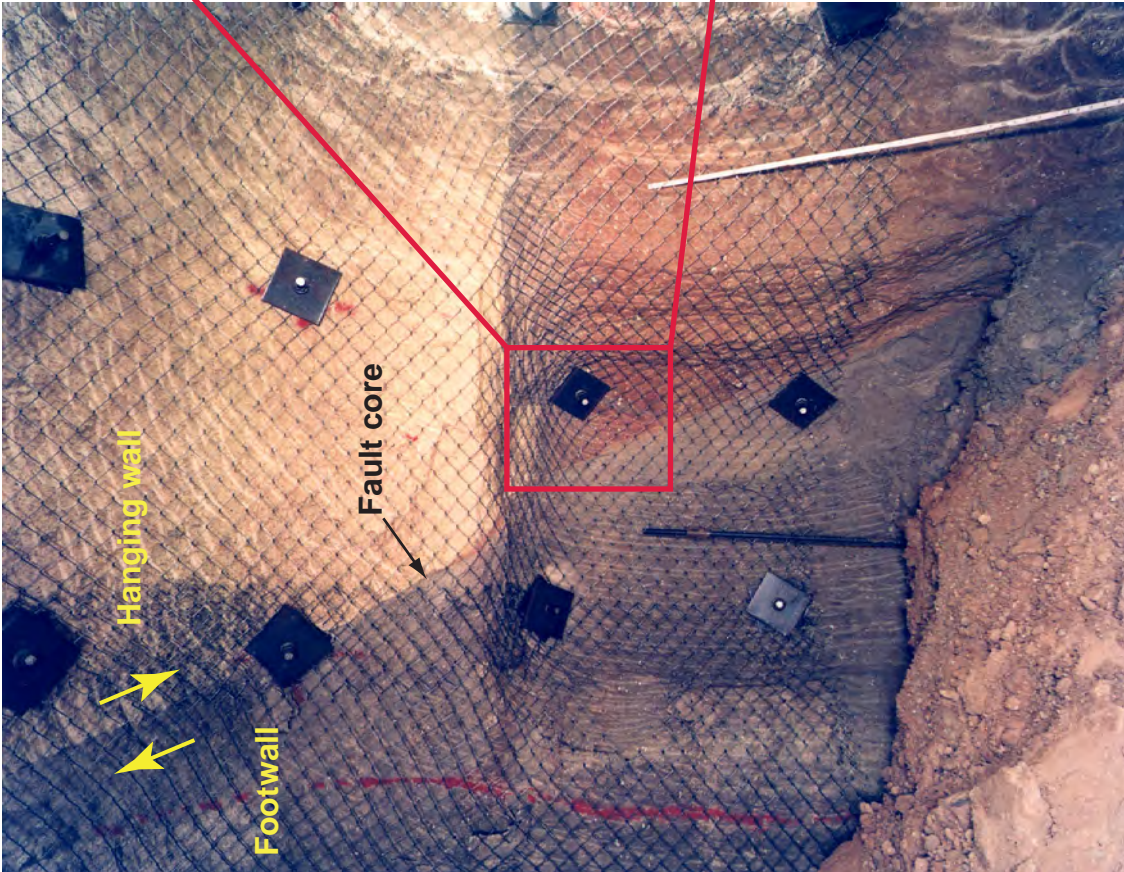
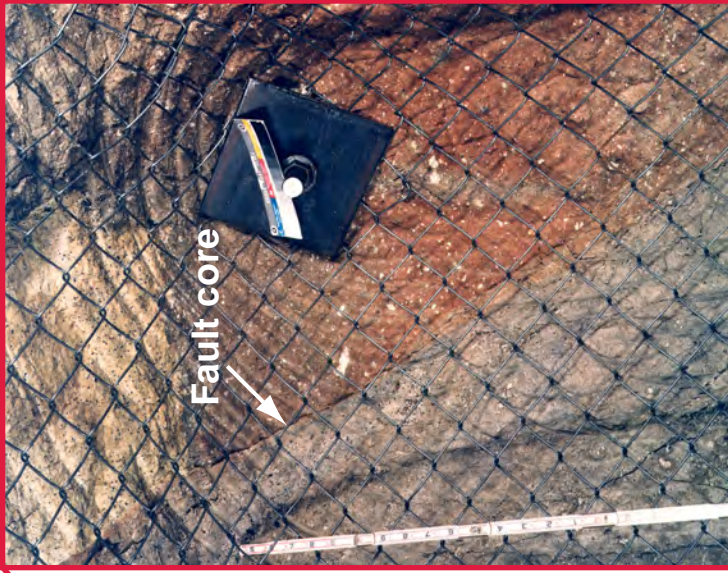
**Figure A-32**  
**Fault Station N-24BP**

This normal fault within **tuff confining unit** in N-Tunnel shows no fault-related damage and has a very thin fault core less than 1 cm (0.4 in) wide. Open aperture is visible along the fault core, but it is likely a surface feature caused by either mining activities or stress relief. Offset is 4.8 m (16 ft). Staff is 1.4 m (4.5 ft) high in photograph at left. Staff in close-up photograph is marked in tenths of inches.

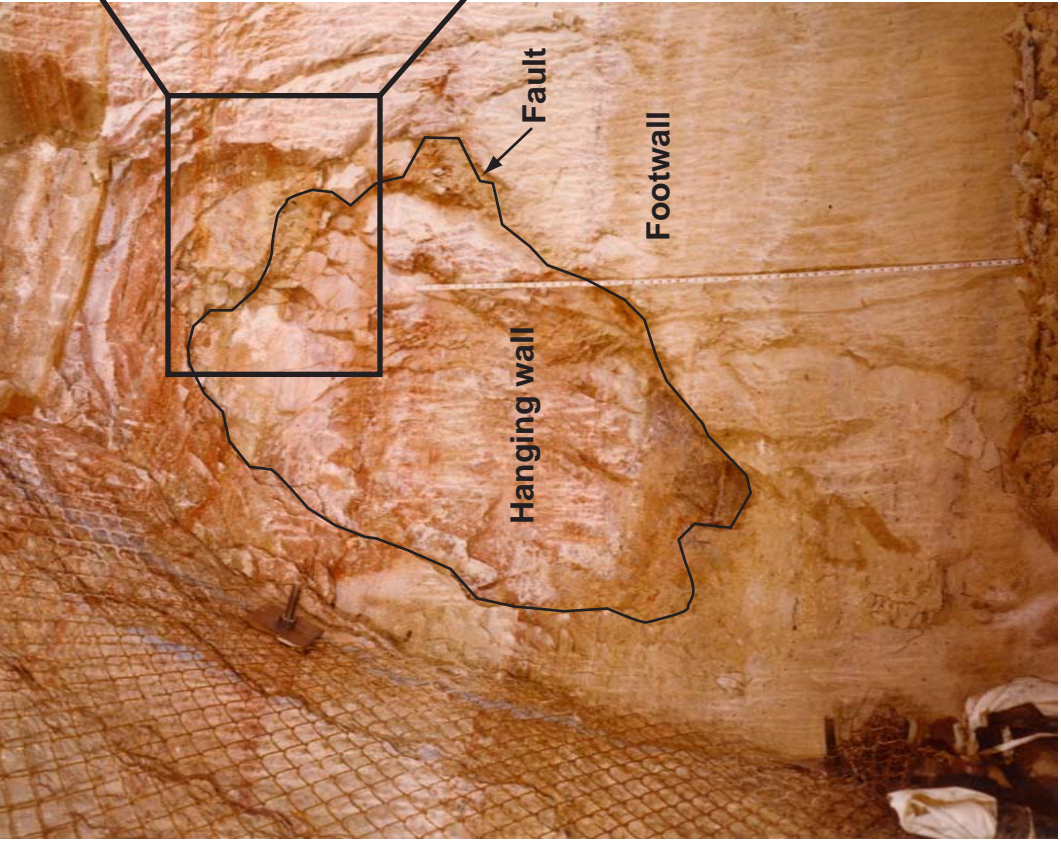
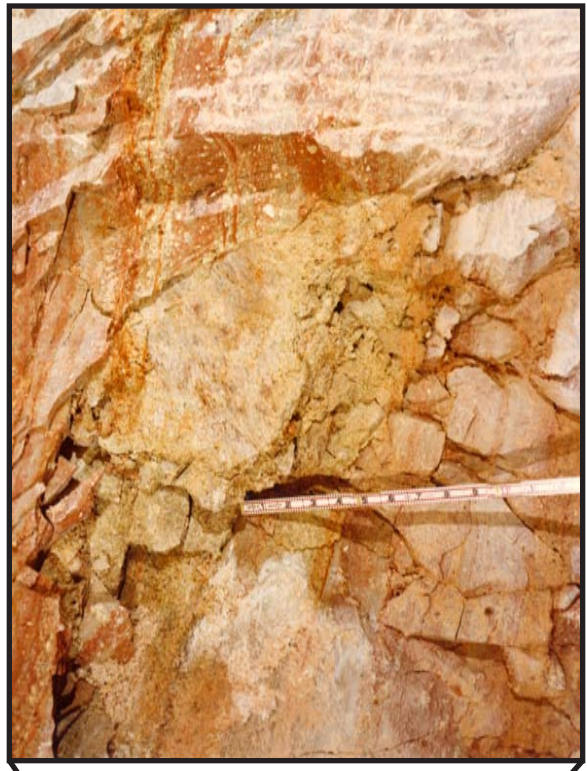
**Figure A-33**  
**Fault Station T-002**

This normal fault in T-Tunnel is within **tuff confining unit** consisting of locally silicified bedded tuff. The fault plane strikes parallel to the view and dips away from the reader. Note the more intense damage in the vicinity of the fault core typical of silicified tuff. Offset is 0.5 m (1.5 ft). Staff at left is 1.7 m (5.5 ft ) high.

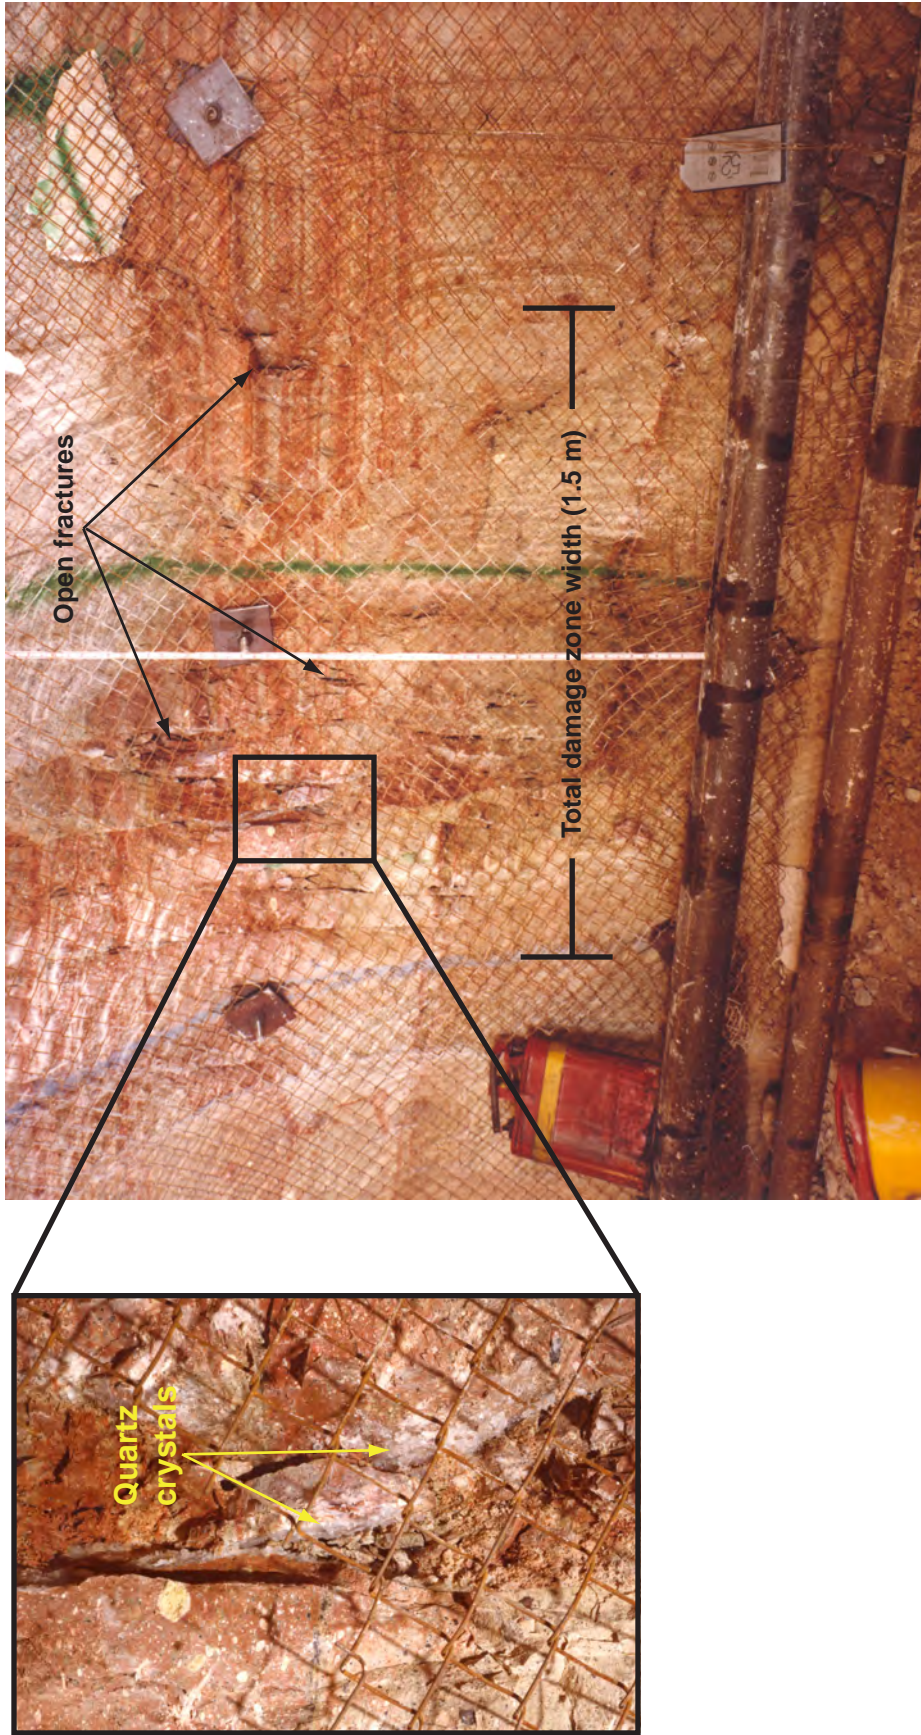
**Figure A-34**  
**Fault Station T-003**

This fault zone is within silicified **tuff confining unit** in T-Tunnel. The fault core cannot be delineated in the photograph. Damage consists of partially open vertical fractures. Some fractures contain secondary crystalline quartz, indicating water has flowed through the fractures. Total width of fault zone is approximately 1.5 m (5 ft). Staff is 1.7 m (5.5 ft) high.

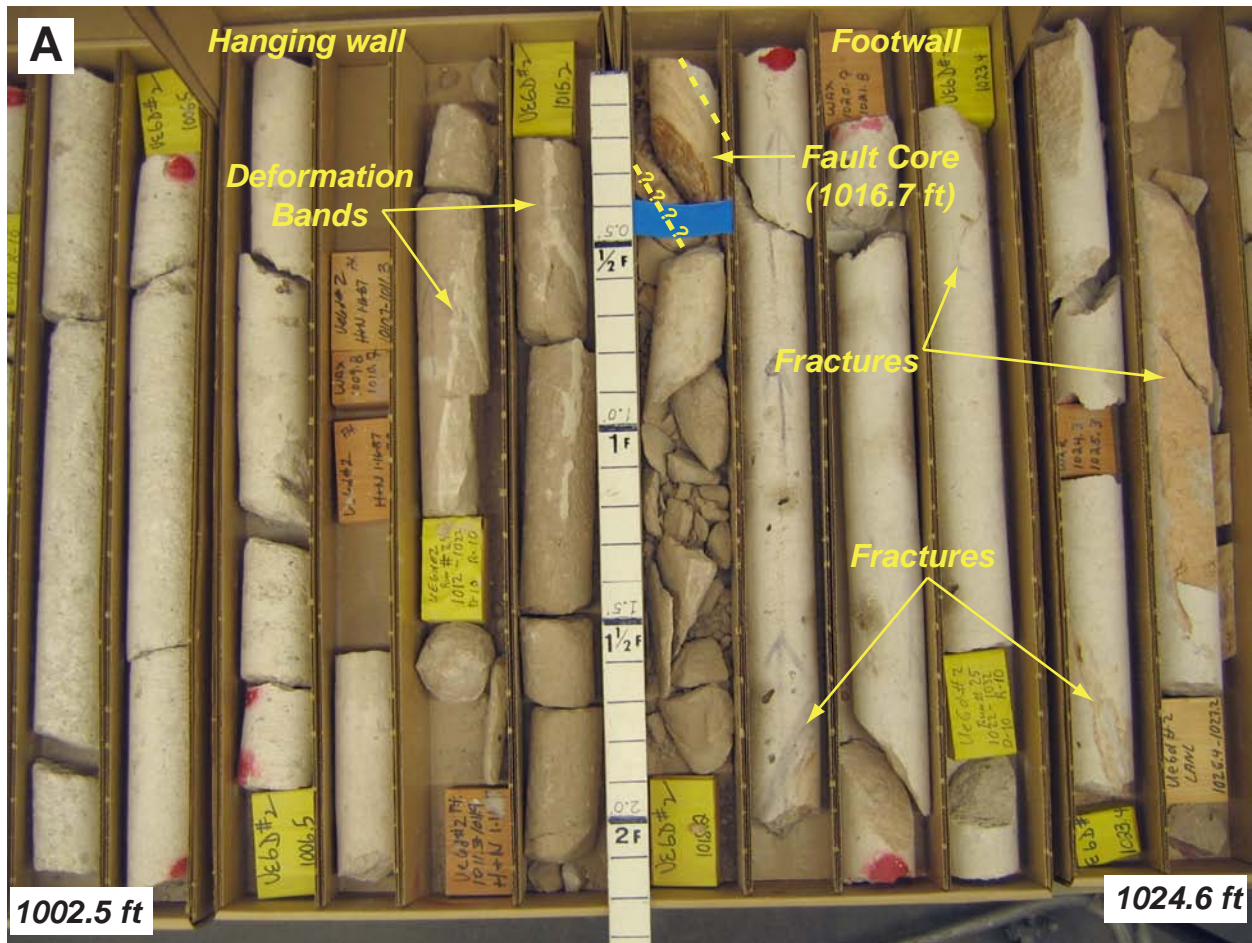
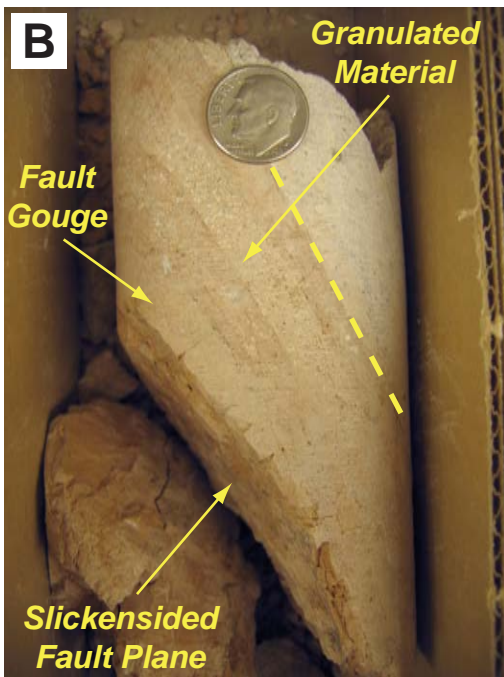
**Figure A-35**  
**Fault Station UE-6d#2-1016.7**

Fault within **vitric-tuff aquifer** in vertical core hole UE-6d#2.

A) Depth of fault is 309.9 m (1,016.7 ft). The fault zone shows structural features typical of faulted **vitric-tuff aquifer** including deformation bands in the vitric nonwelded tuffs comprising the hanging wall damage zone, and fractures within the partially welded tuff that makes up the footwall damage zone. Note that fractures in the footwall are mostly filled with silica.

B) The fault core is estimated to be 6 cm (0.2 ft) wide and composed of granulated cataclastic material and clayey fault gouge. A slickensided fault plane has developed in the fault gouge.

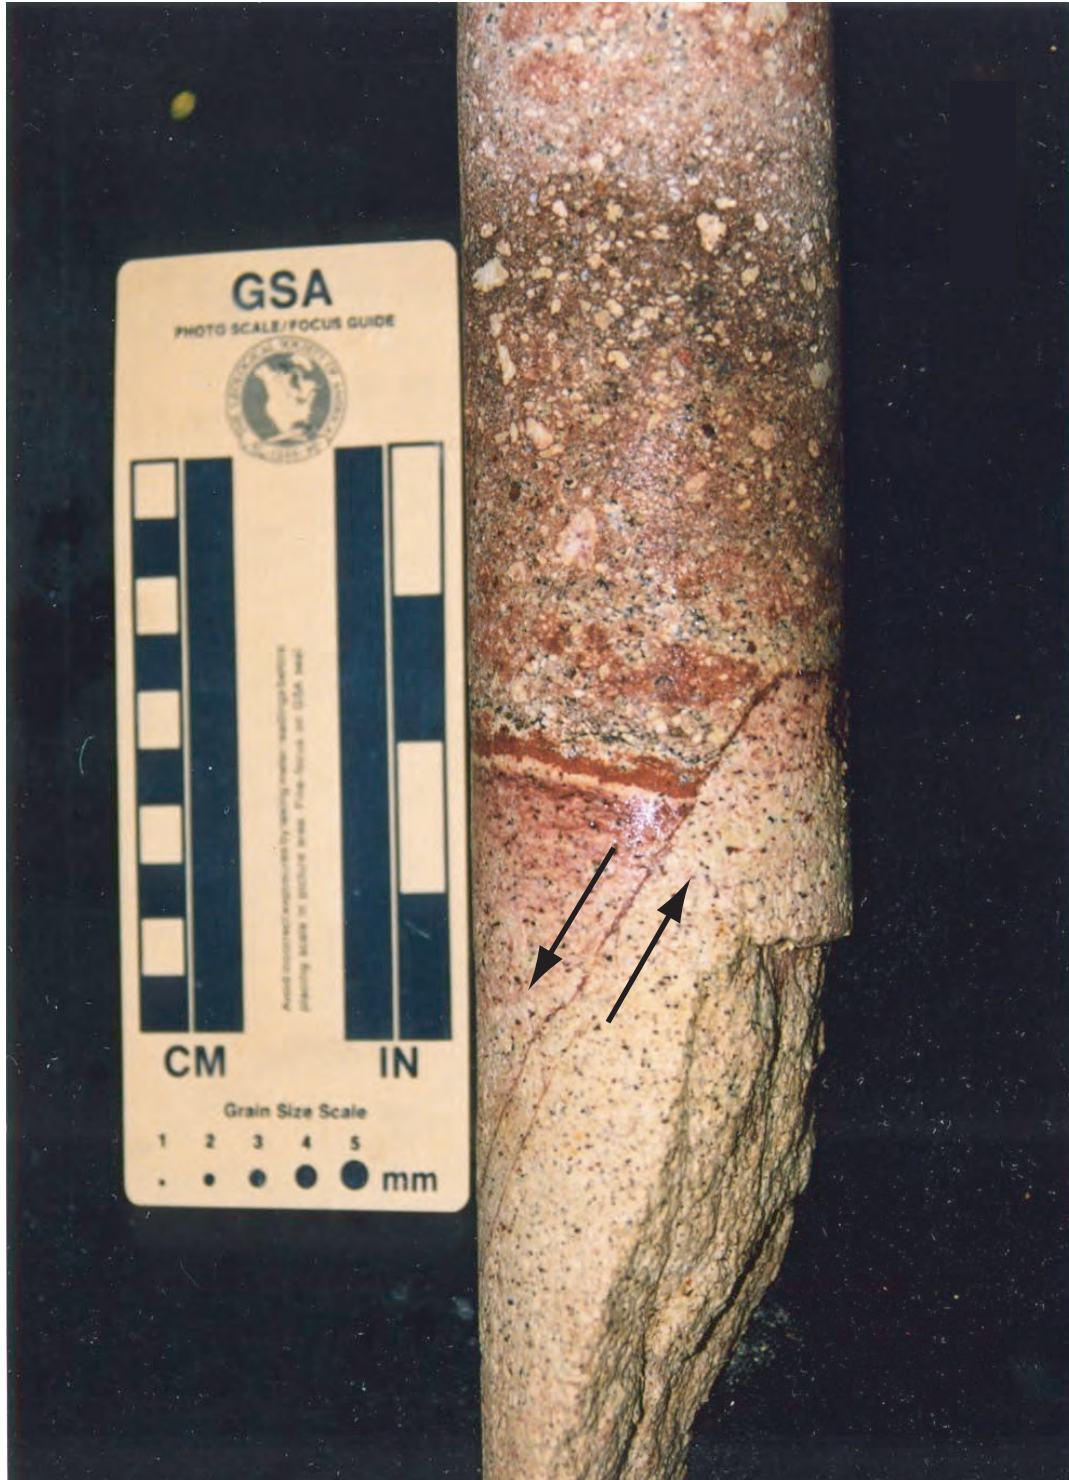
**Figure A-36**  
**Fault Station UE-7f-2321**

Core sample from vertical core hole UE-7f showing offset bedding along normal fault in **tuff confining unit**. This is a small fault with less than 5 cm (2 in.) of displacement. Top of core sample (i.e., uphole) is to the left.

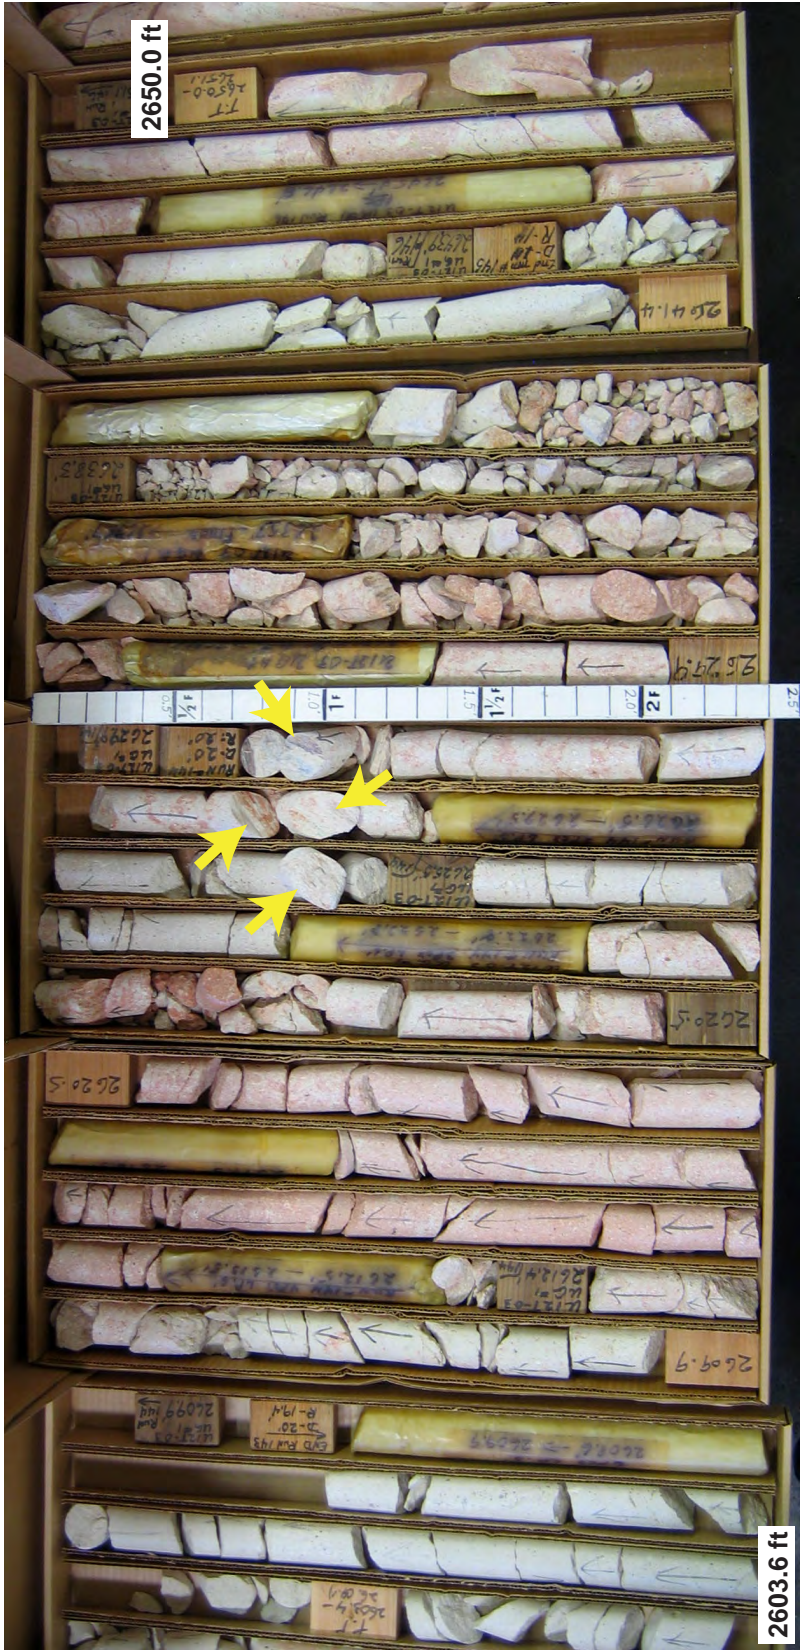
**Figure A-37**  
**Fault Station U12T.03UG1-2628**

Fault zone within **tuff confining unit** in horizontal core hole U-12t.03 UG-1. Fault zone indicated by several striated fault planes (yellow arrows). See Figure A-38 for close-up of fault planes. Fractures with aperture are rare in this core interval, with most breaks related to coring and handling. Elevated core index values within this interval indicate the rocks are mechanically weakened.

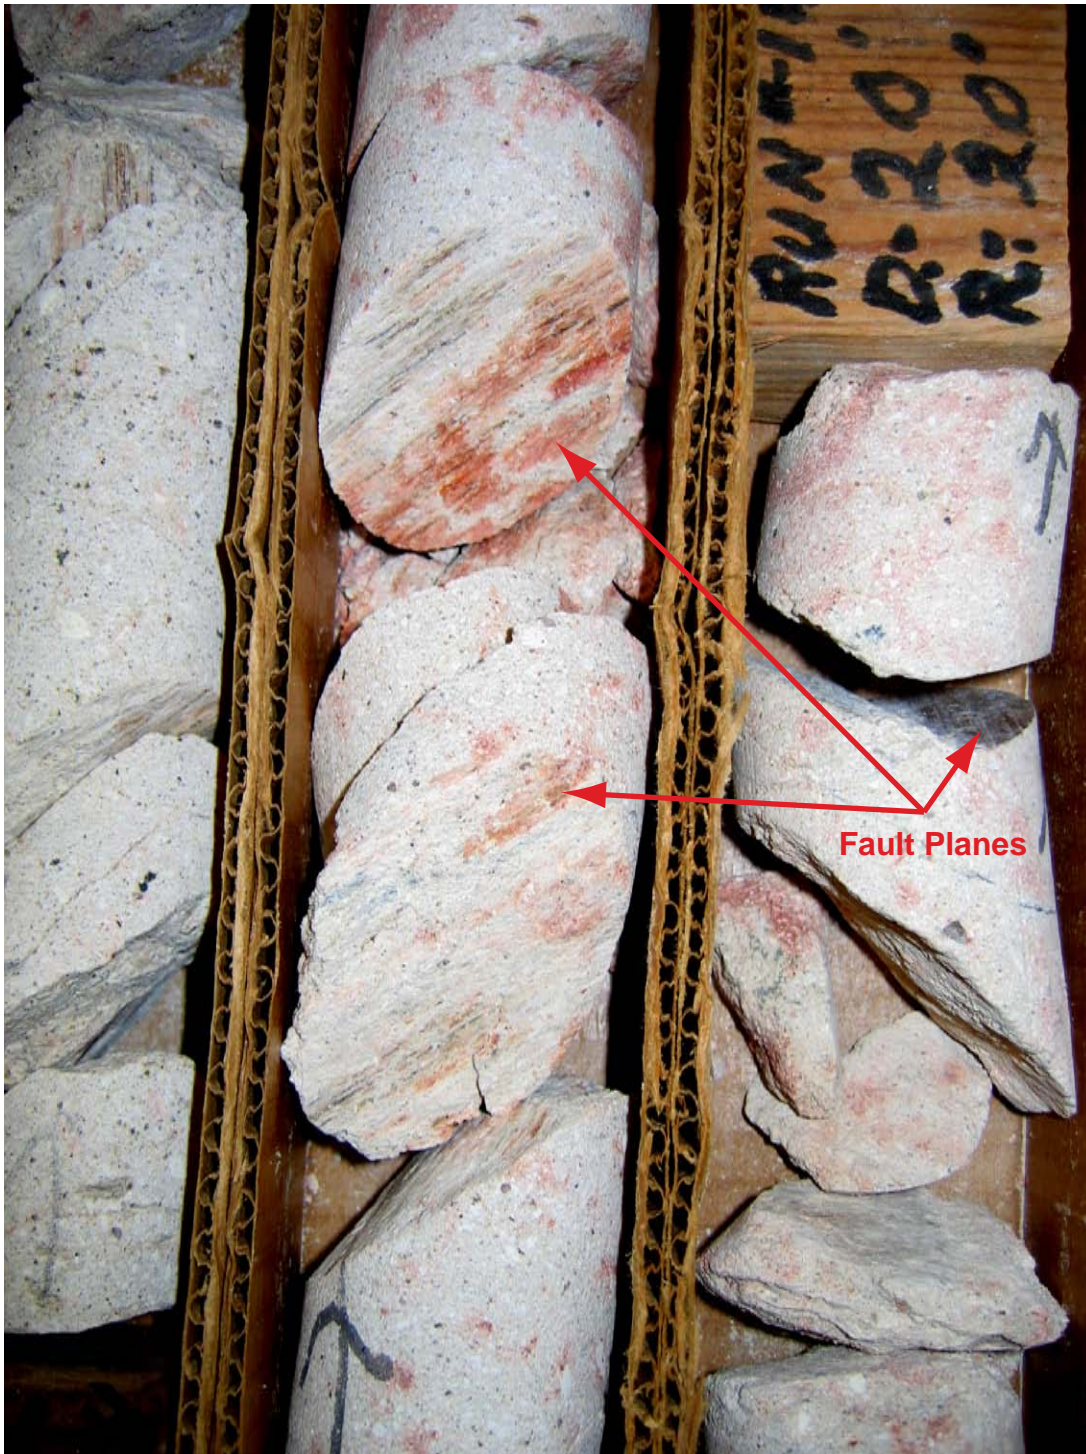
**Figure A-38**  
**Fault Station U12T.03UG1-2628 (detail)**

Close-up of fault planes within **tuff confining unit** in horizontal core hole U-12t.03 UG-1. Core is 5.1 cm (2 in.) in diameter.

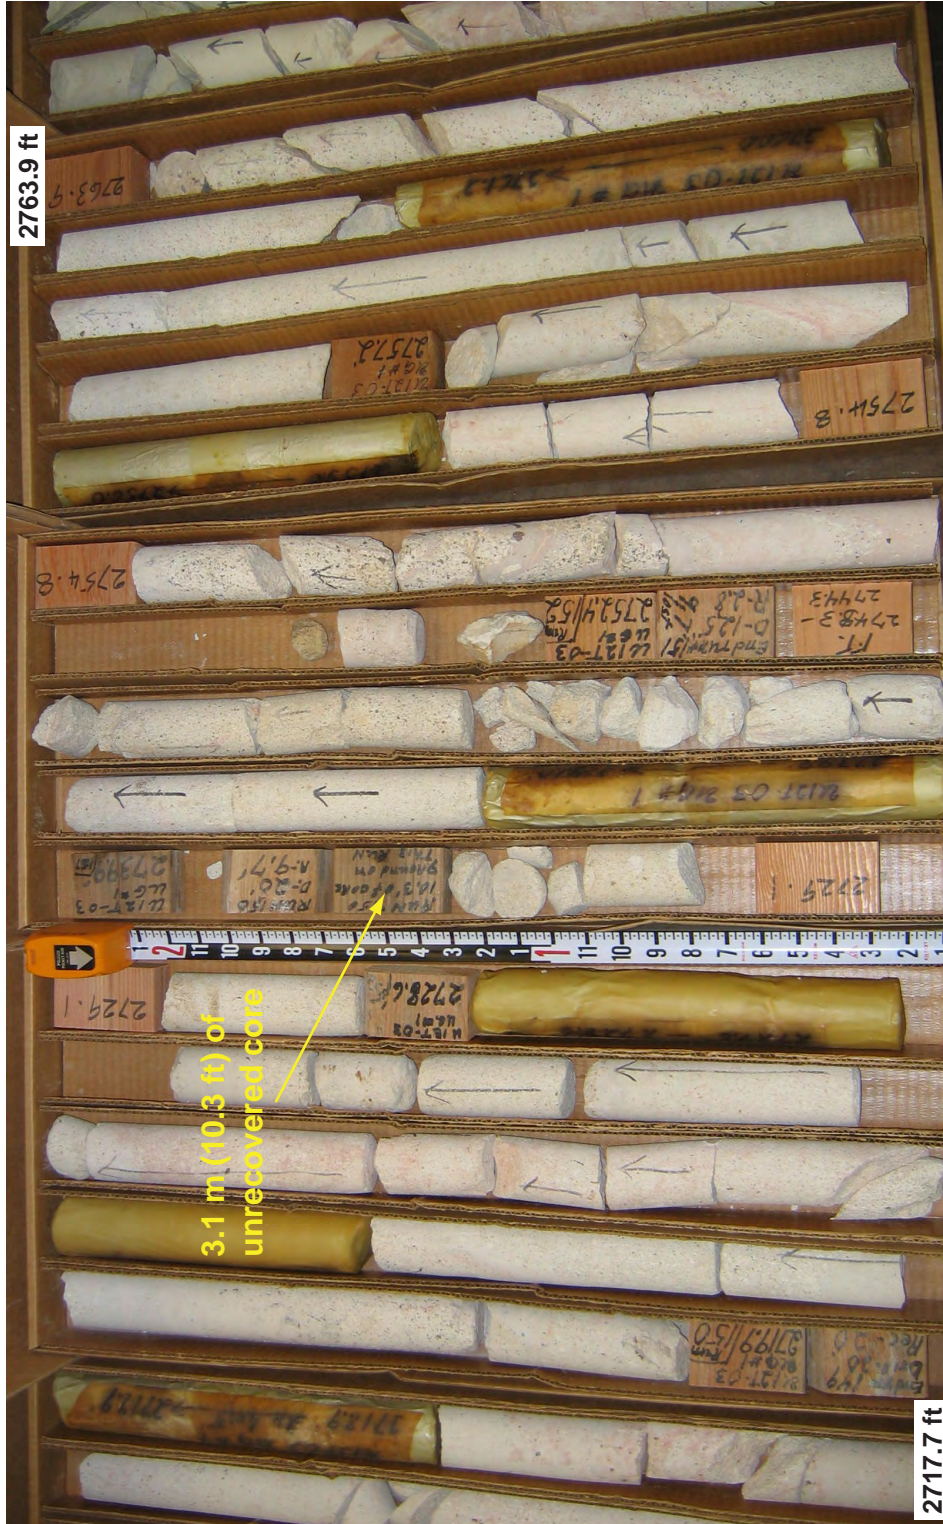
**Figure A-39**  
**Fault Station U12T.03UG1-2735**

Fault within **tuff confining unit** in horizontal core hole U-12t.03 UG-1. Stratigraphic analysis indicates that this fault has greater than 3.0 m (100 ft) of offset, and making it one of the larger faults documented beneath Rainier Mesa. The fault core zone is not represented in the core samples because it was likely within the 3.0 m (10 ft) of core not recovered. Fault-related damage appears to be minimal with most breaks related to coring and handling. Core index values, however, are elevated through the interval, indicating that the rock was mechanically weakened in the vicinity of the fault.

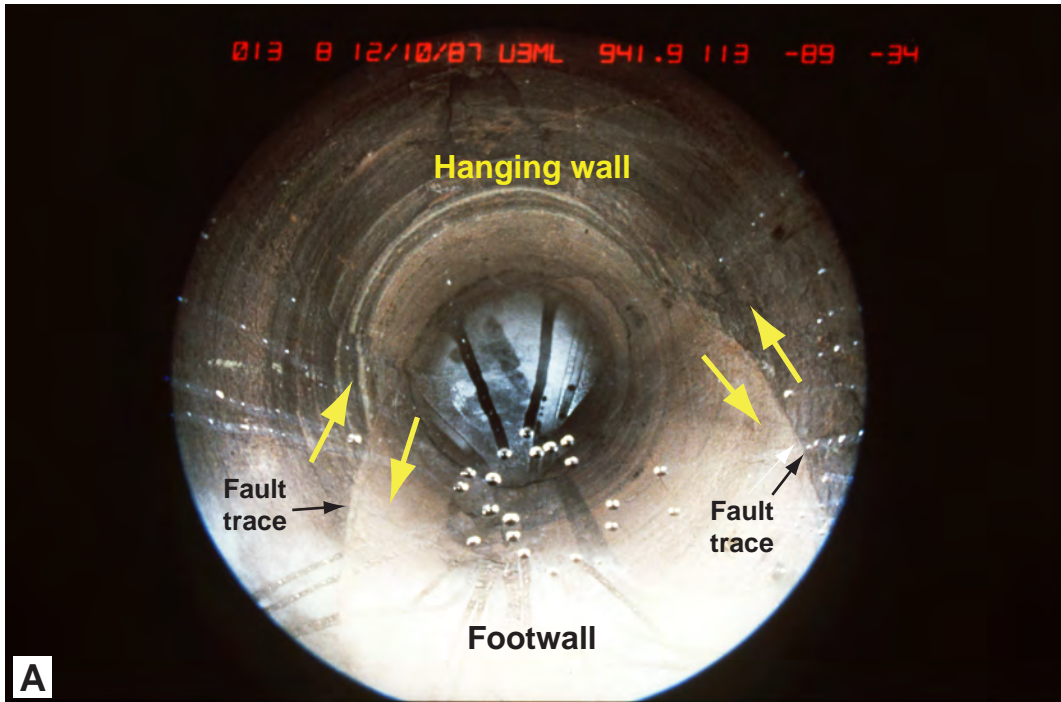
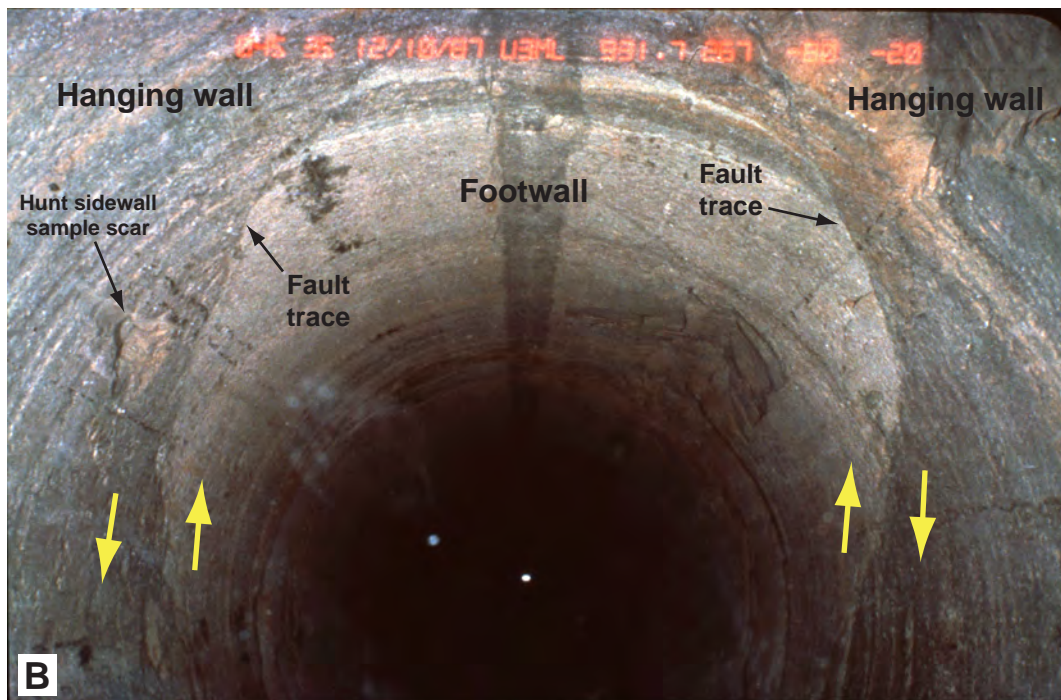
**Figure A-40**  
**Fault Station U-3mL-2940**

Down-hole camera views of fault within **tuff confining unit** in emplacement hole U-3mL. Depth of camera in view A is 287.1 m (941.9 ft), and depth of camera in view B is 284.0 m (931.7 ft). Offset along fault is approximately 1.8 m (6 ft). Hole diameter is 2.4 m (8 ft). Note very thin fault core and lack of noticeable damage in both the footwall and hanging wall.

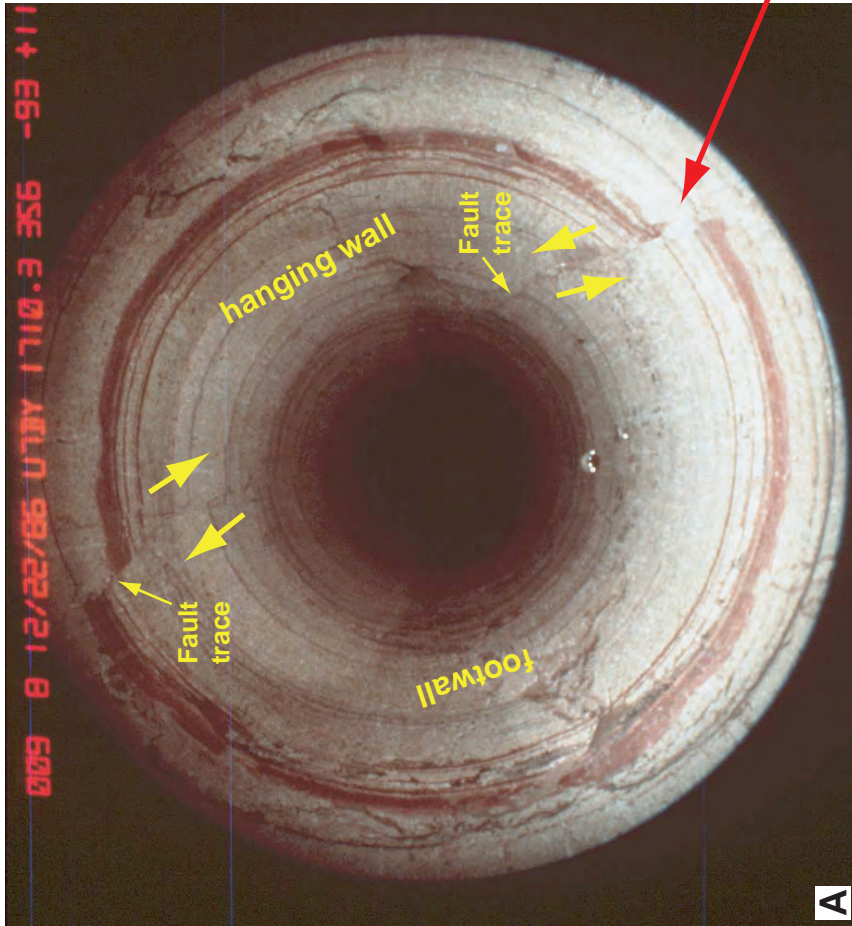
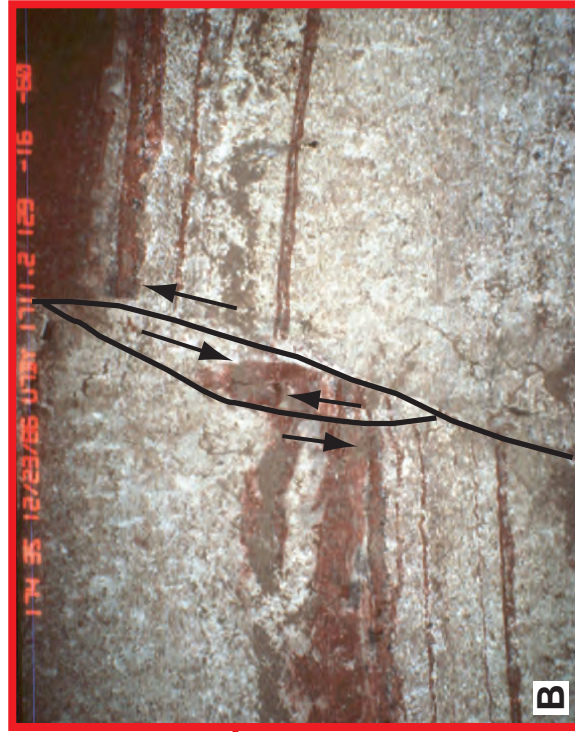
**Figure A-41**  
**Fault Station U-7by-1710**

Down-hole camera views of a small fault within **tuff confining unit** in emplacement hole U-7by. Hole diameter is 2.4 m (8 ft). Fault offset is approximately 0.15 m (0.5 ft). Fish-eye camera depth in view A is 521.3 m (1710.3 ft). Depth of close-up in view B is 521.6 m (1711.2 ft).
