# **SANDIA REPORT**

SAND2009-2757  
Unlimited Release  
Printed May 2009

## **Assembly and Comparison of Available Solar Hot Water System Reliability Databases and Information**

David Menicucci

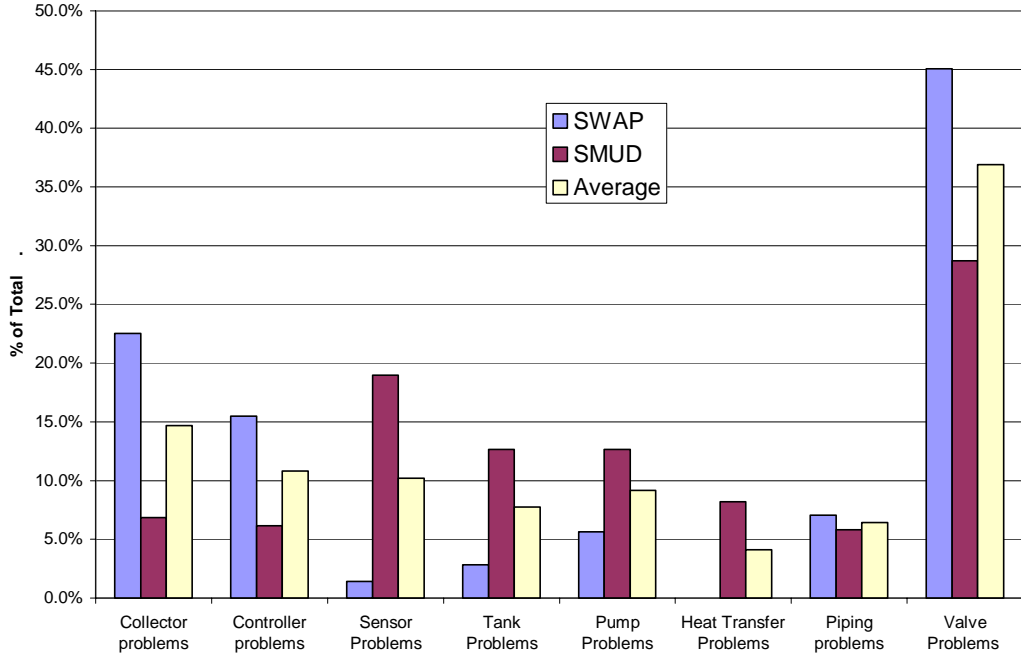
Figure 7. Comparison of Pumped System Problem Allocation.

Only two system types are common between the SMUD and SWAP datasets, ICS and pumped. Table 1 shows the problem totals for each system type expressed as a percentage of total problems. Figures 6 and 7 show the results of comparing the two summary problem datasets.

The ICS system has few moving parts to fail (Figure 6). Therefore, both datasets show the predominate failures to be with the collector itself. Among pumped systems, both datasets show similar trends and indicate that valves are the most problematic component (Figure 7). Collectors and controller problems seem to be more prevalent in the SWAP systems than at SMUD. Conversely, sensor, tank, and pump problems constitute a greater percentage of the problems at SMUD than in SWAP.

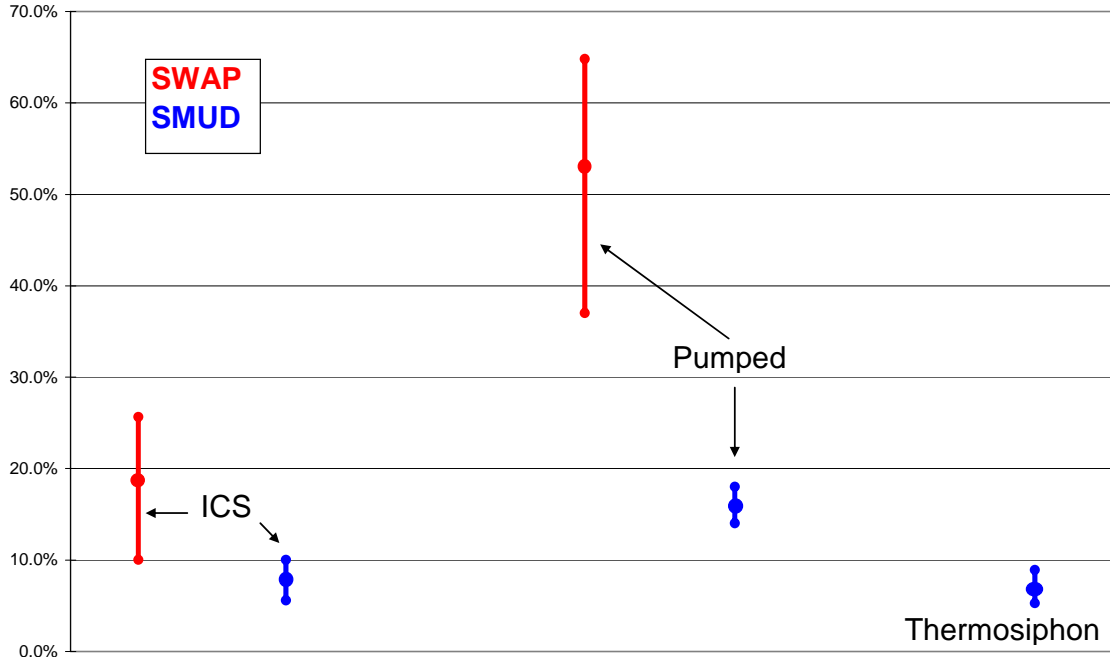
Figure 9. Proportion of Problematic Systems as a Percentage of Total Installed (plus approximate 95% confidence limits).

Figure 9 shows a plot of the proportions of nonoperational systems taken from the respective SWAP and SMUD samples. The three values, the lower 95% limit, the sample proportion, and the upper 95% limit are shown as a vertical line. The large dot in the middle of the line is the computed proportion from the database. The lines are color-coded to show the dataset origin. The confidence limits are large for the SWAP data because the sample size is relatively small, at least as compared with SMUD.

As can be seen within the SWAP dataset, the differences between the proportions for the ICS and pumped systems appear to be statistically significant. There are no thermosiphon system data in the SWAP dataset.

Within the SMUD dataset, there appears to be no significant difference between the ICS and thermosiphon system. However, there appears to be a significant difference between these two systems and the pumped systems.

The results are reasonable and consistent with expectations. Pumped systems have many more components that can potentially fail than do the ICS and thermosiphon systems, which are relatively simple.
