# The Repair of Laterally Damaged Concrete Bridge Girders Using Carbon Fiber Reinforcing Polymers (CFRP)

A thesis submitted to the School of Engineering in partial  
fulfillment of the requirements for the degree of

Master of Science in Civil Engineering

UNIVERSITY OF NORTH FLORIDA

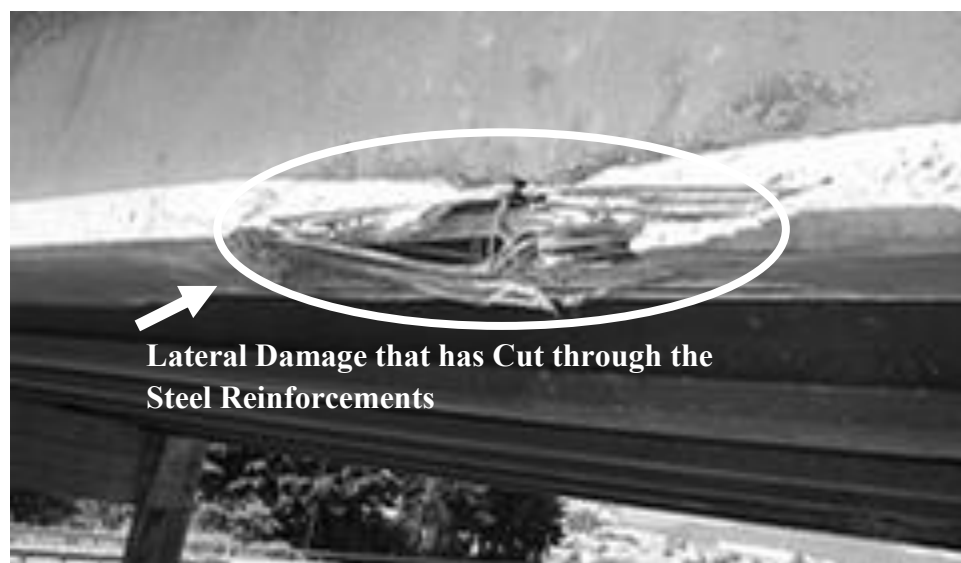
**Figure 1-1:** *Example of overheight impact damage to prestressed concrete bridge girder*

The following research investigates the effectiveness of using non-prestressed CFRP fabric laminates in repairing both RC and PSC girders damaged by lateral impacts that cut through the steel reinforcements and/or prestressing cables; example in Figure 1. Included in the investigation is an evaluation of the proper configuration, size, and spacing of CFRP U-wrappings to mitigate the debonding problem. Other repair application and design considerations such as reinforcement ratio, level of strengthening (number of CFRP soffit layers), development length, and continuity are also addressed in the experimental program and the resulting recommendations are ultimately presented.

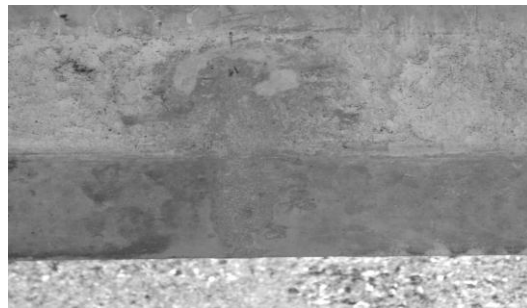
**Figure 3-7:** Finished repaired section

cut was then thoroughly cleaned with a water jet and pressurized air. The cleaned opening was filled with a high strength cementitious repair mortar and a high pressure epoxy injection procedure was performed after the mortar set (Figure 3-6). The procedure resulted in a near perfect repaired cross-section, as seen in Figure 3-7.

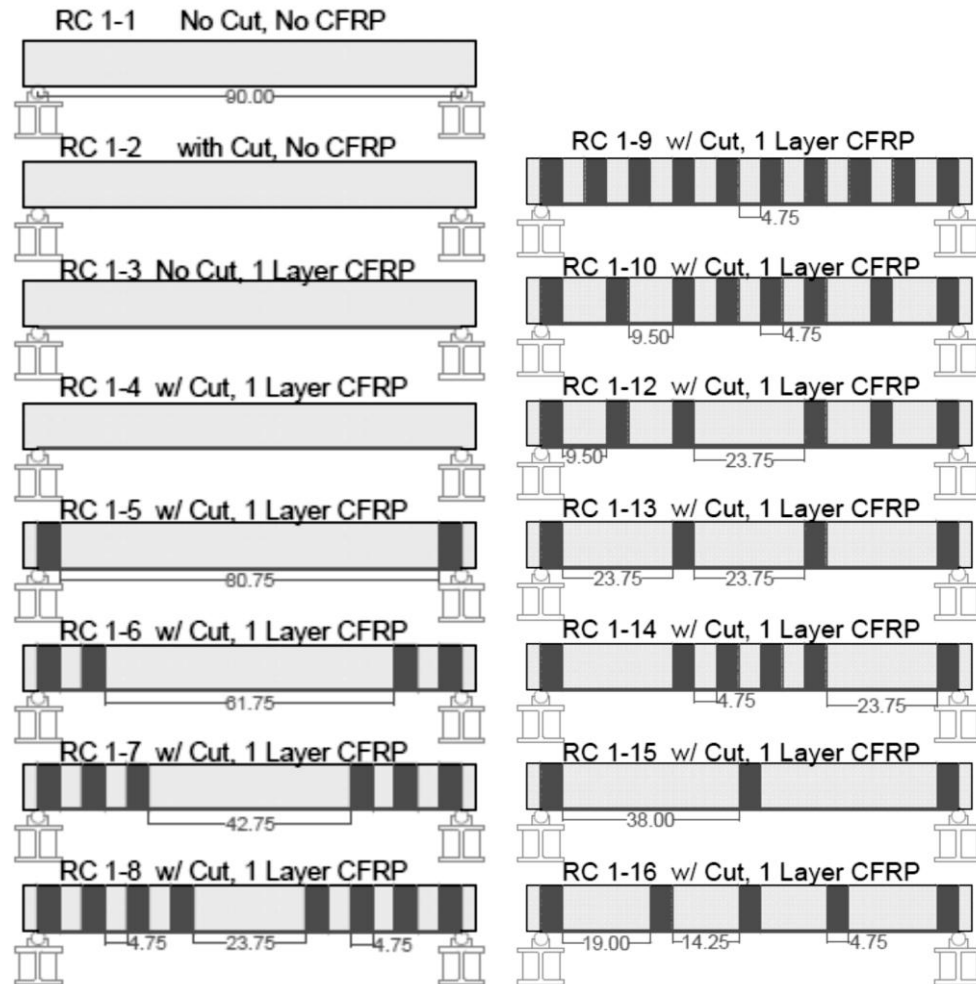
**Figure 3-9:** First Set (“TB” set) of 15 RC Beams, CFRP Configuration Layouts

The first set “TB”, containing fifteen beams, was cast at the FDOT lab facilities in Tallahassee, Florida. This set of beams contained the #4 steel rebar for flexural reinforcements. The control beams without a cut rebar had a reinforcement ratio ( $\rho$ ) of 0.0128 and the damaged beams, with a cut rebar, had a reinforcement ratio of 0.0085. Each beam in this set receiving CFRP was repaired with one longitudinal layer of 4in (10.2cm) wide, 0.04in (1.0mm) thick CFRP laminate bonded to the beam soffit. The U-wrappings applied for the repairs were 4.75in (12.1cm) wide and (0.04 in 1.0mm) thick and they extended to the top fiber of the beams. The spacing distances were also set at a standard of 4.75in (12.1cm) or multiples thereof. Figure 3-8 presents a picture of a set of finished specimens and the various configurations tested for the first set are shown in Figure 3-9.

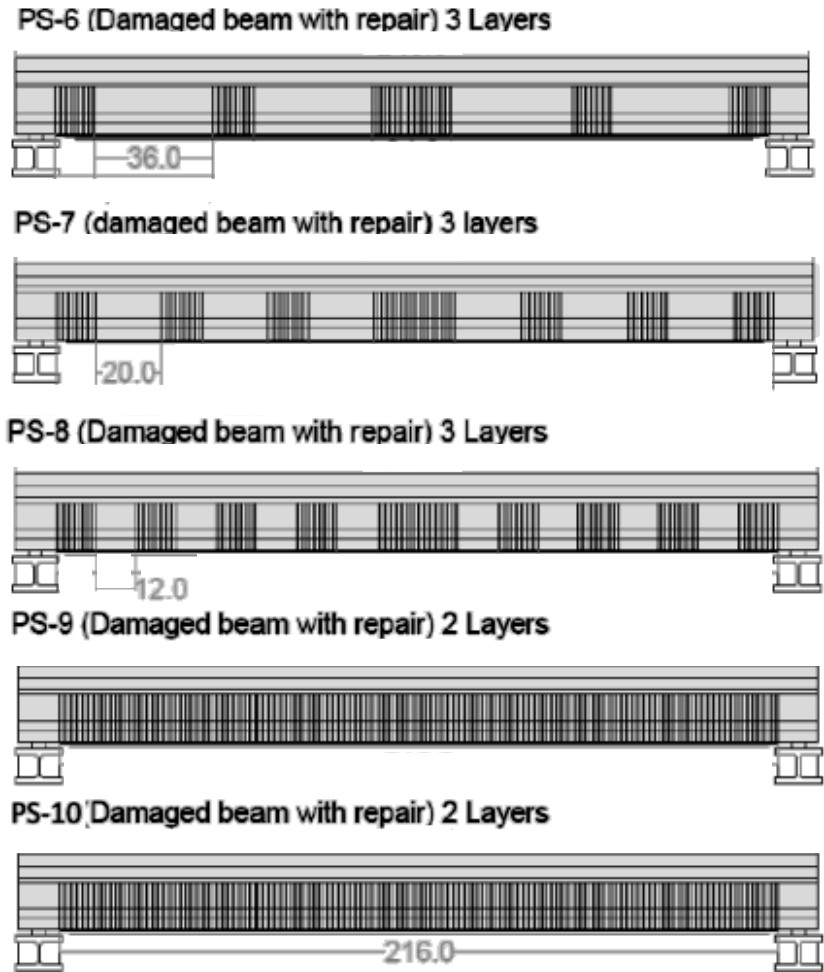
**Figure 3-12:** Second Set of 15 Beams, CFRP Configuration Layouts

Similarly, Figure 3-12 displays the CFRP configurations for the remaining girders tested. The first three girders presented (PS-6 through PS-8) are damaged and repaired with 3 layers of CFRP at the girder soffit and U-wrappings at the same spacings of twelve inches, twenty inches, or thirty-six inches. The final two beams (PS-9 & PS-10) are fully wrapped girders, having U-wrappings cover the entire beam, using 2 layers of CFRP for both the longitudinal and U-wrapping laminates. However, the U-wrappings applied to PS-10 were overlapped by approximately an inch, whereas those applied to PS-9 were not. This was intended to investigate a simple question of needed continuity in the direction opposite to the direction which the fibers run.

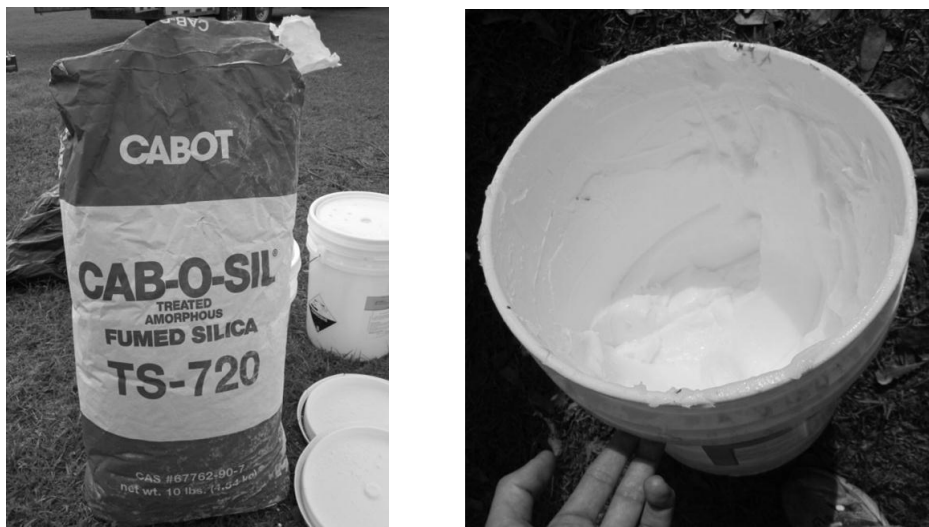
**Figure 3-14: (left) Fumed Silica used to Thicken Epoxy; (right) Thickened Epoxy**

For the prestressed concrete girders, employees of Fibrwrap® performed the installation procedure for the ten statically tested samples in which a traditional wet lay-up procedure was implemented. Their crew first took grinders to the entire surface below the top flange of the girders. Next pressurized air was used to blow the concrete dust from the surfaces and a pressure washer was used to clean the girders. After drying in the sun, pressurized air was blown over the girders again and they began to mix the epoxy. Each portion of the epoxy was split and half was mixed with a substantial amount of Cab-o-Sil® fumed silica in order to gain a more desirable consistency. Figure 3-14 shows the silica product and the resulting thickened epoxy.

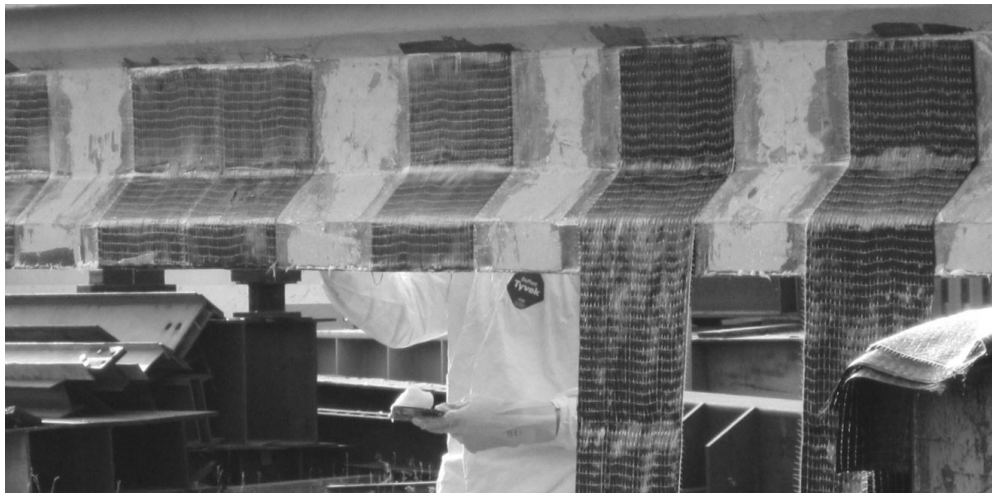
**Figure 3-15:** Transverse CFRP U-wrappings being applied by FIBRWRAP

Using the original thinner Tyfo® S epoxy a layer was rolled onto the concrete surface of the girders where the CFRP laminates would be applied. A thin layer of the thickened epoxy, containing the fumed silica, was then applied to the tension side of the girders and the first pre-cut longitudinal laminate, saturated in un-thickened epoxy, was attached. Trowels and paint rollers were used to remove any air voids once the first layer was adhered. Next, a second layer of the thickened epoxy was applied on top of the first laminate layer. At this point any required subsequent longitudinal layers were applied in the same manner. This procedure was identically followed for each layer of transverse U-wrapping applied with one added important process. To attach the transverse laminates all bonding procedures were performed on one side first while the remaining fabric hung towards the ground. Then with one side secure, the laminates were pulled tightly to ensure effectiveness as they wrapped around the cross-section. Figure 3-15 provides a moment of the process.

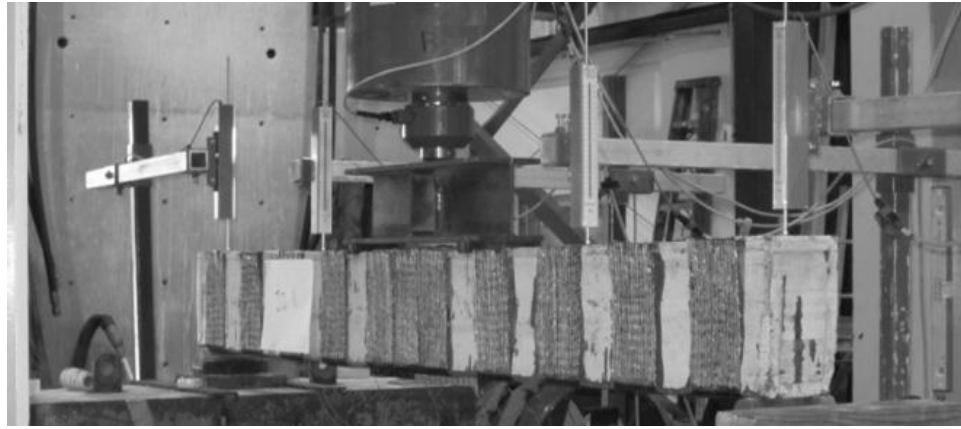
**Figure 3-16:** Example of Testing Setup for RC beams

The beams were instrumented with two laser deflection gages, four linear variable differential transformer (LVDT) deflection gages, and between 4 to 7 strain gages (30 mm long- 120 ohm). The two laser deflection gages were positioned at the center of the beams' span both above and below each beam. Two of the LVDTs were placed on the beams' top surface above the supports and the remaining two LVDTs were placed

on the beams' top surface at quarter points of the beams' span. Figure 3-16 displays a picture of the testing setup for the RC beams.

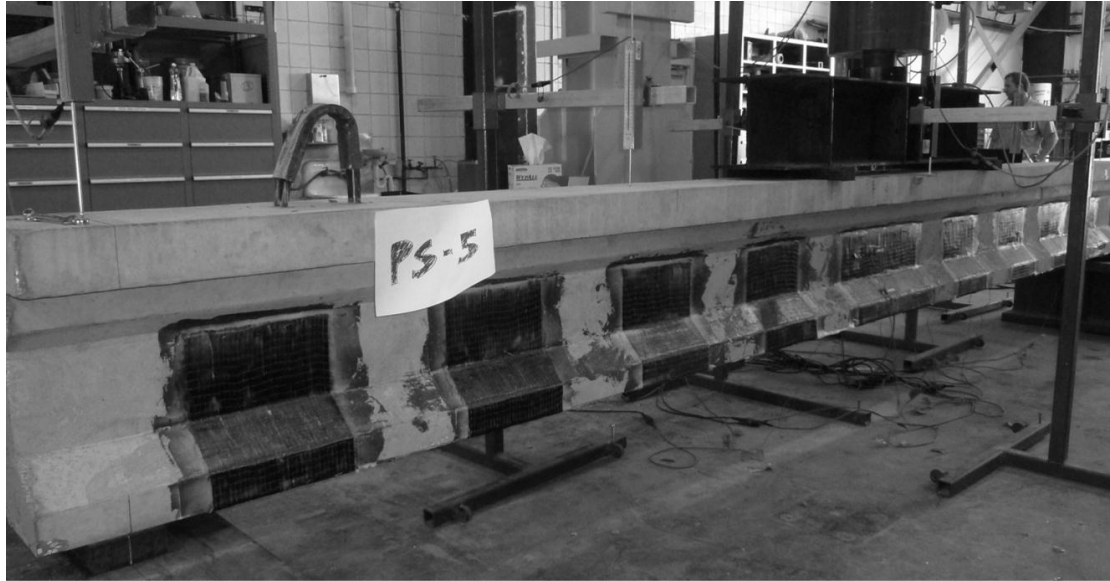
**Figure 3-19:** Testing Setup Photo for Statically Loaded PSC Girders

The statically loaded girders were tested under a four point loading arrangement using an 800 kip load actuator at the FDOT structures research lab. The 20-ft long PSC girders spanned nineteen feet between the centerlines of the bearing pads which rested on stationary supports. The girder loading was applied using a steel spreader beam resting on another set of two pads with a center to center distance of fifty inches. Along with the structural arrangement, measurements were recorded through the set-up of many gage devices. Other than load measurements recorded by the actuator, the girders were also instrumented with six LVDT (linear variable differential transformer) deflection gages and up to twelve strain gages (30 mm long-120 ohm). Two LVDT deflection gages were positioned at center span on each side of the girder, two LVDTs were placed at girder top surface above the support areas, and the remaining two LVDTs were placed at quarter points of the girder span. On each girder, four of the strain gages were placed along the height of the cross-section at mid-span and the remaining strain gages were distributed along the flexural tension side at various locations depending on the CFRP configuration. The general placements of all measurement devices mentioned are also shown in Figure 3-18 and a photo of PCS 5 set up for testing is given in Figure 3-19.

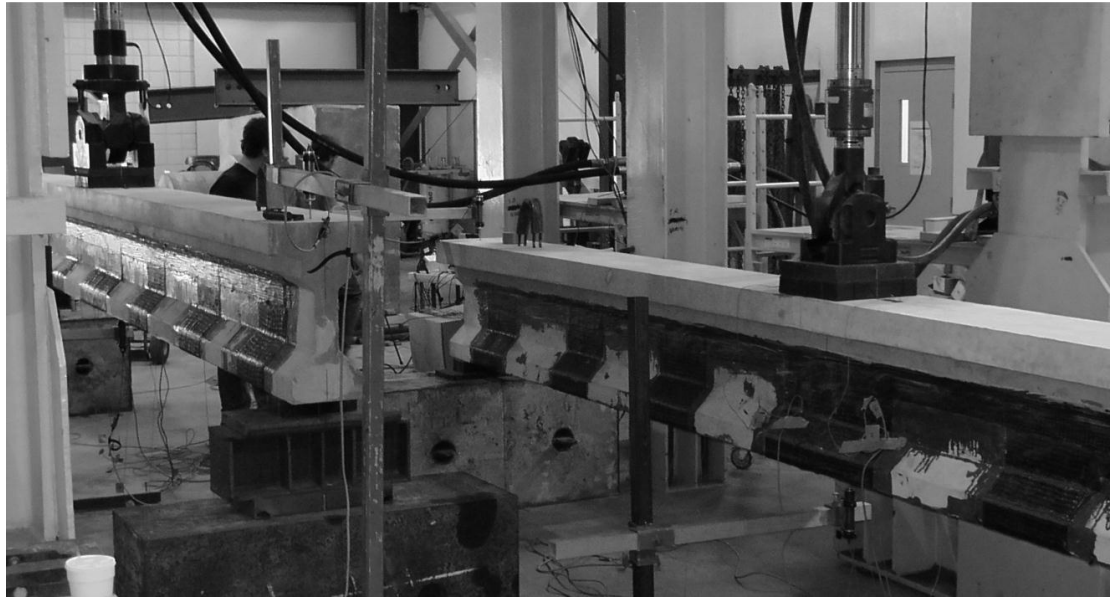
**Figure 3-21:** Testing Setup Schematic for Dynamically Loaded PSC Girders

configuration. The general placements of all measurement devices mentioned are also shown in Figure 3-20 and a photo is available in Figure 3-21.

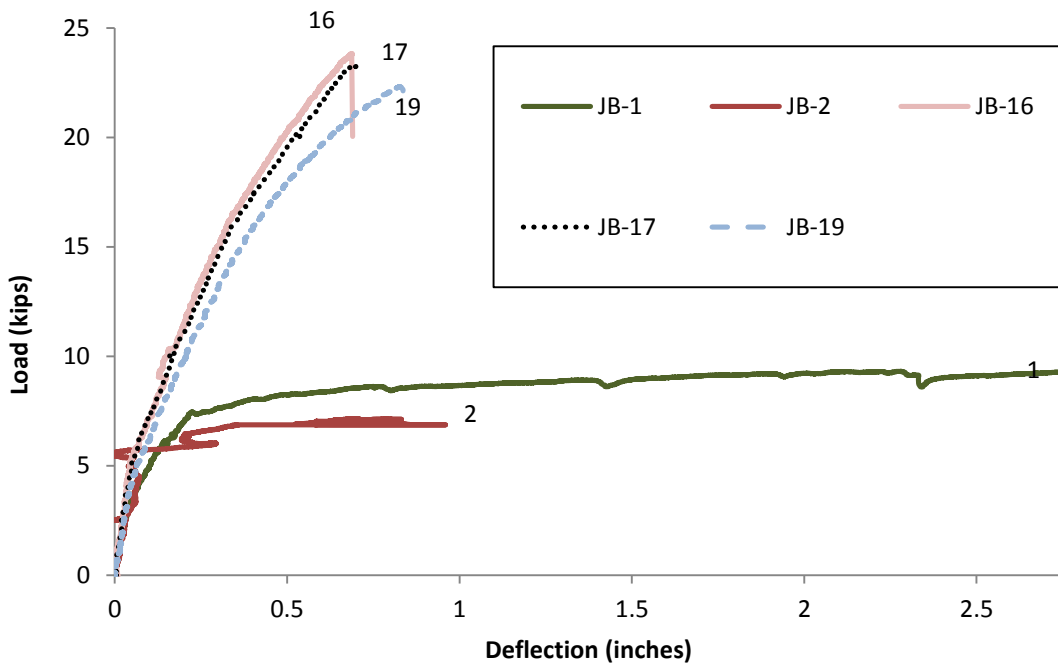
**Figure 4-6:** Load-deflection comparison concerning intermediate anchors

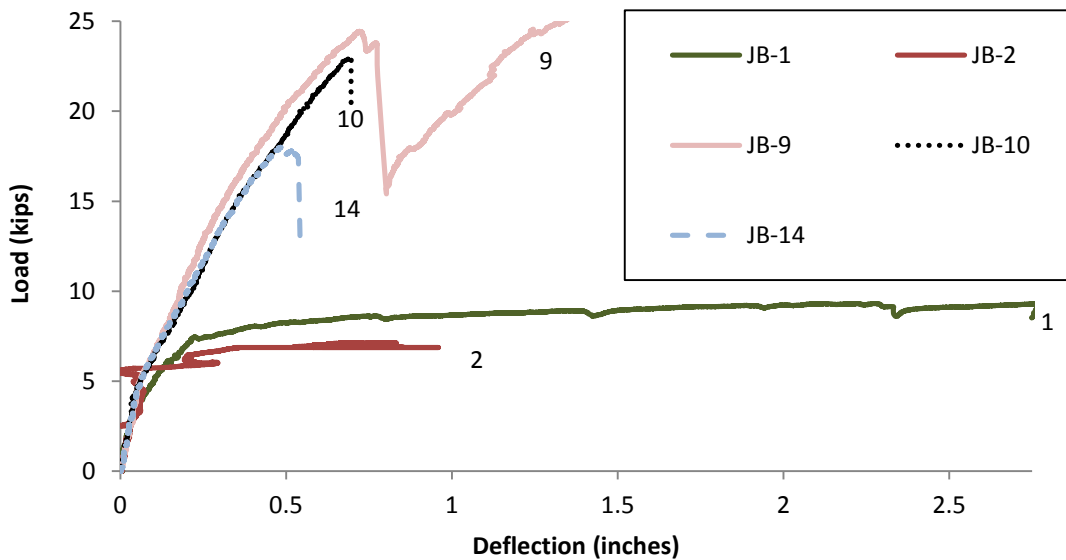
**Figure 4-7:** Load-deflection comparison concerning longitudinal length

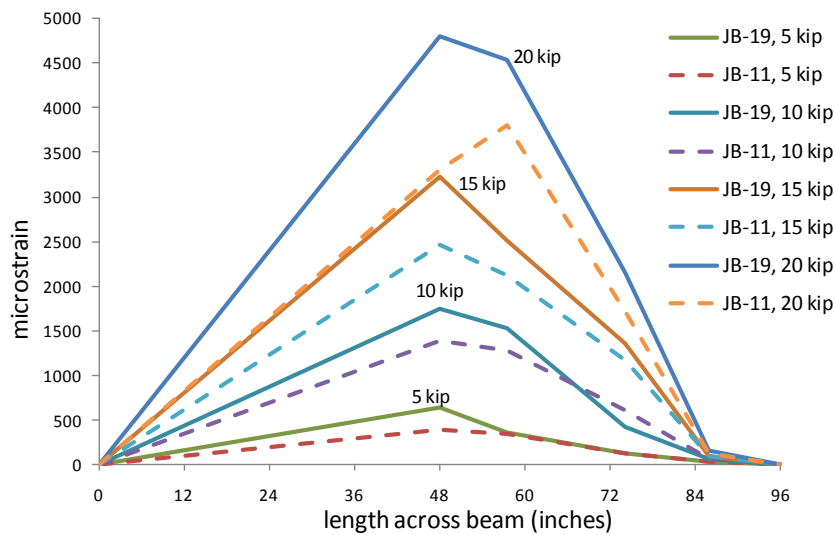
**Figure 4-8:** Comparison of strain developed along beams soffit for best repair and control beams from 2<sup>nd</sup> set (“JB” set)

The test results indicated that the repairs greatly decrease the soffit's max tensile strain felt by the member at mid-span when compared to the control beams. Also, when comparing the repairs with intermediate anchors (RC 2-11 & RC 2-12) to one without intermediate anchors (RC 2-19) the reduction is evident. Yet, what is interesting is that the repair which utilizes spacing experiences similar to the fully wrapped beam.

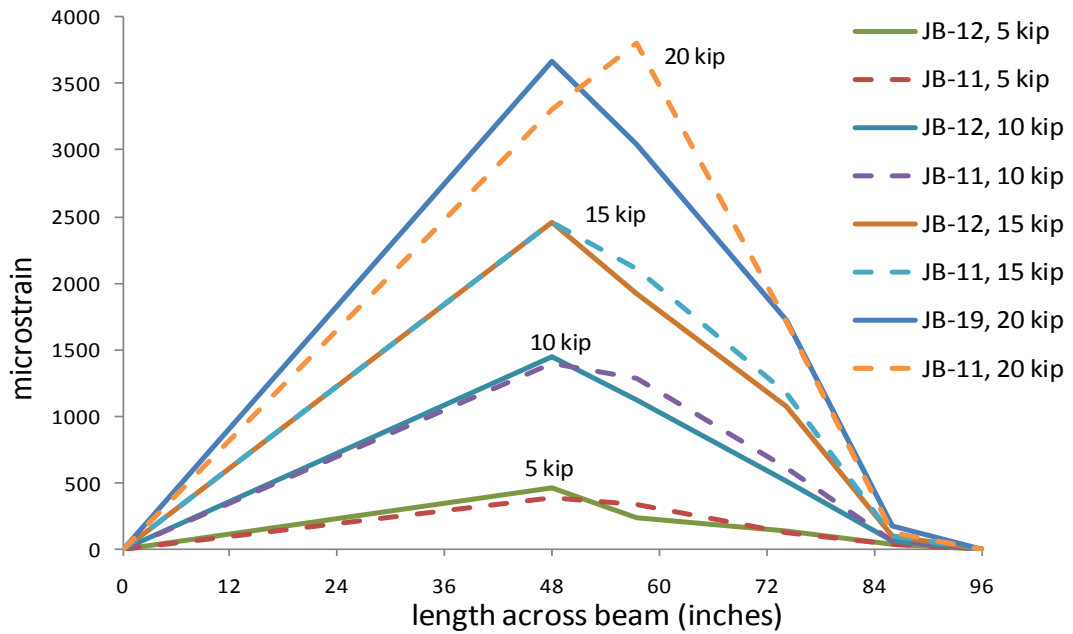
**Figure 4-9:** Comparison of strain developed along beams soffit for best repair and fully wrapped beam in 2<sup>nd</sup> set (“JB” set)

Reinforced Concrete Strain Development Results: The comparison mentioned is graphically presented in Figure 23. It can be seen by the comparison in Figure 23 that the use of intermediate U-wraps for anchoring does suppress the strain developed in the longitudinal laminate applied to the beams soffit.

From the reported results, it can be seen that although the fully wrapped beam reduces the strain more throughout the length of the beam, the configuration with spaces between anchoring appears to similarly reduce the strain at the mid-span (the critical location of damaged steel reinforcements) at higher loads.

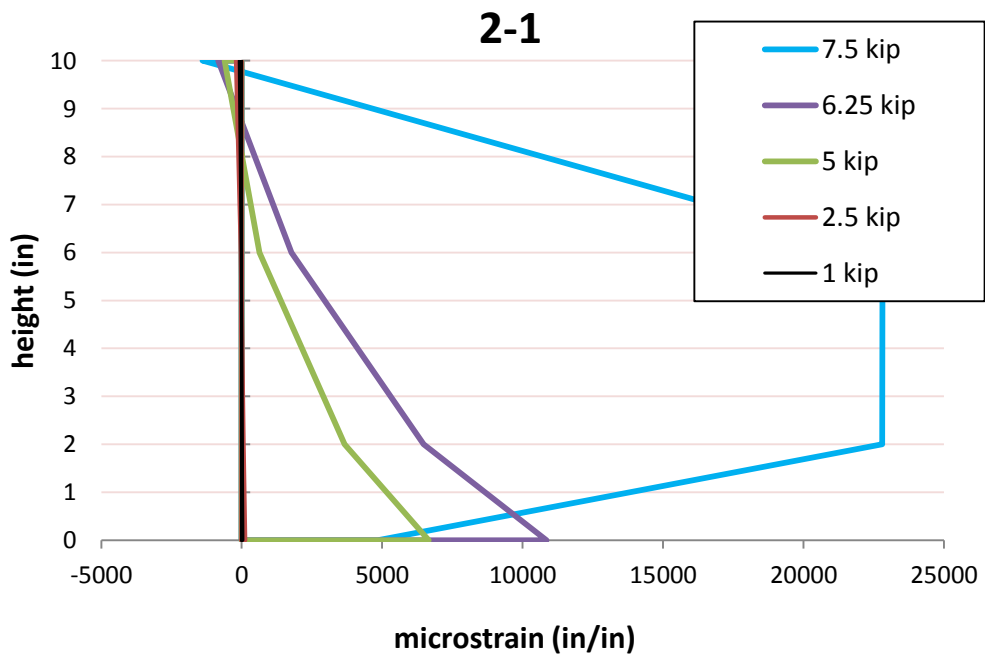
**Figure 4-10:** Strain per height of cross-section for Control beam of 2<sup>nd</sup> set at various loads

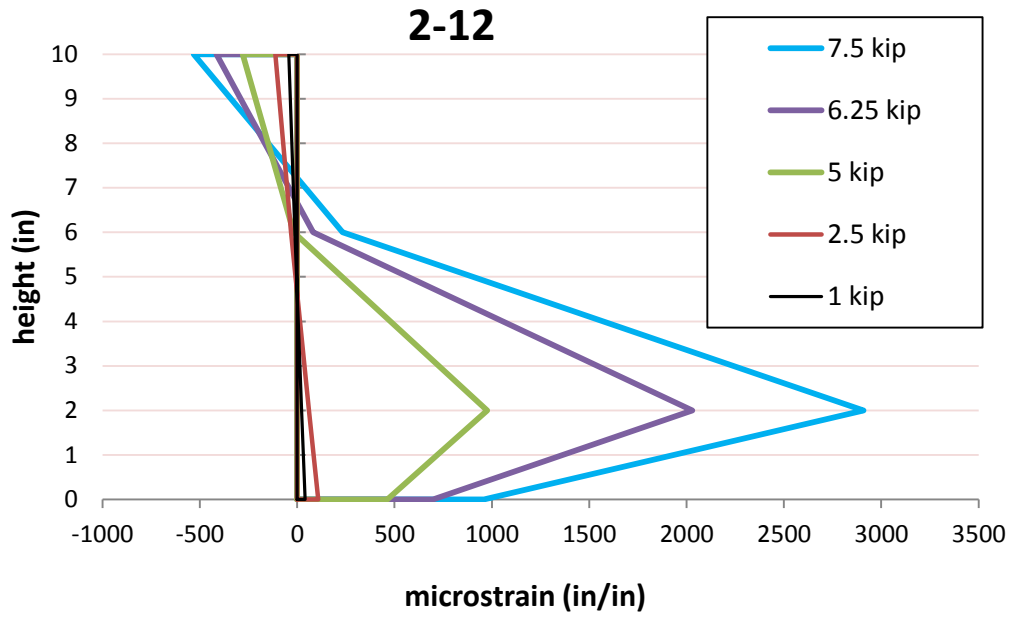
**Figure 4-13:** Strain per height of cross-section for repaired beam of 2<sup>nd</sup> set (“JB” set) at various loads

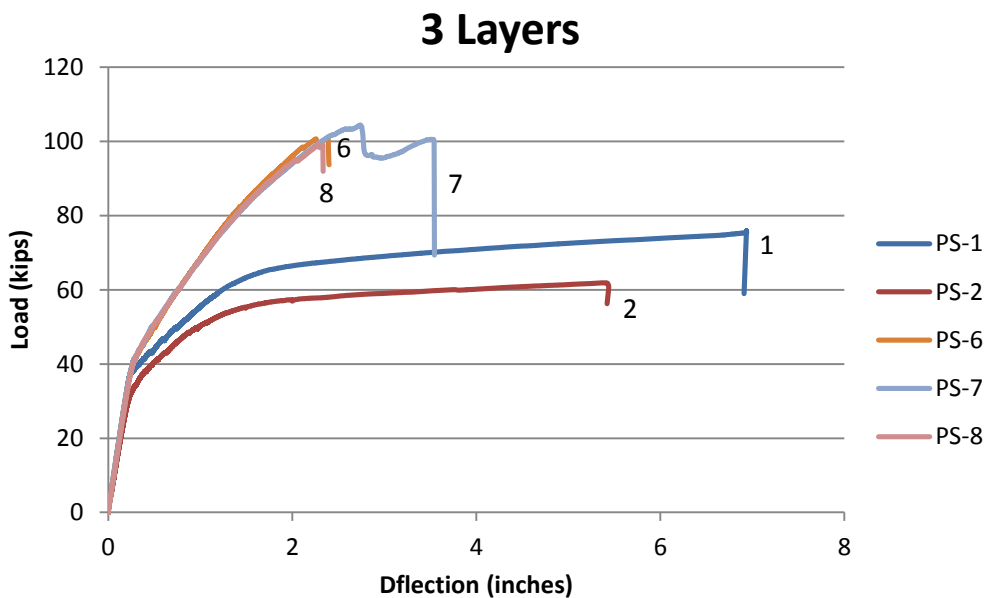
**Fig. 4-16:** Load vs. deflection for controls and girders with 3 layers of CFRP

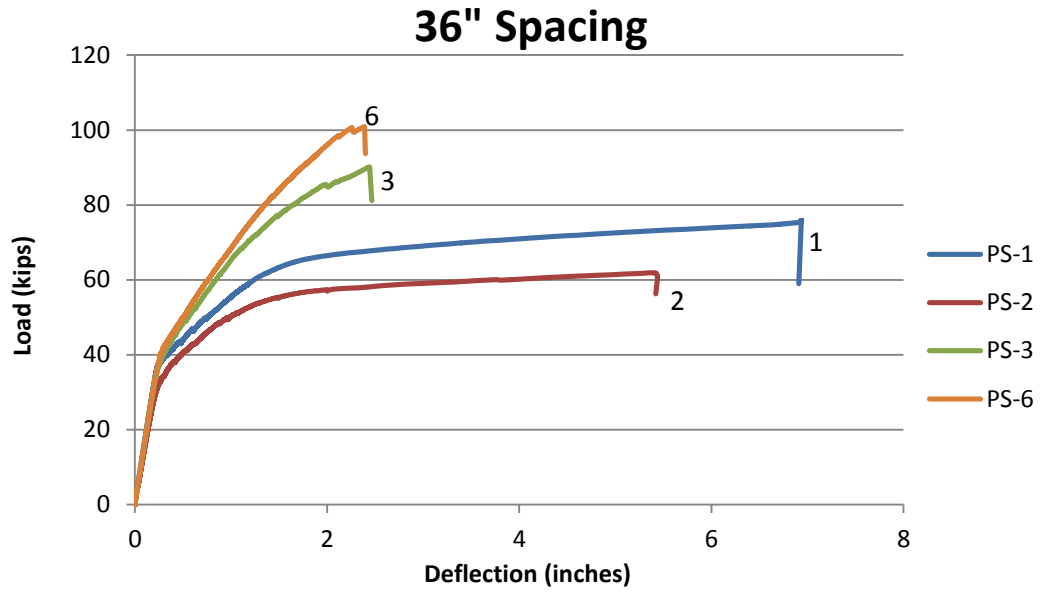
**Fig. 4-17:** Load vs. deflection for controls and 36" spacing configurations

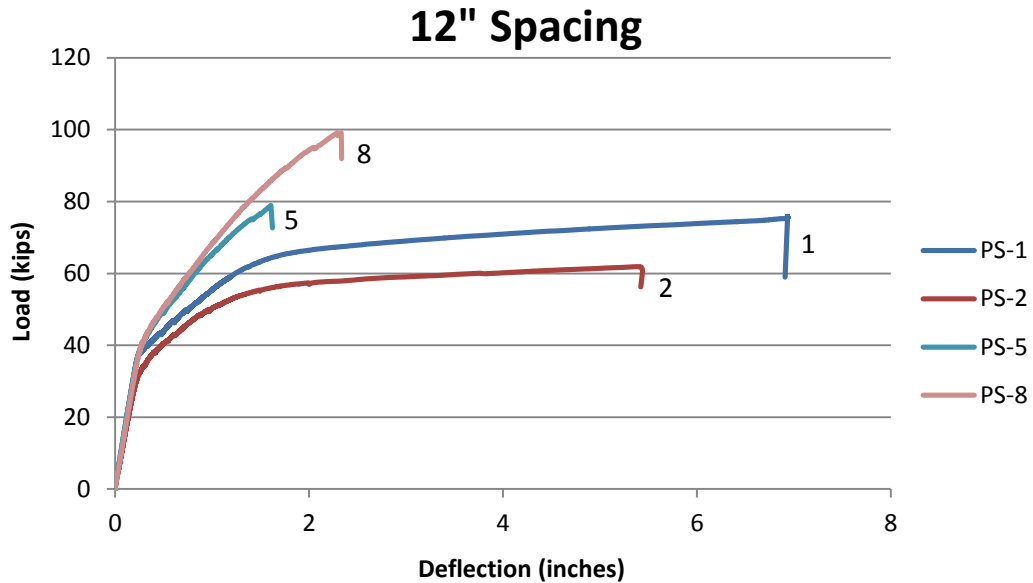
**Fig. 4-19:** Load vs. deflection for controls and 12” spacing configurations

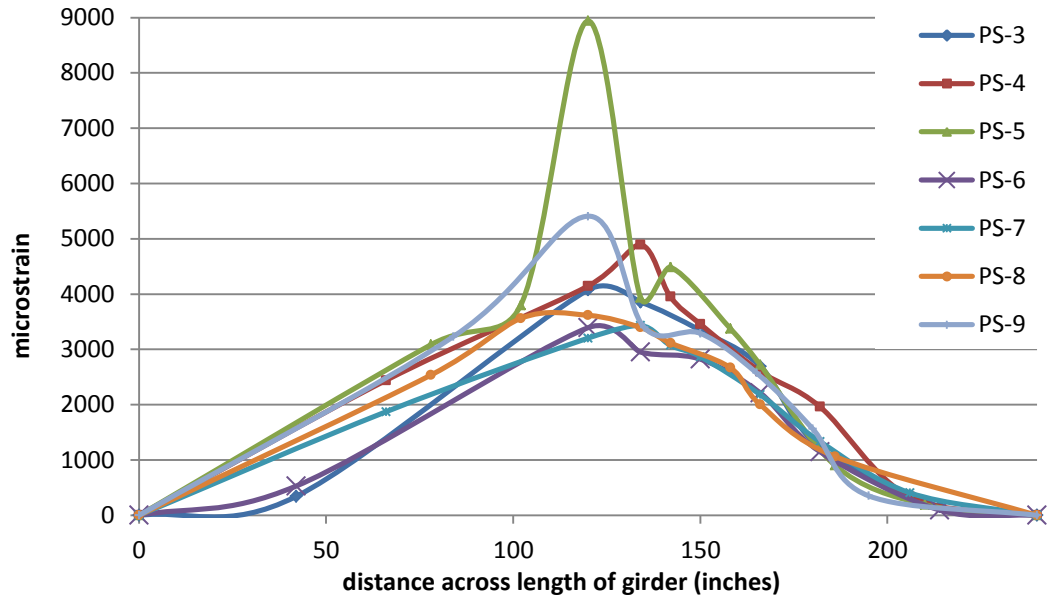
The strains measured at a load level of 70 kips are presented in Fig. 12. Half of the span lengths of the symmetrical girders were instrumented with a multitude of strain gages while the other half of the span length had one strain gage. Therefore, the profiles shown in Fig. 12 depict much more detailed behavior on the girder right side of the center peaks.

**Fig. 4-20:** Strain of CFRP at girder soffit vs. length for repaired girders

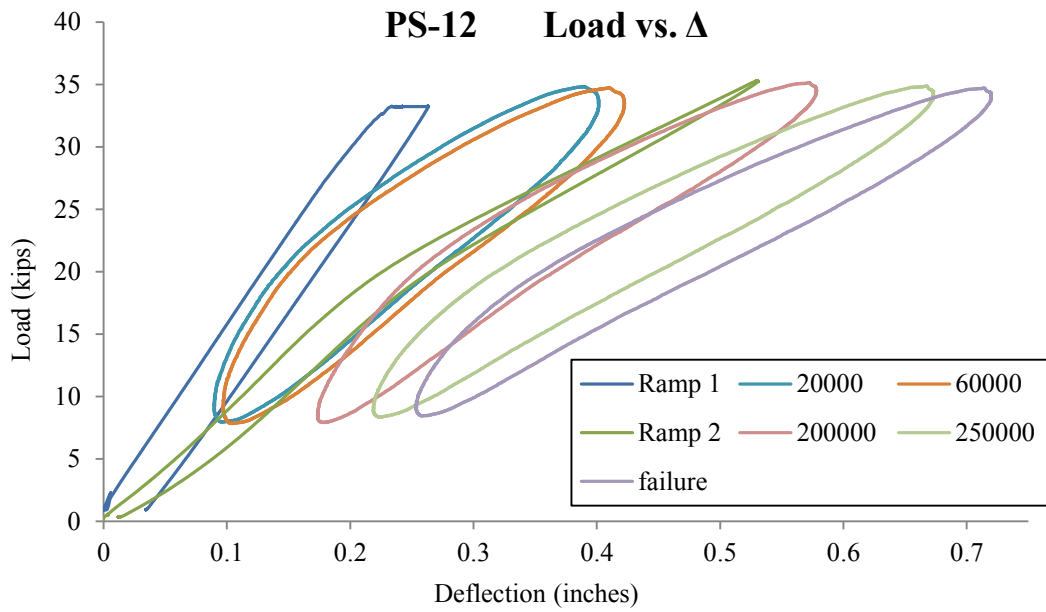
**Figure 4-22:** Fatigue Behavior and Degradation until Failure for Girder PS-12

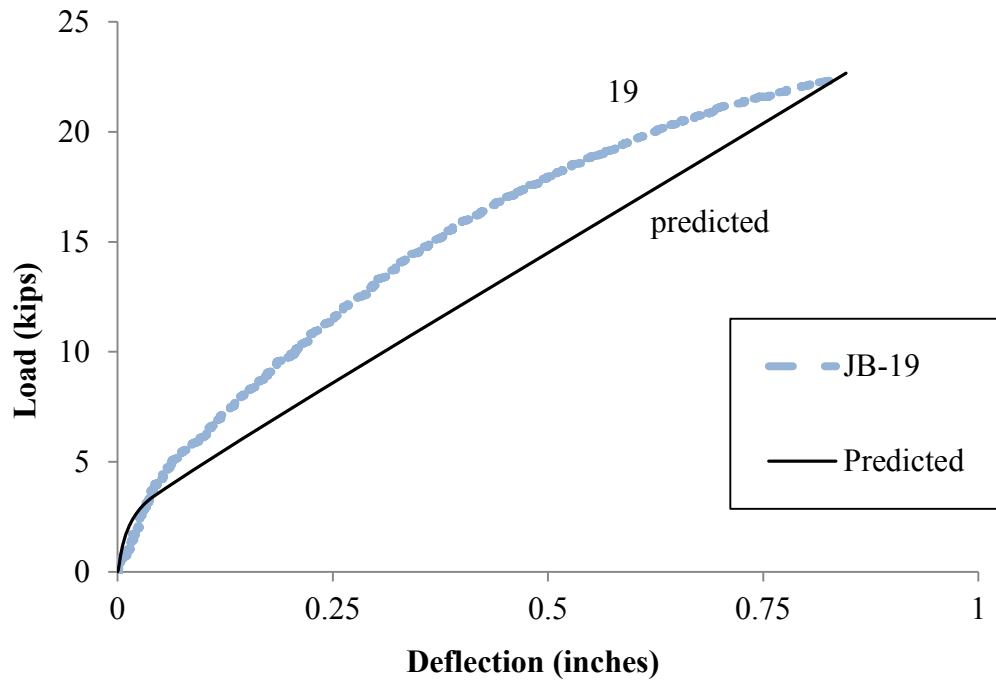
All numerical are available in previous tables 5-1 through 5-3. However, figure 5-1 displays a graphical comparison of the theoretical load-deflection values, at cracking and ultimate stages, calculated from the two models presented and the tested values of an associated repair design configuration. Since the models do not consider the inclusion of intermediate U-wrappings the beam chosen does not utilize any either (RC 2-19).

**Figure 5-1:** Predicted load vs. deflection for second RC set

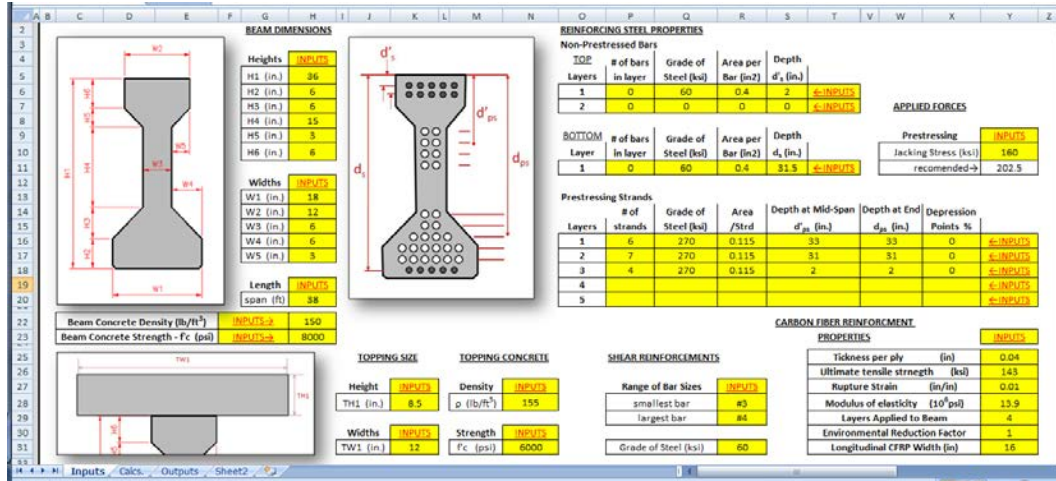
4. If appropriate equation in step 3 is satisfied open affiliated excel spreadsheet and enter dimensional values and material properties in the yellow cells of the input tab. A display of the input tab is shown below in figure 6-1

Figure 6-1: Display of input tab from affiliated excel spreadsheet

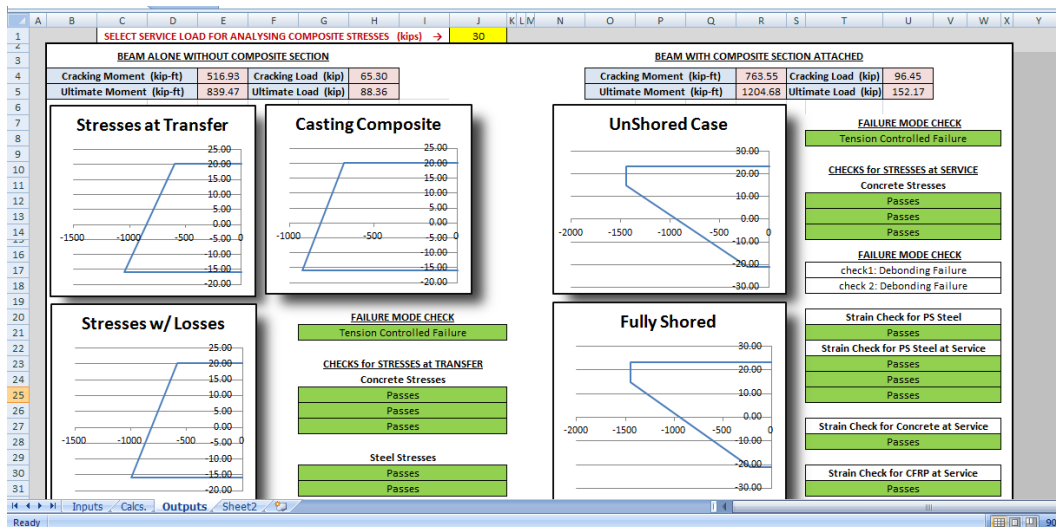
- After entering all values required for input tab check the output tab and verify that the calculated ultimate moment is at least equivalent to that of the girder of interest prior to damage. If calculated ultimate moment is not sufficient return to input page and increase the width or number of layers of the CFRP, if ultimate moment exceeds that of the undamaged girder in question return to input page and decrease the same values. Repeat until most desirable width and number of layers is selected. Figure 6-2 shows output tab of excel spreadsheet.

Figure 6-2: Display of output tab from affiliated excel spreadsheet
