Archaeological Monitoring of the Caldwell County Courthouse Rehabilitation, Lockhart, Texas

Steve A. Tomka

Anne A. Fox

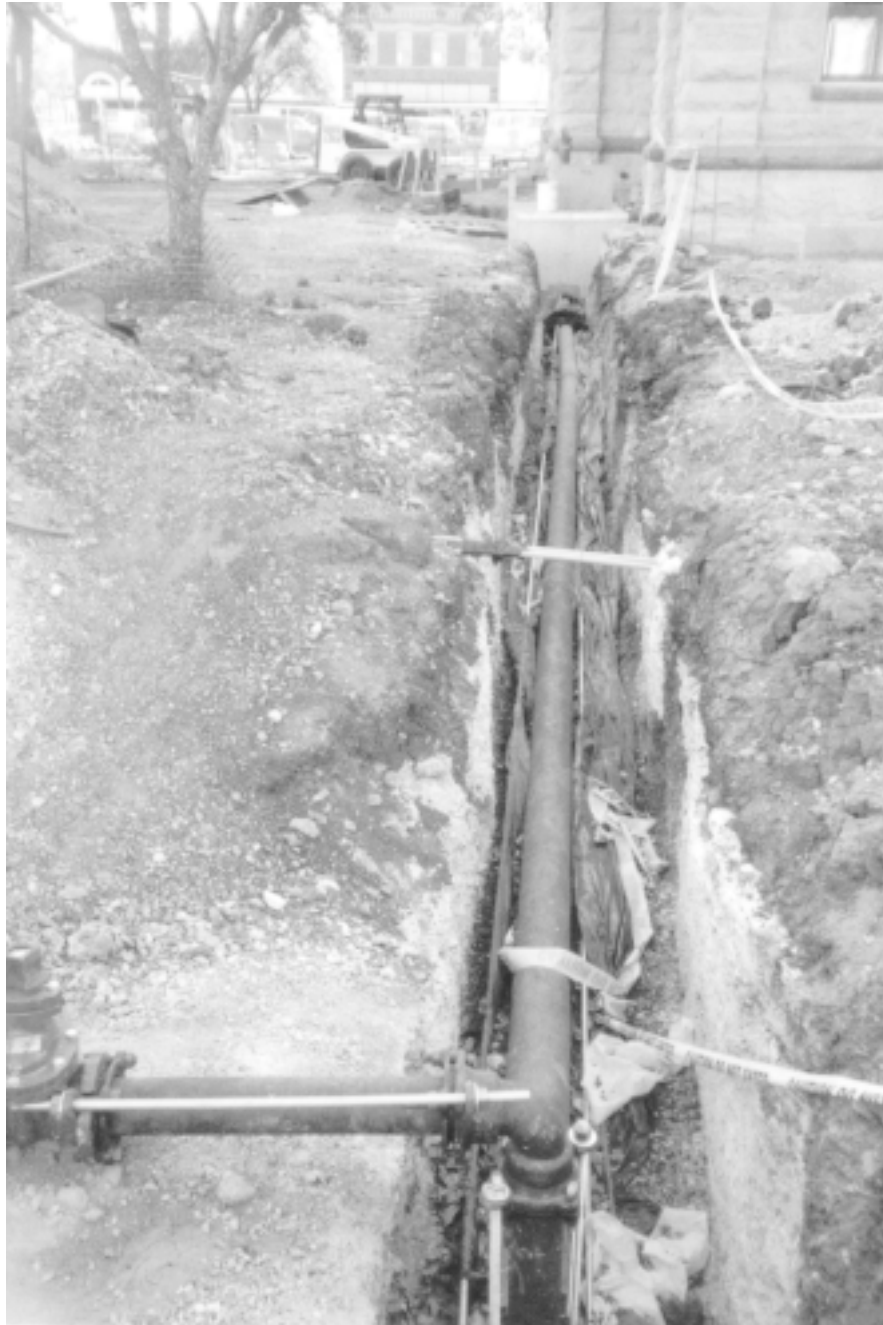
Figure 2. *Fire line trench on NW side of courthouse lot.*

In general, water, sewage, and drain lines required the excavation of 12–16 inch wide and 36–inch deep trenches (Figure 2). The installation of electric lines, encased in 1", 2" and 4" (under sidewalks) diameter PVC conduit, required the excavation of 6–inch wide and 18–24 inch deep trenches (Figure 3).

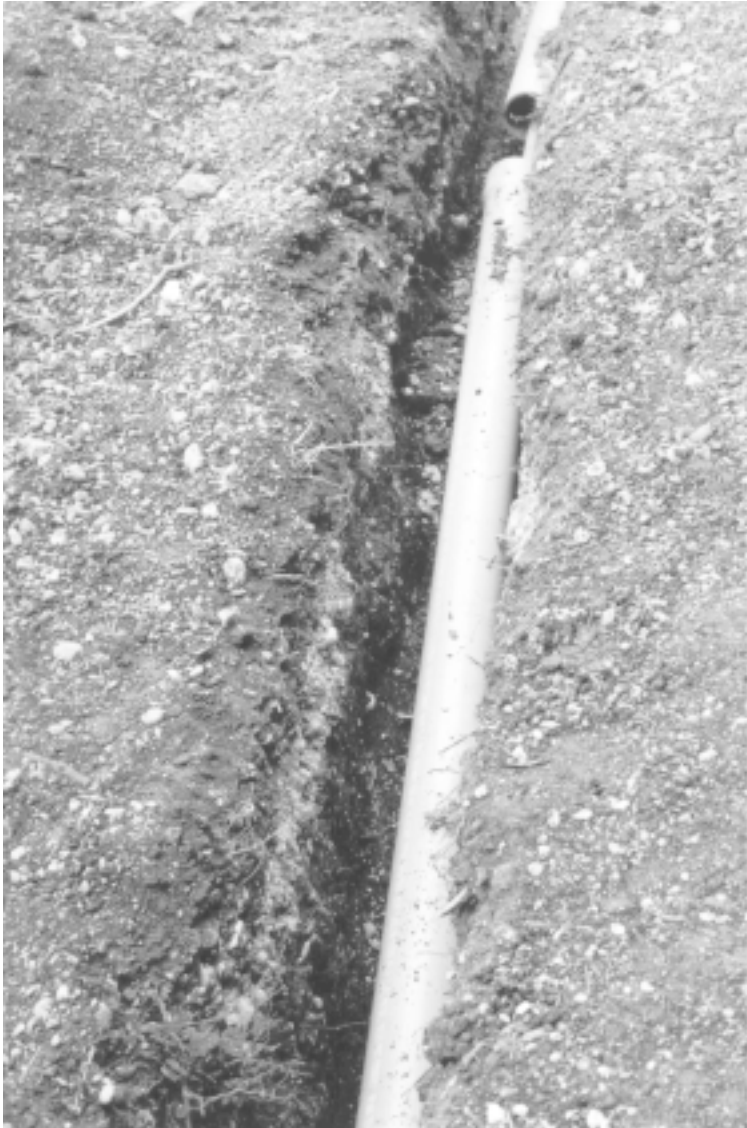
Figure 3. *Electric line in 2-inch and 4-inch PVC conduit in Trench F.*

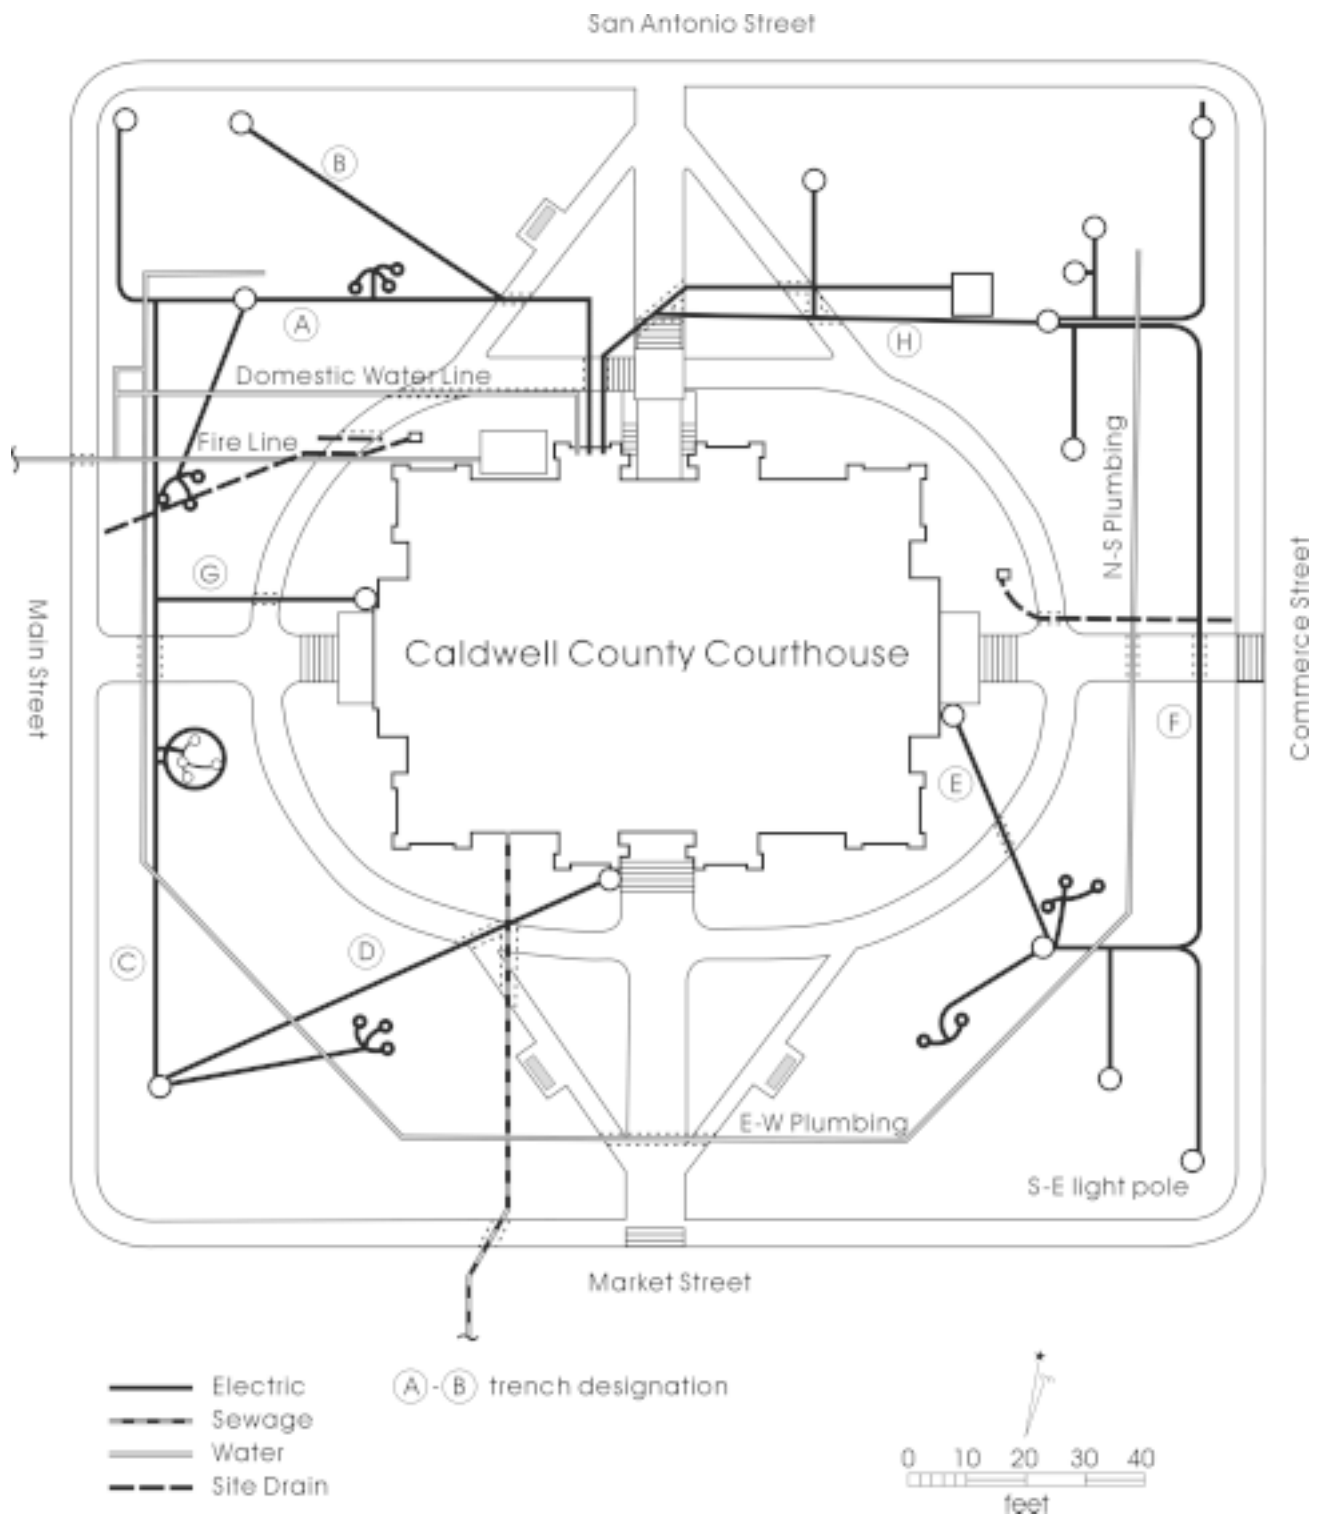
Figure 4. Map of trenching associated with exterior rehabilitation of the courthouse.

Trenches associated with the installation of main and branch electric circuits were excavated along the entire perimeter of the courthouse (Figure 4). The installation of water lines also required trenching around all but the northeast front of the building. A single sewage line was installed in a trench which extended from the southwest half of the building to the sewer main next to Market Street on the south side of the

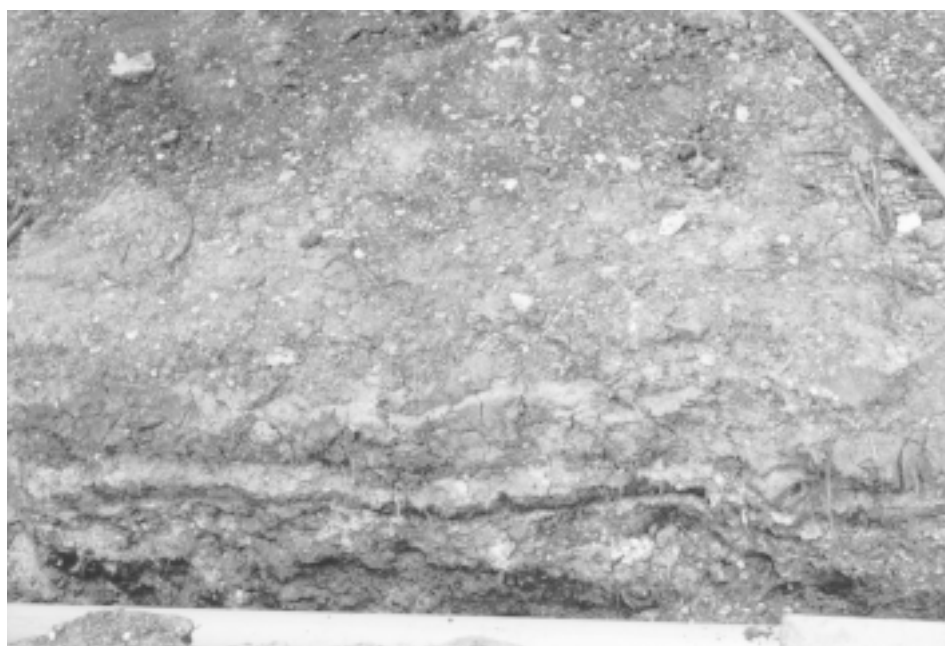
Figure 5. *Superimposed construction layers and underlying disturbed zones in Trench F.*

Although landscaping-related disturbances were not noted on the other sides of the courthouse lot, the profiles examined showed other substantial disturbances. In general, the stratigraphy noted along the northern, eastern, and western sides of the courthouse consisted of between 6–12 inches of relatively recent dark brown clay loam introduced as fill. This fill is underlain by between 2–6 inches of disturbed matrix containing chunks of concrete (i.e., old sidewalk), gravel and/or caliche fill (Figure 5), electrical conduit, piping, and other modern materials. A lens of Houston black clay, ranging from 3–7 inches in thickness is found under this disturbed zone. Close examination of the profiles on each of the three sides of the courthouse revealed no artifacts in this zone.

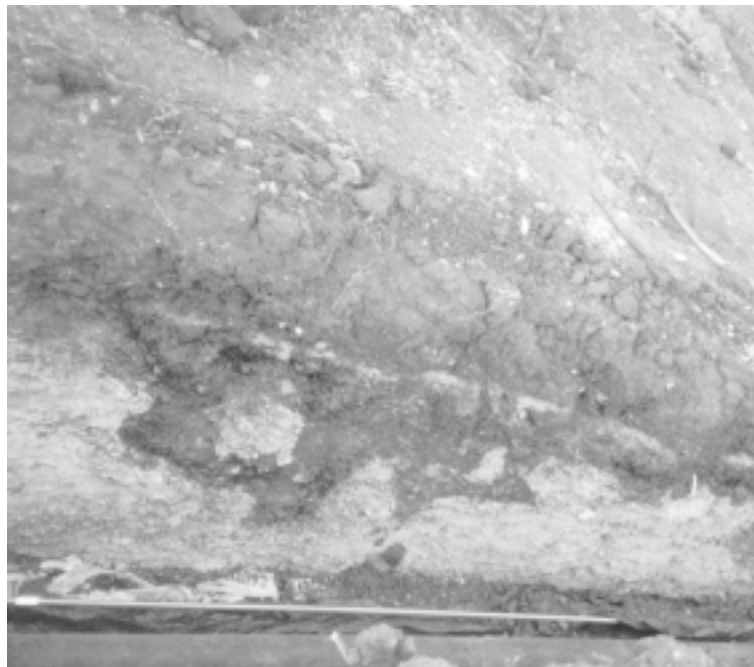
Figure 6. Close-up of fire line trench showing level of disturbance into underlying caliche.

This layer of clay sits on caliche bedrock around the entire perimeter of the lot. In some instances the apparently sterile clay zone on top of the caliche is itself dug through by the previous trenching associated with the installation of water lines (Figure 6).
