Archaeological Studies for the San Antonio Channel Improvement Project, including Investigations at Guenther's Upper Mill (41BX342)

Center for Archaeological Research
The University of Texas at San Antonio
Archaeological Survey Report, No. 136

ARCHAEOLOGICAL STUDIES FOR THE
SAN ANTONIO CHANNEL IMPROVEMENT PROJECT,
INCLUDING INVESTIGATIONS AT
GUENTHER'S UPPER MILL (41 BX 342)

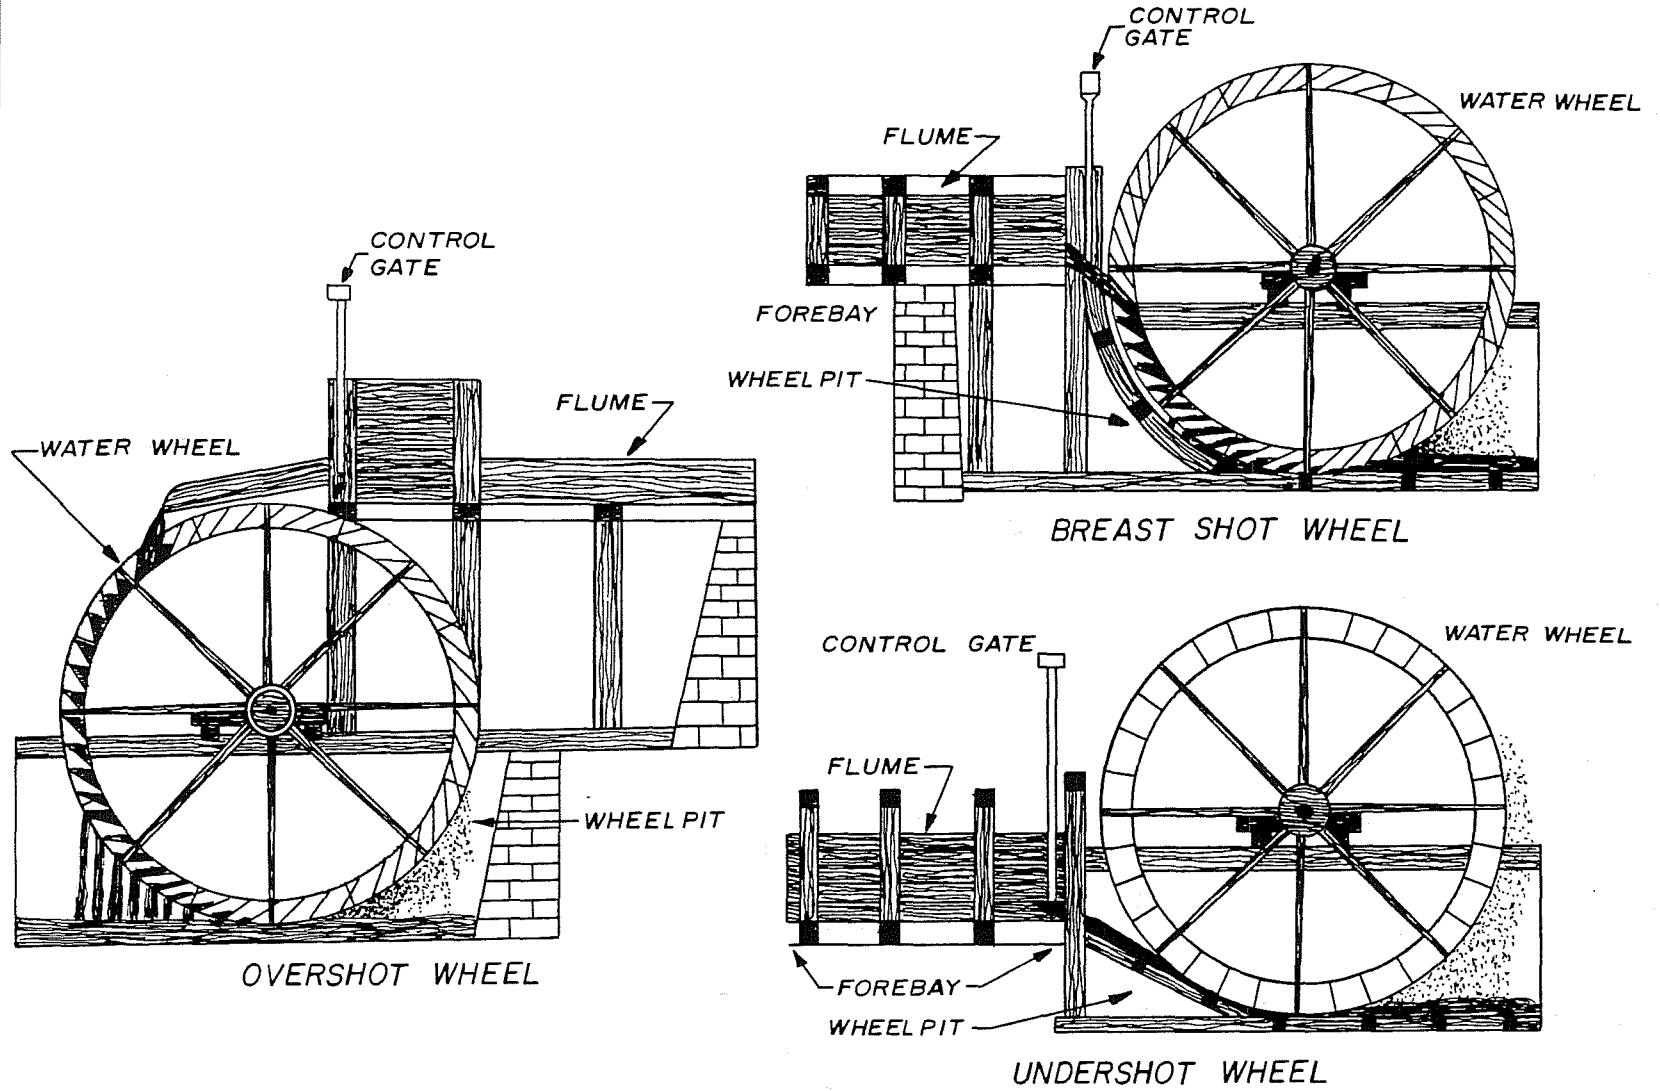
Figure 3. Various Types of Water Wheel Installation.

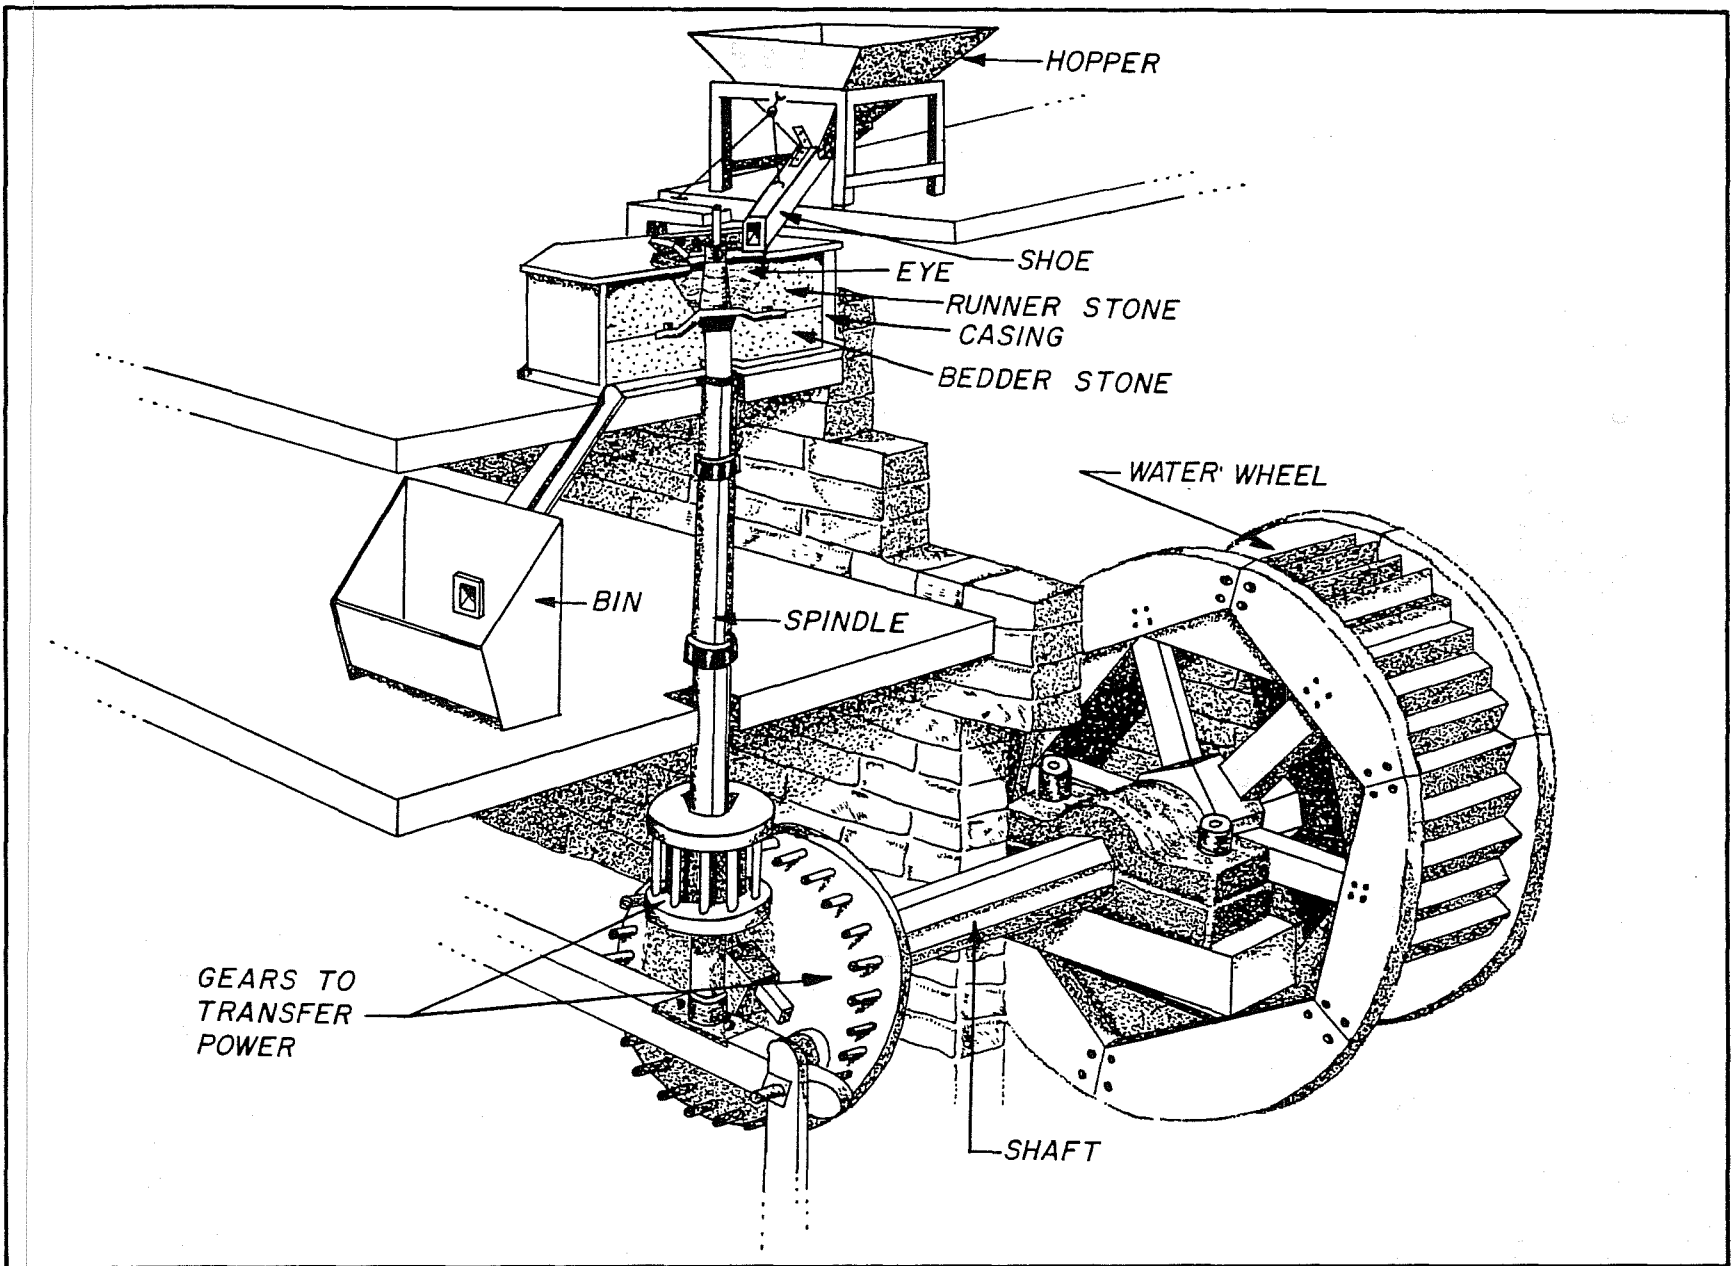
Figure 4. Diagram of Mill Operation.

Once the grain is in the bin, the power of gravity takes over (Fig. 4) as the grain drops into a wooden hopper set over the millstones on the next floor. The hopper allows a controlled stream of grain to fall into the "eye" in the center of the upper or "runner" stone, to be ground between it and the lower or "bedder" stone. A wooden casing surrounds the stones, and brushes or tabs attached to the runner sweep the ground material around to a spout where it falls into a bin (Storck and Teague 1953:102).

The machinery base was probably originally the location of the gearing for transfer of power from the horizontal shaft of the water wheel to the vertical spindle that drove the millstones (see Fig. 4). When the turbine was installed, it would no longer have been used.

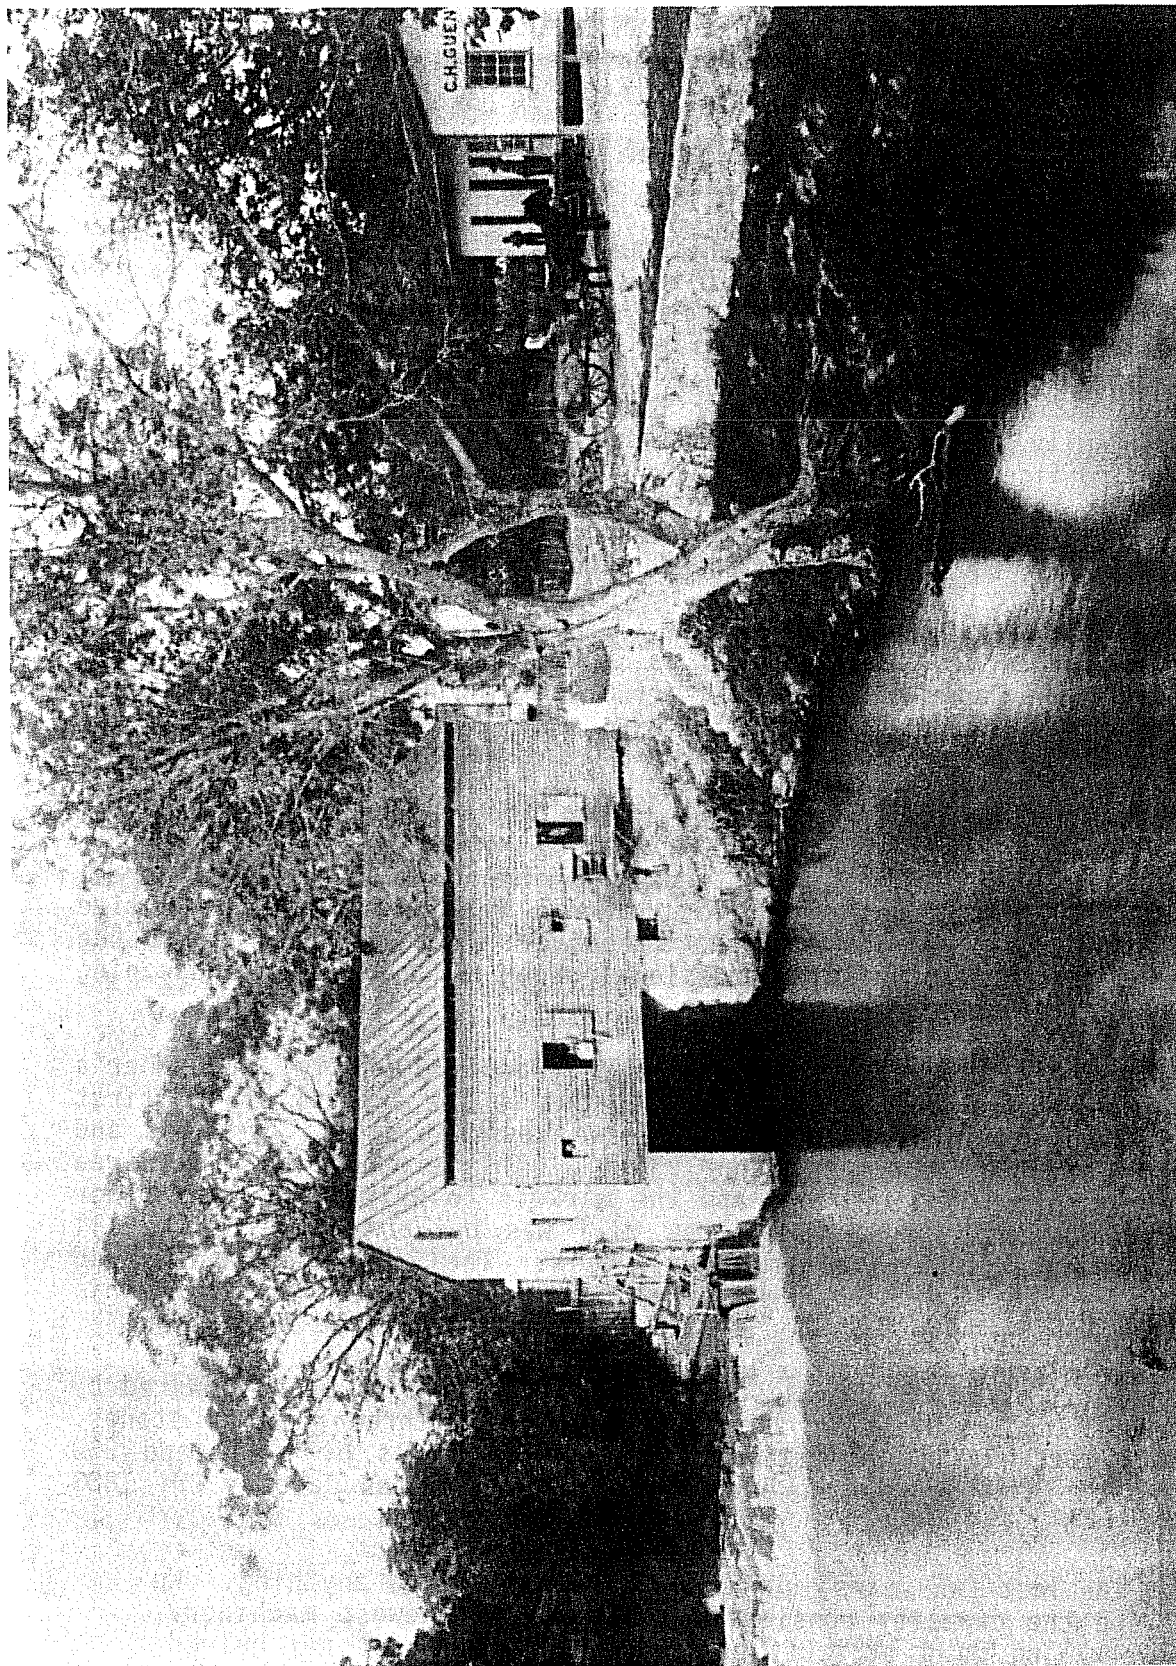
Figure 6. Guenther's Upper Mill in the 1870s. Photograph in the DRT Library.

The Upper Mill was constructed ca. 1868 and remained in remarkably good condition until it was razed in 1926. The walls of the river or basement level were built of cut limestone blocks, and contained the forebay and wheel pit on the west side. There was probably at least a partial basement on the east side, since openings are visible in photographs of the south foundation wall (see Figs. 6 and 8).

A 30- by 120-inch unit south of Unit 1 and extending east from the river bank was designated Area A. Early photographs of the mill show a terraced stone retaining structure along the south face of the mill (Fig. 6). This area was cleared to see if any of the structure remained.

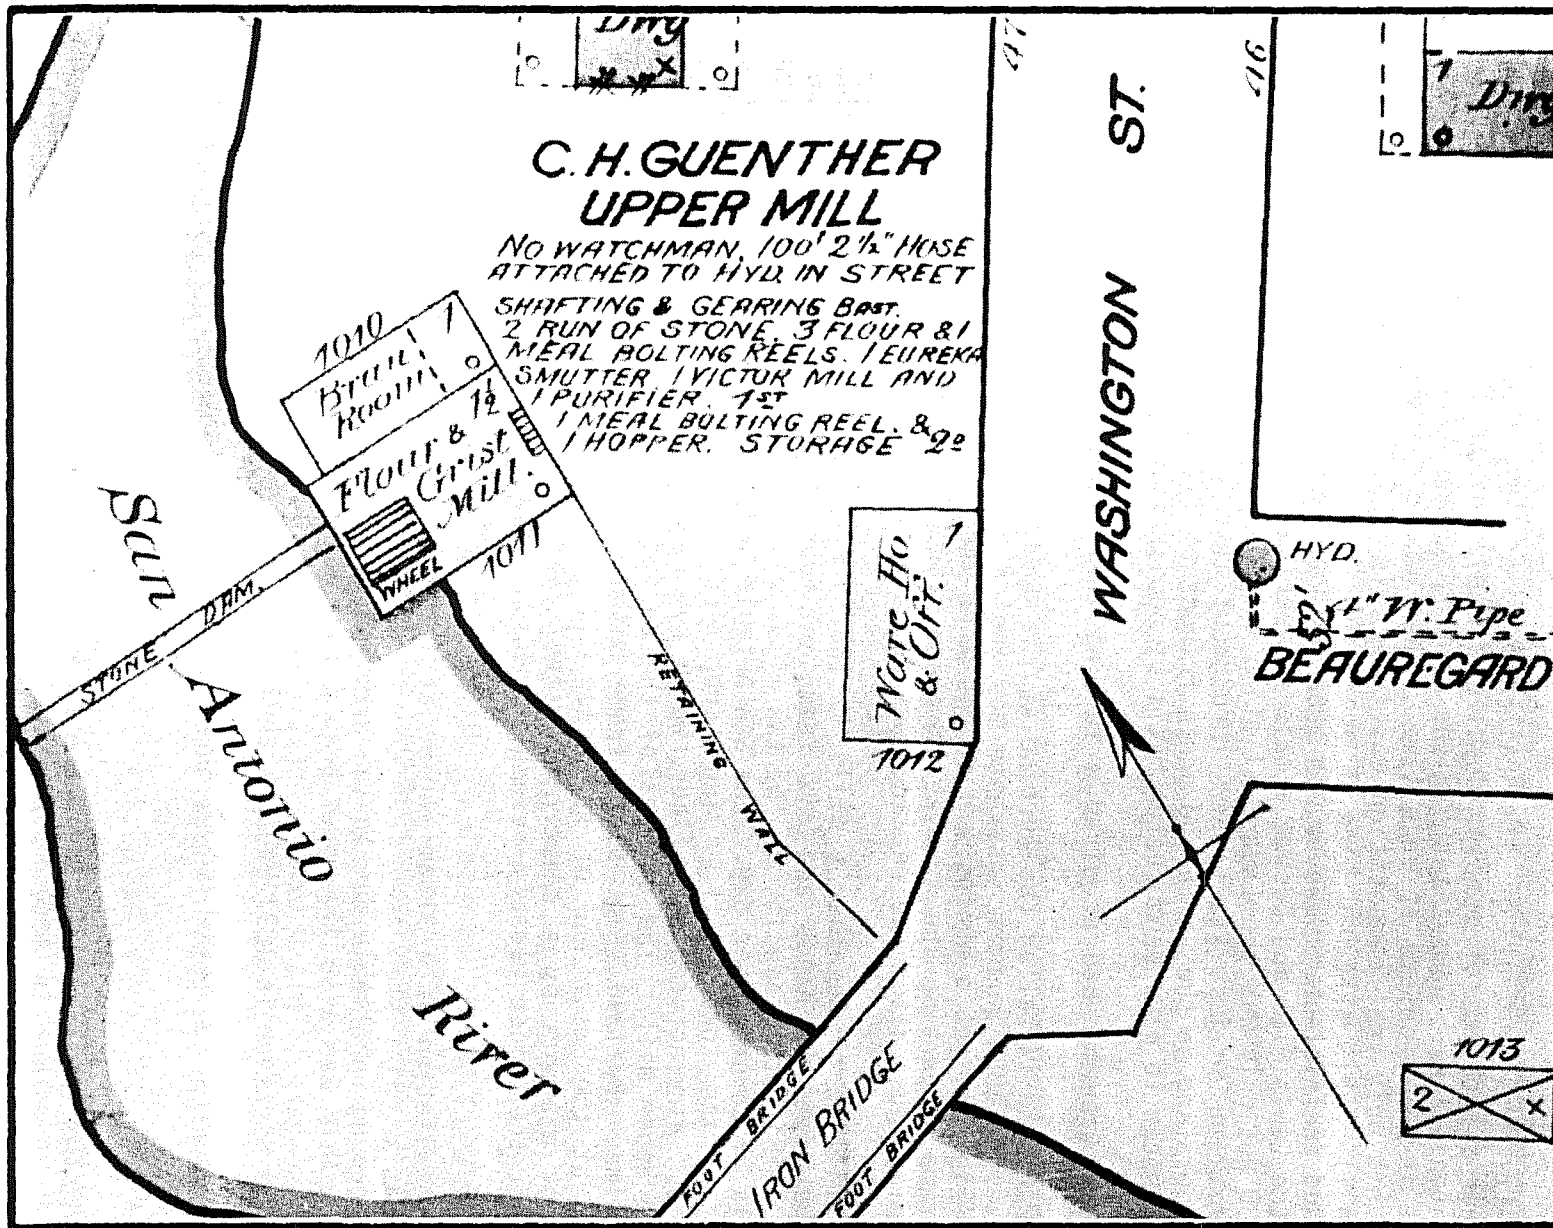
Figure 7. Sanborn's Insurance Map of 1885 and 1888. The 1885 and 1888 maps were identical (Sanborn Map and Publishing Company, Ltd. 1885, 1888).

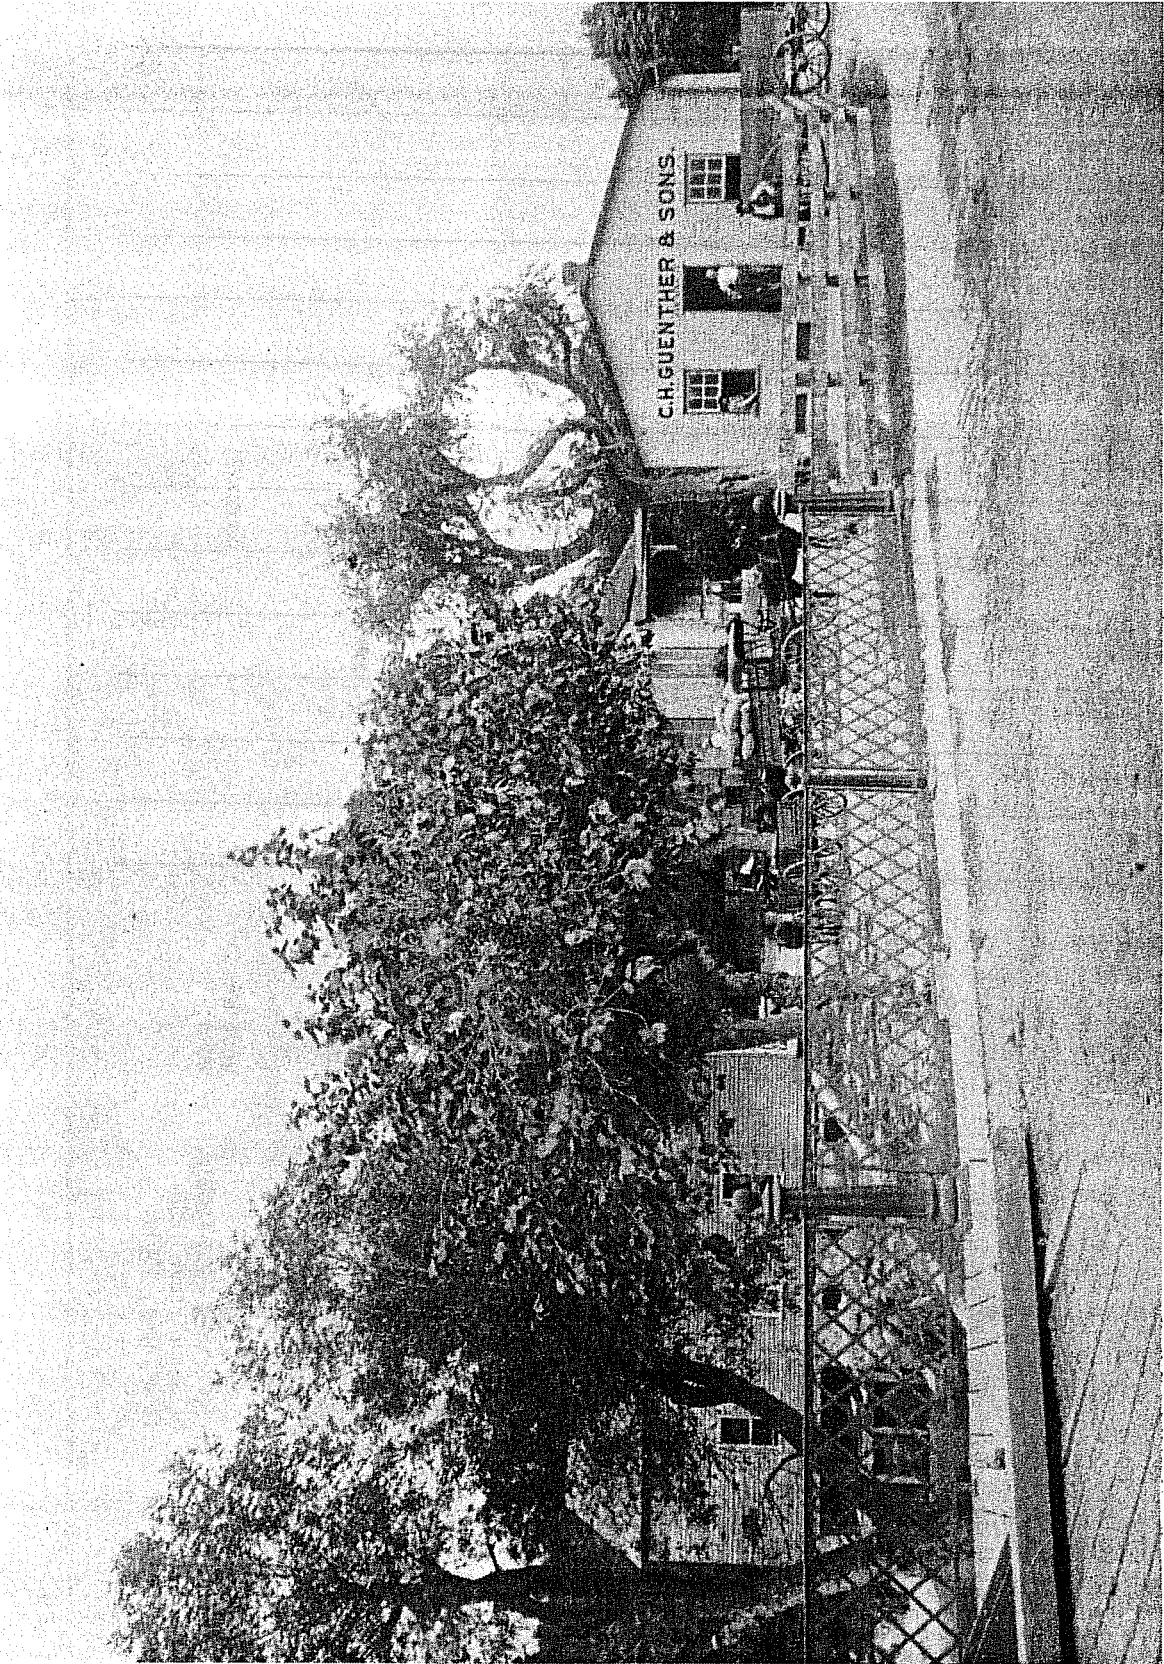
Figure 8. Guenther's Upper Mill in 1888. Photograph in the DRT Library.

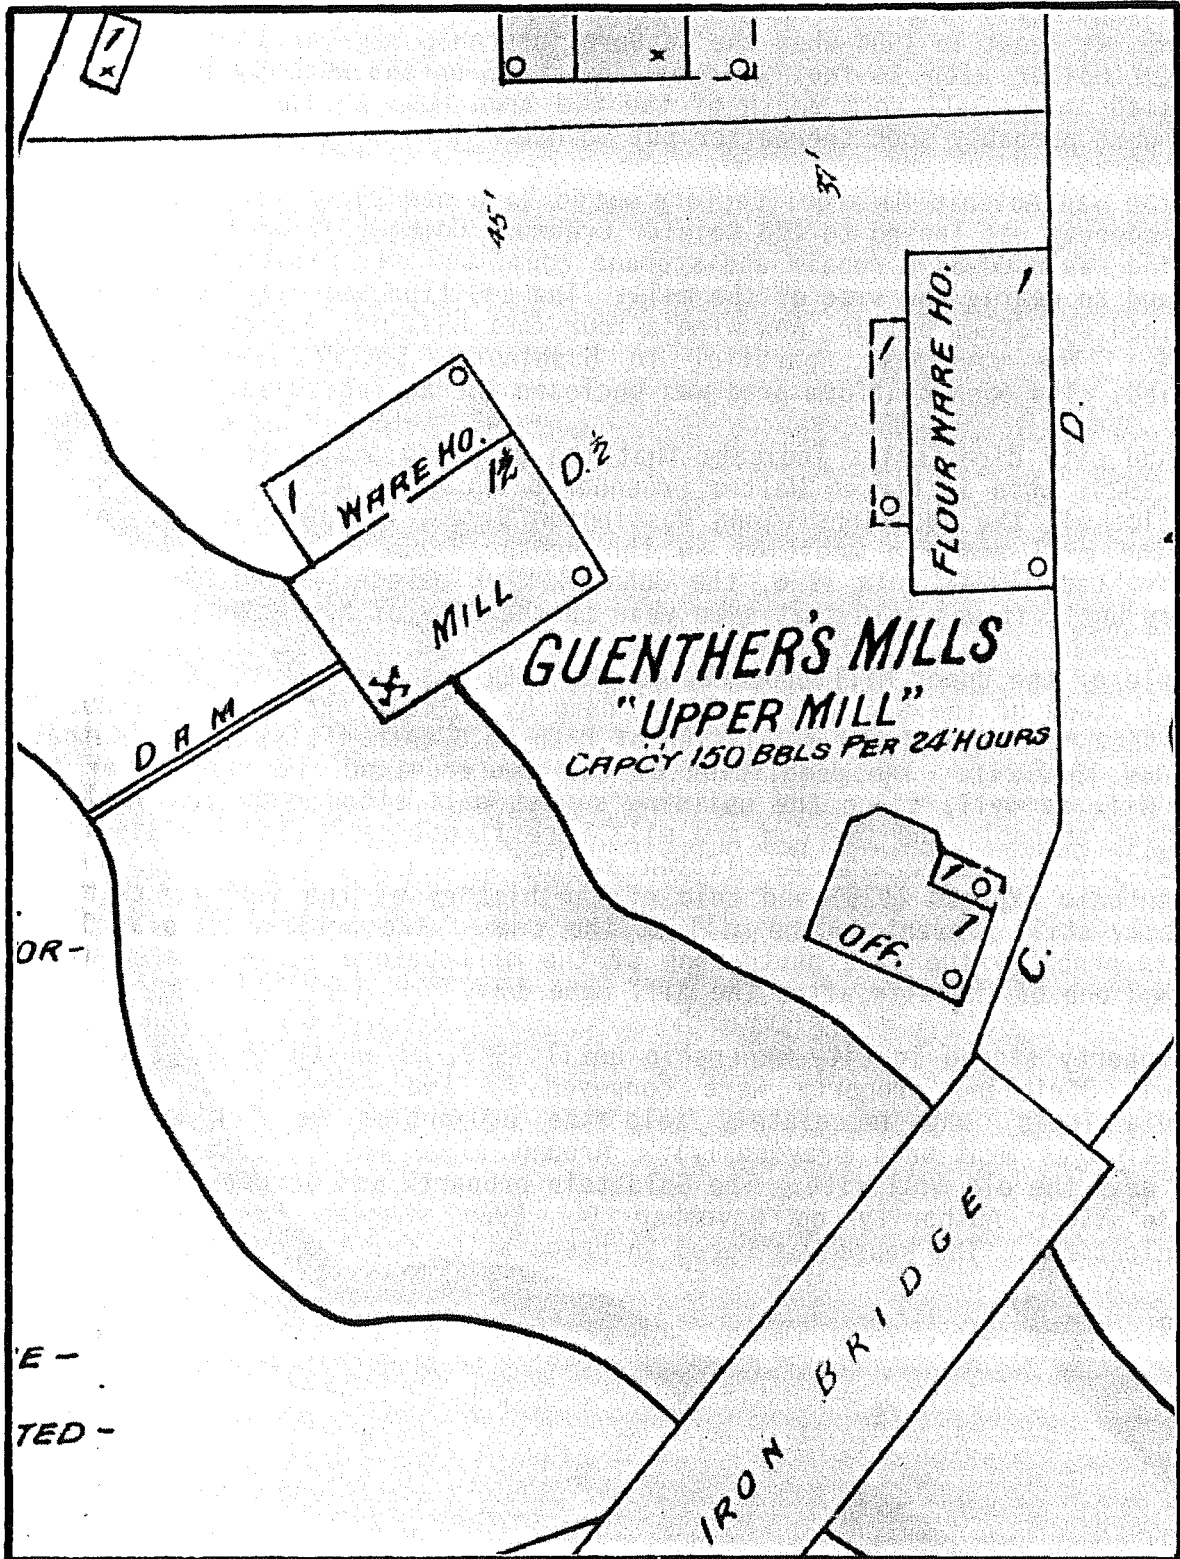
Figure 9. Sanborn's Insurance Map of 1896. Taken from Sanborn Map and Publishing Company, Ltd. (1896).

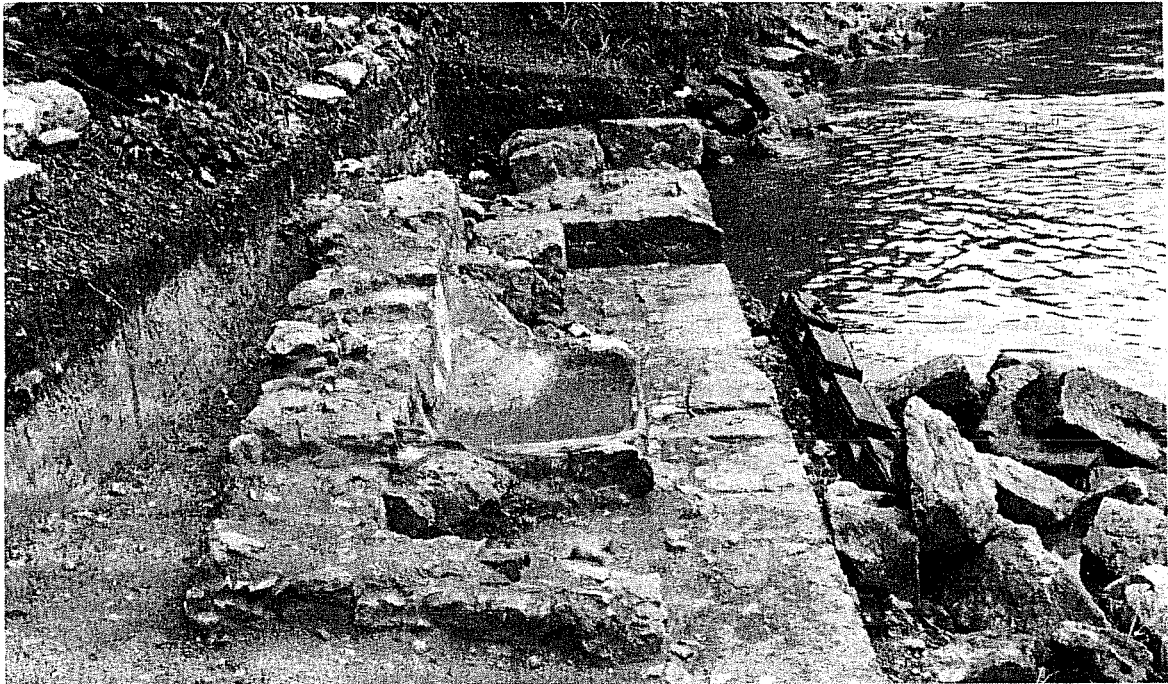
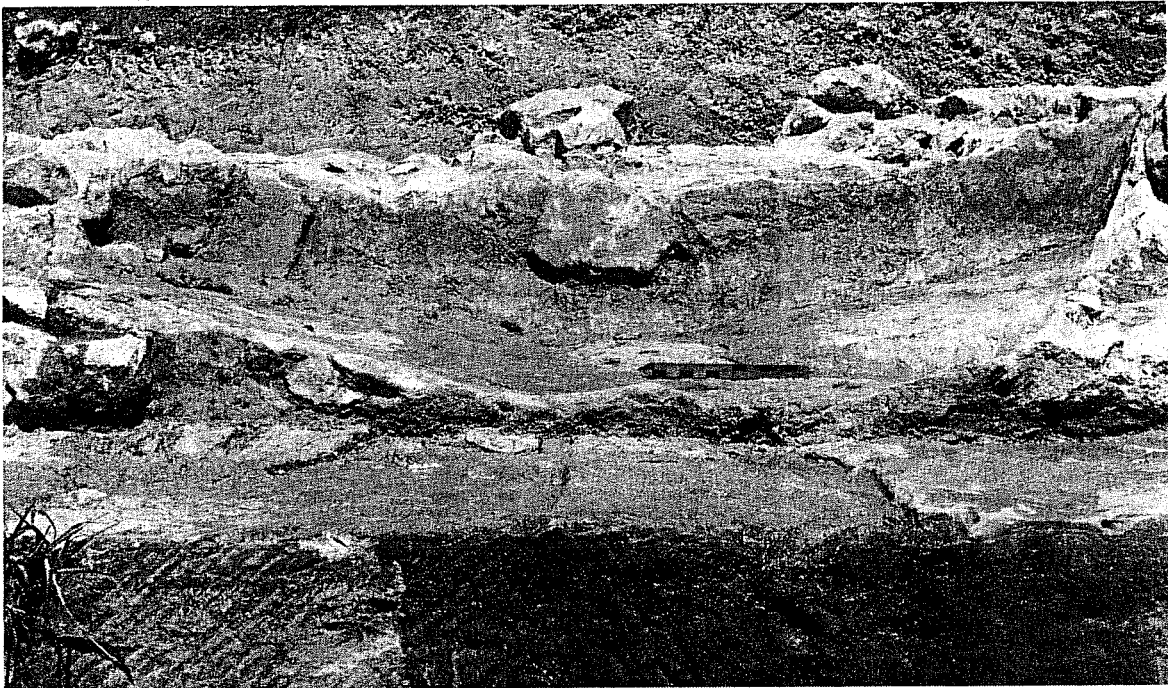
Figure 15. Views of Area B. a, looking south; b, close-up of machinery area looking east.

An area 75 by 200 feet north of Unit 1 was designated Area B (Fig. 15,a,b). The purpose of this unit was to expose and follow the top of the east foundation of the forebay/wheel pit and that of the foundation parallel to it on the east. The fill was removed across this area in a single operation.

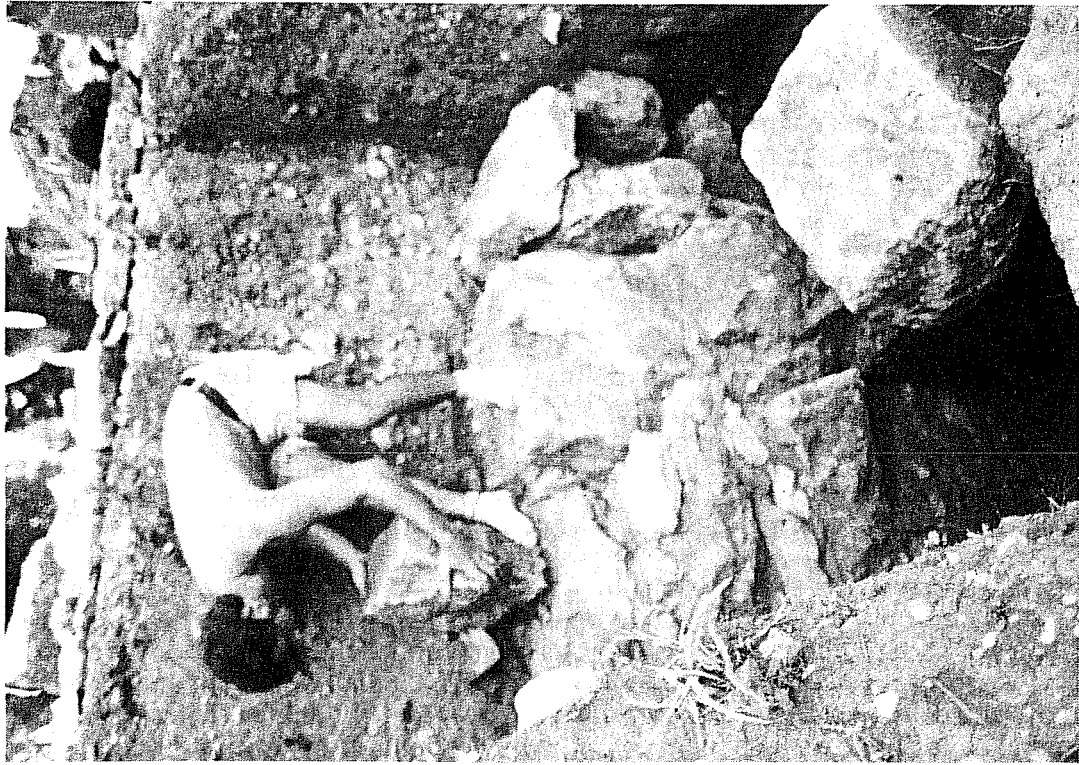
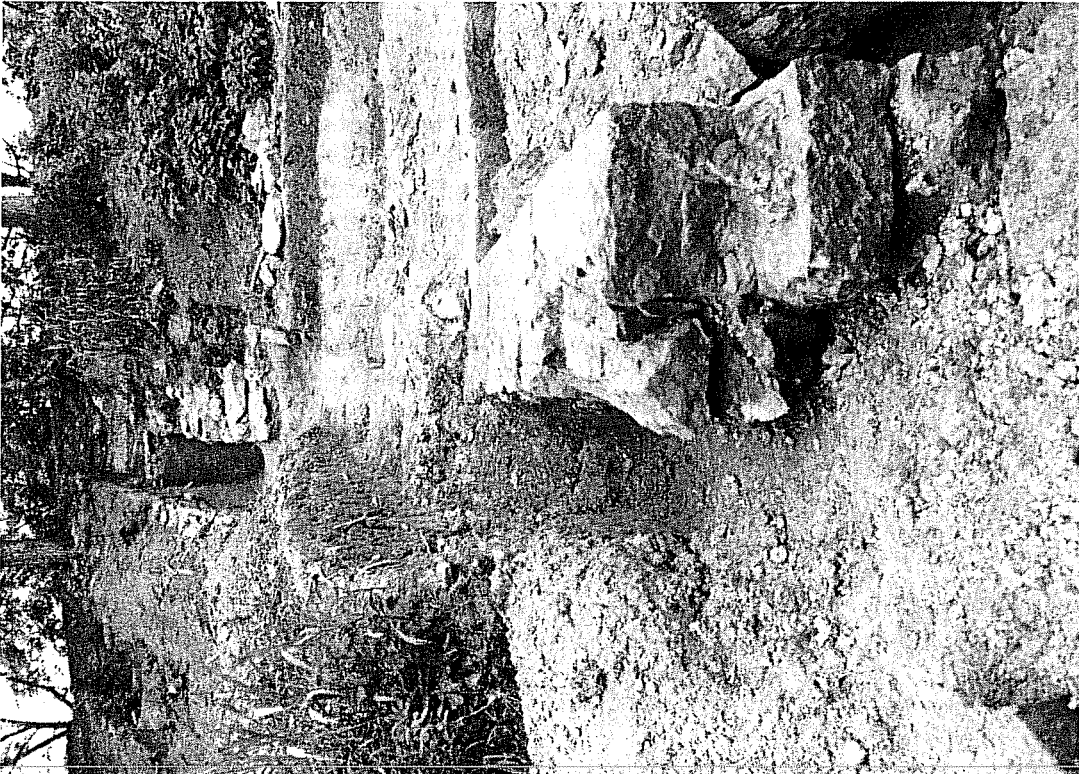
Figure 16. Foundations of the Mill. a, north wall looking east, Unit 4; b, east wall looking east, Unit 5.

The north wall foundation (Fig. 16,a) ran west for seven feet beyond its junction with the east foundation of the forebay/wheel pit wall. The surface of the north wall was uneven, and there were deep scrape marks on several of the stones. The bottom of the foundation of the forebay was set much deeper into the ground than that of the structure to the east. No trace was found of the bran room foundation.

Unit 5 was placed to test for the southeast corner of the mill and the retaining wall that butted against it. It was begun as a 50-inch square, but soon expanded into a 100-inch-square unit. Not all areas of the unit were excavated to the same depth, due to numerous large stones encountered during excavation (Fig. 16,b).

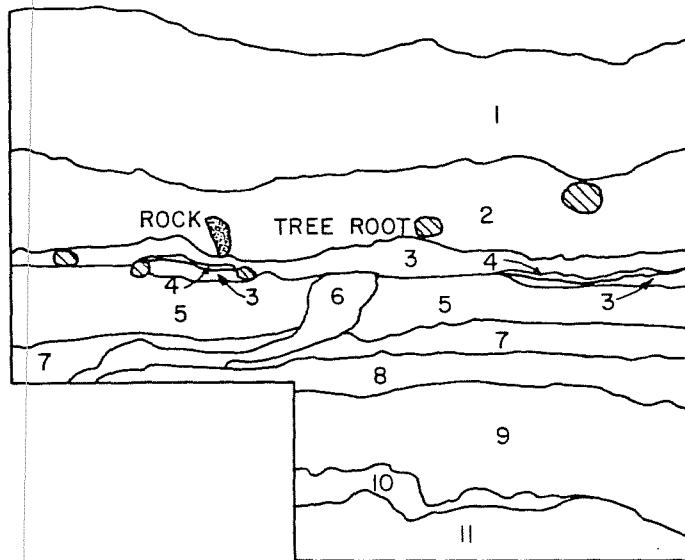
1. COMPACT DARK BROWN CLAY FILL
2. LIGHTER BROWN CLAY FILL WITH PEBBLES
3. YELLOW BROWN SANDY CLAY LOAM
4. BLACK GREASY SOIL
5. GRAY CLAY
6. LIGHT GRAY MORTAR
7. STERILE WHITE CALICHE
8. STERILE DARK GRAY CLAY WITH ROCKS
9. LIGHT YELLOW BROWN CLAY
10. BLACK BROWN CLAY
11. DARK TAN CLAY

WAREHOUSE AND OFFICE

UNIT 6—EAST PROFILE

Layer 1 (Fig. 19,a) consisted of 10 inches of compact dark brown clay with lenses of sandy loam. Plaster, fiberglass, large chunks of concrete and

limestone, nails, glass, and ceramics were found throughout the layer. Two inches below the surface, extending seven inches into the northwest corner of the unit, an uneven edge of a reinforced concrete slab was found. Layer 2 was a seven-inch deposit of slightly lighter brown clay, containing much the same sort of artifacts.

Layer 3 consisted of one and one-half to three inches of compact yellow brown sandy clay loam. A portion of the soil in the southeast quadrant contained black, greasy patches. Varying from three to six inches thick, Layer 4 consisted of a gray clay, broken in the east half of the unit by patches of tan gray sandy loam with cobbles and compact white caliche. The black greasy soil now formed an irregular-shaped ring with an iron stain along its edge. Extending from under the concrete slab was a cedar post lying in what appeared to be a trench that ran parallel to the north wall of the unit.

Layer 5, a three-inch layer of sterile white caliche, was underlain by dark gray clay from one to three inches thick, which also contained no artifacts. Next was five to nine inches of yellow brown clay, below which was an irregular surface of black brown clay. No evidence of a structure was found in this unit, other than the concrete slab and cedar post in the upper levels. It seems probable that Layers 1 and 2 were fill brought in during the later occupation of the site and were contemporary with the concrete slab. Layers 3 and 4 accumulated after ca. 1900, and the caliche in Layer 5 was the original surface of the yard when the mill was in operation.

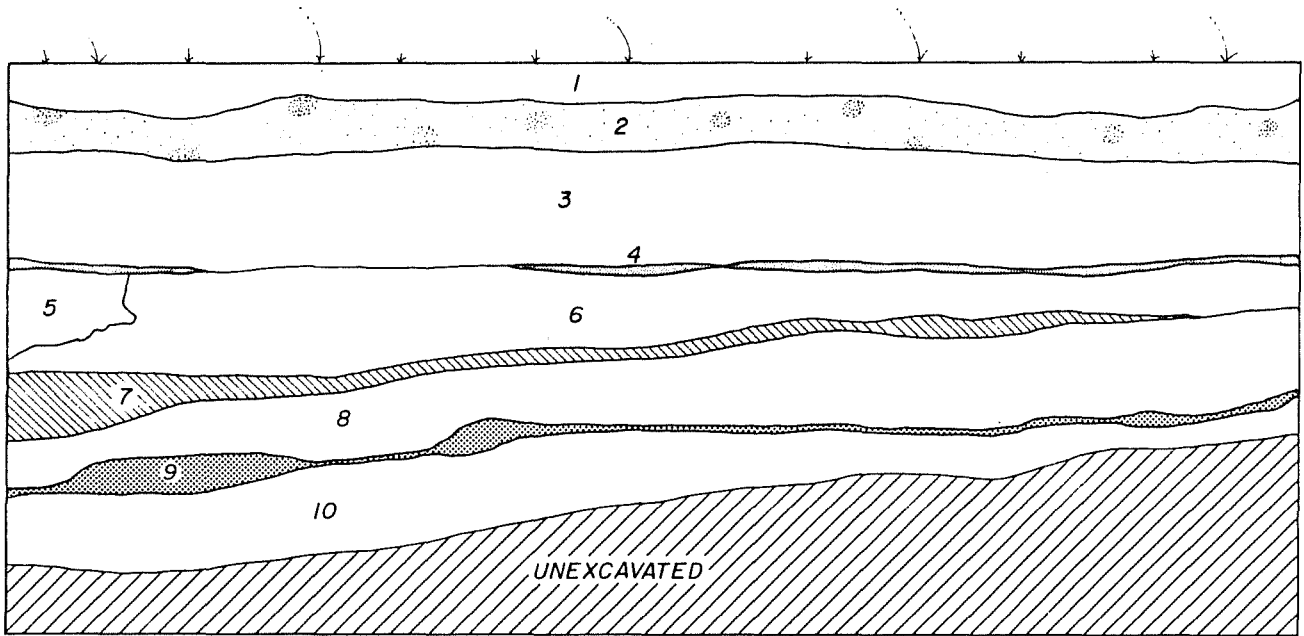
Figure 20. North Wall Profile of Unit 9.

1. DARK BROWN CLAY FILL
2. GRAVEL
3. BROWN CLAY LOAM
4. SAND
5. DARK GRAY BROWN ASH AND CINDERS
6. GRAY BROWN CLAY WITH CALICHE
7. BLACK STICKY CLAY
8. MEDIUM BROWN CLAY
9. TAN MARL
10. BLACK STICKY CLAY

As mentioned previously, Unit 9 started with a 50-inch-square excavation. Layer 1 (Fig. 20) consisting of three to five inches of fill was shoveled out, as was Layer 2, a five-inch gravel layer. Beneath the gravel was found a 10-inch-wide concrete and stone foundation which ran east-west across the

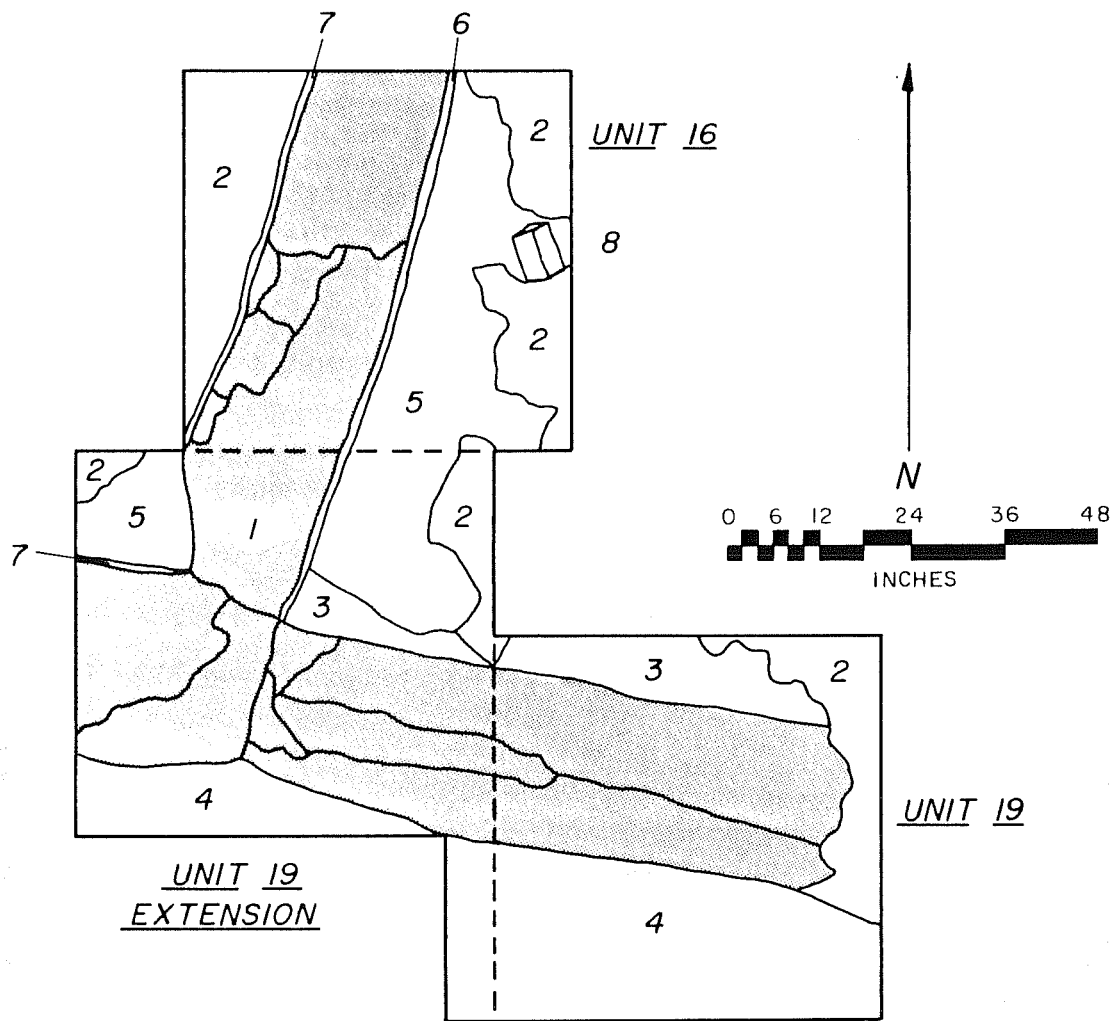
Figure 21. Plan of Stribling House Excavations, Units 16 and 19.

- 1. LIMESTONE WALLS
- 2. LOOSE ROCKS
- 3. FLAGSTONE
- 4. DARK BROWN CLAYEY SOIL
- 5. LIGHT TAN SANDY SOIL
- 6. STUCCO FACING
- 7. PLASTER
- 8. YELLOW BRICK

Unit 16 was a 50-inch-square (Fig. 21) unit placed on the estimated location of the southeast corner of the house (Fig. 14). The soil in Layer 1 was three inches of sandy loam and contained wire nails. Layer 2 was a light tan sandy deposit that looked like disintegrated mortar or rough plaster. It contained a yellow brick and several limestone fragments. This layer averaged about five inches thick. Below this was a layer of dark brown sticky clay, varying from three inches at the north end of the unit to 12 inches at the south end. Layer 4 was composed of reddish tan sandy soil containing numerous fragments of broken limestone, yellow bricks, and broken cement fragments. The top of the remains of the foundation wall of the Stribling House was found to be approximately five inches below the top of Layer 4, or 21 inches below the ground surface.

Unit 19 was a 50-inch-square unit (Fig. 21) placed over the south wall of the front porch of the house (Fig. 14). The unit was extended to connect with Unit 16 and to locate the southeast corner of the stone portion of the main house. In Layer 1, the soil to the south or outside the building was dark brown clay with no artifacts. Soil to the north was the same light tan sandy loam found in Unit 16, only with cut nails. This same differentiation in soil color and texture continued until the top of the wall was encountered beneath a layer of rubble at ca. 20 inches. The porch wall foundation was found to butt against the house foundation, and fragments of flagstone were found against the porch foundation.

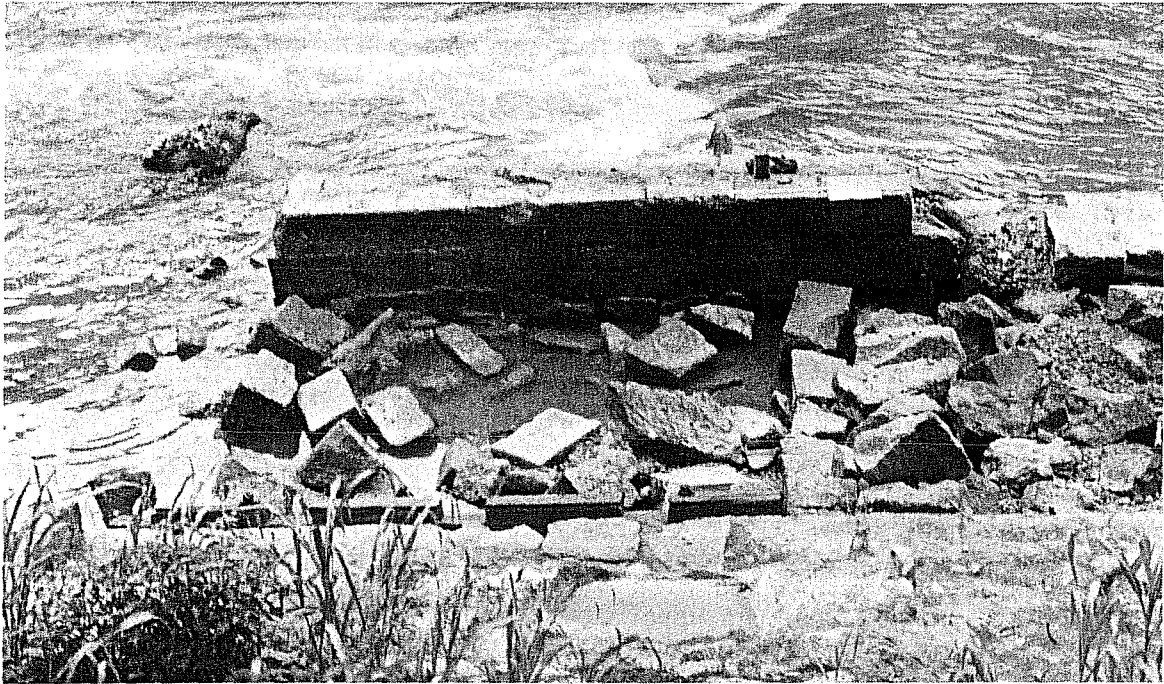
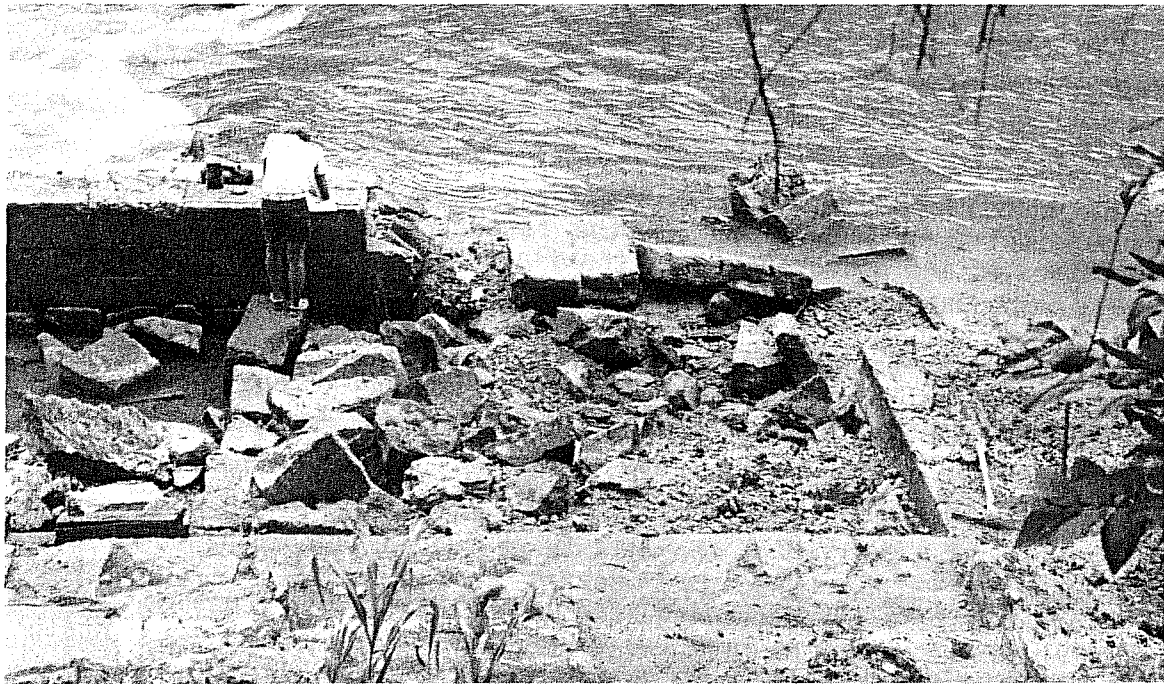
Figure 22. Wheel Pit and Forebay Before Clearing, Looking West.
a, south end; b, north end.

The 15- by 30-foot section of the mill in the riverbed that had been littered with random cut stones and river debris was now clean, and construction details were visible for recording (Fig. 22,a,b). A low stone wall two feet thick divided the interior into two chambers, the forebay to the north and the wheel pit to the south. Three courses of stone survived in this wall. Only a few stones of the top course were still in place, and several in the next course were out of alignment.
