Archaeological Studies for the San Antonio Channel Improvement Project, including Investigations at Guenther's Upper Mill (41BX342)

Center for Archaeological Research
The University of Texas at San Antonio
Archaeological Survey Report, No. 136

ARCHAEOLOGICAL STUDIES FOR THE
SAN ANTONIO CHANNEL IMPROVEMENT PROJECT,
INCLUDING INVESTIGATIONS AT
GUENTHER'S UPPER MILL (41 BX 342)

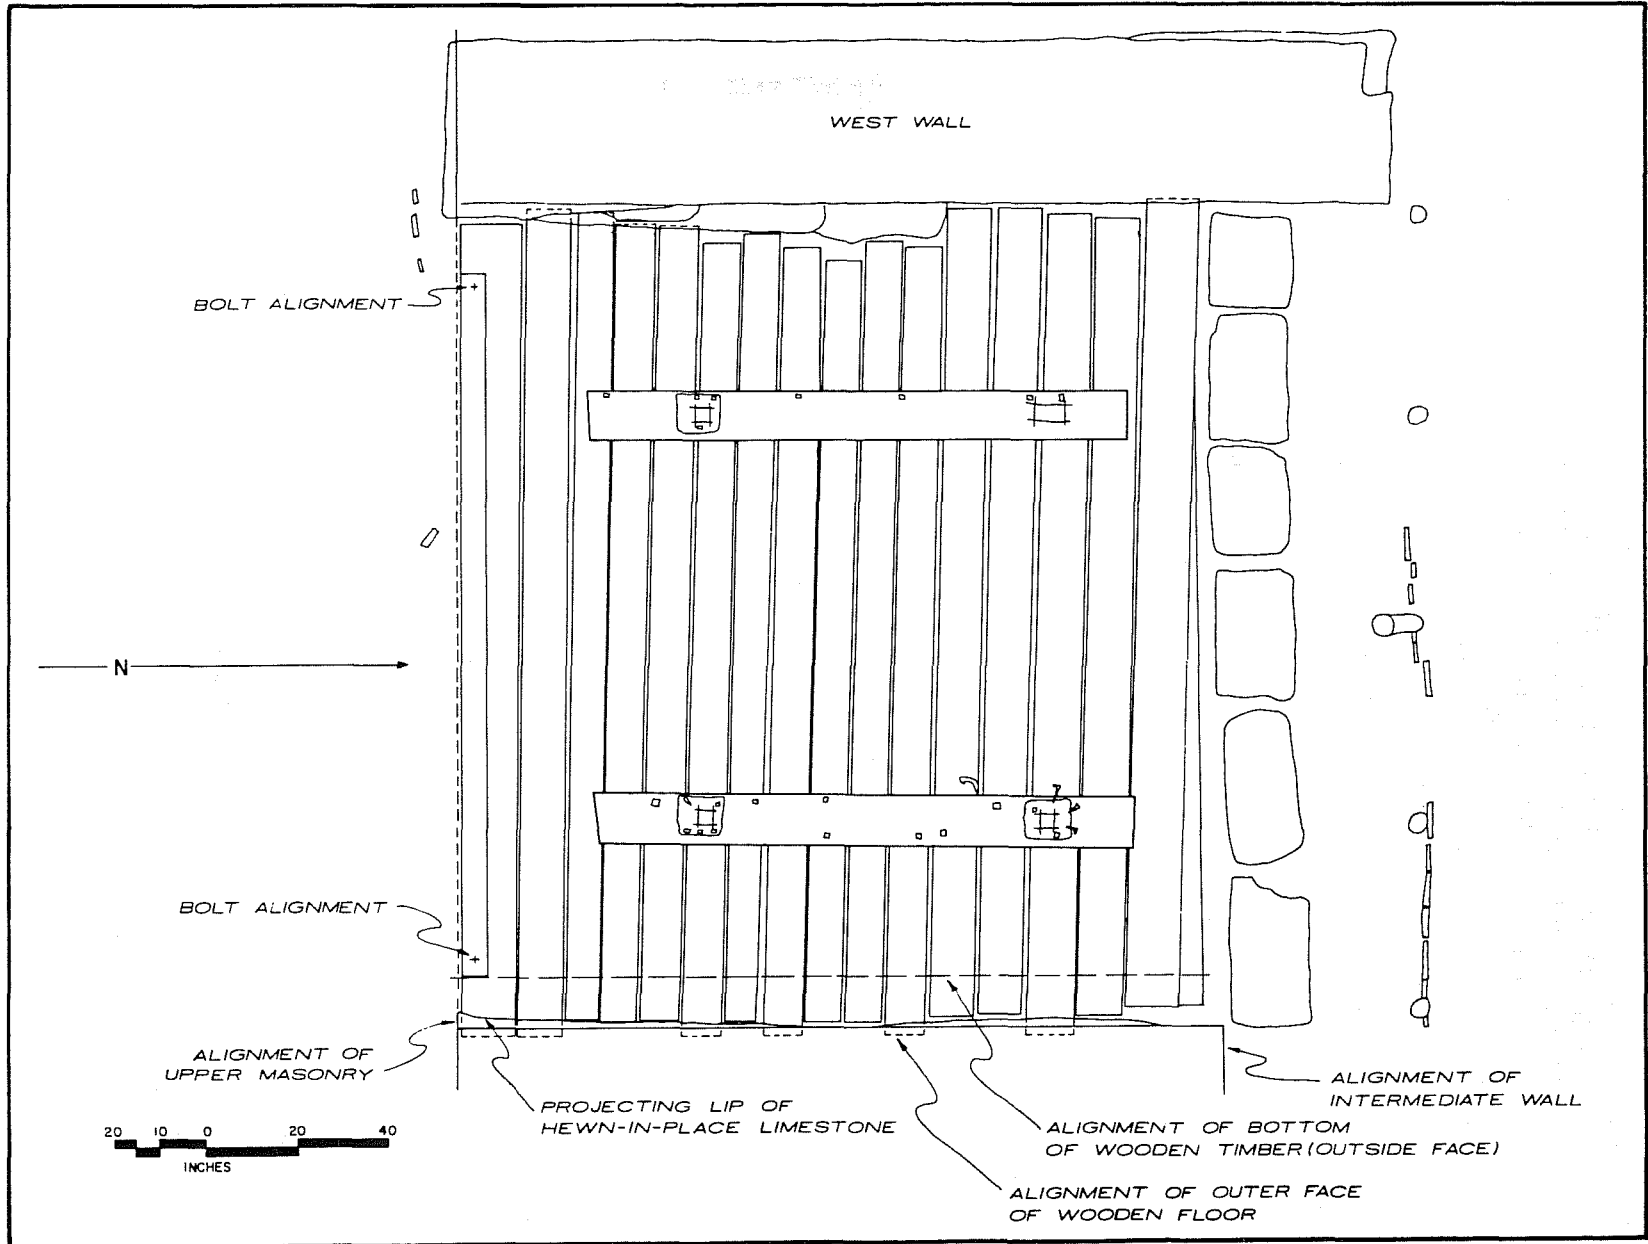
Figure 23. Plan of Wheel Pit Timbers.

The bottom of the wheel pit was covered by a wooden plank floor (Fig. 23) that was one inch higher along its north edge than on its south edge and had a slight slope to the west. Examination of the floor showed each beam to be composed of several planks fastened together. This floor guided the water

out from the wheel and kept the river bottom beneath the wheel from being eaten away by the force of the water. Against the east wall of the wheel pit and tilted slightly away from it at the top was a heavy cypress upright member. This was constructed of four horizontal beams joined by an iron rod running through them at either end (Fig. 24,a). The upright was not attached to the floor, but was recessed two inches under the lower edge of the east wall of the wheel pit. Two wooden beams ran north and south on the surface of the wheel pit floor. They were attached with cut nails to the flooring and had notches cut into them, apparently for the framing that supported the turbine. The southern edge of the wheel pit floor was faced with a beam that also recessed two inches under the eastern wall of the wheel pit.

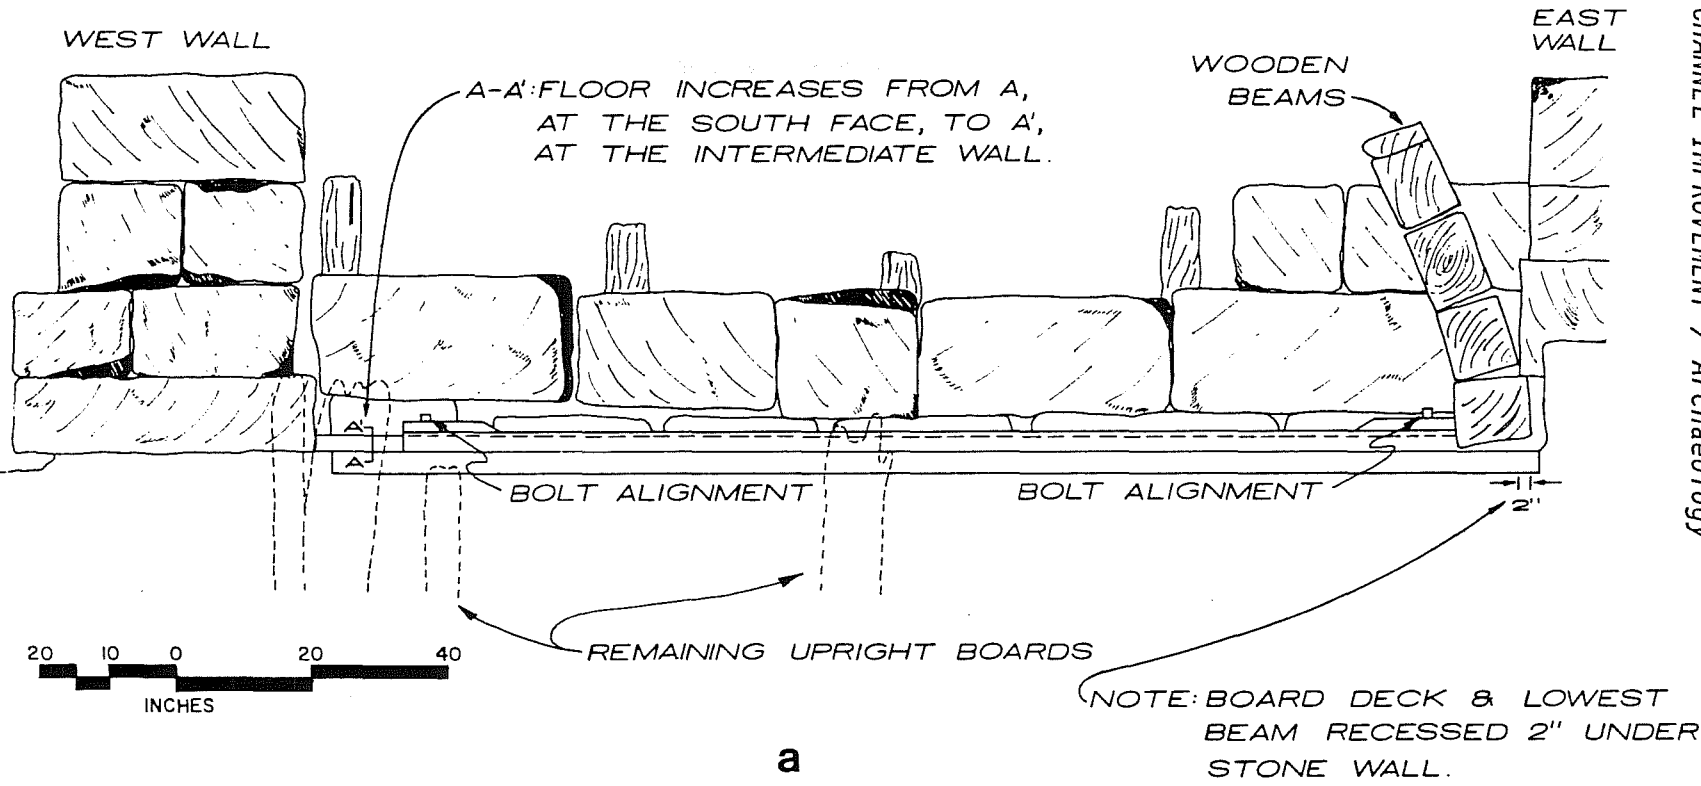
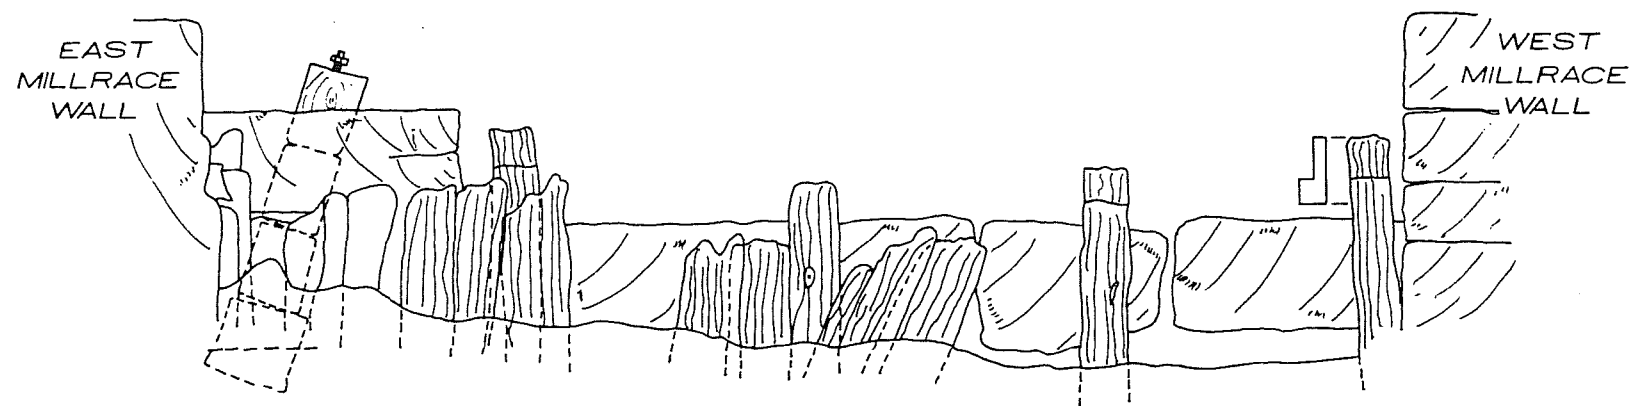
Figure 24. Cross Sections. a, through wheel pit, looking north; b, through forebay looking south.

The north mill foundation extended west to become the north wall of the forebay. The riverbed surface appeared to form the floor of the forebay. A series of cedar posts supporting cedar planks was located north of the partition wall dividing the forebay from the wheel pit. The tops of the posts were sheared off, but traces of notches survived in the tops of several (Fig. 24,b).

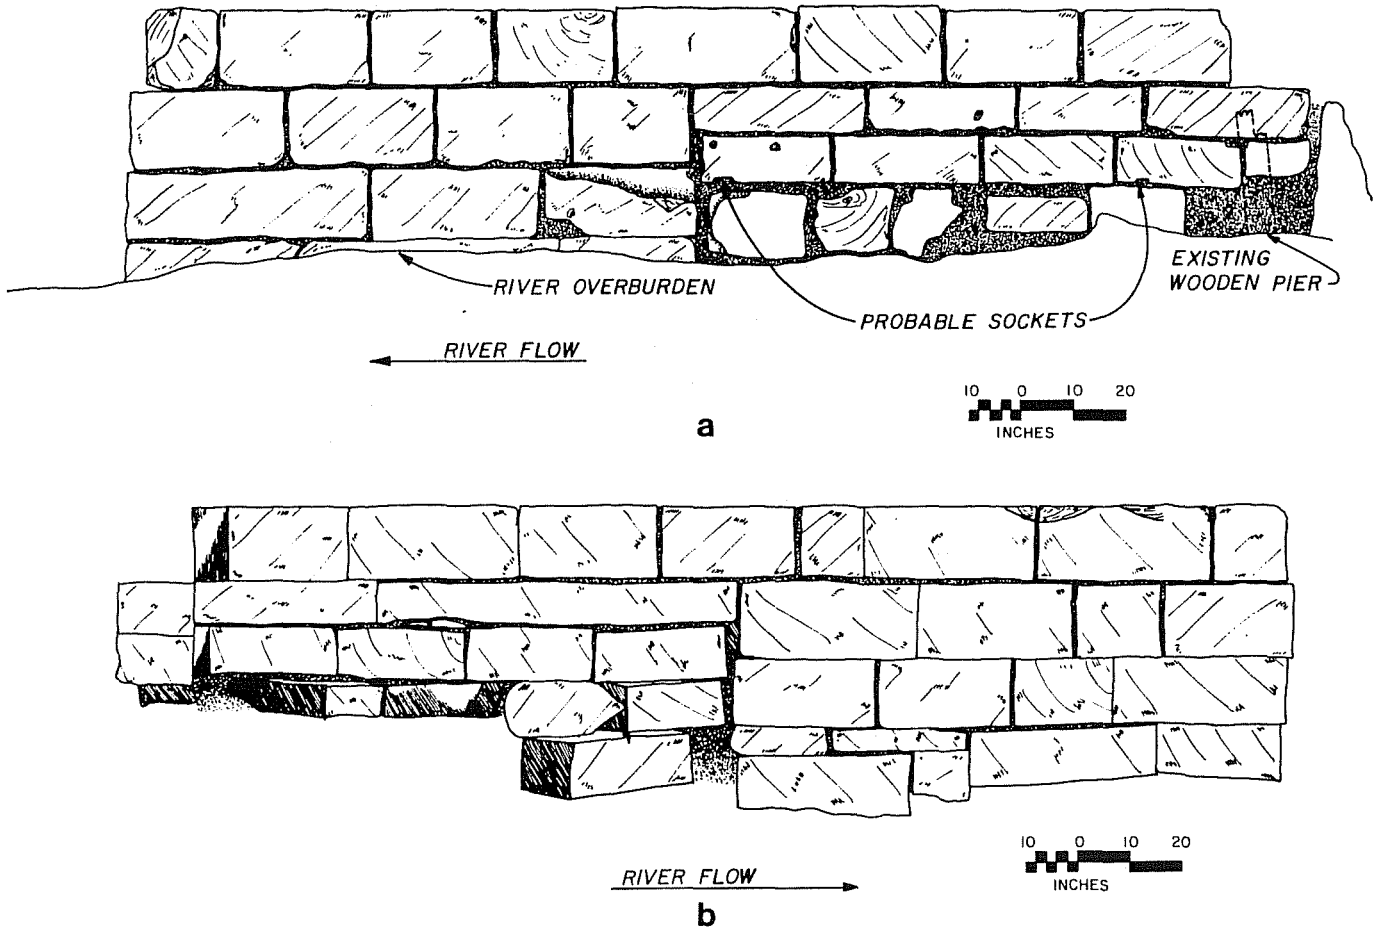
Figure 25. Record Drawings of West Wall. a, looking west; b, looking east.

The top of the west wall stood at about the same elevation as that of the east wall for the forebay/wheel pit. The west wall crossed the natural dam of caliche in the river, and this was reflected in the way it was constructed. The wall, built of cut stone, was three feet wide. The outer faces of the stones were dressed, but the inner faces were irregular. The spaces between them were filled with random-sized chunks of limestone and very hard sandy lime mortar. In the northern half of the wall, the two lowest courses of stone were fitted to the contour of the dam, and some of the stones were irregular in shape. Several of these stones projected from the foundation at odd angles. The west wall was carefully recorded by photographs and measured drawings in preparation for its removal and later replacement (Fig. 25,a,b).

Detailed documentation of the west mill wall was done in measured drawings indicating the description and location of each stone (Fig. 25), and photographs were taken from all directions to aid in its later reconstruction after the channelization was completed. The upper right hand corner of the exposed face of each stone in the wall was given a coded identification number, applied with a black magic marker. The code number indicated course, stone number, and wall face, referring to the measured drawings.

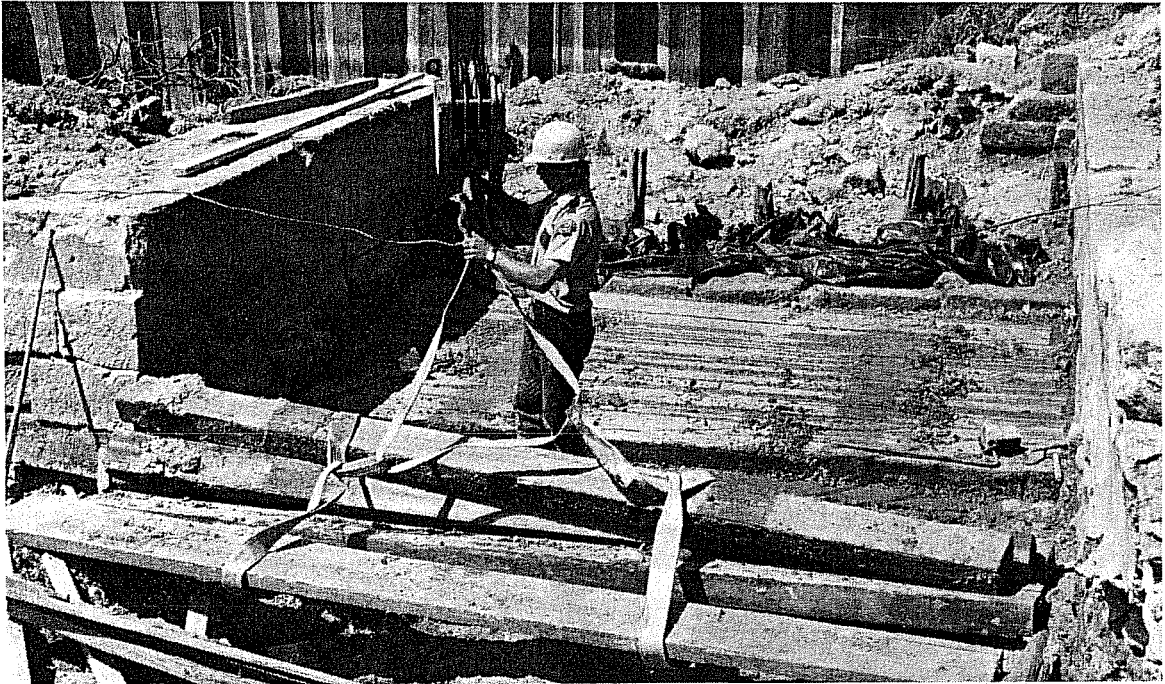
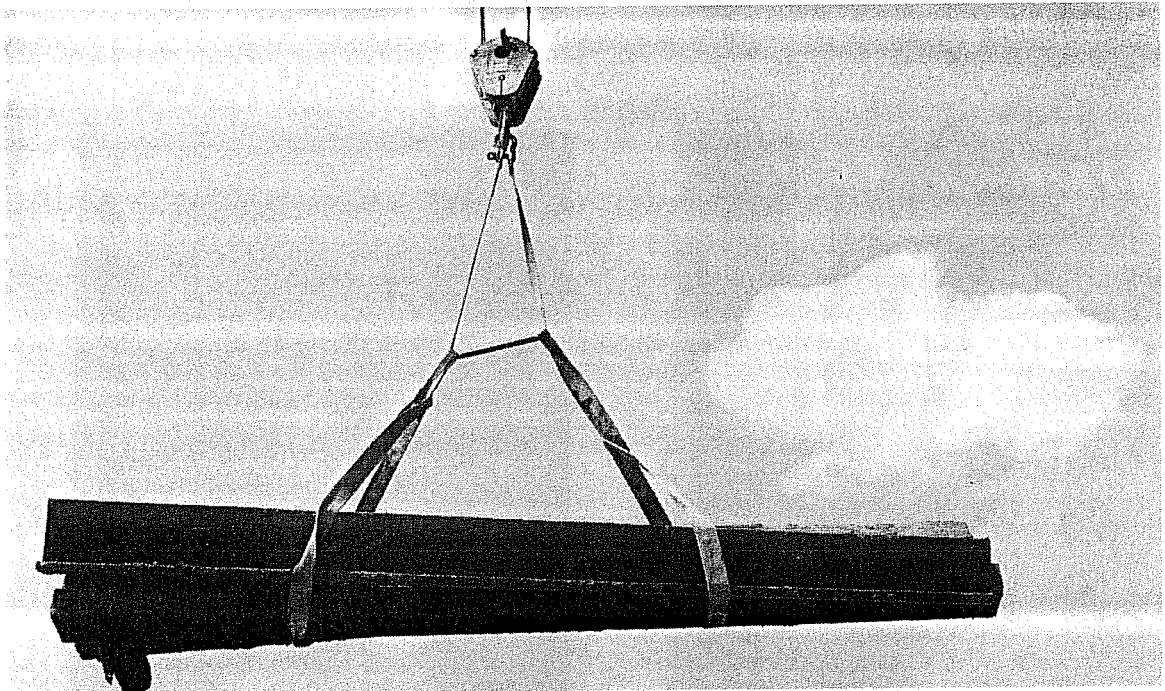
Figure 26. Removal of Wheel Pit Timbers. a, attaching slings; b, hoisting with crane.

The wooden pieces attached north-south to the floor of the wheel pit were removed first. It was found that the best method for lifting the boards was to put two slings around several boards at a time and lift them slowly, allowing the boards to adjust and stack themselves within the slings as they were raised from the ground (Fig. 26,a,b). At the storage area, all debris was scraped and was hosed from the surface of the boards, and they were sprayed with fungicide as they were lowered into the pit. An eight-inch-layer of sand wetted with fungicide was placed between each of the three layers of wooden members. The wooden upright structure was lifted to the storage area and placed on top of the floor timbers. Some samples of the posts and fence boards from the feature in the forebay were also placed in the pit. The drying pit was then completely filled with sand wetted with fungicide, and a low wooden crib was built around the edge at ground surface to keep the sand from being washed away. The documentation and removal of the wooden materials took two days.

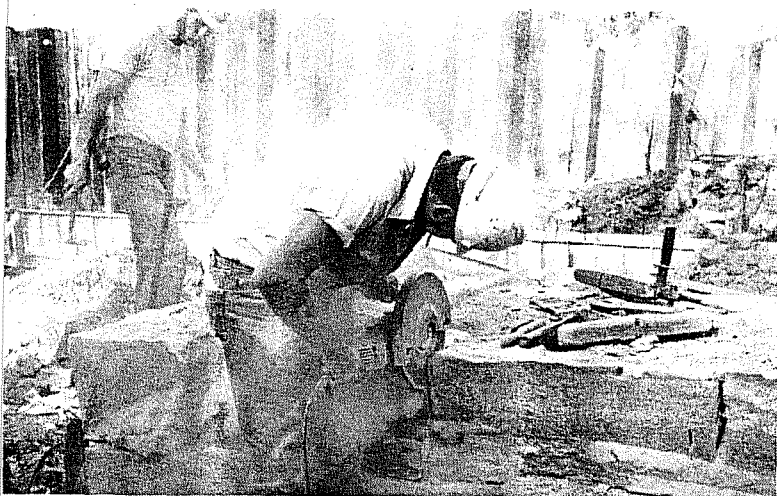
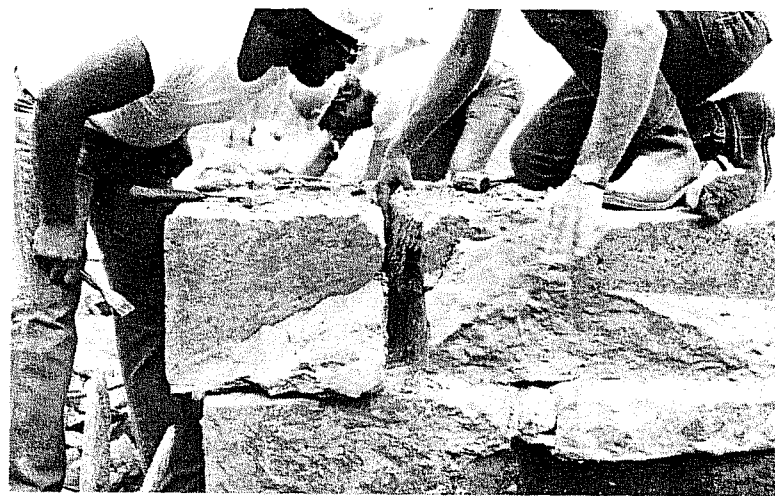
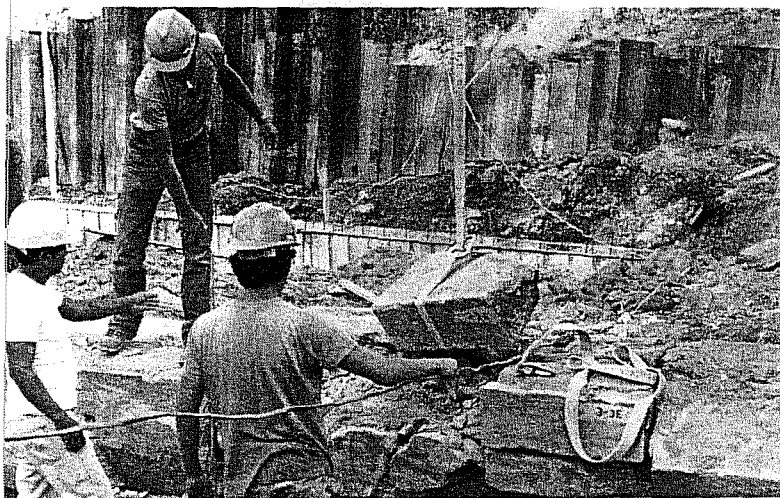
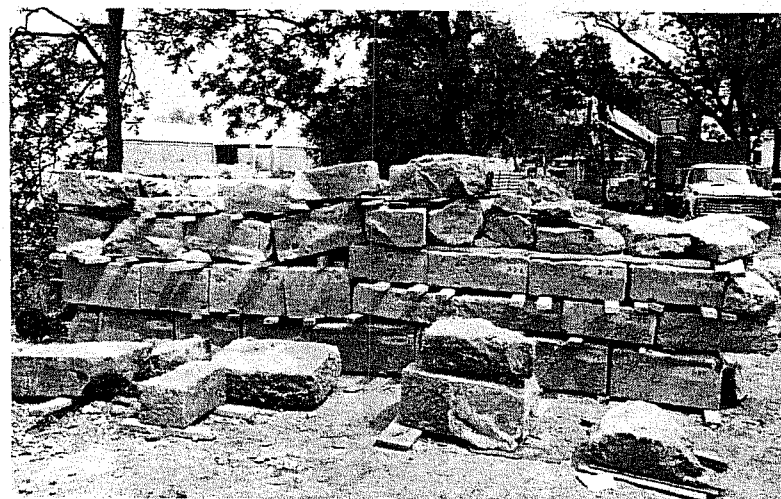
Figure 27. Removing West Wall. a, cutting mortar joints; b, loosening stone; c, attaching sling; d, temporary storage on top of bank.

Two stonemasons, aided by members of the construction crew, dismantled the wall. Wire brushes were used to clean the surfaces of the stones. The stones were separated with a variety of tools: metal hammers, flat chisels, brick splits, plug-ins, wooden wedges, an electric Roto Hammer, and a flat blade saw (Fig. 27,a,b). It was obvious that the masons who built the original mill foundation had used an excellent mortar mix (see Oliver Evans' instructions in Section III), for the mortar was, if anything, harder than the limestones set into it. However, thanks to the skill of the masons, the stones were removed in excellent condition. Wooden planks and a crowbar were used to position the stones to receive the slings for lifting (Fig. 27,c).

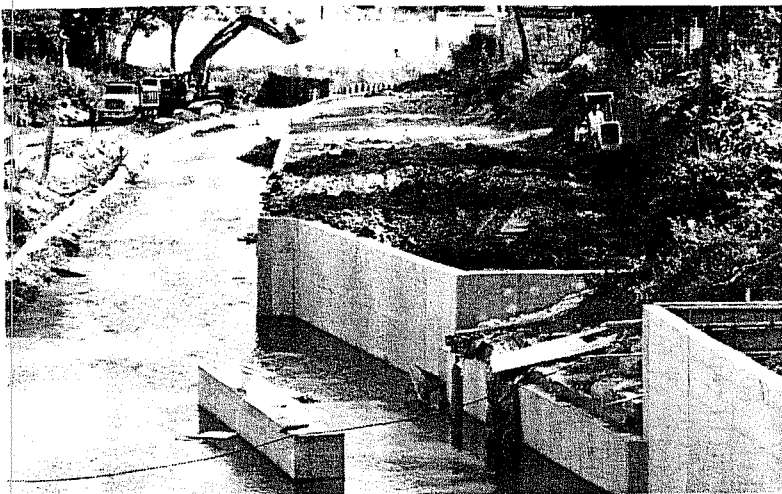
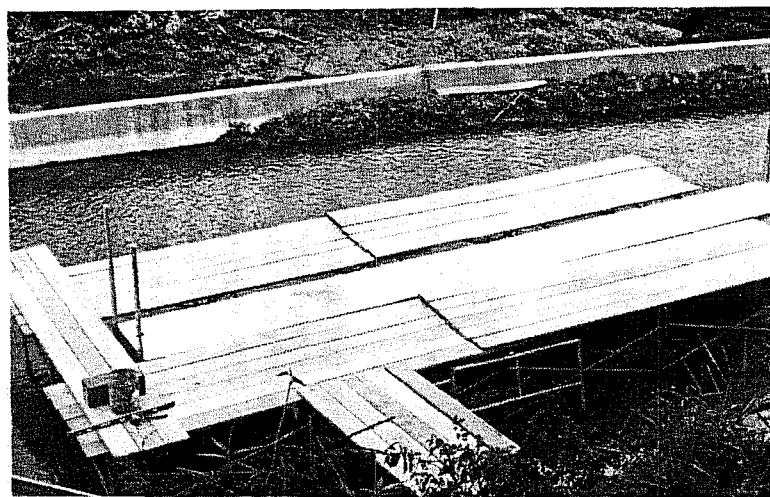
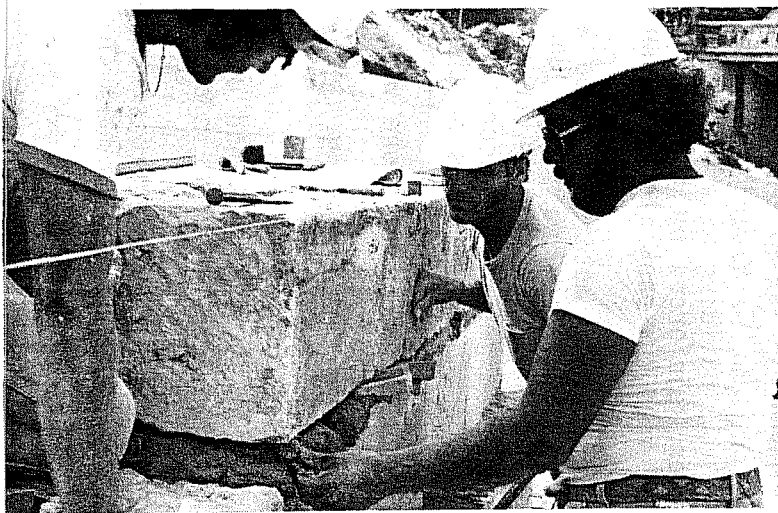
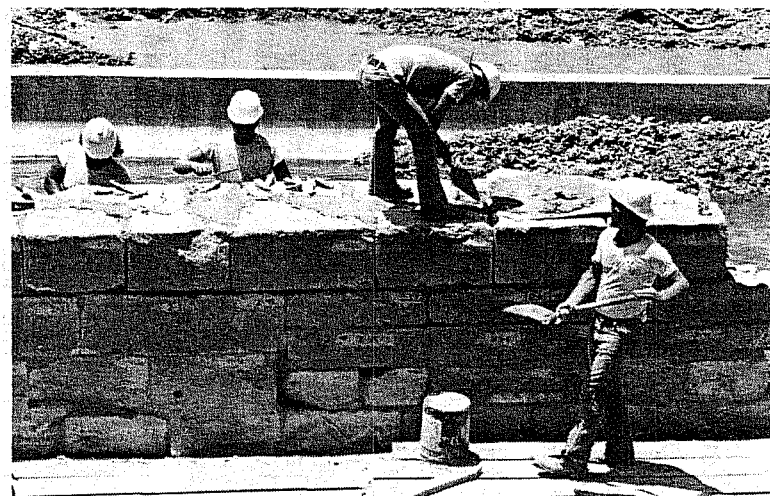
Figure 28. Reconstruction of West Wall. a, concrete footing; b, working platform in place; c, setting individual stones; d, finishing wall.

The bottom course of the wall had originally been fitted to the surface of the natural fall in the river. In order to keep the proper coursing, several stones salvaged from elsewhere in the mill were substituted for the natural formation. As the wall was reconstructed, stones selected from the pile of salvaged cut stone were used to make chinkers and levelers.

The reconstruction of the west wall took seven days. Three full-time and two part-time masons were needed in addition to the crane operator. The masons

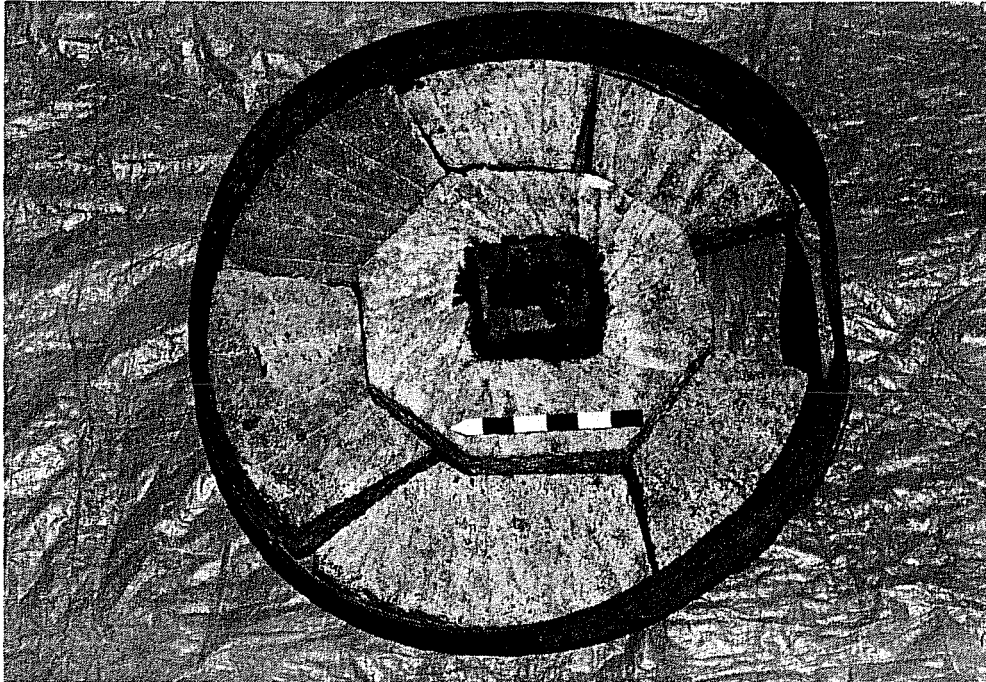
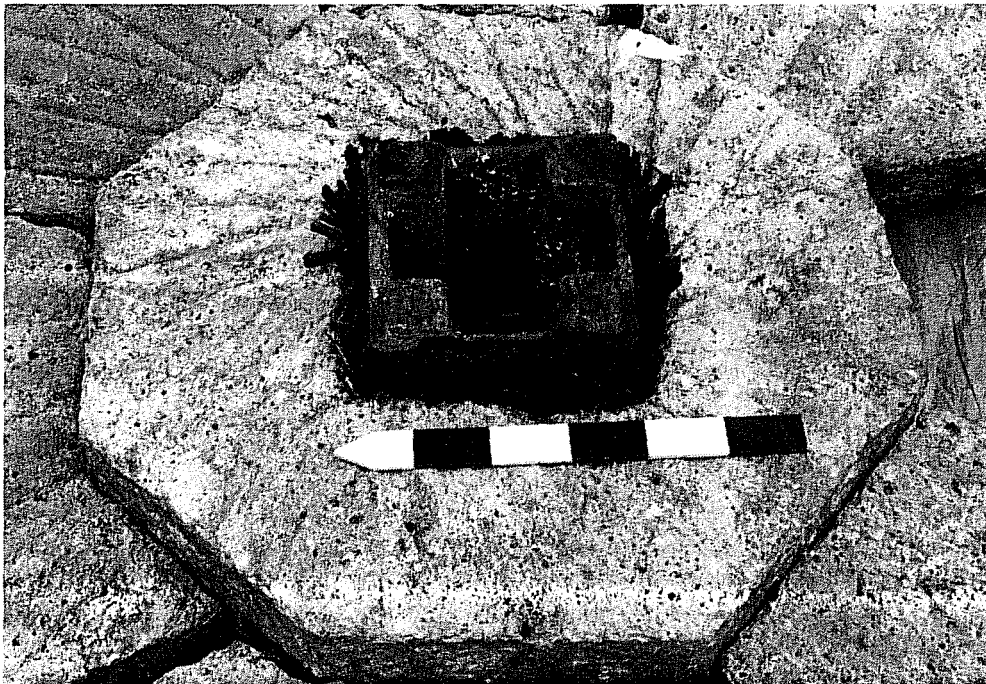
Figure 29. Millstone. a, French burr stone recovered during dredging of the river; b, central section showing metal portion that attached to the drive shaft, indicating that this was the runner, or upper, stone.

However, a fortuitous find has given us one last glimpse of the milling operation that, like the timbers and the foundation stones, can be examined and appreciated for what it says about the rugged construction and the awe-inspiring power of the mill in operation. When the construction crew excavated the river channel to the southwest of the mill site, they found a circular iron band and a number of very heavy, oddly shaped stones. These were immediately recognized by the archaeologists as pieces of a French burr stone. Careful examination of the stones dredged from that area turned up all but one section of the original stone (Fig. 29,a,b). The stone probably was discarded in the river after the conversion of the mill to rollers. It was not mentioned in the newspaper article on the demolition in 1926, at which time it would probably have been saved, for sentimental reasons if for no other. The millstone is identical to a burr stone that once stood on display next to the gate at the Lower Mill (Schuchard 1951:41).
