Effectiveness of the repair of unstabilised rammed earth with injection of mud grouts

R.A. Silva¹, D.V. Oliveira², L. Schueremans³, T. Miranda⁴, J. Machado⁵

^{1-2, 4-5} *ISISE, University of Minho, Guimarães, Portugal*

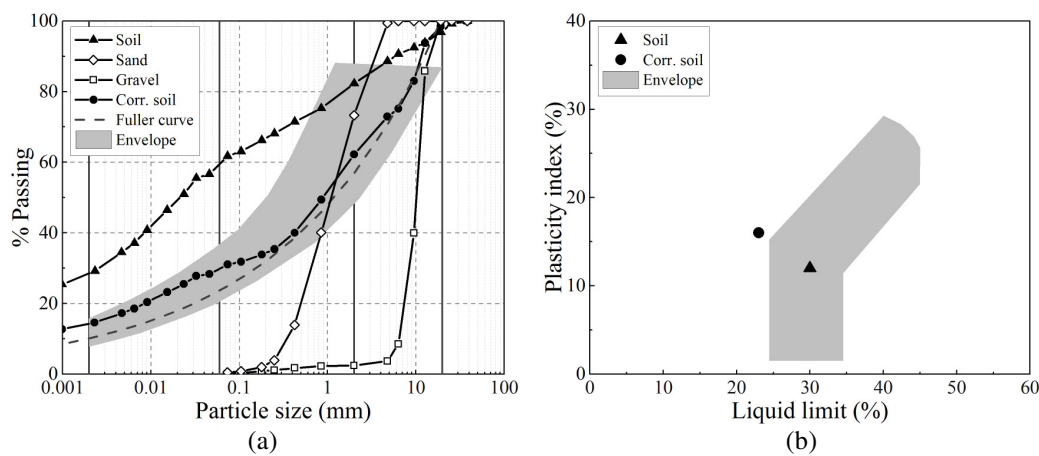
Fig. 1 – Comparison of the properties of the soils with the recommendations of Houben and Guillaud [4] for: (a) PSD; (b) consistency limits.

The PSD correction of the soil was performed with addition of river sand and gravel (crushed granite). Fig. 1 presents the PSD curves of the corrective materials, as well as the PSD of the corrected soil. The corrected soil

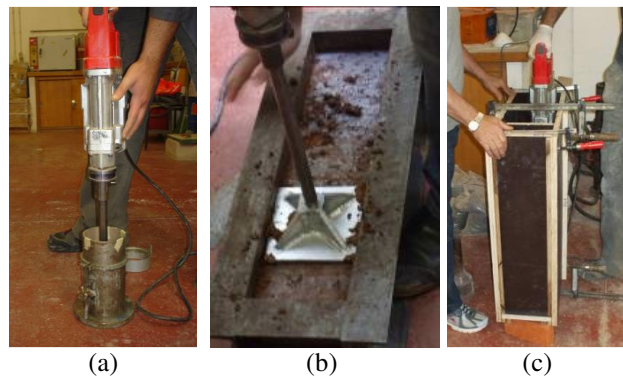
Fig. 2 – Compaction of the URE specimens: (a) cylinders; (b) beams; (c) wallets.

The cylindrical specimens were compacted in three layers inside a metallic mould with dimensions of 100 mm diameter and 200 mm height. An electric rammer was used for this process and the specimens were demolded immediately after compaction (Fig. 2a). The mixture of soil and water of each cylinder was prepared with OWC and hand-mixed, and then was stored inside a plastic bag for about 24 h before compaction. The compaction process aimed at achieving a density close to ρ_{dmax} .

The beam specimens were compacted inside a metallic mould with dimensions 150x150x600 mm³ in three layers with similar thickness (Fig. 2b). The mixture of soil and water was prepared just before the compaction and the water content was controlled by means of the drop test [26]. The OWC was not used, since the mixtures

The wallets were compacted in nine layers with similar thickness and using a high density plywood formwork with dimensions 550x550x200 mm³ (Fig. 2c). The mixture of soil and water was performed according to a procedure similar to that of the beams. The compaction procedure was also similar and the wallets were also demoulded immediately after compaction.

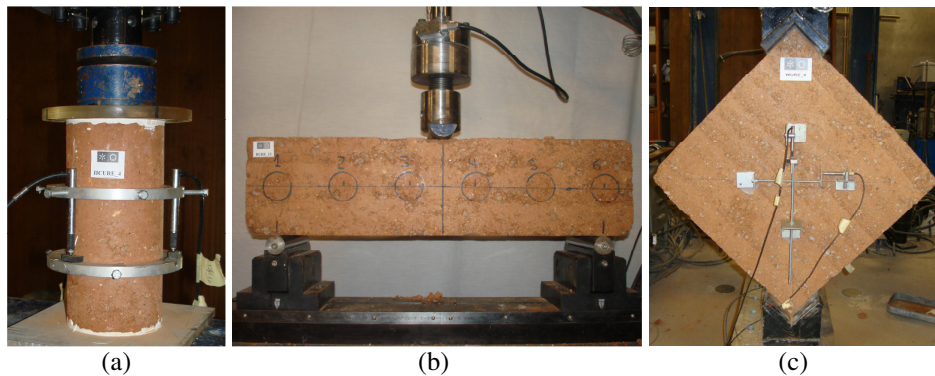
Fig. 3 – Testing setups: (a) axial compression; (b) three-point bending; (c) diagonal compression.

The axial compression tests were carried out after the specimens achieved equilibrium water content at 20°C temperature and 57.5% relative humidity (drying period between 27 and 35 days). The equilibrium water content was measured after testing and was found to be in average 1.04%. The vertical deformations at the middle third of each specimen were measured by means of three linear variable displacement transducers (LVDT) radially-disposed to allow computing the Young's modulus. The load was applied under displacement control at a rate of 0.18 mm/min. In the day before testing, specimens had their top and bottom capped by a layer of gypsum (see Fig. 3a).

The three-point bending tests were first carried out after drying the specimens for 6 weeks at a room temperature of about 22±2°C. The load was applied at middle span and the distance between supports was of about 500 mm (Fig. 3b). The application of the load was carried out under monotonic displacement control at a rate of 0.06 mm/min. The testing procedure of the specimens after injection was similar, but these tests were carried out 3 weeks after the repair. The drying was processed under a room temperature similar to that of the specimens before testing. It should be noted that only the maximum force was recorded from these tests.

The diagonal compression tests were carried out after drying the wallets for 12 weeks at a room temperature of about $22\pm 2^{\circ}\text{C}$. The procedure used was similar to that of ASTM E 519 [27]. The supports were made of steel, with a width of about 100 mm, and the contact with the specimens was rectified by means of neoprene rubbers introduced between specimens and supports. The load was applied under monotonic displacement control at a rate of 0.12 mm/min and the vertical and horizontal displacements were measured in both faces of the wallets, resorting to LVDTs attached to the middle third of each diagonal (see Fig. 3c). The same procedure was used for the wallets tested after repair with injection of mud grouts.

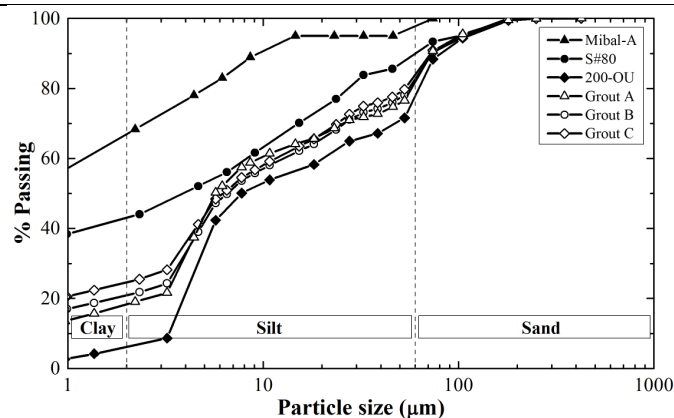
Fig. 4 – PSD of the mud grouts.

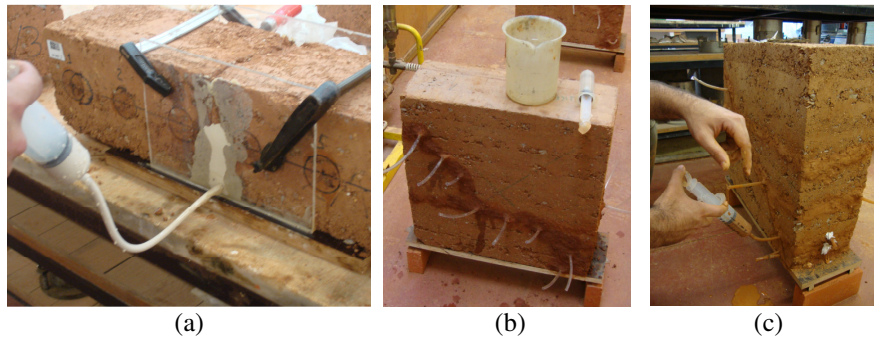
Fig. 5 – Repair of the URE specimens: (a) injection of the beams; (b) sealing of the cracks in a wallet; (c) injection of the wallet.

but the rising of the grouts could be visualised from the sides through the Plexiglas plates (Fig. 5a). The specimens' parts were positioned in such a way that the gap between them (d_{cr}) was of about 2 mm or 8 mm, totalizing 6 specimens for each case. The injection was performed using a 100 ml syringe coupled to a 4 mm diameter tube installed at the bottom of one of the Plexiglas plates. For each set of six specimens with the same d_{cr} , three specimens were injected with grout A and other three with grout B.

The failure of the wallets split them in some parts, which were removed from the testing apparatus and remounted together on a plywood board. Loose debris were removed from the failure surfaces before remounting the wallets. The remounting was performed by assembling piece by piece, and when a specimen presented high instability, it was tied by means of two plywood boards. The assembling was carried out with the aid of an earth mortar to seal the cracks, prepared with the original soil sieved to remove the particles larger than 4.75 mm. Flexible plastic tubes with 6 mm diameter were installed in one of the sides of the specimens. The injection tubes were installed first in the intersection of cracks and then along the cracks, in such way that the spacing between injection tubes was less than 100 mm. In the case of horizontal cracks, additional injection tubes were installed in the other side of the wallets to just facilitate the air evacuation (see Fig. 5b).

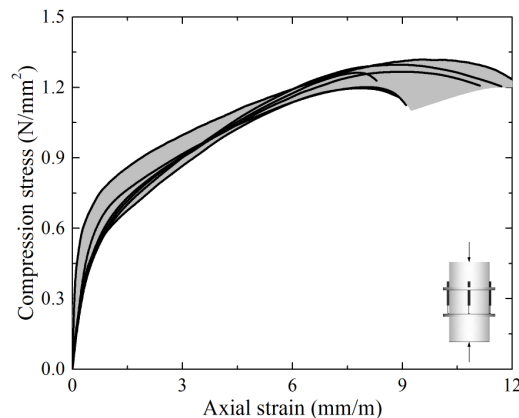
Fig. 6 – Stress-strain curves of the URE specimens tested under axial compression.

The stress-strain curves of the URE specimens tested under axial compression are presented in Fig. 6, where a high non-linear behaviour can be observed. The average compressive strength (f_c) was of about 1.26 N/mm², with a corresponding coefficient of variation (CoV) of about 4%. The lowest value obtained was of about 1.20 N/mm², meaning that the compressive strength obtained deems with the minimum requirements of NZS 4298 [26] for standard grade rammed earth constructions, where the least value of a set of specimens must be higher than 1.14 N/mm² (after considering the aspect ratio of the specimens). The average Young's modulus (E_0), computed between 5% and 30% of the respective compressive strength by linear fitting, was of about 1034 N/mm², where variability was found to be high, with a CoV of about 23%. Despite the manufacturing of the specimens was controlled in lab, E_0 was shown to be more sensitive than f_c to any variability existing between the testing of the specimens. Moreover, the average E_0 is found to be of about 820 times the average f_c , which is a rather high relation if one takes into account that NZS 4297 [32] estimates this parameter as 300 f_c , meaning that a careful use of this last relation should be taken for other cases.

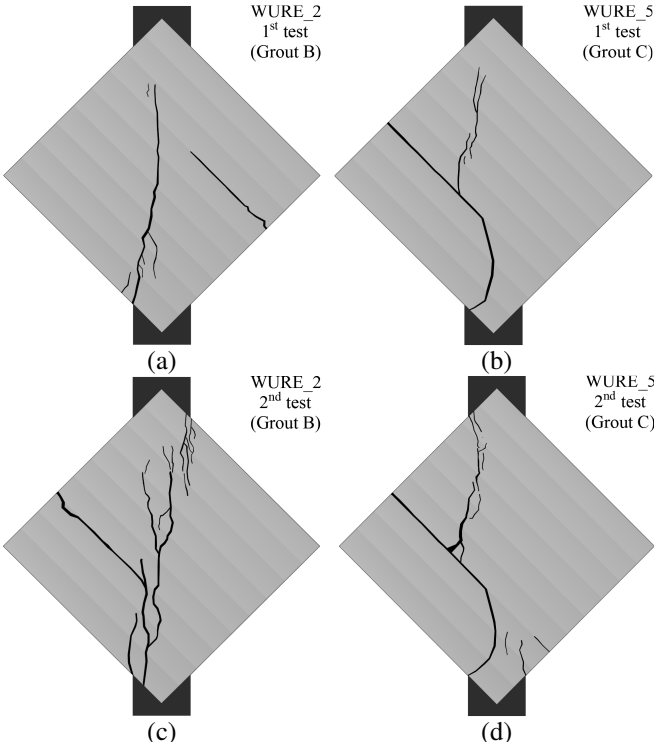
Fig. 9 – Failure mode: (a) WURE_2 after the first test; (b) WURE_5 after the first test; (c) WURE_2 after the second test; (d) WURE_5 after the second test.

The failure of the wallets in the first test occurred as a consequence of the formation of a main crack or set of cracks with a predominant diagonal orientation, crossing the entire specimen (Fig. 9a and b). The formation of these cracks was observed visually to start just before the peak load, at the middle of the specimens, and then developed toward the top and bottom supports. Some cracks occurred also at the interface between layers, which propagated from the edges to the interior of the wallet. This failure mode means that these interfaces constitute weak surfaces when the rammed earth is subjected to tension and/or shear. It should be noted that the onset formation of these cracks occurred just before the specimens achieving the maximum load, meaning that maybe they have little importance regarding the shear behaviour of the wallets.

In general, the crack pattern of the wallets in the second test followed that of the first test, confirming that the initial cracks, once repaired, still constitute preferential failure surfaces (see Fig. 9). This behaviour is a consequence of the impossibility of the mud grout in repairing the micro-damage in the rammed earth material at the vicinity of the repaired cracks, and of the loss of interlocking capacity, as discussed previously.

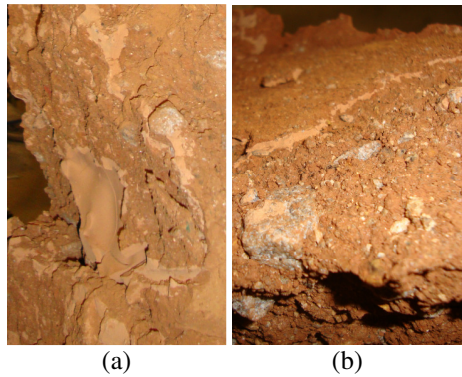
Fig. 10 – Failure surface of the wallets after the second test: (a) presence of a gap in the grout (WURE_1); (b) injected crack with about 1 mm width (WURE_3).

The observation of the failure surfaces after the second test of the wallets allowed assessing the great difficulty in injecting the cracks at the interfaces between layers, since some of these horizontal cracks were only partially filled. This situation occurred due to difficulties in evacuating the air from the cracks, despite the care taken. Small gaps (2-6 cm of maximum size) in the hardened grout were also detected, which are probably associated to flowing of the grout to unfilled horizontal cracks, as they appear immediately above them (see Fig. 10a). The presence of these gaps probably contributed also for a lower performance of wallets after repair, since the failure surfaces tended to cross them. Regarding the minimum width of the injected cracks, it was observed to be of about 1 mm (see Fig. 10b). However, this observation does not imply that thinner cracks cannot be injected by the tested grouts. According to Miltiadou [35], only cracks with width larger than three times the maximum particle size of the grout are injectable, which in the case of the tested grouts corresponds to 0.54 mm (3x0.180 mm). This value shows a good penetrability capacity of the mud grouts used.
