Repair of composite-to-masonry bond using flexible matrix

Abstract

The paper presents an experimental investigation on an innovative repair method, in which composite reinforcements, after debonding, are re-bonded to the substrate using a highly deformable polymer. In order to assess the effectiveness of this solution, shear bond tests were carried out on brick and masonry substrates within two Round Robin Test series organized within the RILEM TC 250-CSM: Composites for Sustainable strengthening of Masonry. Five laboratories from Italy, Poland and Portugal were involved. The shear bond performance of the reinforcement systems before and after repair were compared in terms of ultimate loads, load-displacement curves and strain distributions. The results showed that the proposed repair method may provide higher strength and ductility than stiff epoxy resins, making it an effective and cost efficient technique for several perspective structural applications.

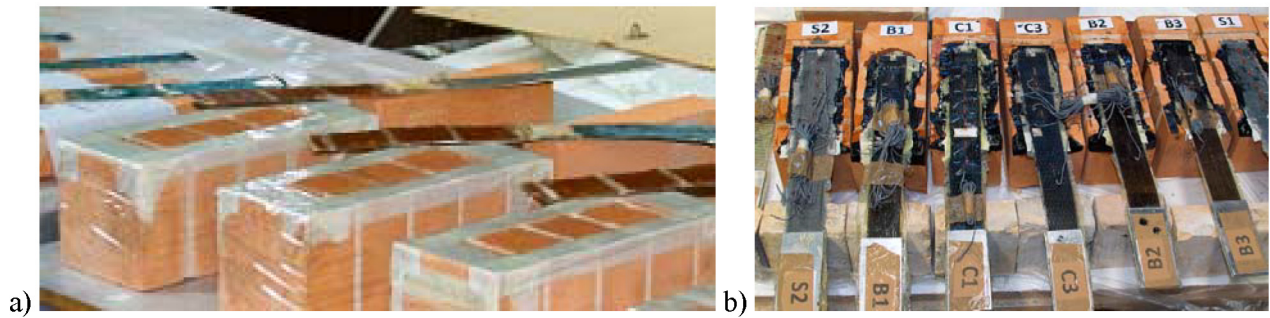
Figure 1 Prism specimens before repair (RRT2) (a) and after repair (RRT3) (b).

In the framework of RRT2, Single Lap Shear Tests (SLST) and Double Lap Shear Tests (DLST) were carried out on single bricks and masonry prism specimens, on which glass, basalt, carbon and steel textiles were bonded with epoxy resin (de Felice et al., 2015a). In most tests, failure on brick substrates occurred by cohesive debonding involving the substrate, with the detachment of a uniform thin layer of brick, which remained attached to the FRP strip along the whole bonded length. Differently, in case of masonry substrates, the failure surface was rougher, due to the presence of the mortar bed joints. After RRT2 tests, the specimens with the detached FRP strip in good conditions (Fig. 1a) were reused within RRT3. The failure surfaces were cleaned from loose particles using compressed air and impregnated by special primer for polyurethane adhesives (Fig. 1b). Then, the detached composites were bonded again to the substrate using flexible polyurethane adhesive of high deformability made of the polymer PS (Fig. 1b), so that the PS was glued between two surfaces of substrate. The thickness of the adhesive PS was rather variable, because of the roughness of the surfaces. Curing time of the polymer PS is 24 hours (producer data), and all the specimens were tested few months after repair. The repair application of the polymer PS at failure surfaces was done in

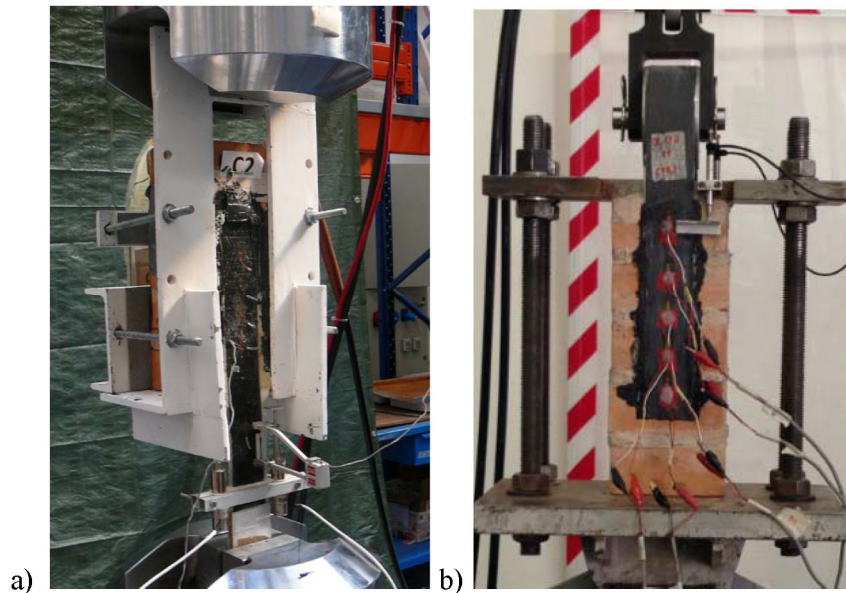
Figure 2 Testing setups: Single Lap Shear Test (SLST, a) and Double Lap Shear Test (DLST, b) schemes.

Tests were carried out using a Single Lap (SL) setup in CUT, UNIBO, UMINHO and UNIRM (Fig. 2a). More specifically, UMINHO, UNIBO and UNIRM3 used a rigid supporting steel frame (Valluzzi et al., 2012; Ghiassi et al., 2014; de Felice et al., 2015a; Mazzotti et al., 2012; 2015a; 2015b), while CUT used a hinged C-shaped steel frame (Valluzzi et al., 2012; Kwiecień, 2012). Differently, UNINA used a Double Lap (DL) setup (Fig. 2b) comprising a steel cylinder of diameter 110mm and a hinged H-shaped steel frame (Valluzzi et al., 2012). In most cases, and on both brick and masonry substrates, the bonded length (L_b) was 200mm, its width (b_f) was 50mm and the distance from the loaded end of the bonded area and the edge of the substrate (c) was 30mm. Only in UMINHO, $L_b=150$ mm and $c=40$ mm. On masonry substrate, the bonded length corresponded to three bricks and three mortar joints. In addition, two other bonded length values were investigated, such as $L_b=65$ mm and $L_b=135$ mm, corresponding to one brick and one joint and to two bricks and two joints, respectively. In these cases, $c=55$ mm.

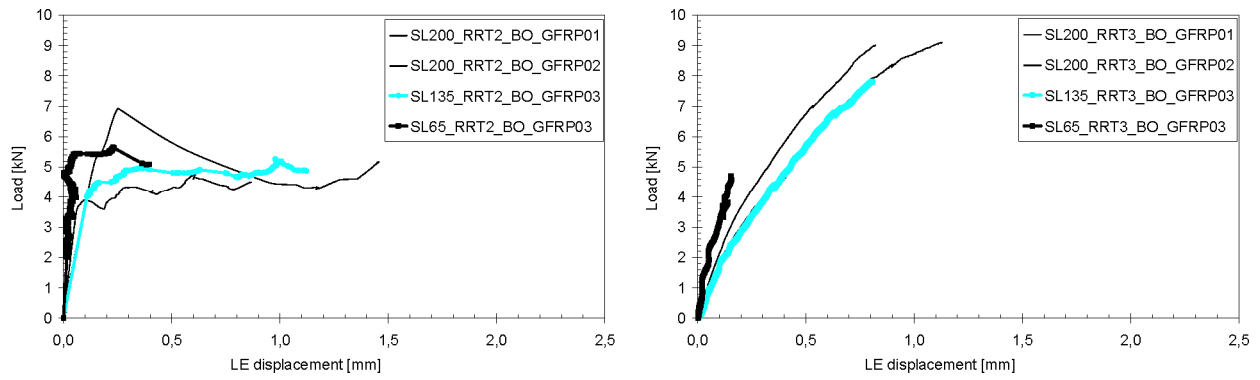
Figure 5 Load-slip curves of prism specimens before (RRT2 - left) and after (RRT3 - right) repair, for GFRP specimens with bond length of 65mm, 135mm, and 200mm

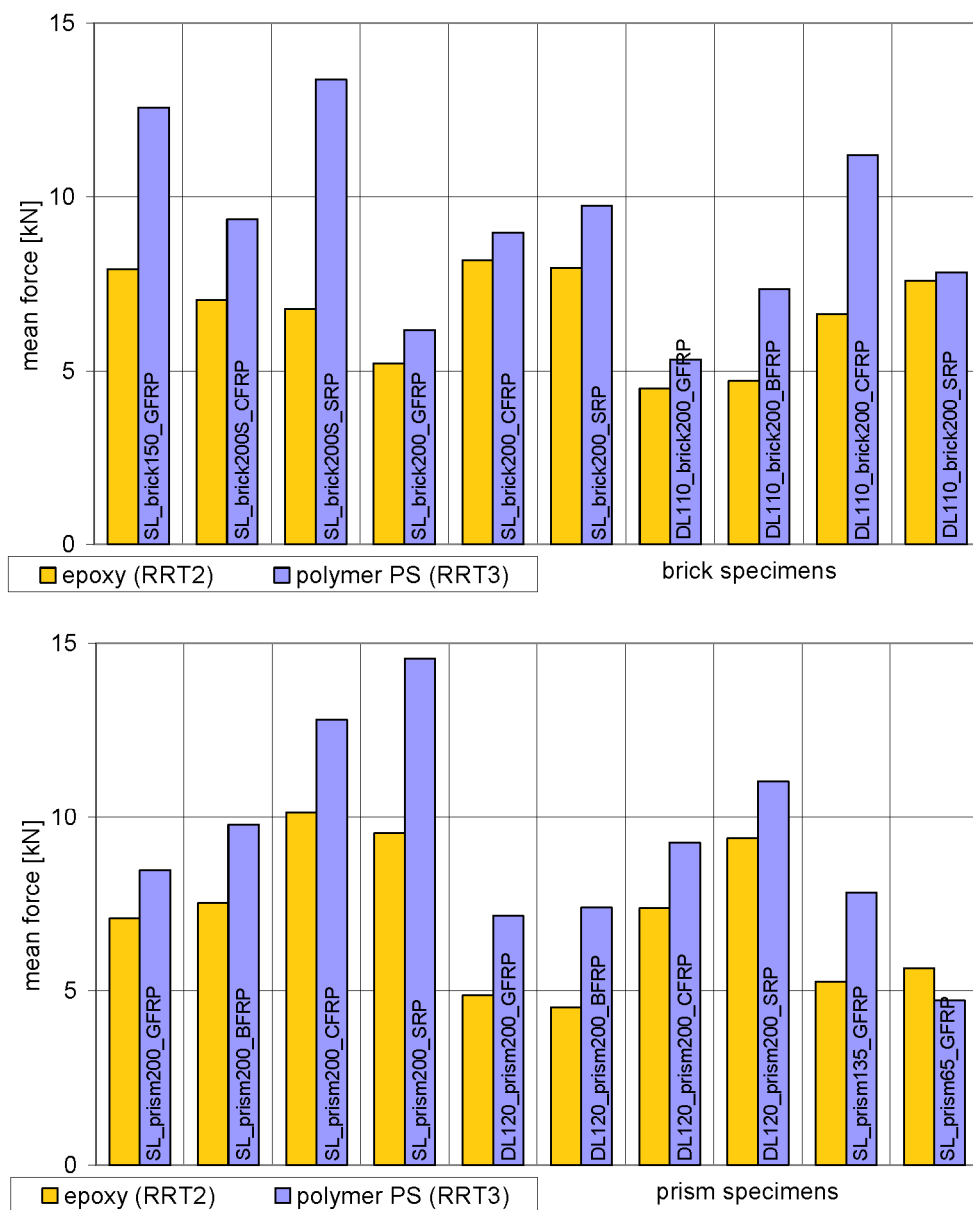
Figure 6 Comparison of mean ultimate loads before and after repair obtained on brick and masonry substrates.

Similarly to the tests on brick substrates, the shear bond performance of FRP reinforcements on brickwork increased after repair with polymer PS. The average strengthening ratios were always larger than 1 and ranged between 1.18 and 1.63 (Fig. 6), provided that the bonded length is not too short. These results prove the effectiveness of reusing detached composite strengthening systems by re-bonding them with the highly deformable polymer PS. The comparisons in terms of load-slip curves (Figs. 4 and 5), confirm the more deformable behavior of the repaired reinforcement if compared to that exhibited before repair, confirming
