Theses (Historic Preservation)

# (In)Forming and Pressing Matters: Laying the Foundations for the Preservation and Interpretation of the Western Clay Manufacturing Company

archie bray sr., charles bray, brickmaking, structural and hollow clay tile, montana

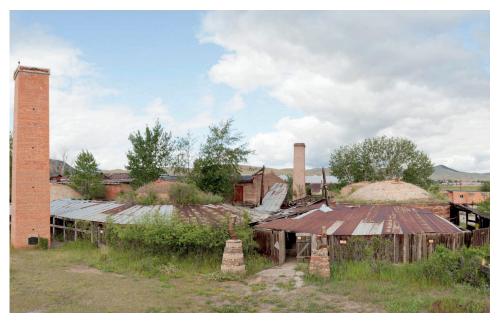
Figure 1.1: "The Western Clay Manufacturing Company, overview from northewast looking southwest." Joe E. B. Elliott, photographer, July 2011. Courtesy of the University of Pennsylvania Architecture Conservation Laboratory.

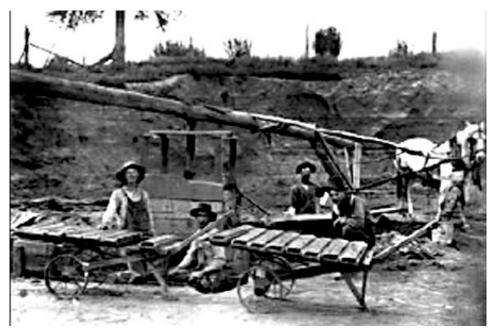
Figure 2.10: Horse operated pug mill at the Soft Salida Brick Company. Image courtesy of the Salida Library. From http://cozine.com/2009-october/the-story-of-soft-salida-brick/.

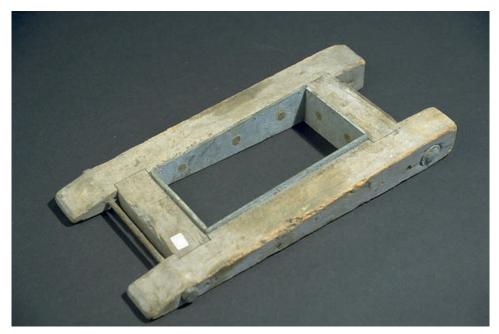
Figure 2.11: "Wood and Steel Brick Mould." Photographer unknown, 2007. Courtesy of the East Lothian Museum, East Lothian, United Kingdom. Image from http://www.flickr.com/photos/eastlothian/540650616/in/photostream/lightbox/.

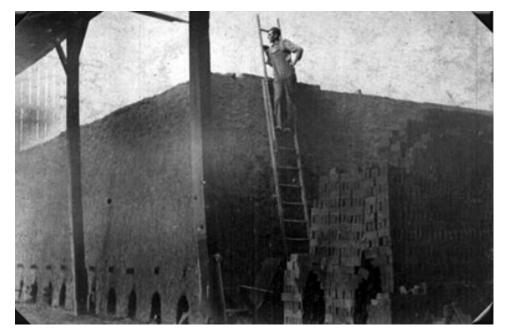
Figure 2.13: Image of a scove kiln. Photographer unknown, circa 1900. Image from http:// brickcollecting.com/history.htm.

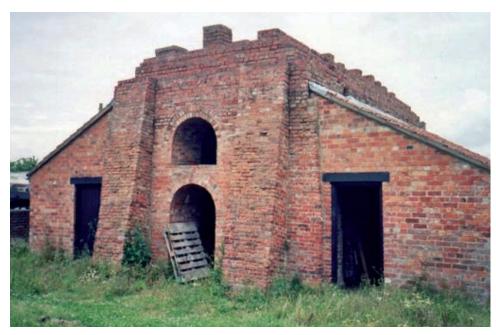
Figure 2.14: Modified version of a Scotch Kiln. "Baumber Brick Kiln." Ken Redmore, photographer, 2006. Society for Lincolnshier History and Archaeology. Image from http://slha.org.uk/slha/Main/GalleryBricks.

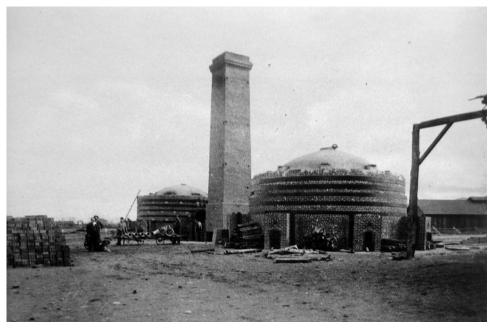
Figure 2.16: "Early beehive kilns at either the Kessler or Western Clay Works." Courtesy of the Montana Historical Society, Helena, MT.

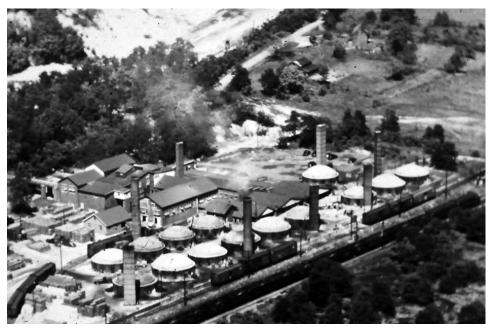
Figure 2.18: Image showing the location and arrangement of beehive kilns. Image of the North Mountain Brick Plant in Eastern West Virginia. Photographer unknown, circa 1950. Image Courtesy of Jeff Hollis, Continental Brick Company, Martinsburg, WV.

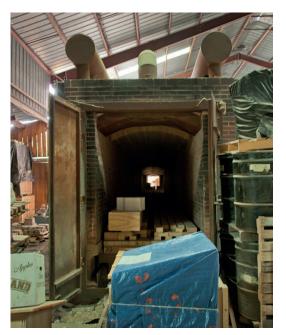
Figure 2.22: Remains of the late 1950's Tunnel Kiln at Western Clay. Joe, E. B. Elliott, photographer, July 2011.

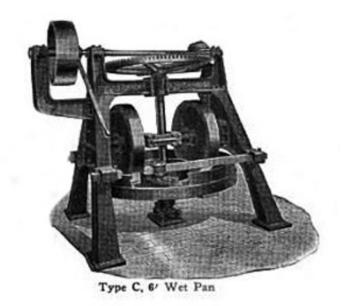
Figure 2.32: Wet pan, "The Toronto Foundry and Machine Company's Type C, 6 Foot Wet Pan." *Brick and Clay Record*, 57, no. 13 (1920): 1074.

similarly to the dry pan, yet unlike the dry pan the wet pan had a solid bottom.<sup>266</sup> Clay entered the pan, water was added, and the mixture was afterward tempered thoroughly as the pan rotated round and the centrifugal force threw clay to the rim. When considered thoroughly worked, a plough-like device was inserted into the pan and tempered clay was mechanically scraped from the pan. The scraped clay was deposited on another belt conveyor and transferred up to the second level of the shop—in an area above the location of the wet pan. After reaching this second level, the clay was fed into a steam-powered hydraulic pipe press that was fitted with a die.<sup>267</sup> This press, known as a vertical extruder, was a two-story configuration. (Fig. 2.33) Depending on the desired shape or size of the product, the press's die was changed. If, however, it was necessary to produce a flowerpot, clay, instead of being fed to the hydraulic pipe press, was supplied directly from the wet pan to the flowerpot machine that was located in the manufactory's flowerpot shop.<sup>268</sup> This particular shop was a designated workroom adjacent to the wet pan.<sup>269</sup> While the flowerpot press was mechanically powered, it could not be operated without the help of a workman<sup>270</sup> (Fig. 2.34).

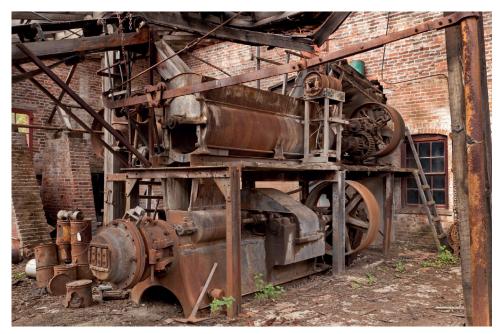
Figure 2.35: Western Clay tile shop pug mill. Joe E. B. Elliott, photographer, July 2011. Courtesy of the University of Pennsylvania Architecture Conservation Laboratory.

If not intended for pressing as sewer or drainpipe or flowerpots, clay pulverized in the tile shop was fed from the clay storage area to a one story room located at the southeastern-most end of the agglomeration buildings comprising the tile shop.<sup>271</sup> In this room sat a large, horizontal pug mill that was designed to accept clay from above<sup>272</sup> (Fig. 2.35). Within its multiple chambers clay, water and any desired additives that were not previously combined with the processed clay were thoroughly mixed and worked together by means of a series of rotating knife-like blades into a solid pliable form.<sup>273</sup> The worked clay then proceeds through an auger, which by means of a screwing action forced the tempered clay forward, through a die, and out onto a table outfitted

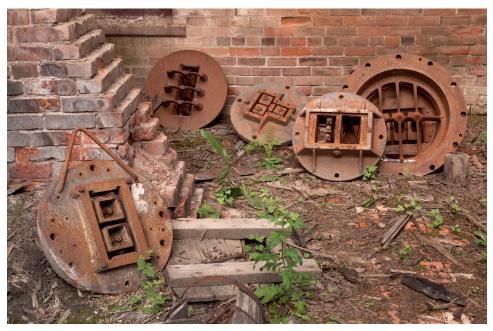
Figure 2.36: Hollow clay product dies at Western Clay. Joe E. B. Elliott, photographer, July 2011. Courtesy of the University of Pennsylvania Architecture Conservation Laboratory.

with a machine called a cutter<sup>274</sup> (Fig. 2.36). Western Clay's cutter was known as a side cutter. It was a hollow, cylindrical form strung with a series of specifically spaced piano wires. As it rotated, it cut into the column of extruded clay and sliced off individual tile products of the desired shape and size (Fig. 2.37). Afterward, the formed products were "hacked," or taken off of the conveyor belt and properly stacked on either a drying pallet or cart by four or five men interchangeably termed "hackers" and "off-bearers."275 At Western Clay, as many as five men at a time could be found loading the carts full of unfired products and afterward wheeling them into the adjacent drying area.<sup>276</sup>

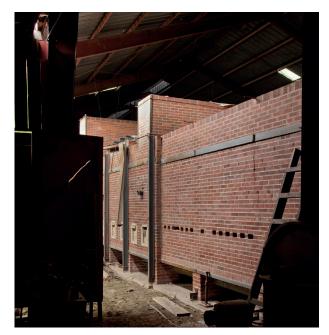
Figure 3.20: Building housing the Western Clay tunnel kiln. Joe E. B. Elliott, photographer, July 2011. Courtesy of the University of Pennsylvania Architecture Conservation Laboratory.

Today, the metal shed that housed the tunnel kiln is extant (Fig. 3.20). This kiln has, however, been physically compromised as a result of the adaptive use of the space inside the tunnel kiln shed (Fig. 3.21). Additionally, the recent construction of several ABF buildings on the principal manufactory grounds has severed both the direct visual and the physical-in terms of transfer tracks—connection of this tunnel kiln with both the brick and tile shop. Therefore, in terms of their setting and association, this tunnel kiln and the building that houses it are now lack integrity. The kiln itself is also lacking integrity with regard to its materials. Although this kiln was U-shaped, only one leg of the greater U exists. Still, due to being sheltered from the elements by the larger shed in which it is housed, this remaining section of the kiln is in good physical condition. Thus, at least some portion of the greater story of this particular kiln technology can be told via the extant material fabric. While the compromised physical integrity, setting, and association of this kiln type may inhibit the telling of a rich history of this particular technology, I still recommend to Western Clay's stewards that the remaining section of this tunnel kiln, along with the shed that houses it, be preserved. Having this third-generation kiln technology on site, and being able to compare and contrast it—especially in terms of labor intensity and firing methods—with the other two kiln technologies helps to round out the picture both of Western Clay's evolution as well as the progression of brick and hollow and structural clay tile industries firing technologies. As touched on previously, Western Clay stands as extraordinary example of a site that has examples of all three of the industry's main kiln types. Keeping all three kiln types,

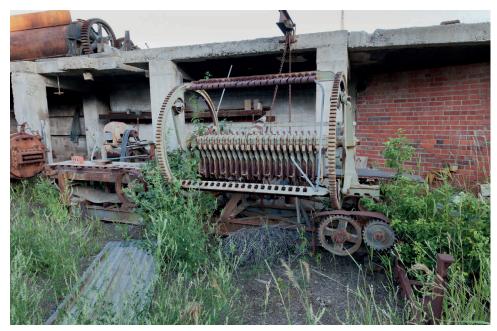
Figure 3.22: Brick shop remains. Joe E. B. Elliott, photographer, July 2011. Courtesy of the University of Pennsylvania Architecture Conservation Laboratory.

As discussed previously, such a paucity of Western Clay's original brick shop remains that this building currently lacks the integrity necessary for the process of brickmaking to be accurately and effectively interpreted. The remains of this structure—including a line shaft and several significant pieces of the machinery that this shop was meant to house—do stand, however, as testaments to the site's principal industry (Figs. 3.22 and 3.23). Although I certainly would not advise the ABF or any other steward to invest time, money, and effort into the reconstruction of any part of this building, it may be helpful in terms of the overall interpretative ability of Western Clay were the ruins of this brick shop stabilized and retained. Although in poor condition and lacking integrity, the remains of this shop do manage to contribute minimally to the overall feeling of this industrial landscape. From the location of these ruins, one can also gain some understanding of where the brick shop stood in relation to many of the site's other buildings and infrastructural elements.
