Young, Andrew and Kay, Andy and Marshall, Stephen and Torr, Ralph and Gray, Alison (2016) Hyperspectral imaging for erosion detection in wind turbine blades. In: Proceedings of HSI 2016, 12-13th October 2016. UNSPECIFIED, England. ,

Hyperspectral Imaging for Erosion Detection in Wind Turbine Blades

This paper demonstrates a Hyperspectral Imaging technique in its application to imaging surface defects on a section of wind turbine blade in a laboratory.

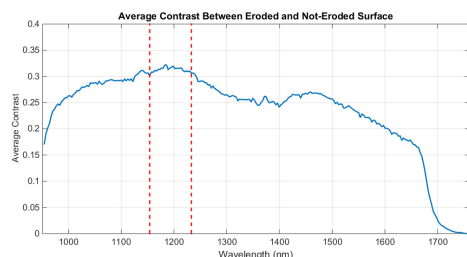
Figure 4: Average contrast between eroded and not-eroded surface

As the hyperspectral camera outputs 256 bands between 950nm and 1800nm before any further processing is performed, it was necessary to determine what the optimal bands to use were. This was done by manually selecting a region of eroded and non-eroded surface. The difference

between each eroded and non-eroded surface was calculated, an average was taken and this was performed for each band. It was found that the bands between 1154nm and 1233nm were the best bands to use for the analysis, see Figure 4.

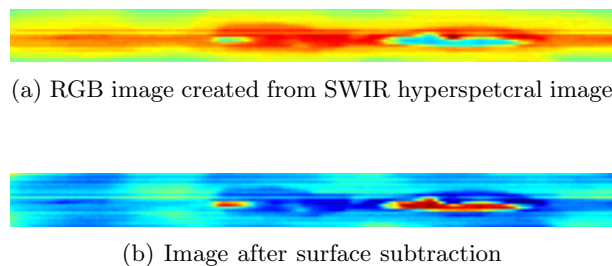
To try and improve the contrast of the images, the surface of the wind turbine blade was assumed to have the geometry of a circular pipe. This profile was then subtracted to flatten the image. This increased the contrast between the eroded and non-eroded surface and the results are shown in Figure 5.

Figure 5: Image after surface subtraction

Having compared the processed results, see Figure 5, to the high resolution camera, see Figure 3 it is clear that there is more detail shown from the hyperspectral images. Specifically the depth of the erosion indicated by the intensity of the image. However for field applications such as condition monitoring this added information is not necessarily useful. Currently the damage is classified into four main categories using standard imaging techniques it is possible to do this therefore for this application hyperspectral imagery may not be necessary. However there are many other applications for the technology in this field.
