Capacitive Imaging of Impact Damage in Composite Material

Maxim Morozov, William Jackson and S.G.Pierce

Department of Electronic and Electrical Engineering, University of Strathclyde

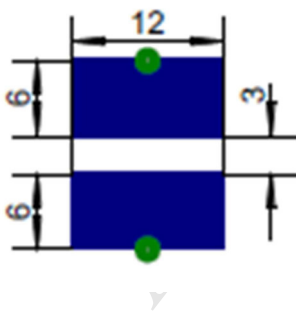
Figure 2. Drawing of the capacitive probe

The capacitive probe consisted of two coplanar rectangular electrodes parallel to the sample surface, as shown in Figure 2. An impedance analyser Agilent 4395A was used to measure impedance variation (series resistance and series capacitance) of the coplanar capacitor in the range of swept excitation frequencies from 100kHz to 500MHz. The CI probe was moved above sample surface in a stepwise motion utilising a XYZ scanner. The scanned area was 70mm × 70mm. The steps were 1mm in X and 2mm in Y directions.

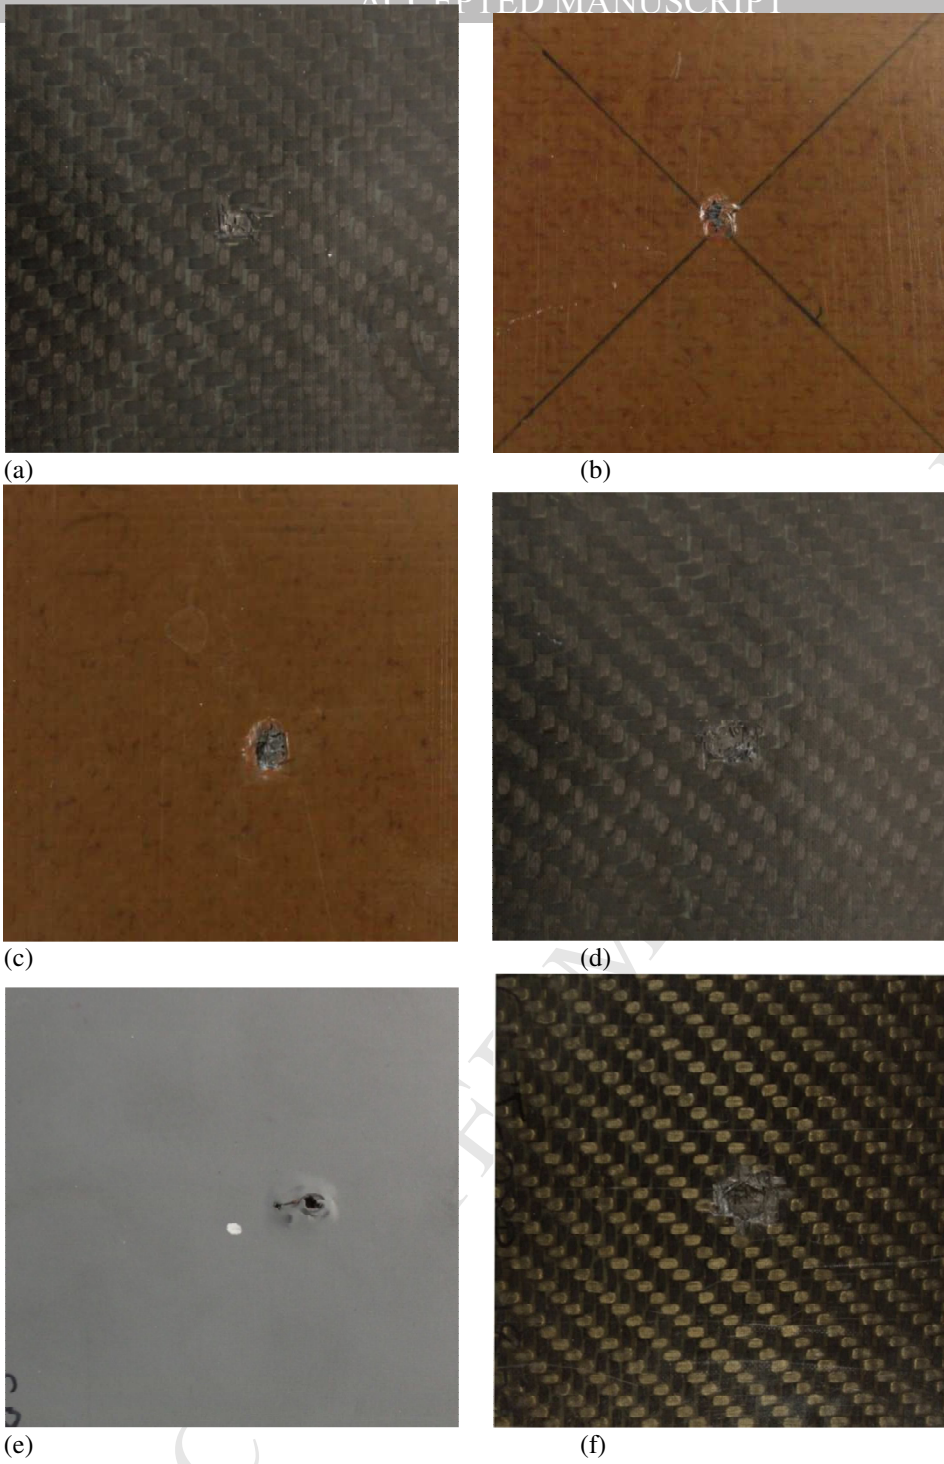
Figure 1. Photographs of the CFRP samples, impact side: (a) IG4J-08A, (b) IG4Q-04H, (c) IG4Q-04N, (d) IG4J-08G, (e) IG4A-01C, (f) IG4J-08B

Samples represented square slabs of woven fabric CFRP with side of 100mm and thickness of 10mm. Each sample had 25 layers of twill weave fabric with alternating orientation. Three of the samples had a polymer film applied to the impact surfaces. Figure 1 shows photographs of the CFRP samples taken from the impact side. Table 1 shows impact energies for each sample. A woven fabric CFRP sample with drilled holes of 6mm diameter has been capacitively imaged for reference. Comparison of capacitive

images of drilled holes with those of impact damage demonstrated that CI of the latter reveals bigger area due to the subsurface damage than due to the visible impact dent.

Notice that samples (b), (c) and (e) which had polymer films on the impact surfaces (see Fig. 1) have peak amplitude backgrounds which differ from the rest of the samples due to reduced acoustic impedance on the interfaces with the films.

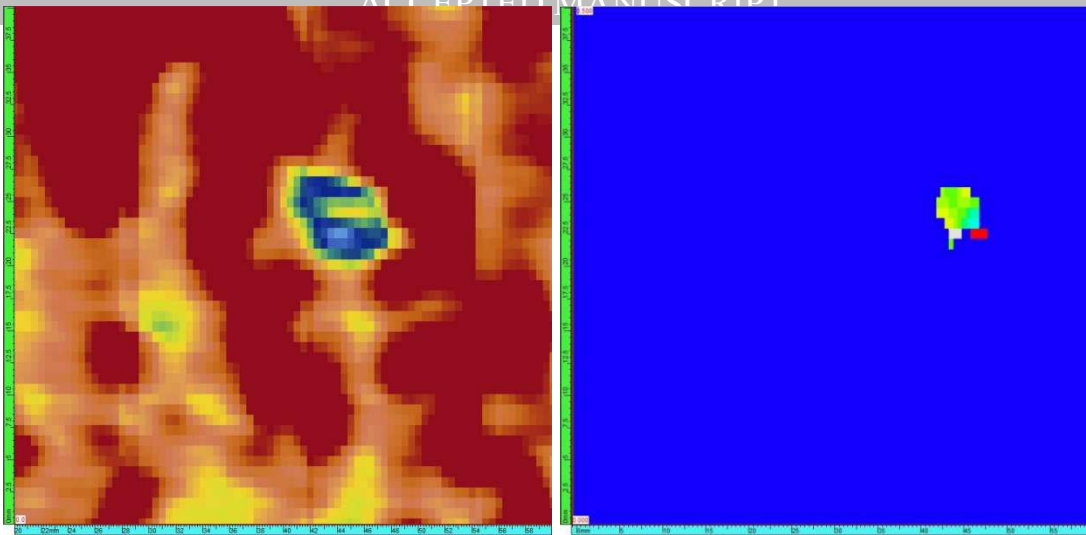
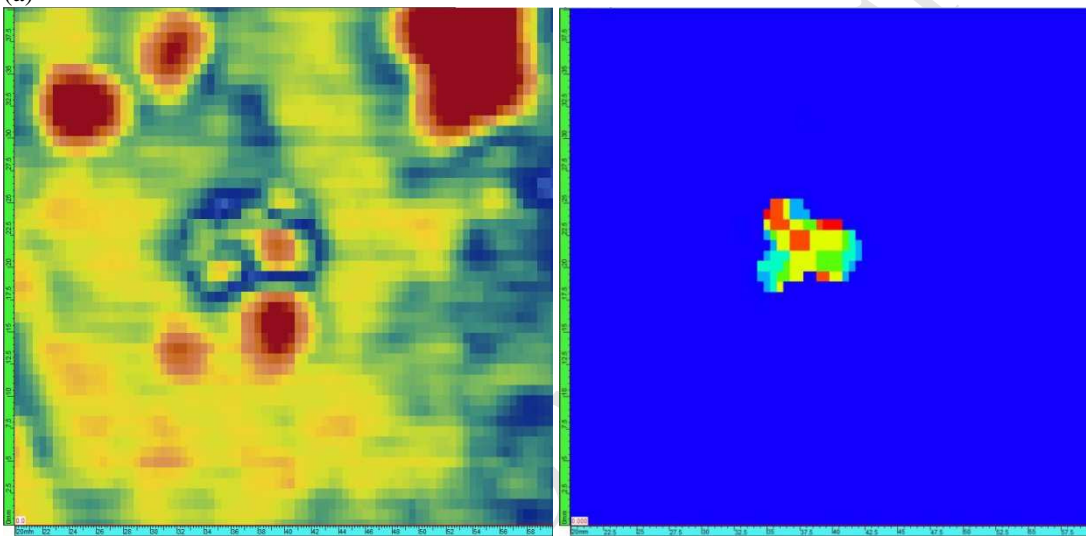
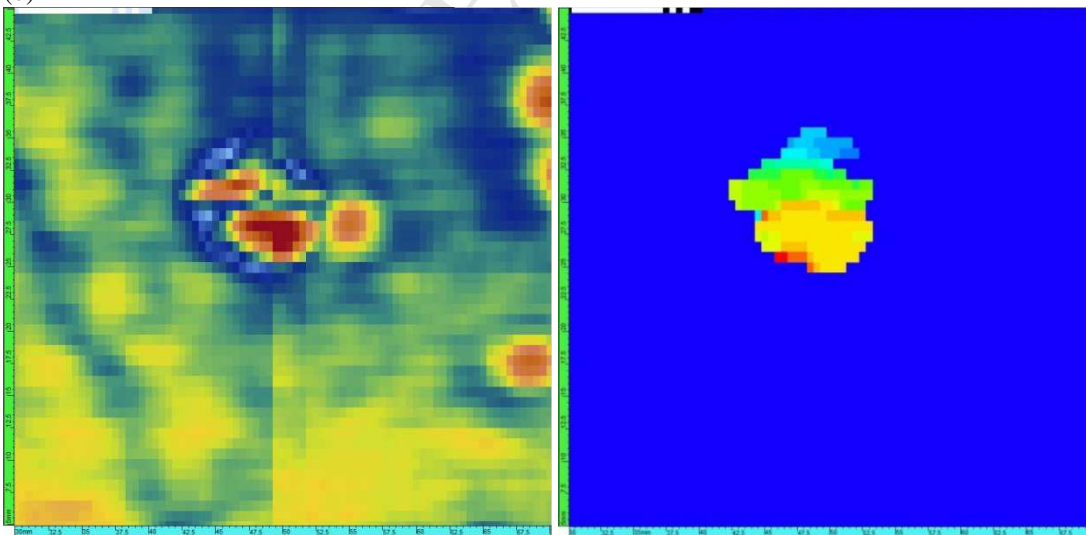
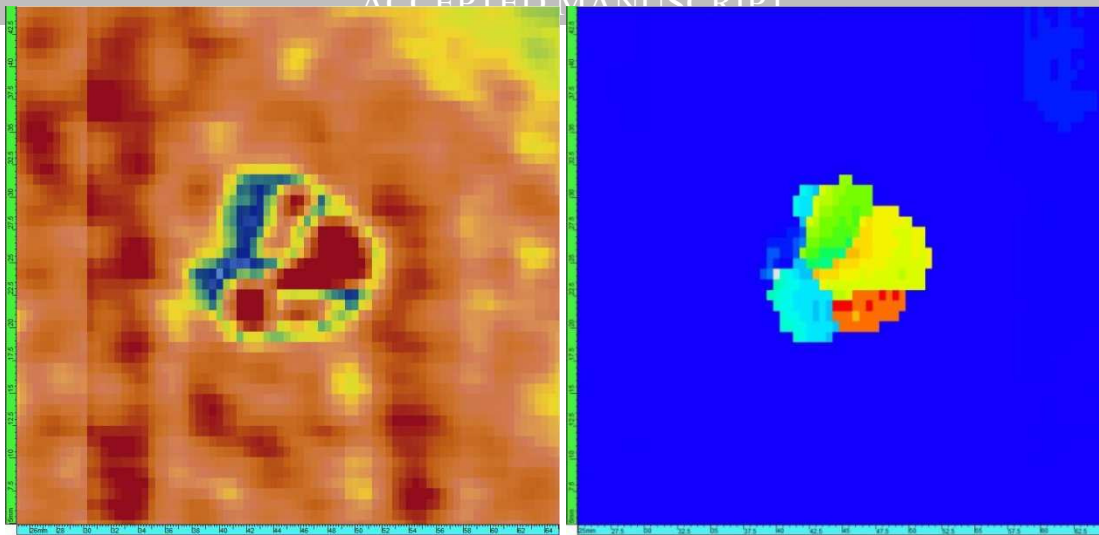
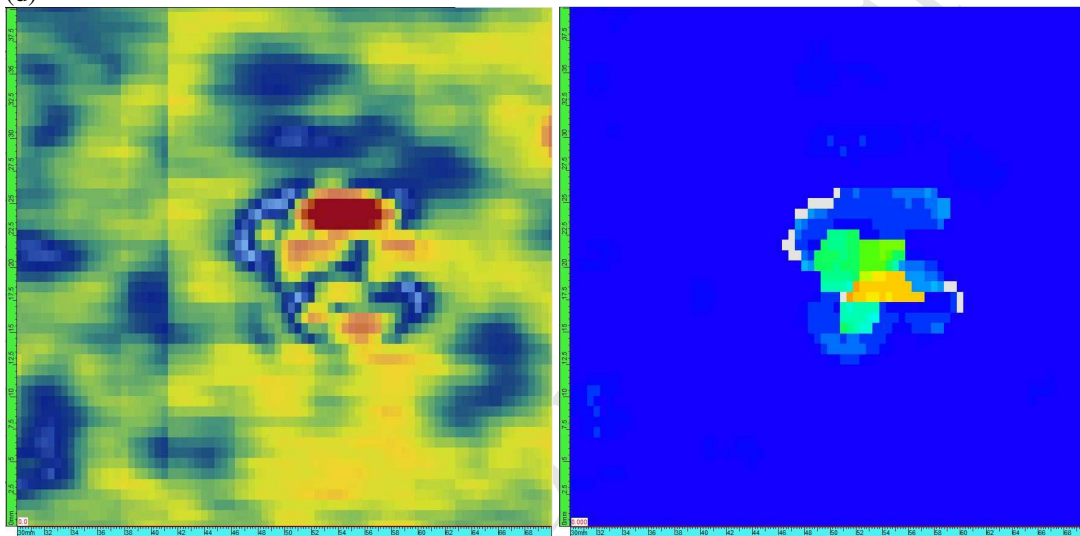
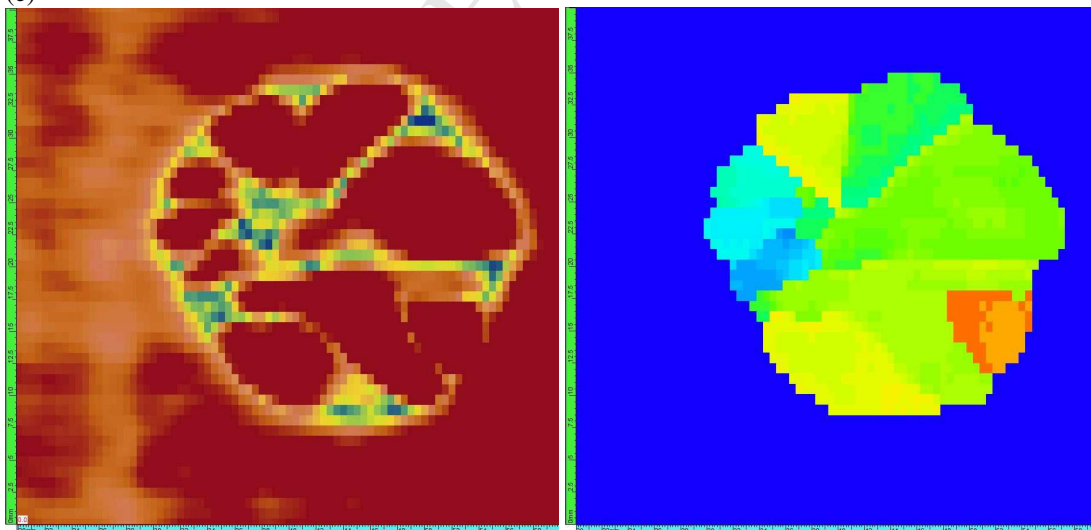
Figure 3. Ultrasonic C-scans (40mm X 40mm) of delamination due to impact in the CFRP samples, left column represents peak amplitude, right column represents thickness: (a) IG4J-08A, (b) IG4Q-04H, (c) IG4Q-04N, (d) IG4J-08G, (e) IG4A-01C, (f) IG4J-08B

Figure 3 shows ultrasonic C-scans of delaminations due to impacts in the CFRP samples acquired from the reverse sides of the samples. Areas of the C-scans are 40mm X 40mm. Left column represents peak amplitude and right column represents thickness C-scans. The delamination area grows with increasing impact energy.

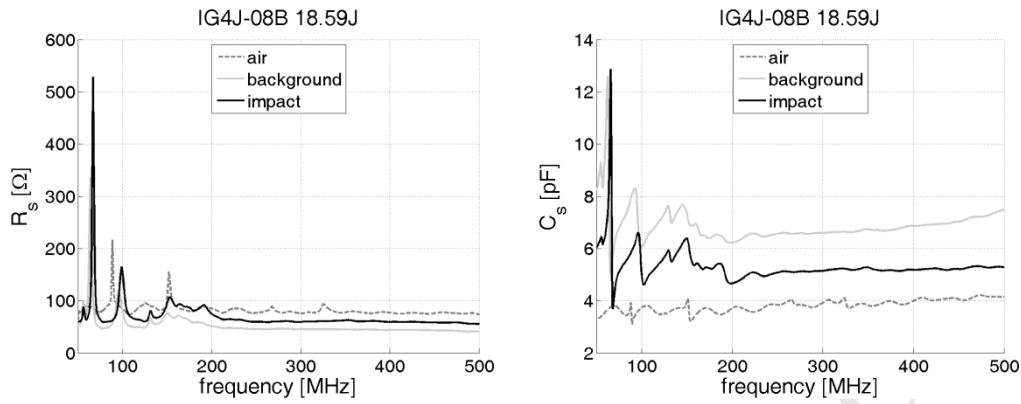
Figure 4. Frequency responses obtained in an undamaged location (background) and in the centre (impact) of sample IG4J-08B: (a) serial resistance, (b) serial capacitance

Responses of the CI transducer are obtained in form of a capacitor impedance $\underline{Z} = R_s + 1/j\omega C_s$, where R_s is the series resistance (real part), $\omega=2\pi f$, f being the excitation frequency, C_s is the series capacitance. Figures 4(a&b) show frequency responses obtained in an undamaged location (background) and in the centre (impact) of sample IG4J-08B: serial resistance and serial capacitance, respectively. As expected, capacitance between the coplanar electrodes increases with approach of a dielectric material. Resistance also increases due to eddy currents losses in the conductive carbon fibre. Multiple resonances can be observed between 100kHz and 200MHz. Certainly, the real electric circuit of the coplanar capacitor electromagnetically coupled with the CFRP material is much more complex than the simplified lumped component model consisting of series resistance and series capacitance assumed by the impedance analyser. Moreover, such a model depends on simplifying assumptions appropriate for a particular excitation frequency. The material structure of CFRP is very complex from the electromagnetic point of view [20, 22], carbon fibres insulated by resin represent a complex network of capacitances. Electrical contact between woven fibres effectively represents a network of mesoscopic coils in which eddy currents are induced. Moreover, taking into account that depth of penetration of electromagnetic field into the sample decreases with increasing frequency, it is obvious that at lower frequencies the capacitive transducer is electromagnetically coupled with thicker layer of CFRP.

However, evaluating the skin depth in CFRP is very challenging due to its inhomogeneous and anisotropic properties. Spectral analysis of CI response is a simple experimental way to determine appropriate excitation frequency of inspection of given material. Based on frequency responses shown in Figure 4 it can be concluded that stable capacitive images can be obtained above 200MHz, since capacitive images at or near resonance frequencies offer low sensitivity/resolution.

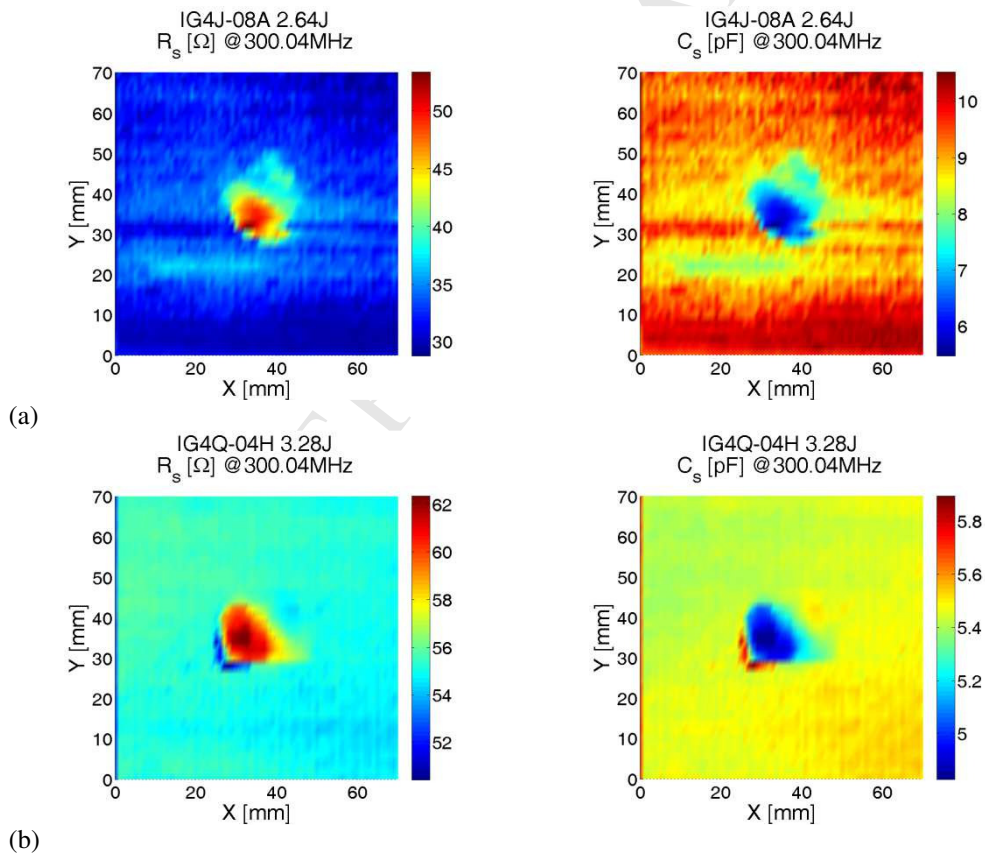
(f) Figure 5. Capacitive images of delamination due to impact in the CFRP samples acquired at 300.04MHz, left column represents serial resistance, right column represents serial capacitance: (a) IG4J-08A, (b) IG4Q-04H, (c) IG4Q-04N, (d) IG4J-08G, (e) IG4A-01C, (f) IG4J-08B

Figures 5(a-f) show capacitive images of delaminations caused by impact in the CFRP samples acquired at 300.04MHz, the left column representing series resistance and the right column representing series capacitance. For each sample a clear image of damage is obtained with the area of the defect response being much bigger than area of the visible flaw on the samples' surfaces caused by impact. The sizes of the impact damage signatures in the capacitive images are comparable with those shown in ultrasonic PA C-scans, Fig.3. This indicates that capacitive images of the impacted samples show signatures of subsurface defects, that is the delaminations. It has to be pointed out that the edges of impact dents were flat for the most of the samples, therefore the CI responses are not due to tilting of the transducer. Notice that samples (b), (c) and (e) which had polymer films on the impact surfaces (see Fig. 1) have background signals which differ from the rest of the samples due to different dielectric properties on the interfaces with the films.

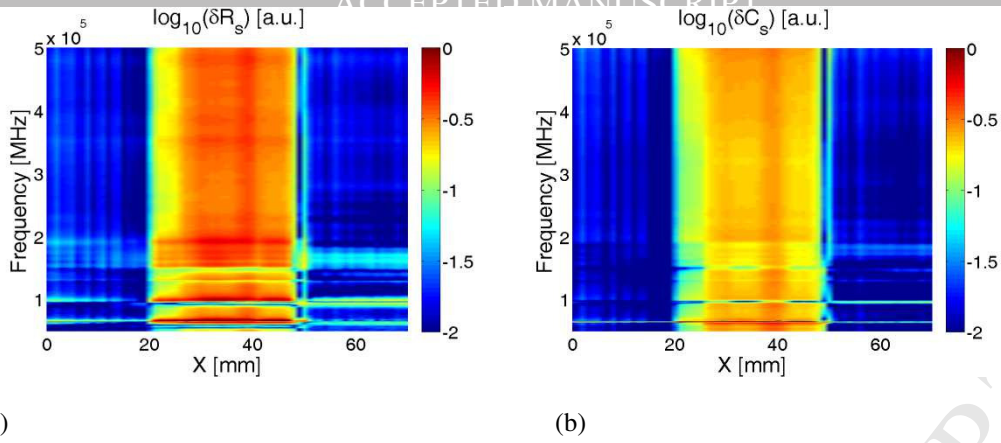
Figure 6. Spectrograms obtained along a single line scan in X direction across sample IG4J-08B at Y = 35mm (B-scans): (a) relative difference serial resistance, (b) relative difference serial capacitance

Figures 6(a&b) show spectrograms obtained along a single line scan in X direction across sample IG4J-08B at Y = 35mm (B-scans): relative difference serial resistance and relative difference serial capacitance, respectively. A spectrogram is a 2D representation of the spectrum of frequencies in the CI response as they vary with the scan distance across a sample. Top of a spectrogram (highest frequency) corresponds to the sample surface due to the skin depth. Figures 7(a&b) illustrate line scans obtained along a single line scan in X direction across sample IG4J-08B at Y = 35mm at three

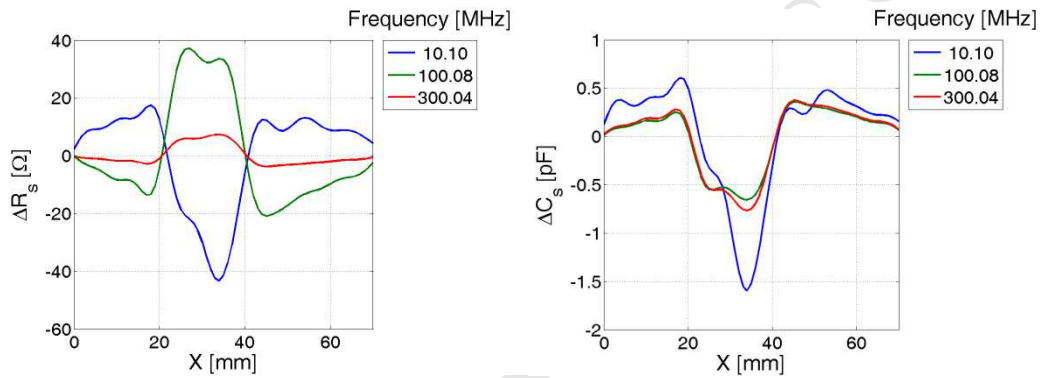
Figure 7. Line scans obtained along a single line scan in X direction across sample IG4J-08B at Y = 35mm at three selected frequencies: (a) absolute difference serial resistance, (b) absolute difference serial capacitance

selected frequencies: absolute difference serial resistance and absolute difference serial capacitance, respectively.

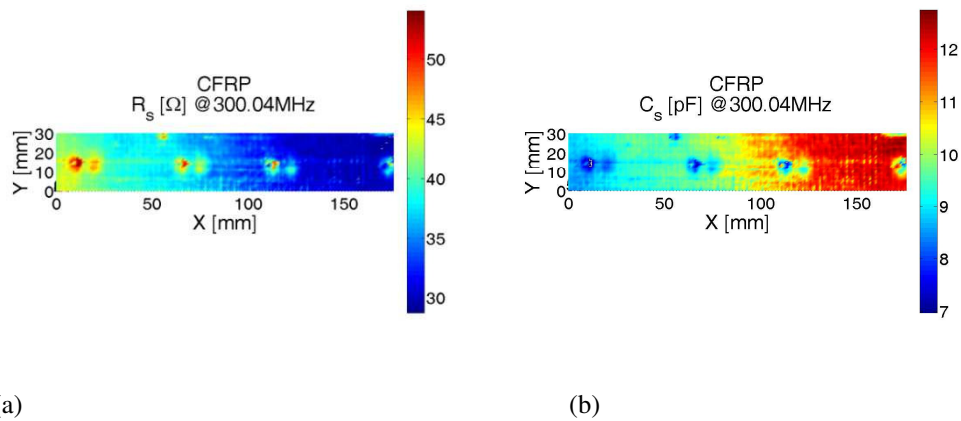
Figure 8. Capacitive images of drilled holes in a CFRP slab: (a) serial resistance, (b) serial capacitance

Figures 8(a&b) show capacitive images of drilled holes in a CFRP slab: serial resistance and serial capacitance, respectively. The holes had diameters of 6mm, which roughly correspond to the size of the biggest impact dent in Figure 1(f). The CI signatures of the drilled holes have diameter of circa 6mm at half height. This confirms conclusion that capacitive images of the impacted samples show signatures of subsurface defects, that is delaminations.
