Ultrasonic Imaging of Electrofusion Welded Polyethylene Pipes Employed in Utilities Industry

Abstract

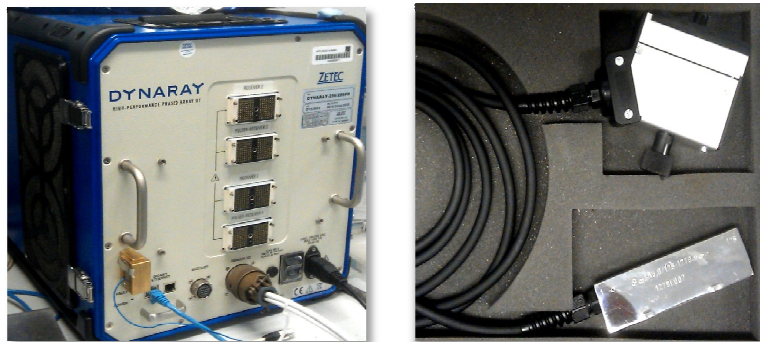
Figure 3: (Left) Zetec *Dynaray* phased array controller and (Right) Vermon 5MHz, 128 element probe

For the 110 mm coupling, the embedded heating wire has a diameter of 0.6 mm with a pitch 2 mm. An inspection wavelength that is less than the wire diameter would be expected to resolve the wires and any defects that appear between them. The velocity obtained in the ultrasonic characterisation experiment presented in Section 2.2 was used to calculate the inspection wavelengths for different frequencies. A 5MHz probe which would result in a wavelength of approximately 0.4 mm in the sample at room temperature was considered a good trade-off between resolution and wave attenuation. The final inspection setup involved a 5MHz linear array with 128 elements, Zetec *Dynaray* Phased array controller (Shown in Figure 3) and a PC running the Zetec *Ultravision* software.

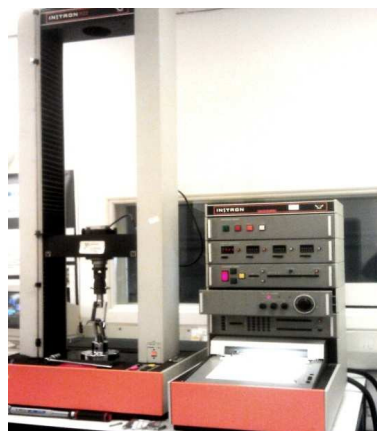
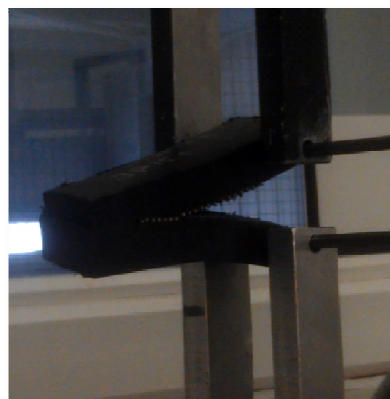
Figure 12: (Left) Instron tensile testing device (Right) Weld being pulled apart during destructive testing

Once the samples were ultrasonically inspected, they were destructively tested by the double cantilever cleavage test. Six rectangular sections of diameter approximately 20 mm were cut from each weld using a band saw, ensuring the pipe and coupling surfaces remained parallel to the axis formed by the weld interface. Two holes were drilled at the cold zone end – one through the coupling and the other through the pipe, to fit metal pins. The *Instron* tensile testing machine was used to pull the joint apart at a constant rate (See Figure 12), with data being logged for the *Force/Displacement* value. From this data, the mean value for a weld is noted and used to determine weld strength.
