Developments of the Midwest Guardrail System for Standard and Reduced Post Spacing and in Combination with Curbs

Karla A. Polivka

**DEVELOPMENT OF THE *MIDWEST GUARDRAIL*
SYSTEM (MGS) FOR STANDARD AND REDUCED POST
SPACING AND IN COMBINATION WITH CURBS**

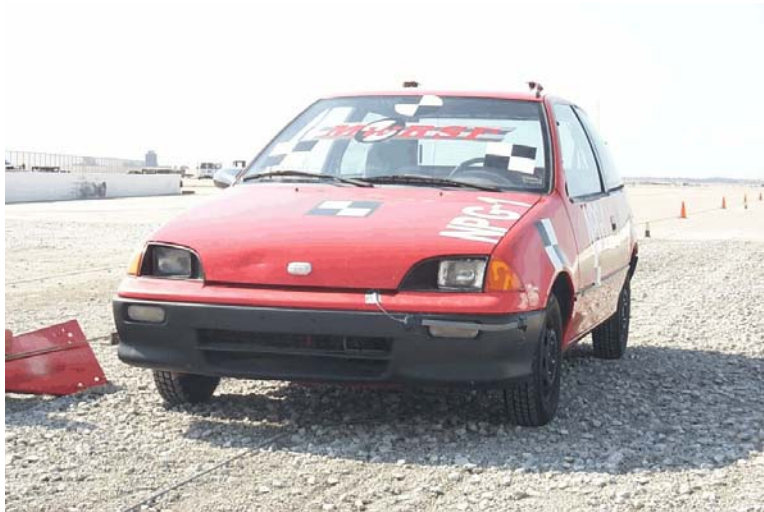
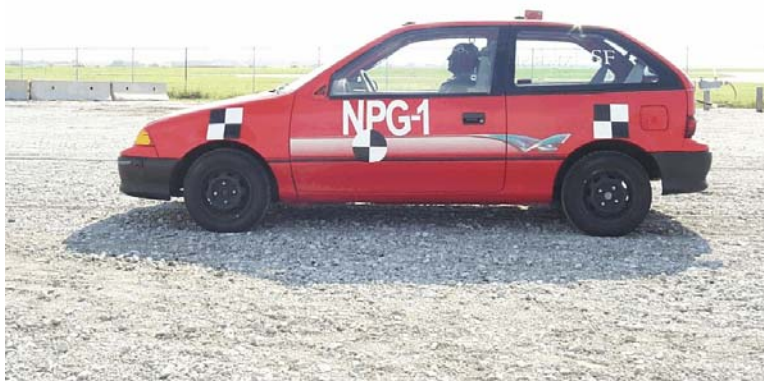
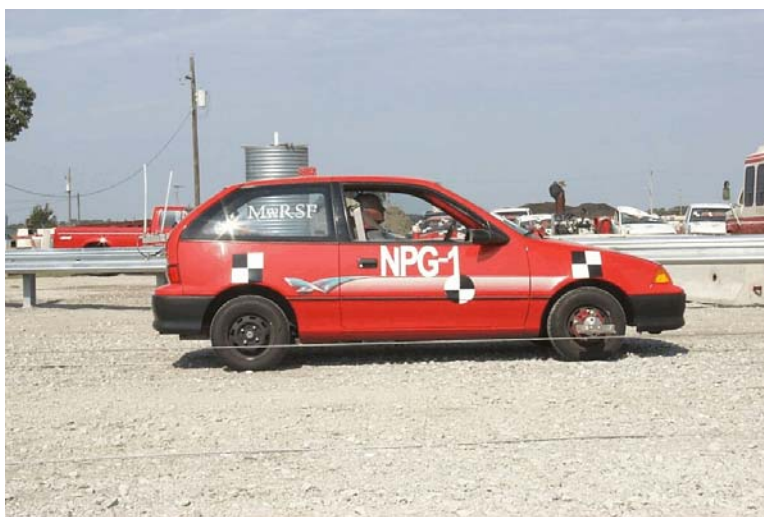
Figure 1. Test Vehicle, Test NPG-1

Date: 6/1/01 Test Number: NPG-1 Model: 820C
 Make: Geo Metro 2Dr. Vehicle I.D.#: 2C1MR2461R6771926
 Tire Size: 145/80 R12 Year: 1994 Odometer: 83315

static weights were 812 kg (1,790 lbs) and 887 kg (1,956 lbs), respectively. The test vehicle is shown in Figure 1, and vehicle dimensions are shown in Figure 2.

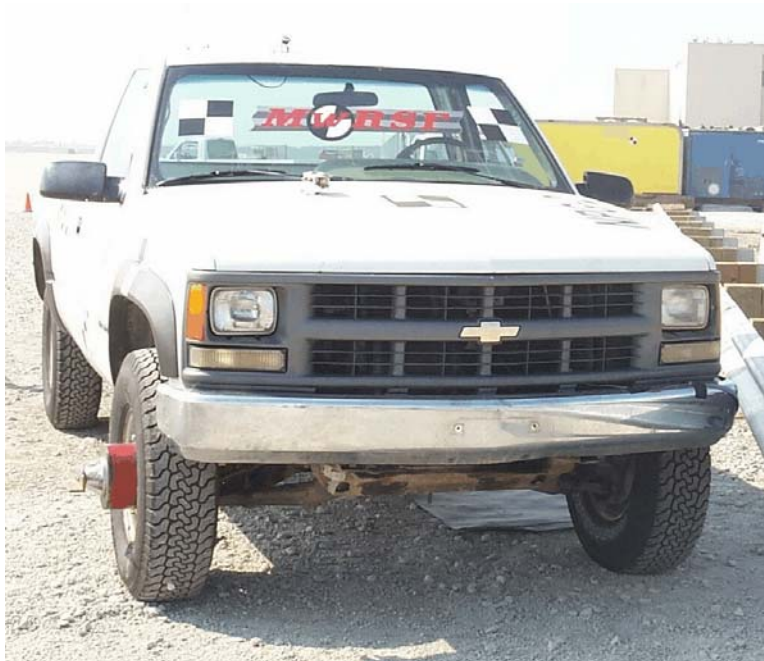
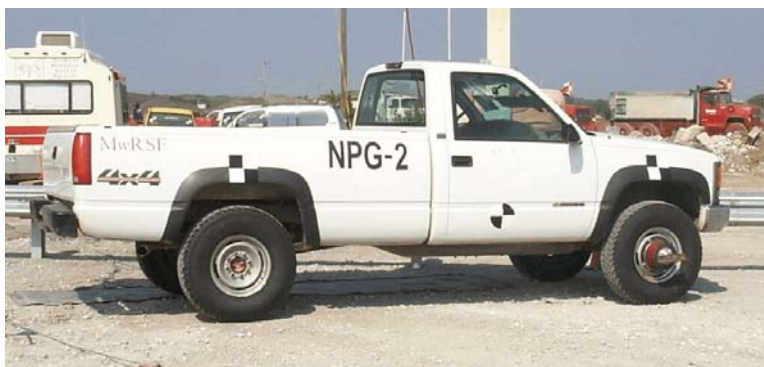
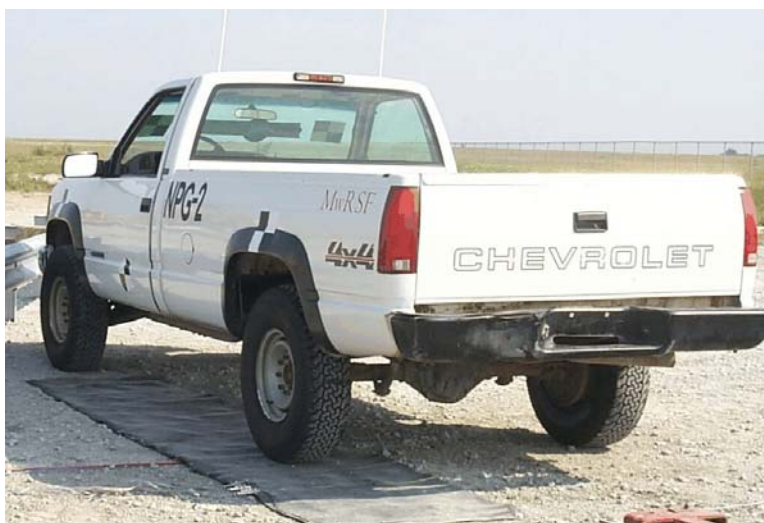
Figure 3. Test Vehicle, Test NPG-2

Date: 8/9/01 Test Number: NPG-2 Model: 2500
 Make: Chevrolet Vehicle I.D.#: 1GCGK24K25E103796
 Tire Size: 255/85 R16 Year: 1995 Odometer: 127172

For test NPG-2, a 1995 Chevrolet 2500 $\frac{3}{4}$ -ton 4-wheel drive pickup truck was used as the test vehicle. The test inertial and gross static weights were 2,241 kg (4,941 lbs). The test vehicle is shown in Figure 3, and vehicle dimensions are shown in Figure 4.

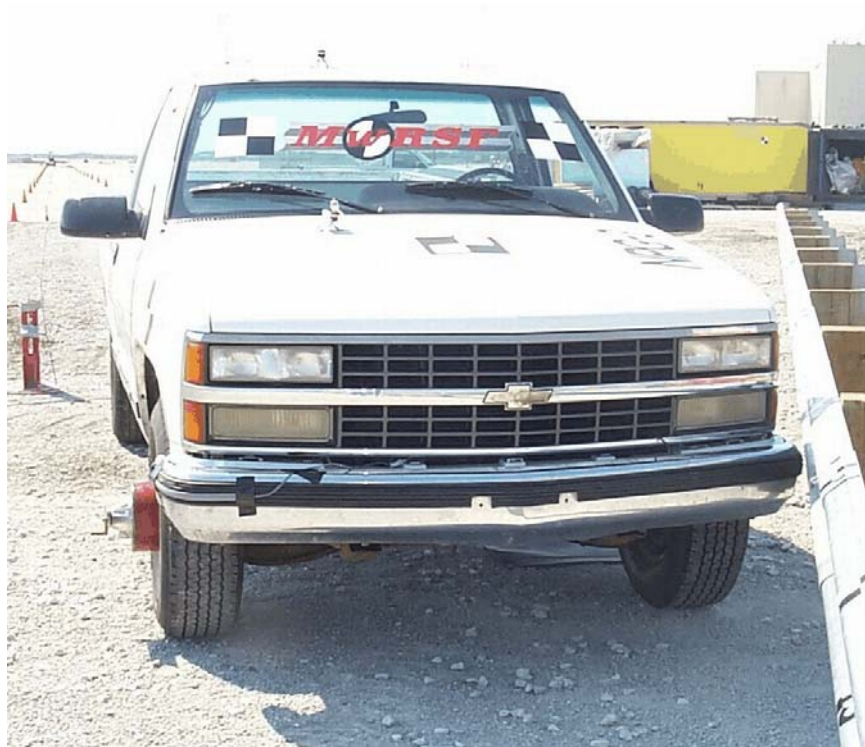
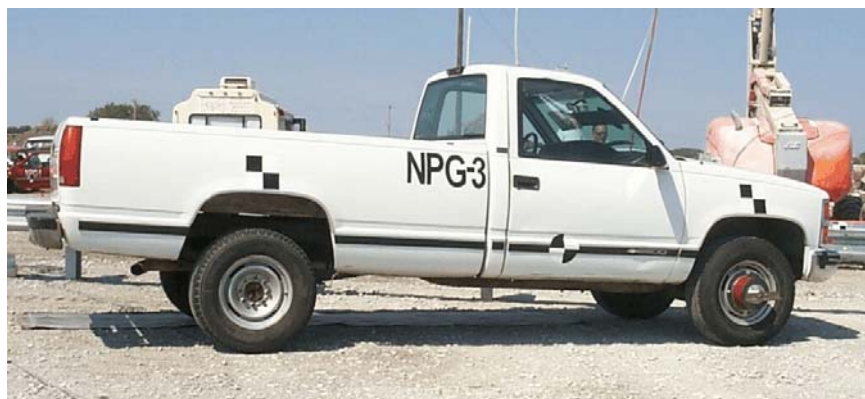
Figure 5. Test Vehicle, Test NPG-3

Date: 8/20/01 Test Number: NPG-3 Model: 2500
 Make: Chevrolet Vehicle I.D.#: 1CGGC24K35E148680
 Tire Size: 245/75 R16 Year: 1995 Odometer: 213433

For test NPG-3, a 1995 Chevrolet 2500 $\frac{3}{4}$ -ton pickup truck was used as the test vehicle. The test inertial and gross static weights were 2,037 kg (4,491 lbs). The test vehicle is shown in Figure 5, and vehicle dimensions are shown in Figure 6.

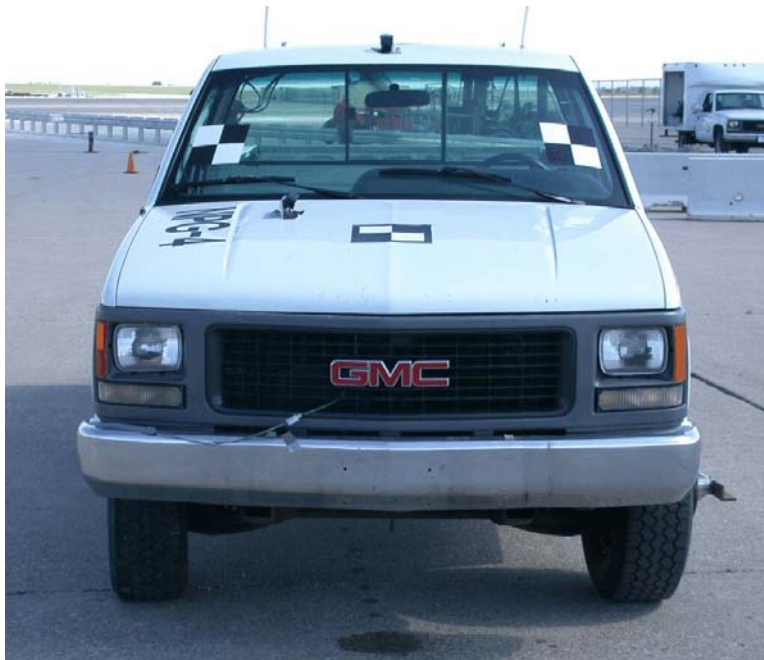
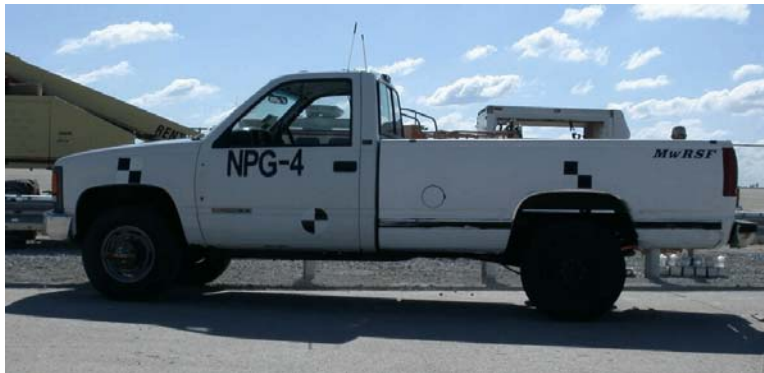
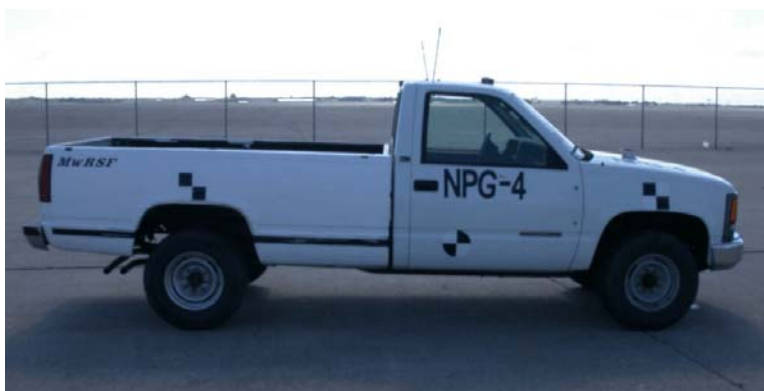
Figure 7. Test Vehicle, Test NPG-4

Date: 6/14/02 Test Number: NPG-4 Model: C/K 2500
 Make: GMC Vehicle I.D.#: 1GDGC24K15Z538097
 Tire Size: 245/75 R16 Year: 1995 Odometer: 253138

For test NPG-4, a 1995 GMC 2500 $\frac{3}{4}$ -ton pickup truck was used as the test vehicle. The test inertial and gross static weights were 1,986 kg (4,378 lbs). The test vehicle is shown in Figure 7, and vehicle dimensions are shown in Figure 8.

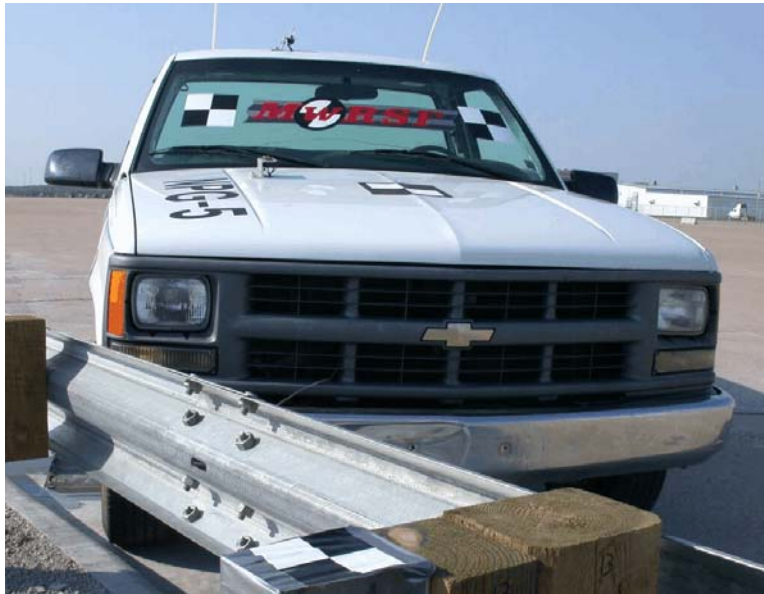
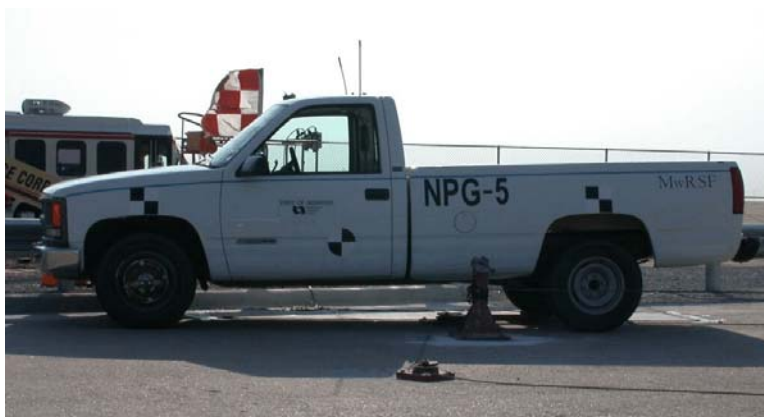
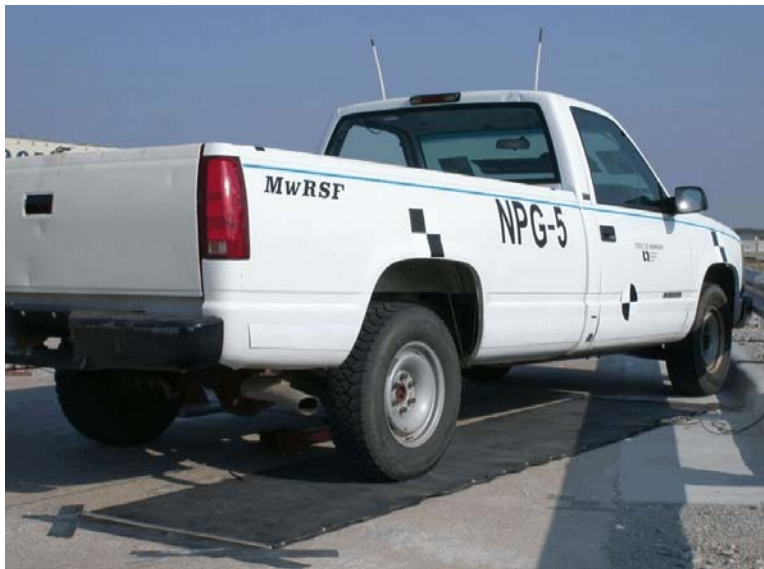
Figure 9. Test Vehicle, Test NPG-5

Date: 8/4/02 Test Number: NPG-5 Model: 2500
 Make: Chevrolet Vehicle I.D.#: 1GCFC24M9VZ164862
 Tire Size: LT225/75 R16 Year: 1997 Odometer: 144400

For test NPG-5, a 1997 Chevrolet 2500 $\frac{3}{4}$ -ton pickup truck was used as the test vehicle. The test inertial and gross static weights were 1,991 kg (4,389 lbs). The test vehicle is shown in Figure 9, and vehicle dimensions are shown in Figure 10.

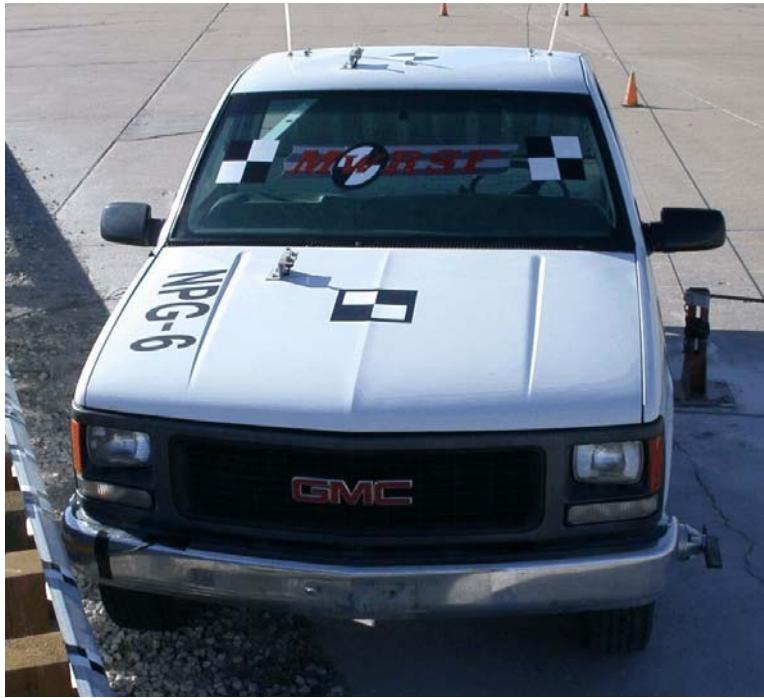
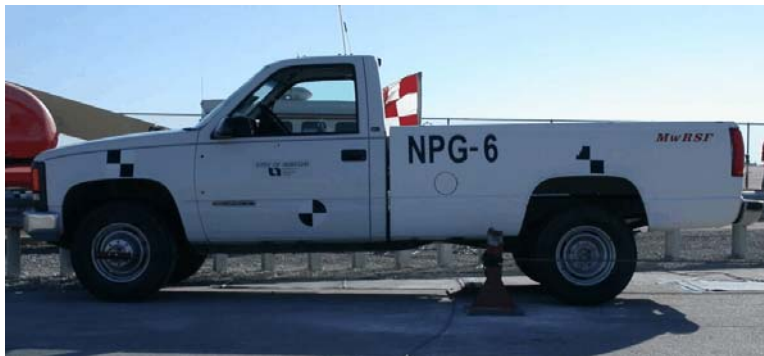
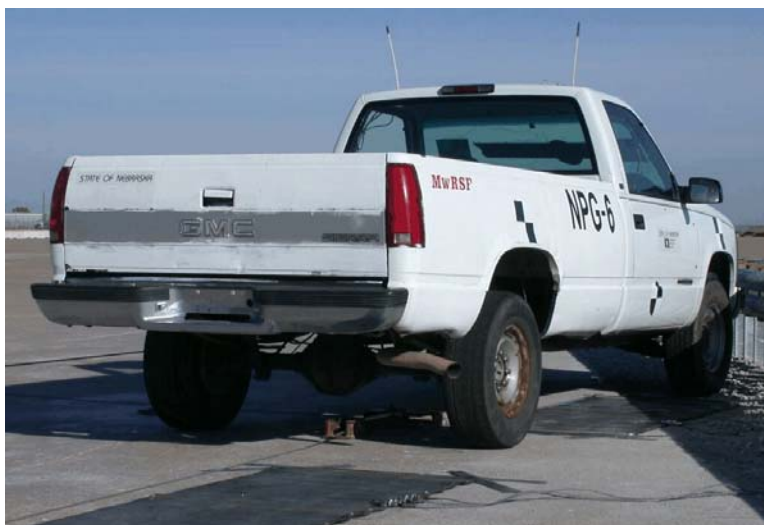
Figure 11. Test Vehicle, Test NPG-6

Date: 10/18/02 Test Number: NPG-6 Model: 2500
 Make: GMC Vehicle I.D.#: 1GDGC24R4VZ535003
 Tire Size: 245/75 R16 Year: 1997 Odometer: 268475

For test NPG-6, a 1997 GMC 2500 $\frac{3}{4}$ -ton pickup truck was used as the test vehicle. The test inertial and gross static weights were 2,001 kg (4,411 lbs). The test vehicle is shown in Figure 11, and vehicle dimensions are shown in Figure 12.

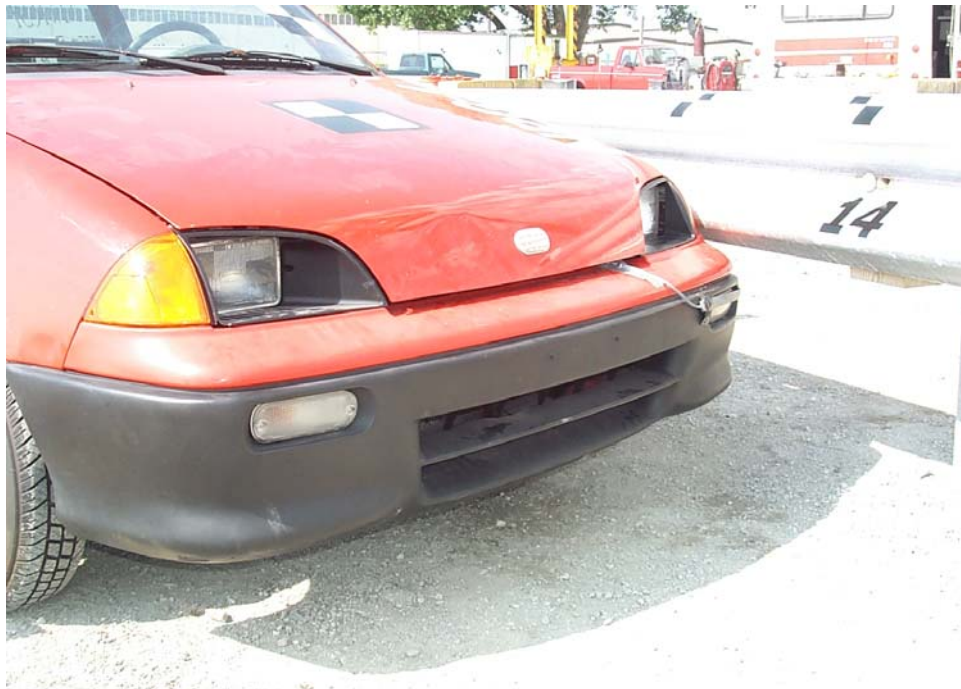
Figure 27. Front of Vehicle vs. Guardrail Height

respectively. Higher mounting heights would require deeper blockouts to minimize the chances for severe snagging on the guardrail posts. As shown in Figure 27, increasing the height of the guardrail above 657 mm (25 7/8 in.) to the center would become a major concern for bullet-nosed vehicles that might dive under the rail.

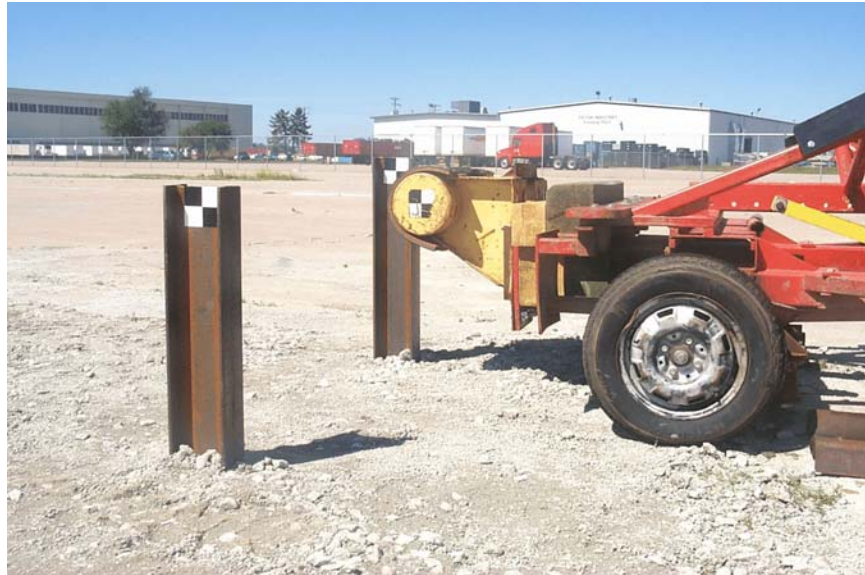
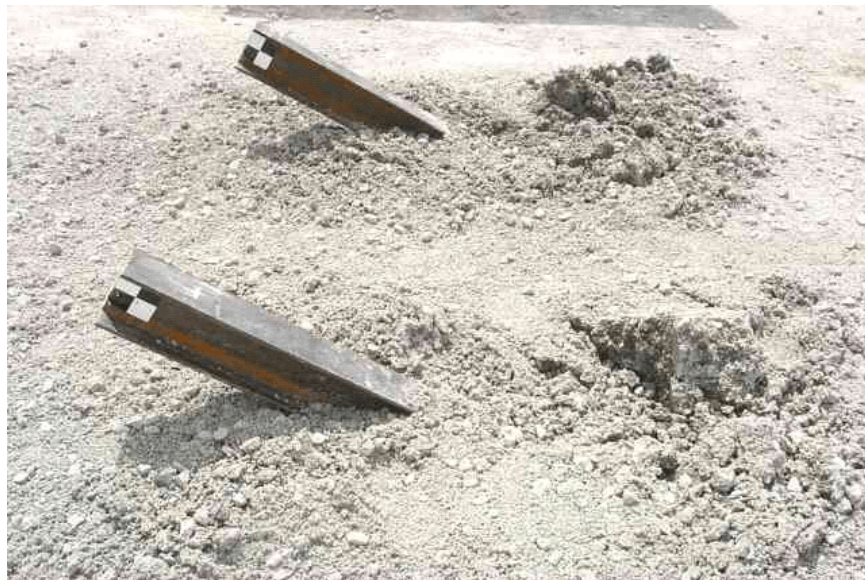
Figure 28. (a) Typical Installed Post for Bogie Tests, (b) Typical Post-Soil Behavior

A total of ten dynamic bogie tests were performed on the embedded steel posts. Actual impact conditions, post embedment depths, and test results for the tests are provided in Table 3. All steel posts were impacted perpendicular to the front face of the posts or about the post's strong axis of bending, as shown in Figure 28. Typical post and soil deformations following two bogie tests are provided in Figure 28. Typical force-deflection curves for the steel posts embedded 1,016 mm (40 in.) into the soil are provided in Figure 29.

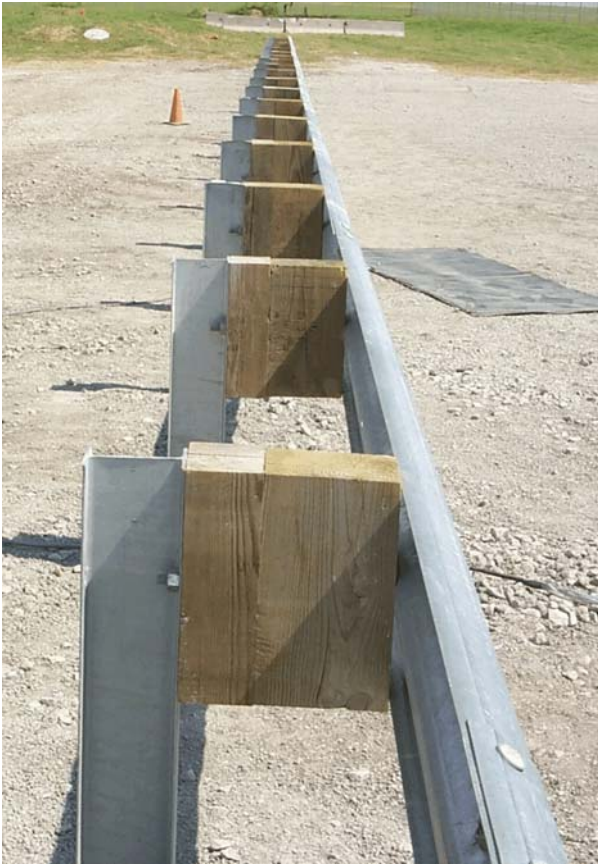
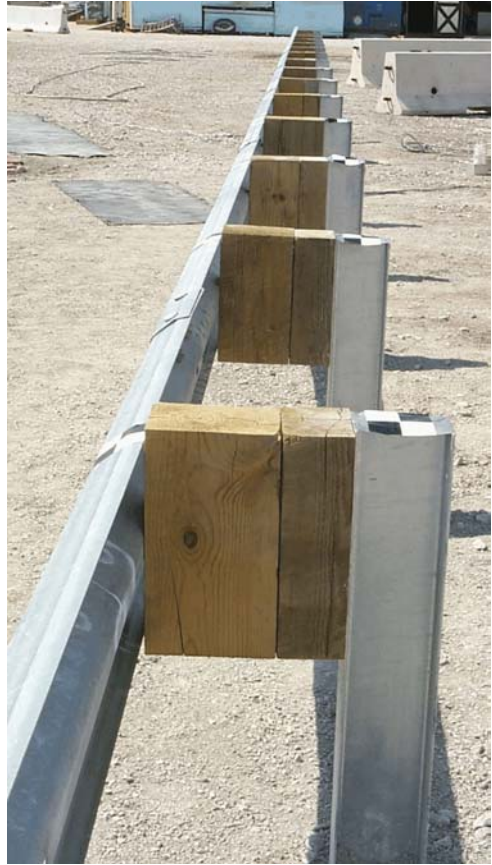
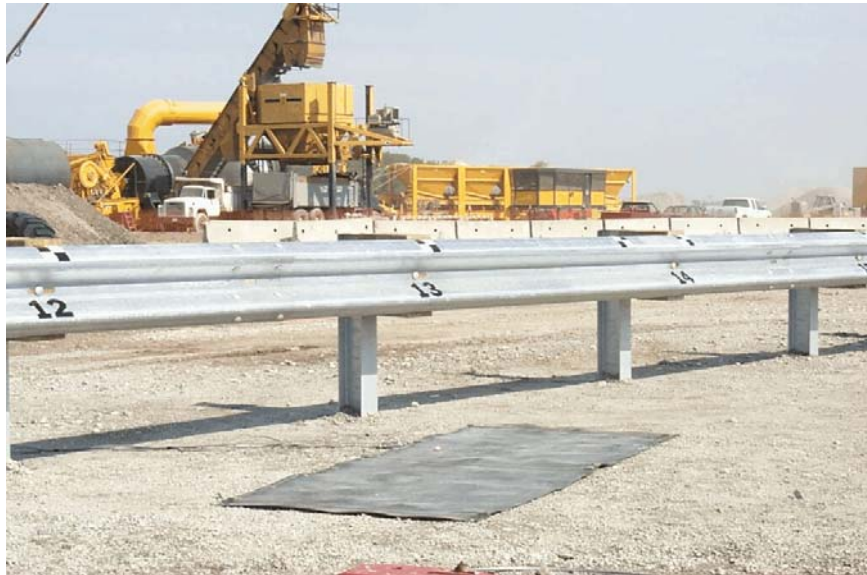
Figure 35. *Midwest Guardrail System* Maximum Height Tolerance

The test installation consisted of 55.25 m (181 ft - 3 in.) of standard 2.66-mm (12-gauge) thick W-beam guardrail supported by steel posts, as shown in Figure 30. Anchorage systems similar to those used on tangent guardrail terminals were utilized on both the upstream and downstream ends of the guardrail system. Design details are shown in Figures 30 through 34. Photographs of the test installation are shown in Figures 35 and 36.

787 mm (31 in.) and center mounting height of 632 mm (24 $\frac{7}{8}$ in.). The rail splices have been moved to the center of the span location, as shown in Figures 30, 35, and 36. In order to reduce rail/post attachment forces, the post bolt slots were increased to 102 mm (4 in.) in length. All lap-splice connections between the rail sections were configured to reduce vehicle snag at the splice during the crash test.

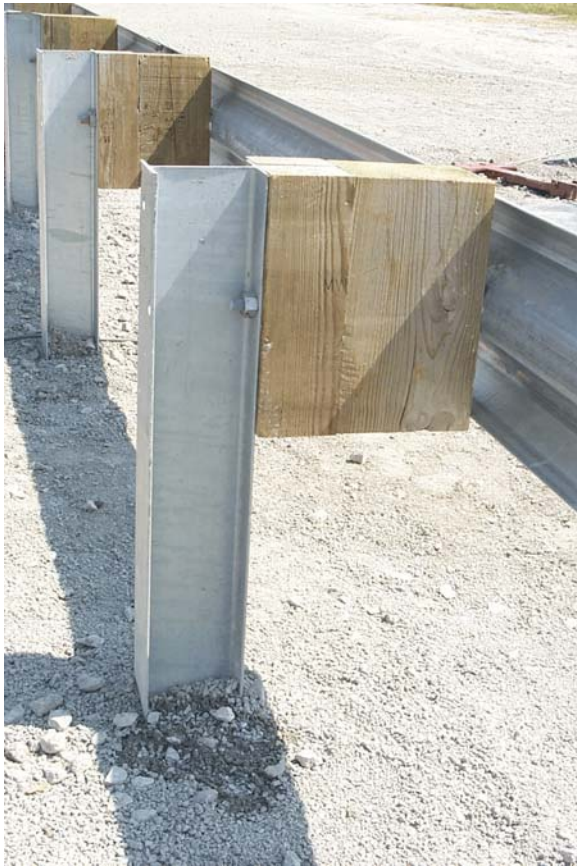
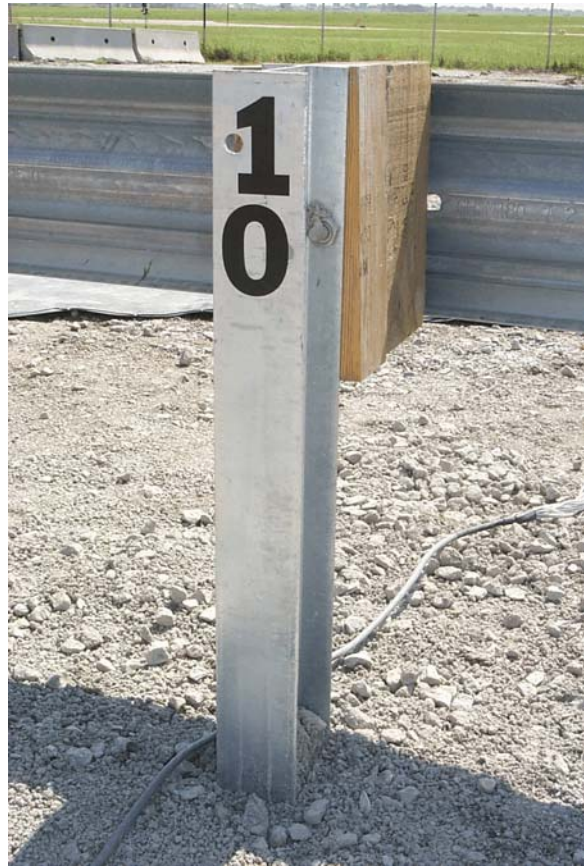
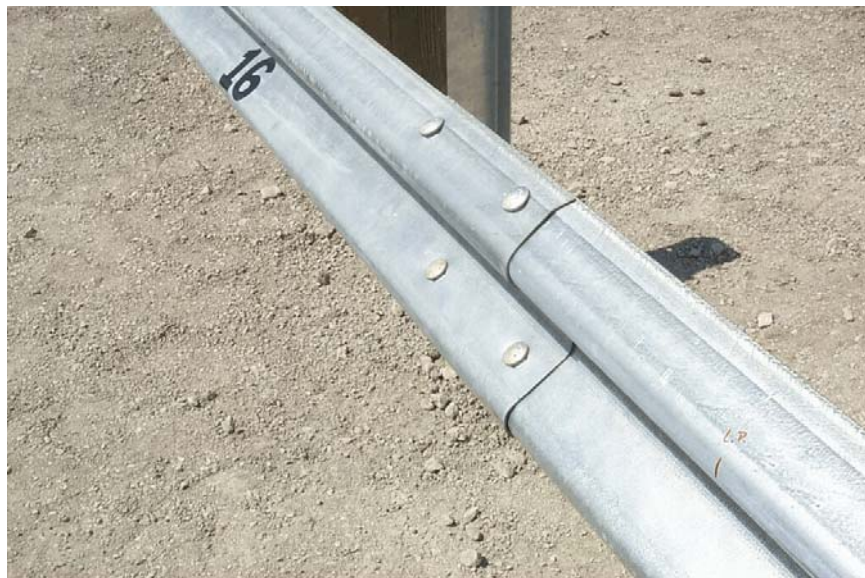
Figure 36. *Midwest Guardrail System* Maximum Height Tolerance

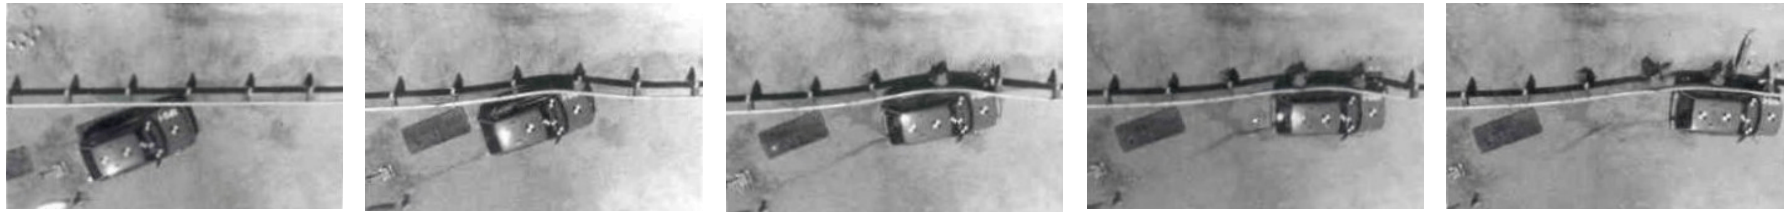
- Test Number NPG-1
- Date 6/29/01
- Appurtenance *Midwest Guardrail System*
 - Key Elements increased mounting height, blockout depth, and bolt slot length, mid-span splices

The *Midwest Guardrail System* (MGS) with standard post spacing was installed with the top guardrail height set to the design's maximum rail height tolerance. The 887-kg (1,956-lb) small car impacted the *Midwest Guardrail System* (MGS) with maximum height tolerance at a speed of 102.9 km/h (63.9 mph) and at an angle of 20.0 degrees. A summary of the test results and the sequential photographs are shown in Figure 37. The summary of the test results and sequential photographs in English units are shown in Appendix A. Additional sequential photographs are shown in Figure 38. Documentary photographs of the crash test are shown in Figures 39 and 40.

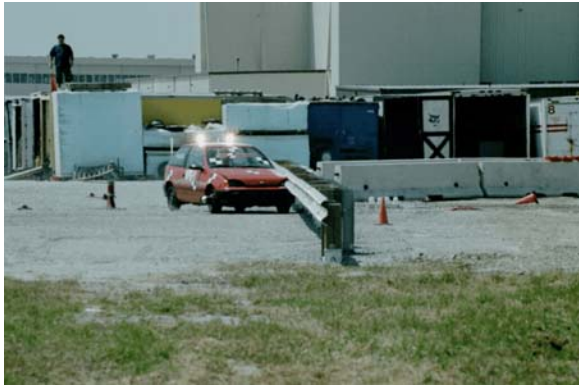
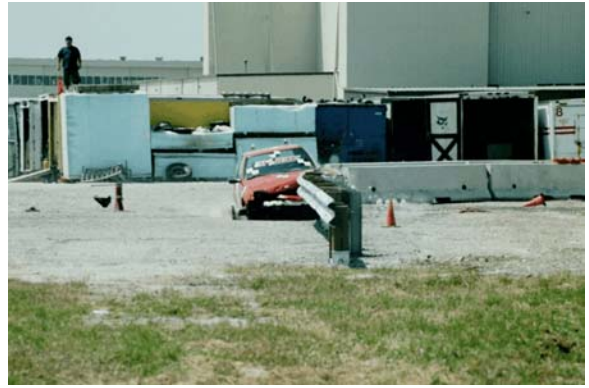
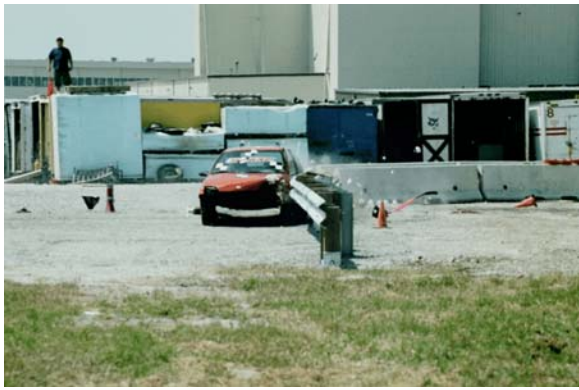
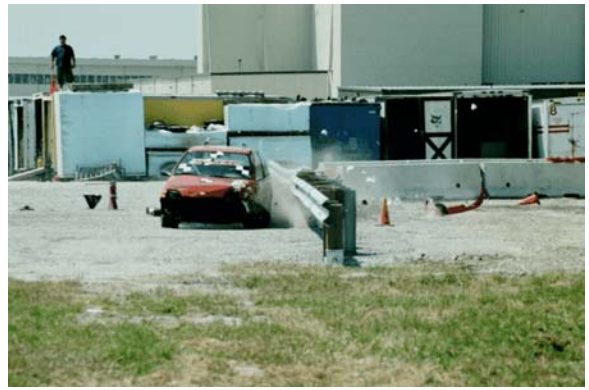
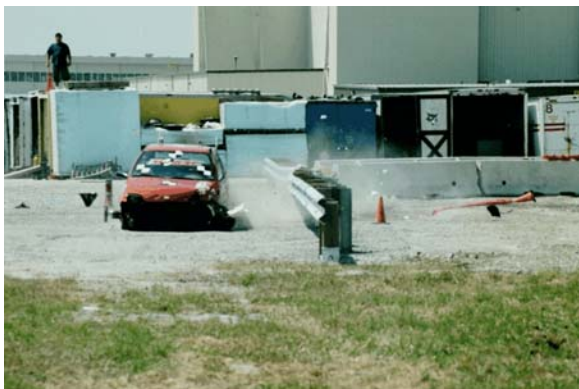
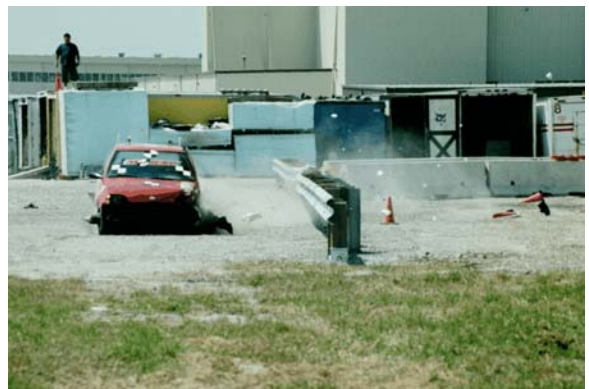
Figure 39. Documentary Photographs, Test NPG-1

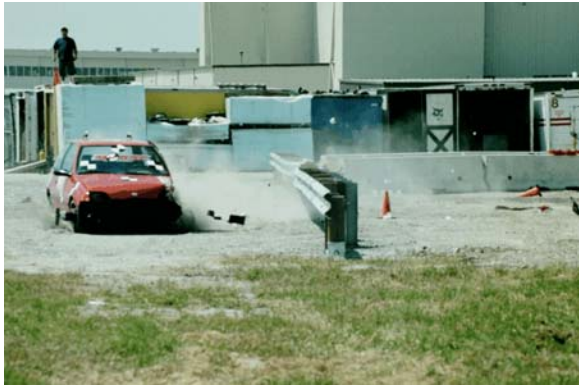
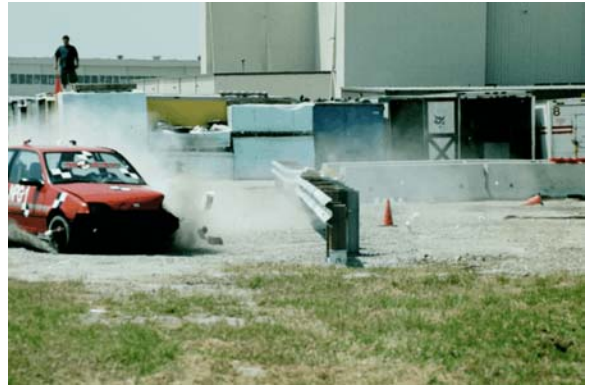
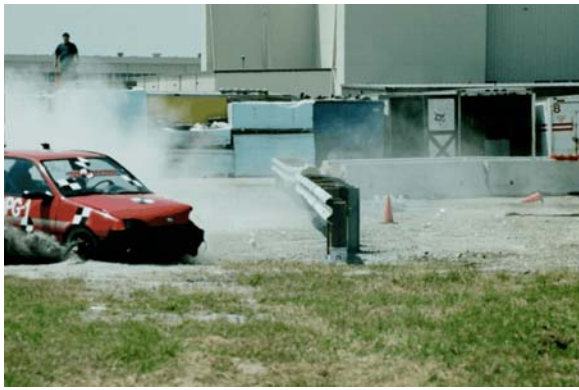
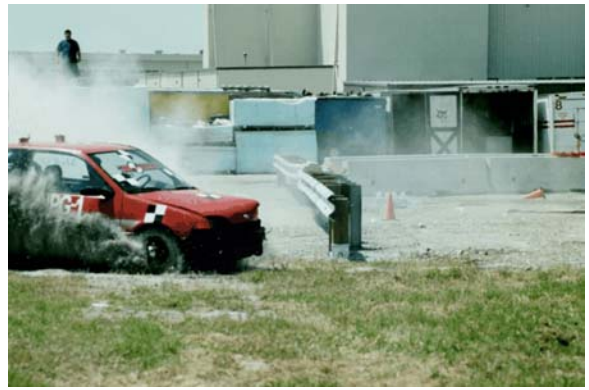
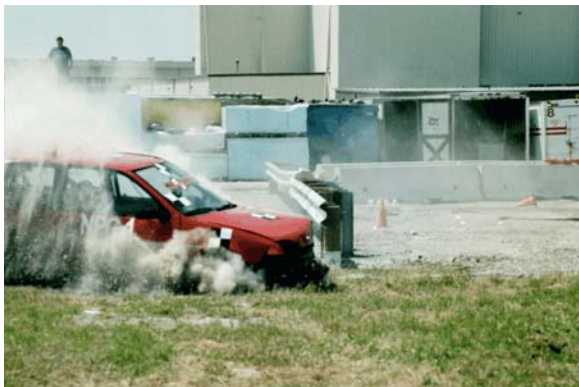
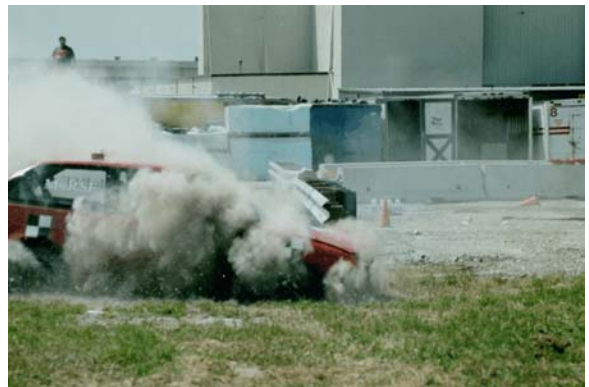
Figure 40. Documentary Photographs, Test NPG-1

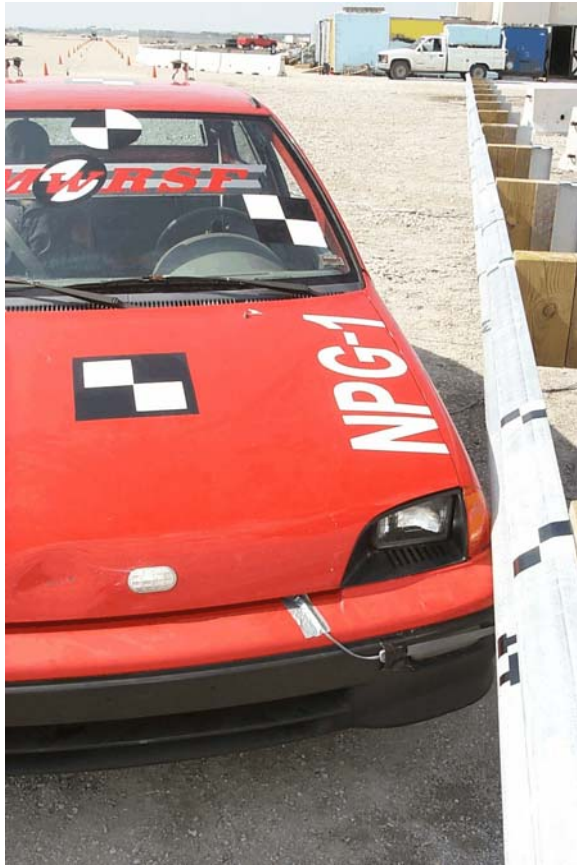
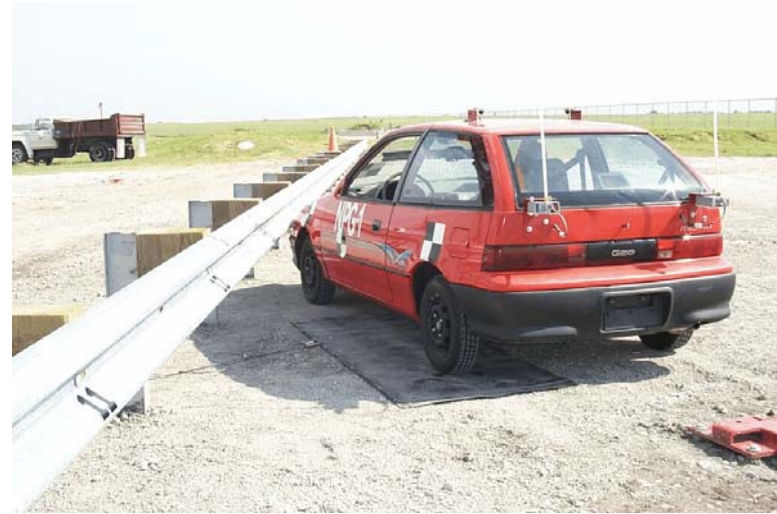
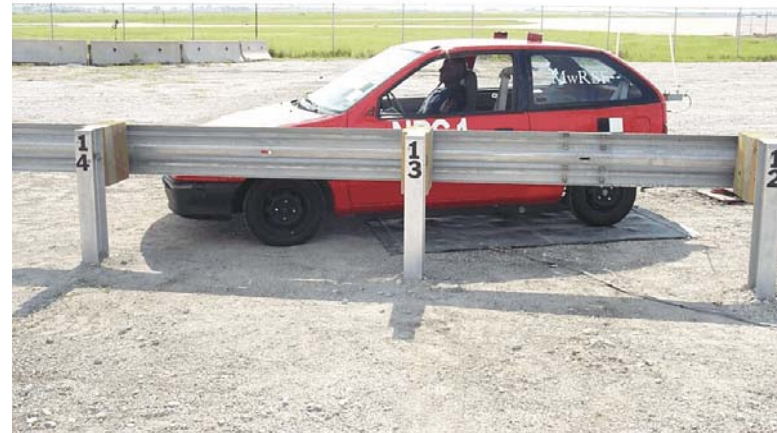
Figure 41. Impact Location, Test NPG-1

Initial impact was to occur between post nos. 13 and 14 or 1,461-mm (57 ½-in.) upstream from the centerline of the splice between post nos. 14 and 15, as shown in Figure 41. Actual vehicle impact occurred 1,562-mm (61 ½-in.) upstream from the centerline of the splice between post nos. 14 and 15. At 0.012 sec after initial impact, post no. 14 began to rotate backward. At 0.026 sec, post nos. 13, 15, and 16 began to rotate backward as the left-front corner of the vehicle protruded under the bottom of the guardrail. At 0.052 sec, the left-front corner of the vehicle crushed inward toward the engine compartment as post nos. 13 through 15 continued to rotate backward. At 0.080 sec, the left-front corner of the vehicle rolled away from the barrier system and contacted the wood blockout at post no. 15, causing it to rotate clockwise (CW) about the post bolt. At this same time, post no. 14 deflected downstream as it continued to rotate backward and post no. 17 began to rotate backward. At 0.106 sec, the guardrail released away from post no. 15. At 0.120 sec, the left-front corner of the vehicle contacted the wood blockout at post no. 16, causing it to rotate CW about the

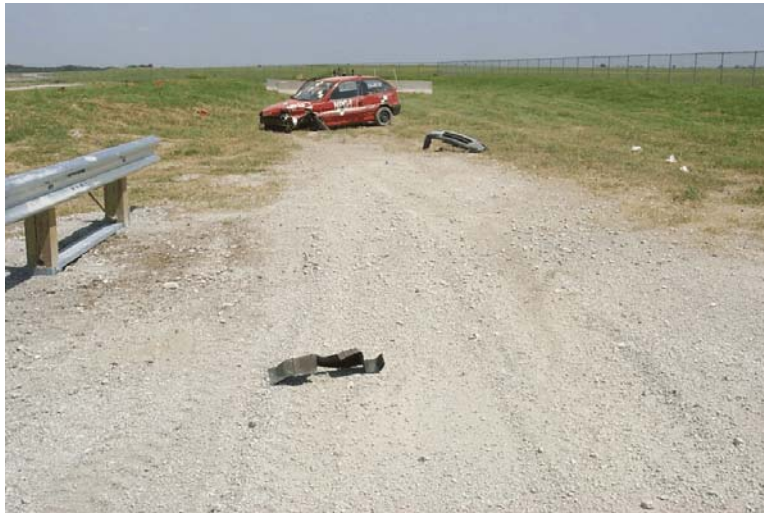
Figure 42. Vehicle Final Position and Trajectory Marks, Test NPG-1

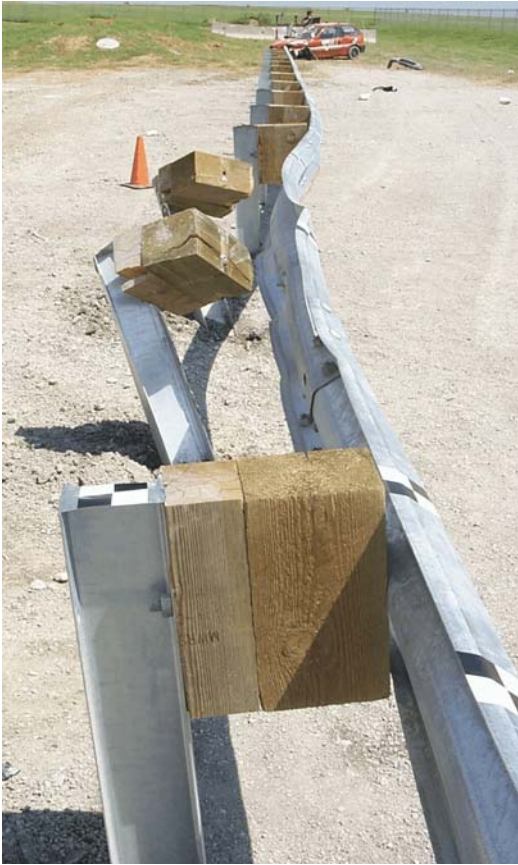
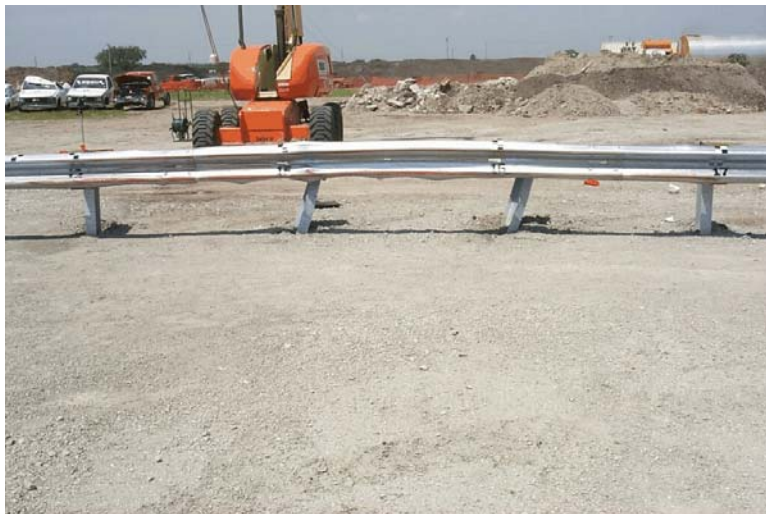
Figure 43. System Damage, Test NPG-1

Damage to the barrier was minimal, as shown in Figures 43 through 45. Barrier damage consisted of deformed W-beam and guardrail posts, contact marks on a guardrail section, and damaged wooden blockouts.

The guardrail damage consisted of moderate deformation and flattening of the impacted section of W-beam rail between post nos. 13 and 17. Contact marks were found on the guardrail between post nos. 13 and 17. A small tear was found on the downstream side of the post bolt slot

The permanent set of the guardrail and posts is shown in Figures 43 through 45. The maximum lateral permanent set rail and post deflections were 238 mm (9 $\frac{3}{8}$ in.) at the centerline of post no. 15 and 432 mm (17 in.) at post no. 15, respectively, as measured in the field. It should be noted that the rail was removed from this post. The maximum lateral dynamic rail deflection was 443 mm (17 $\frac{3}{8}$ in.) at the centerline of post no. 15, as determined from the high-speed film analysis.

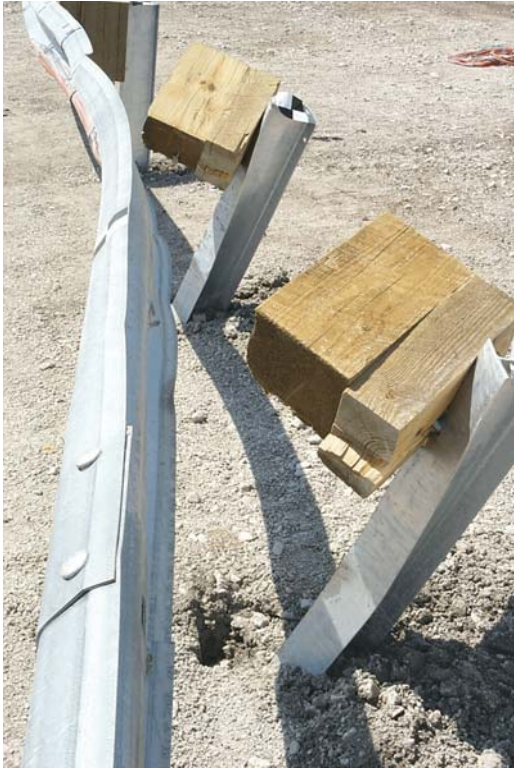
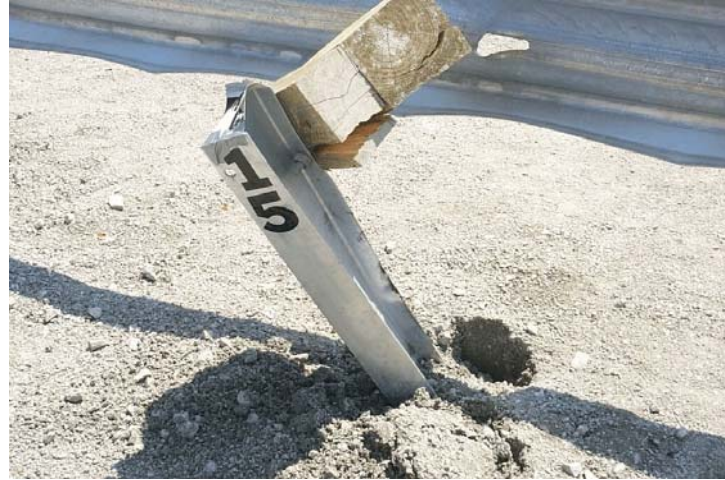
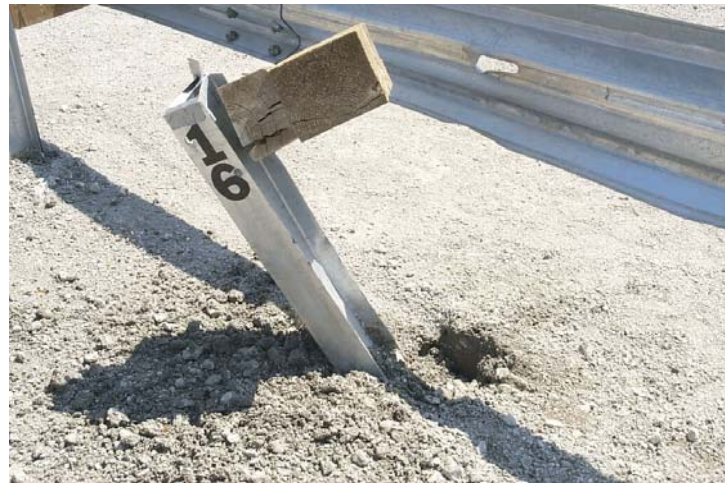
Figure 44. Post Nos. 15 and 16 Damage, Test NPG-1

Steel post nos. 3 through 12 were slightly twisted but did not encounter any rotational deflections. Post nos. 13, 14, 17, and 18 rotated backward slightly in the soil. Post nos. 15 and 16 rotated in the soil and bent laterally toward the ground. Contact marks were found on the front face of post nos. 15 and 16. Longitudinal splitting through the bolt holes was found on the wooden blockouts at post nos. 15 and 16. No significant post damage or movement occurred to post nos. 19 through 28, and the blockouts at post nos. 3 through 14 and 17 through 28 remained undamaged. The upstream and downstream anchorage systems slightly moved longitudinally, but the posts in both the upstream and downstream anchorage systems were not damaged.

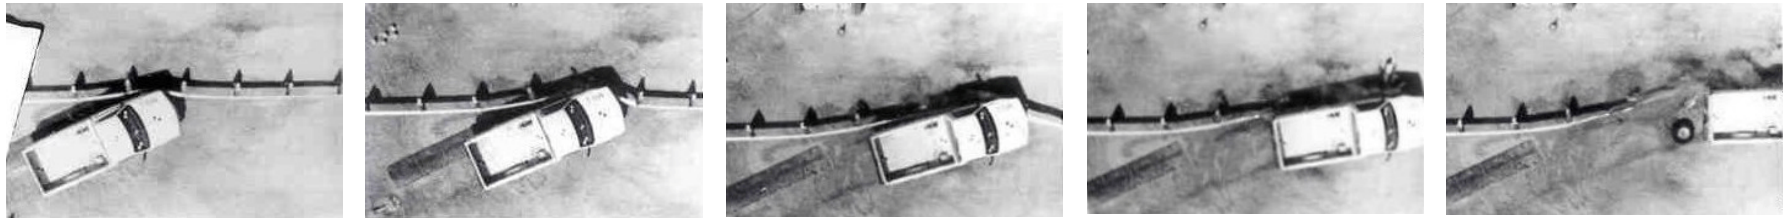
- Test Number NPG-2
- Date 8/9/01
- Appurtenance *Midwest Guardrail System*
 - Key Elements increased mounting height, blockout depth, and bolt slot length, mid-span splices

- Lateral (not required) 3.15 m/s
- Vehicle Damage Extensive
 - TAD³¹ 11-FFQ-3, L&T-4
 - SAE³² 11LFEW3, 00TDDO6
- Vehicle Stopping Distance 24.80 m downstream

- 1.52 m laterally behind
- Barrier Damage Extensive
- Maximum Deflections
 - Permanent Set NA
 - Dynamic NA
- Working Width NA

The *Midwest Guardrail System* (MGS) with standard post spacing was installed with the top guardrail height set to the design's nominal rail height. The developmental, non-compliant 2,241-kg (4,941-lb) 4x4 pickup truck impacted the *Midwest Guardrail System* (MGS) with nominal rail height at a speed of 99.0 km/h (61.5 mph) and at an angle of 24.7 degrees. A summary of the test results and the sequential photographs are shown in Figure 57. The summary of the test results and sequential photographs in English units are shown in Appendix A. Additional sequential photographs are shown in Figures 58 and 59. Documentary photographs of the crash test are shown in Figures 60 and 61.

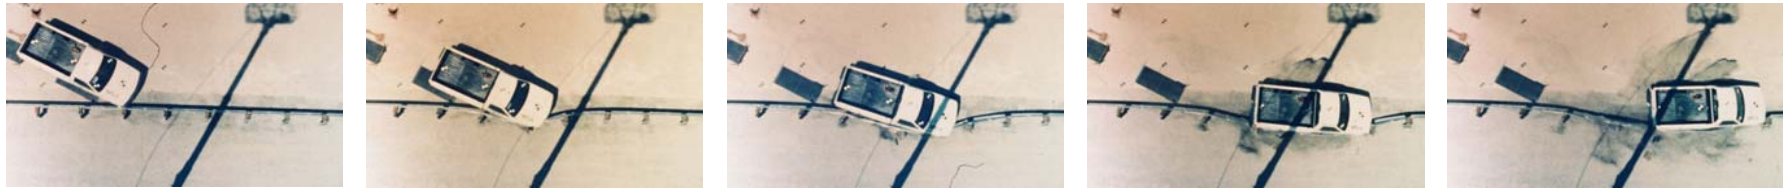
0.000 sec

0.101 sec

0.323 sec

0.446 sec

- Test Number NPG-4
- Date 6/14/02
- Appurtenance *Midwest Guardrail System*
 - Key Elements increased mounting height, blockout depth, and foundation tube length, mid-span splices
- Total Length 55.25 m
- Steel W-beam
 - Thickness 2.66 mm
 - Top Mounting Height 787 mm
 - Bolt Slot Length 64 mm
- Steel Posts
 - Post Nos. 3 - 27 W152 x 13.4 by 1,829-mm long
 - Spacing 1,905 mm
- Wood Posts
 - Post Nos. 1 - 2, 28 - 29 (BCT) 140 mm x 190 mm by 1,080-mm long
- Steel Foundation Tube Length 1,829 mm
- Wood Spacer Blocks
 - Post Nos. 3 - 27 152 mm x 305 mm by 356-mm long
- Soil Type Grading B - AASHTO M 147-65 (1990)
- Vehicle Model 1995 GMC 2500 3/4-ton pickup
 - Curb 1,913 kg
 - Test Inertial 1,986 kg
 - Gross Static 1,986 kg
- Vehicle Speed
 - Impact 98.1 km/h
 - Exit (resultant) 55.1 km/h

The *Midwest Guardrail System* (MGS) with standard post spacing was installed with the top guardrail height set at the design's nominal rail height. The 1,986-kg (4,378-lb) pickup truck impacted the *Midwest Guardrail System* (MGS) with standard post spacing at a speed of 98.1 km/h (61.0 mph) and at an angle of 25.6 degrees. A summary of the test results and the sequential photographs are shown in Figure 87. The summary of the test results and sequential photographs in English units are shown in Appendix A. Additional sequential photographs are shown in Figures 88 and 89. Documentary photographs of the crash test are shown in Figures 90 and 91.
