Developments of the Midwest Guardrail System for Standard and Reduced Post Spacing and in Combination with Curbs

Karla A. Polivka

**DEVELOPMENT OF THE *MIDWEST GUARDRAIL*
SYSTEM (MGS) FOR STANDARD AND REDUCED POST
SPACING AND IN COMBINATION WITH CURBS**

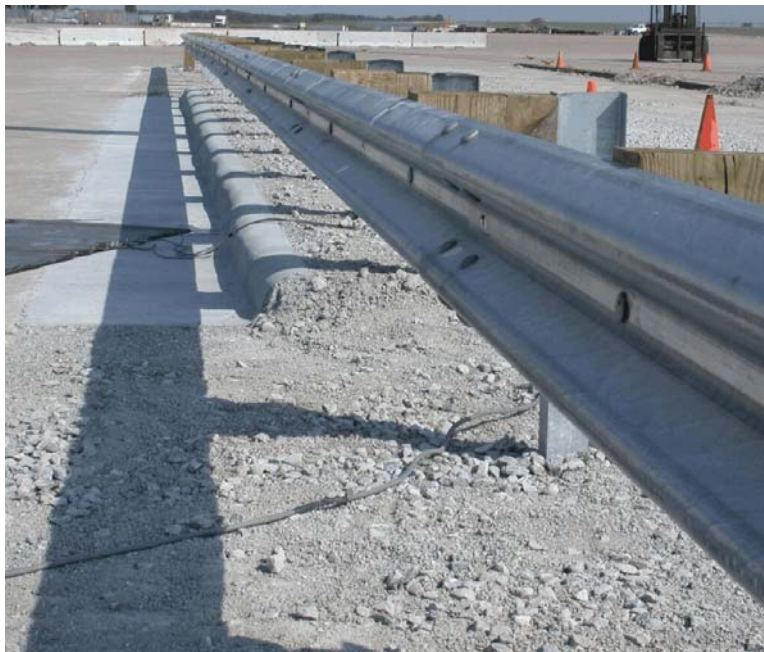
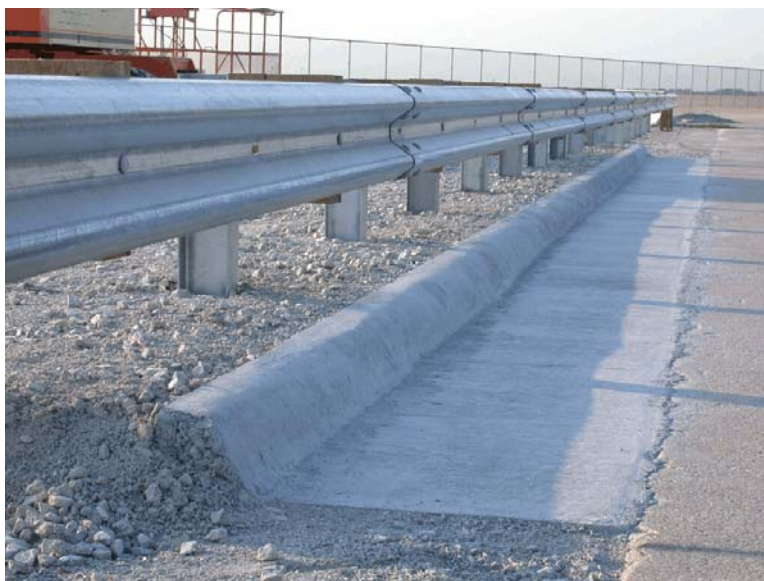
Figure 102. Standard Post Spacing *Midwest Guardrail System* with Curb

This installation was identical to the standard *Midwest Guardrail System* (MGS) except that the guardrail system was installed over a 152-mm (6-in.) tall, American Association of State Highway and Transportation Officials (AASHTO) Type “B” concrete curb. A 152-mm (6-in.) versus a 102-mm (4-in.) high concrete curb was selected for testing since increased hydraulic drainage is often required at the roadway edge, and the taller curb is believed to provide a “worst case” impact scenario for the guardrail-to-curb barrier combination. Therefore, if the test results are found to be satisfactory, then shorter curb heights would also be acceptable and not require additional testing. The curb located beneath the W-beam guardrail was 19.05-m (62-ft 6-in.) long, spanning between post nos. 10 and 20. The curb was constructed such that the center of the curb’s front face was placed 152 mm (6 in.) in front of the front face of the guardrail, as shown in Figure 101. It should be noted that the top mounting height of the guardrail remained at 787 mm (31 in.), which was measured from the gutter line to the top of the W-beam rail. It should be noted that the length of the steel foundation tubes remained at the increased length of 1,829 mm (6 ft) as used in the standard *Midwest Guardrail System* design (test no. NPG-4). Photographs of the test installation are shown in Figures 102 through 104. The complete set of system drawings along with the corresponding English-unit drawings are shown in Appendix H.

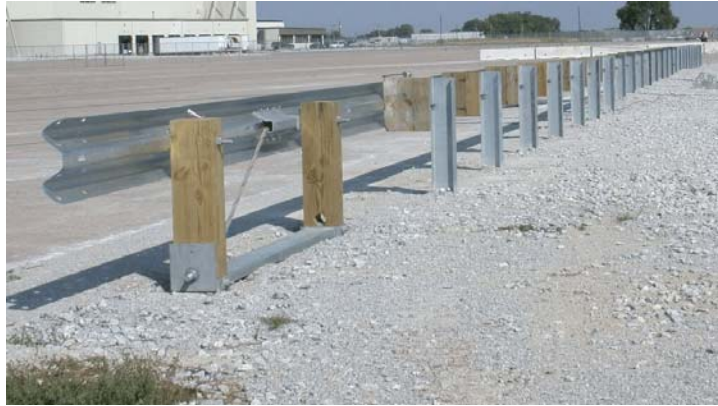
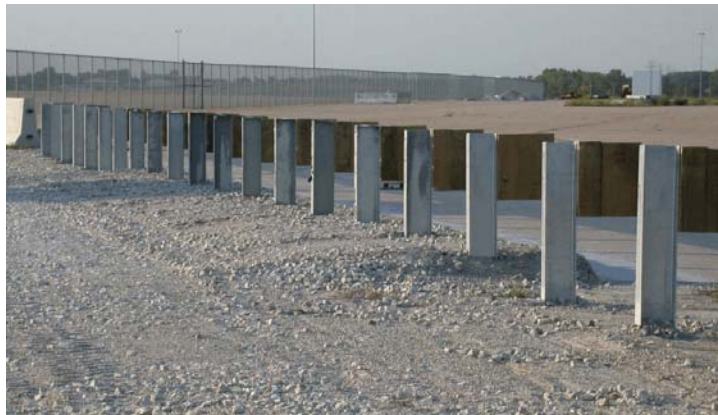
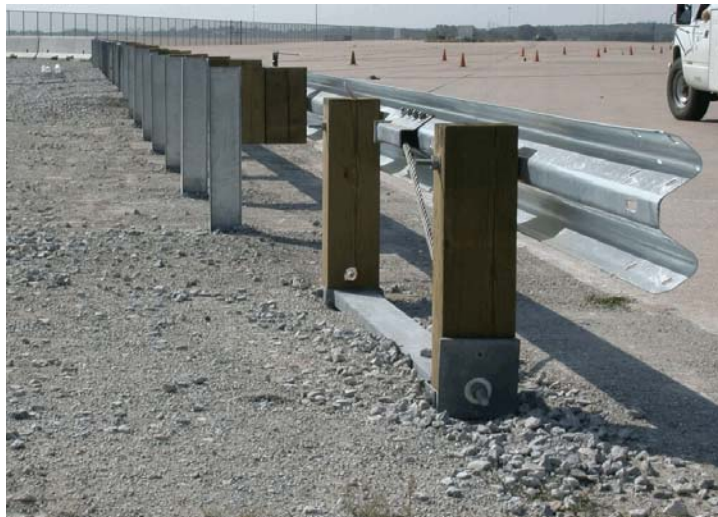
Figure 103. Standard Post Spacing *Midwest Guardrail System* with Curb

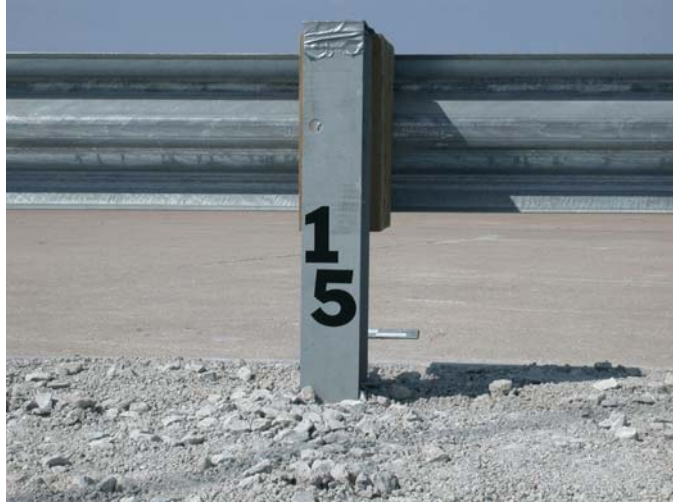
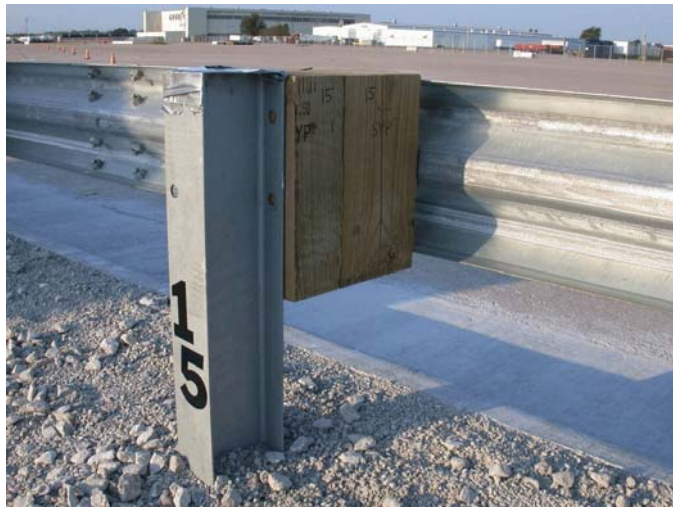
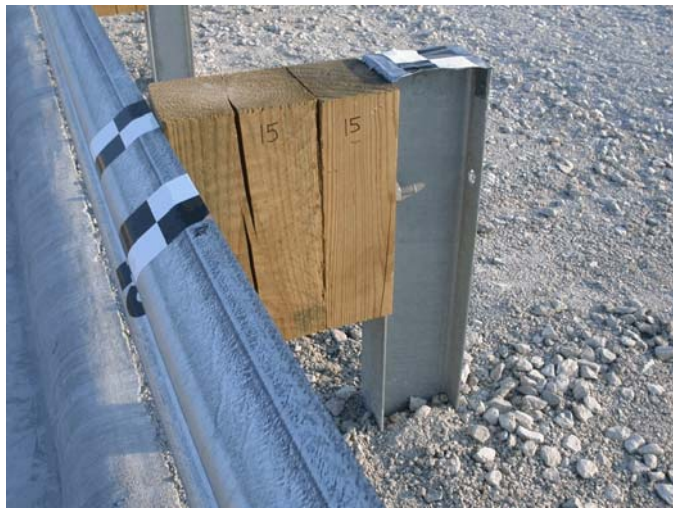
Figure 104. Standard Post Spacing *Midwest Guardrail System* with Curb

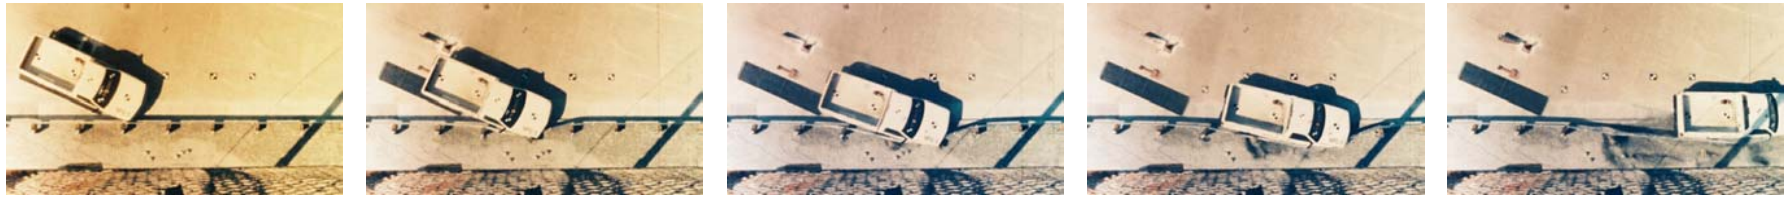
- Test Number NPG-5
- Date 9/4/02
- Appurtenance *Midwest Guardrail System with Curb*
 - Key Elements increased mounting height, blockout depth, and foundation tube length, mid-span splices, and curb

- Spacing 1,905 mm
- Wood Posts
 - Post Nos. 1 - 2, 28 - 29 (BCT) 140 mm x 190 mm by 1,080-mm long
- Steel Foundation Tube Length 1,829 mm
- Wood Spacer Blocks

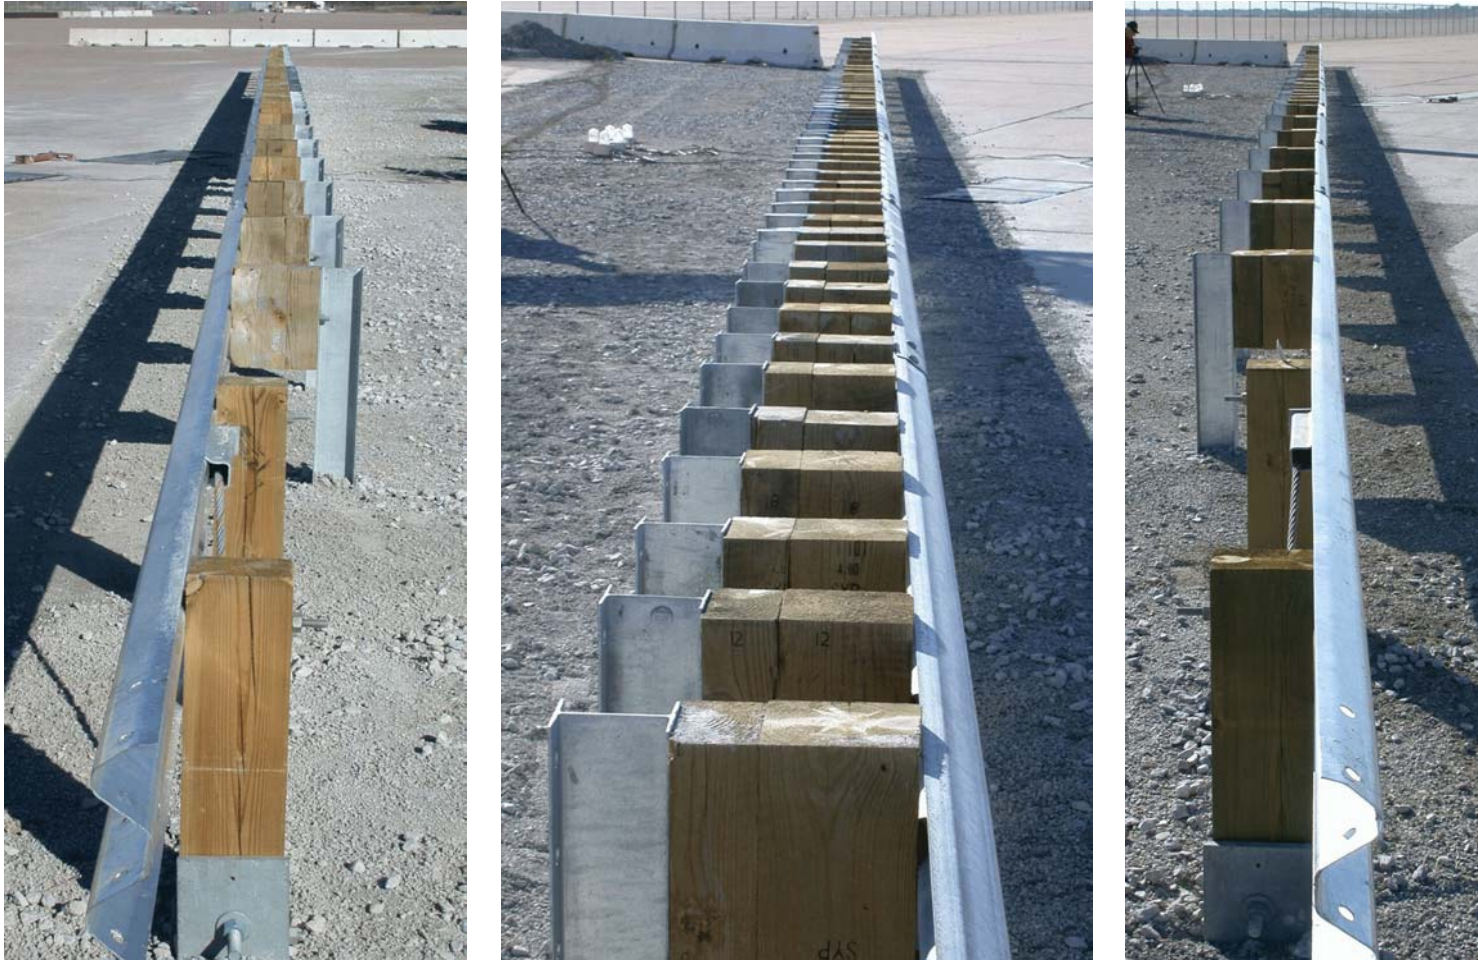
The reduced post spacing test installation was identical to the standard *Midwest Guardrail System* (MGS) except that the original guardrail system was stiffened through the use of a reduced post spacing. Post nos. 9 through 11 and 51 through 53 were spaced 952.5 mm (37 ½ in.) on center while post nos. 11 through 51 were spaced 476.25 mm (18 ¾ in.) on center. The standard 2.66-mm (12-gauge) thick W-beam rails located between post nos. 9 and 53 were modified to include additional post bolt slots at the half-post and quarter-post spacing intervals, as shown in Figure 120. It should be noted that the length of the steel foundation tubes remained at the increased length of 1,829 mm (6 ft) as used in the standard *Midwest Guardrail System* design (test no. 4). Photographs of the test installation are shown in Figures 121 through 123. The complete set of system drawings along with the corresponding English-unit drawings are shown in Appendix J.

Figure 120. Reduced Post Spacing Midwest Guardrail System Test Installation

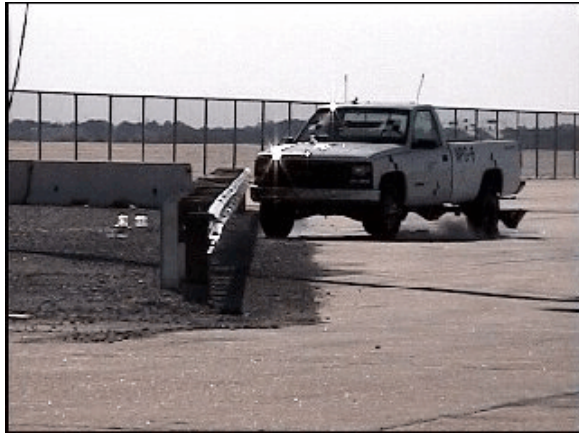
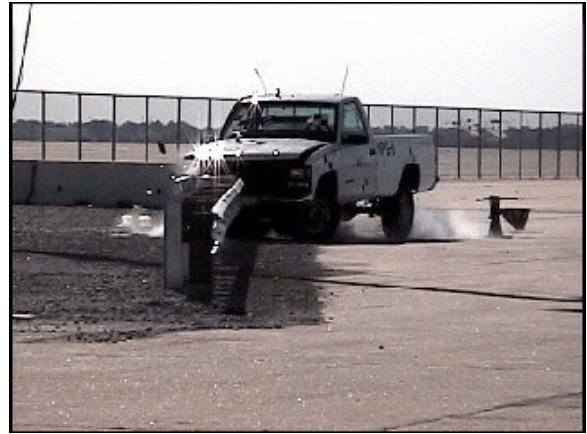
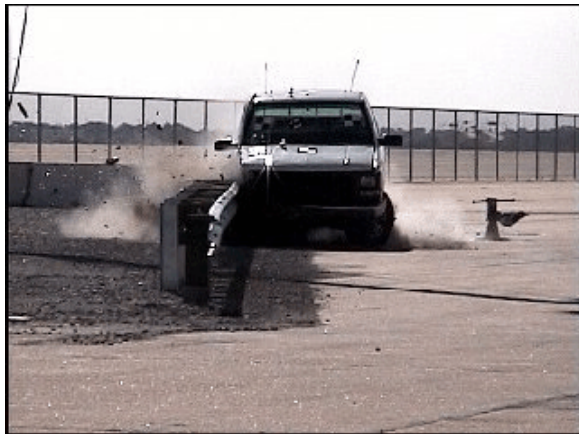
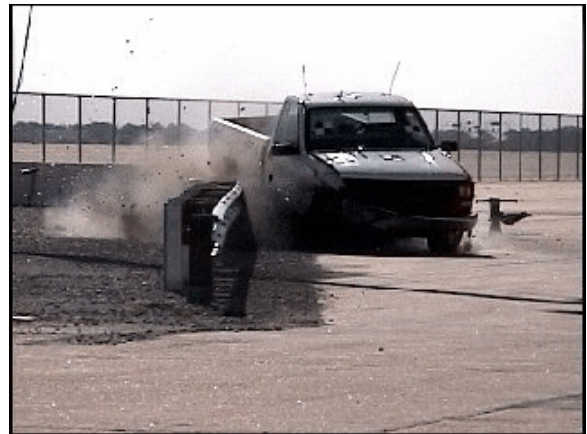
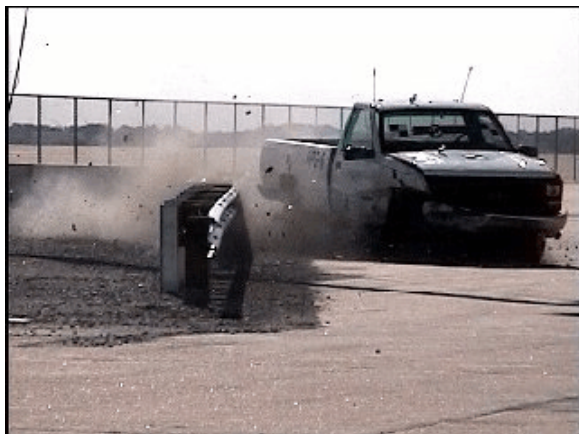
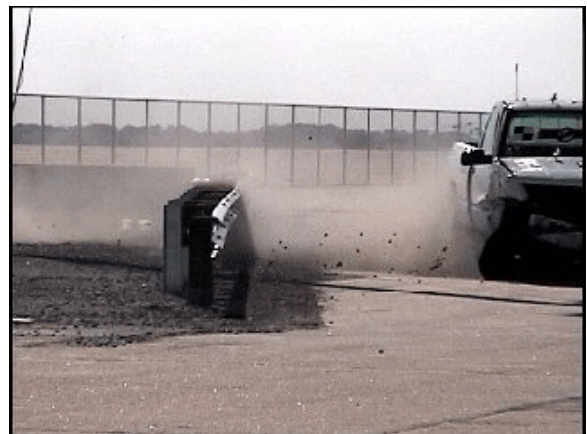
Figure 127. Documentary Photographs, Test NPG-6

The test installation consisted of the *Midwest Guardrail System* (MGS) stiffened with reduced post spacings. The 1,986-kg (4,378-lb) pickup truck impacted the *Midwest Guardrail System* (MGS) with reduced post spacing at a speed of 96.8 km/h (60.2 mph) and at an angle of 25.6 degrees. A summary of the test results and the sequential photographs are shown in Figure 124. The summary of the test results and sequential photographs in English units are shown in Appendix A. Additional sequential photographs are shown in Figures 125 and 126. Documentary photographs of the crash test are shown in Figures 127 and 128.

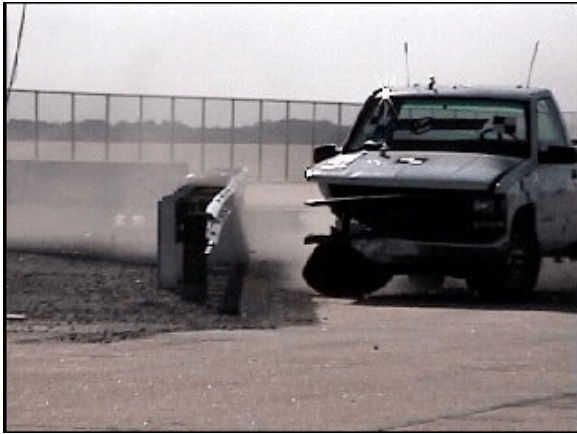
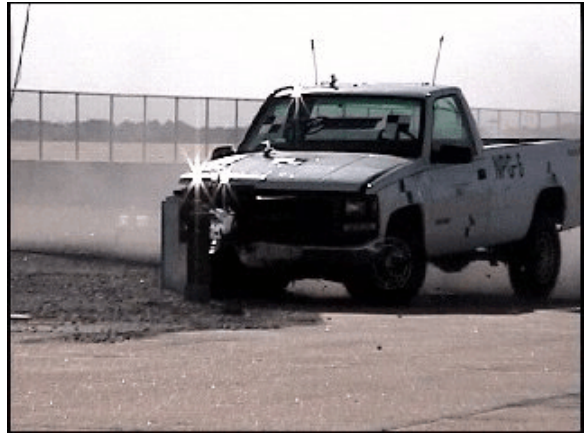
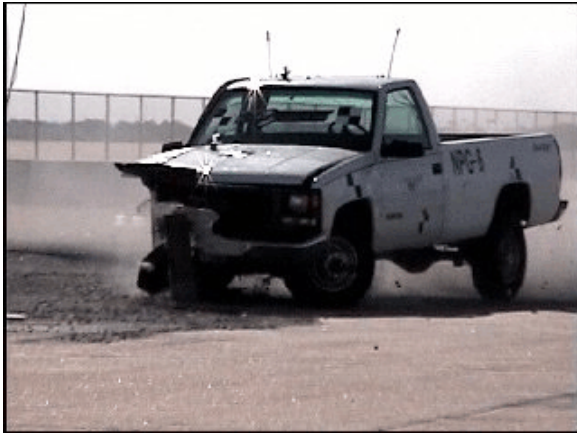
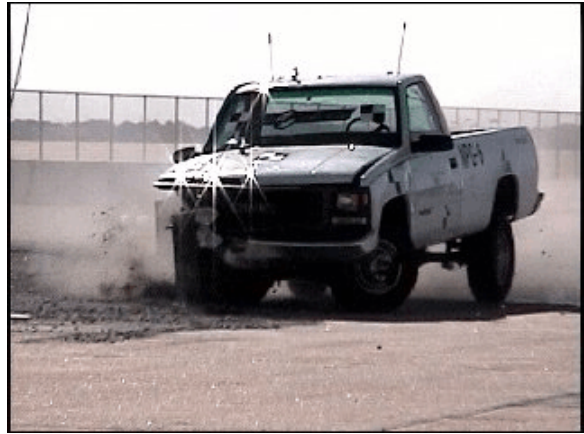
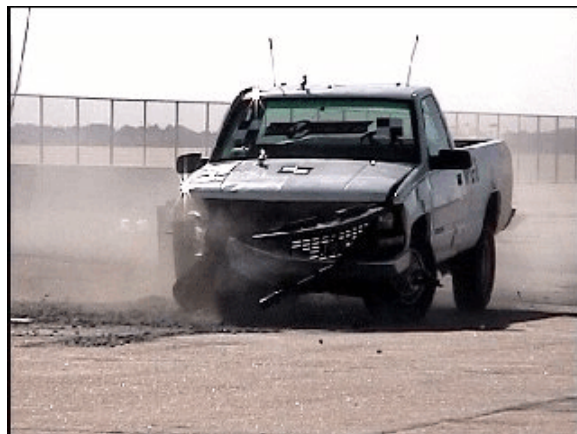
Figure 128. Documentary Photographs, Test NPG-6

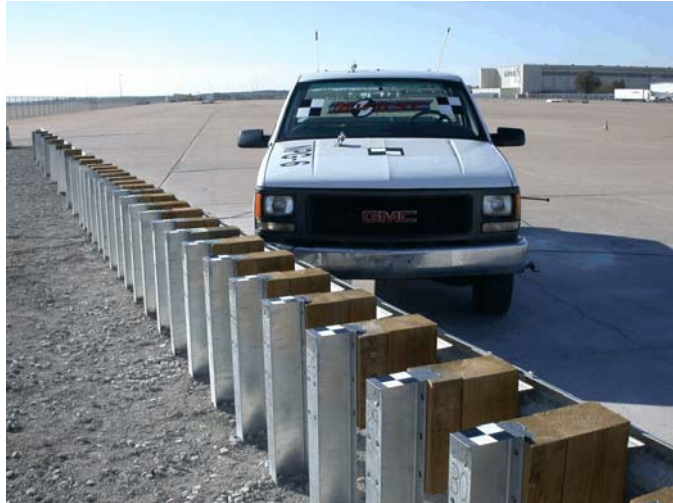
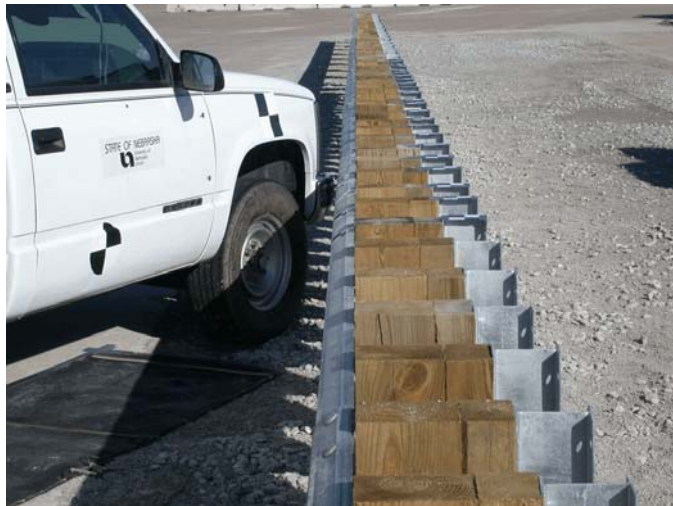
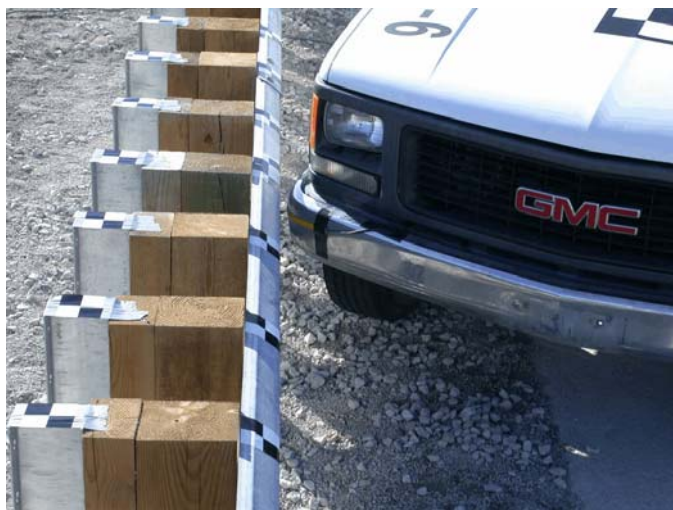
Figure 129. Impact Location, Test NPG-6

Initial impact was to occur between post nos. 22 and 23 or 2,920-mm (9-ft 7-in.) upstream from the centerline of post no.29, as shown in Figure 129. Actual vehicle impact occurred 2,946-mm (9-ft 8-in.) upstream from the centerline of post no. 29 or 89-mm (3.5-in.) upstream from the center of post no. 23. At 0.020 sec after initial impact, the front of the vehicle was located at post no. 24. By this same time, post nos. 22 through 25 deflected. At 0.038 sec, the front of the vehicle was located at post no. 25. At this same time, the left side of the hood popped open as the right side was crushed inward. At 0.057 sec, the front of the vehicle was located at post no. 26, and post nos. 12 through 21 rotated CW. At this same time, the top of the right-side door jarred open. At 0.077 sec, the vehicle was located at post no. 27 and began to redirect. At this same time, post no. 26 deflected downstream. At 0.101 sec, the front of the vehicle was located at post no. 28 with the left-front tire rotated inward to approximately perpendicular to the rail. At this same time, post no. 31 began to deflect. At 0.123 sec, the front of the vehicle was located at post no. 29, and post nos. 32 and 33

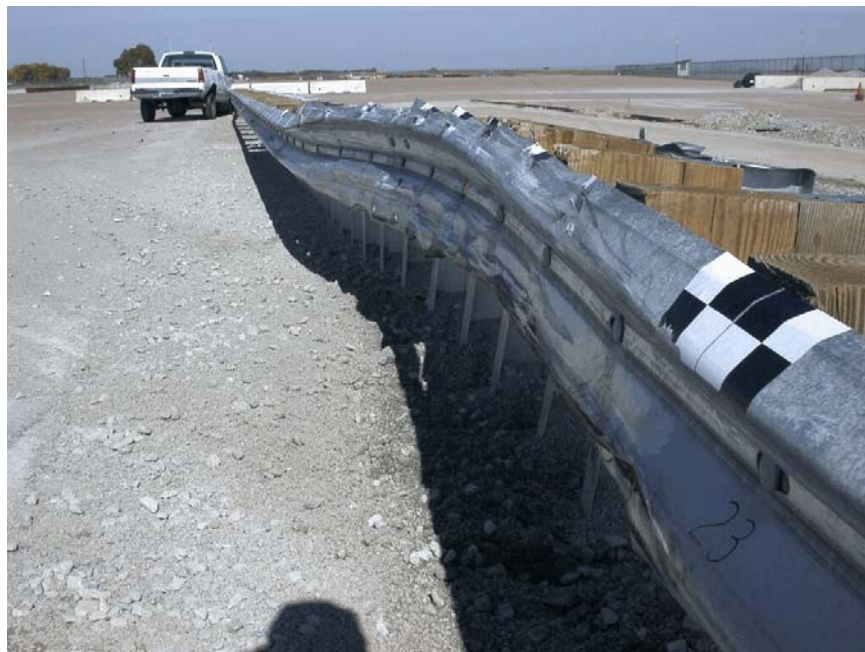
Figure 130. Vehicle Final Position and Trajectory Marks, Test NPG-6

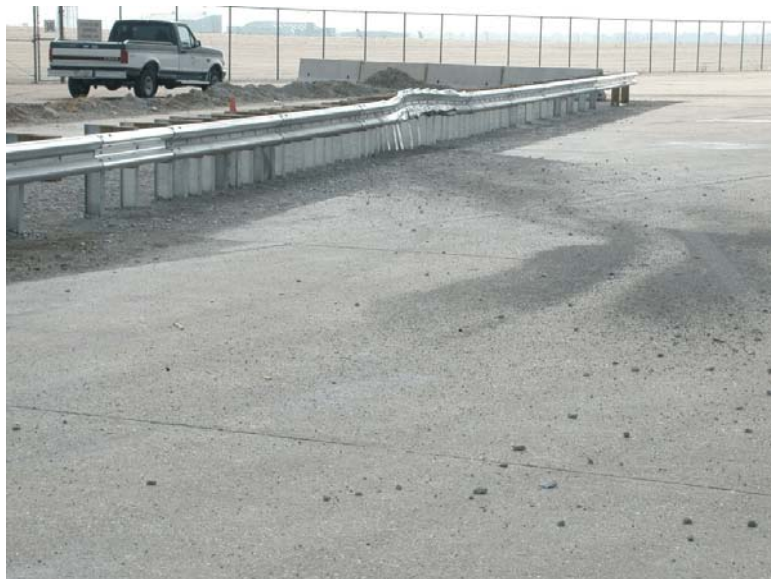
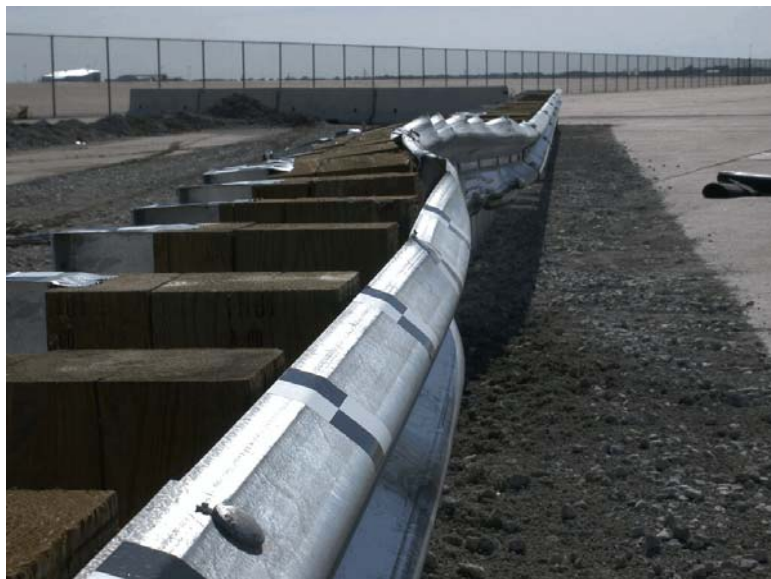
Figure 131. System Damage, Test NPG-6

Damage to the barrier was moderate, as shown in Figures 131 through 133. Barrier damage consisted of deformed W-beam and guardrail posts, contact marks on a guardrail section, and disengaged wooden blockouts. The guardrail damage consisted of moderate deformation, flattening, and buckling of the impacted section of W-beam rail between post nos. 23 and 34. Contact marks

The permanent set of the barrier system is shown in Figures 131 and 132. The maximum lateral permanent set rail and post deflections were 305 mm (12 in.) at the centerline of post no. 28 and 286 mm (11¼ in.) at post no. 27, respectively, as measured in the field. The maximum lateral dynamic rail and post deflections were 447 mm (17½ in.) at the centerline of post no. 27 and 424 mm (16 ⅝ in.) at post no. 28, respectively, as determined from the high-speed film analysis.

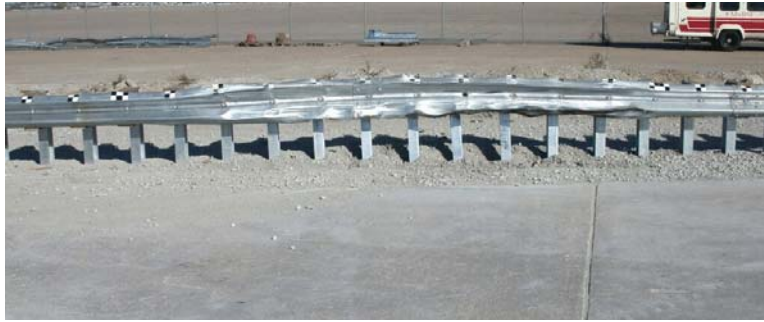
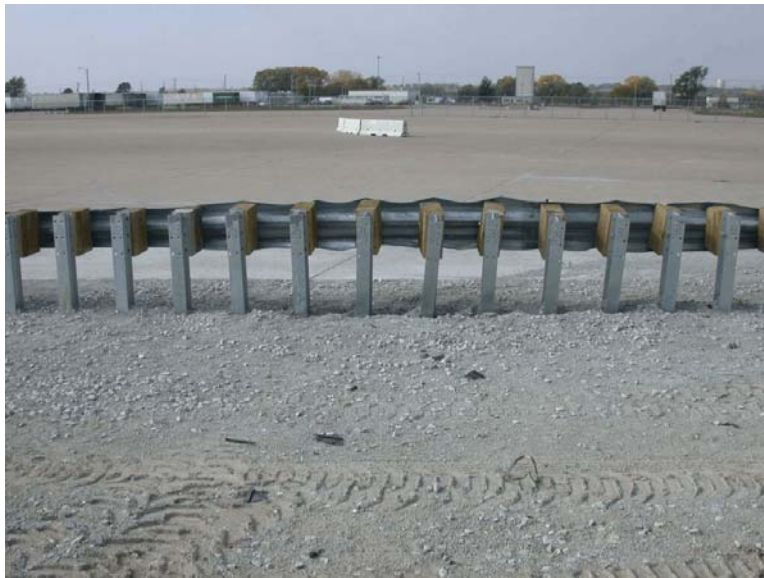
Figure 132. System Damage, Test NPG-6

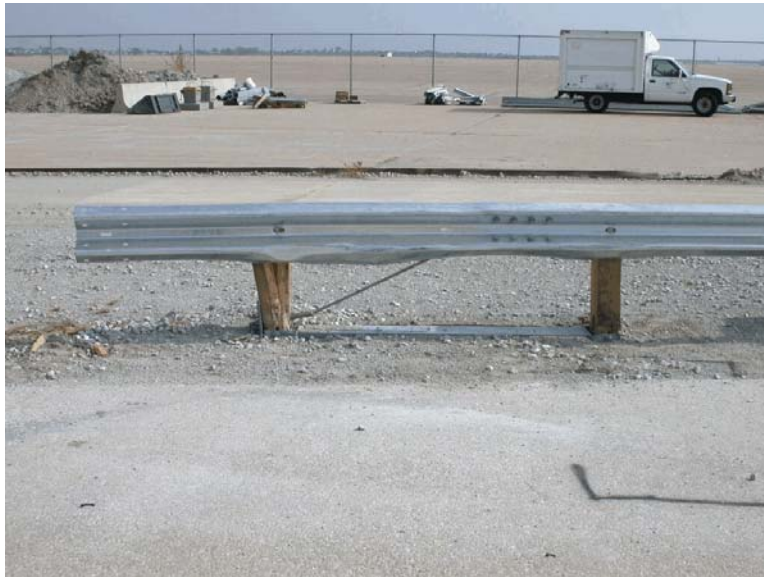
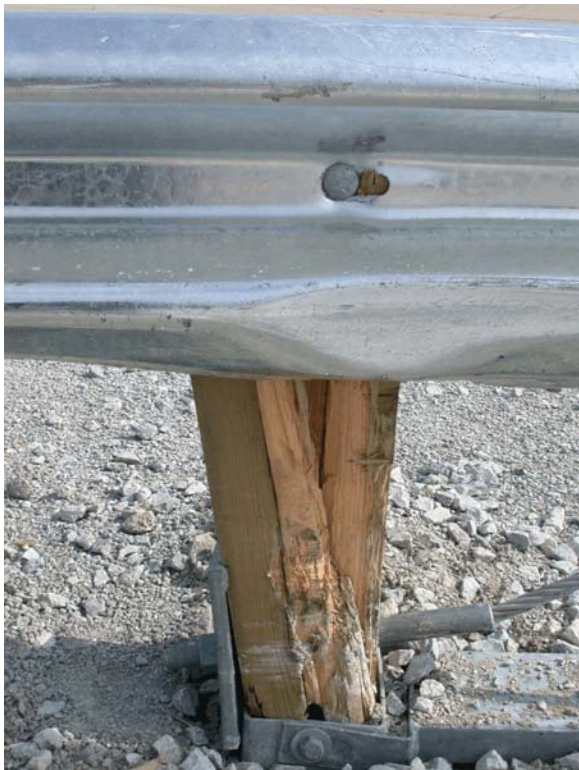
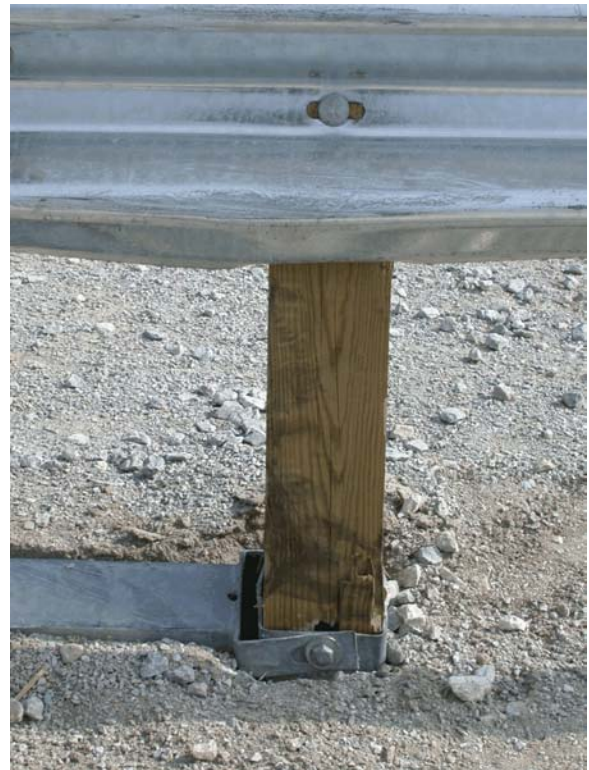
Figure 133. System Damage, Test NPG-6

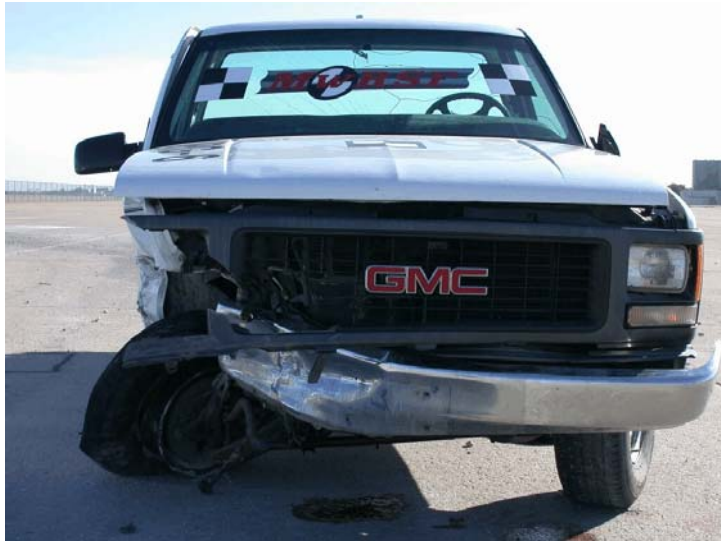
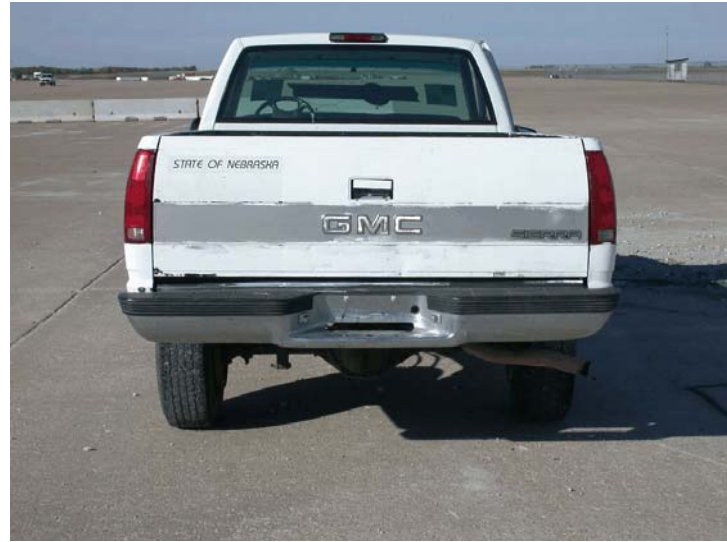
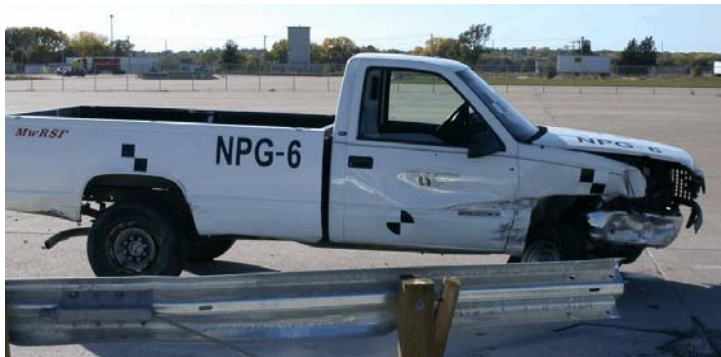
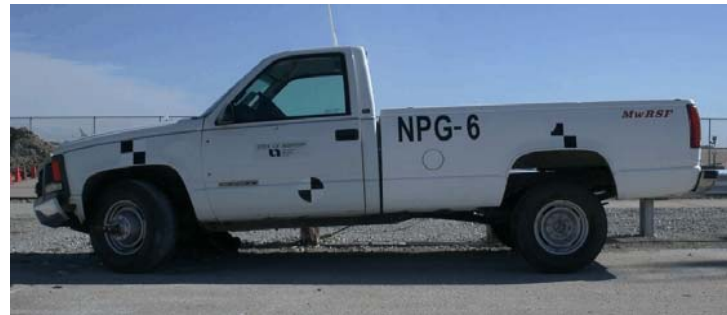
Figure 134. Vehicle Damage, Test NPG-6

Exterior vehicle damage was moderate, as shown in Figures 134 through 137. Damage was concentrated on the right-front corner of the vehicle and below the hood line. The right-front quarter panel and wheel well were crushed inward. The right side of the front bumper and bumper supports

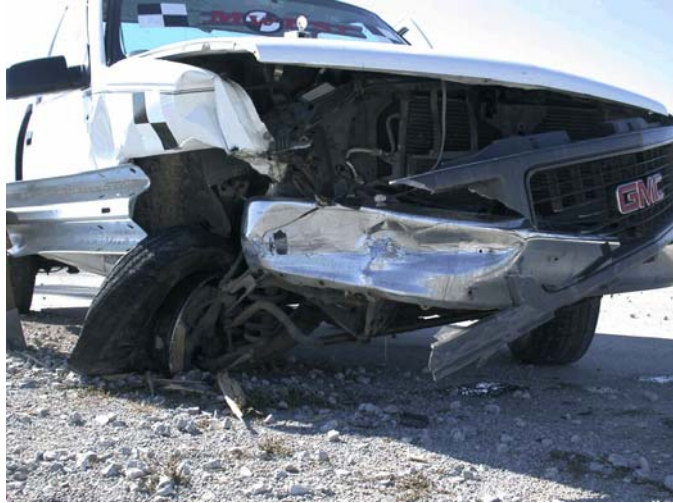
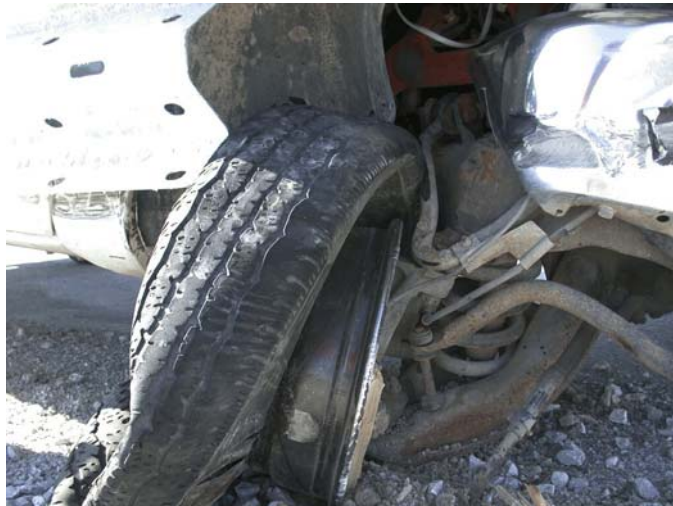
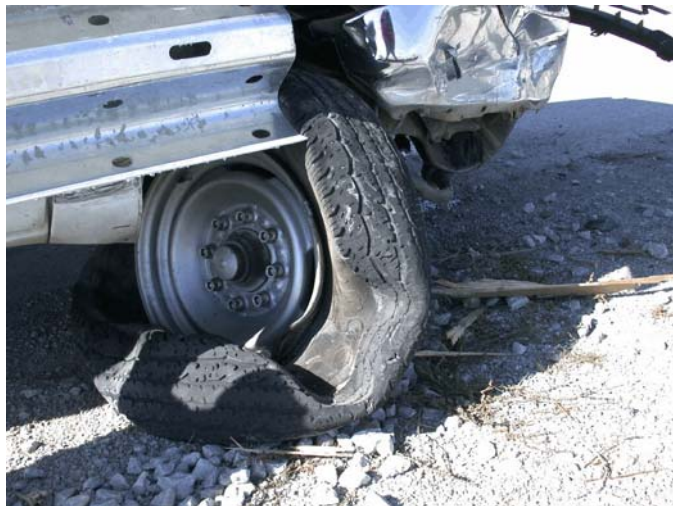
Figure 135. Vehicle Damage, Test NPG-6

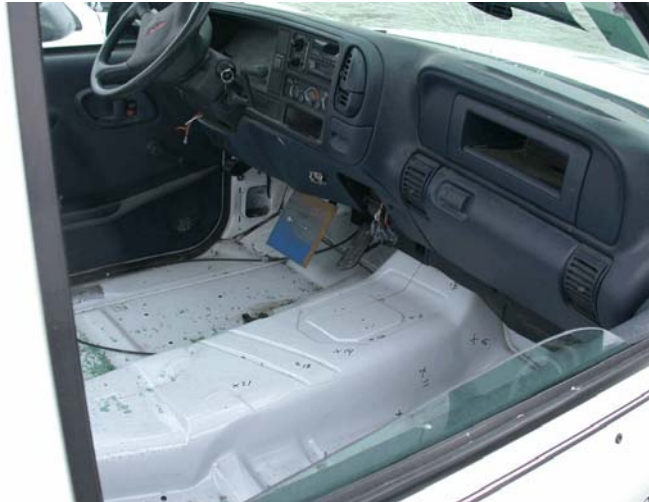
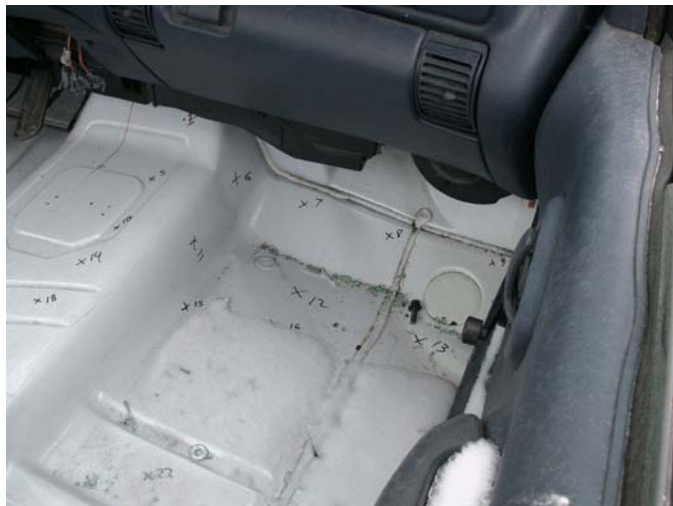
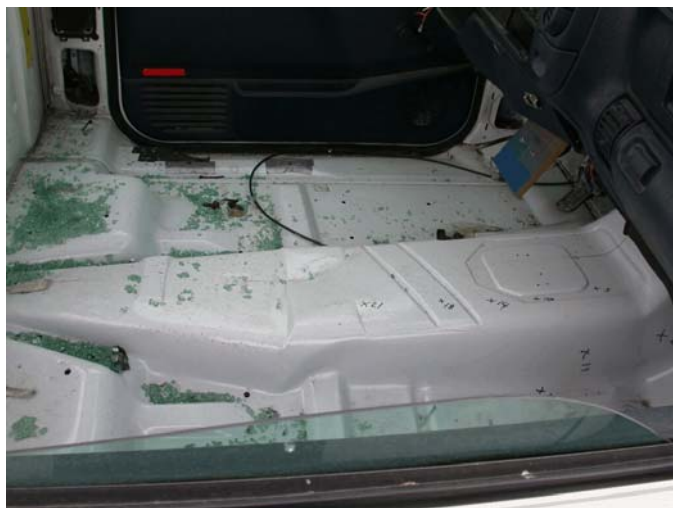
Figure 137. Occupant Compartment Damage, Test NPG-6

Minor occupant compartment deformations occurred with slight deformations to the right-side floorboard, as shown in Figure 137. Occupant compartment deformations and the corresponding locations are provided in Appendix D. A maximum vertical deflection of 44 mm (1.75 in.) was found near the firewall at the center of the right side. Maximum longitudinal and lateral deflections of the floor pan were measured as 44 mm (1.75 in.) and 13 mm (0.5 in.), respectively. Maximum dash deflection was found to be approximately 64 mm (2.5 in.).

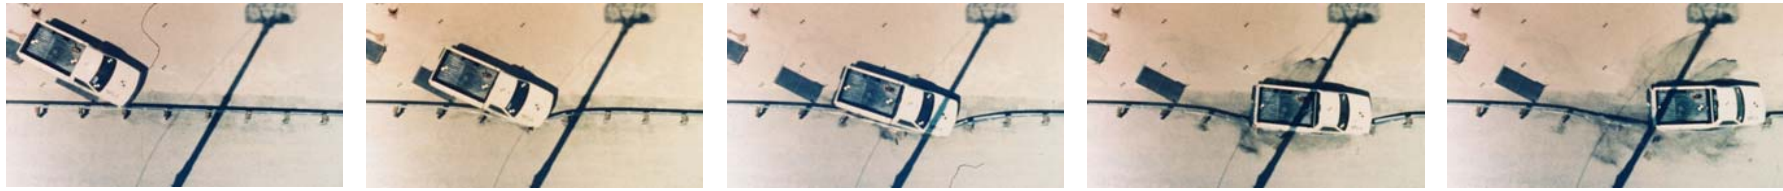
Figure A-3. Summary of Test Results and Sequential Photographs (English), Test NPG-3

- Lateral (not required) 11.97 ft/s
- Vehicle Damage Minimal
 - TAD³¹ 11-LFQ-4, 11-FL-3
 - SAE³² 11LFEW4
- Vehicle Stopping Distance 47 ft-5 in. downstream

- 0 m lateral
- Barrier Damage Moderate
- Maximum Deflections
 - Permanent Set NA
 - Dynamic NA
- Working Width NA

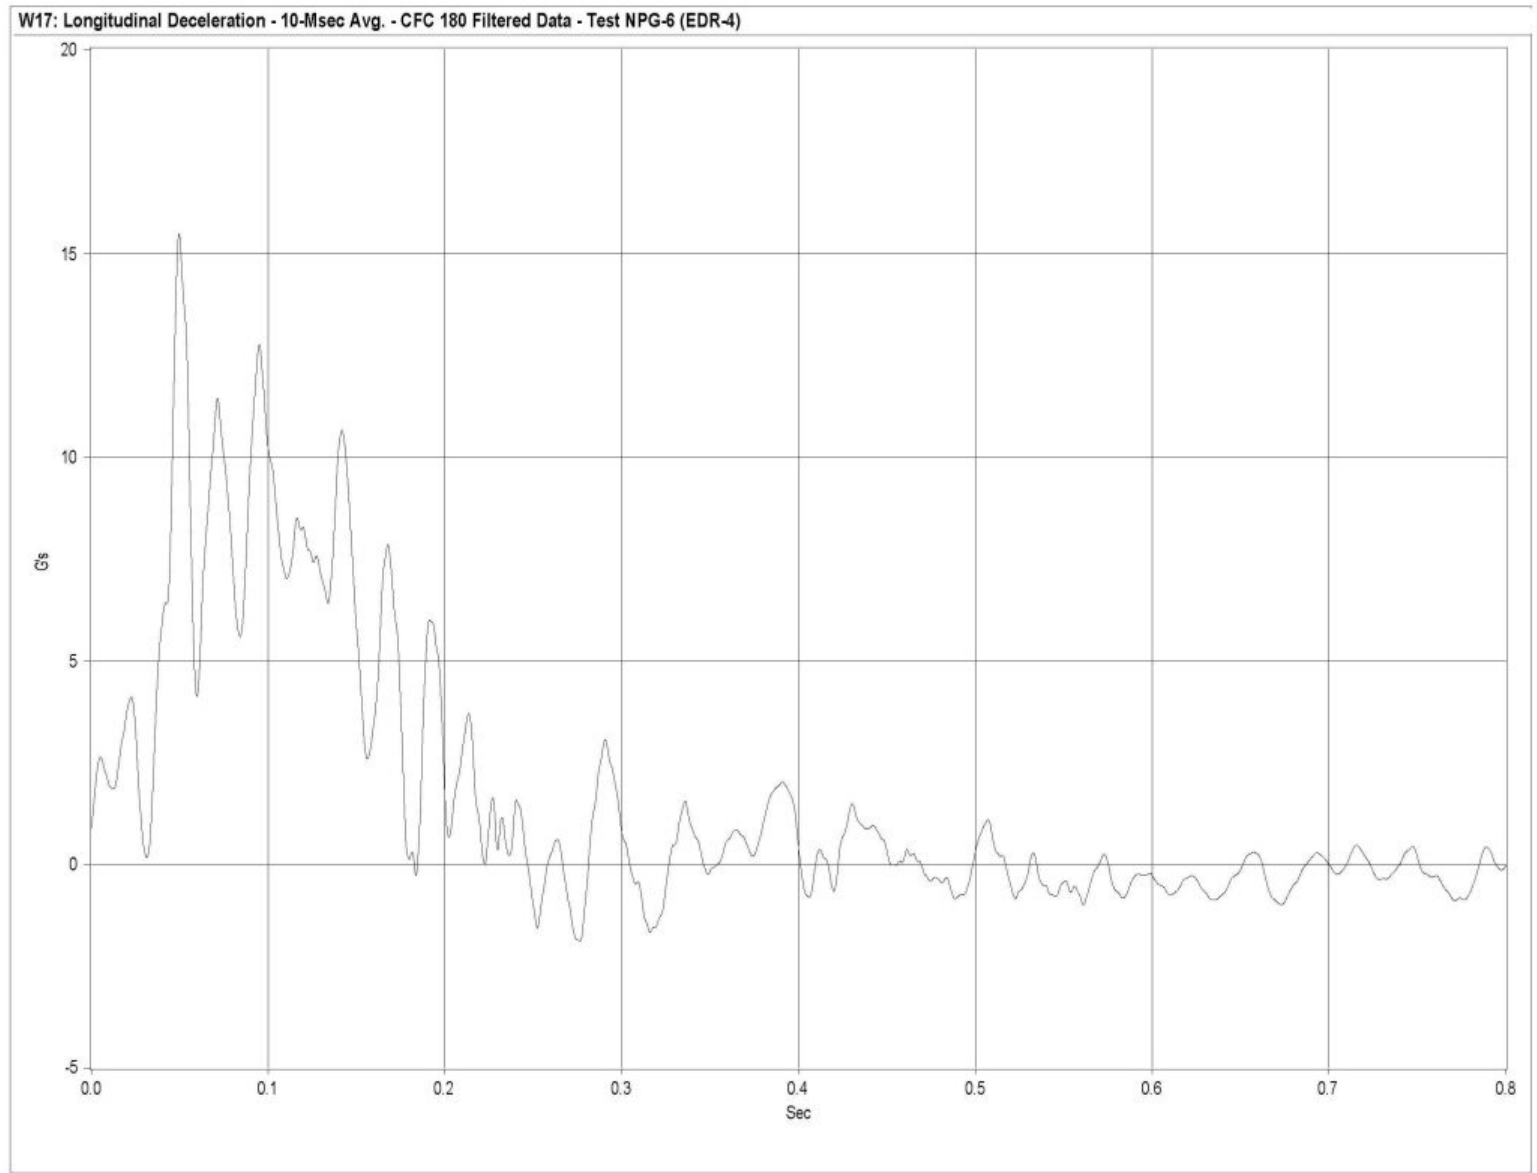
Figure K-1. Graph of Longitudinal Deceleration Test NPG-6
