# Performance Evaluation of Safety Grates for Cross-Drainage Culverts

Polivka, Karla A.; Sicking, Dean L.; Bielenberg, Robert W.; Rohde, John R.; Faller, Ronald K.; and Reid, John D., "Performance Evaluation of Safety Grates for Cross-Drainage Culverts" (2008). *Nebraska Department of Transportation Research Reports*. 84.  
<http://digitalcommons.unl.edu/ndor/84>

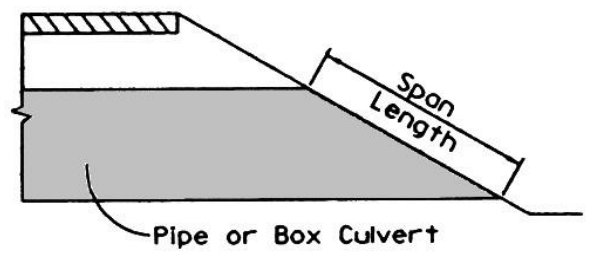
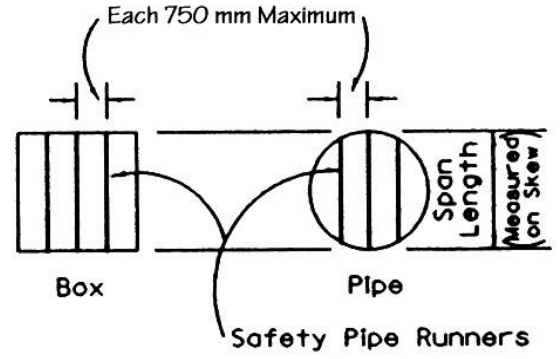
Figure 1. AASHTO RDG Culvert Grating Guidelines

Culvert grating guidelines developed by Ross et al. (4) were subsequently included in American Association of State Highway Transportation Officials (AASHTO) Roadside Design Guide (RDG) (7), as shown in Figure 1. Based strictly on the 1981 computer modeling of traversable slopes, these designs were recommended for use on slopes as steep as 3:1. Hence, the cross-drainage culvert grating guidelines contained in the RDG have never been subjected to full-scale crash testing under the current Test Level 3 (TL-3) safety performance evaluation guidelines (8), and no testing has ever been conducted on slopes steeper than 4:1. In recognition of the need to examine the safety performance of cross-drainage culvert grates under current criteria when installed on roadside slopes as steep as 3:1, the Midwest States Pooled Fund Program initiated the study described herein.

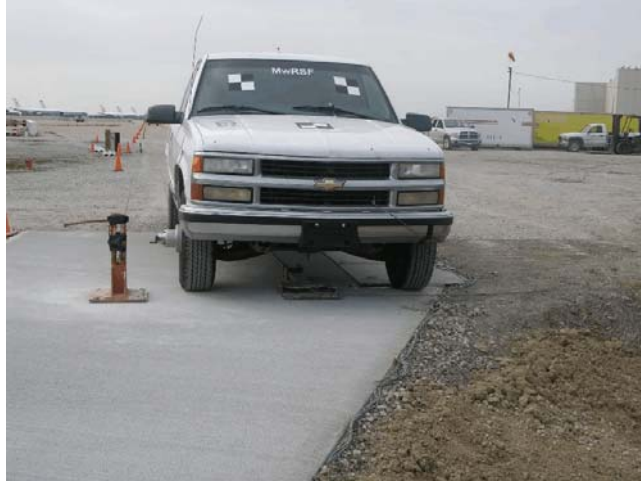
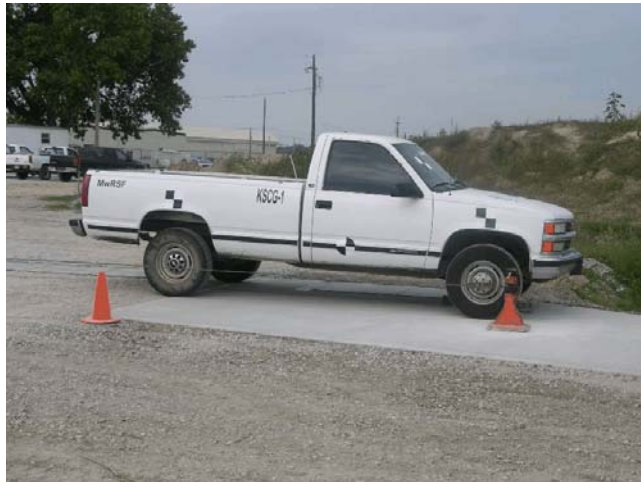
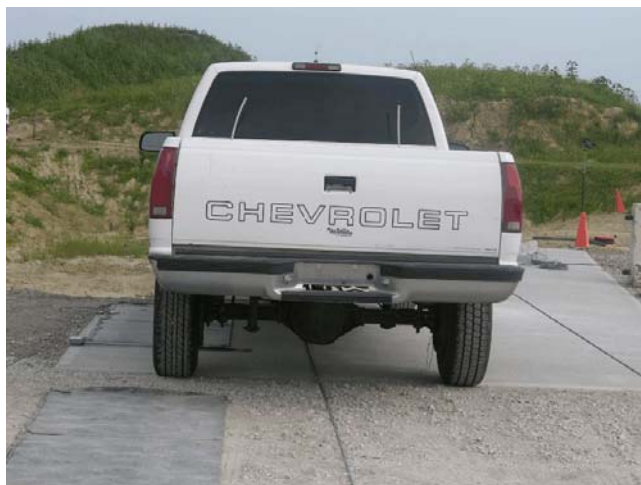
Figure 2. Test Vehicle, Test KSCG-1

For test KSCG-1, a 2000 Chevrolet C2500 ¾-ton pickup truck was used as the test vehicle. The test inertial and gross static weights were both 2,034 kg (4,484 lbs). The test vehicle is shown in Figure 2, and vehicle dimensions are shown in Figure 3.

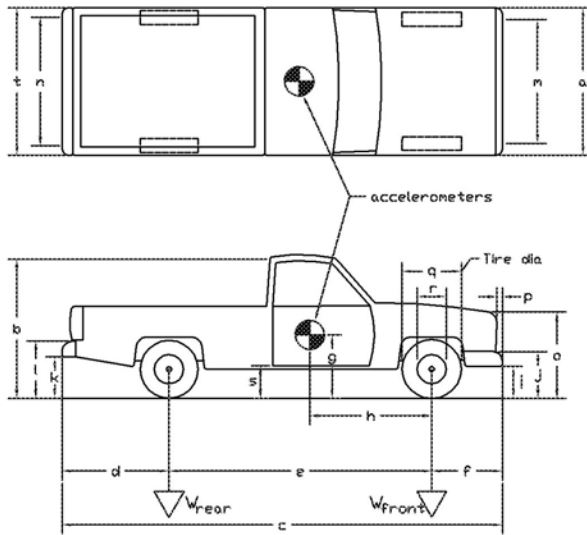
a 1899 (74.75) b 1835 (72.25)  
 c 5550 (218.5) d 1308 (51.5)  
 e 3340 (131.5) f 902 (35.5)  
 g 665 (26.2) h 1394 (54.9)  
 i 445 (17.5) j 660 (26.0)  
 k 610 (24.0) l 787 (31.0)  
 m 1597 (62.875) n 1629 (64.125)  
 o 1016 (40.0) p 102 (4.0)  
 q 762 (30.0) r 445 (17.5)  
 s 476 (18.75) t 1867 (73.5)  
 Wheel Center Height Front 368 (14.5)  
 Wheel Center Height Rear 371 (14.625)  
 Wheel Well Clearance (FR) 905 (35.625)  
 Wheel Well Clearance (RR) 959 (37.75)  
 Frame Height (FR) 406 (16.0)  
 Frame Height (RR) 686 (27.0)  
 Engine Type 8 CYL. GAS  
 Engine Size 5.7 L 350 CID

Figure 3. Vehicle Dimensions, Test KSCG-1

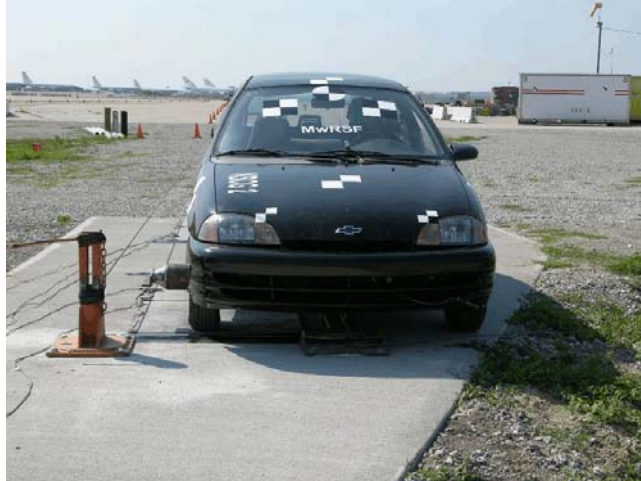
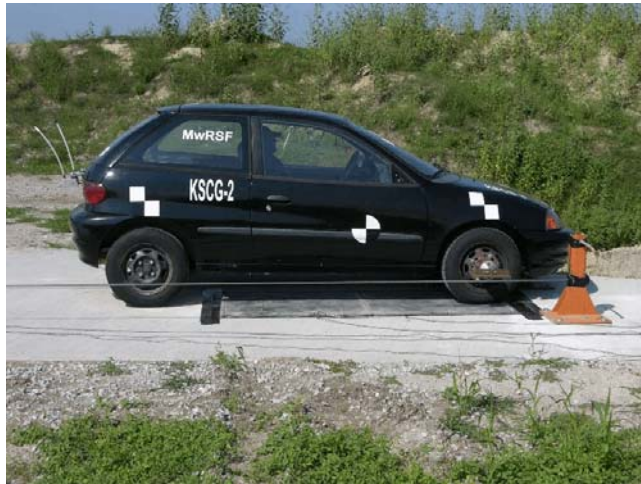
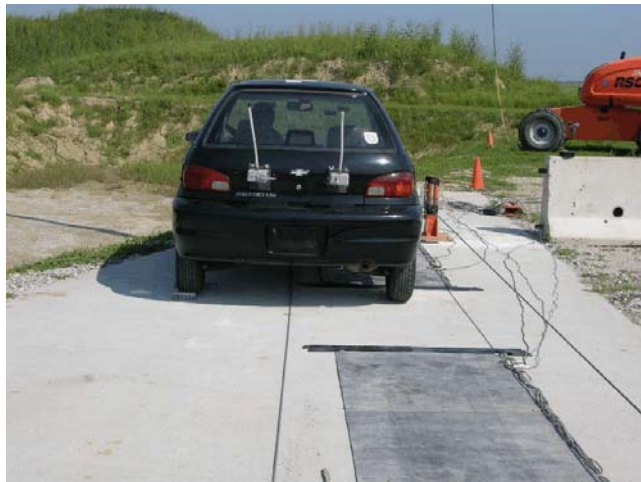
Figure 4. Test Vehicle, Test KSCG-2

For test KSCG-2, a 1999 Chevrolet Metro was used as the test vehicle. The test inertial and gross static weights were 831 kg (1,833 lbs) and 906 kg (1,997 lbs), respectively. The test vehicle is shown in Figure 4, and vehicle dimensions are shown in Figure 5.

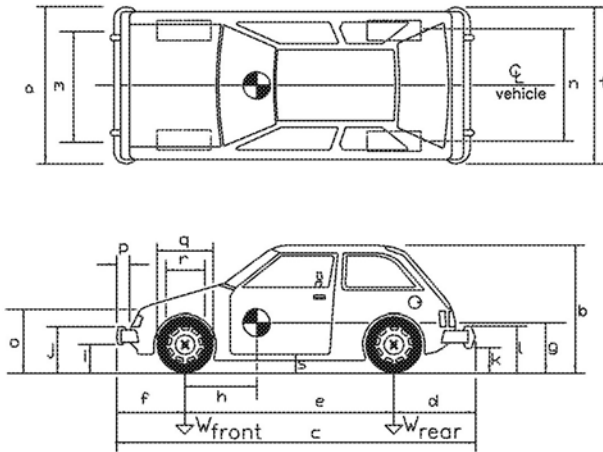
a 1568 (61.75) b 1416 (55.75)  
 c 3797 (149.5) d 603 (23.75)  
 e 2369 (93.25) f 826 (32.5)  
 g 546 (21.5) h 841 (33.125)  
 i 413 (16.25) j 521 (20.5)  
 k 305 (12.0) l 648 (25.5)  
 m 1384 (54.5) n 1353 (53.25)  
 o 572 (22.5) p 89 (3.5)  
 q 578 (22.75) r 362 (14.25)  
 s 318 (12.5) t 1568 (61.75)

Figure 5. Vehicle Dimensions, Test KSCG-2

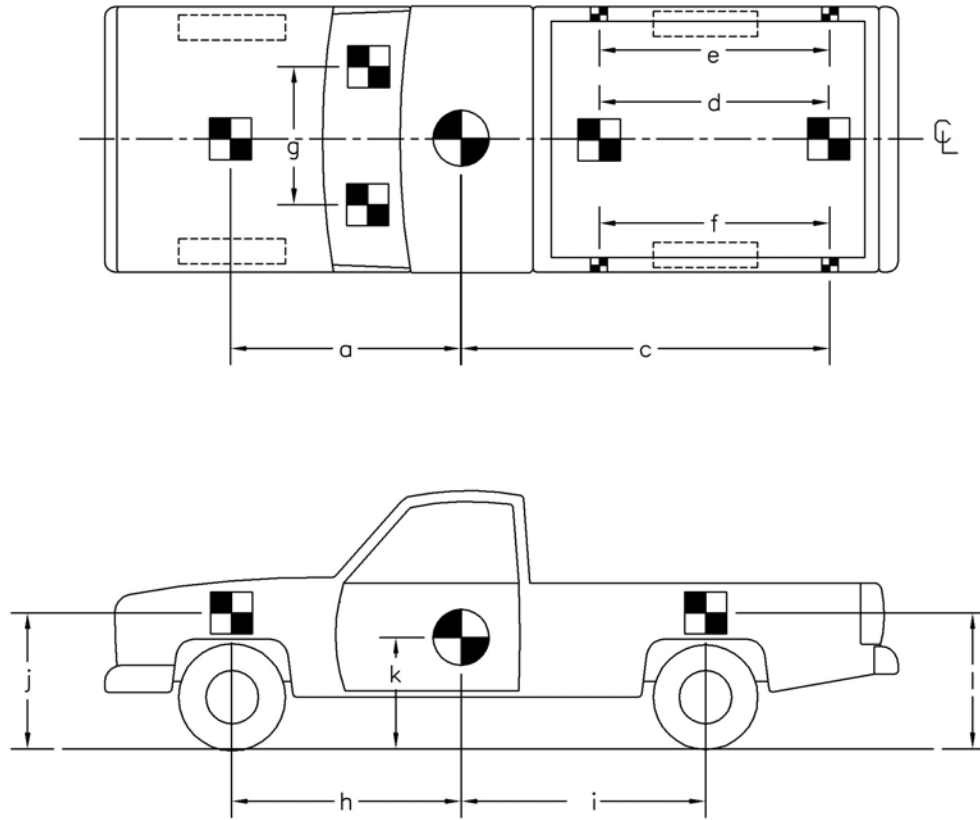
TEST #: <u>  KSCG-1  </u>											
TARGET GEOMETRY -- mm (in.)											
a	<u>  1641  </u>	(64.625)	d	<u>  1581  </u>	(62.25)	g	<u>  870  </u>	(34.25)	j	<u>  1022  </u>	(40.25)
b	<u>    -    </u>		e	<u>  2153  </u>	(84.75)	h	<u>  1394  </u>	(54.9)	k	<u>  665  </u>	(26.2)
c	<u>  286  </u>	(11.25)	f	<u>  2153  </u>	(84.75)	i	<u>  1946  </u>	(76.6)	l	<u>  1073  </u>	(42.25)

Figure 6. Vehicle Target Locations, Test KSCG-1

Square black and white-checked targets were placed on the vehicle to aid in the analysis of the high-speed E/cam and AOS videos, as shown in Figures 6 and 7. Round, checkered targets were placed on the center of gravity, on the left-side door, on the right-side door, and on the roof of the vehicle. The remaining targets were located for references so that they could be viewed from the high-speed cameras for video analysis.

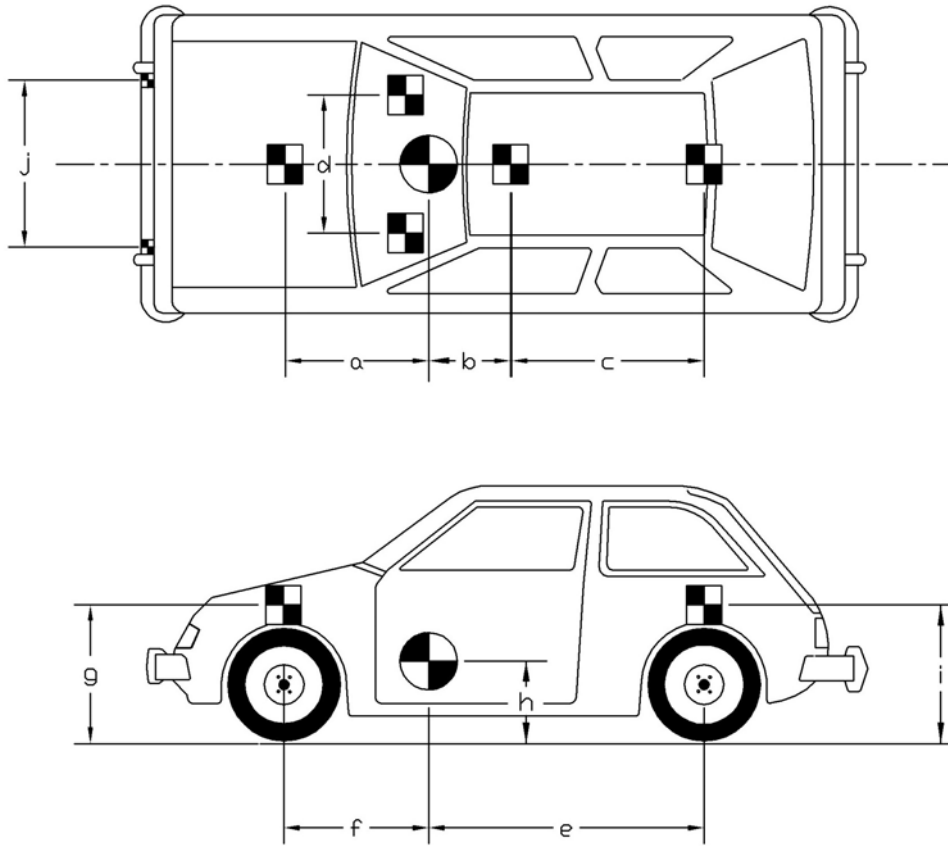
TEST #: <u>KSCG-2</u>			
TARGET GEOMETRY -- mm (in.)			
a	<u>1092 (43.0)</u>	b	<u>222 (8.75)</u>
c	<u>1086 (42.75)</u>	d	<u>546 (21.5)</u>
e	<u>1527 (60.125)</u>	f	<u>841 (33.125)</u>
g	<u>737 (29.0)</u>		
i	<u>765 (30.125)</u>	j	<u>784 (30.875)</u>
k	<u>581 (22.875)</u>

Figure 7. Vehicle Target Locations, Test KSCG-2

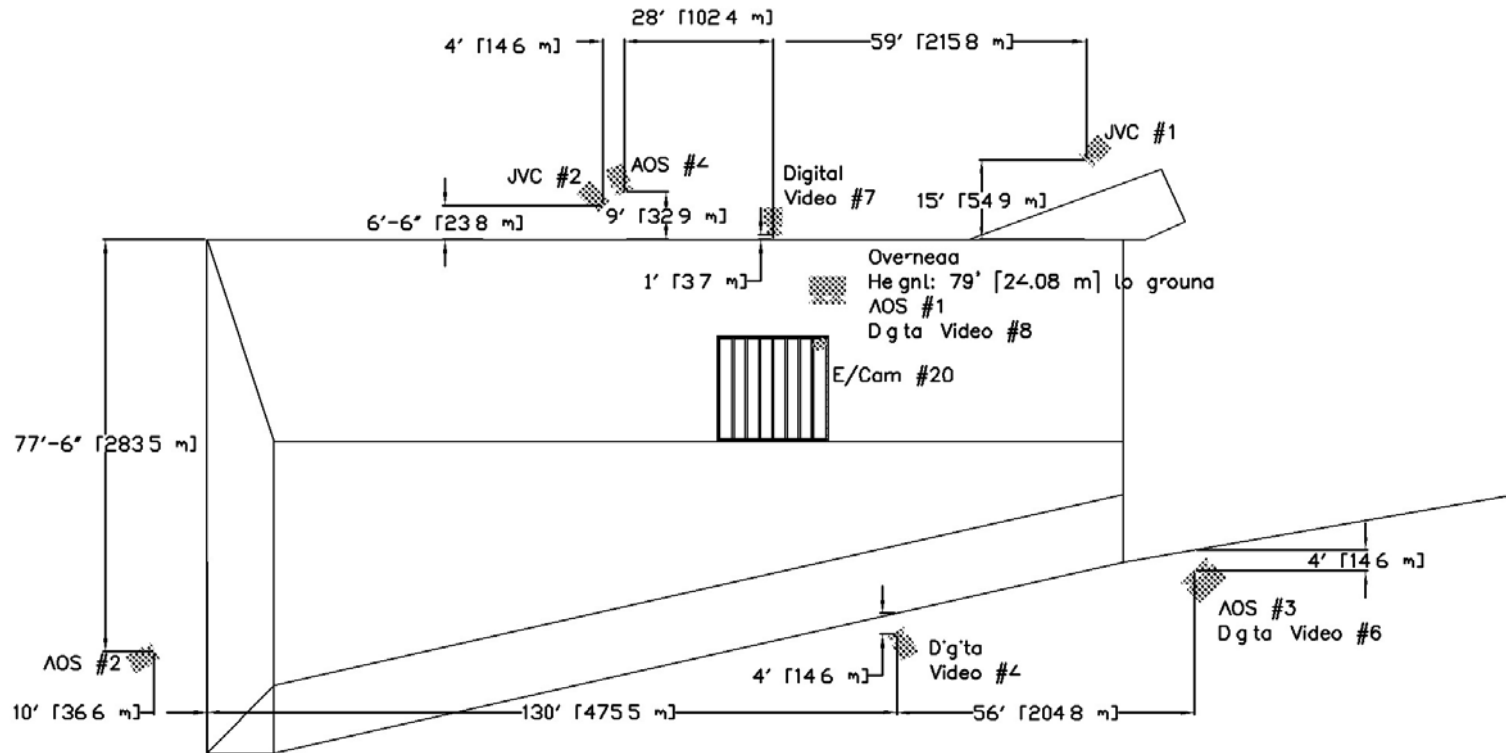
Figure 8. Locations of High-Speed Cameras, Test KSCG-1

operating speeds of 29.97 frame/sec, were also used to film the crash test. Camera details and a schematic of all ten camera locations for test KSCG-1 are shown in Figure 8.

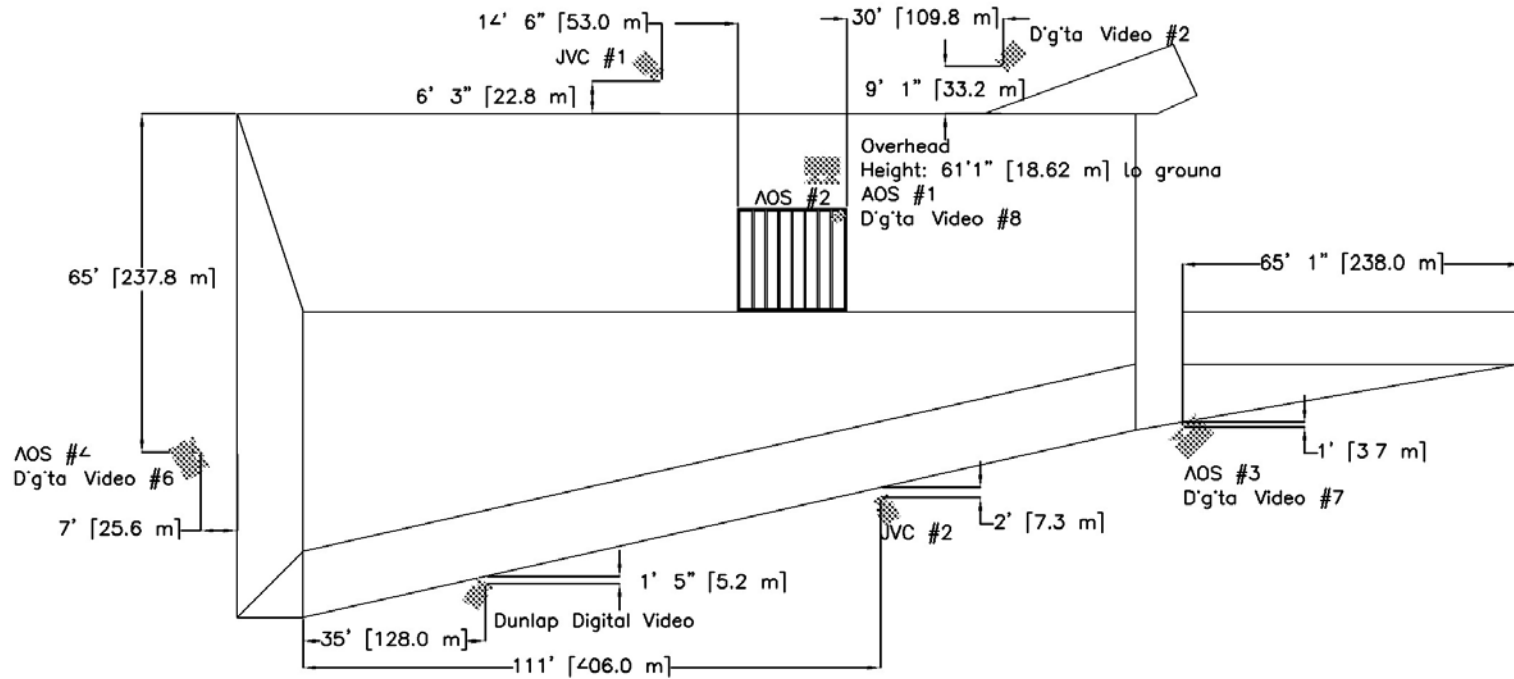
Figure 9. Locations of High-Speed Cameras, Test KSCG-2

For test KSCG-2, four high-speed AOS VITcam video cameras, with operating speeds of 500 frame/sec, were used to film the crash test. Five Canon digital video cameras and two JVC digital video cameras, all with standard operating speeds of 29.97 frame/sec, were also used to film test KSCG-2. Camera details and a schematic of all eleven camera locations for test KSCG-2 are shown in Figure 9.

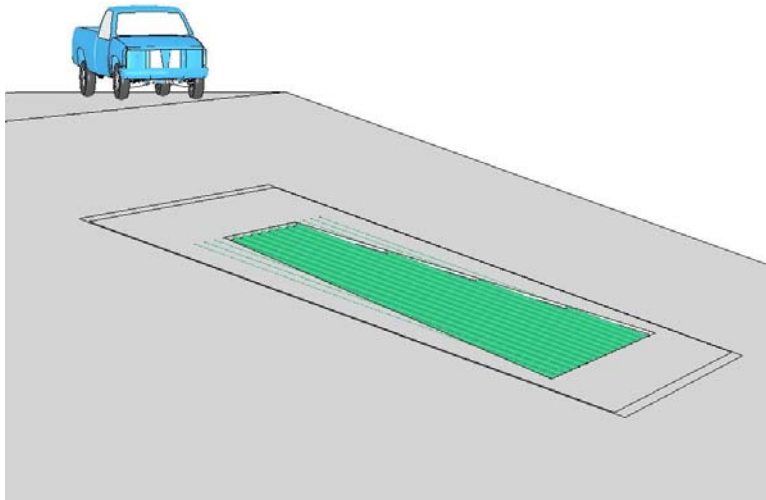
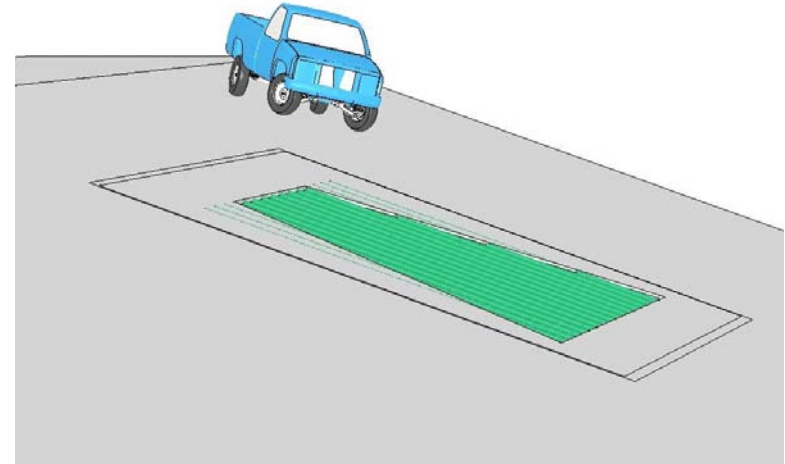
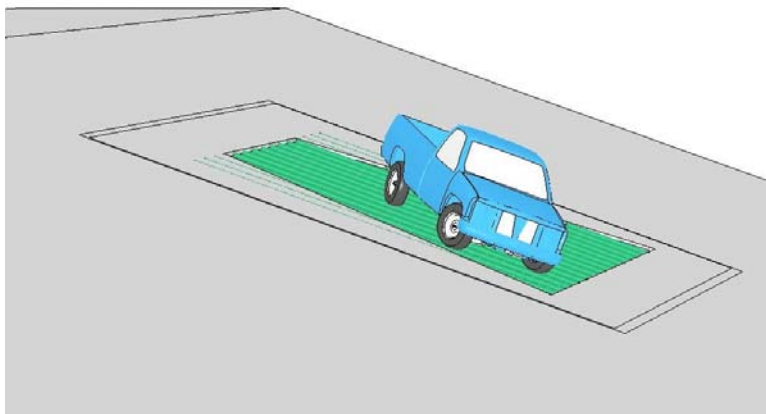
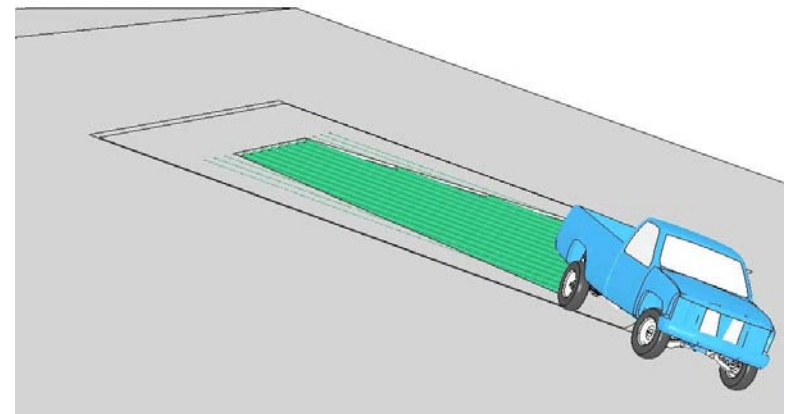
Figure 10. Simulation Results for 2000P Test Vehicle

When a vehicle encroaches onto a 3:1 roadside slope at a high rate of speed, it lifts off of the ground for some time as it falls into the ditch. High exit angles increase the maximum height that the vehicle attains above the slope and the distance that the encroaching vehicle travels before impacting the slope. LS-DYNA indicated that the risk of vehicle suspension damage and snagging on the grate bars is increased with increasing encroachment angle and when the impacting vehicle re-contacts the ground directly on the culvert grate. Note that, because the truck test involves a higher allowable impact angle and a higher vehicle mass, this test produces the maximum loading on the culvert grate and the greatest risk of grate bar yielding, vehicle suspension failure, and snagging on the grate system. Simulation results from this impact condition are shown in Figure 10, while the target landing conditions for the 2000P pickup truck test are shown in Figure 11.

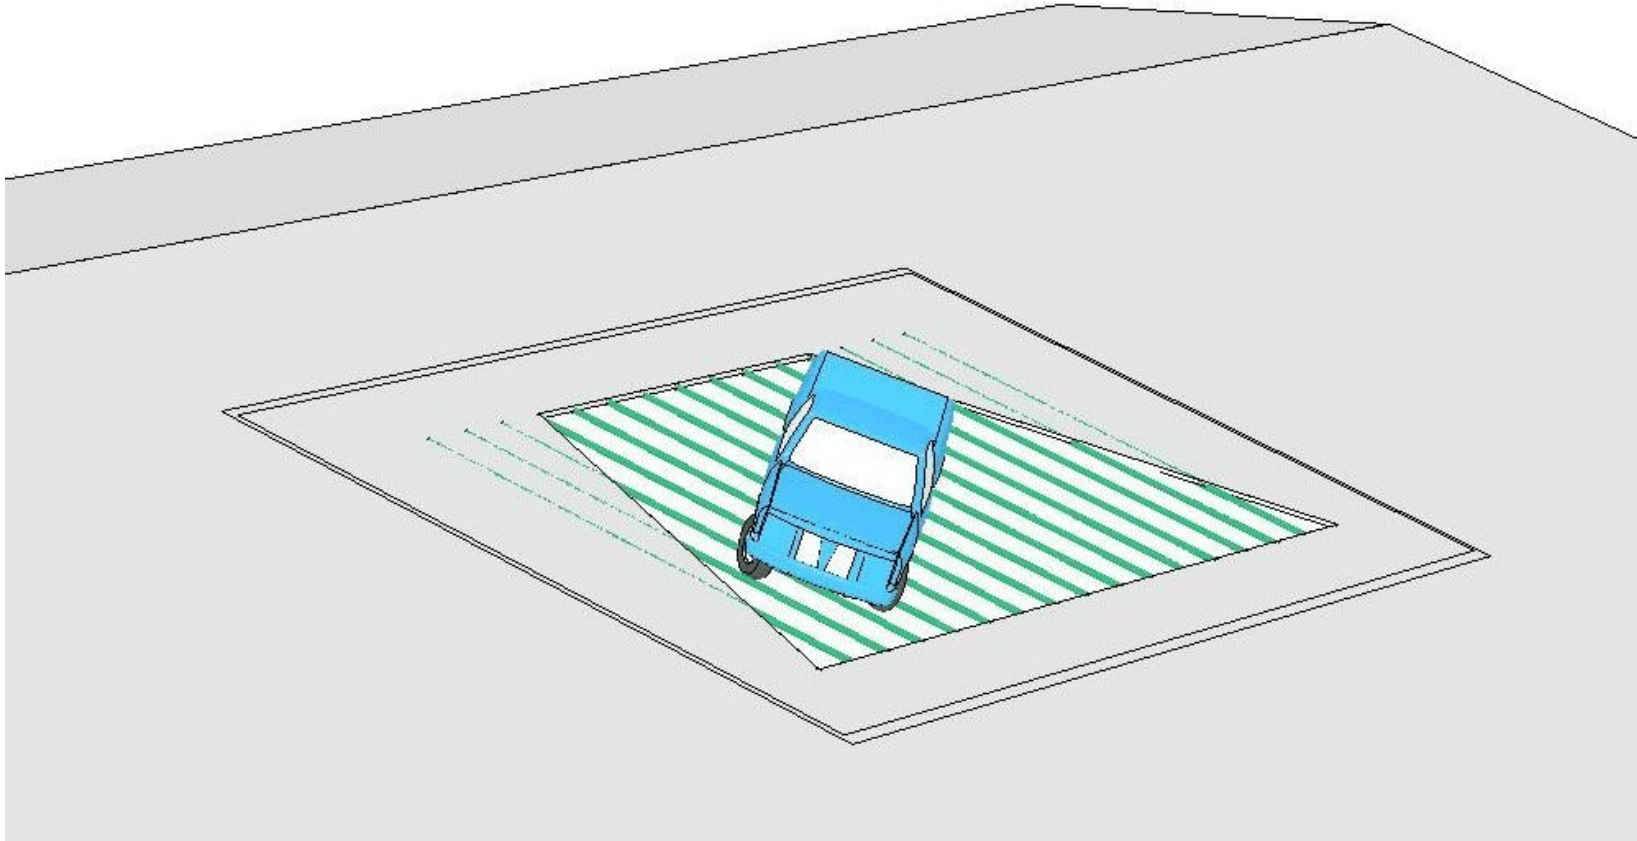
Figure 11. Impact Condition for 2000P Test Vehicle

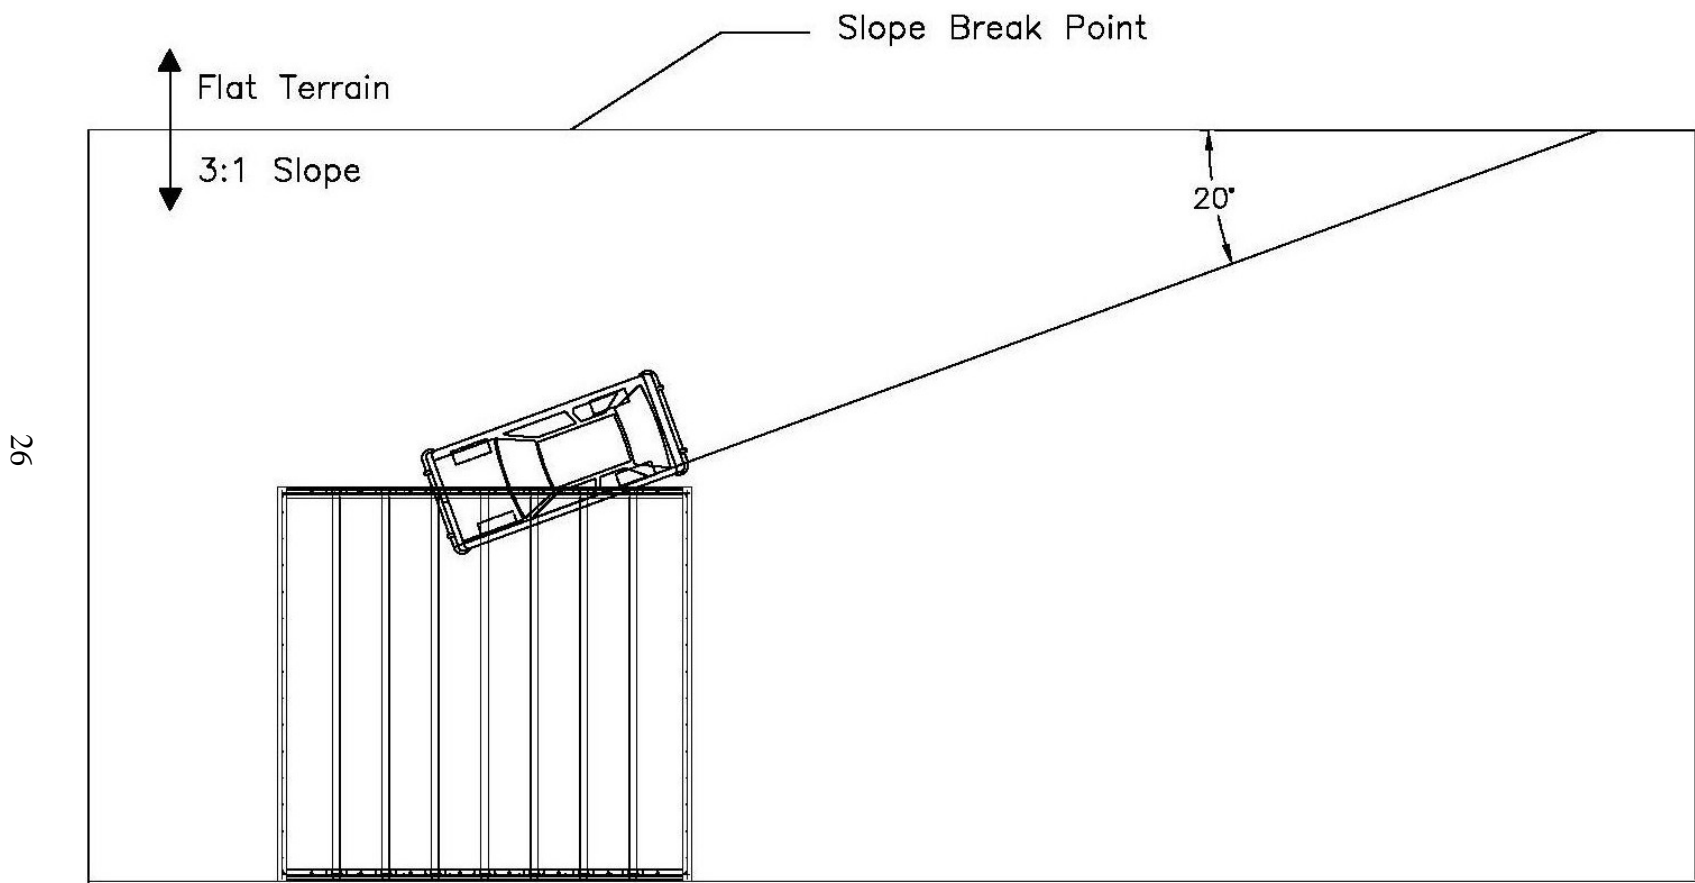
Figure 12. Impact Condition for 820C Test Vehicle

location was moved to allow only one side of the vehicle to land on the grate while the other side landed on the slope. This modeling indicated a potential for the test vehicle to begin to spin out as it traversed across the grating. If the yaw progressed to the point that the vehicle was no longer tracking, the sides of the vehicle tires would begin to contact grate bars and vehicle tripping becomes likely. The impact conditions for the 820C test were therefore chosen to investigate this potential mode of failure. The target landing conditions for the 820C test is shown in Figure 12.

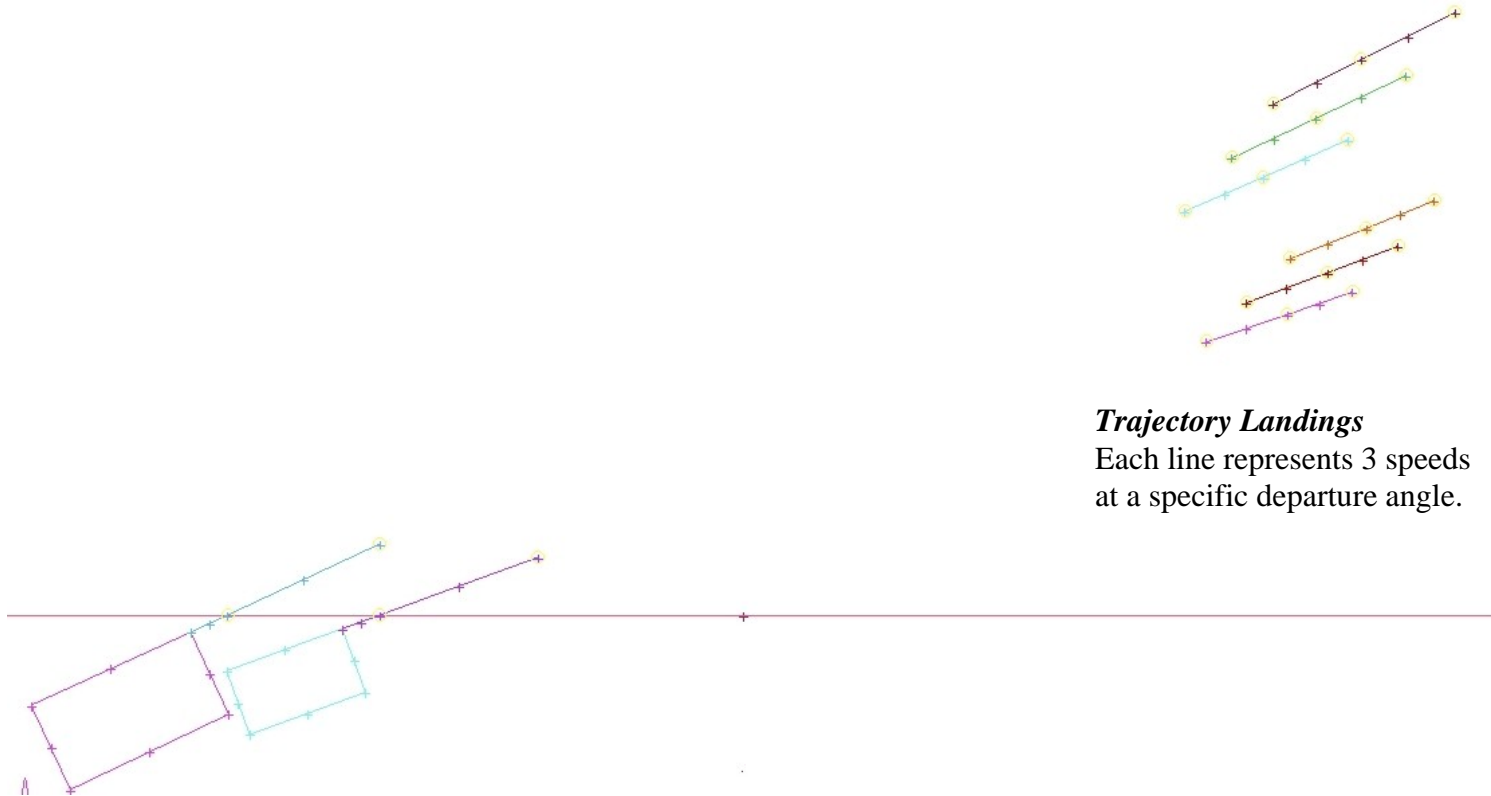
***Trajectory Landings***  
Each line represents 3 speeds  
at a specific departure angle.

Figure 13. Example of Trajectories Used for Sizing Culvert Grate

Minor variations in impact conditions create significant variation in the landing position of the test vehicles. Thus, trajectory runs were made in order to determine bounds for vehicle landing. These bounds were then used to size the culvert grate. A schematic of the trajectory landings for the simulations are shown in Figure 13. For the truck, a total of nine runs were made varying the speed and departure angle: 3 speeds (96, 100, 104 km/h or 59.7, 62.1, 64.6 mph) and 3 angles (23.5, 25, 26.5 deg). Similarly, for the Geo Metro a total of nine runs were made at 3 speeds (96, 100, 104 km/h or 59.7, 62.1, 64.6 mph) and 3 angles at each speed (18.5, 20, 21.5 deg).

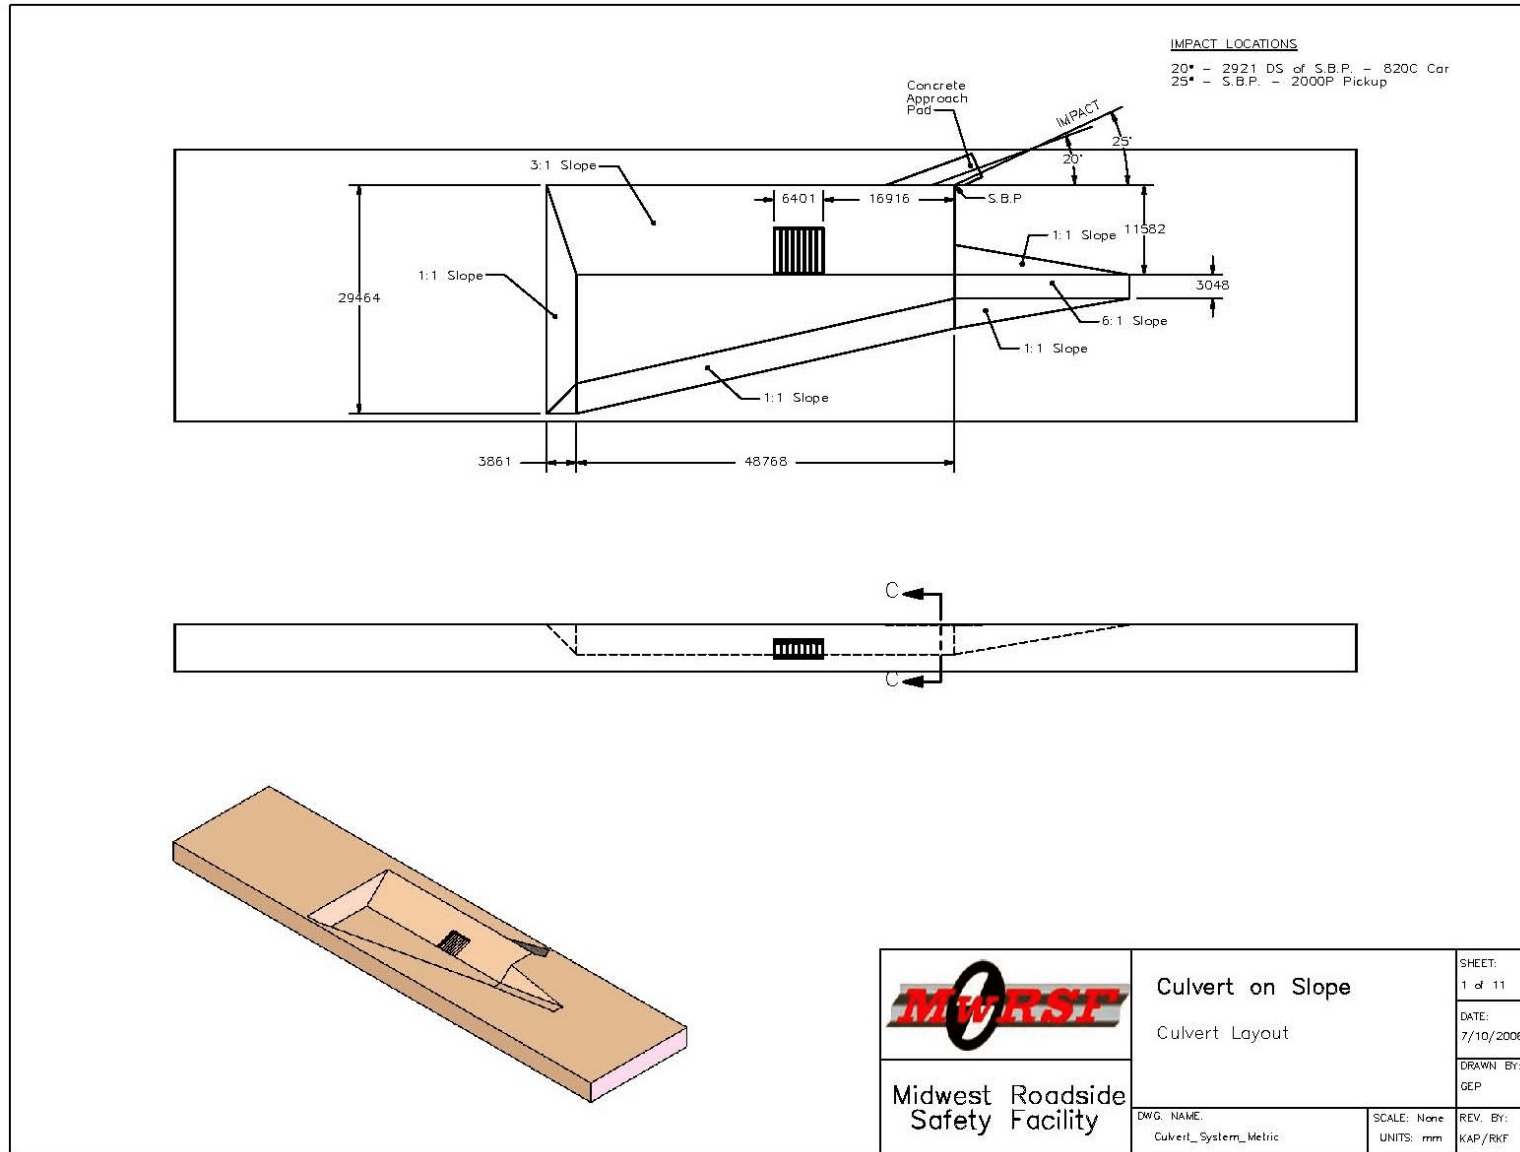
Figure 14. Culvert Layout

The test installation consisted of a 6.1 m x 6.1 m (20 ft x 20 ft) simulated culvert grate system mounted on top of a mock culvert. Design details are shown in Figures 14 through 20. The corresponding English-unit drawings are shown in Appendix B. Photographs of the test installation are shown in Figure 21.

The culvert grate system was intended to simulate a safety treatment of a 2.1 m (7 ft) high by 6.4 m (21 ft) wide culvert installed on a 3:1 slope. The culvert grate consisted of seven 102-mm (4-in.) diameter schedule 40 steel pipes which were 6.1 m (20 ft) long. The pipes were spaced 762 mm (30 in.) on center with the outside ones 762 mm (30 in.) away from the culvert's outside edges. Note that the 6.1 m (20 ft) span is the maximum allowable length for 102-mm (4-in.) diameter pipe (7). The culvert was constructed 5.8 m (19 ft) downhill from the top of a 3:1 embankment.

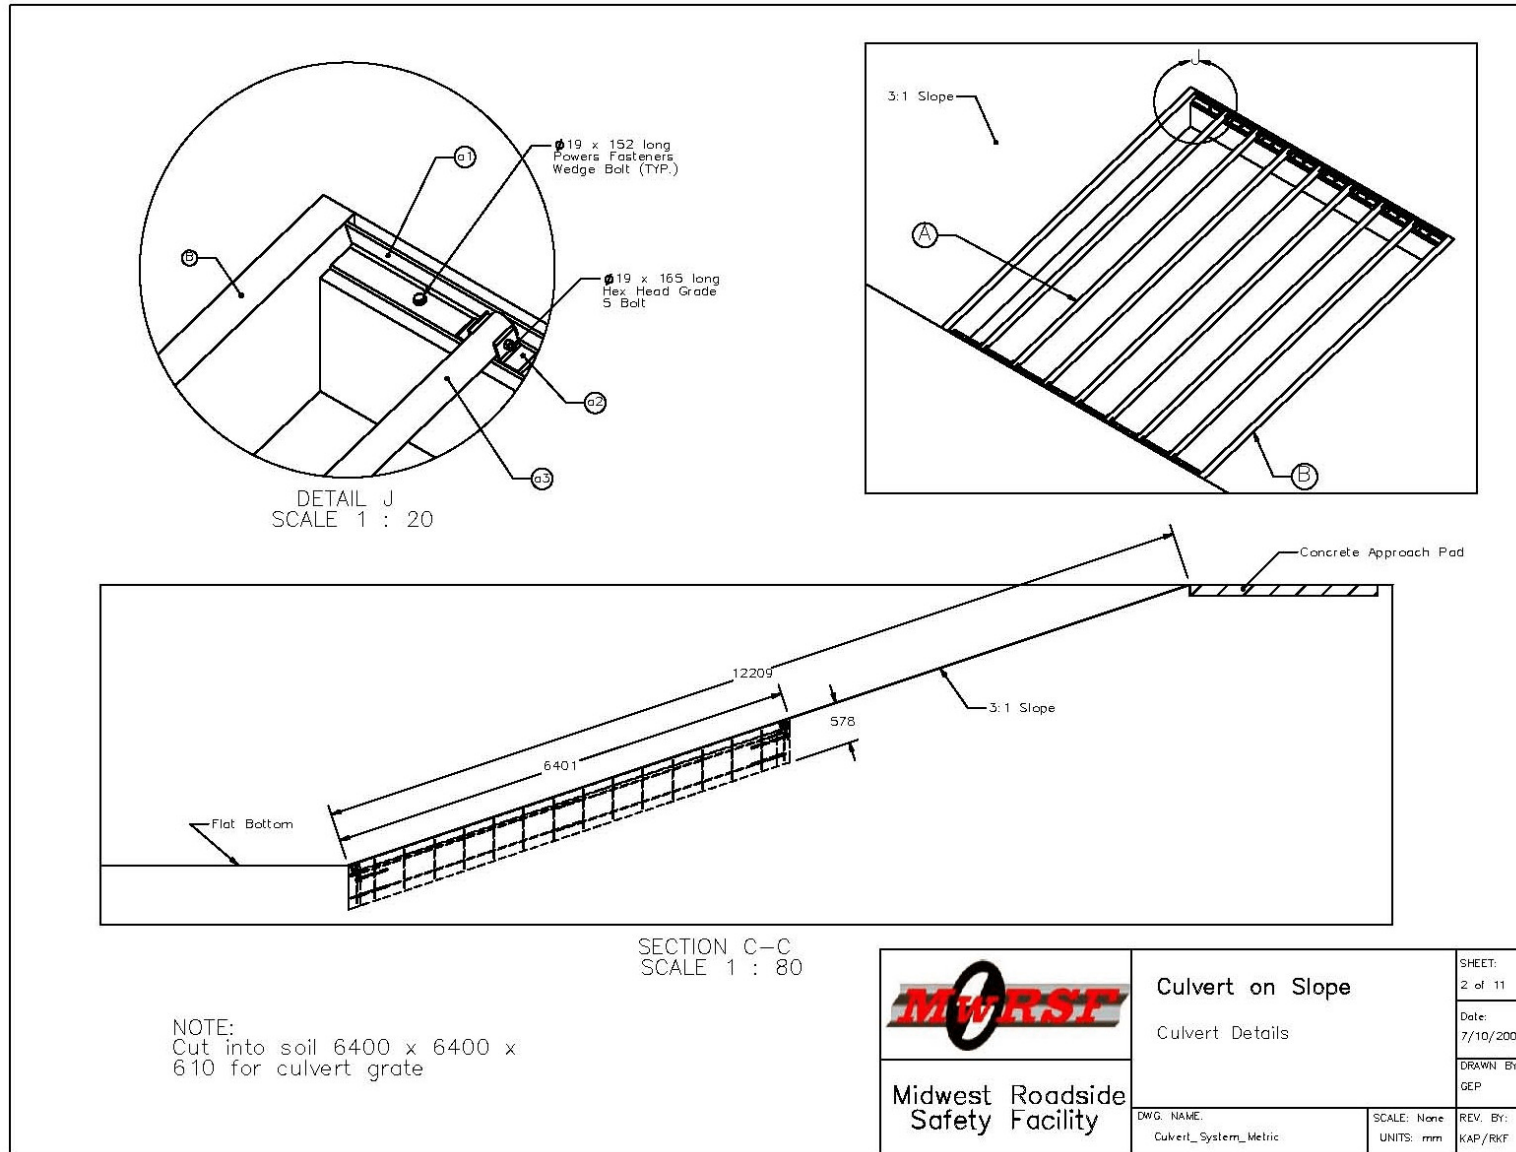
Figure 15. Culvert Details

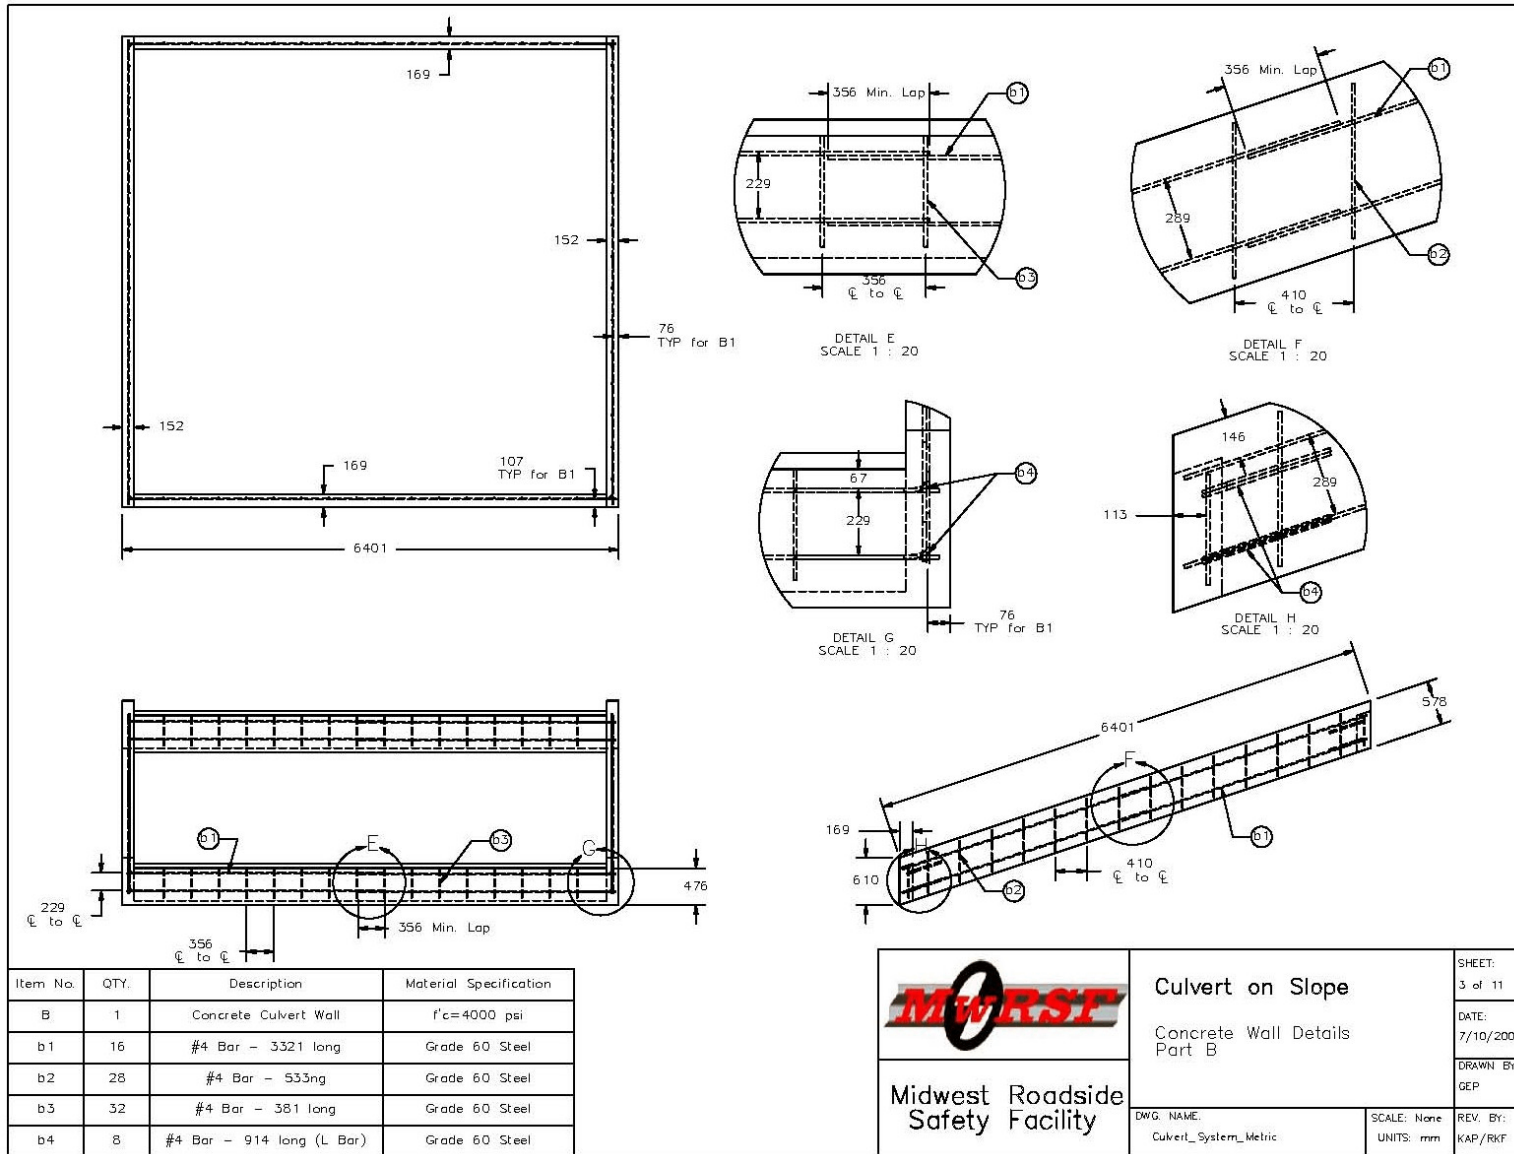
Figure 16. Concrete Wall Details

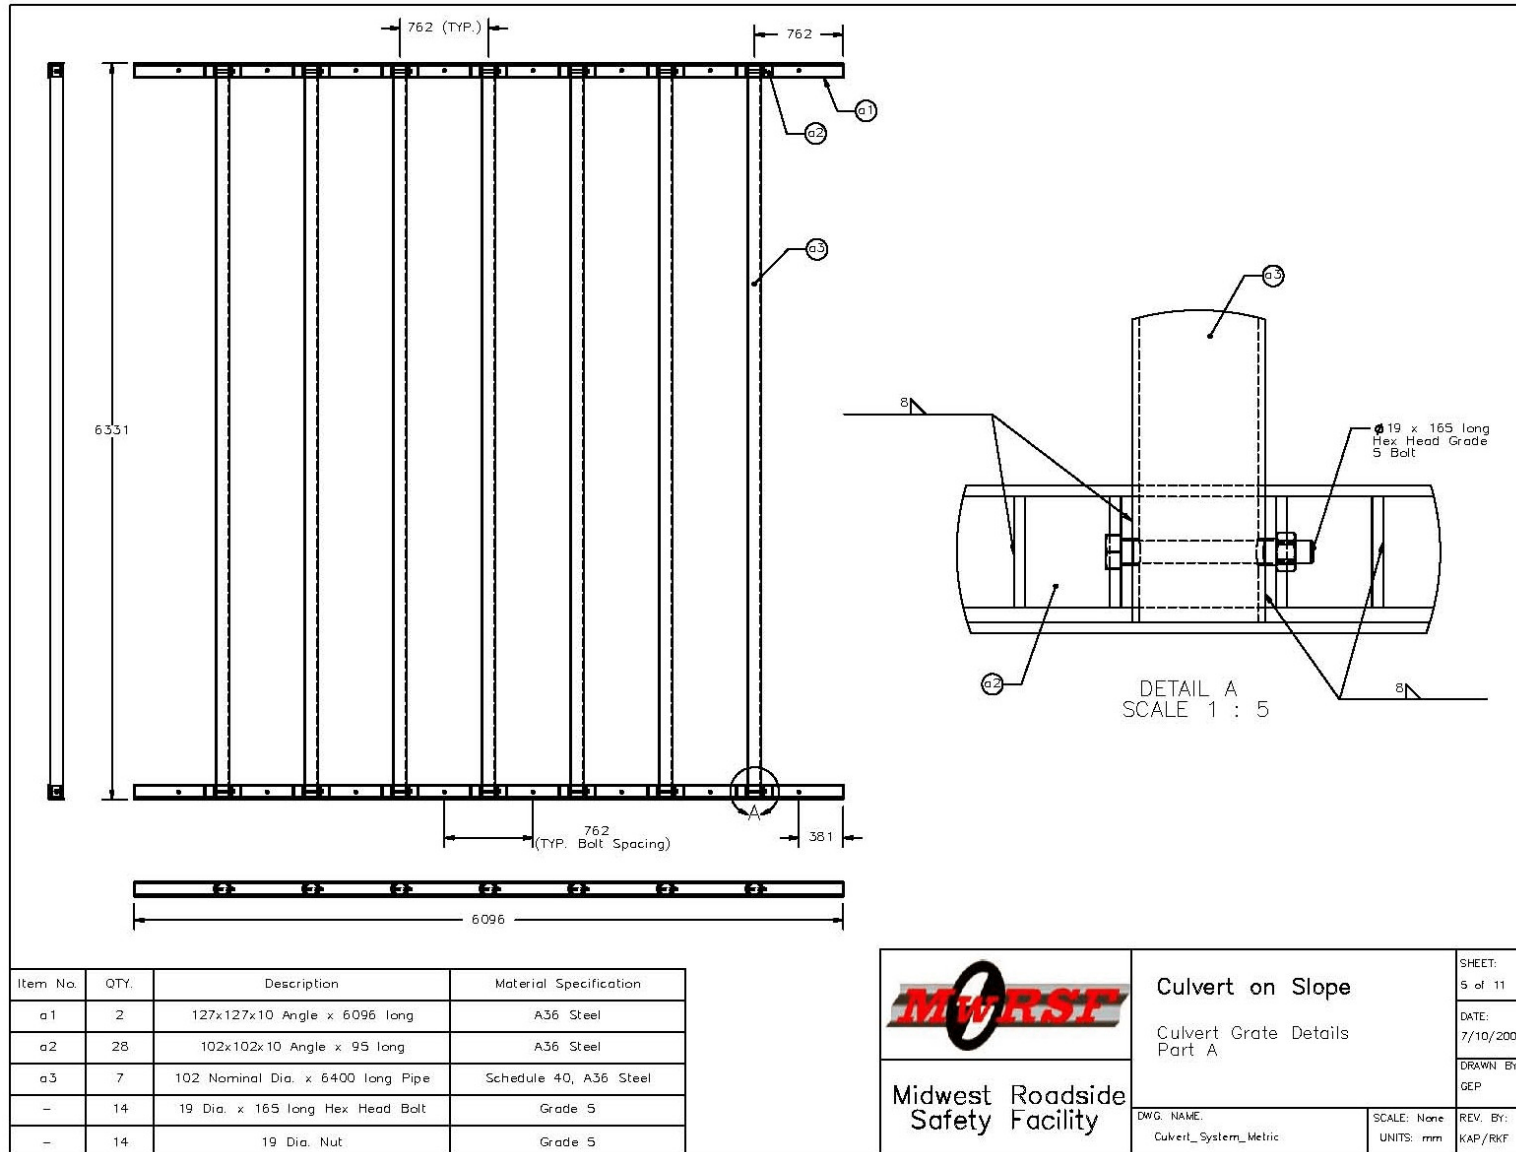
Figure 18. Culvert Grate Details

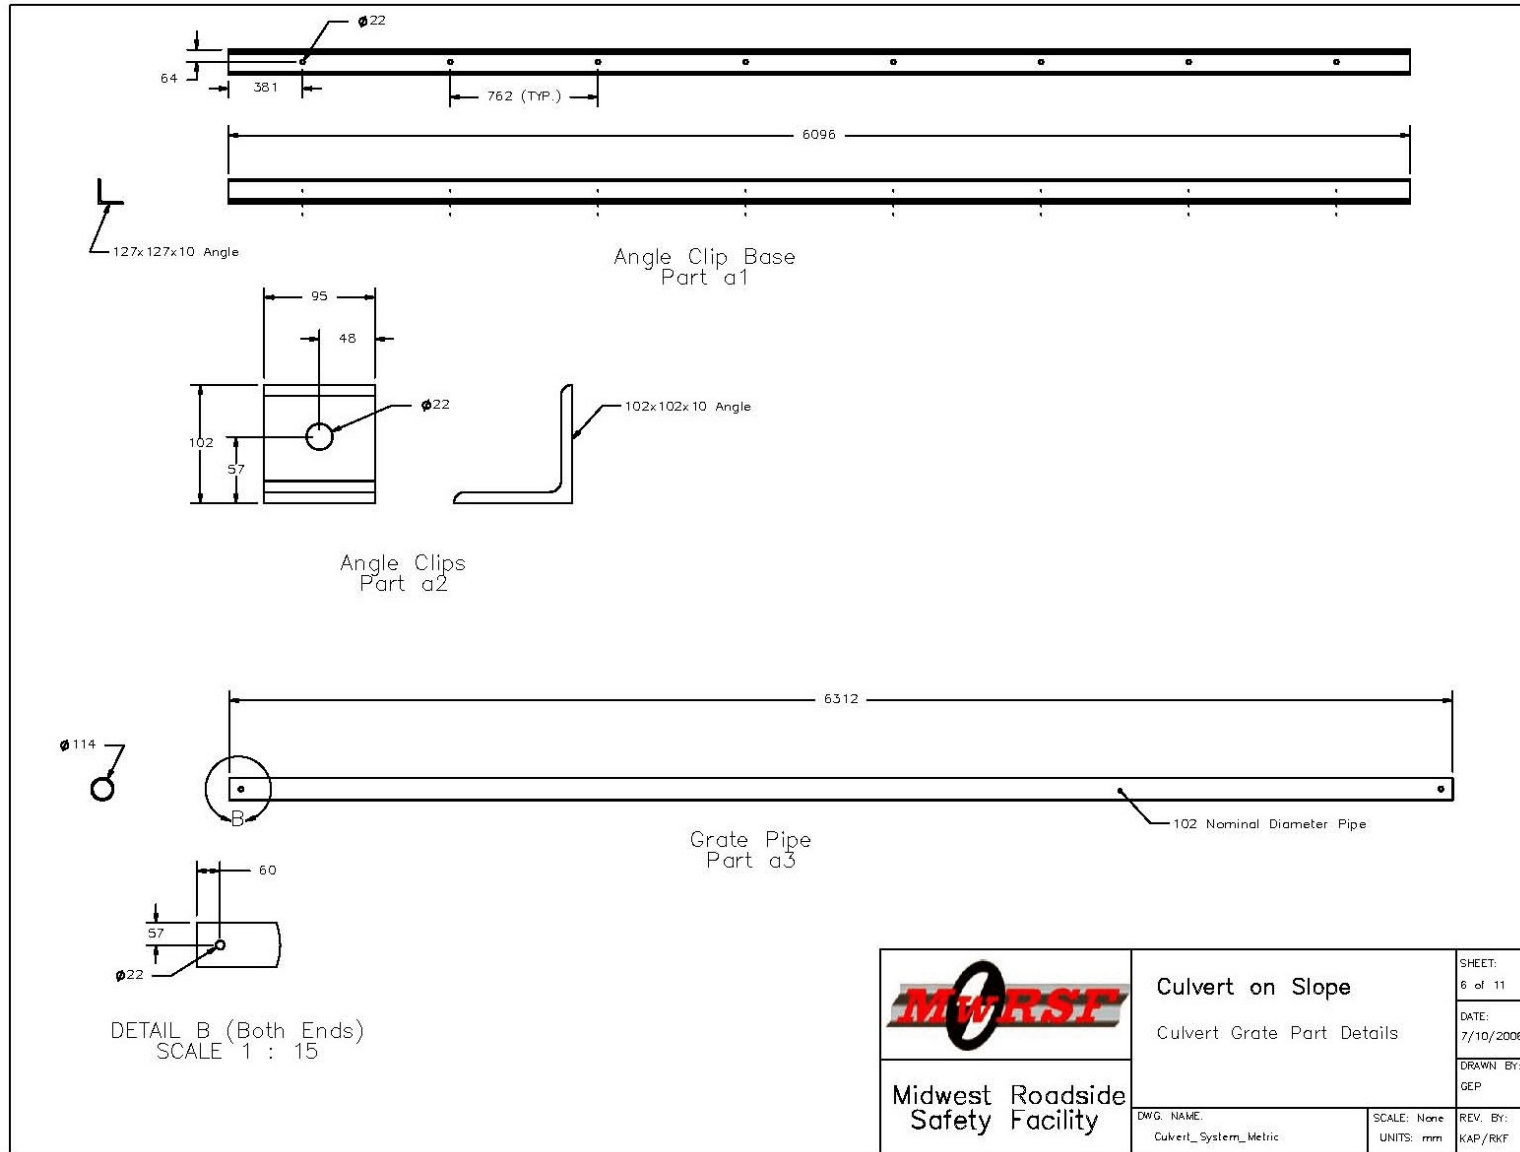
Figure 19. Culvert Grate Part Details
