# Performance Evaluation of Safety Grates for Cross-Drainage Culverts

Polivka, Karla A.; Sicking, Dean L.; Bielenberg, Robert W.; Rohde, John R.; Faller, Ronald K.; and Reid, John D., "Performance Evaluation of Safety Grates for Cross-Drainage Culverts" (2008). *Nebraska Department of Transportation Research Reports*. 84.  
<http://digitalcommons.unl.edu/ndor/84>

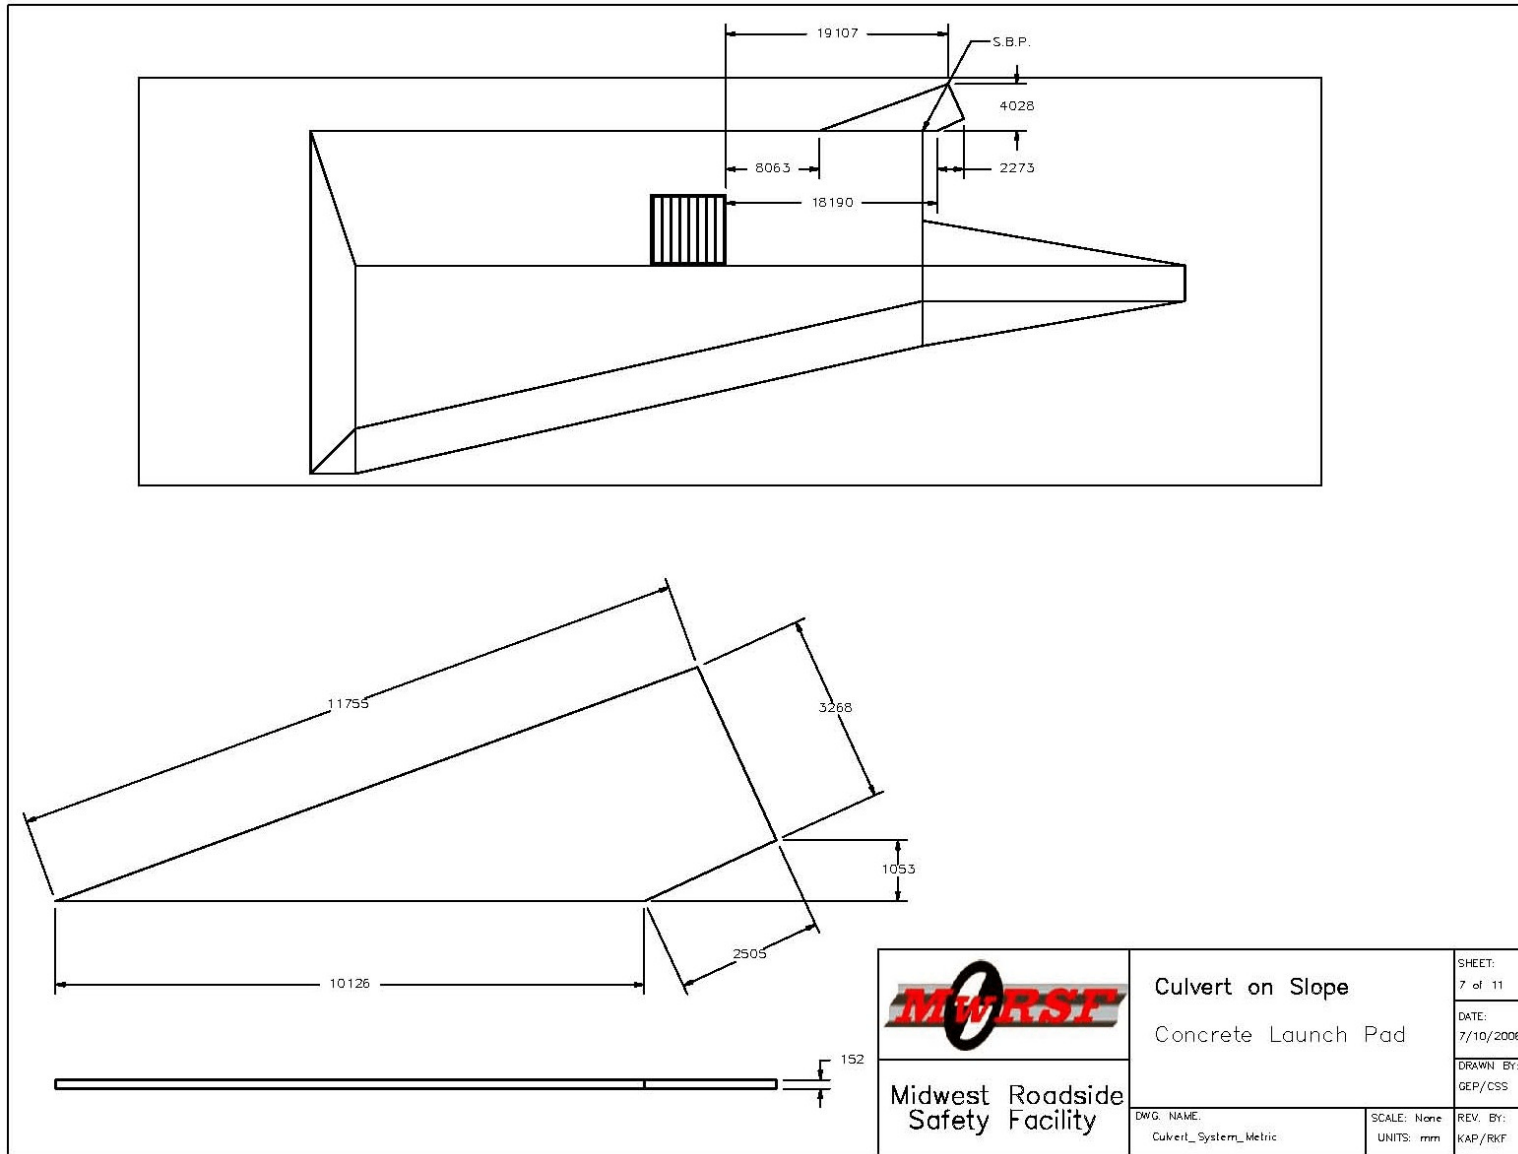
Figure 20. Concrete Launch Pad

The test installation consisted of a 6.1 m x 6.1 m (20 ft x 20 ft) simulated culvert grate system mounted on top of a mock culvert. Design details are shown in Figures 14 through 20. The corresponding English-unit drawings are shown in Appendix B. Photographs of the test installation are shown in Figure 21.

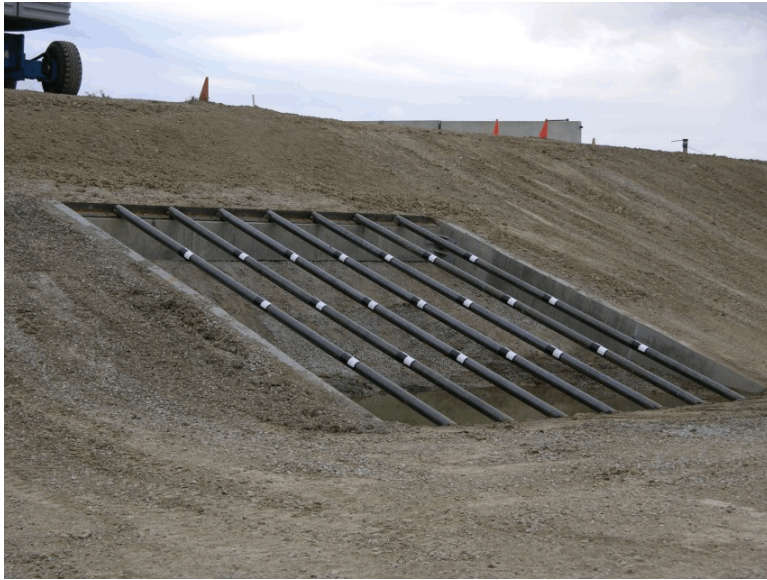
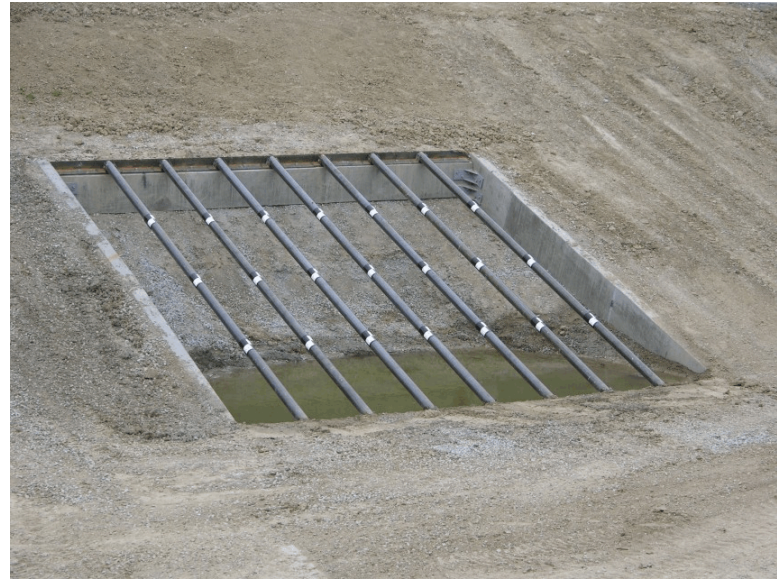
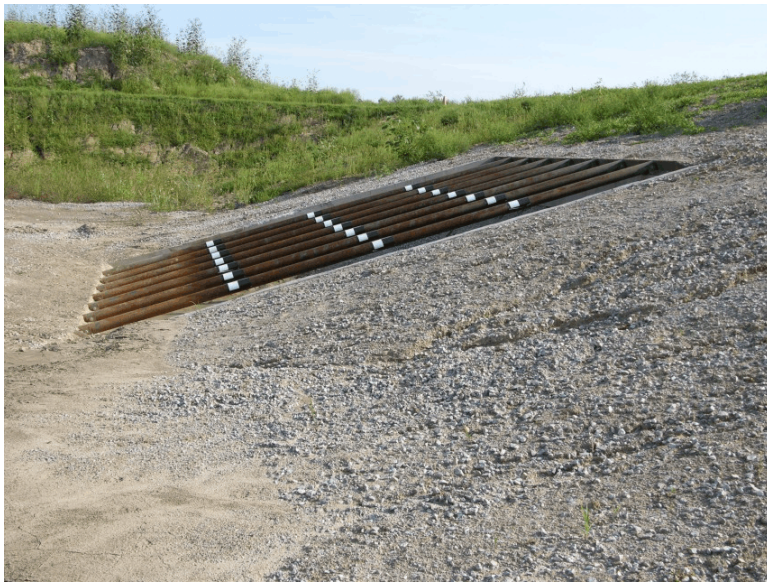
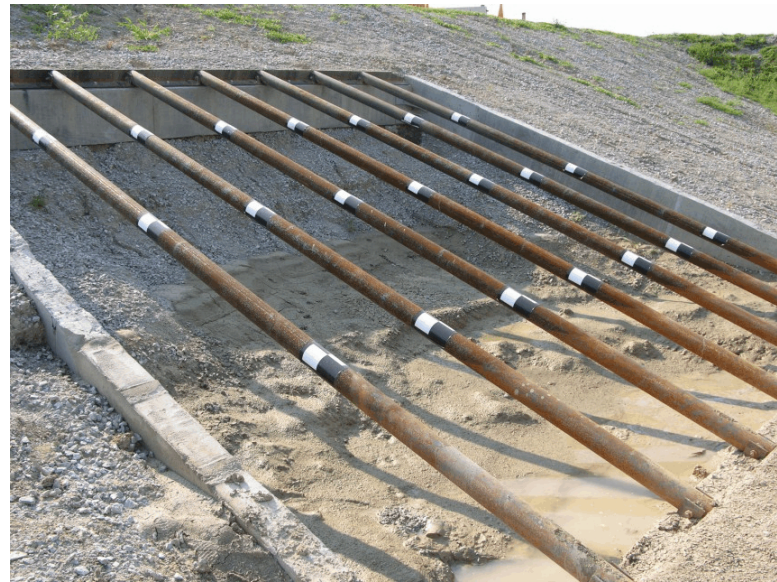
Figure 21. Culvert Grate System Details, Tests KSCG-1 and KSCG-2

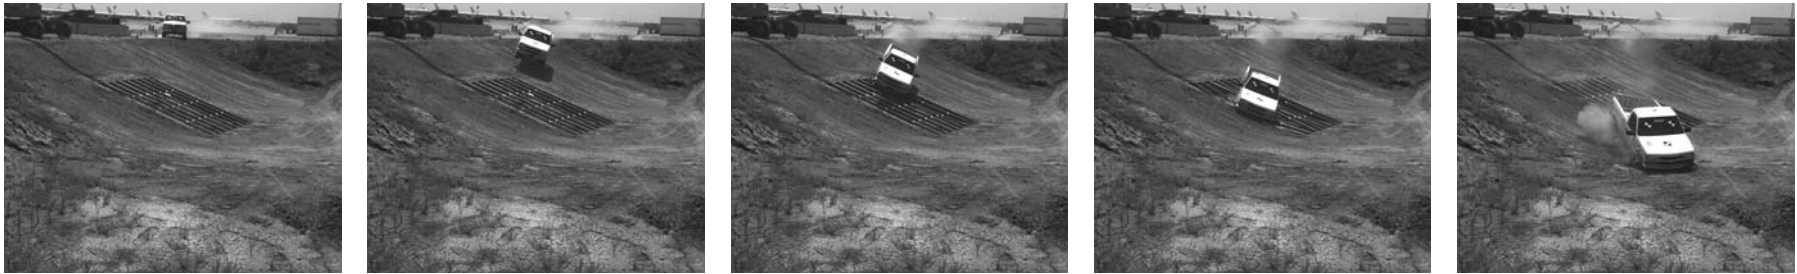
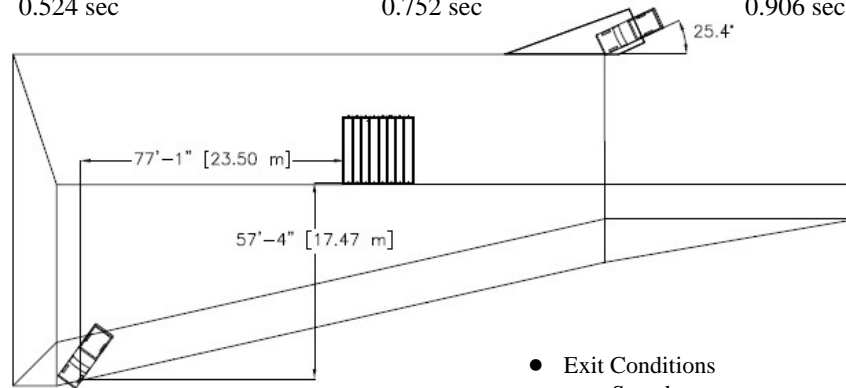
- Test Agency ..... MwRSF
- Test Number ..... KSCG-1
- Date ..... 7/20/06
- NCHRP 350 Test Designation ..... 3-11
- Test Article ..... Transverse Culvert Safety Grate
- Total Length ..... 6.1 m
- Total Width ..... 6.1 m
- Placement ..... 5.81 m down from 3:1 slope breakpoint
- Key Elements - Grate Piping
  - Type ..... Schedule 40 pipe
  - Diameter ..... 102 mm
  - Length ..... 6.1 m
  - Spacing ..... 762 mm
- Type of Soil ..... NA
- Test Vehicle
  - Type/Designation ..... 2000P
  - Make and Model ..... 2000 Chevrolet C2500
  - Curb ..... 2,196 kg
  - Test Inertial ..... 2,034 kg
  - Gross Static ..... 2,034 kg
- Impact Conditions
  - Speed ..... 97.9 km/h
  - Angle (trajectory) ..... 25.4 deg

- Exit Conditions
  - Speed ..... 61.5 km/h
  - Angle ..... 31.0 deg
- Post-Impact Trajectory
  - Vehicle Stability ..... Satisfactory
  - Stopping Distance ..... 23.50 m downstream and 17.47 m laterally from lower-downstream corner of culvert
- Occupant Impact Velocity
  - Longitudinal ..... 7.15 m/s < 12 m/s
  - Lateral (not required) ..... 1.09 m/s
- Occupant Ridedown Deceleration (10 msec avg.)
  - Longitudinal ..... 4.03 g's < 20 g's
  - Lateral (not required) ..... 3.69 g's
- THIV (not required) ..... 7.62 m/s
- PHD (not required) ..... 4.92 g's
- Test Article Damage ..... Moderate
- Test Article Deflections
  - Permanent Set ..... 184 mm
  - Dynamic ..... NA
  - Working Width ..... NA
- Vehicle Damage ..... Moderate
  - VDS<sup>10</sup> ..... 1-FC-1
  - CDC<sup>11</sup> ..... 1-RFWE2
  - OCDI ..... F000000000
  - Maximum Deformation ..... 19 mm

Figure 22. Summary of Test Results and Sequential Photographs, Test KSCG-1

The 2,034-kg (4,484-lb) pickup truck encroached onto a 3:1 slope approximately 16.9 m (55 ft - 6 in.) upstream of the culvert grate at a speed of 97.9 km/h (60.8 mph) and at an angle of 25.4 degrees. No steer input was imparted to the airborne vehicle prior to landing on the slope. A summary of the test results and sequential photographs are shown in Figure 22. The summary of the test results and sequential photographs in English units are shown in Appendix C. Additional sequential photographs are shown in Figures 23 and 24. Documentary photographs of the crash test are shown in Figures 25 through 27.

with the surface of the slope. The test vehicle rolled forward until it contacted a nearly vertical embankment and came to rest 23.50 m (77 ft - 1 in.) downstream and 17.47 m (57 ft - 4 in.) laterally away from the lower-downstream corner of the culvert grate system. The trajectory and final position of the pickup truck are shown in Figures 22 and 28.

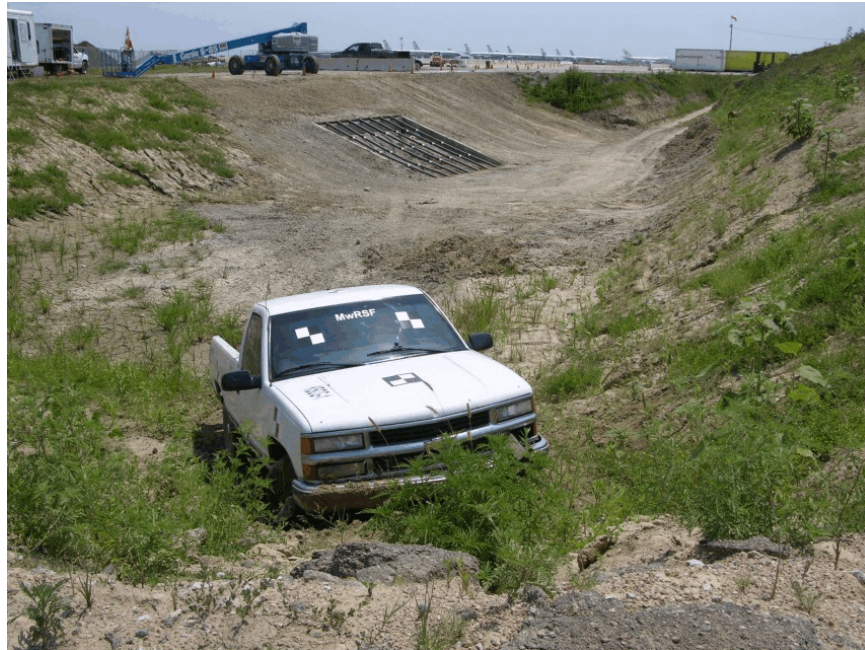
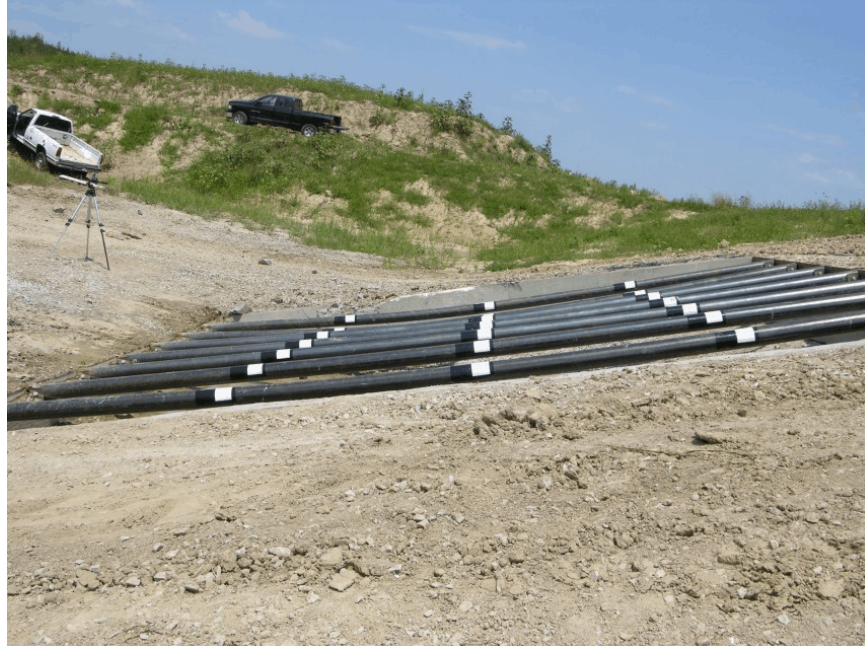
Figure 28. Vehicle Final Position and Trajectory Marks, Test KSCG-1

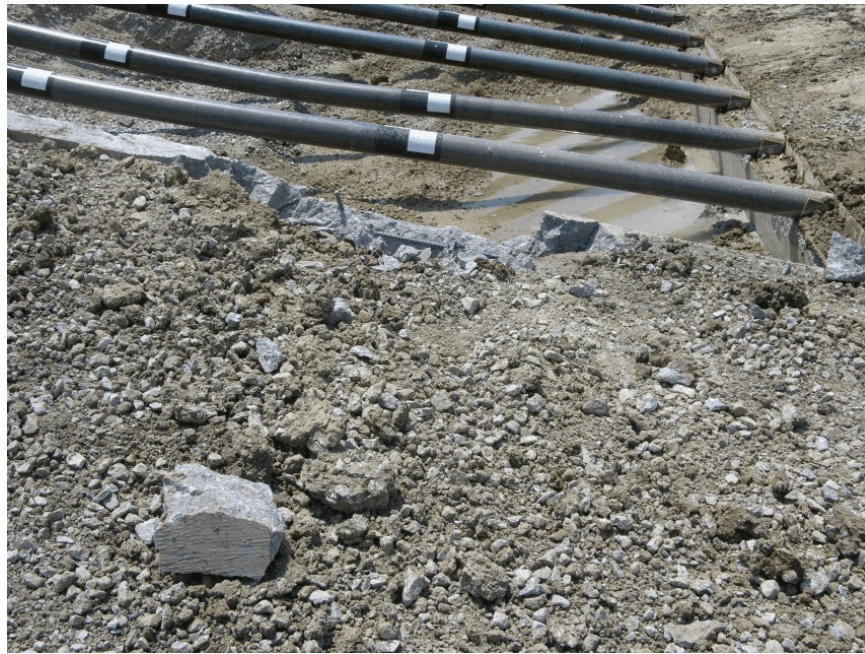
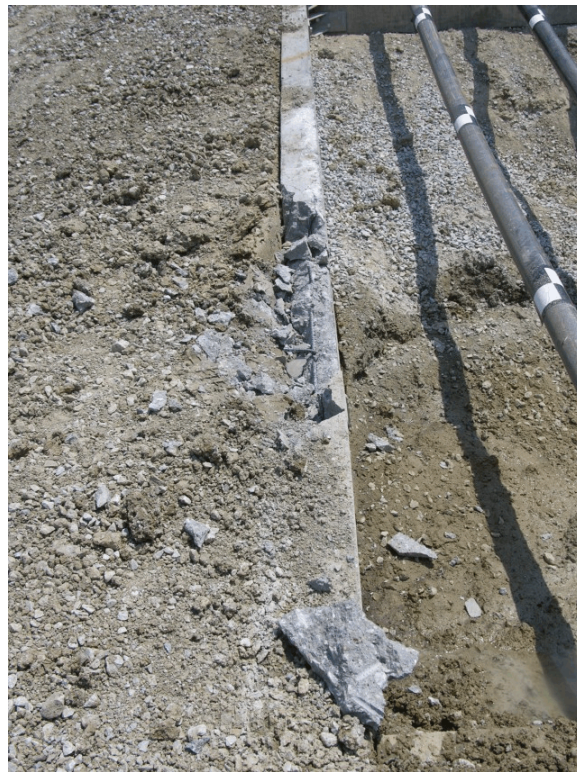
Figure 30. Culvert Grate System Damage, Test KSCG-1

Damage to the barrier was moderate, as shown in Figures 29 and 30. System damage consisted mostly of deformed pipes, contact marks on the grate and the concrete culvert wall, and damaged concrete.

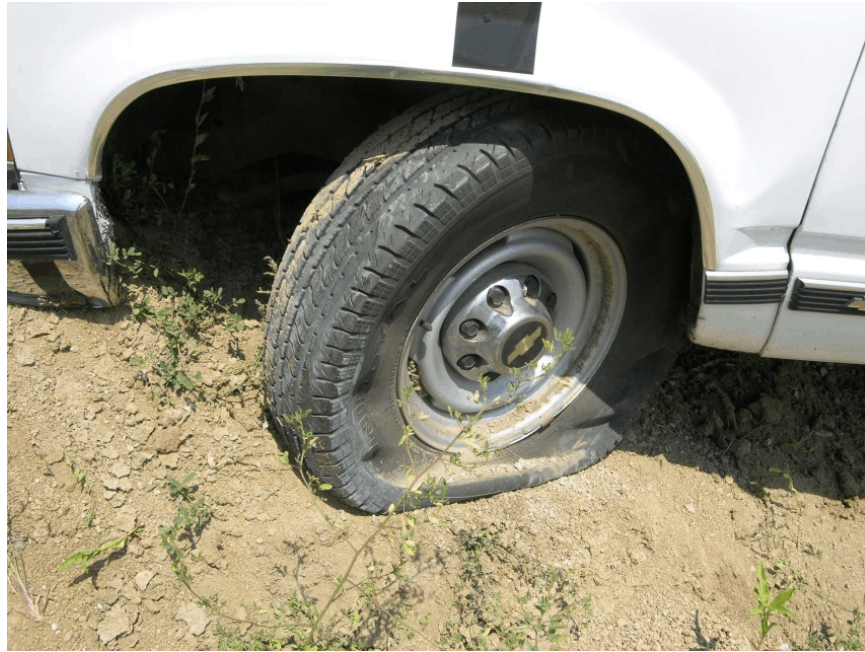
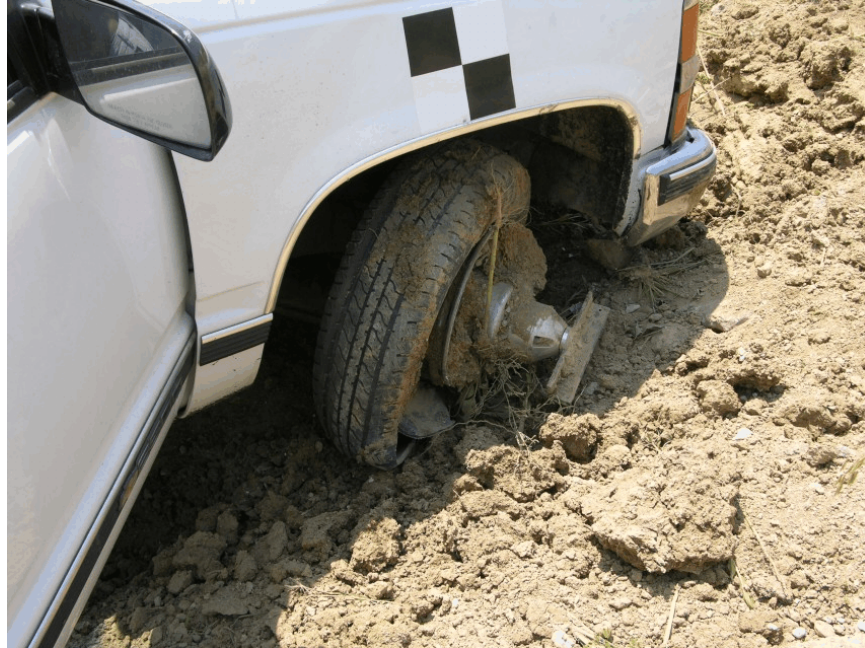
Figure 32. Vehicle Damage, Test KSCG-1

Exterior vehicle damage was minimal, as shown in Figures 31 through 33. Occupant compartment deformations to the right side and center of the floorboard were judged insufficient to cause serious injury to the vehicle occupants. Maximum longitudinal deflections of 6 mm (0.25 in.) were located at several points throughout the right-side floor pan. Maximum lateral deflections of

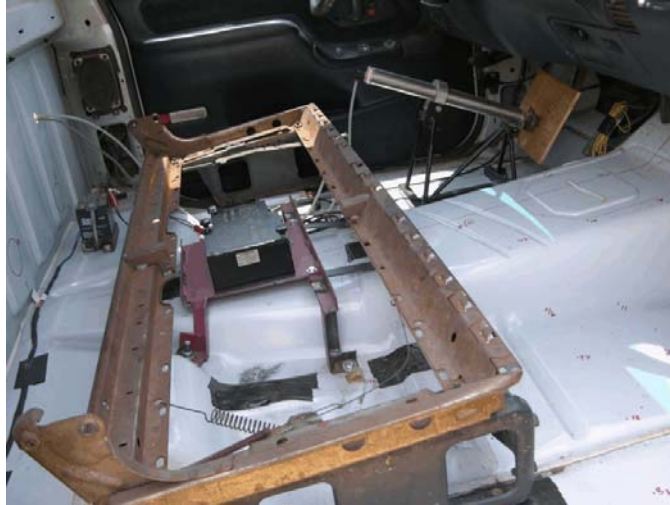
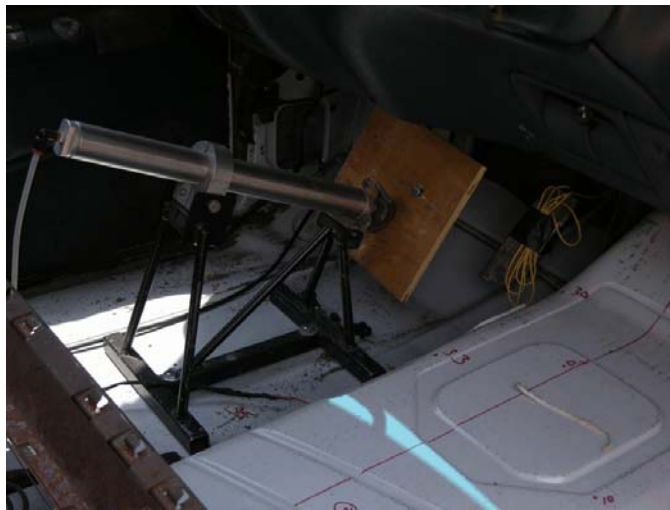
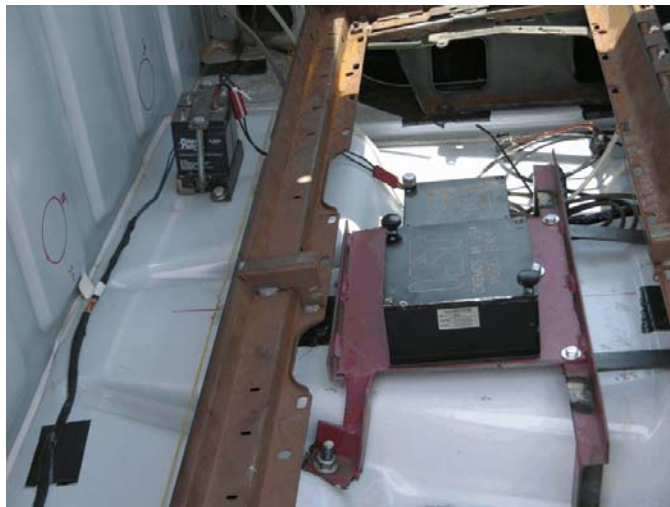
Figure 33. Occupant Compartment Damage, Test KSCG-1

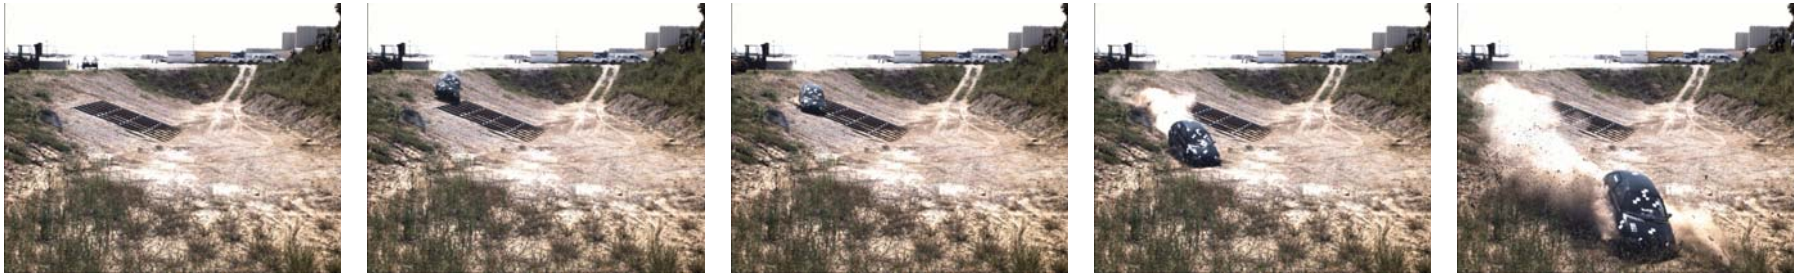
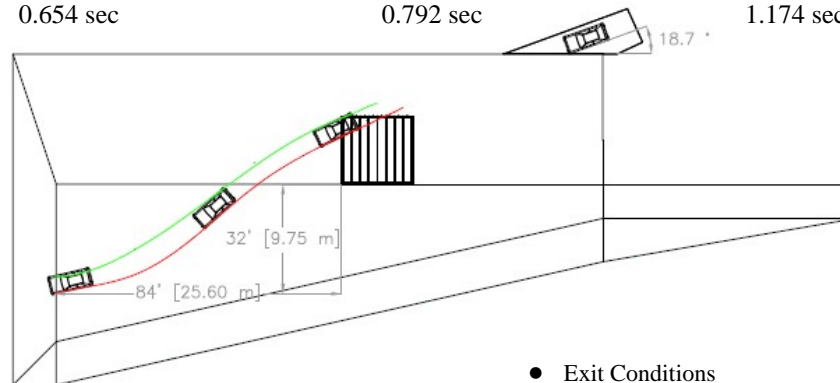
- Test Agency ..... MwRSF
- Test Number ..... KSCG-2
- Date ..... 8/23/06
- NCHRP 350 Test Designation ..... 3-10
- Test Article ..... Transverse Culvert Safety Gate
- Total Length ..... 6.1 m
- Total Width ..... 6.1 m
- Placement ..... 5.81 m down from the 3:1 slope breakpoint
- Key Elements - Grate Piping
  - Type ..... Schedule 40 pipe
  - Diameter ..... 102 mm
  - Length ..... 6.1 m
  - Spacing ..... 762 mm
- Type of Soil ..... NA
- Test Vehicle
  - Type/Designation ..... 820C
  - Make and Model ..... 1999 Chevrolet Metro
  - Curb ..... 836 kg
  - Test Inertial ..... 831 kg
  - Gross Static ..... 906 kg
- Impact Conditions
  - Speed ..... 98.6 km/h
  - Angle (trajectory) ..... 18.7 deg

- Exit Conditions
  - Speed ..... NA
  - Angle ..... NA
- Post-Impact Trajectory
  - Vehicle Stability ..... Satisfactory
  - Stopping Distance ..... 25.60 m downstream and 9.75 m laterally from lower-downstream corner of culvert
- Occupant Impact Velocity
  - Longitudinal ..... 3.80 m/s < 12 m/s
  - Lateral ..... 2.03 m/s < 12 m/s
- Occupant Ridedown Deceleration (10 msec avg.)
  - Longitudinal ..... 14.38 g's < 20 g's
  - Lateral ..... 3.58 g's < 20 g's
- THIV (not required) ..... 4.36 m/s
- PHD (not required) ..... 14.65 g's
- Test Article Damage ..... Minimal
- Test Article Deflections
  - Permanent Set ..... 0 mm
  - Dynamic ..... NA
  - Working Width ..... NA
- Vehicle Damage ..... Minimal
  - VDS<sup>10</sup> ..... 1-FD-1
  - CDC<sup>11</sup> ..... 1-FDWW1
  - OCDI ..... F000000000
  - Maximum Deformation ..... None observed

Figure 34. Summary of Test Results and Sequential Photographs, Test No. KSCG-2

The 906-kg (1,997-lb) small car was propelled off of the edge of a 3:1 slope approximately 14.0 m (45 ft - 11 in.) upstream of the culvert grate at a speed of 98.6 km/h (61.3 mph) and at an angle of 18.7 degrees. No steer input was imparted to the airborne vehicle prior to landing on the slope. A summary of the tests results and sequential photographs are shown in Figure 34. The summary of the test results and sequential photographs in English units are shown in Appendix C. Additional sequential photographs are shown in Figure 35. Documentary photographs of the crash test are shown in Figures 36 and 37.

continued downstream until it came to rest on the 1:1 upslope approximately 25.60 m (84 ft) downstream and 9.75 m (32 ft) laterally away from the lower-downstream corner of the culvert grate. The trajectory and final position of the small car are shown in Figures 34 and 38.

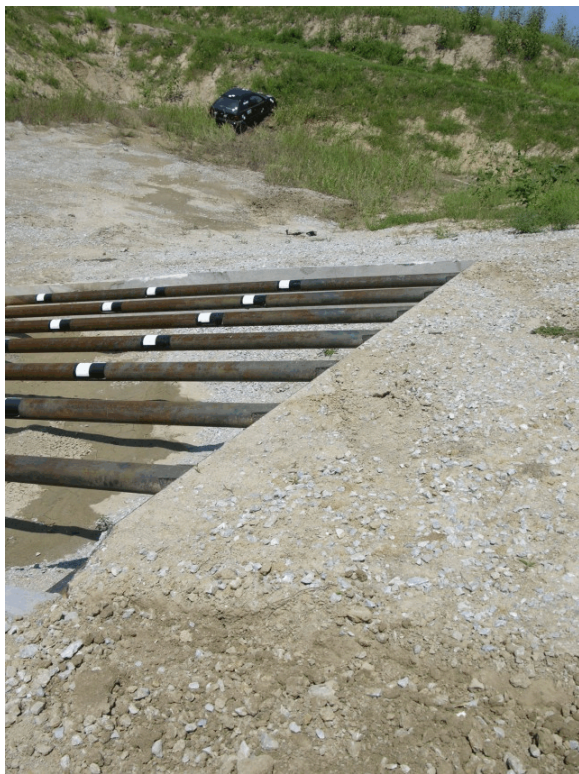
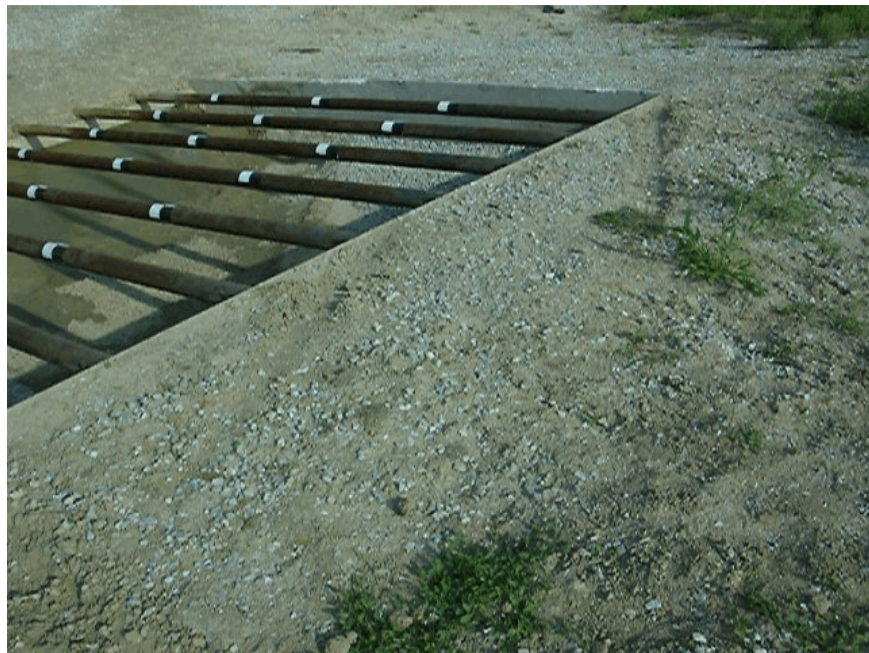
Figure 38. Vehicle Final Position and Trajectory Marks, Test KSCG-2

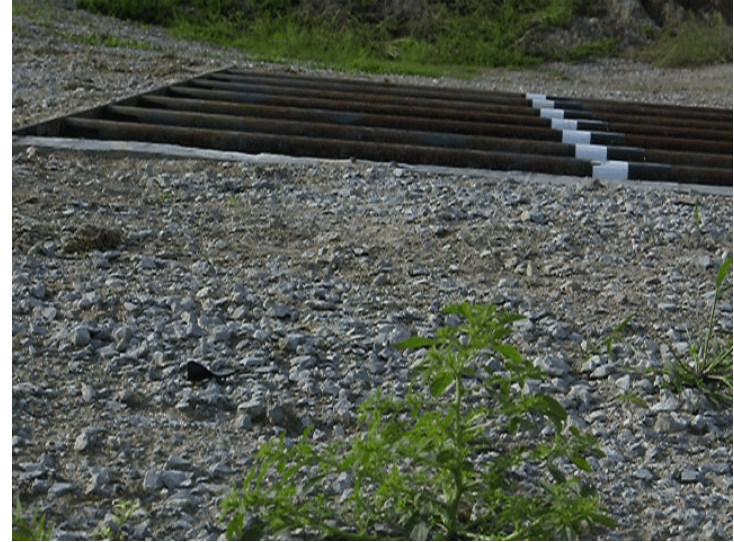
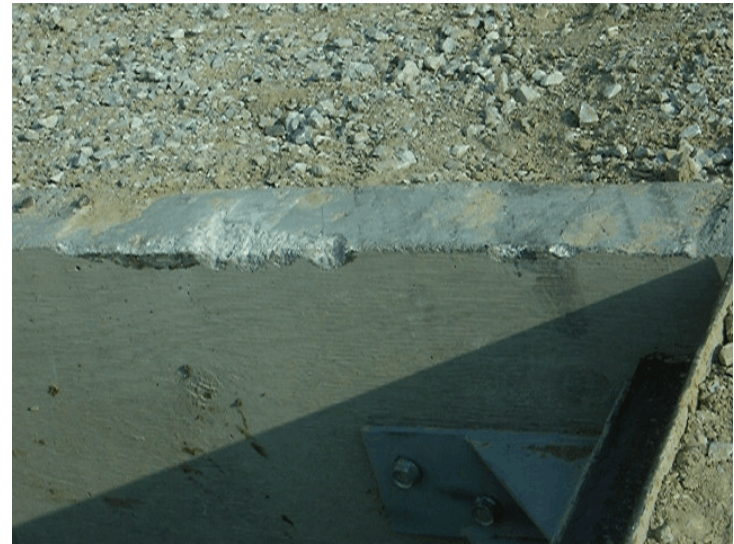
Figure 39. Culvert Grate System Damage, Test KSCG-2

Damage to the system was minimal, as shown in Figure 39. System damage consisted of contact marks on the grate pipes and concrete culvert wall and damaged concrete. None of the culvert pipes displayed permanent deformation. Contact marks were found on all seven grate pipes. Concrete damage was observed on the upper portion of the downstream edge of the culvert wall due to the impact of the wheels and tires. The concrete damage consisted of broken and spalled concrete beginning 508 mm (20 in.) from the upper, downstream corner of the culvert and extending down the downstream culvert wall for 559 mm (22 in.).

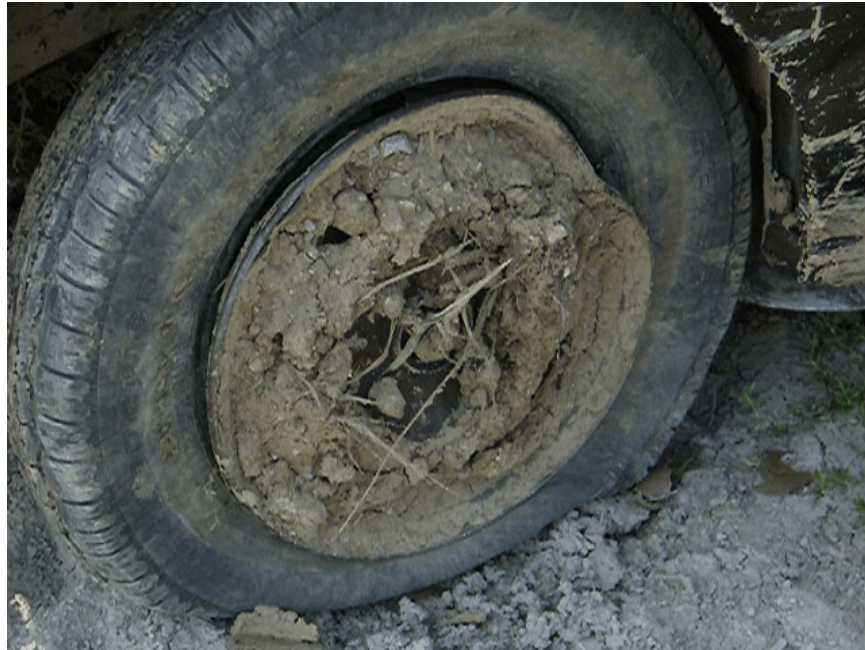
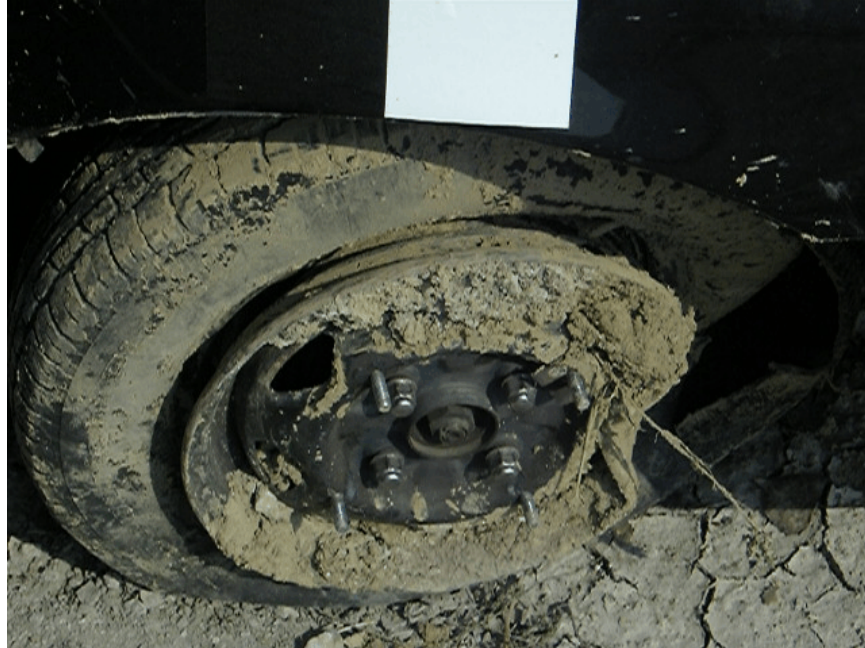
Figure 41. Vehicle Damage, Test KSCG-2

Exterior vehicle damage was minimal, as shown in Figures 40 through 43. Interior occupant compartment damage was negligible with no significant observable deformations of the occupant compartment observed. The occupant compartment deformations and the corresponding locations are provided in Appendix D.

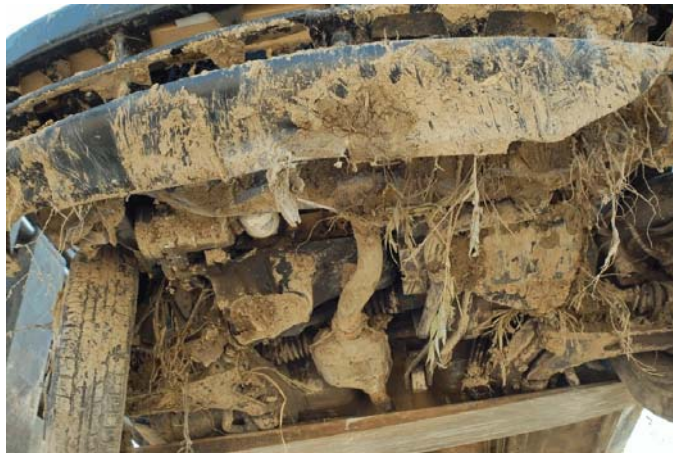
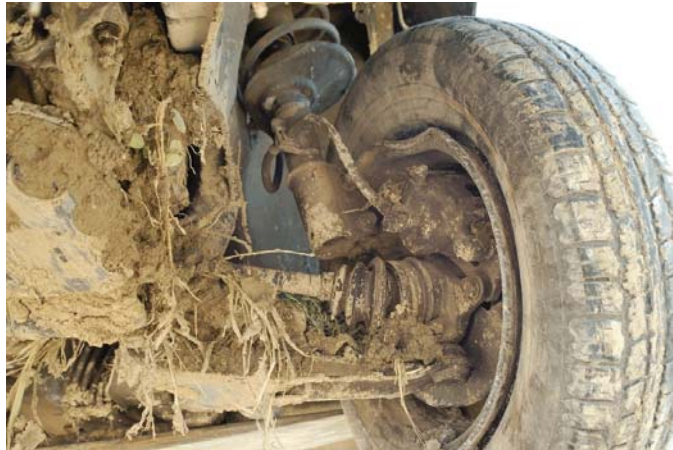
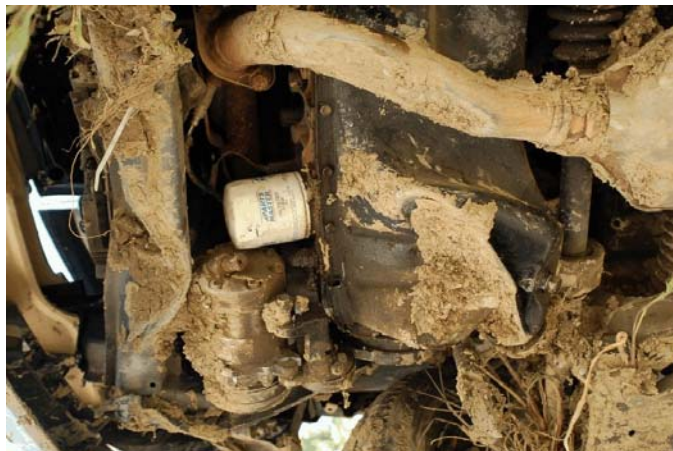
Figure 42. Undercarriage Damage, Test KSCG-2

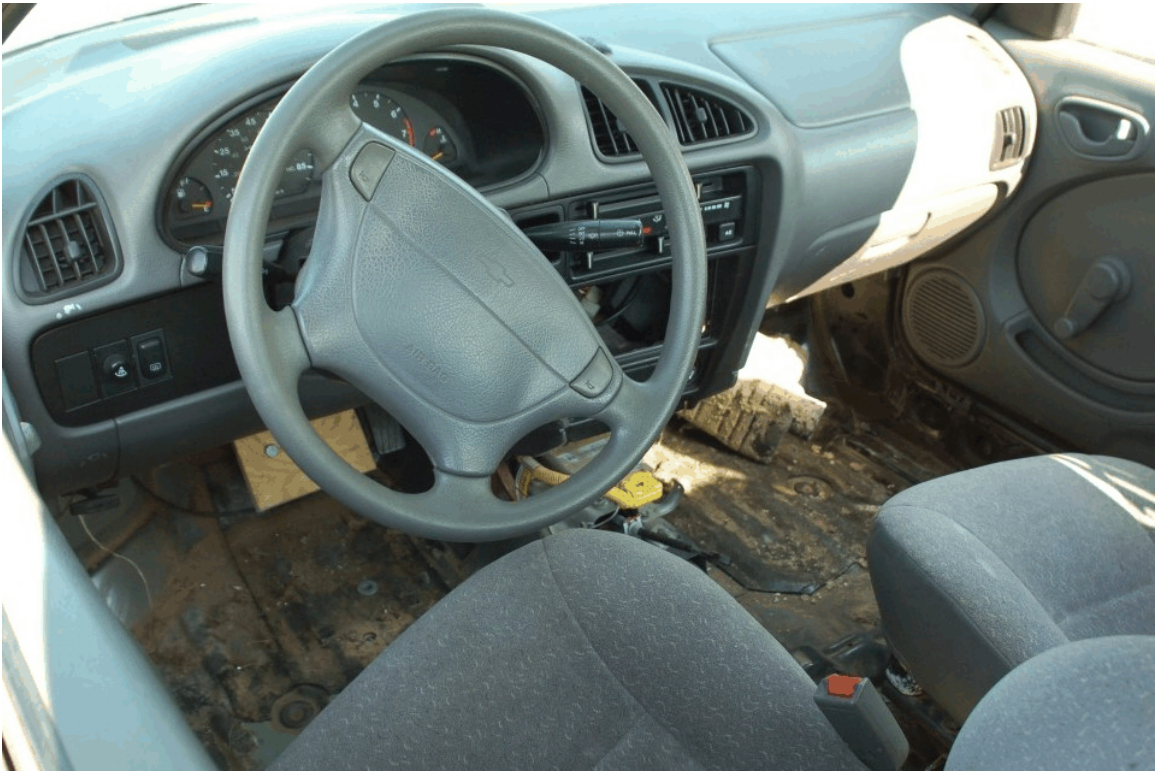
Figure 43. Occupant Compartment Damage, Test KSCG-2

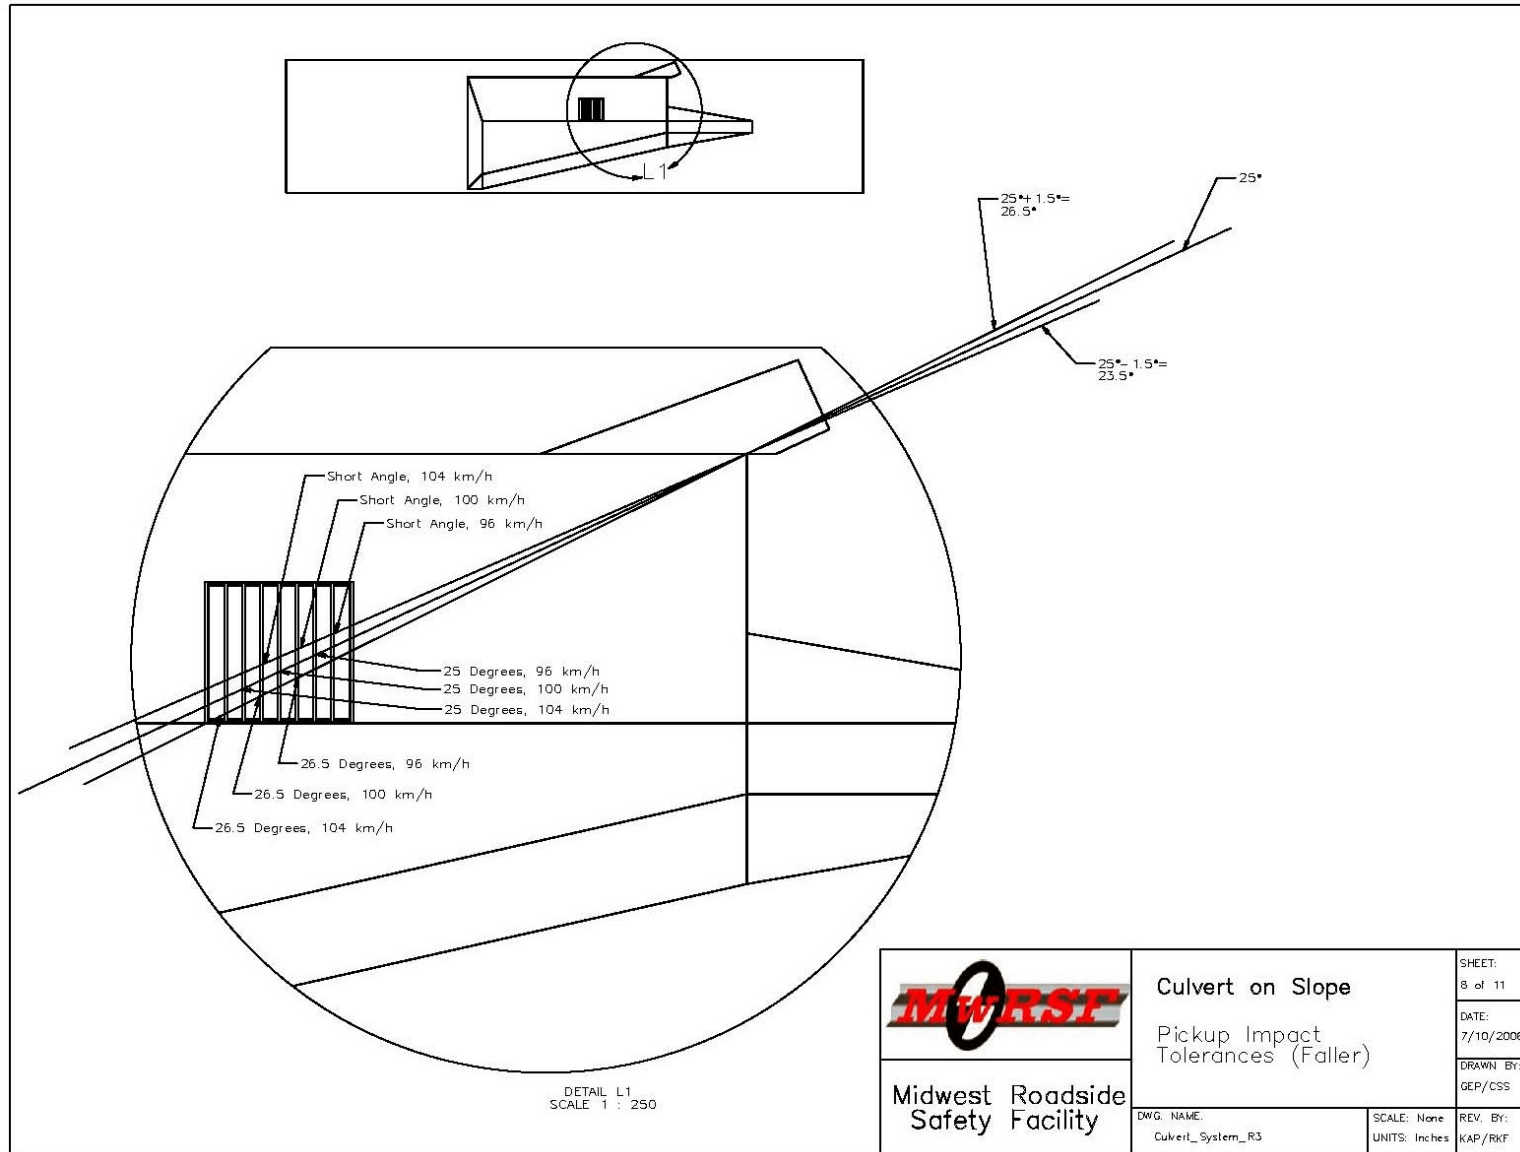
Figure A-1. Pickup Impact Tolerance - Particle Analysis

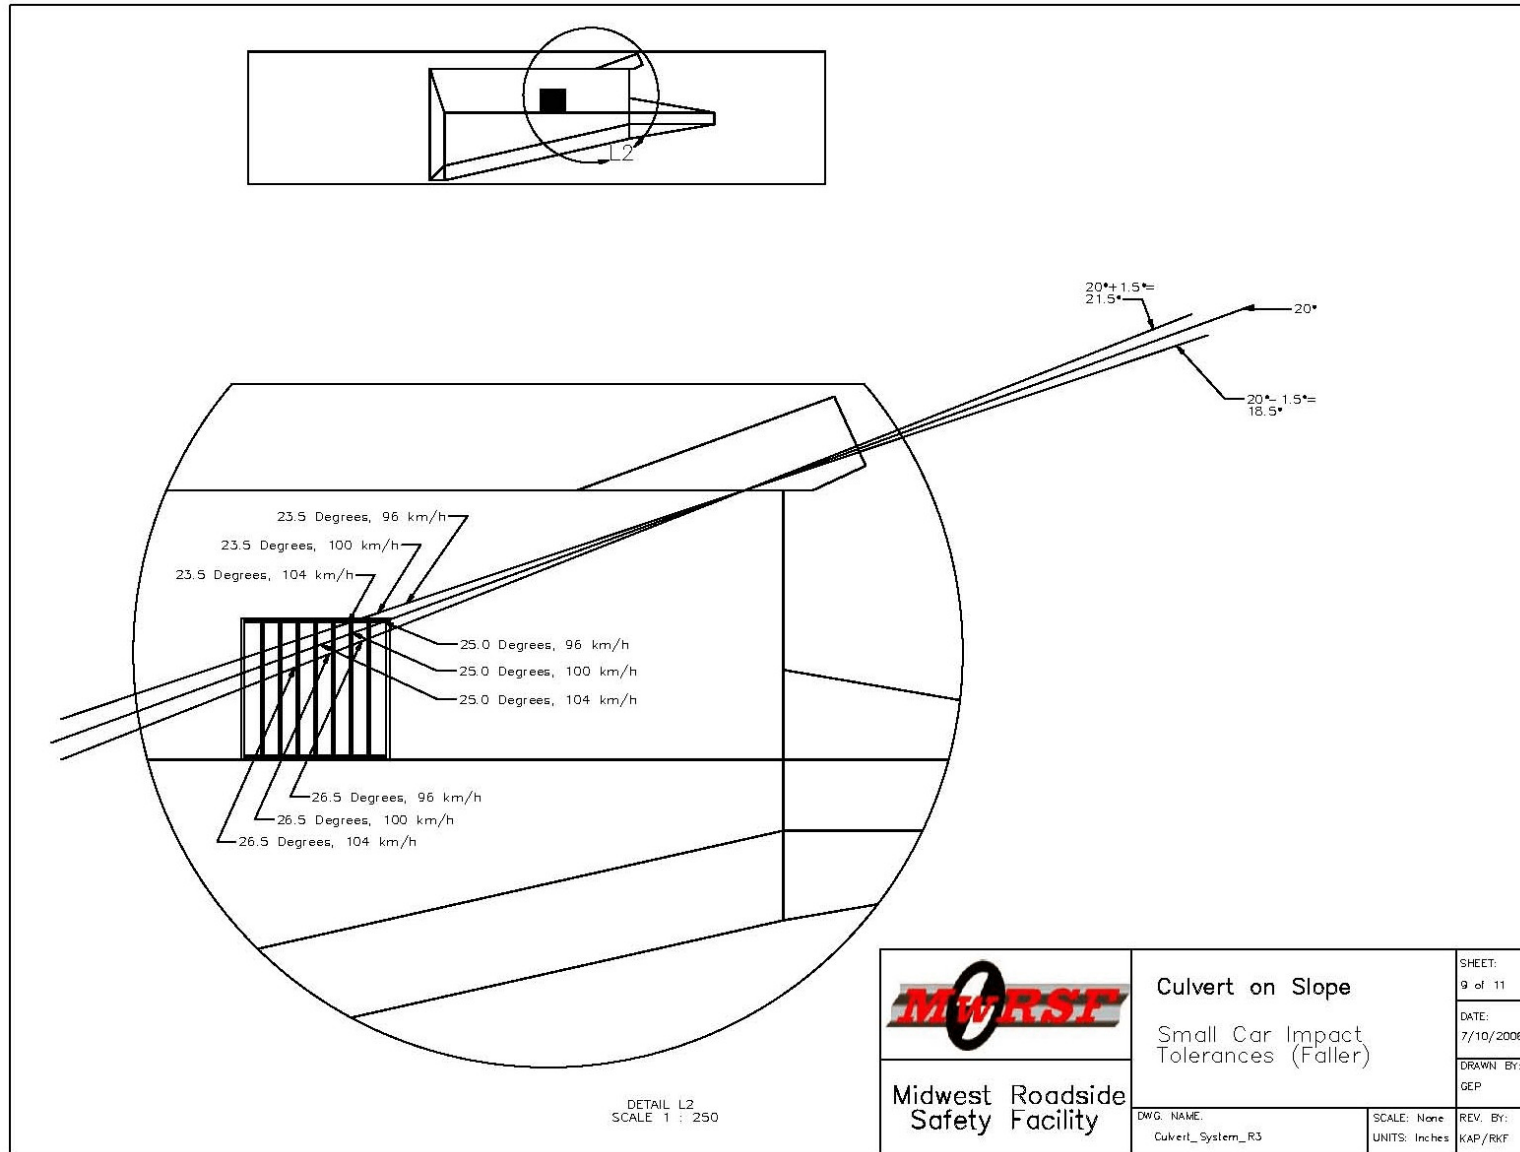
Figure A-2. Small Car Impact Tolerance - Particle Analysis

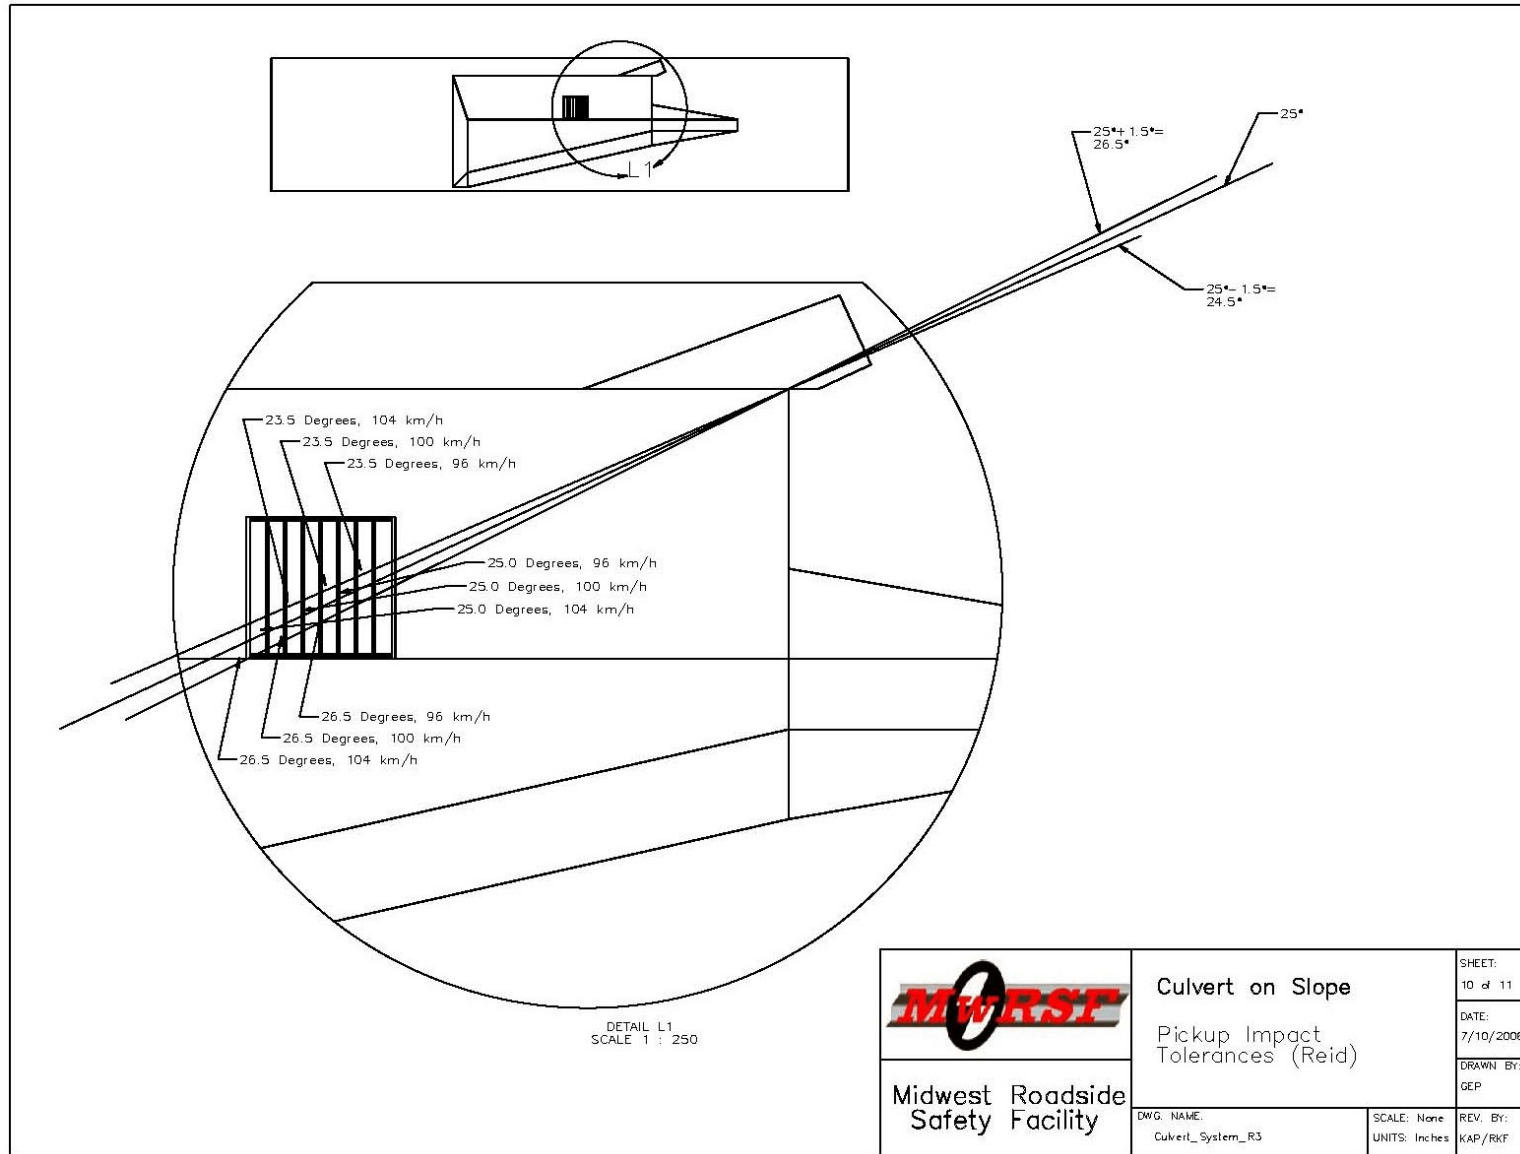
Figure A-3. Pickup Impact Tolerance - LS-DYNA Analysis
