# Performance Evaluation of Safety Grates for Cross-Drainage Culverts

Polivka, Karla A.; Sicking, Dean L.; Bielenberg, Robert W.; Rohde, John R.; Faller, Ronald K.; and Reid, John D., "Performance Evaluation of Safety Grates for Cross-Drainage Culverts" (2008). *Nebraska Department of Transportation Research Reports*. 84.  
<http://digitalcommons.unl.edu/ndor/84>

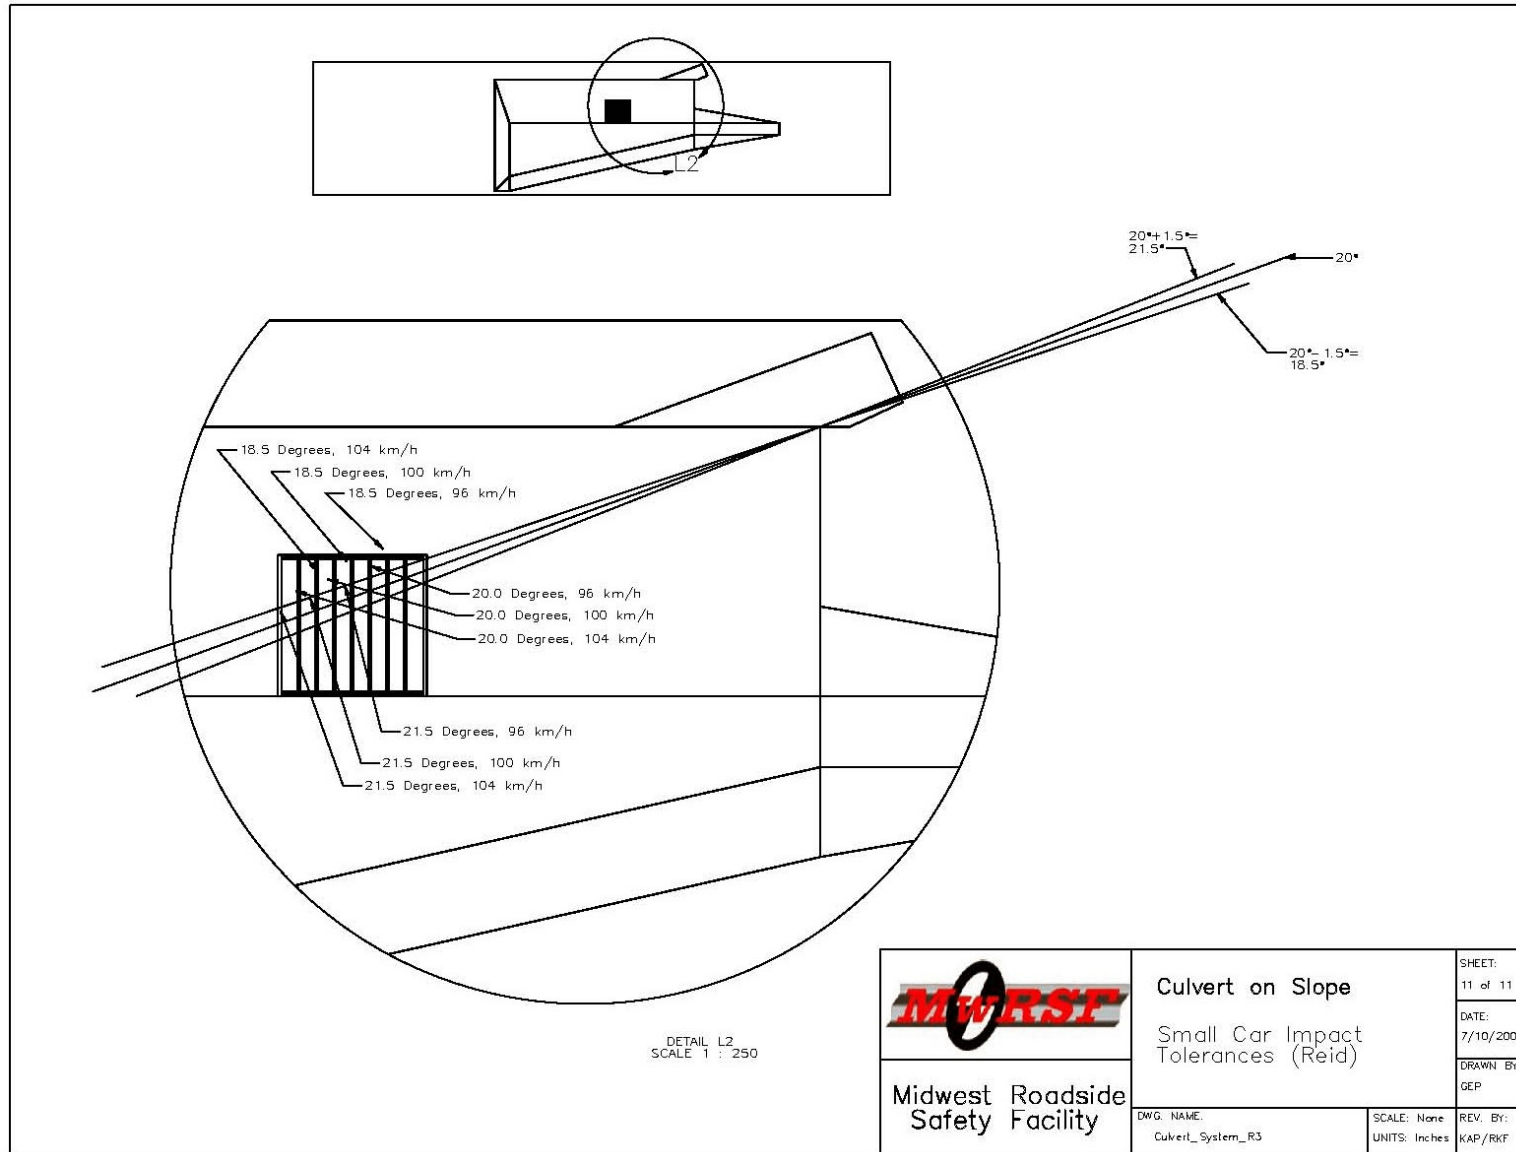
Figure A-4. Small Car Impact Tolerance - LS-DYNA Analysis

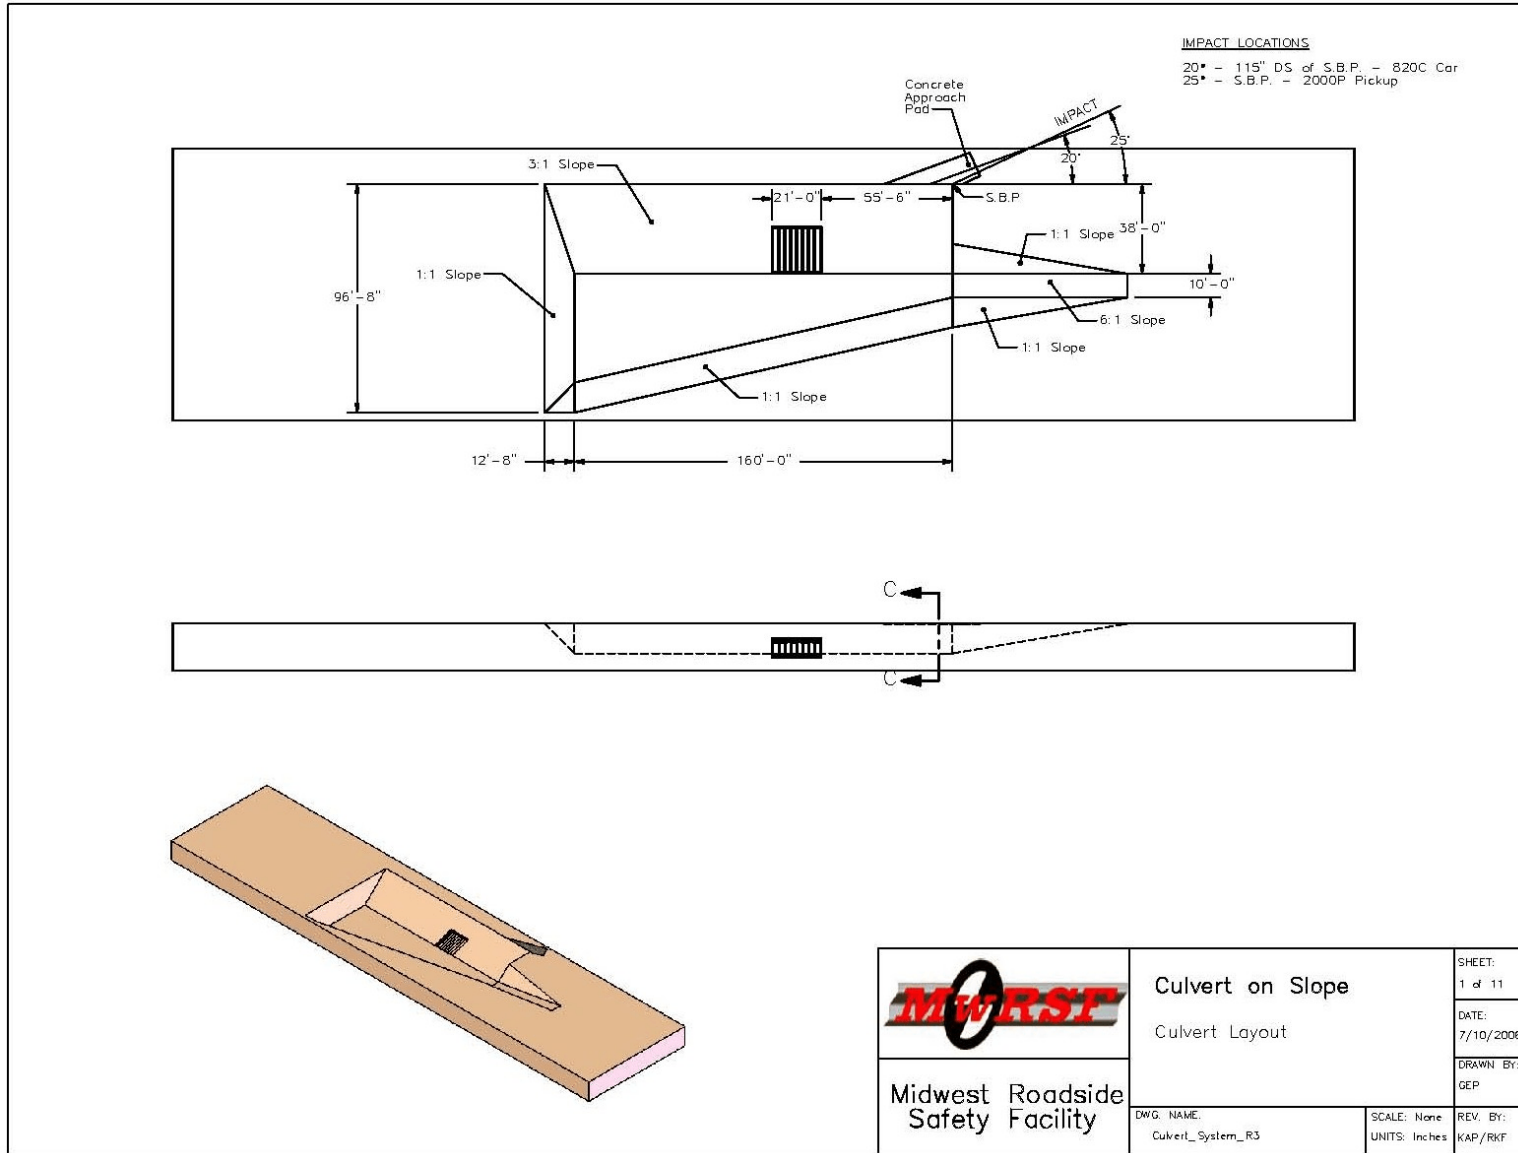
Figure B-1. Culvert Layout (English), Tests KSCG-1 and KSCG-2

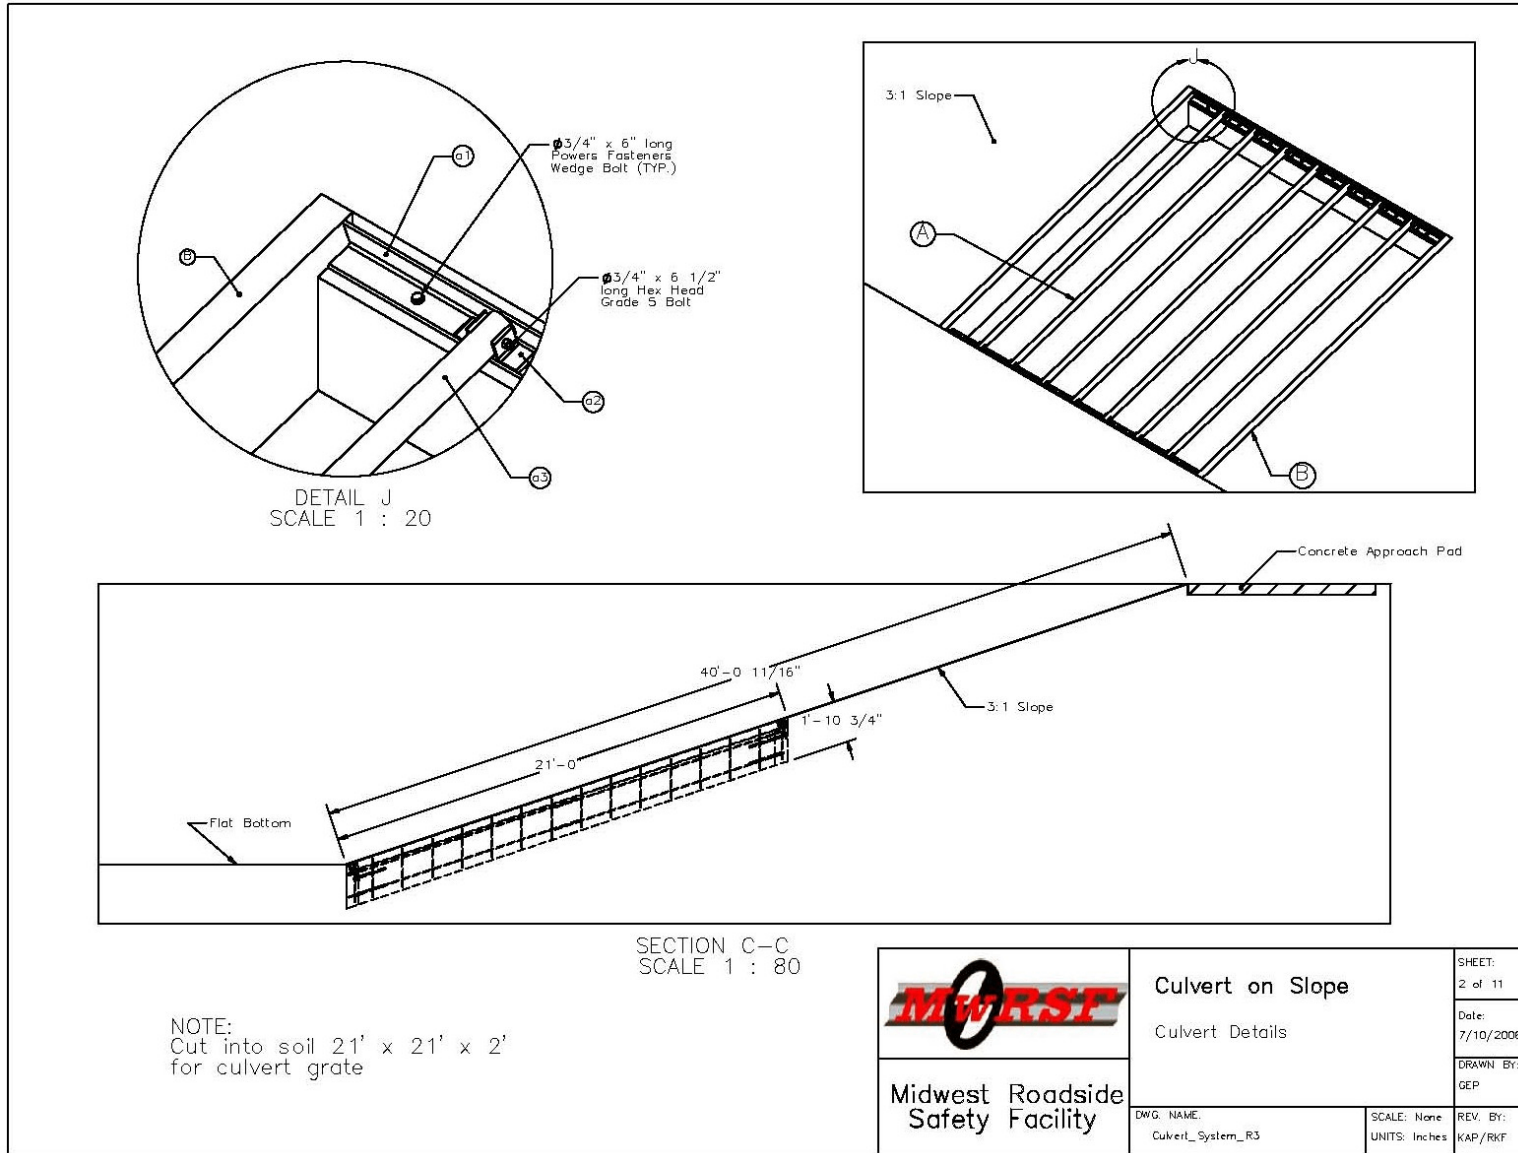
Figure B-2. Culvert Details (English), Tests KSCG-1 and KSCG-2

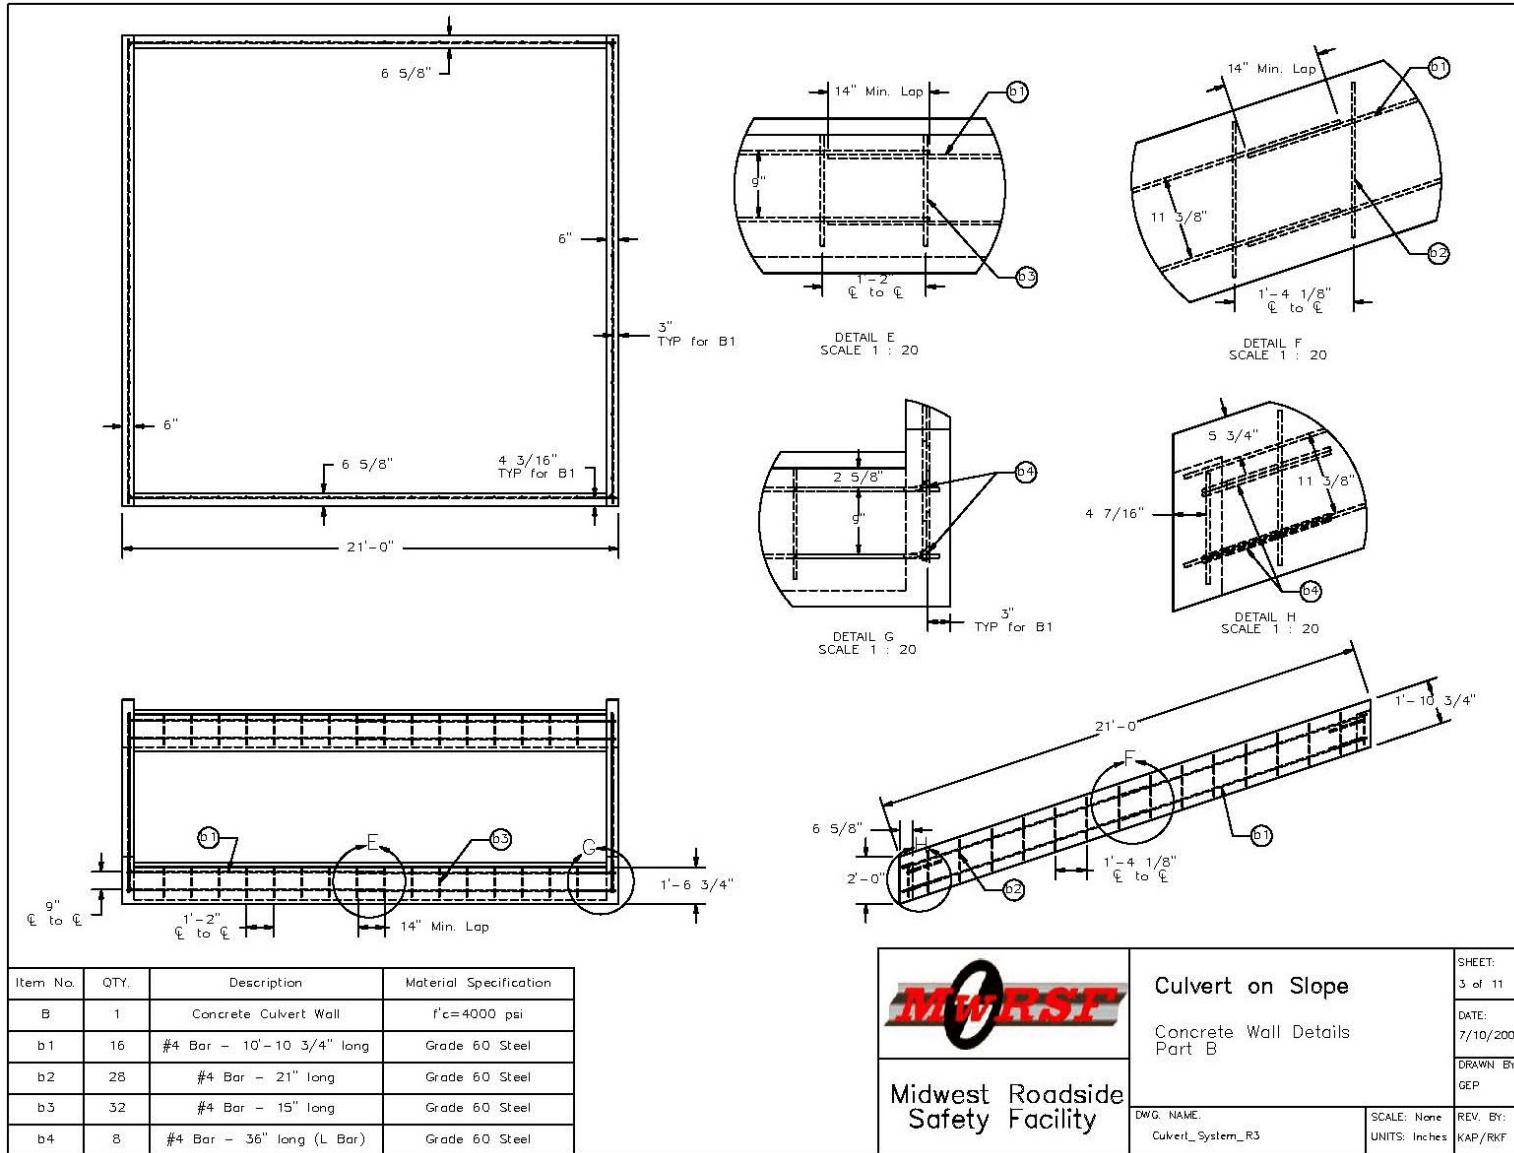
Figure B-3. Concrete Wall Details (English), Tests KSCG-1 and KSCG-2

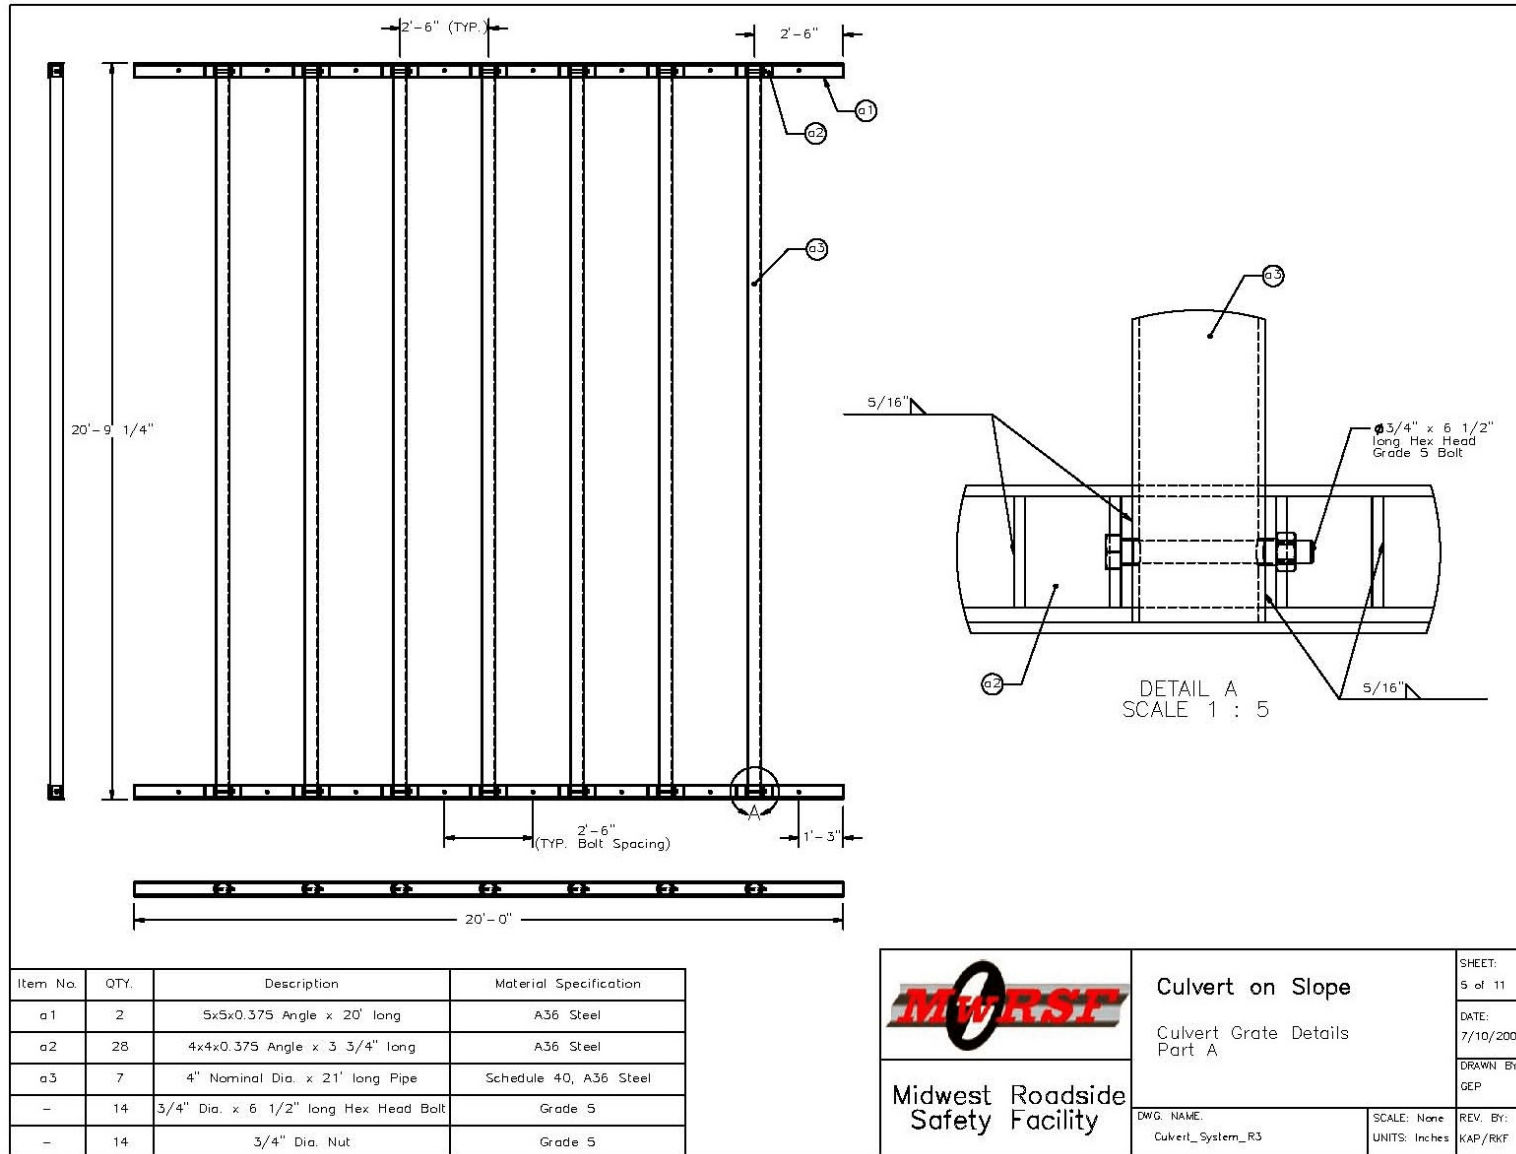
Figure B-5. Culvert Grate Details (English), Tests KSCG-1 and KSCG-2

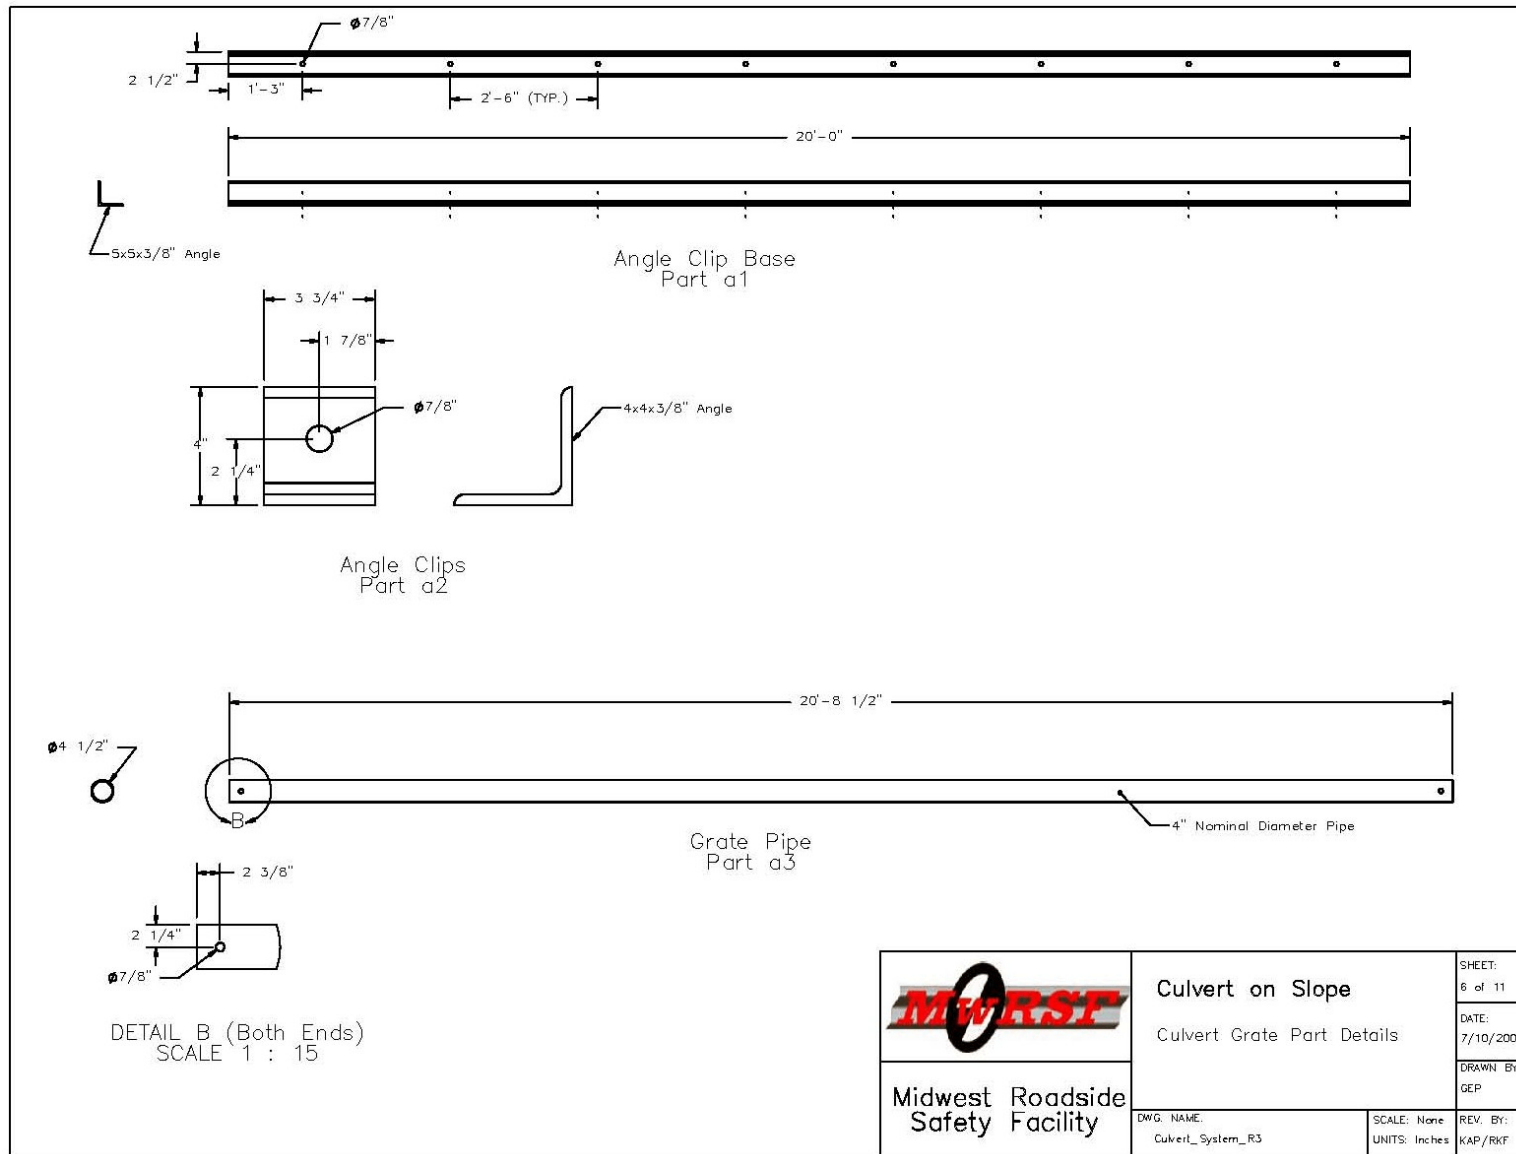
Figure B-6. Culvert Grate Part Details (English), Tests KSCG-1 and KSCG-2

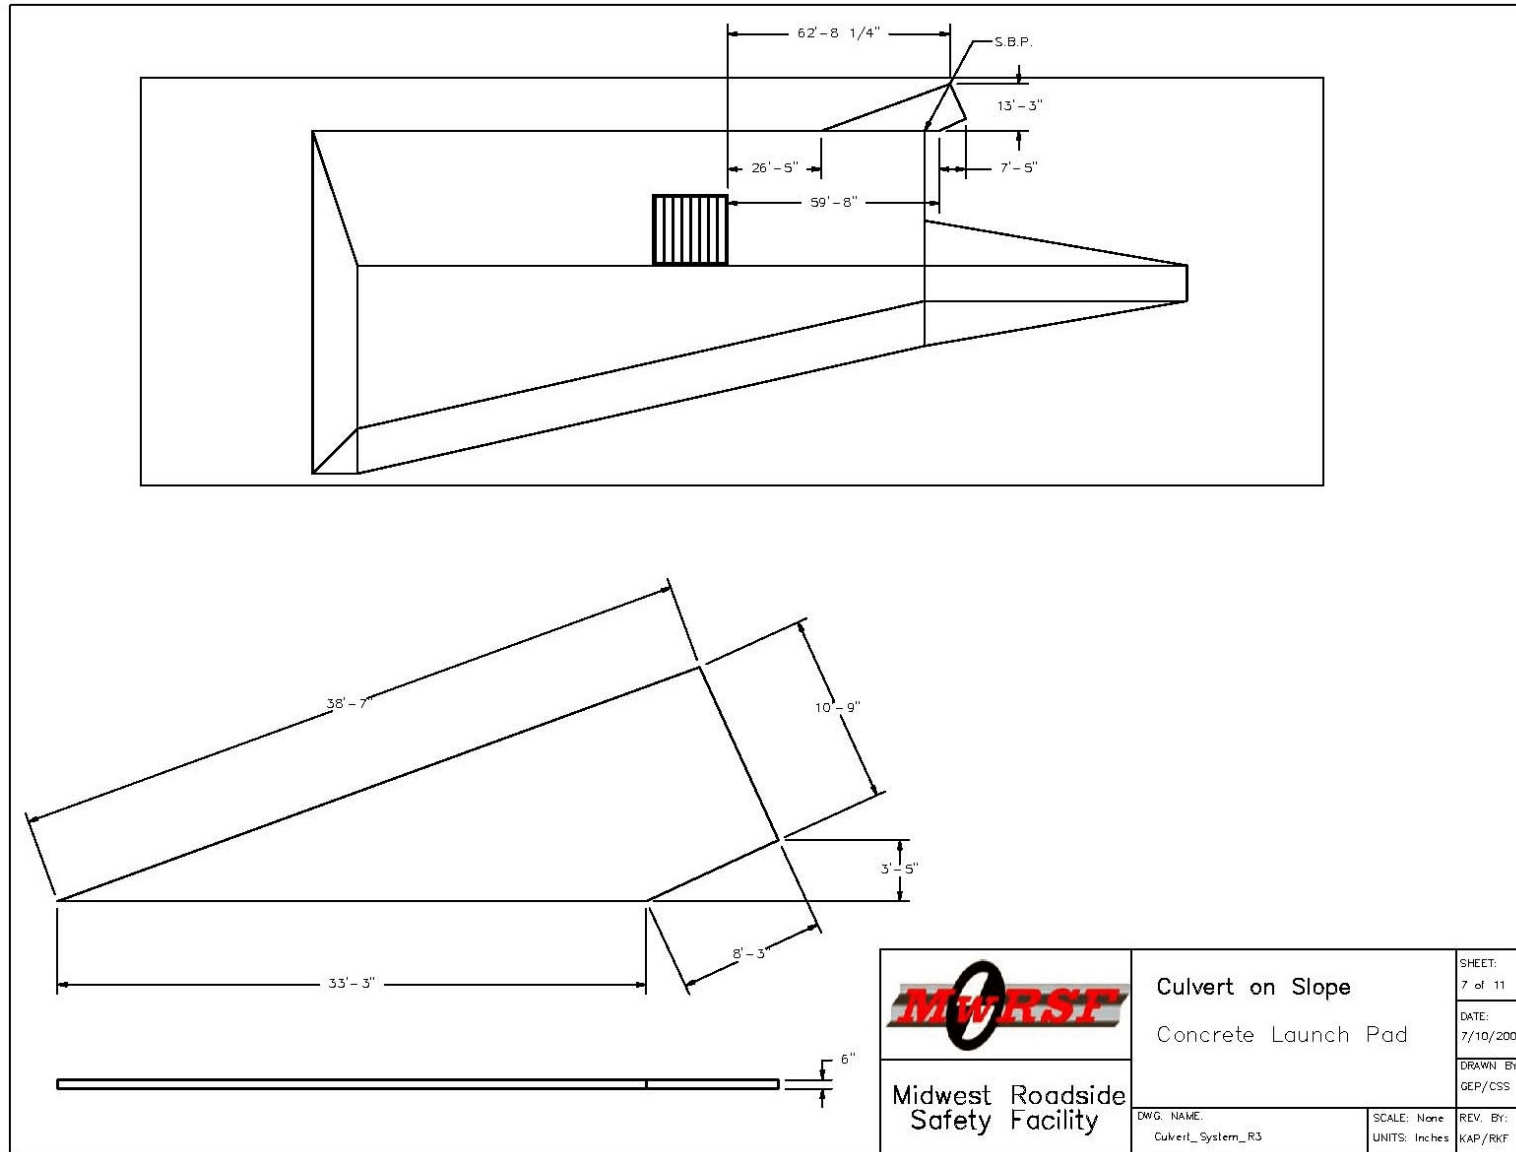
Figure B-7. Concrete Launch Pad (English), Tests KSCG-1 and KSCG-2

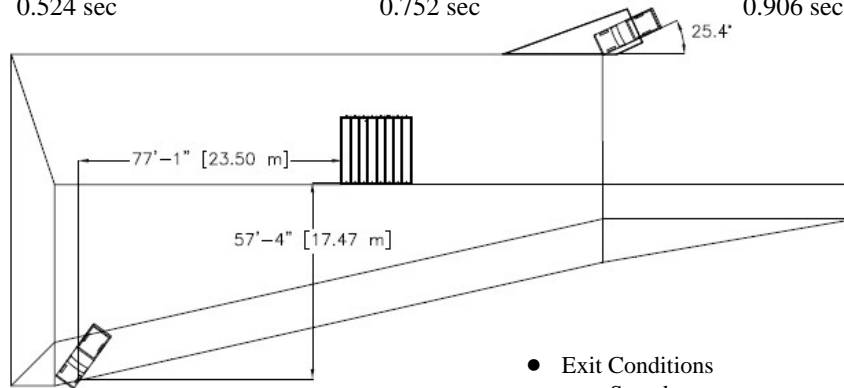
Figure C-1. Summary of the Test Results and Sequential Photographs (English), Test KSCG-1

- Test Agency ..... MwRSF
- Test Number ..... KSCG-1
- Date ..... 7/20/06
- NCHRP 350 Test Designation ..... 3-11
- Test Article ..... Transverse Culvert Safety Grate
- Total Length ..... 20 ft
- Total Width ..... 20 ft
- Placement ..... 19 ft down from 3:1 slope breakpoint
- Key Elements - Grate Piping
  - Type ..... Schedule 40 pipe
  - Diameter ..... 4 in.
  - Length ..... 20 ft
  - Spacing ..... 30 in.
- Type of Soil ..... NA
- Test Vehicle
  - Type/Designation ..... 2000P
  - Make and Model ..... 2000 Chevrolet C2500
  - Curb ..... 4,841 lbs
  - Test Inertial ..... 4,484 lbs
  - Gross Static ..... 4,484 lbs
- Impact Conditions
  - Speed ..... 60.8 mph
  - Angle (trajectory) ..... 25.4 deg

- Exit Conditions
  - Speed ..... 38.2 mph
  - Angle ..... 31.0 deg
- Post-Impact Trajectory
  - Vehicle Stability ..... Satisfactory
  - Stopping Distance ..... 77 ft - 1 in. downstream and 57 ft - 4 in. laterally from lower-downstream corner of culvert
- Occupant Impact Velocity
  - Longitudinal ..... 23.47 ft/s < 39.4 ft/s
  - Lateral (not required) ..... 3.57 ft/s
- Occupant Ridedown Deceleration (10 msec avg.)
  - Longitudinal ..... 4.03 g's < 20 g's
  - Lateral (not required) ..... 3.69 g's
- THIV (not required) ..... 23.82 ft/s
- PHD (not required) ..... 4.92 g's
- Test Article Damage ..... Moderate
- Test Article Deflections
  - Permanent Set ..... 7.25 in.
  - Dynamic ..... NA
  - Working Width ..... NA
- Vehicle Damage ..... Moderate
  - VDS<sup>10</sup> ..... 1-FC-1
  - CDC<sup>11</sup> ..... 1-RFWE2
  - OCDI ..... F000000000
  - Maximum Deformation ..... 0.75 in.

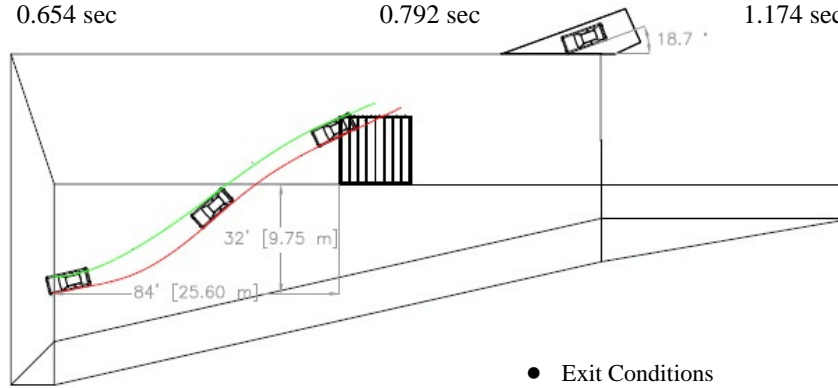
Figure C-2. Summary of the Test Results and Sequential Photographs (English), Test KSCG-2

- Test Agency ..... MwRSF
- Test Number ..... KSCG-2
- Date ..... 8/23/06
- NCHRP 350 Test Designation ..... 3-10
- Test Article ..... Transverse Culvert Safety Grate
- Total Length ..... 20 ft
- Total Width ..... 20 ft
- Placement ..... 19 ft down from the 3:1 slope breakpoint
- Key Elements - Grate Piping
  - Type ..... Schedule 40 pipe
  - Diameter ..... 4 in.
  - Length ..... 20 ft
  - Spacing ..... 30 in.
- Type of Soil ..... NA
- Test Vehicle
  - Type/Designation ..... 820C
  - Make and Model ..... 1999 Chevrolet Metro
  - Curb ..... 1,844 lbs
  - Test Inertial ..... 1,833 lbs
  - Gross Static ..... 1,997 lbs
- Impact Conditions
  - Speed ..... 61.3 mph
  - Angle (trajectory) ..... 18.7 deg

- Exit Conditions
  - Speed ..... NA
  - Angle ..... NA
- Post-Impact Trajectory
  - Vehicle Stability ..... Satisfactory
  - Stopping Distance ..... 54 ft downstream and 32 ft laterally from lower-downstream corner of culvert
- Occupant Impact Velocity
  - Longitudinal ..... 12.47 ft/s < 39.4 ft/s
  - Lateral ..... 6.65 ft/s < 39.4 ft/s
- Occupant Ridedown Deceleration (10 msec avg.)
  - Longitudinal ..... 14.38 g's < 20 g's
  - Lateral ..... 3.58 g's < 20 g's
- THIV (not required) ..... 14.30 ft/s
- PHD (not required) ..... 14.65 g's
- Test Article Damage ..... Minimal
- Test Article Deflections
  - Permanent Set ..... 0 in.
  - Dynamic ..... NA
  - Working Width ..... NA
- Vehicle Damage ..... Minimal
  - VDS<sup>10</sup> ..... 1-FD-1
  - CDC<sup>11</sup> ..... 1-FDWW1
  - OCDI ..... F000000000
  - Maximum Deformation ..... None observed

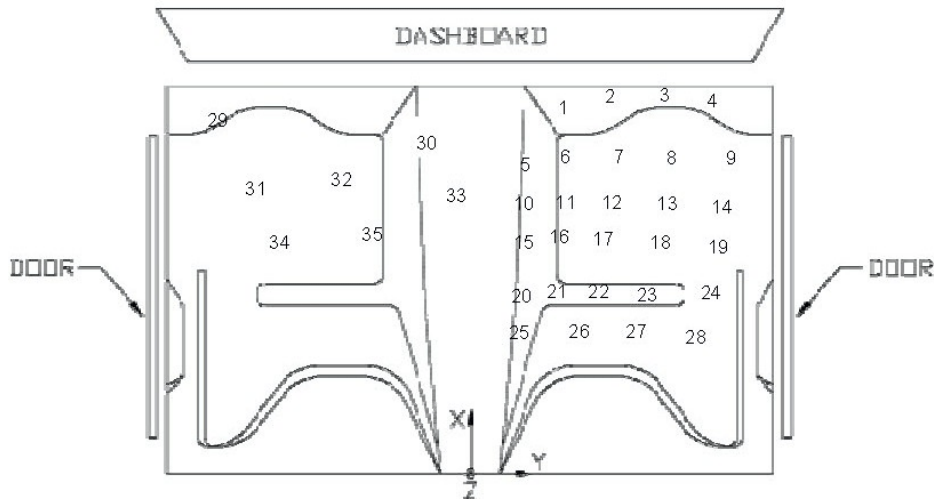
POINT	X	Y	Z	X'	Y'	Z'	DEL X	DEL Y	DEL Z
1	56.5	10.5	0.75	56.75	11	0.75	0.25	0.5	0
2	58.25	15.75	1.5	58.25	16.5	1.75	0	0.75	0.25
3	58.5	22	2	58.5	22.25	1.75	0	0.25	-0.25
4	57.5	27.5	0.75	57.5	27.75	0.75	0	0.25	0
5	48	6.25	1	48	6.25	1	0	0	0
6	49.25	10.75	6.75	49.25	11	6.5	0	0.25	-0.25
7	49.25	16.75	7	49.25	17.25	6.75	0	0.5	-0.25
8	49	22.75	7	49.25	23	6.75	0.25	0.25	-0.25
9	49	28.5	7	49	29	6.75	0	-0.5	-0.25
10	42.25	8	2	42	6.25	1.75	-0.25	0.25	-0.25
11	42.5	10.75	6.75	42.5	10.5	6.75	0	-0.25	0
12	42.5	16	7.5	42.5	16	7.25	0	0	-0.25
13	42.25	22.25	7.5	42.25	22.25	7	0	0	-0.5
14	41.75	28.5	7.75	42	28.5	7.5	0.25	0	-0.25
15	36.5	6	2.75	36.5	6	2.75	0	0	0
16	37.25	10	6.75	37	9.75	6.5	-0.25	-0.25	-0.25
17	37	15	7.5	36.75	14.75	7.25	-0.25	-0.25	-0.25
18	36.5	21.5	7.5	36.5	21.5	7.25	0	0	-0.25
19	35.75	28	8	35.75	27.5	7.75	0	-0.5	-0.25
20	28.5	5.75	3.75	28.5	5.75	3.5	0	0	-0.25
21	29.25	9.75	7.5	29.25	9.5	7.25	0	-0.25	-0.25
22	29.25	14.5	8.25	29	14.25	8	-0.25	-0.25	-0.25

23	28.75	20	8	29	19.5	8	0.25	-0.5	0
24	29	27.25	7.5	29	26.75	7.5	0	-0.5	0
25	23	5.5	4.5	23	5.25	4.25	0	-0.25	-0.25
26	23.25	12.25	8.5	23.25	11.75	8.25	0	-0.5	-0.25
27	23.25	18.75	8.25	23.25	18.5	8	0	-0.25	-0.25
28	22.5	25.5	7.5	22.5	25.25	7.25	0	-0.25	-0.25
29	54.75	-28.75	2.25	54.5	-28.5	2.25	-0.25	0.25	0
30	51.25	-5	0	51	-5	0	-0.25	0	0
31	44.5	-27.25	5.75	44.25	-27	5.5	-0.25	0.25	-0.25
32	45.75	-17.5	6.25	45.5	-17.25	6.25	-0.25	0.25	0
33	43.5	-4.5	1.25	43.25	-4.5	1.25	-0.25	0	0
34	36.5	-24.5	6	36.5	-24.25	6	0	0.25	0
35	37.75	-14	7.25	37.5	-13.75	7.25	-0.25	0.25	0

Figure D-1. Occupant Compartment Deformation Data - Set 1, Test KSCG-1

Exterior vehicle damage was minimal, as shown in Figures 40 through 43. Interior occupant compartment damage was negligible with no significant observable deformations of the occupant compartment observed. The occupant compartment deformations and the corresponding locations are provided in Appendix D.

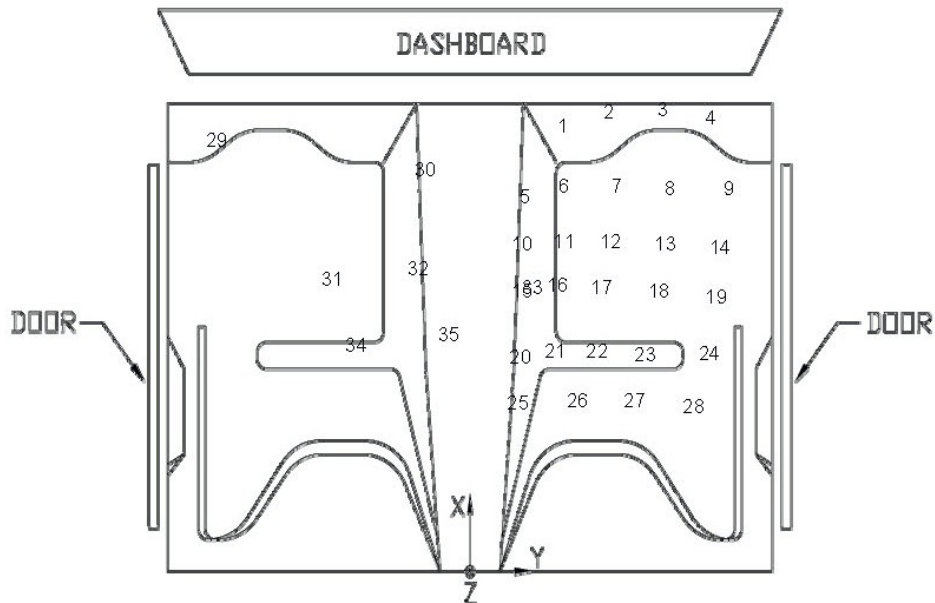
POINT	X	Y	Z	X'	Y'	Z'	DEL X	DEL Y	DEL Z
1	50	19.25	0.25	50.25	19.75	0.25	0.25	0.5	0
2	51.75	24.5	0.75	51.75	25.25	0.75	0	0.75	0
3	52	30.75	1	52	31	1	0	0.25	0
4	51	36.25	0	51	36.5	0	0	0.25	0
5	41.5	15	0.5	41.5	15	0.25	0	0	-0.25
6	42.75	19.5	6	42.75	19.75	6	0	0.25	0
7	42.75	25.5	6.25	42.75	26	6.25	0	0.5	0
8	42.5	31.5	6	42.75	31.75	6	0.25	0.25	0
9	42.5	38.25	6	42.5	37.75	6	0	-0.5	0
10	35.75	14.75	1.25	35.5	15	1.25	0	0.25	0
11	36	19.5	6	36	19.25	6	0	-0.25	0
12	36	24.75	6.5	36	24.75	6.5	0	0	0
13	35.75	31	6.25	35.75	31	6.25	0	0	0
14	35.25	37.25	6.75	35.5	37.25	6.75	0.25	0	0
15	30	14.75	2	30	14.75	2	0	0	0
16	30.75	18.75	5.75	30.5	18.5	5.75	-0.25	-0.25	0
17	30.5	23.75	6.5	30.25	23.5	6.5	-0.25	-0.25	0
18	30	30.25	6.25	30	30.25	6.25	0	0	0
19	29.25	36.75	6.75	29.25	36.25	6.75	0	-0.5	0
20	22	14.5	2.75	22	14.5	2.75	0	0	0
21	22.75	18.5	6.5	22.75	18.25	6.5	0	-0.25	0
22	22.75	23.25	7	22.5	23	7	-0.25	-0.25	0
23	22.25	28.75	6.75	22.5	28.25	7	0.25	-0.5	0.25

24	22.5	36	6.25	22.5	35.5	6.5	0	-0.5	0.25
25	16.5	14.25	3.5	16.5	14	3.5	0	-0.25	0
26	16.75	21	7	16.75	20.5	7.25	0	-0.5	0.25
27	16.75	27.5	6.75	16.75	27.25	7	0	-0.25	0.25
28	16	34.25	6	16	34	6	0	-0.25	0
29	48.25	-20	2.25	48	-19.75	2.5	-0.25	0.25	0.25
30	44.75	3.75	0	44.5	3.75	0	-0.25	0	0
31	38	-18.5	5.5	37.75	-18.25	5.75	-0.25	0.25	0.25
32	39.25	-8.75	6	39	-8.5	6.25	-0.25	0.25	0.25
33	37	4.25	1.25	36.75	4.25	1.25	-0.25	0	0
34	30	-15.75	6	30	-15.5	6.25	0	0.25	0.25
35	31.25	-5.25	7	31	-5	7.5	-0.25	0.25	0.5

Figure D-2. Occupant Compartment Deformation Data - Set 2, Test KSCG-1

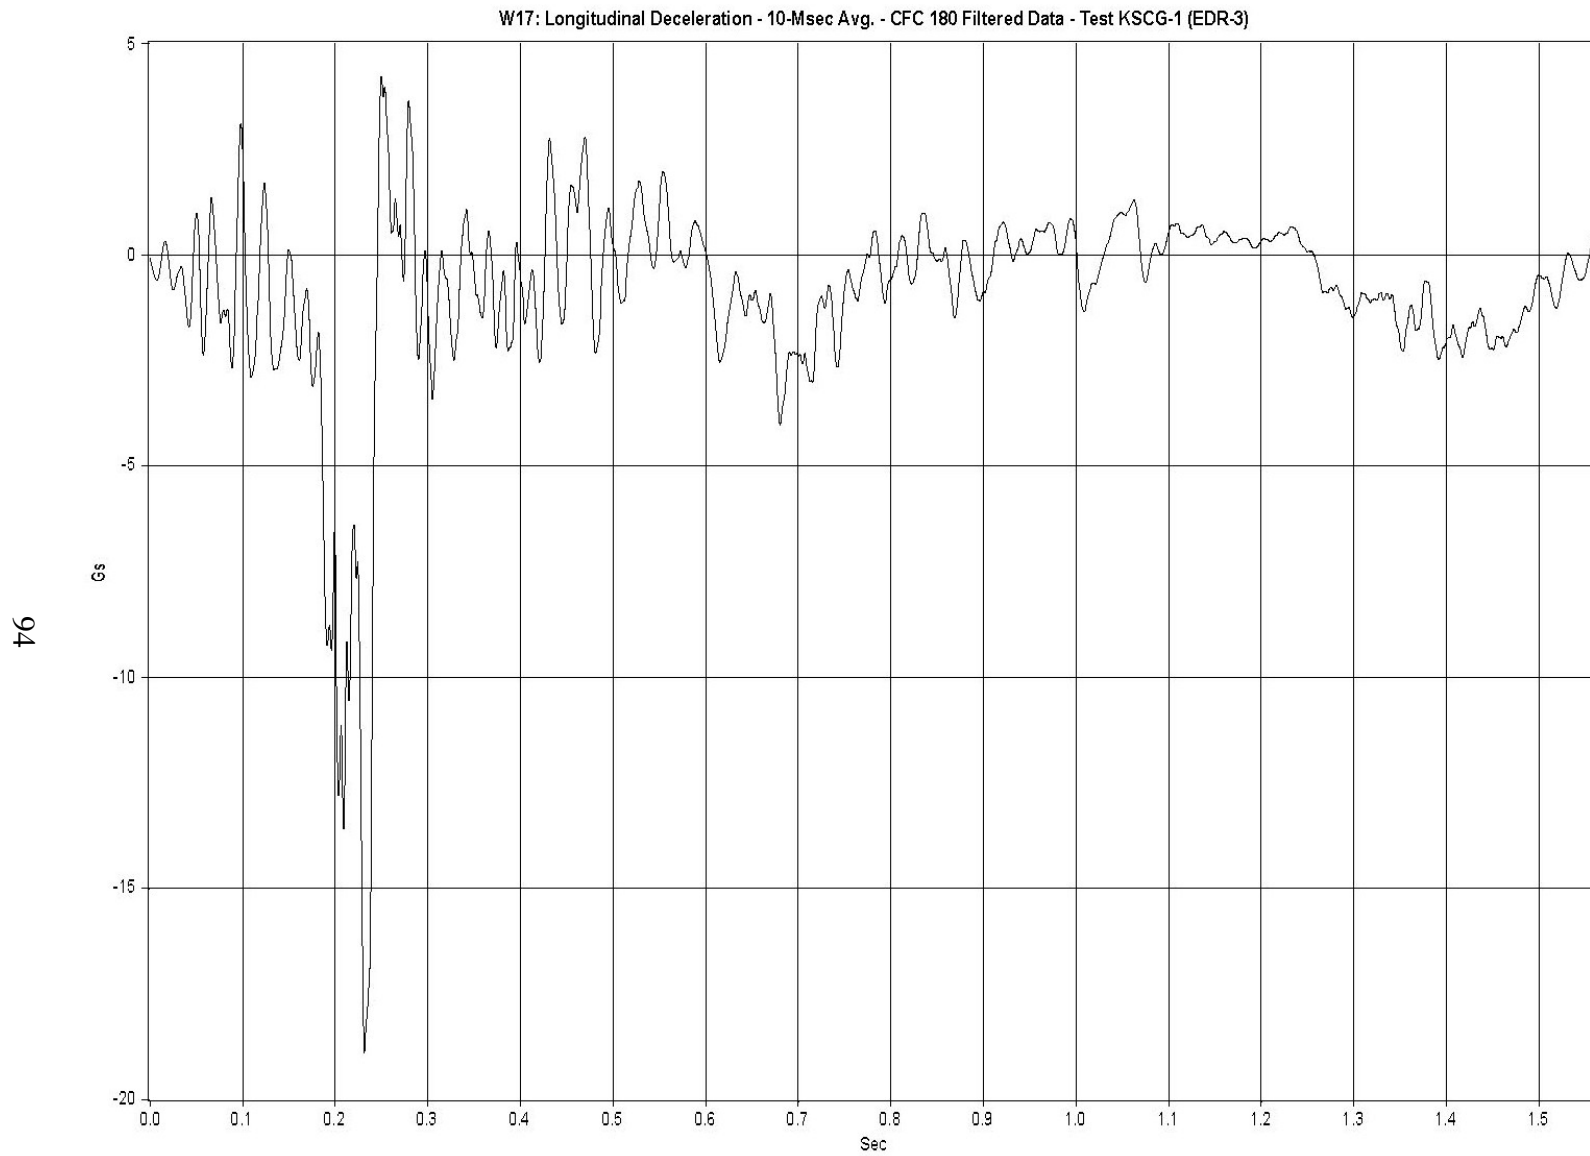
Figure E-1. Graph of Longitudinal Deceleration, Test KSCG-1

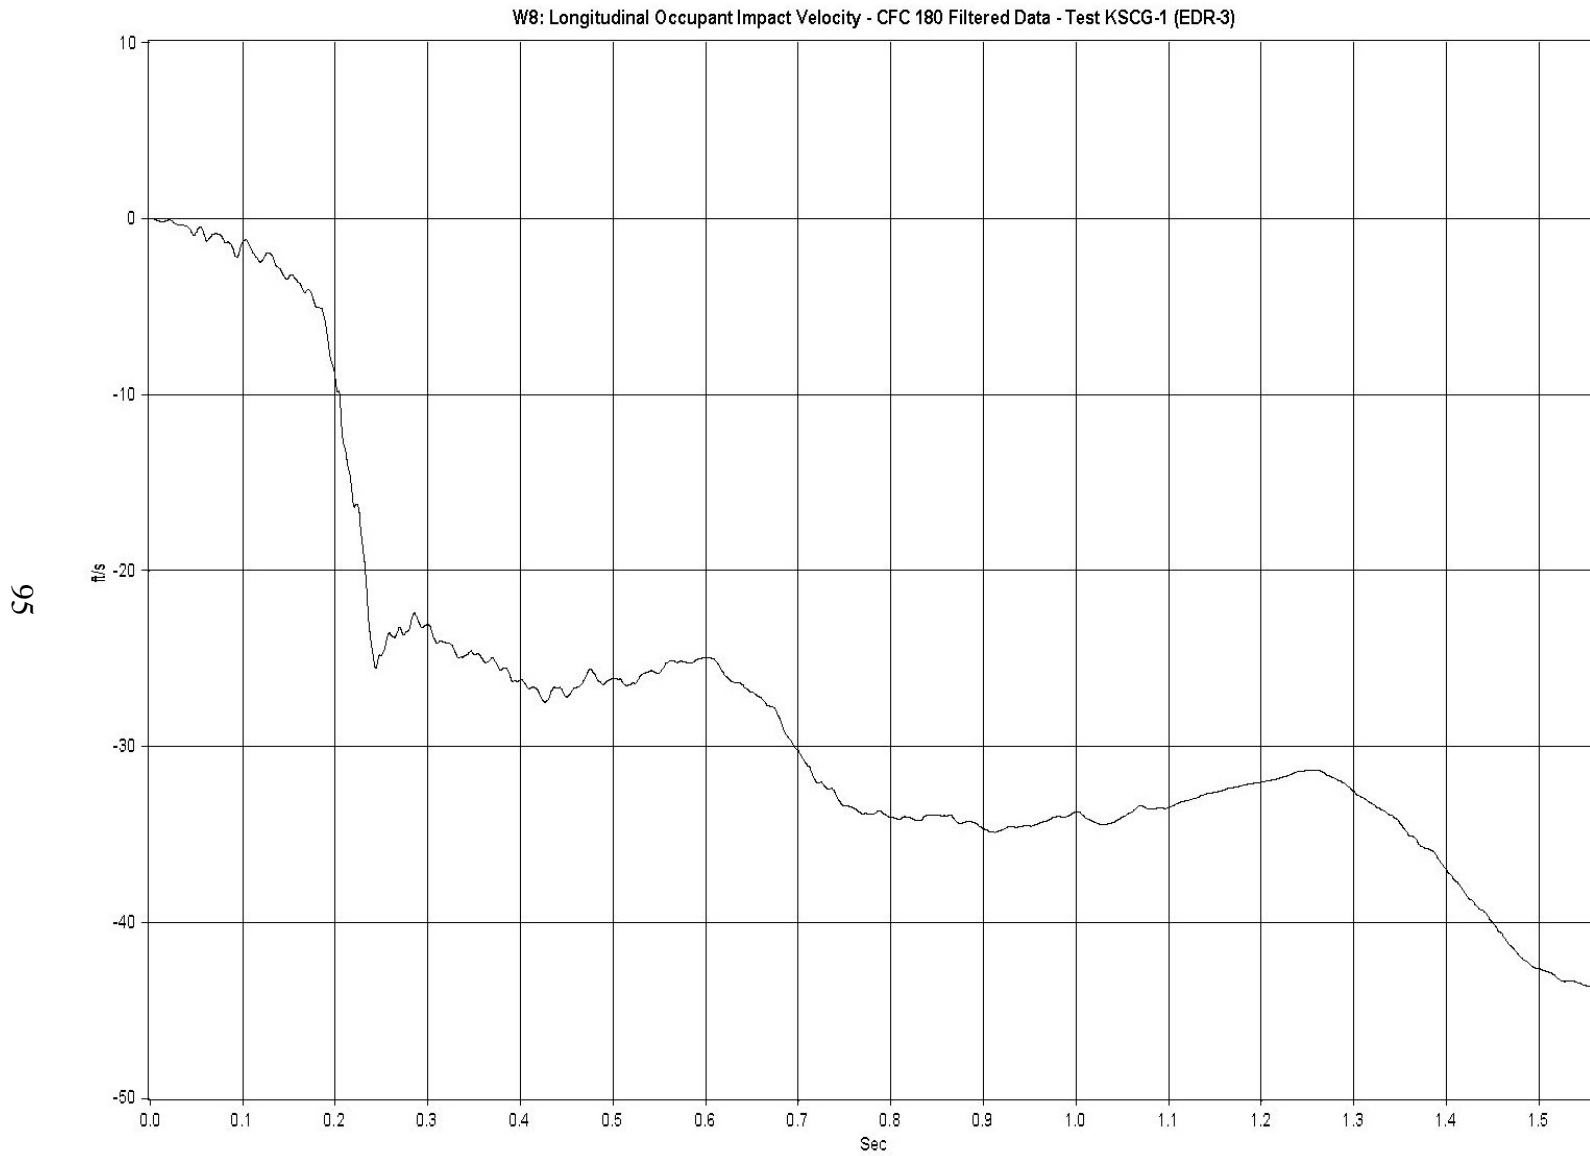
Figure E-2. Graph of Longitudinal Occupant Impact Velocity, Test KSCG-1

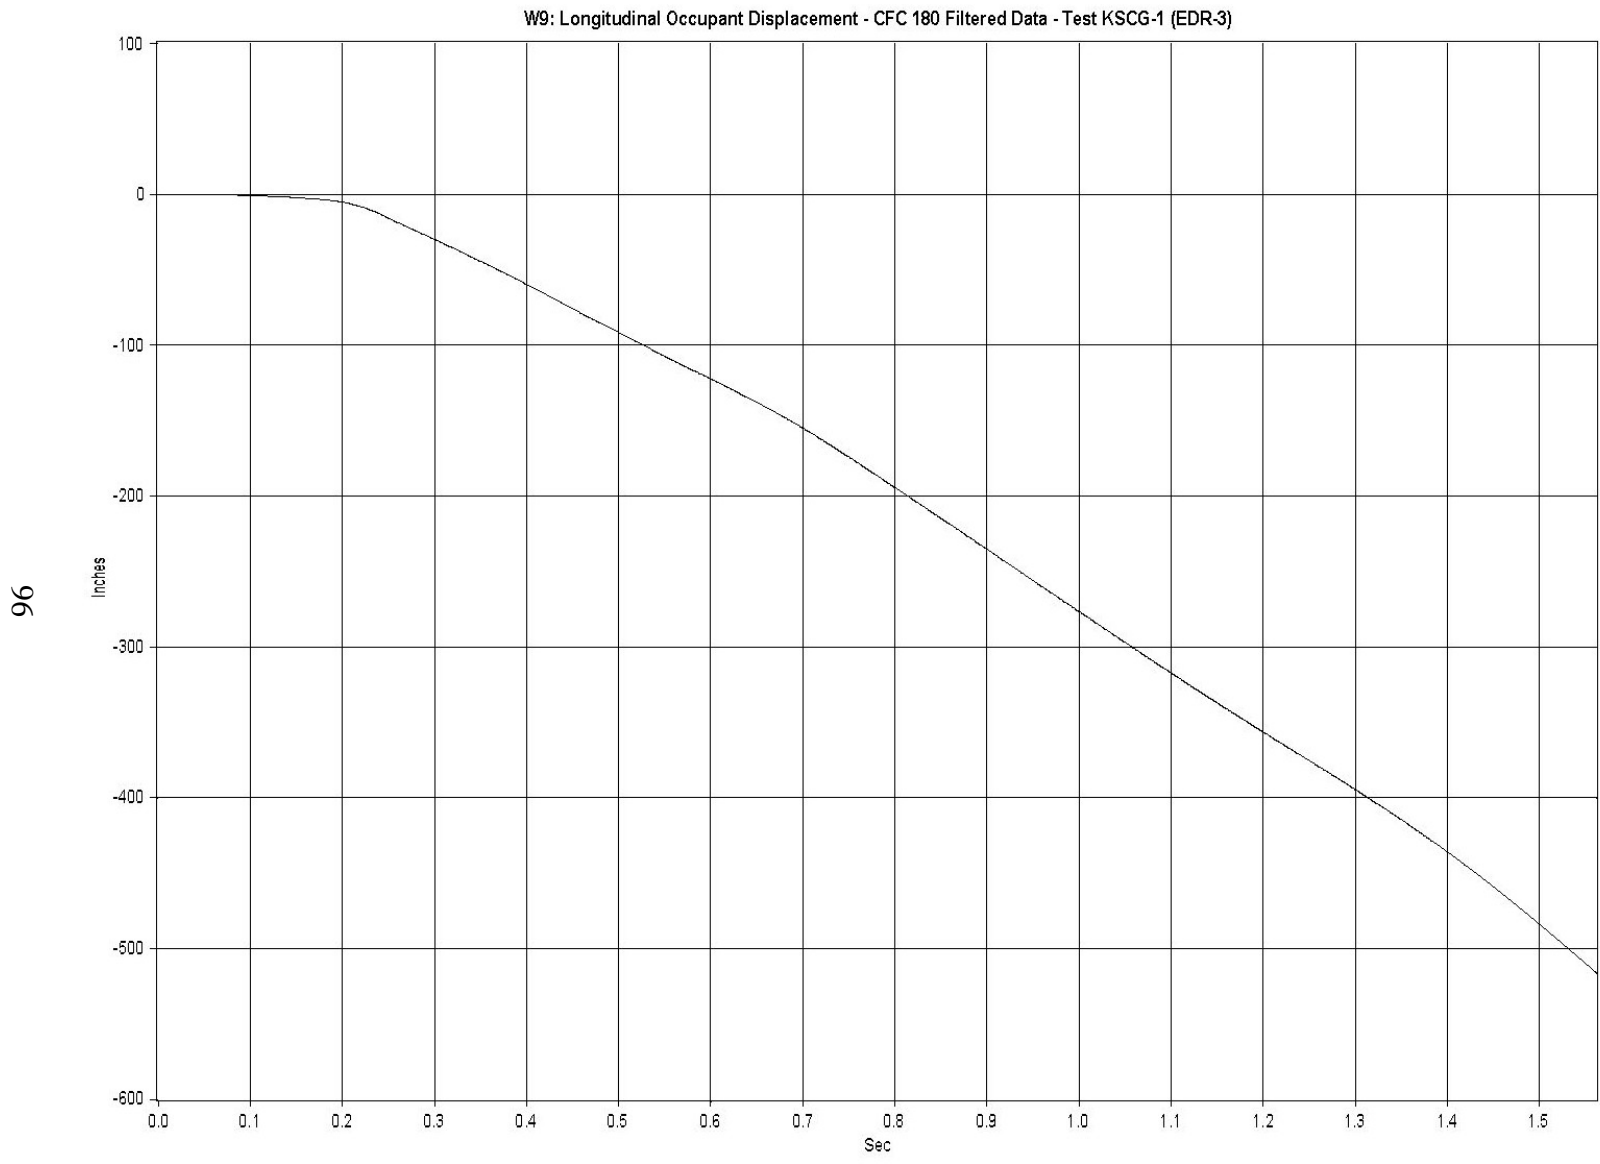
Figure E-3. Graph of Longitudinal Occupant Displacement, Test KSCG-1
