# Performance Evaluation of Safety Grates for Cross-Drainage Culverts

Polivka, Karla A.; Sicking, Dean L.; Bielenberg, Robert W.; Rohde, John R.; Faller, Ronald K.; and Reid, John D., "Performance Evaluation of Safety Grates for Cross-Drainage Culverts" (2008). *Nebraska Department of Transportation Research Reports*. 84.  
<http://digitalcommons.unl.edu/ndor/84>

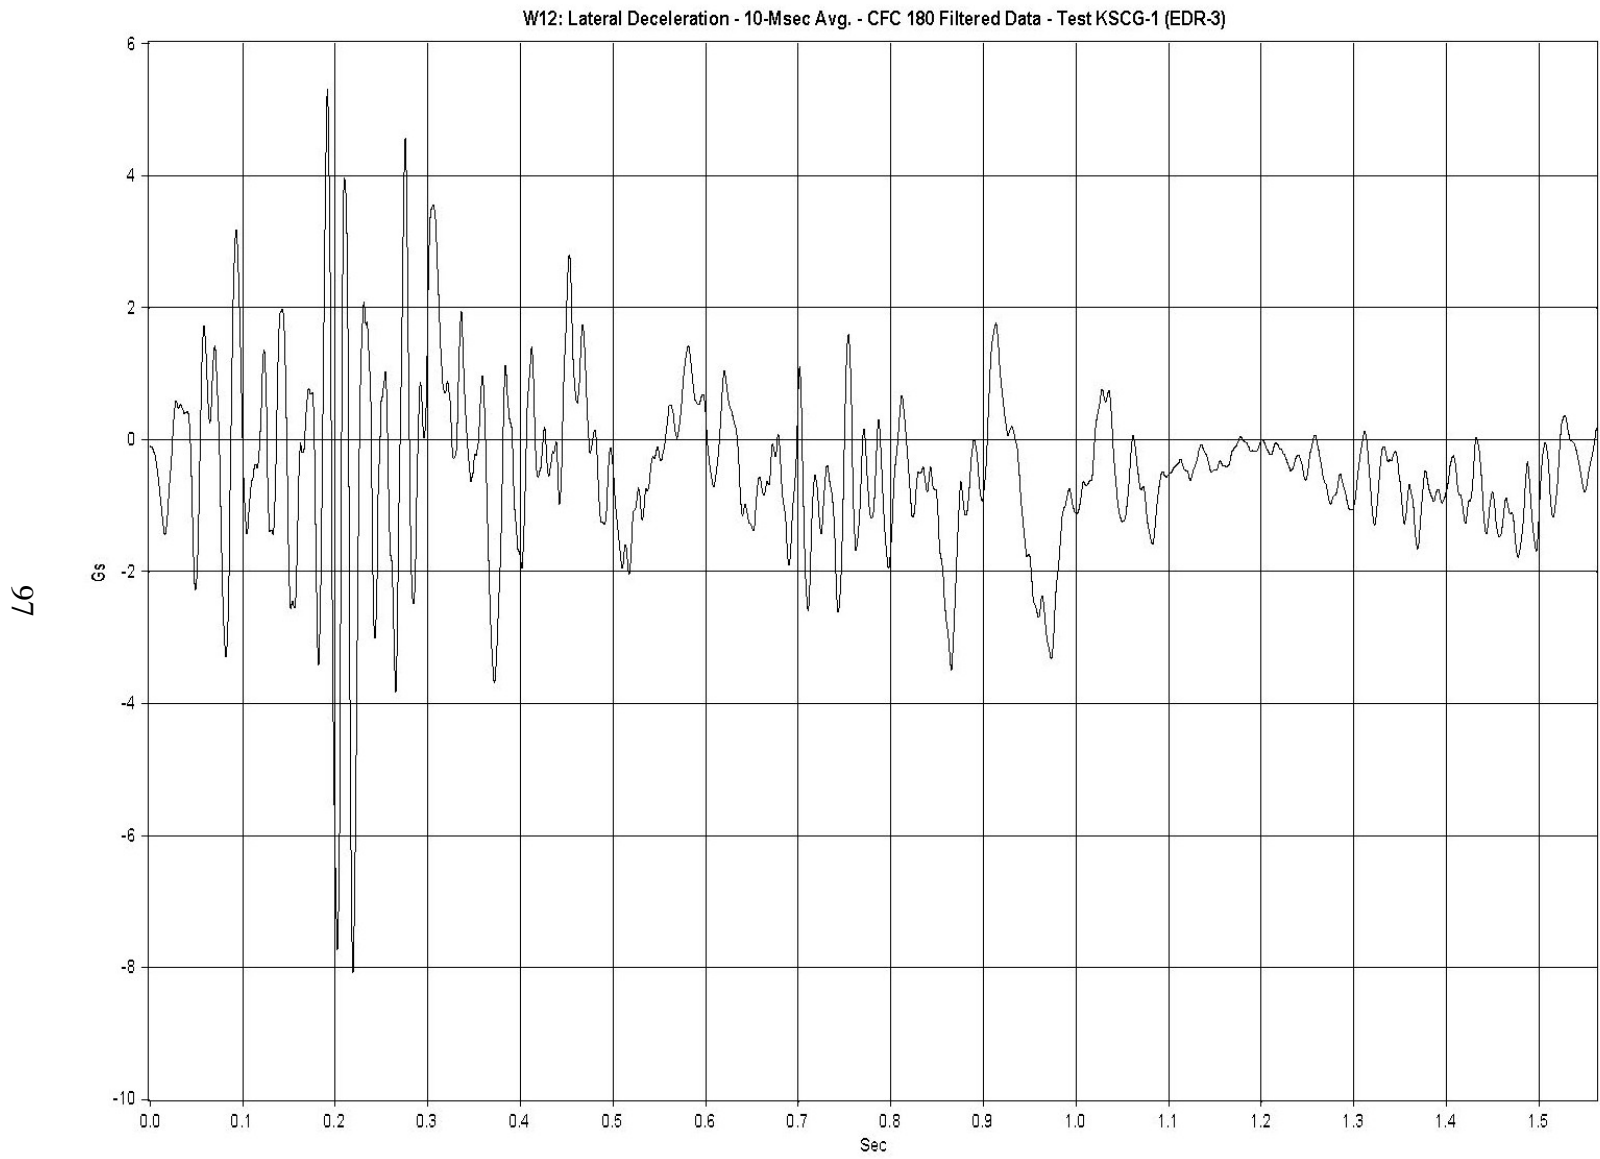
Figure E-4. Graph of Lateral Deceleration, Test KSCG-1

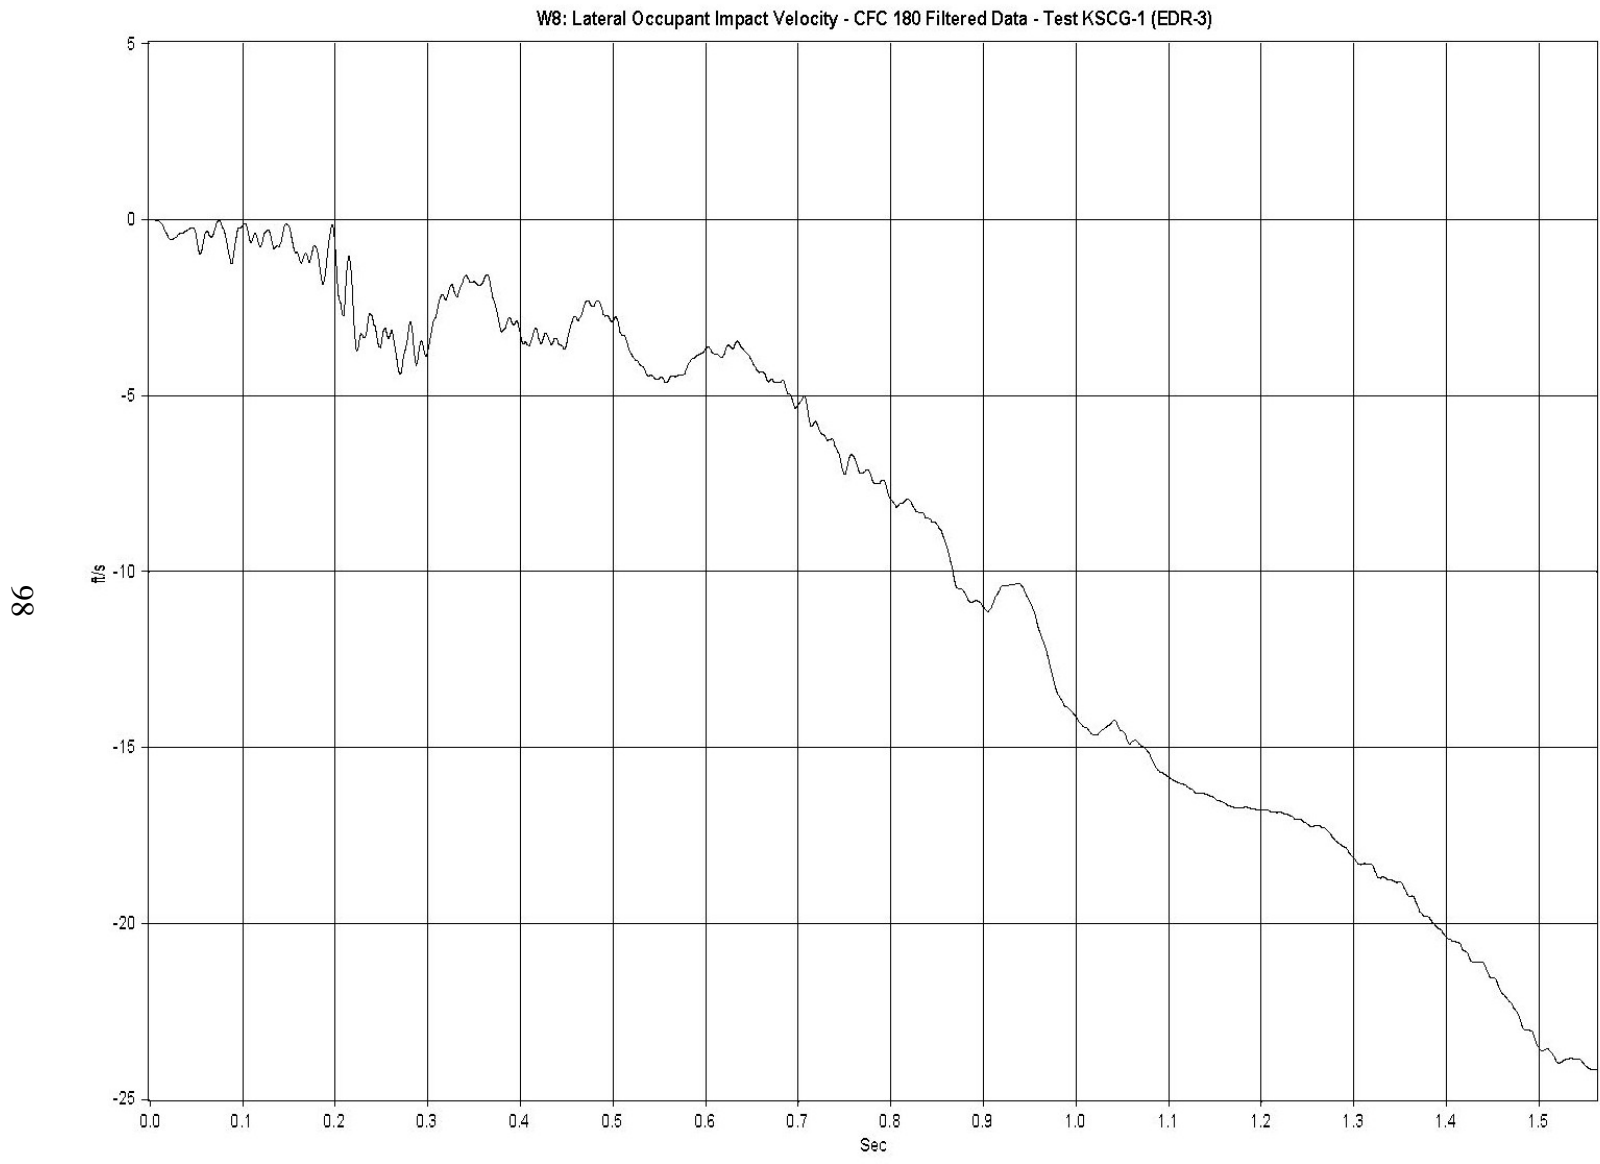
Figure E-5. Graph of Lateral Occupant Impact Velocity, Test KSCG-1

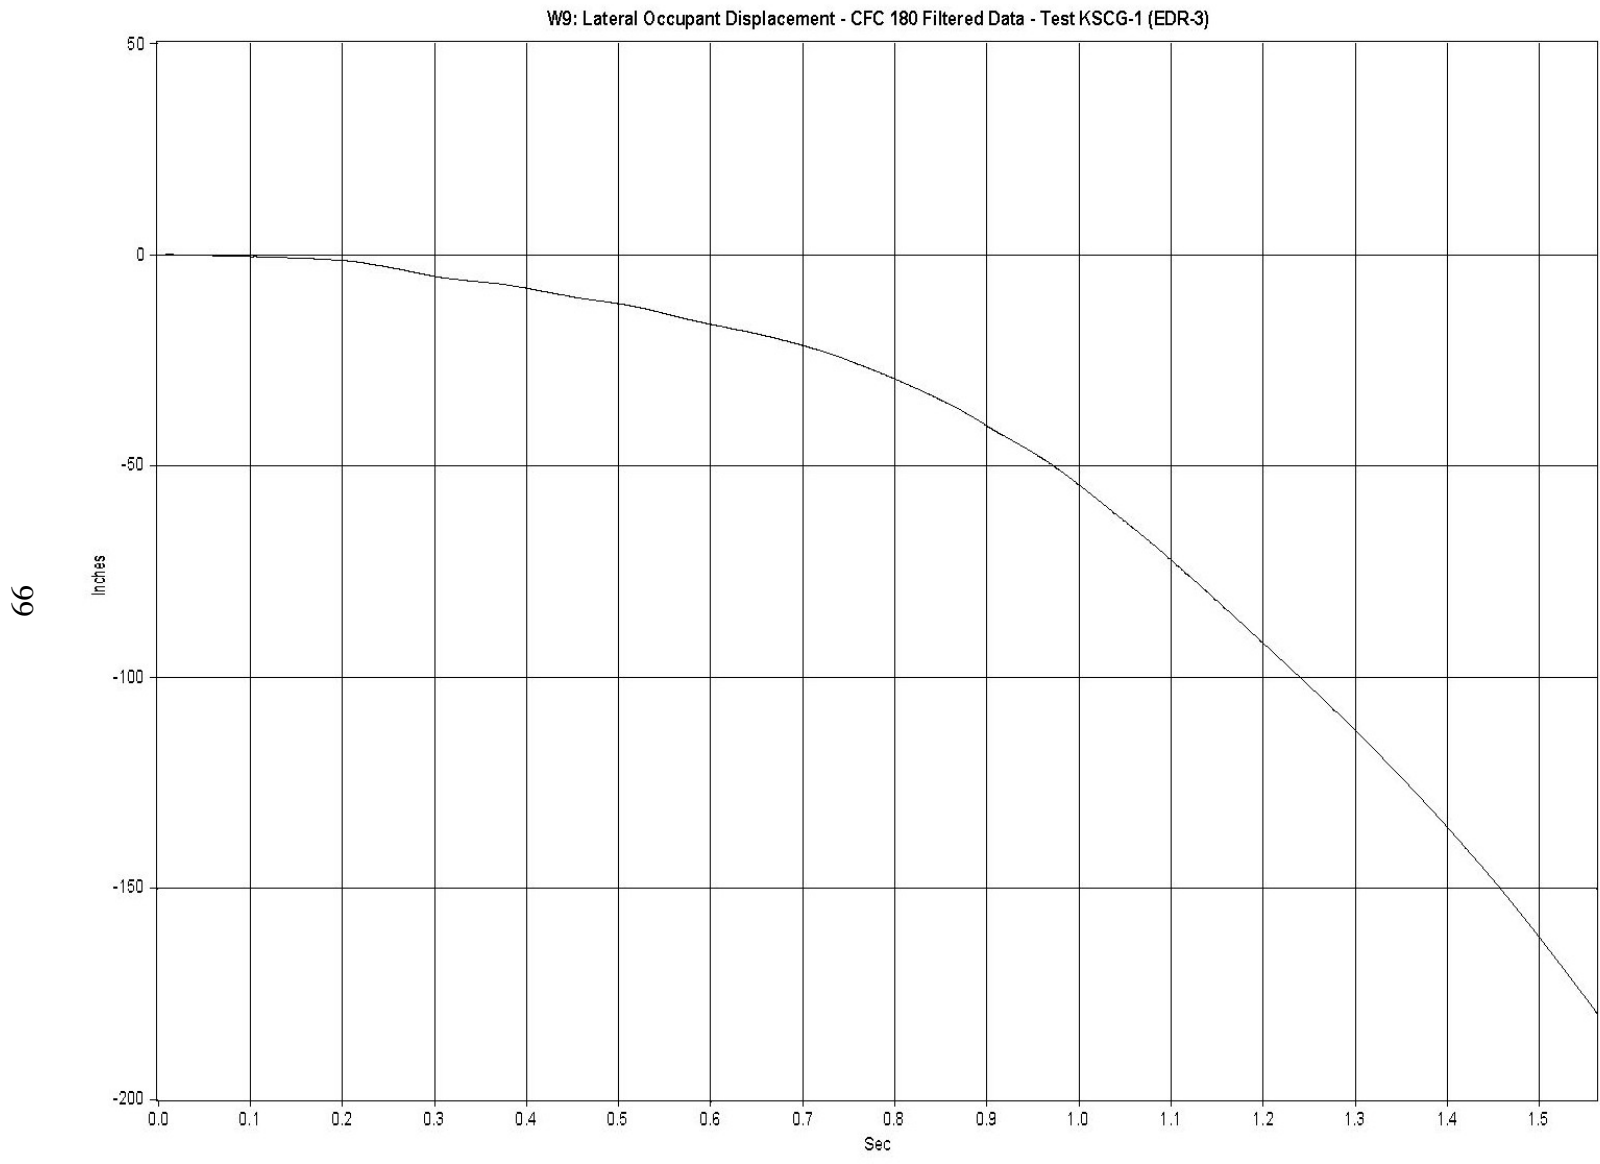
Figure E-6. Graph of Lateral Occupant Displacement, Test KSCG-1

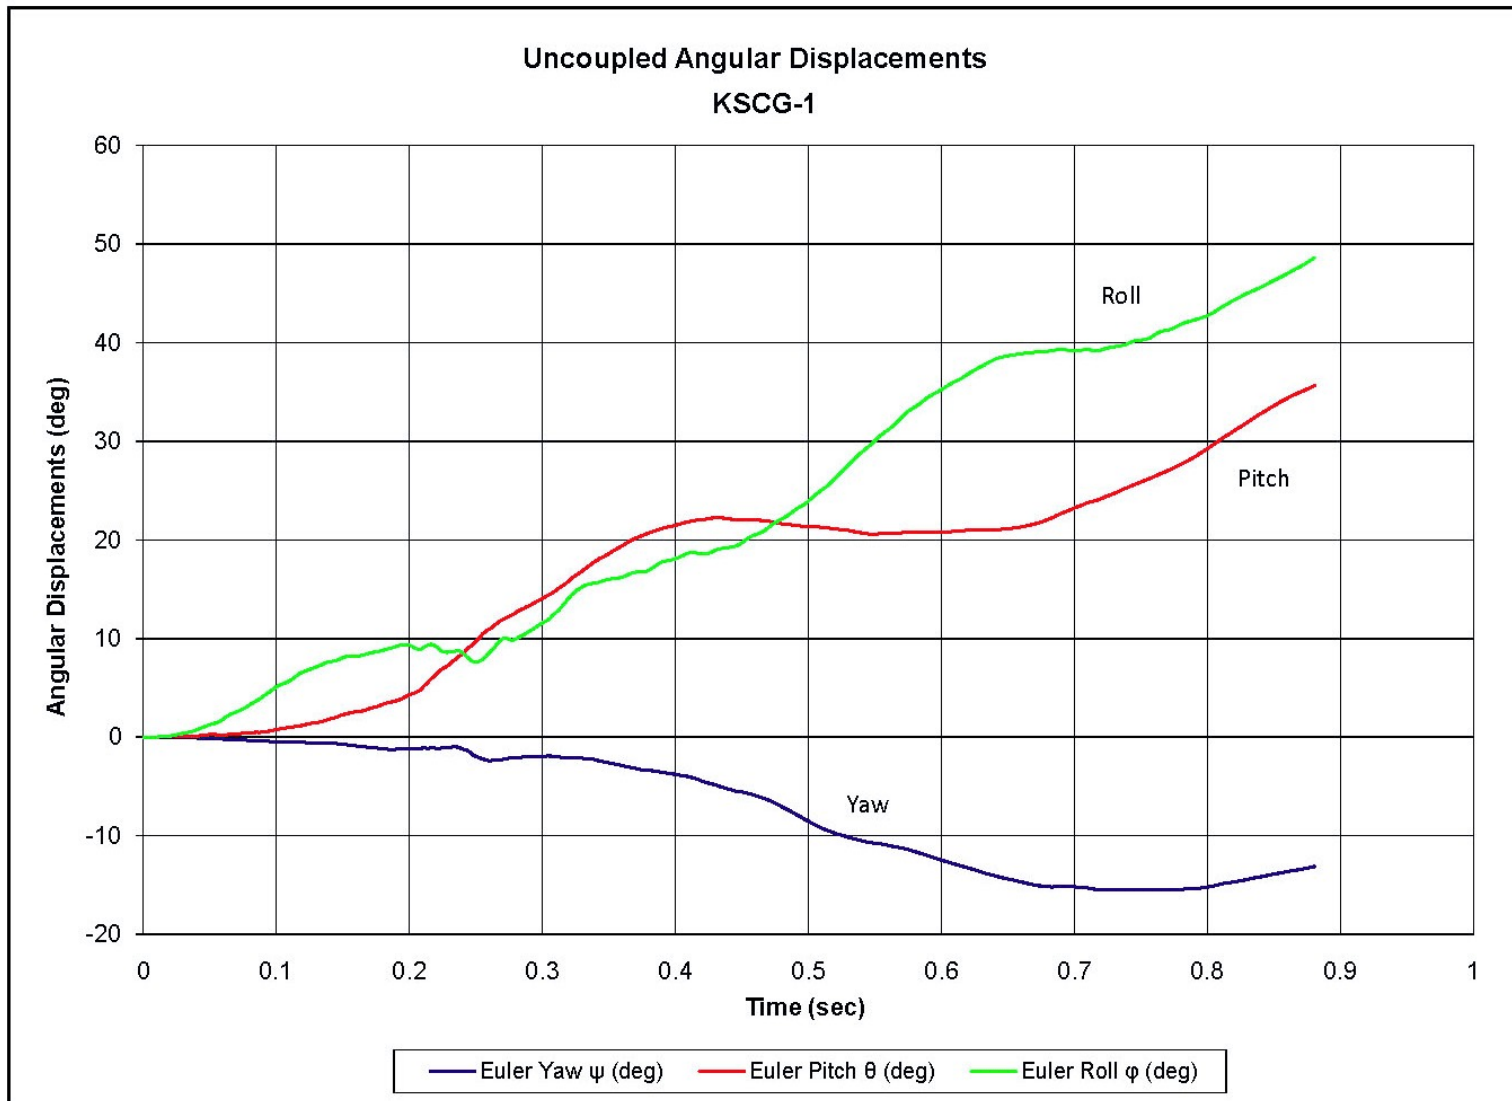
Figure E-7. Graph of Roll, Pitch, and Yaw Angular Displacements, Test KSCG-1 (Note: Time zero is impact with the culvert grate)

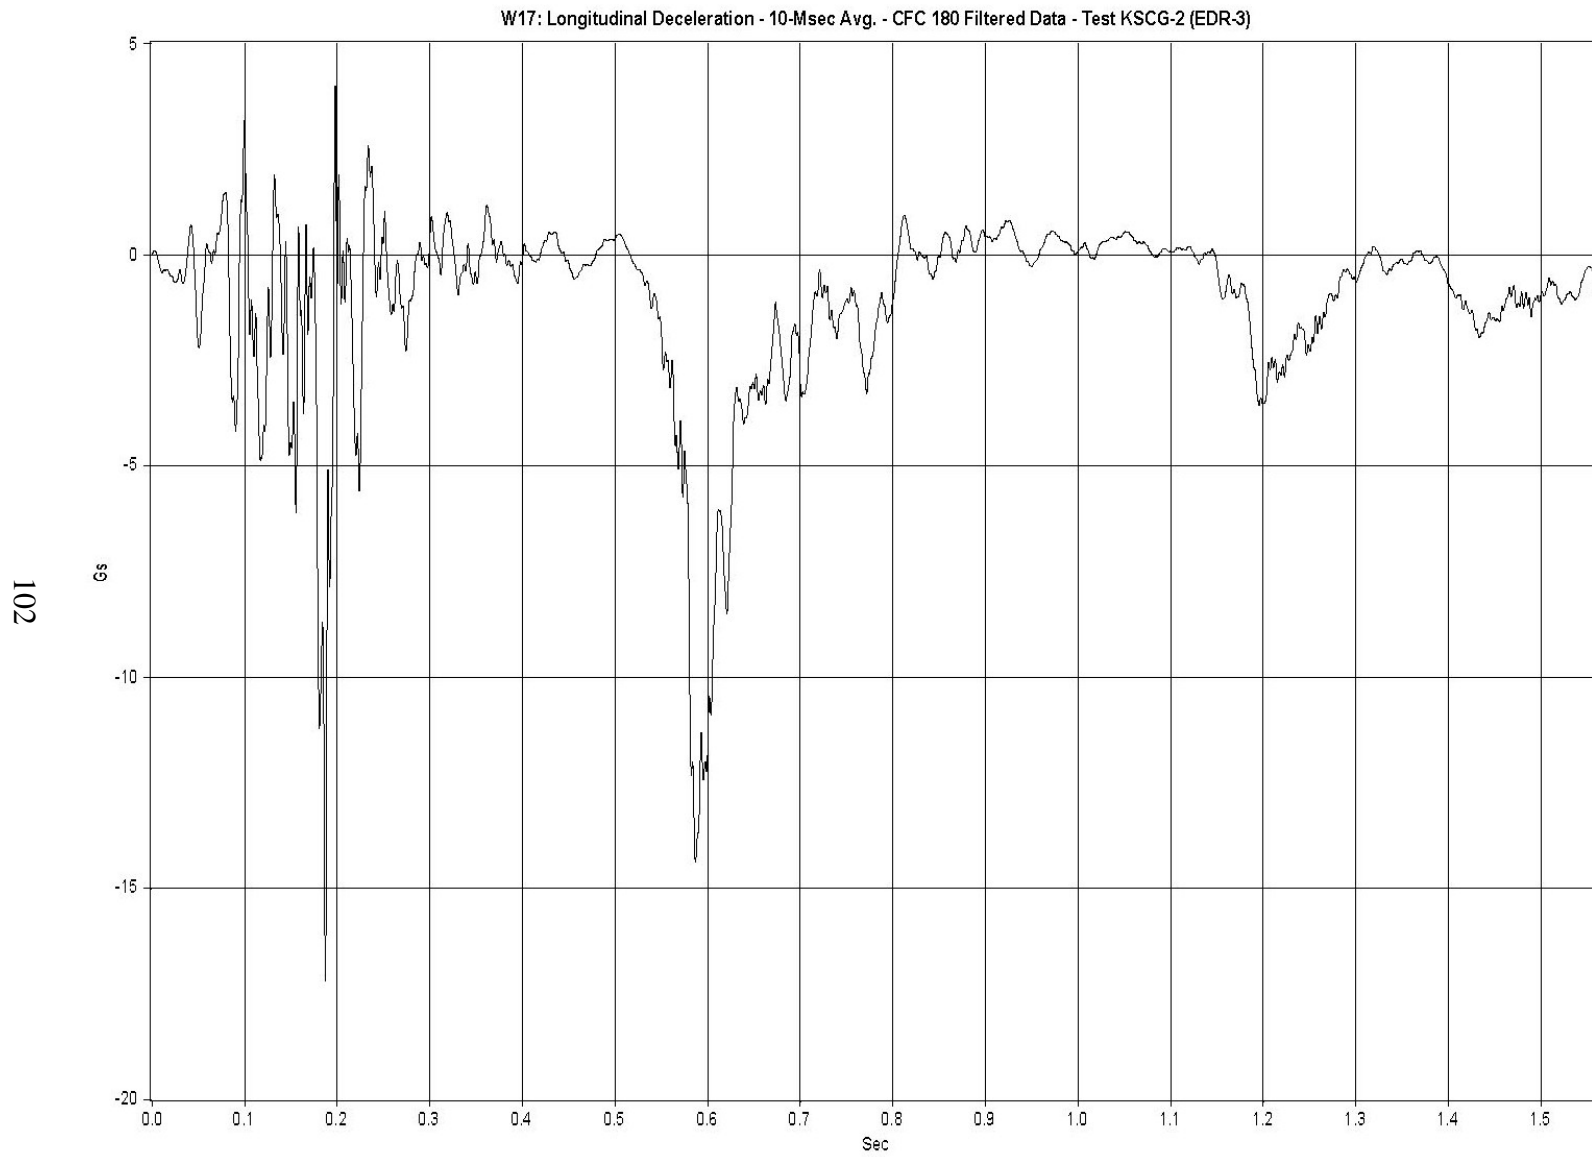
Figure F-1. Graph of Longitudinal Deceleration, Test KSCG-2

The longitudinal and lateral occupant impact velocities were determined to be 3.80 m/s (12.47 ft/s) and 2.03 m/s (6.65 ft/s), respectively. The maximum 0.010-sec average occupant ridedown decelerations in the longitudinal and lateral directions were 14.38 g's and 3.58 g's, respectively. It is noted that the occupant impact velocities (OIVs) and occupant ridedown decelerations (ORDs) were within the suggested limits provided in NCHRP Report No. 350. The THIV and PHD values were determined to be 4.36 m/s (14.30 ft/s) and 14.65 g's, respectively. The results of the occupant risk, as determined from the accelerometer data, are summarized in Figure 34. Results are shown graphically in Appendix F. The results from the rate transducer are shown graphically in Appendix F.

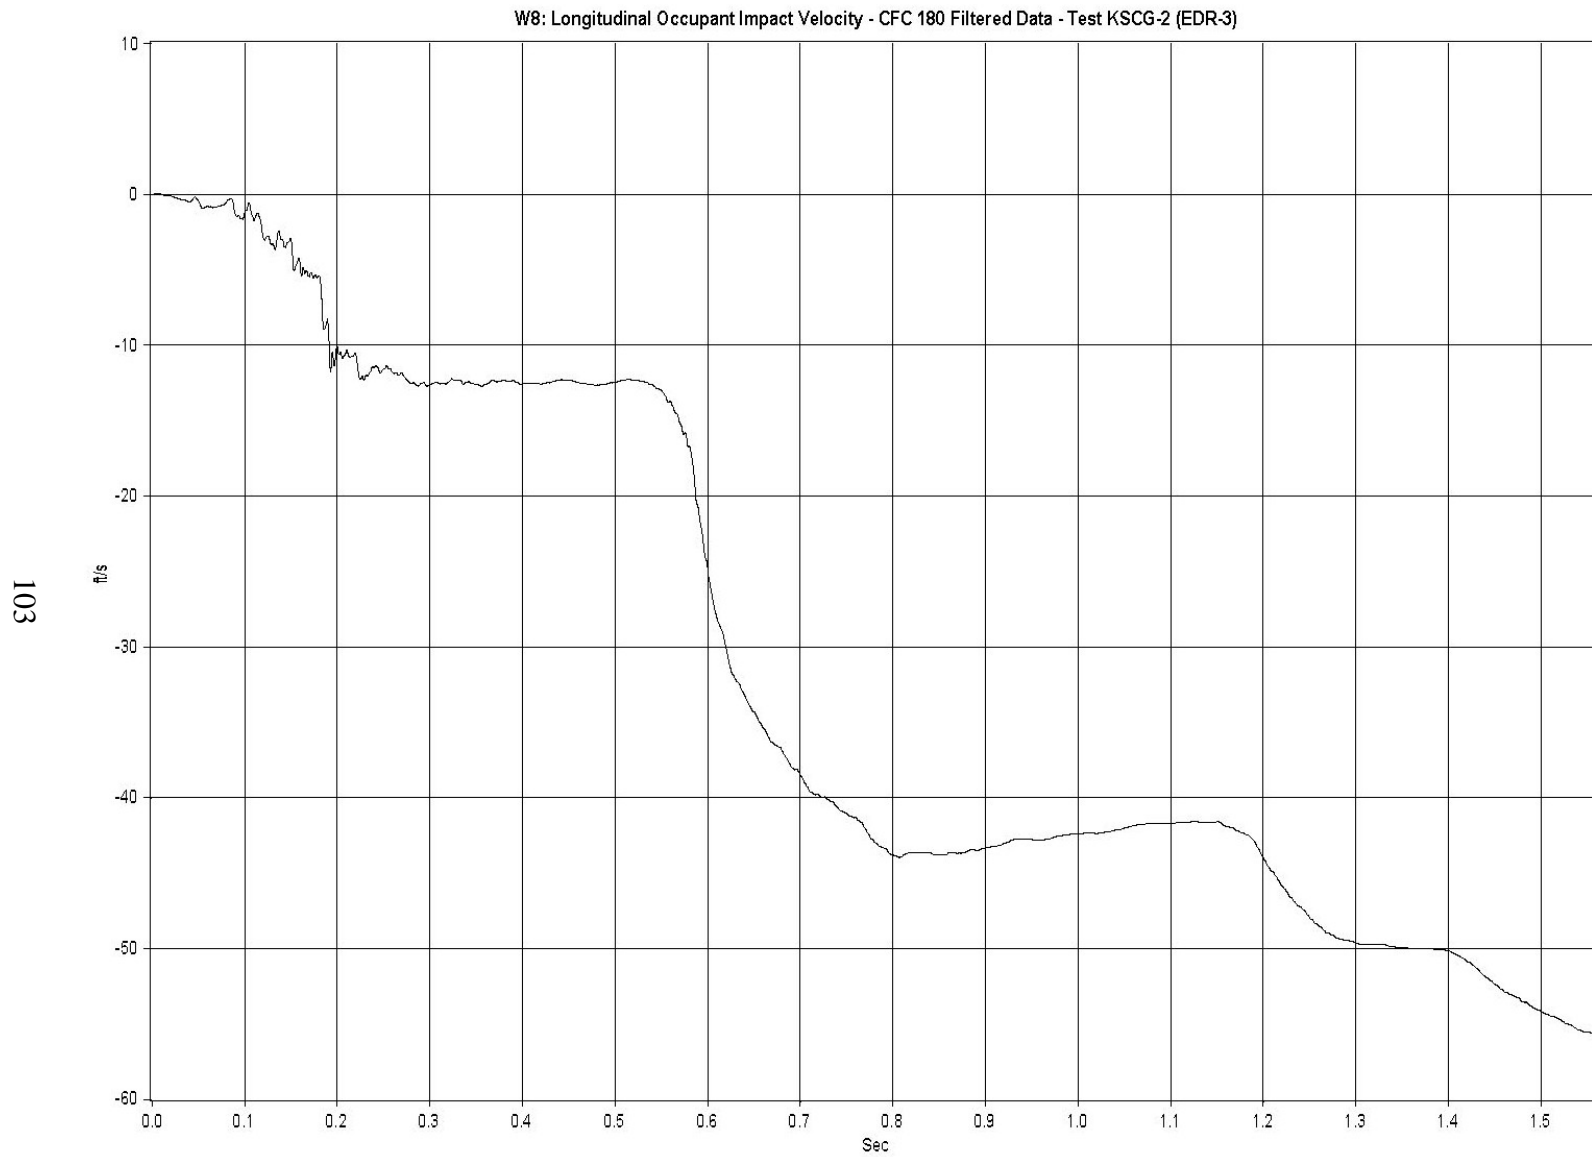
Figure F-2. Graph of Longitudinal Occupant Impact Velocity, Test KSCG-2

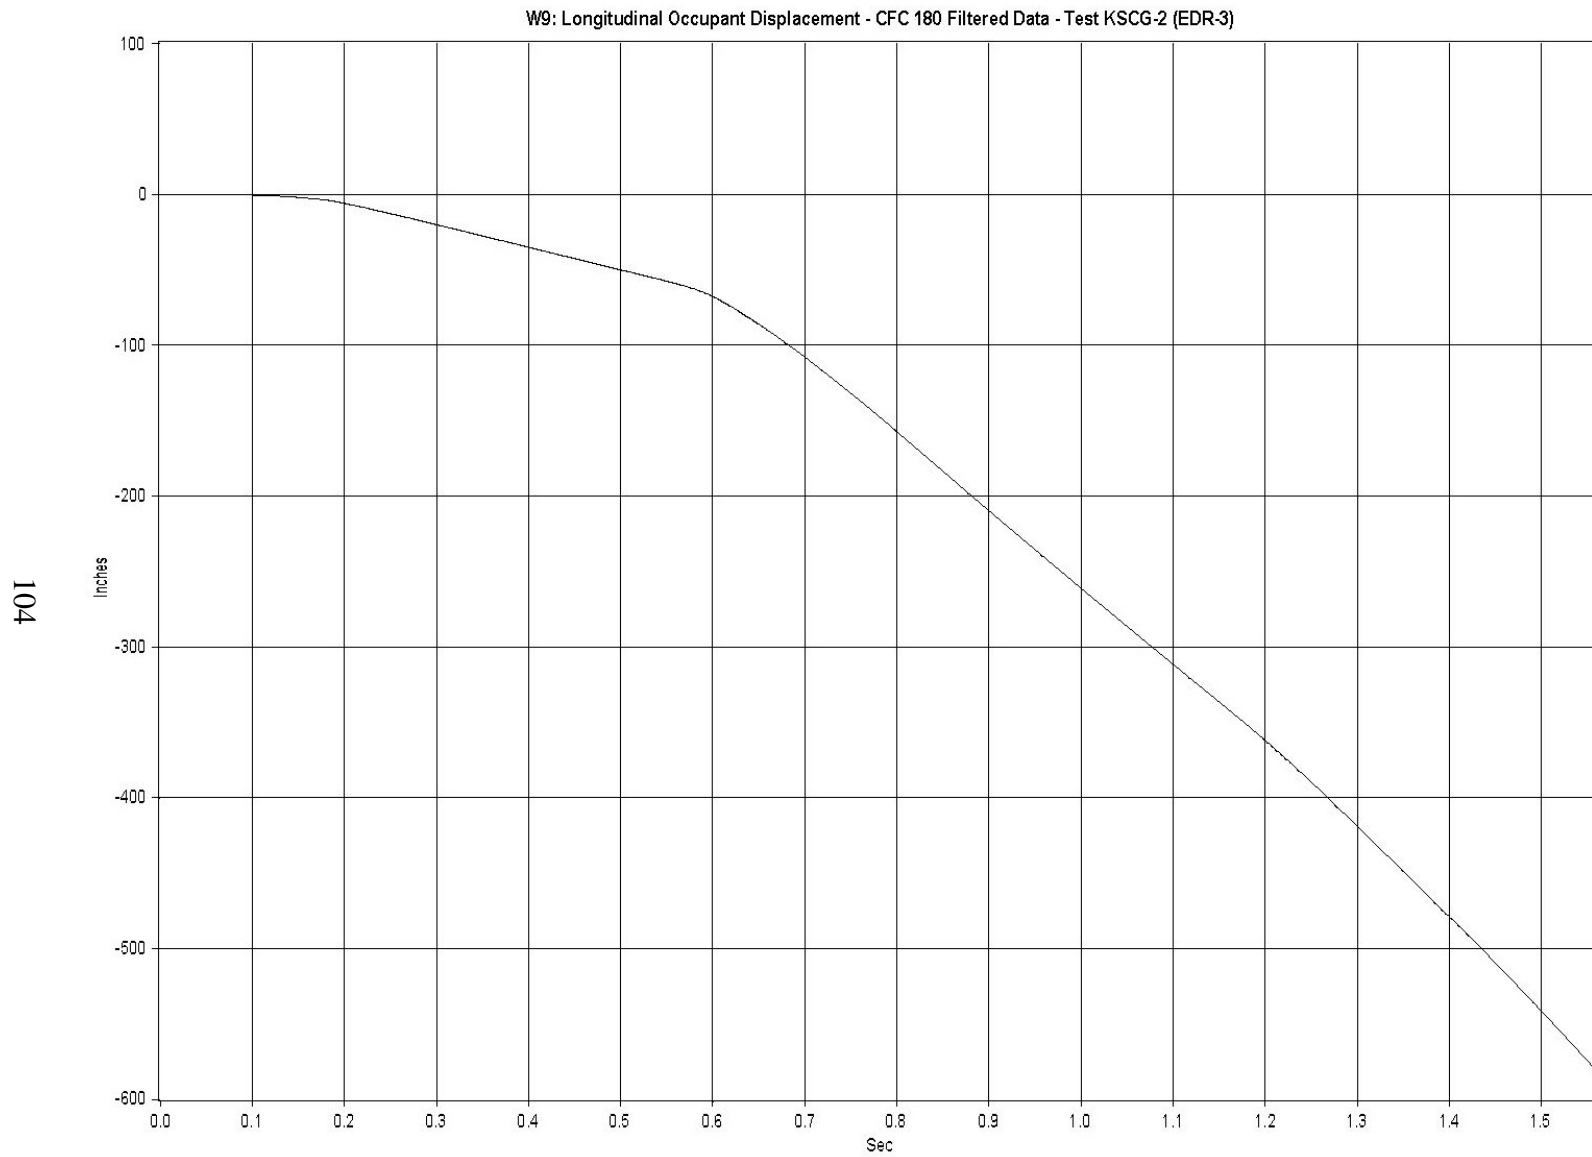
Figure F-3. Graph of Longitudinal Occupant Displacement, Test KSCG-2

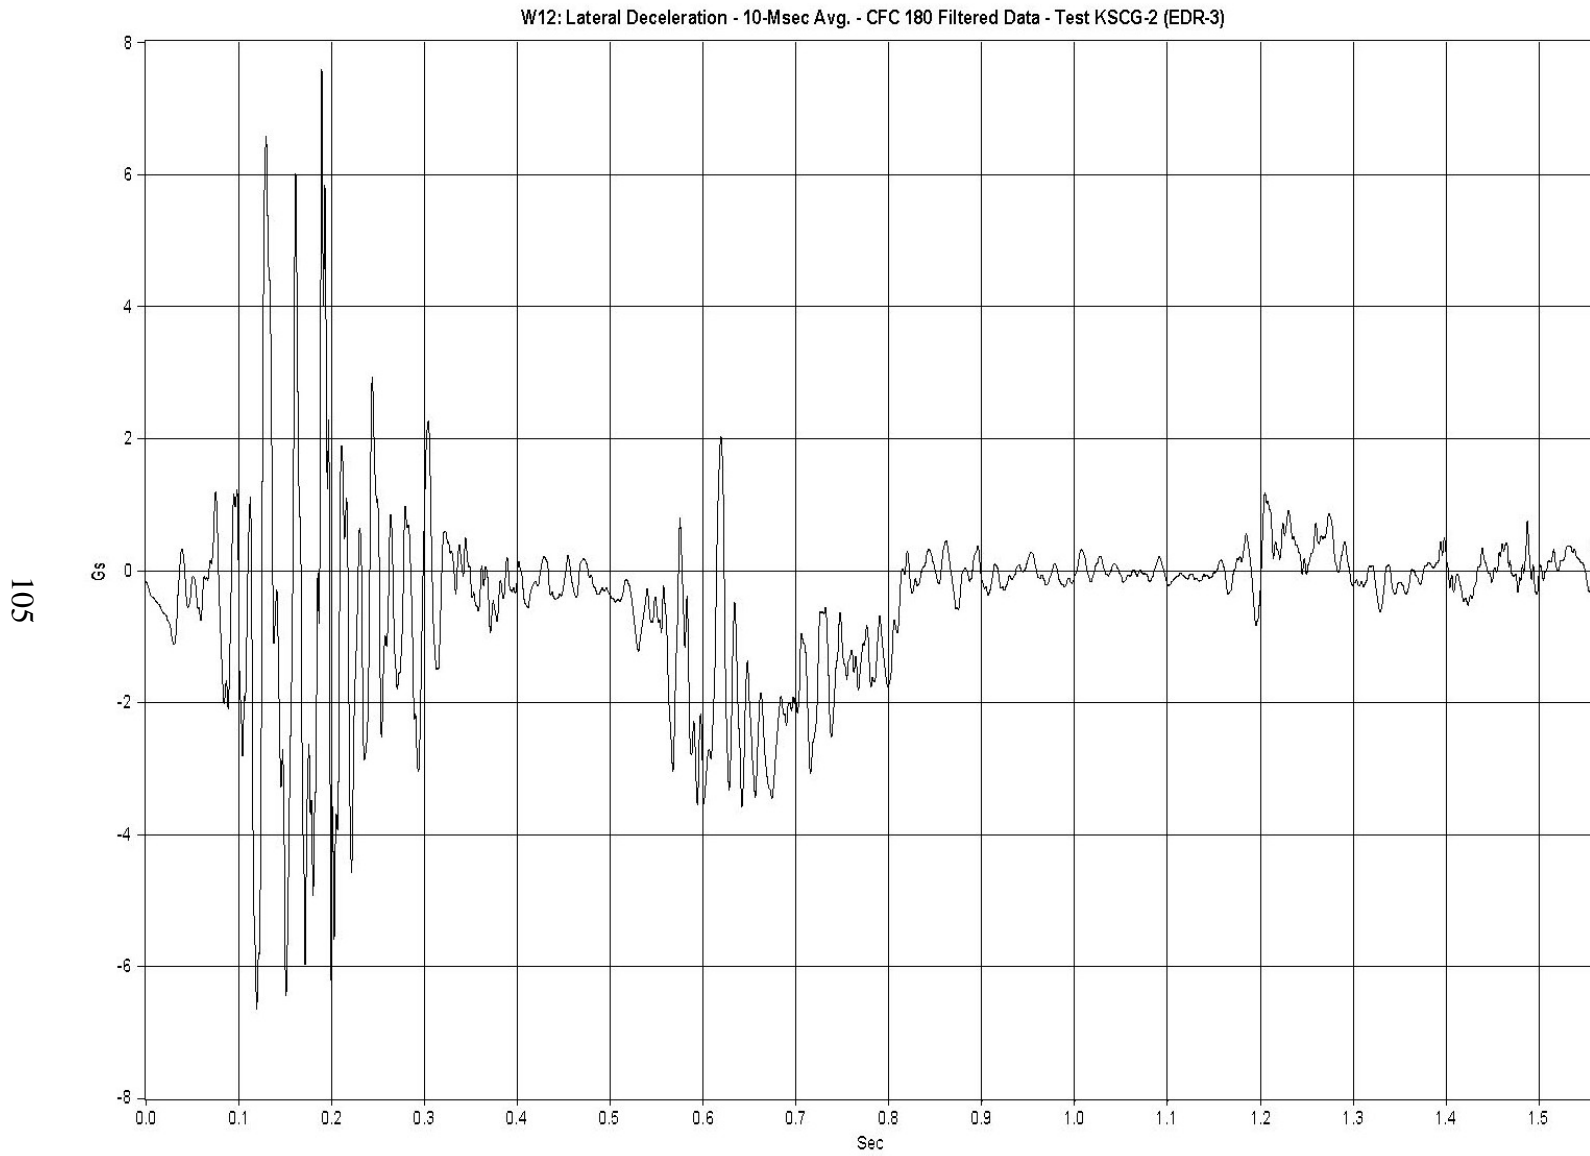
Figure F-4. Graph of Lateral Deceleration, Test KSCG-2

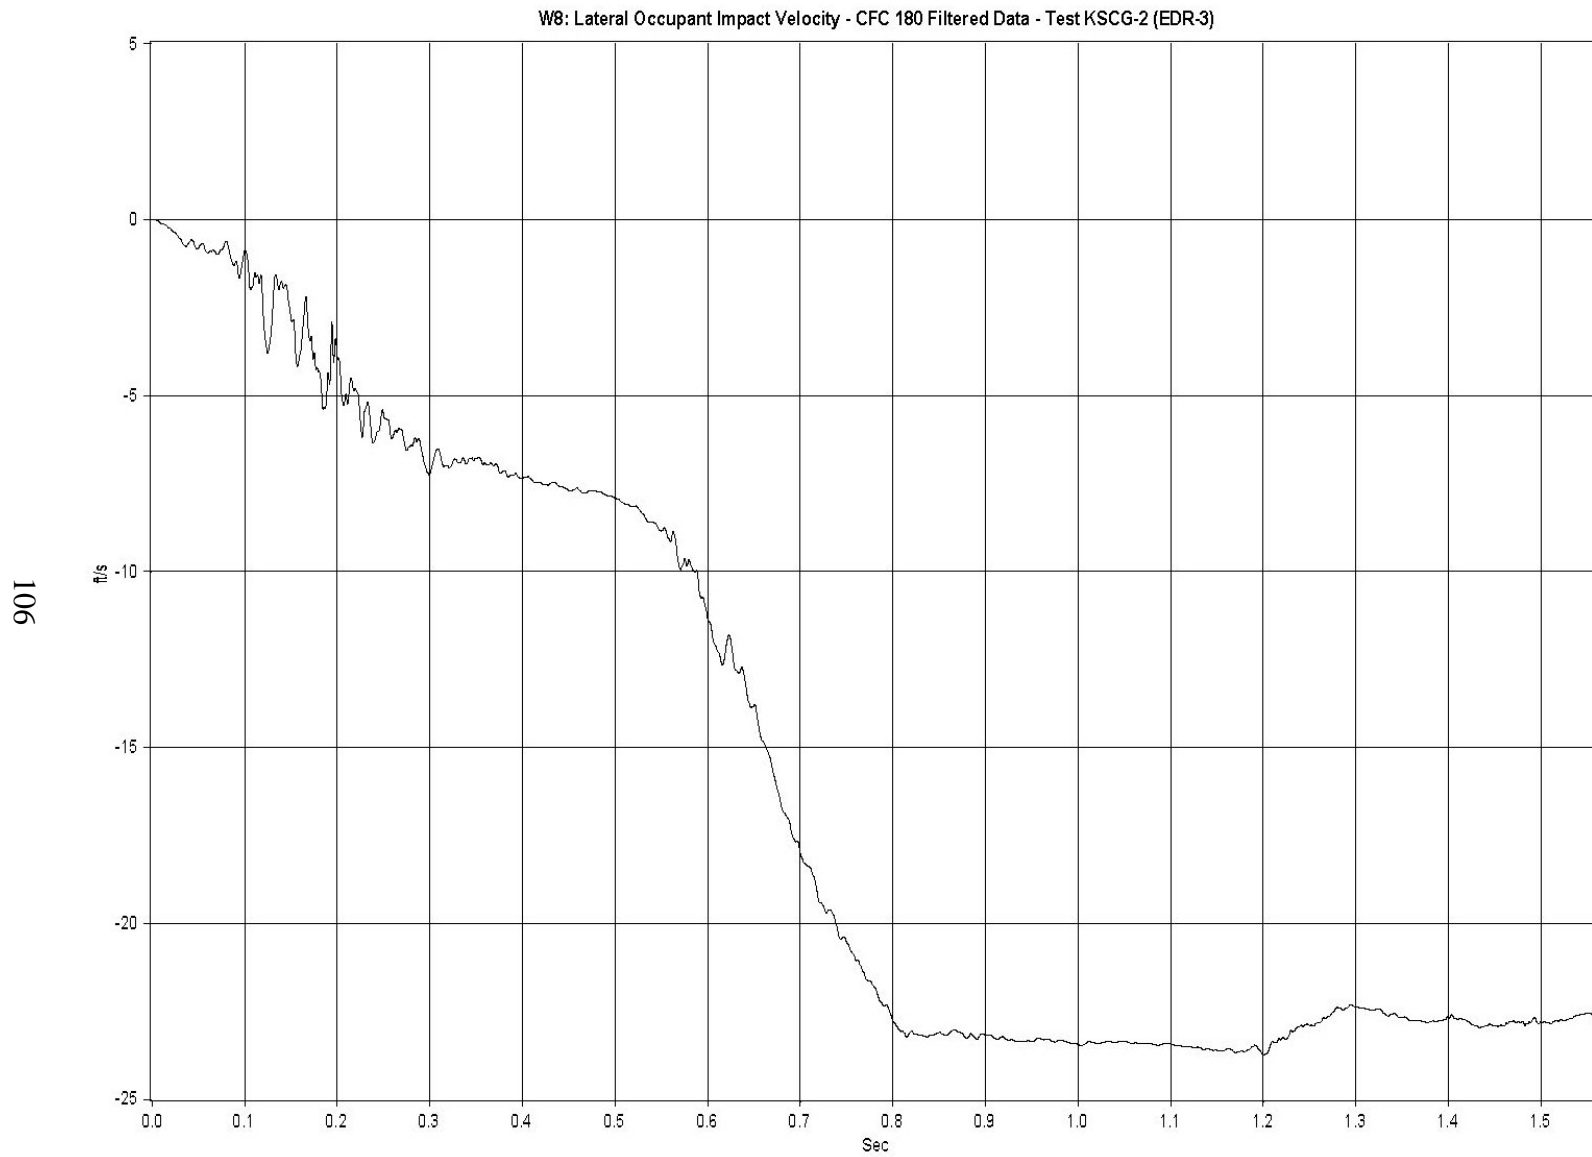
Figure F-5. Graph of Lateral Occupant Impact Velocity, Test KSCG-2

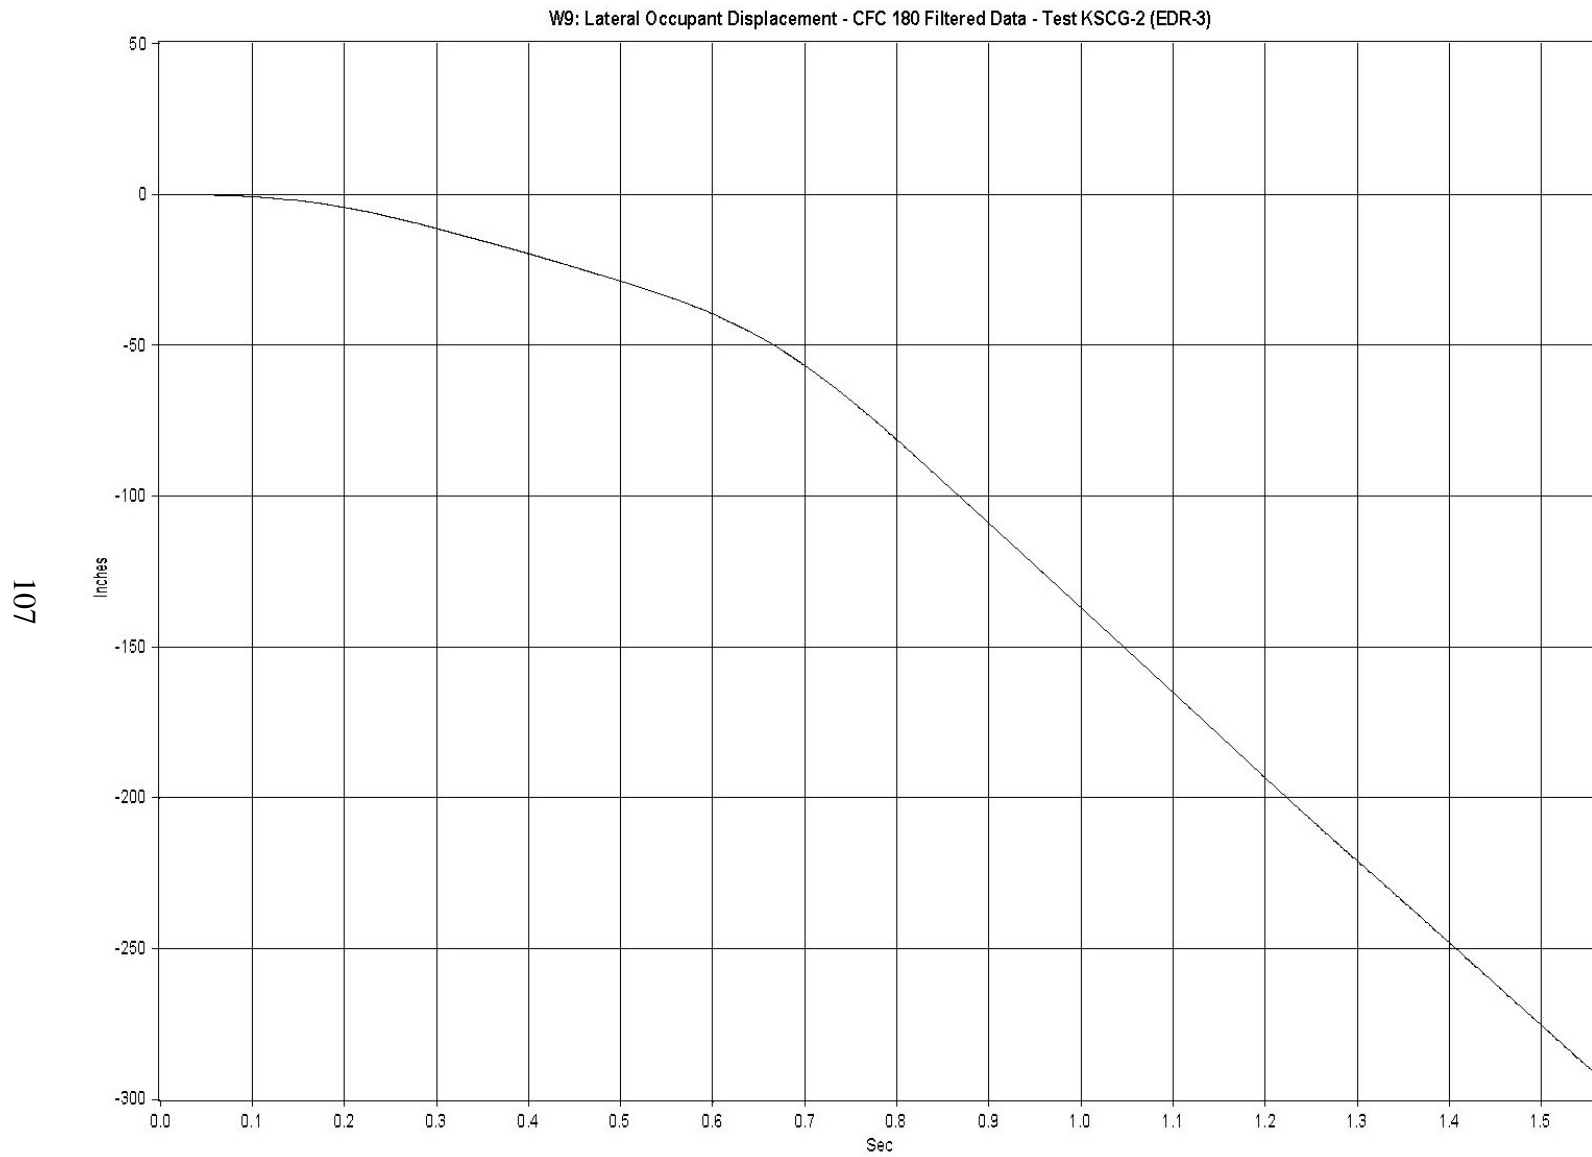
Figure F-6. Graph of Lateral Occupant Displacement, Test KSCG-2

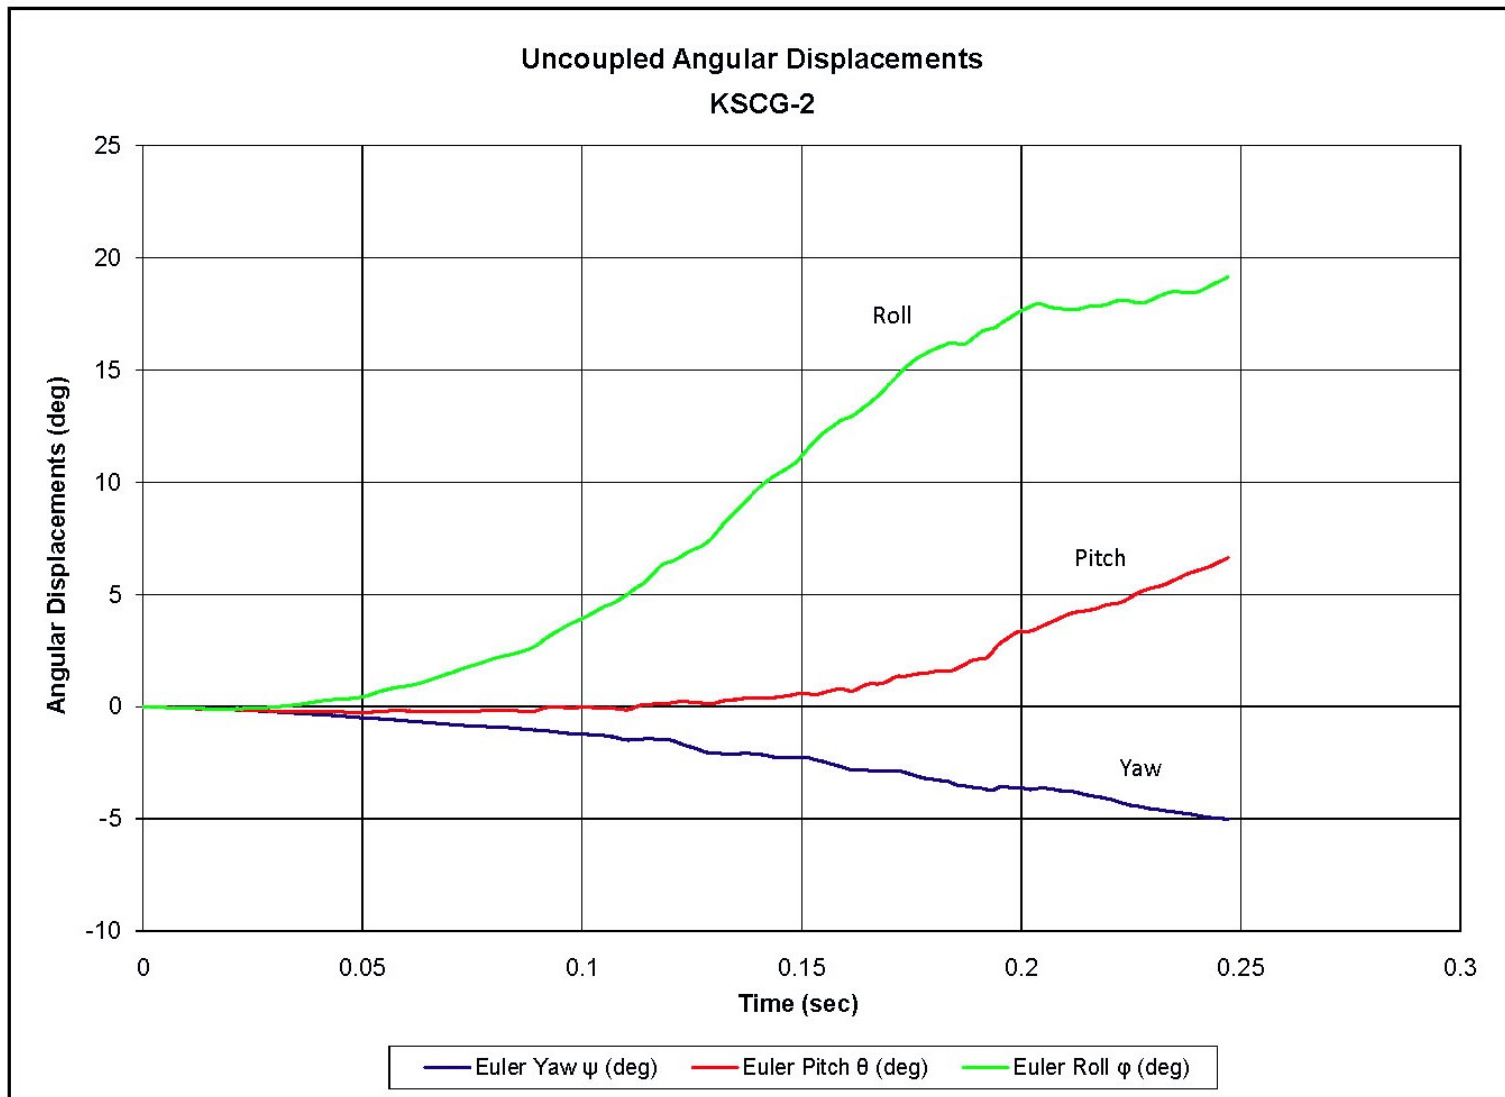
Figure F-7. Graph of Roll, Pitch, and Yaw Angular Displacements, Test KSCG-2 (Note: Time zero is impact with the culvert grate)
