Approach Slope for Midwest Guardrail System

Erin A. Johnson
University of Nebraska - Lincoln

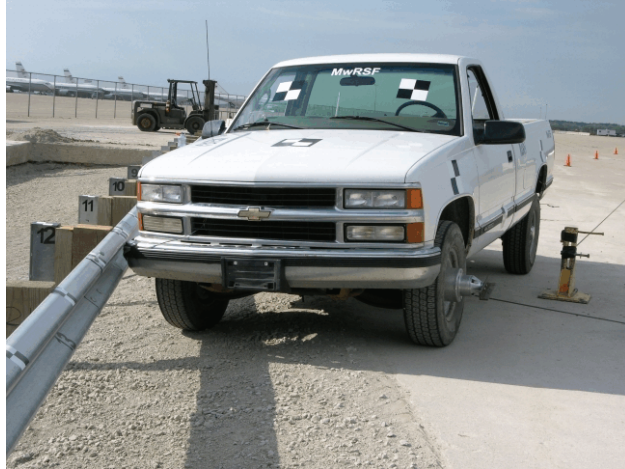
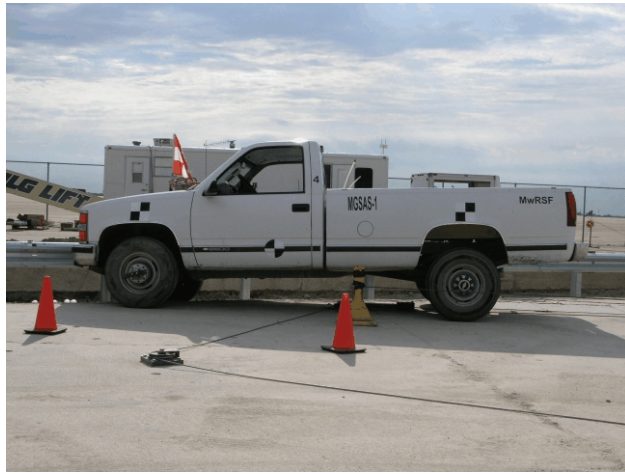
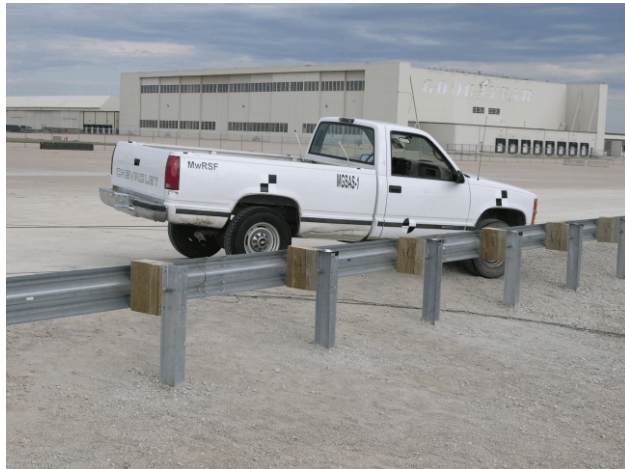
Figure 1. Test Vehicle, Test No. MGSAS-1

For test MGSAS-1, a 1999 Chevrolet 2500 3/4-ton pickup truck was used as the test vehicle. The test inertial and gross static weights were 2,036 kg (4,489 lbs). The test vehicle is shown in Figure 1, and vehicle dimensions are shown in Figure 2.

The longitudinal component of the center of gravity was determined using the measured axle weights. The location of the final center of gravity is shown in Figures 1 through 4.

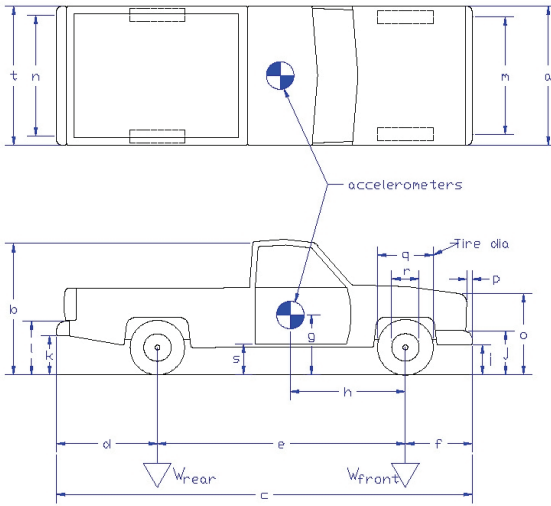
Figure 2. Vehicle Dimensions, Test No. MGSAS-1

Vehicle Geometry - mm (in.)

a 1918 (75.5) b 1867 (73.5)
 c 5537 (218) d 1295 (51)
 e 3340 (131.5) f 908 (35.75)
 g 660 (26) h 1410 (55.5)
 i 184 (7.25) j 667 (26.25)
 k 584 (23) l 794 (31.25)
 m 1597 (62.875) n 1632 (64.25)
 o 1022 (40.25) p 102 (4)
 q 749 (29.5) r 445 (17.5)
 s 416 (16.375) t 1854 (73)

Note any damage prior to test: Right lower box side dented, left front bumper corner pushed in

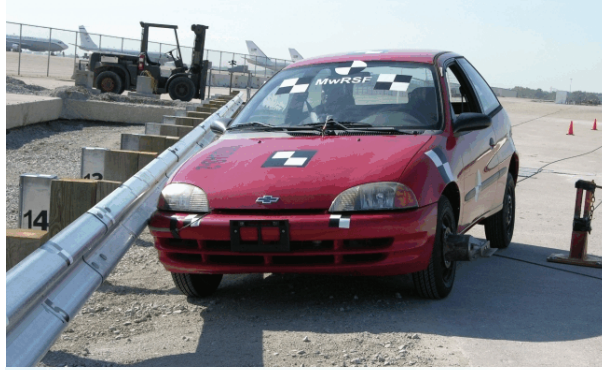
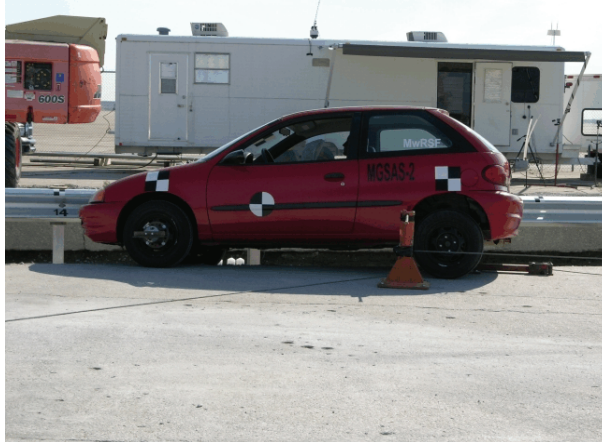
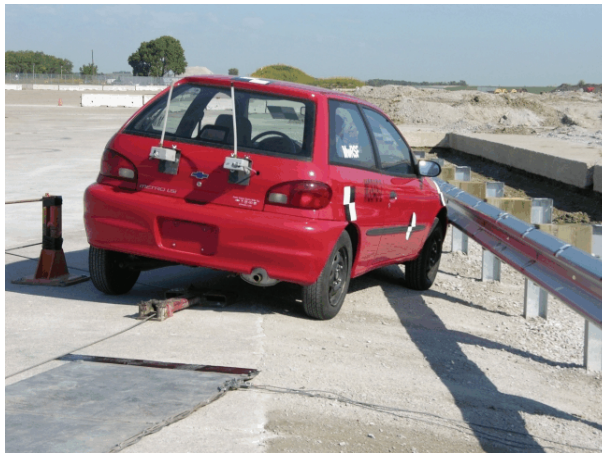
Figure 3. Test Vehicle, Test No. MGSAS-2

For test MGSAS-2, a 2000 Geo Metro was used as the test vehicle. The test inertial and gross static weights were 837 kg (1,845 lbs) and 912 kg (2,011 lbs), respectively. The test vehicle is shown in Figure 3, and vehicle dimensions are shown in Figure 4.

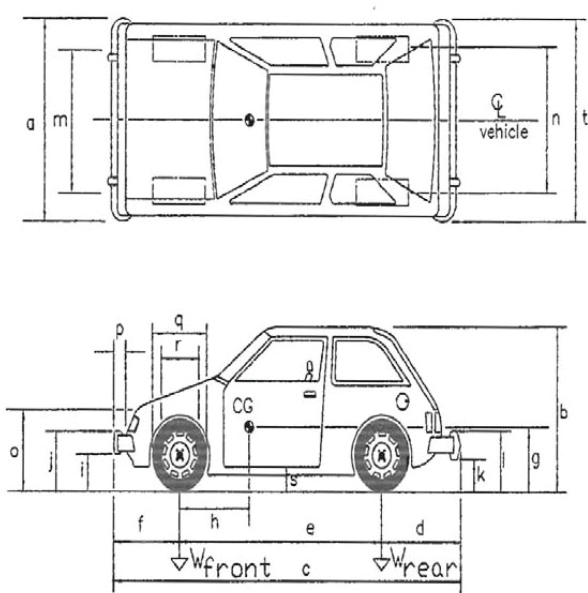
Figure 4. Vehicle Dimensions, Test No. MGSAS-2

Vehicle Geometry -- mm (in.)

a	1555.8 (61.25)	b	1400.2 (55.125)
c	3803.7 (149.75)	d	803.25 (23.75)
e	2362.2 (93.0)	f	863.6 (34.0)
g	542.93 (21.375)	h	876.3 (34.5)
i	280.35 (10.25)	j	533.4 (21.0)
k	298.45 (11.75)	l	635 (25.0)
m	1378 (54.25)	n	1355.7 (53.375)
o	584.2 (23.0)	p	101.6 (4.0)
q	581.03 (22.875)	r	361.95 (14.25)
s	317.5 (12.5)	t	1562.1 (61.5)
Wheel Center Height Front		266.7 (10.5)	
Wheel Center Height Rear		289.88 (10.625)	
Wheel Well Clearance (FR)		654.05 (25.75)	
Wheel Well Clearance (RR)		644.53 (25.375)

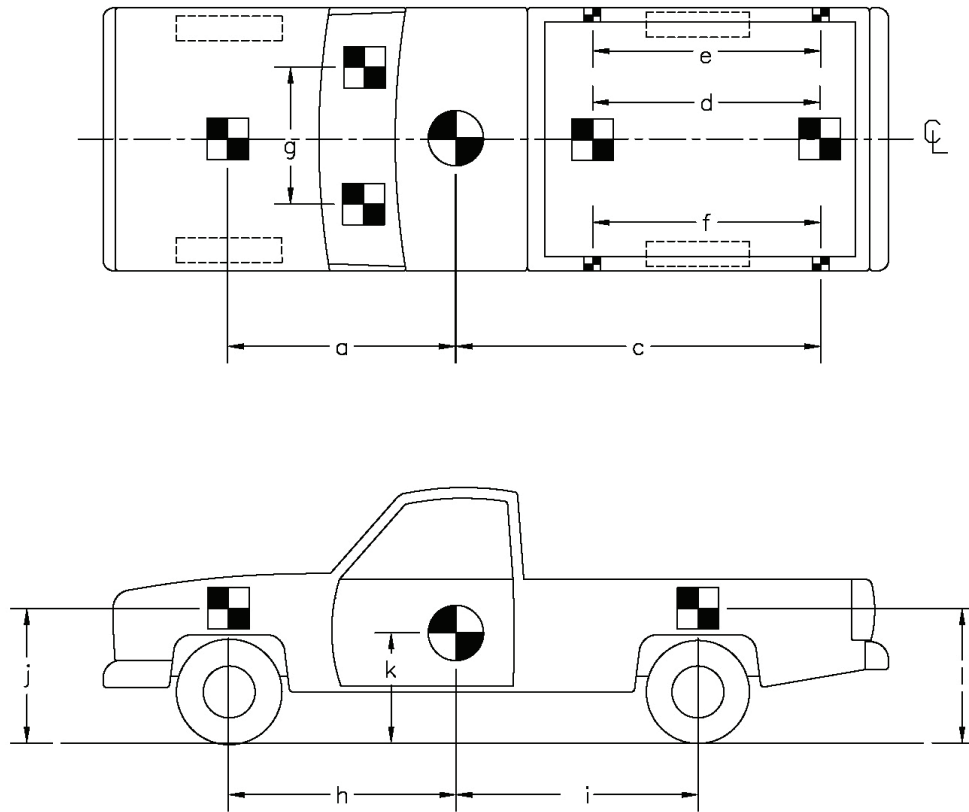
Figure 5. Target Geometry, Test No. MGSAS-1

TARGET GEOMETRY -- mm (in.)

a <u> 1610 (63.375)</u>	d <u> 1613 (63.5)</u>	g <u> 908 (35.75)</u>	j <u> 1022 (40.25)</u>
b <u> - </u>	e <u> 2149 (84.625)</u>	h <u> 1410 (55.5)</u>	k <u> 660 (26)</u>
c <u> 2604 (102.5)</u>	f <u> 2153 (84.75)</u>	i <u> 1924 (75.75)</u>	l <u> 1080 (42.5)</u>

Black and white checkered targets were placed on the vehicle to aid in the analysis of the high-speed videos, as shown in Figures 5 and 6. Checkered targets were placed on the C.G. on the driver's side door, passenger's side door, and roof of the vehicle. The remaining targets were located for reference so that they could be viewed from the high-speed cameras for film analysis.

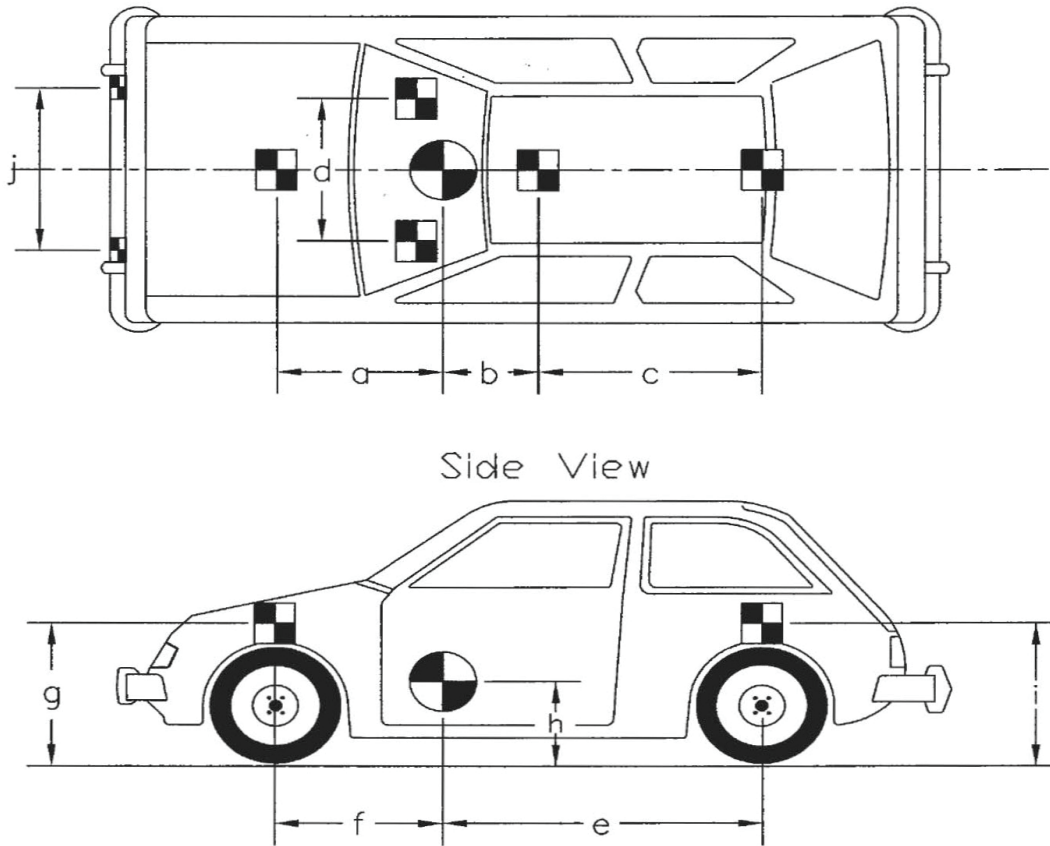
Figure 6. Target Geometry, Test No. MGSAS-2

TEST #: <u>MGSAS-2</u>					
TARGET GEOMETRY-- mm (in.)					
A	<u>1184</u>	<u>(46.625)</u>	E	<u>1486</u>	<u>(58.5)</u>
B	<u>432</u>	<u>(17.0)</u>	F	<u>876</u>	<u>(34.5)</u>
C	<u>921</u>	<u>(36.25)</u>	G	<u>670</u>	<u>(26.375)</u>
D	<u>625</u>	<u>(24.625)</u>	H	<u>543</u>	<u>(21.375)</u>
I	<u>756</u>	<u>(29.75)</u>	J	<u>778</u>	<u>(30.625)</u>

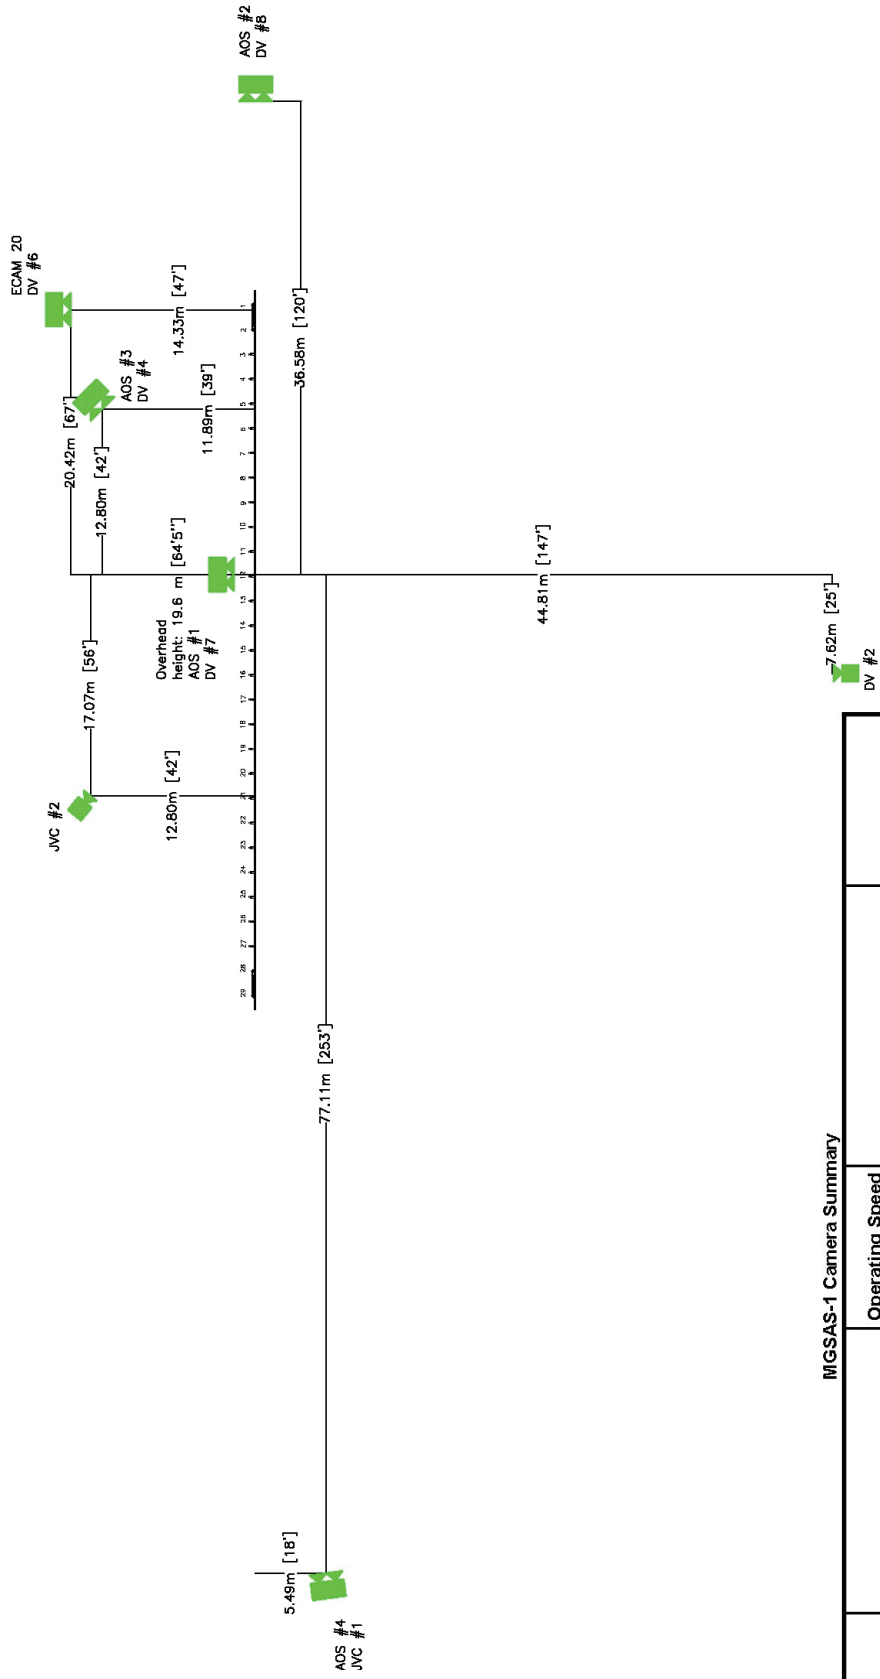
Figure 7. Camera Locations, Test No. MGSAS-1

MGSAS-1 Camera Summary

No.	Type	Operating Speed (frames/sec)	Lens	Lens Setting
1	Vitcam CTM	500	Cosmicar TV fixed 12.5 mm	
2	Vitcam CTM	500	Sigma 24-135 mm	100 mm
3	Vitcam CTM	500	Sigma 24-70 mm	35 mm
4	Vitcam CTM	500	Sigma 70-200 mm	unknown
20	Redlake E/Cam Camera	500	TV zoom 8048 mm	btwn 8 and 12
2	Canon-ZR10	29.97		
4	Canon-ZR30	29.97		
6	Canon-ZR25	29.97		
7	Canon-ZR90	29.97		
8	Canon-ZR90	29.97		
1	JVC - GZ-MC500 (Everio)	29.97		
2	JVC - GZ-IMC40u (Everio)	29.97

For test no. MGSAS-1, four high-speed AOS VITcam digital video cameras and one high-speed RedLake E/cam video camera, all with operating speeds of 500 frames/sec, were used to film the crash test. Five Canon digital video cameras and two JVC digital video cameras, all with standard operating speeds of 29.97 frames/sec, were also used to film the crash test. Camera details and a schematic of all twelve camera locations for test no. MGSAS-1 are shown in Figure 7.

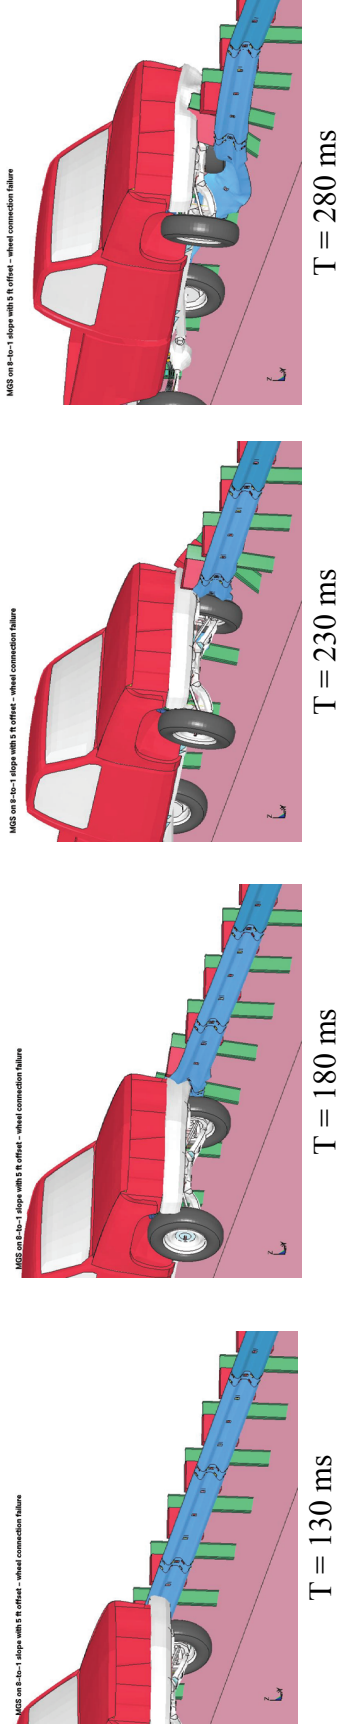
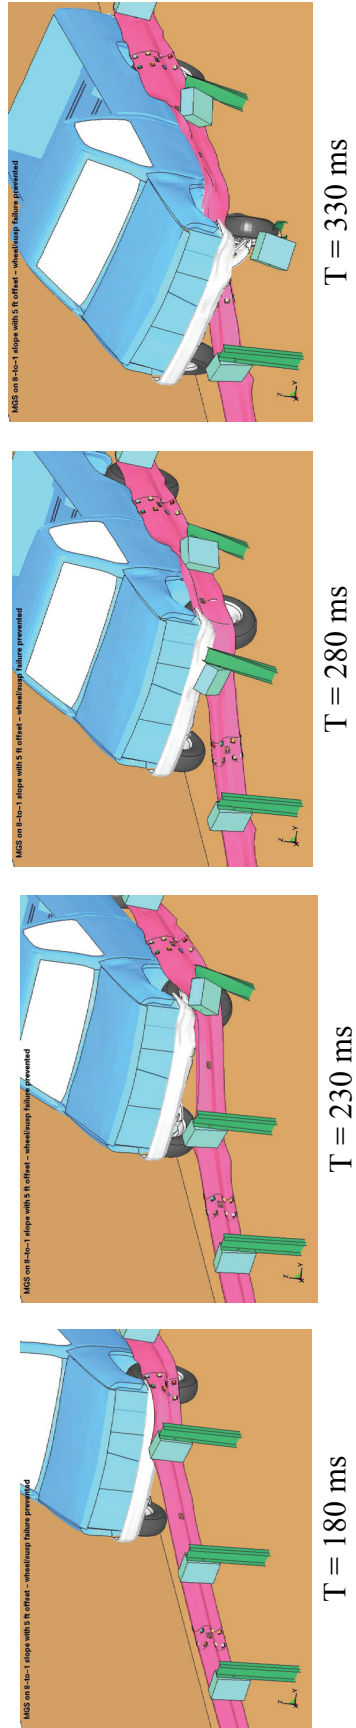
Figure 9. Simulation Results, MGs on 8-to-1 Slope with Rail 1.5 m (5 ft) Offset from Slope Break Point

MGs on 8-to-1 slope, rail 1.5 m (5 ft) offset from slope break point
 Pickup truck – 100 km/h (62.1 mph) at 25 degrees.

Wheel-Suspension Connection Failure Allowed – wheel comes off, truck overrides system

No Connection Failure Allowed – rail tries to capture via tire, gets jammed up into wheel-well
 This could cause rail rupture or vehicle roll-over.

Some results of the refined simulations are shown in Figure 9. The 1.5 m (5 ft) offset, once again, proved to be the worst-case offset for the 8:1 slope system, using the pickup truck impact condition. Results, as indicated in Figure 9, were inconclusive; which supports this slope and barrier

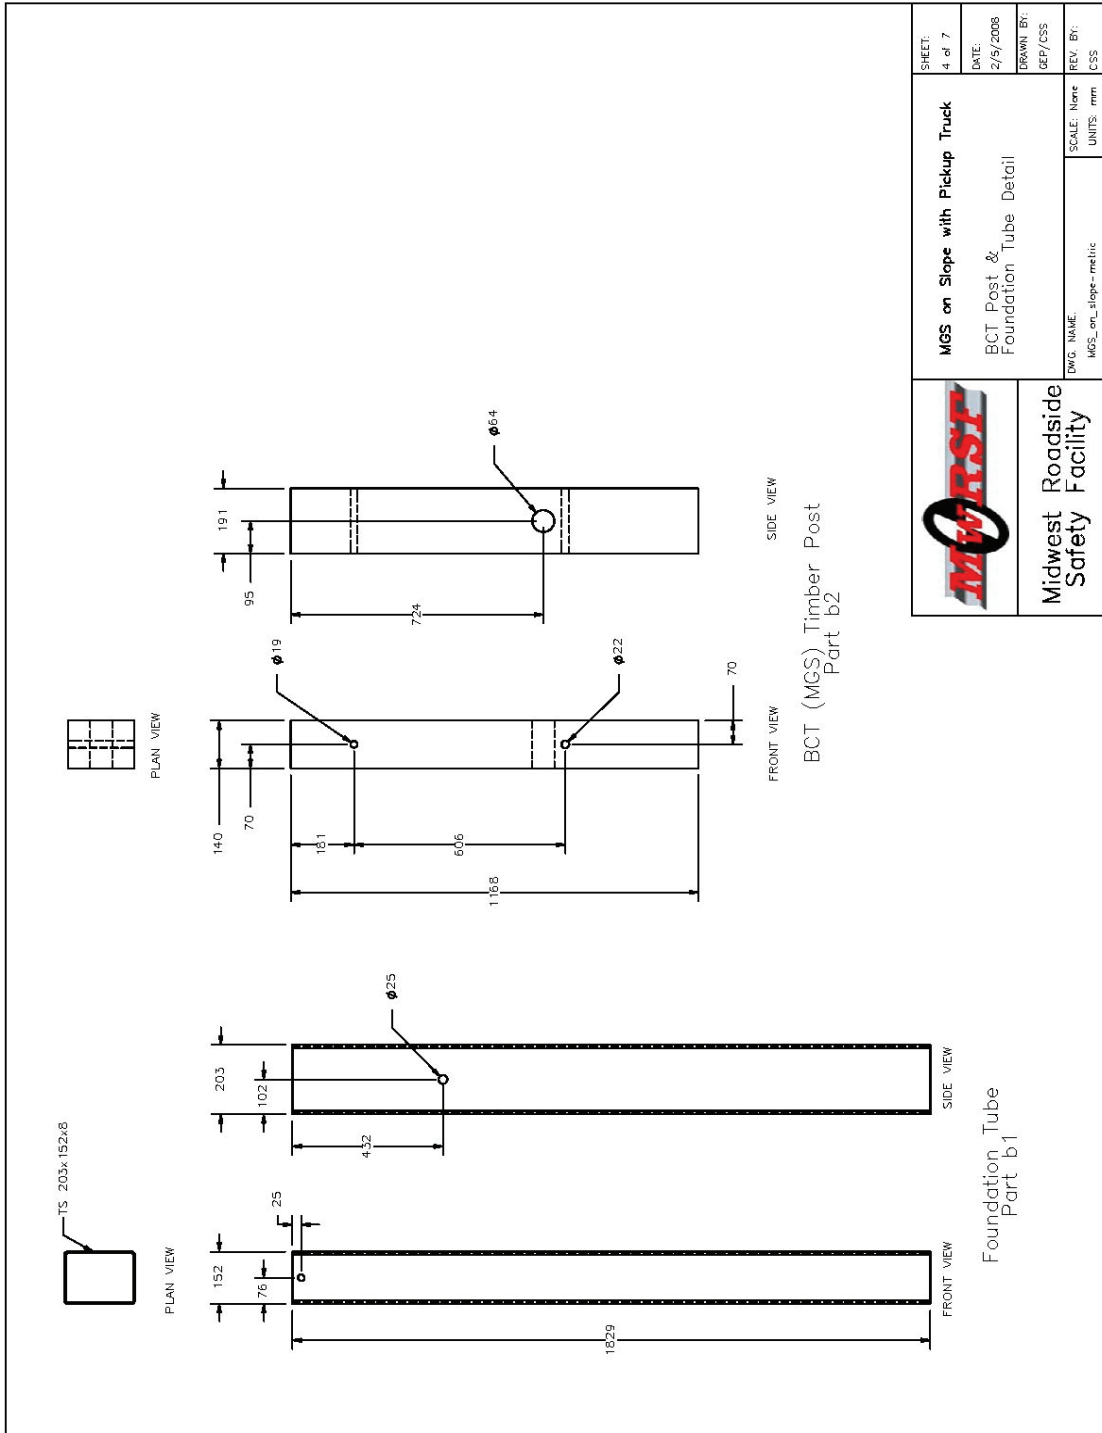
Figure 13. Anchor Post Details

MGS on Slope with Pickup Truck		SHEET: 4 of 7
	BCT Post & Foundation Tube Detail		DATE: 2/5/2008
Midwest Roadside Safety Facility		DWG. NAME: MGS_on_slope-metric	DRAWN BY: GEP/CSS
SCALE: Name UNITS: mm		REV. BY: CSS

The entire system was constructed with twenty-nine guardrail posts. Post nos. 3 through 27 were galvanized ASTM A36 steel W152x13.4 (W6x9) sections measuring 1,829 mm (6 ft) in length. Post nos. 1, 2, 28, and 29 were timber posts measuring 140-mm wide x 190-mm deep x 1,080-mm long (5.5-in. x 7.5-in. x 42.5-in.) and were placed in 1,829-mm (6-ft) long steel foundation tubes, as shown in Figure 13. The timber posts and foundation tubes were part of anchor systems designed to replicate the capacity of a tangent guardrail terminal.

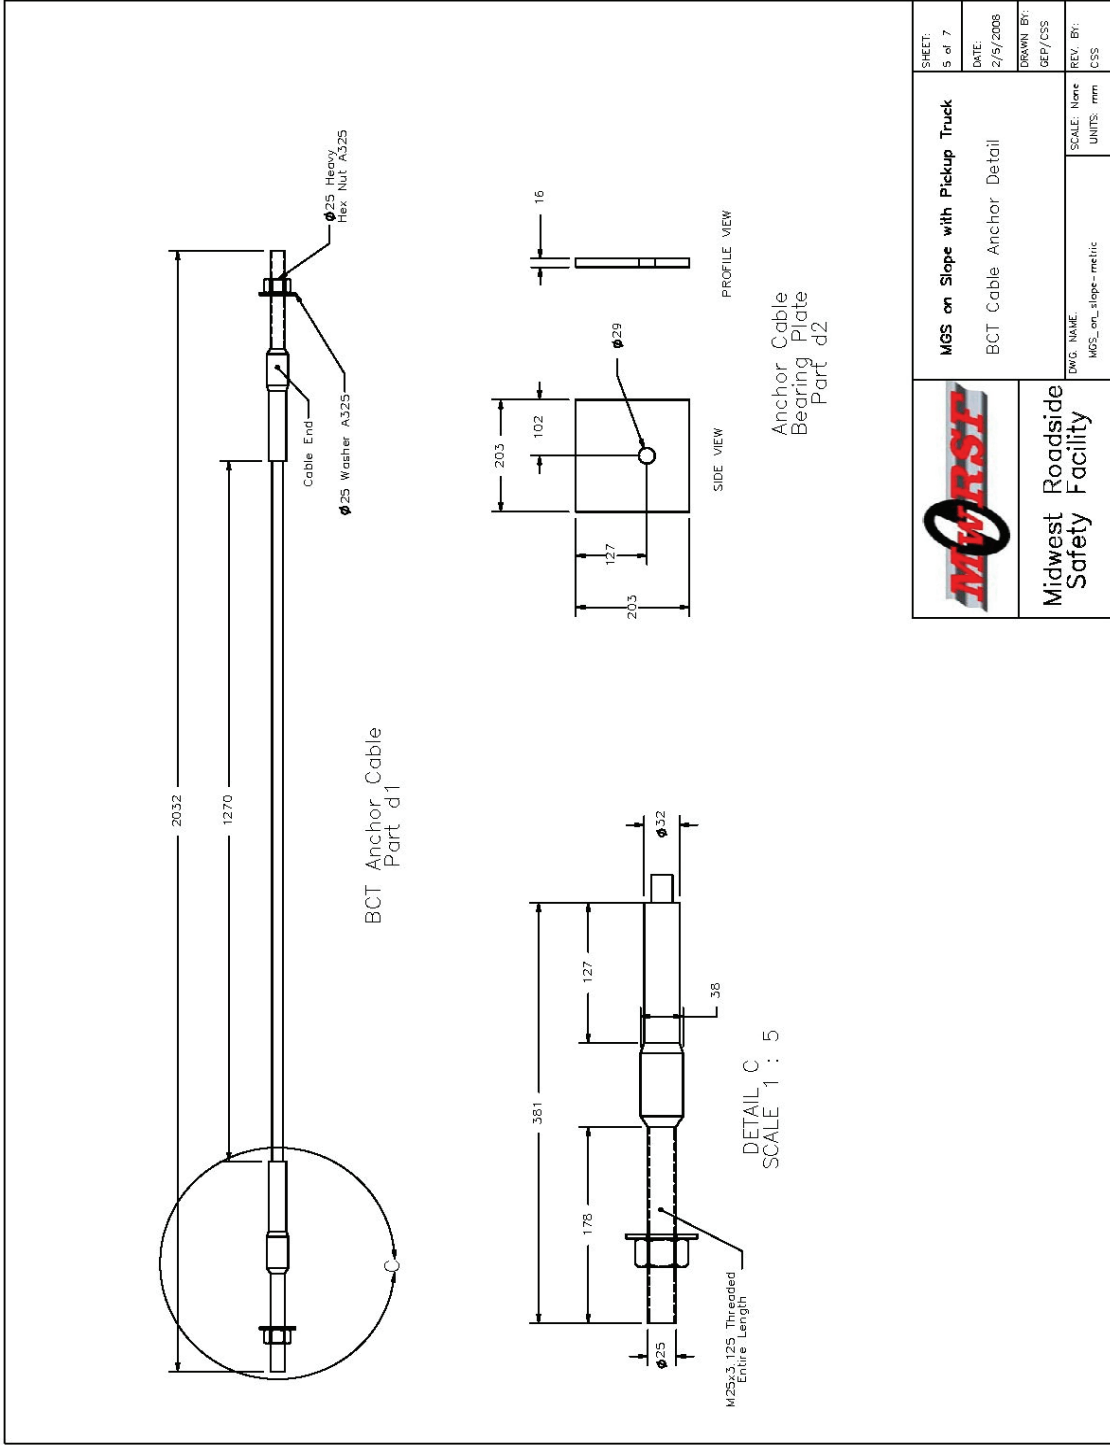
Figure 14. BCT Cable Anchor Details

MGS on Slope with Pickup Truck		SHEET: 5 of 7
	BCT Cable Anchor Detail		DATE: 2/5/2008
DWG. NAME: MGS_on_slope-metric		SCALE: None UNITS: mm	DRAWN BY: GEP/CSS
Midwest Roadside Safety Facility		REV. BY: CSS

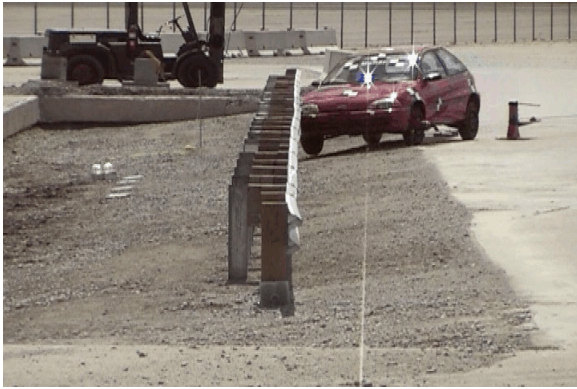
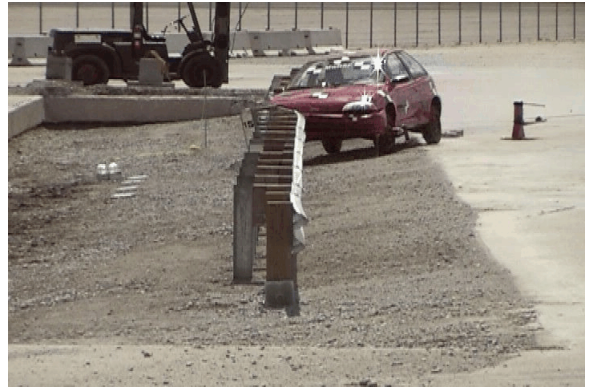
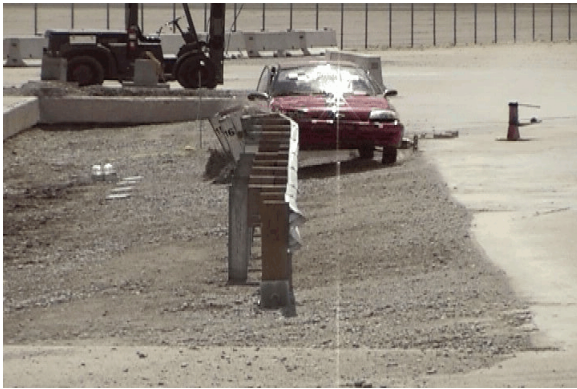
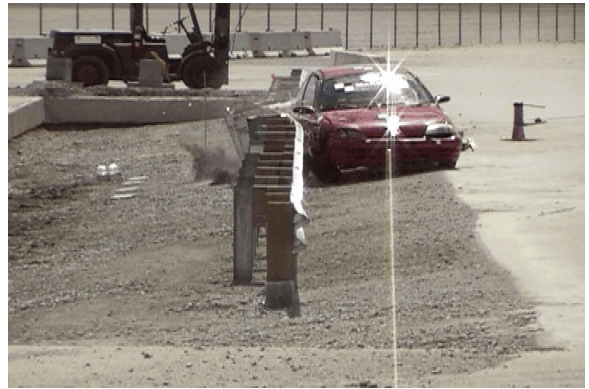
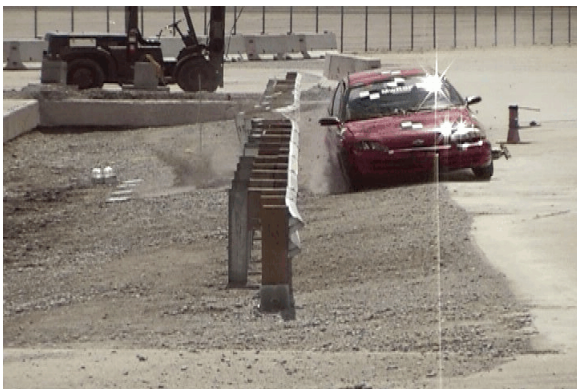
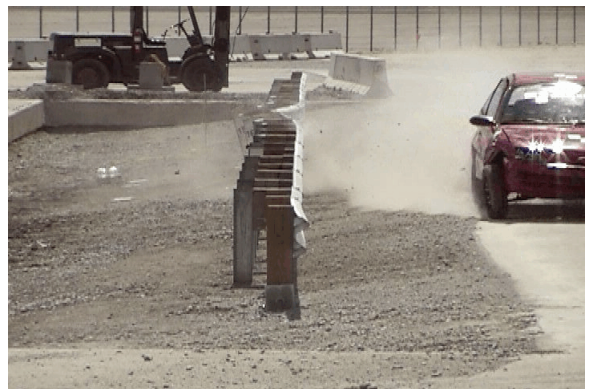
Figure 38. Additional Sequential Photographs, Test No. MGSAS-2

The 912-kg (2,011-lb) small car impacted the MGS, placed 1.5 m (5 ft) down from the slope break point, at a speed of 99.6 km/h (61.9 mph) and at an angle of 21.6 degrees. A summary of the test results and sequential photographs are shown in Figure 36. The summary of the test results and sequential photographs in English units are shown in Appendix B. Additional sequential photographs are shown in Figures 37 and 38. Documentary photographs are shown in Figures 39 and 40.

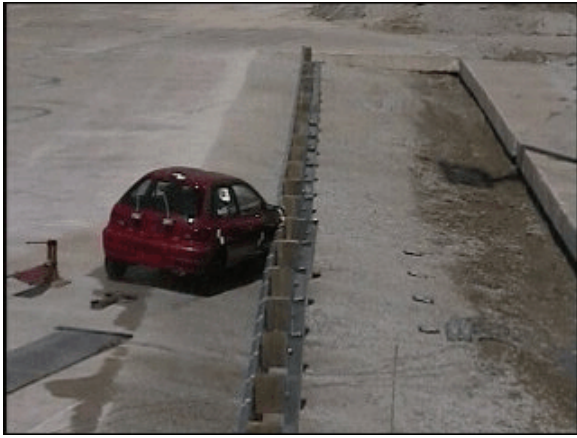
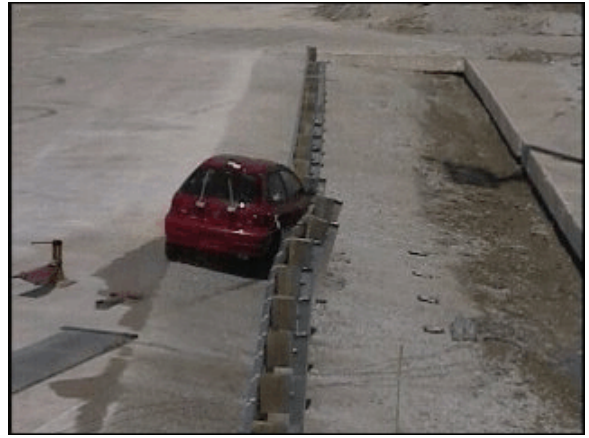
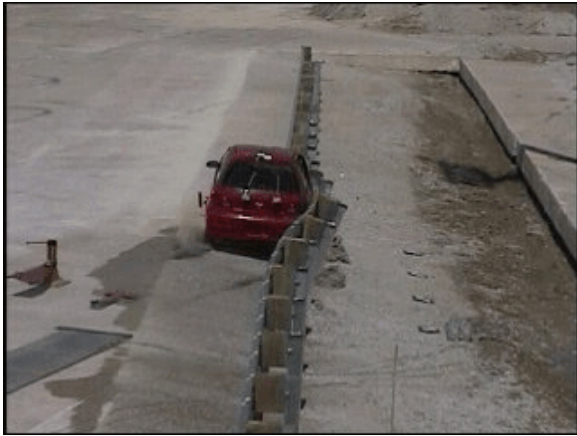
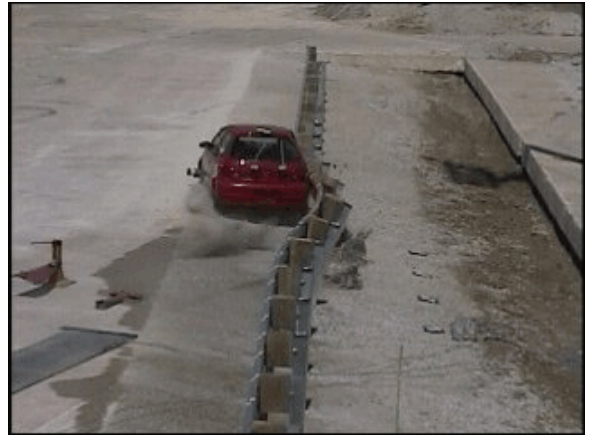
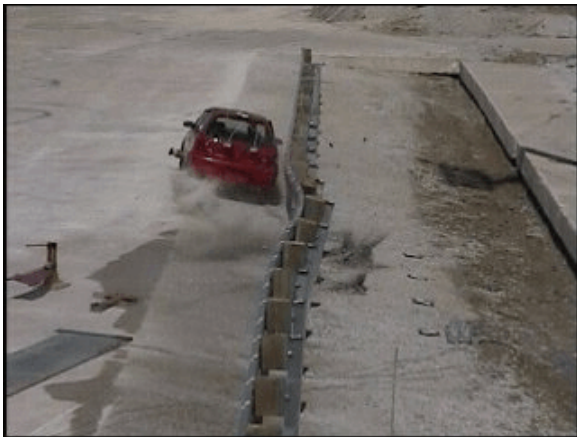
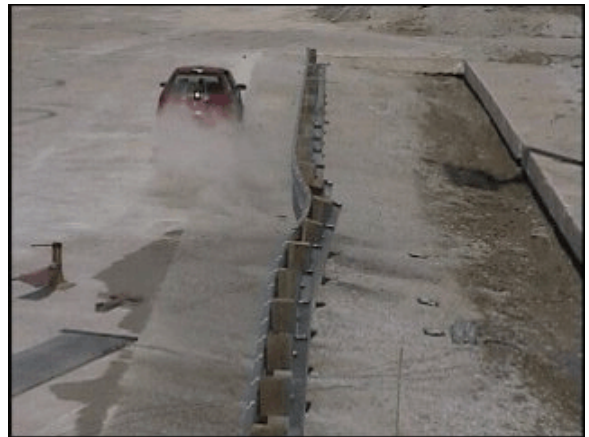
Figure 39. Documentary Photographs, Test No. MGSAS-2

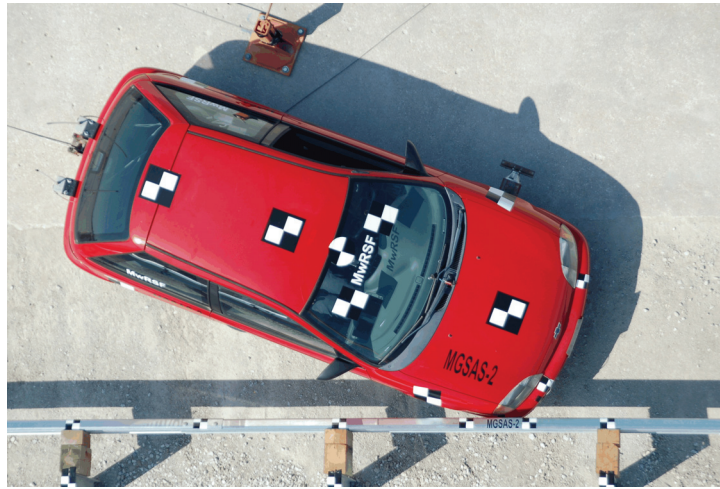
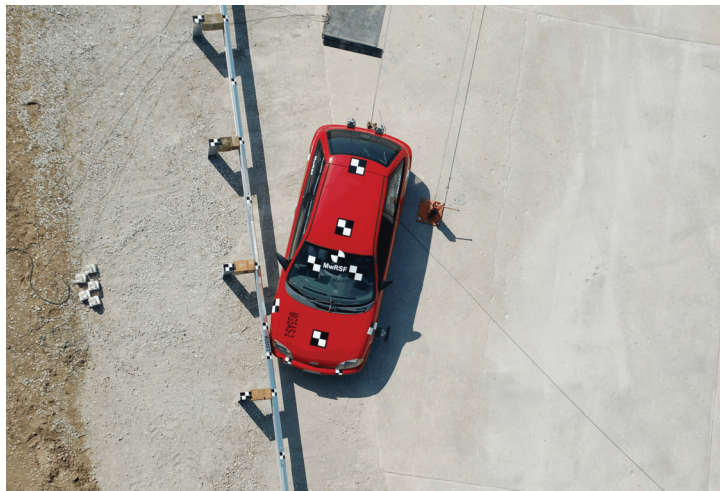
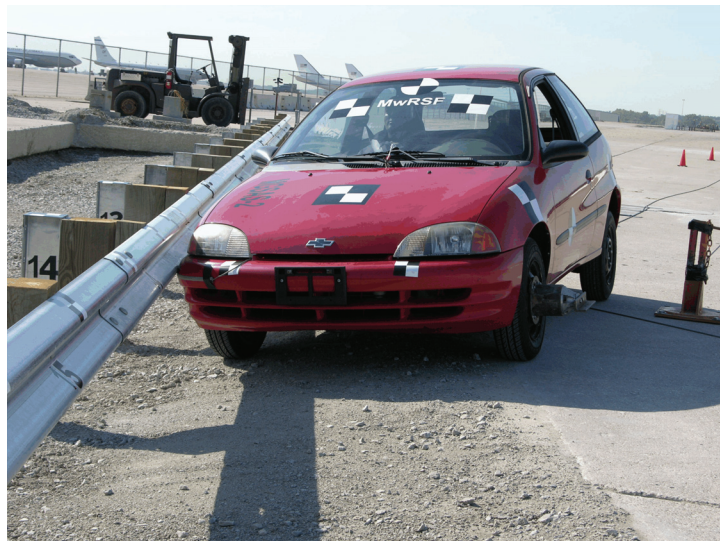
Figure 40. Documentary Photographs, Test No. MGSAS-2

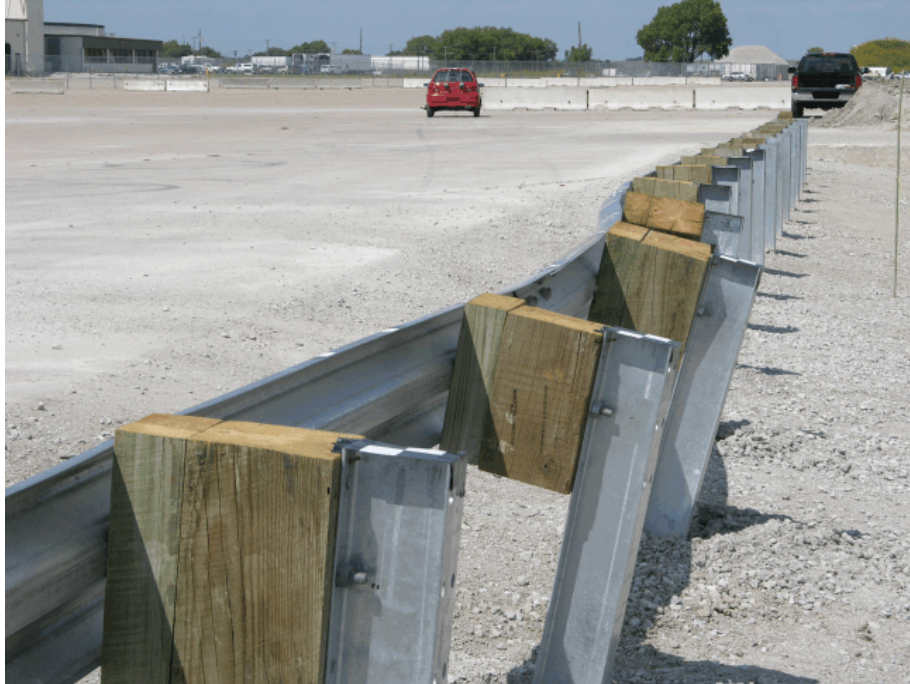
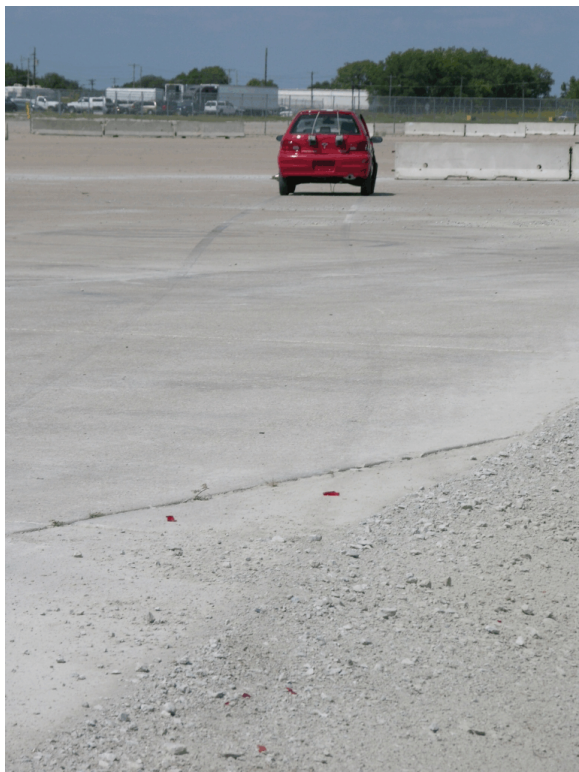
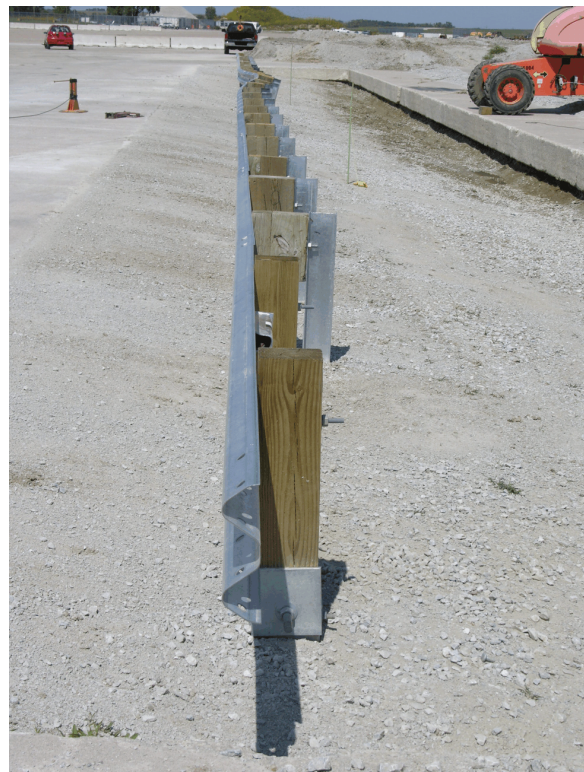
Figure 41. Impact Location, Test No. MGSAS-2

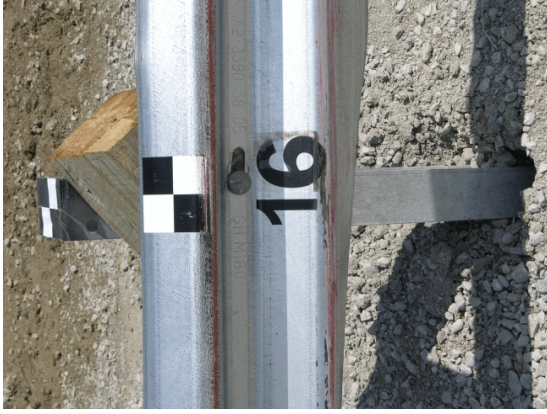
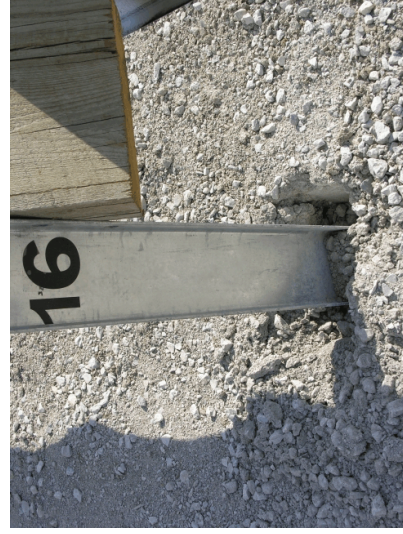
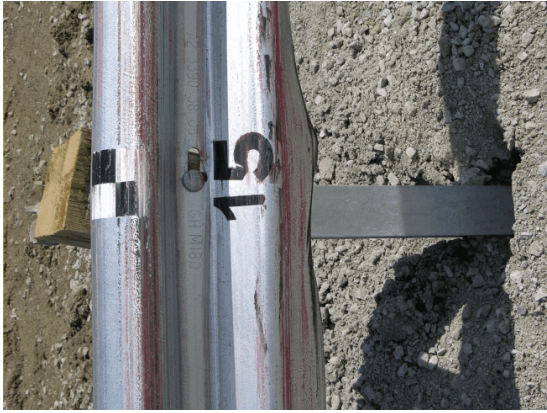
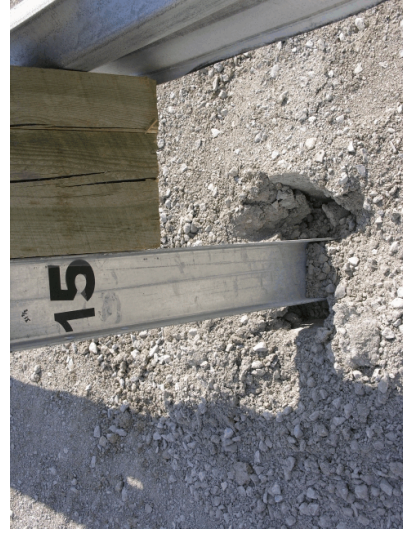
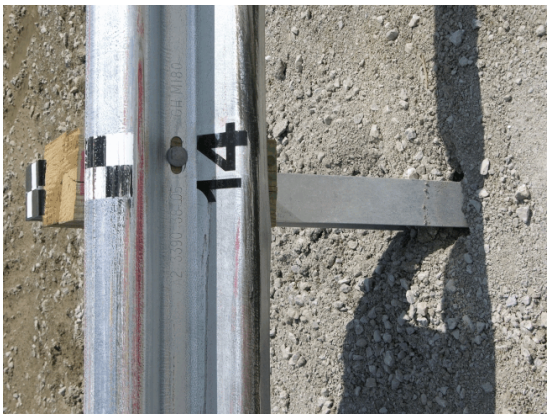
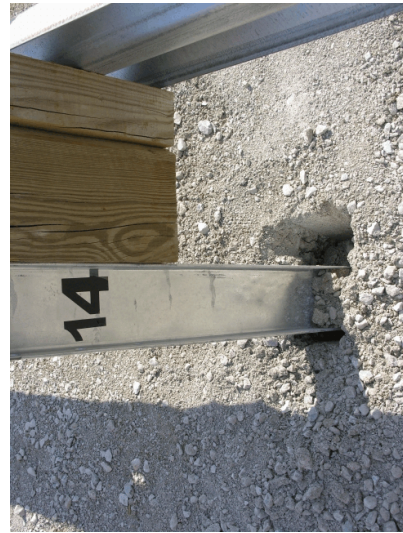
Figure 43. System Damage, Test No. MGSAS-2

Damage to the barrier was moderate, as shown in Figures 43 through 46. Barrier damage consisted of deformed guardrail posts, contact marks on a guardrail section and posts, and deformed W-beam rail. The length of vehicle contact along the system was approximately 6.0 m (19 ft - 8 in.), which spanned from 1,359 mm (53.5 in.) downstream from the centerline of post no. 13 through 267 mm (10.5 in.) upstream from the centerline of post no. 17.

The permanent set of the barrier system is shown in Figure 43. The maximum lateral permanent set rail and post deflections were 372 mm (14.625 in.) at the centerline of post no. 15 and 349 mm (13.75 in.) at post no. 15, respectively, as measured in the field. The maximum lateral dynamic rail and post deflections were 635 mm (25 in.) at the centerline of post no. 15 and 635 mm (25 in.) at post no. 15, respectively, as determined from high-speed digital video analysis. The

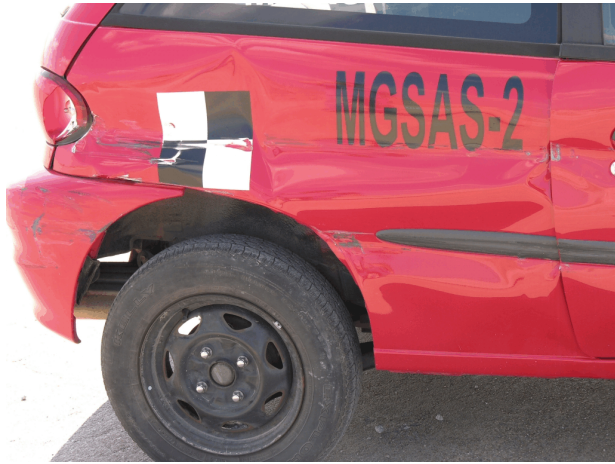
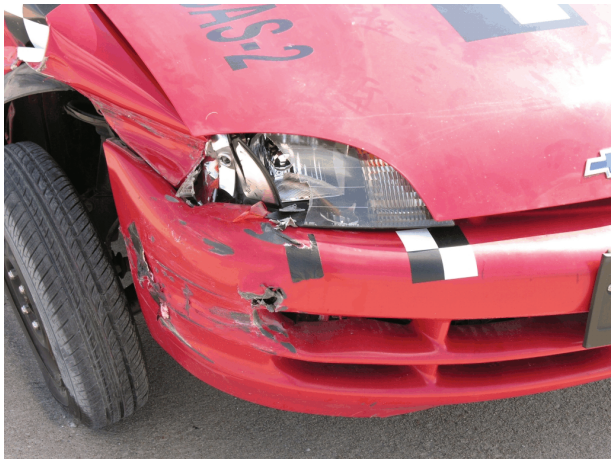
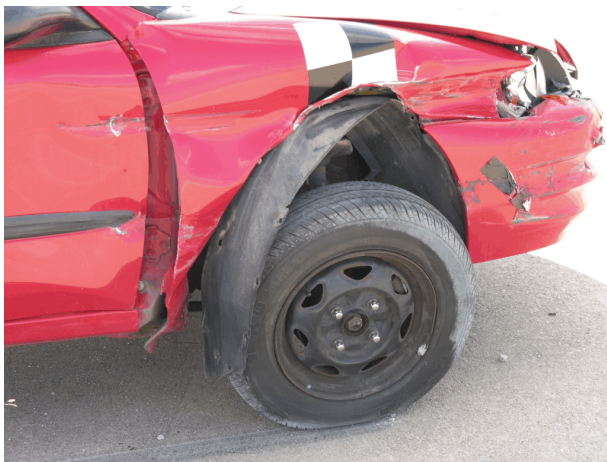
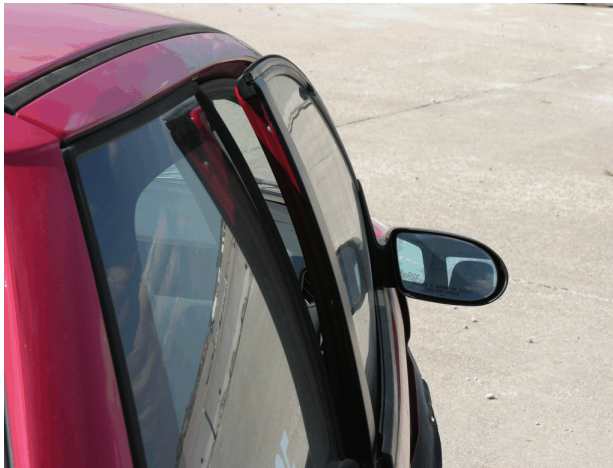
Figure 47. Vehicle Damage, Test No. MGSAS-2

Exterior vehicle damage was minimal, as shown in Figures 47 and 48. Occupant compartment deformations to the right side and center of the floorboard were judged insufficient to cause serious injury to the vehicle occupants. Complete occupant compartment deformations and the corresponding locations are provided in Appendix E.

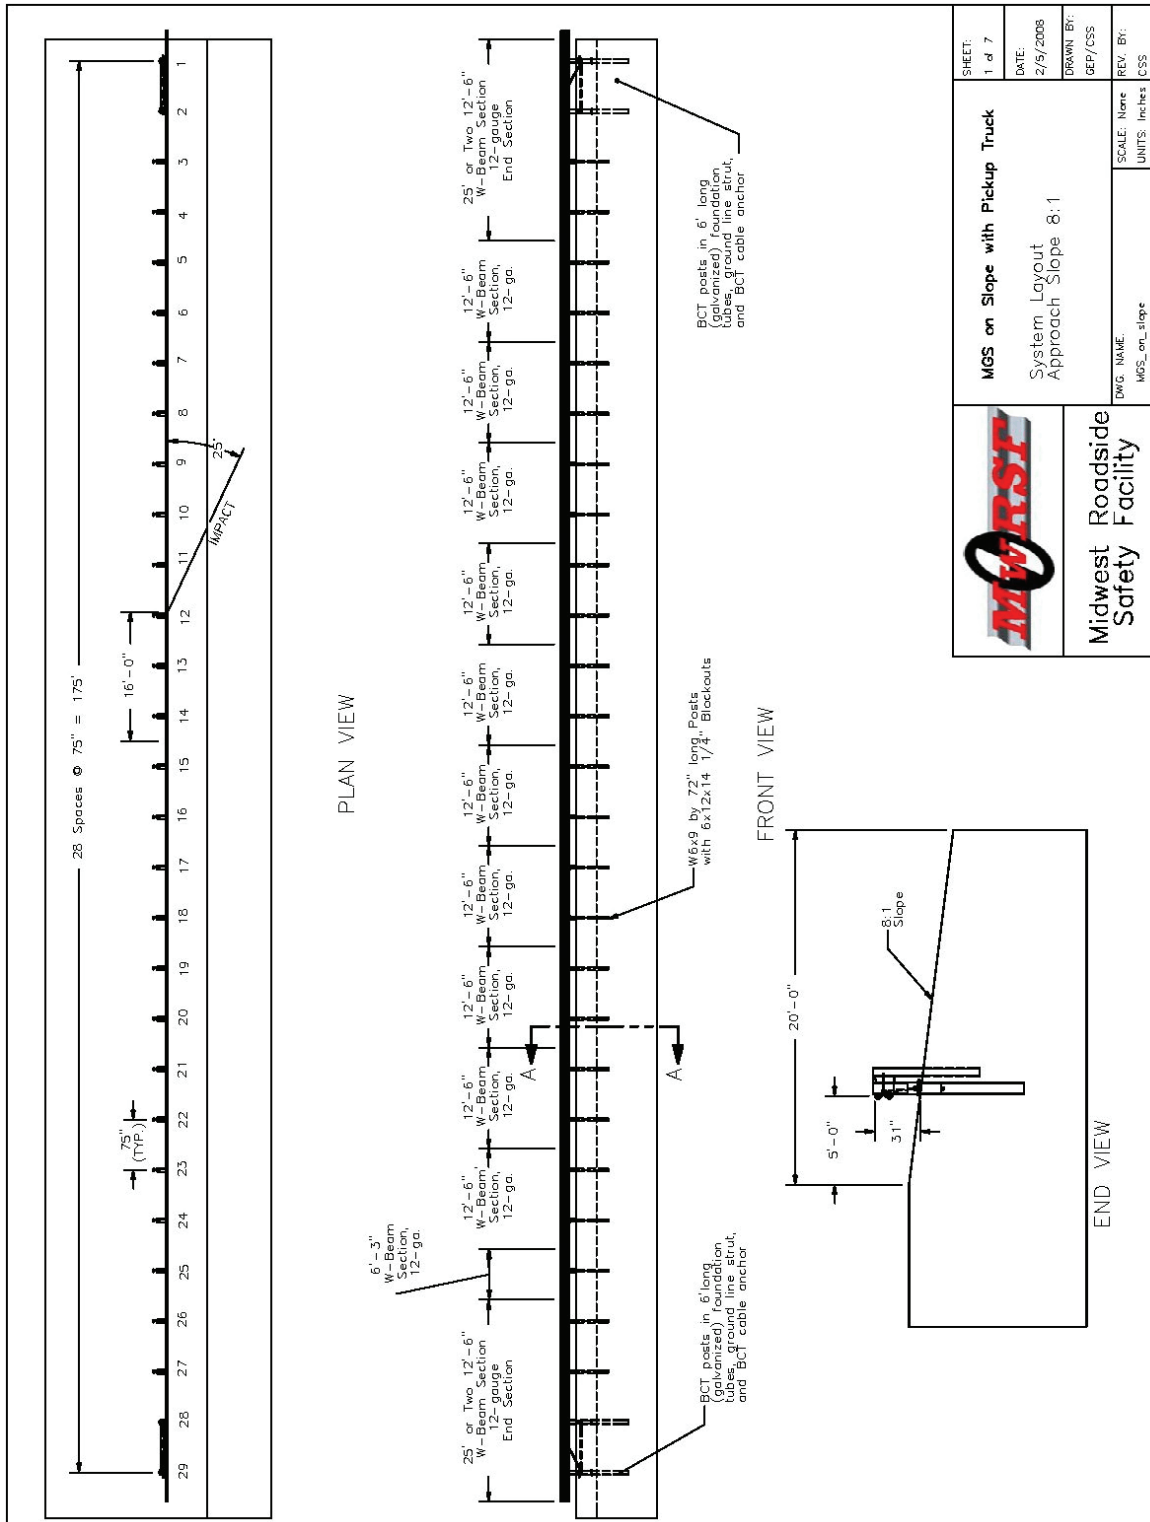
MGS on Slope with Pickup Truck		SHEET:
	System Layout Approach Slope 8:1		1 of 7
Midwest Safety Facility	TOWG NAME: MGS_en_slope		DATE:
	SCALE: None		2/5/2008
	UNITS: Inches		DRAWN BY:
	REV. BY:		GEP/CSS
		CSS

Figure A-1. System Layout (English)
