Approach Slope for Midwest Guardrail System

Erin A. Johnson
University of Nebraska - Lincoln

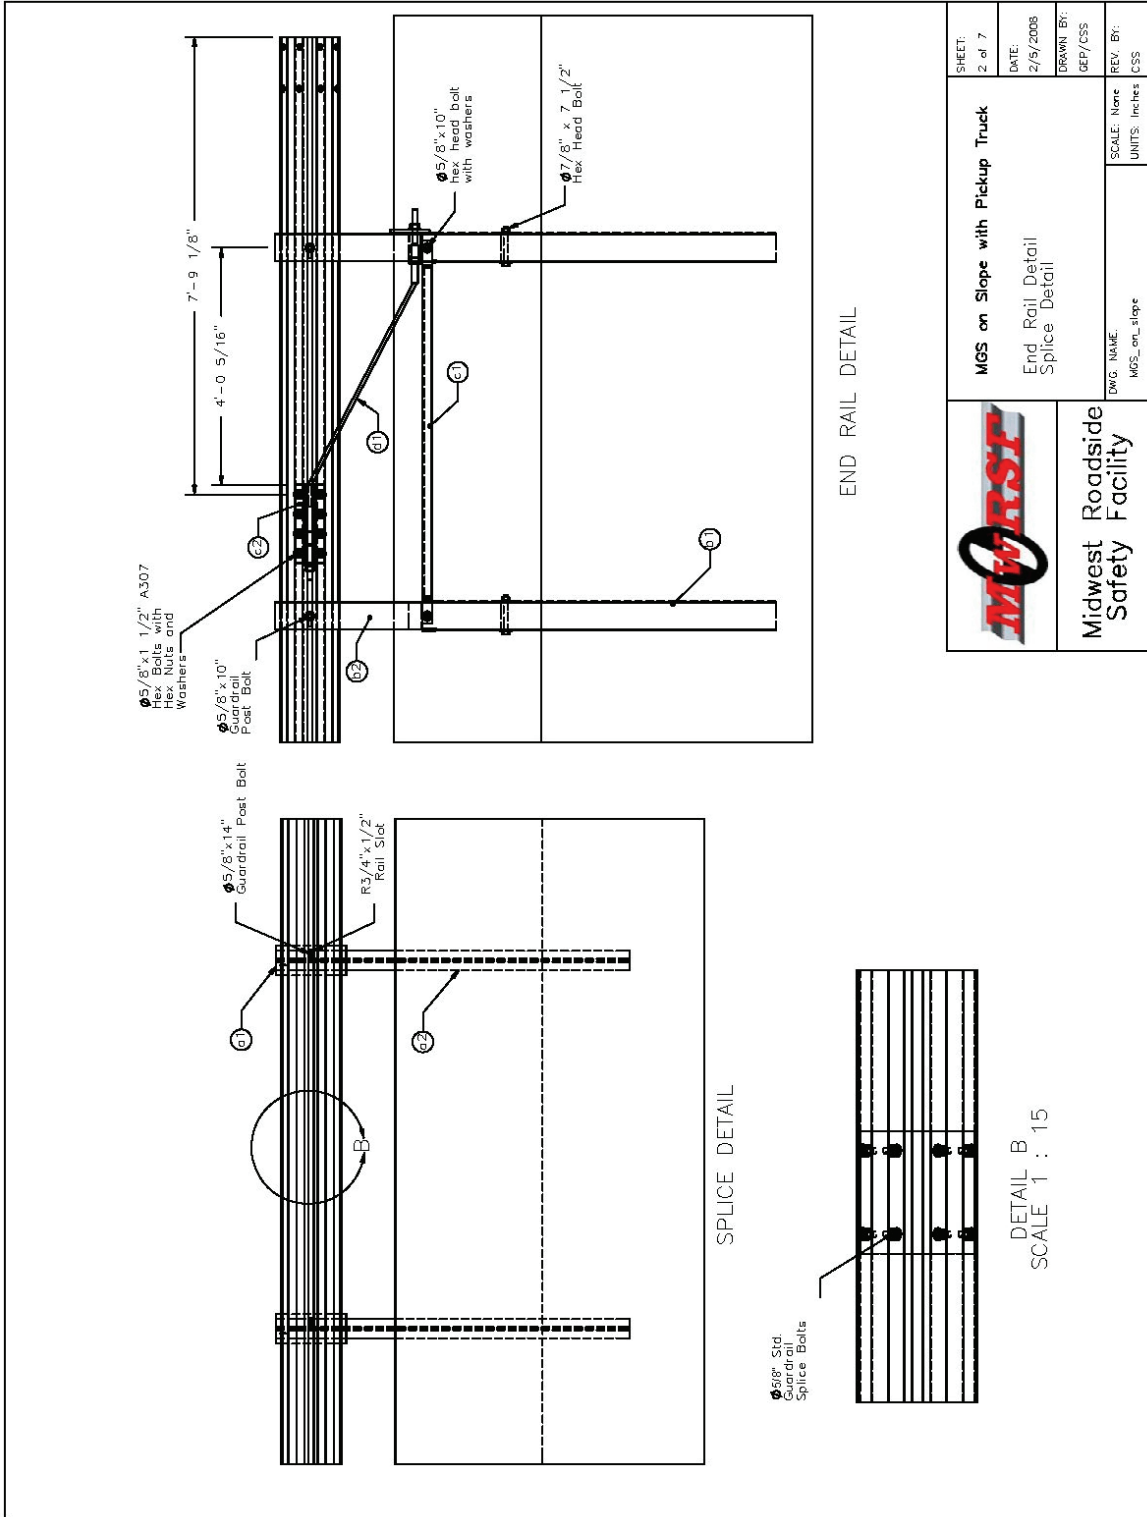
Figure A-2. End Rail and Splice Details (English)

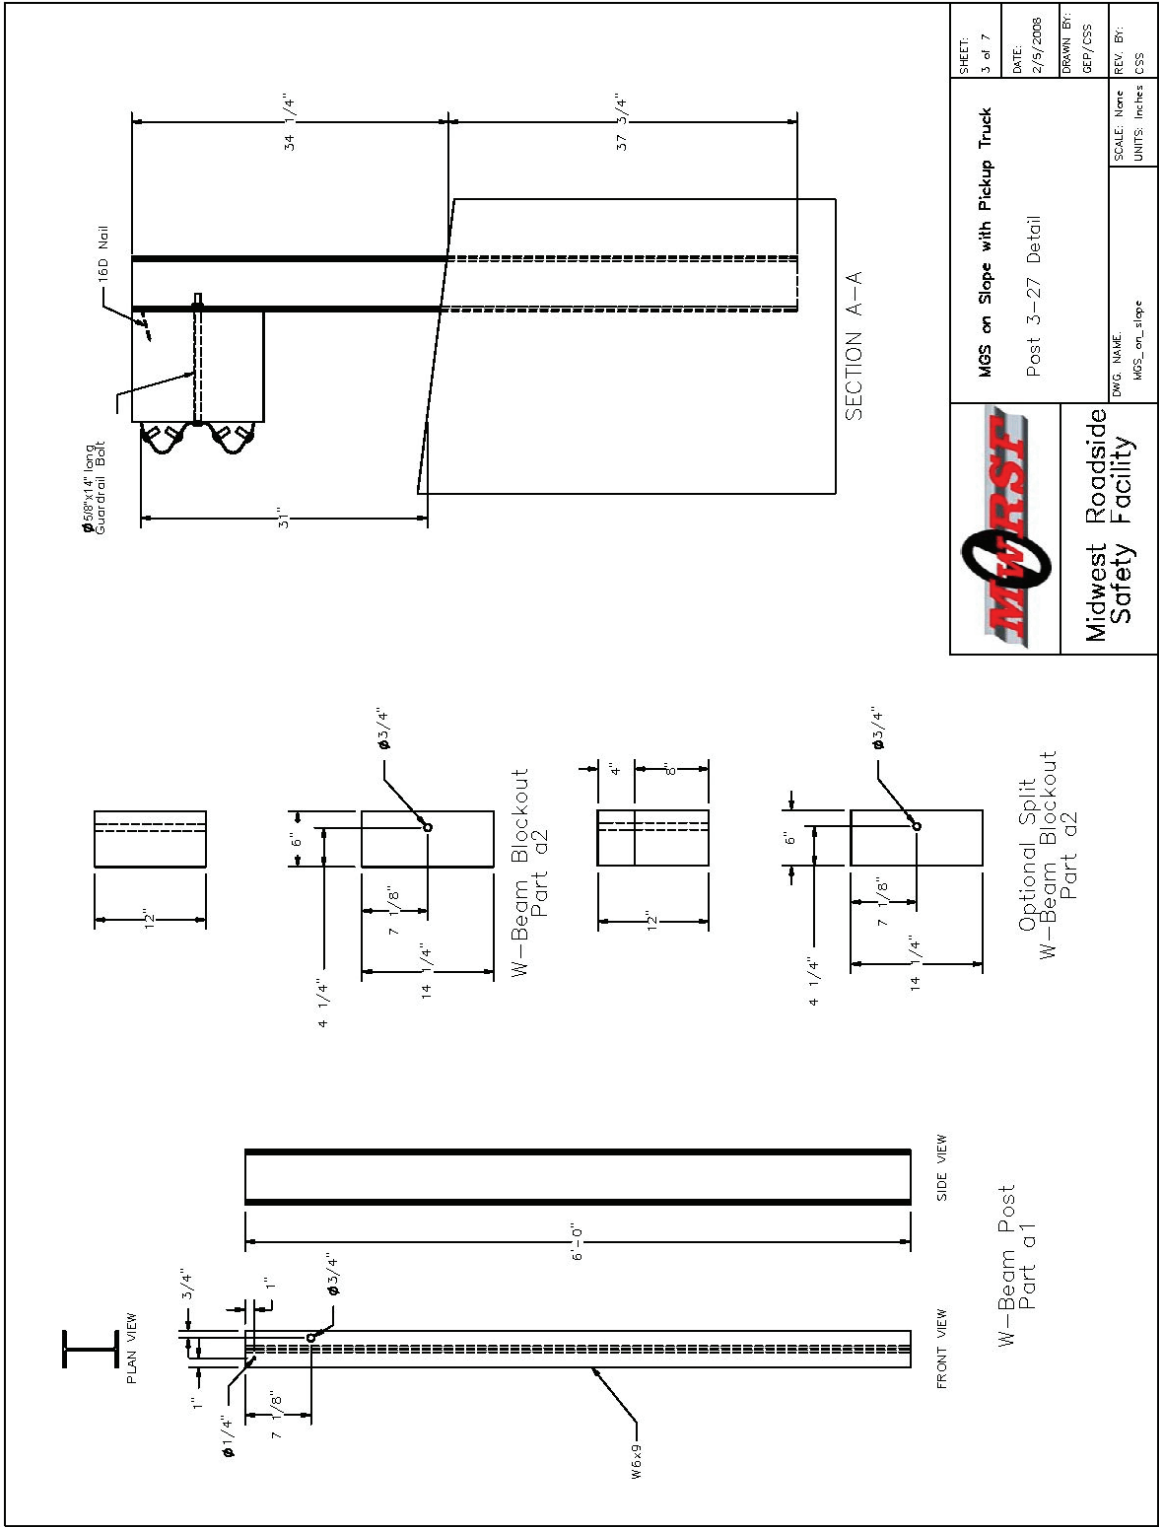
Figure A-3. Post Nos. 3 through 27 Details (English)

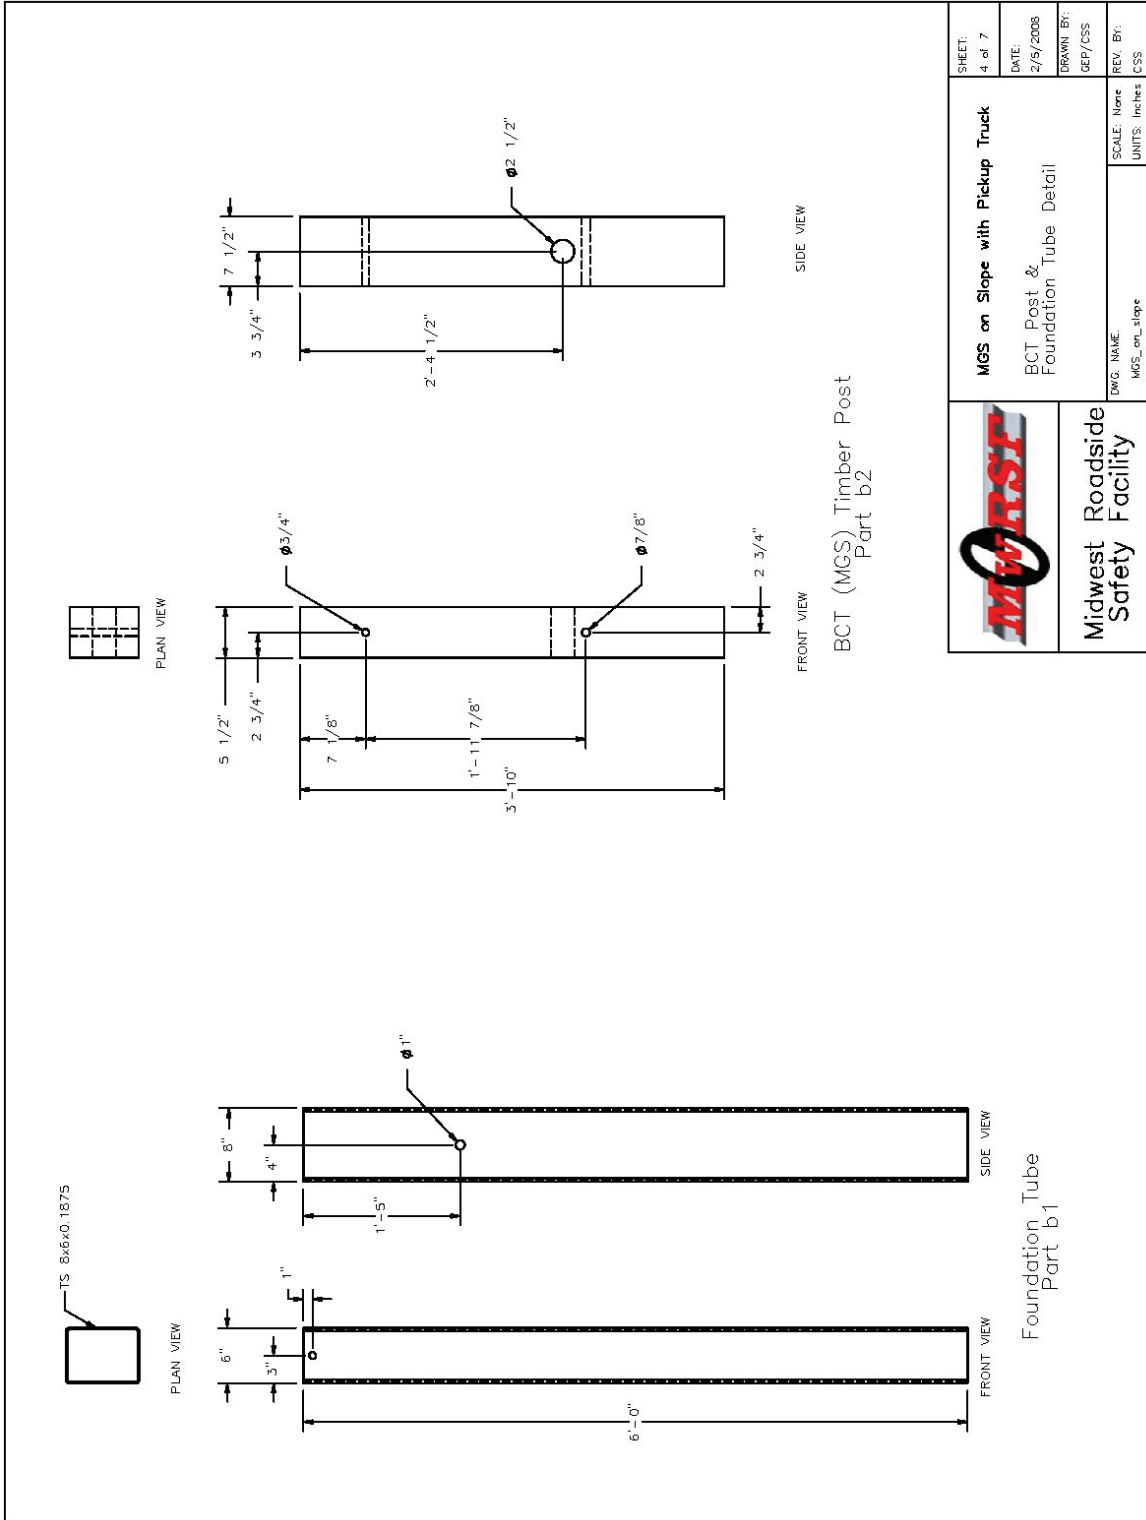
MGS on Slope with Pickup Truck BCT Post & Foundation Tube Detail	SHEET:	4 of 7
		DATE:	2/5/2008
Midwest Roadside Safety Facility	DWG. NAME: MGS_on_slope	DRAWN BY:	GEP/CSS
		REV. BY:	CSS
		SCALE:	None
		UNITS:	Inches

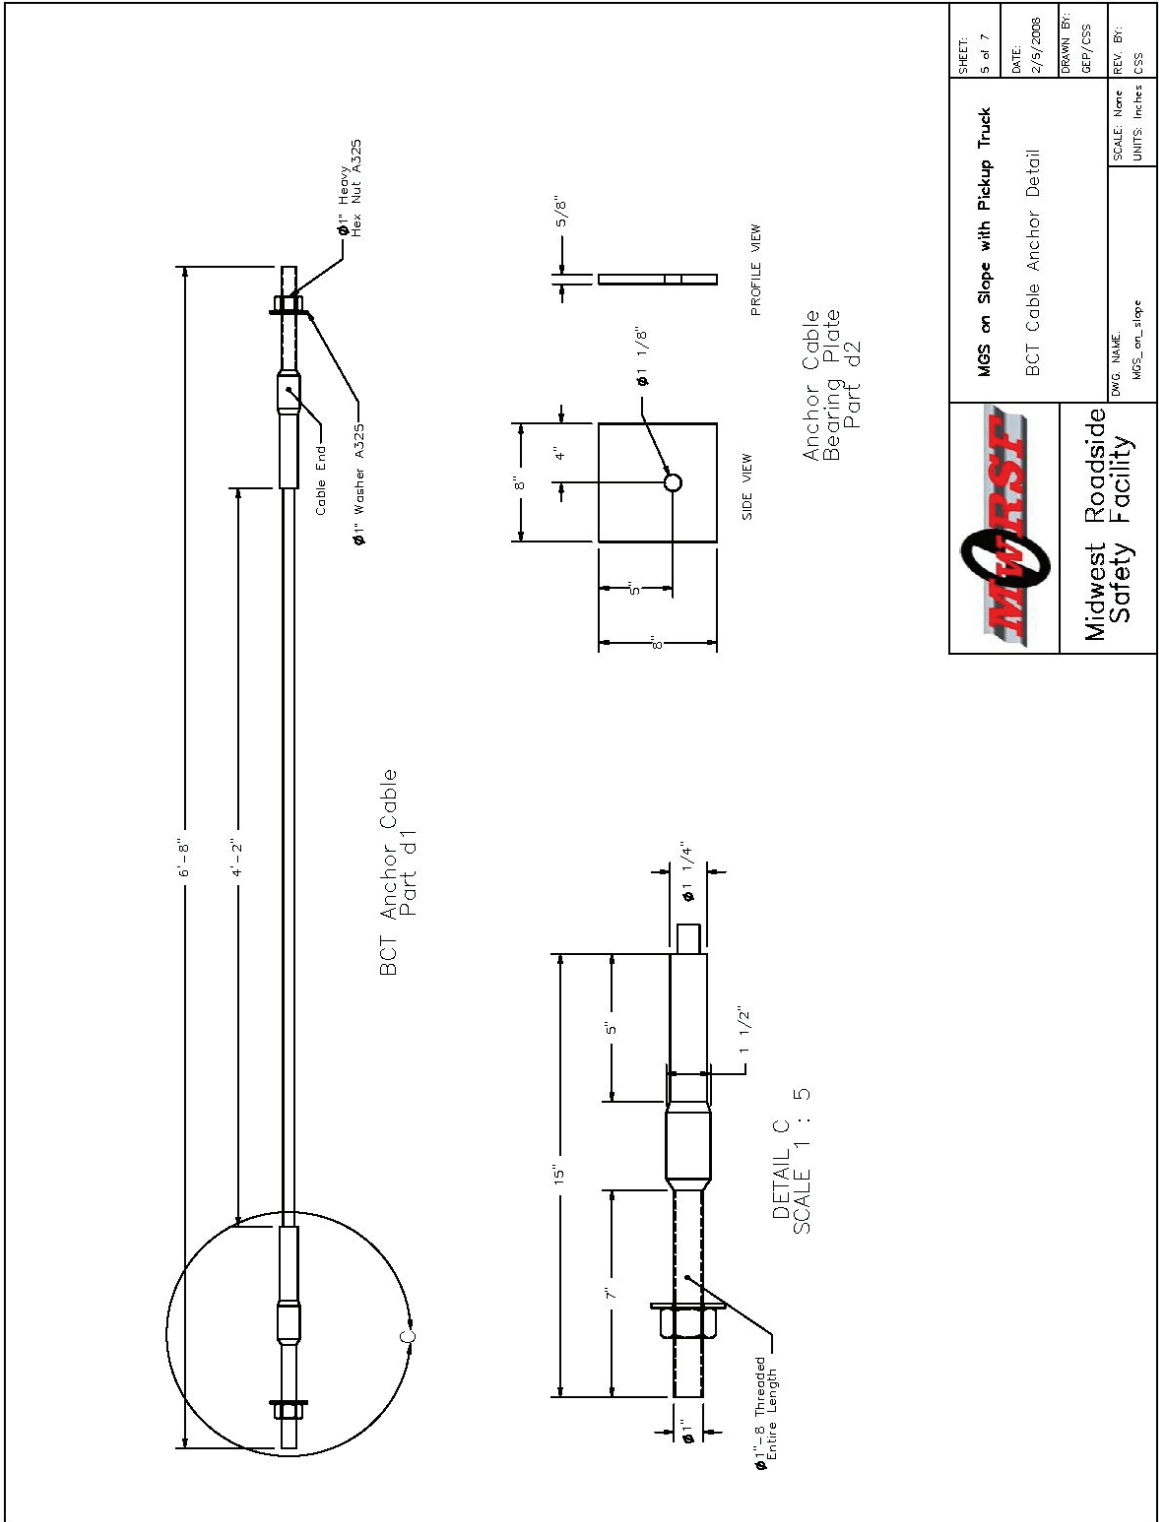
Midwest Roadside Safety Facility	DWG. NAME: MGS_on_slope	SCALE: None UNITS: Inches
	MGS on Slope with Pickup Truck BCT Cable Anchor Detail	DRAWN BY: GEP/CSS
SHEET: 5 of 7	DATE: 2/5/2008

Figure A-5. BCT Cable Anchor Details (English)

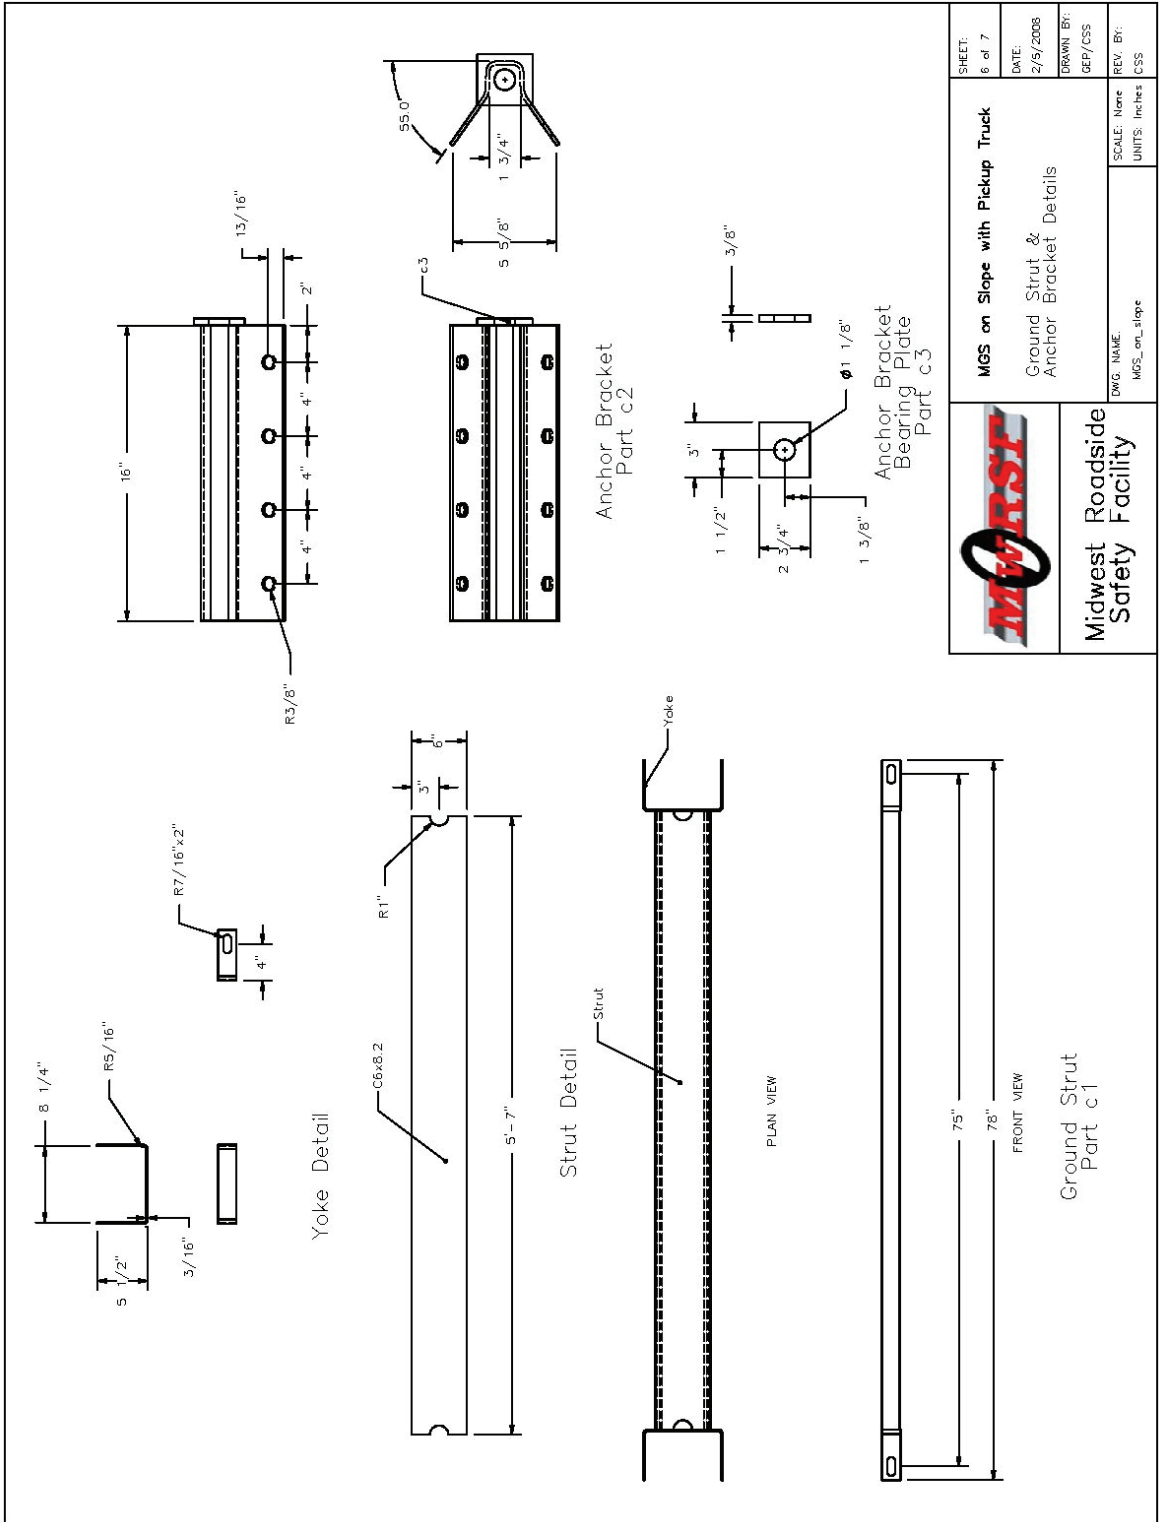
Figure A-6. Ground Strut and Anchor Bracket Details (English)

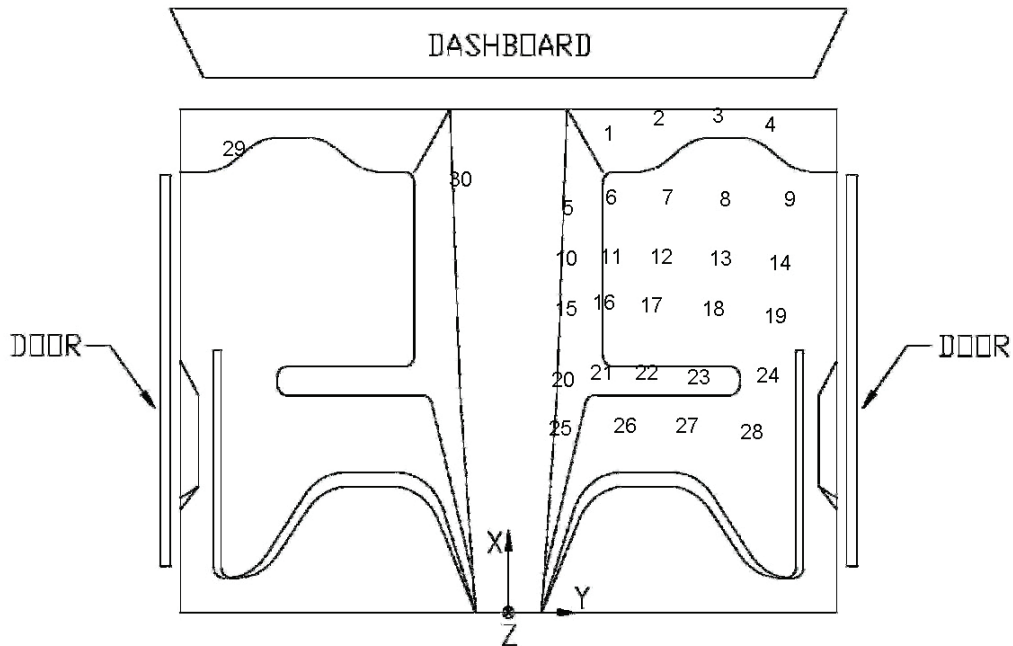
POINT	X	Y	Z	X'	Y'	Z'	DEL X	DEL Y	DEL Z
1	58.25	16.5	-1.75	58.5	16	-1.75	0.25	-0.5	0
2	58.5	22.5	-2	58.5	21.75	-2.25	0	-0.75	-0.25
3	57.5	28.25	-1	57.5	27.5	-1	0	-0.75	0
4	52.5	1.5	0	52.5	1.5	0	0	0	0
5	52.25	6.5	-0.25	52.25	6.5	0	0	0	0.25
6	54.5	12.25	-4.75	54.75	12	-4.75	0.25	-0.25	0
7	54.5	17	-4.5	54.75	17	-4.75	0.25	0	-0.25
8	54.75	23.25	-4.75	54.75	23	-5	0	-0.25	-0.25
9	54.75	28.5	-4.25	54.75	28	-4.5	0	-0.5	-0.25
10	48.25	6.5	-2.25	48.5	6.5	-1.75	0	0	0.5
11	48	12	-8	48	12	-7.75	0	0	0.25
12	48.5	18.25	-8	48.5	18	-7.75	0	-0.25	0.25
13	47.5	24	-7.5	47.5	24	-7.75	0	0	-0.25
14	47.75	29.25	-7.5	48	29.25	-7.5	0.25	0	0
15	43.5	6.5	-3.25	43.5	6.5	-2.75	0	0	0.5
16	43.5	11.5	-8.25	43.5	11.25	-8	0	-0.25	0.25
17	44.5	18.5	-8.5	44.5	18.5	-8.25	0	0	0.25
18	43	24.25	-8.25	43	24	-8.25	0	-0.25	0
19	44	28.75	-8.5	44	28.75	-8.5	0	0	0
20	38.75	6.5	-4.25	38.75	6.5	-3.75	0	0	0.5
21	37.75	11.25	-9	37.75	11	-8.5	0	-0.25	0.5
22	37.75	16.25	-9	37.75	16	-8.75	0	-0.25	0.25

23	37	21.5	-8.75	37	21.5	-8.5	0	0	0.25
24	36.5	26.75	-9	36.75	26.75	-9	0.25	0	0
25	30.25	6.5	-6	30.5	6.5	-5.5	0.25	0	0.5
26	30.25	10.75	-10	30.25	11	-9.5	0	0.25	0.5
27	29.75	16.75	-10	29.5	17	-9.5	-0.25	0.25	0.5
28	30.75	24.75	-9	30.75	25	-8.75	0	0.25	0.25

Figure C-1. Occupant Compartment Deformation Data - Set 1, Test No. MGSAS-1

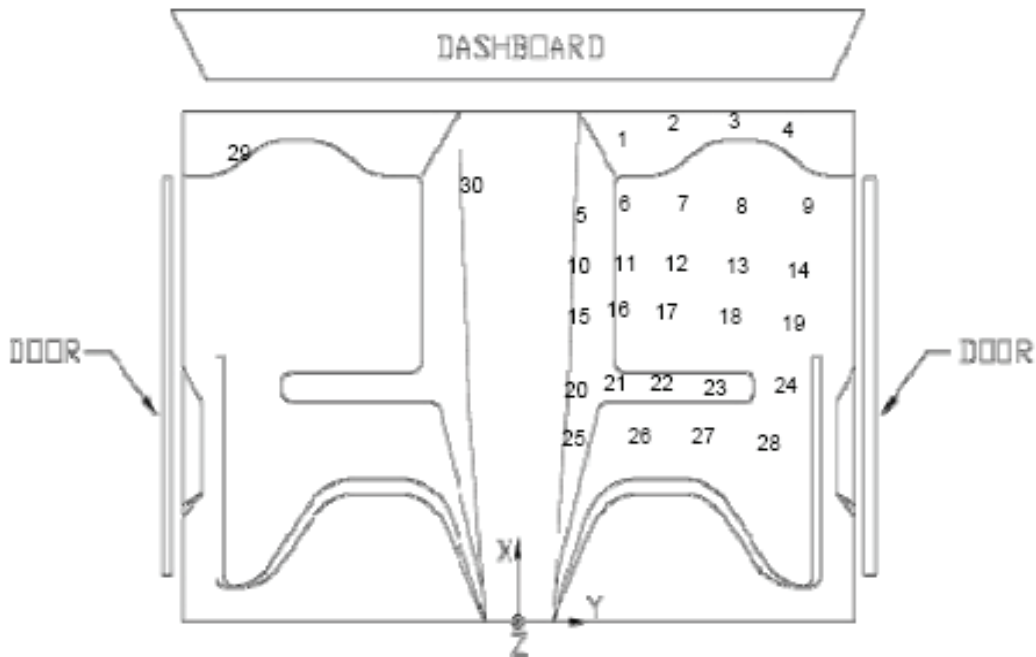
POINT	-6.5			8.5			DEL X	DEL Y	DEL Z
	X	Y	Z	X'	Y'	Z'			
1	51.75	25	-1.5	52	24.5	-1.5	0.25	-0.5	0
2	52	31	-1.75	52	30.25	-1.75	0	-0.75	0
3	51	36.75	-0.25	51	36	-0.25	0	-0.75	0
4	46	10	-0.5	46	10	-0.25	0	0	0.25
5	45.75	15	-0.5	45.75	15	0.25	0	0	0.75
6	48	20.75	-4.75	48.25	20.5	-4.75	0.25	-0.25	0
7	48	25.5	-4.5	48.25	25.5	-4.5	0.25	0	0
8	48.25	31.75	-4.25	48.25	31.5	-4.5	0	-0.25	-0.25
9	48.25	37	-3.5	48.25	36.5	-3.75	0	-0.5	-0.25
10	41.75	15	-2.25	42	15	-2	0	0	0.25
11	41.5	20.5	-7.75	41.5	20.5	-7.5	0	0	0.25
12	42	26.75	-7.5	42	26.5	-7.5	0	-0.25	0
13	41	32.5	-6.75	41	32.5	-7	0	0	-0.25
14	41.25	37.75	-6.5	41.5	37.75	-6.75	0.25	0	-0.25
15	37	15	-3	37	15	-2.75	0	0	0.25
16	37	20	-8	37	19.75	-7.5	0	-0.25	0.5
17	38	27	-7.75	38	27	-7.5	0	0	0.25
18	36.5	32.75	-7	36.5	32.5	-7	0	-0.25	0
19	37.5	37.25	-7	37.5	37.25	-7.25	0	0	-0.25
20	32.25	15	-4	32.25	15	-3.25	0	0	0.75
21	31.25	19.75	-6.25	31.25	19.5	-6	0	-0.25	0.25
22	31.25	24.75	-8.25	31.25	24.5	-8	0	-0.25	0.25

23	30.5	30	-7.75	30.5	30	-7.25	0	0	0.5
24	30	35.25	-7.5	30.25	35.25	-7.5	0.25	0	0
25	23.75	15	-5.25	24	15	-4.75	0.25	0	0.5
26	23.75	19.25	-9	23.75	19.5	-8.5	0	0.25	0.5
27	23.25	25.25	-8.5	23	25.5	-8.25	-0.25	0.25	0.25
28	24.25	33.25	-7.5	24.25	33.5	-7.25	0	0.25	0.25
29							0	0	0
30							0	0	0

Figure C-2. Occupant Compartment Deformation Data - Set 2, Test No. MGSAS-1

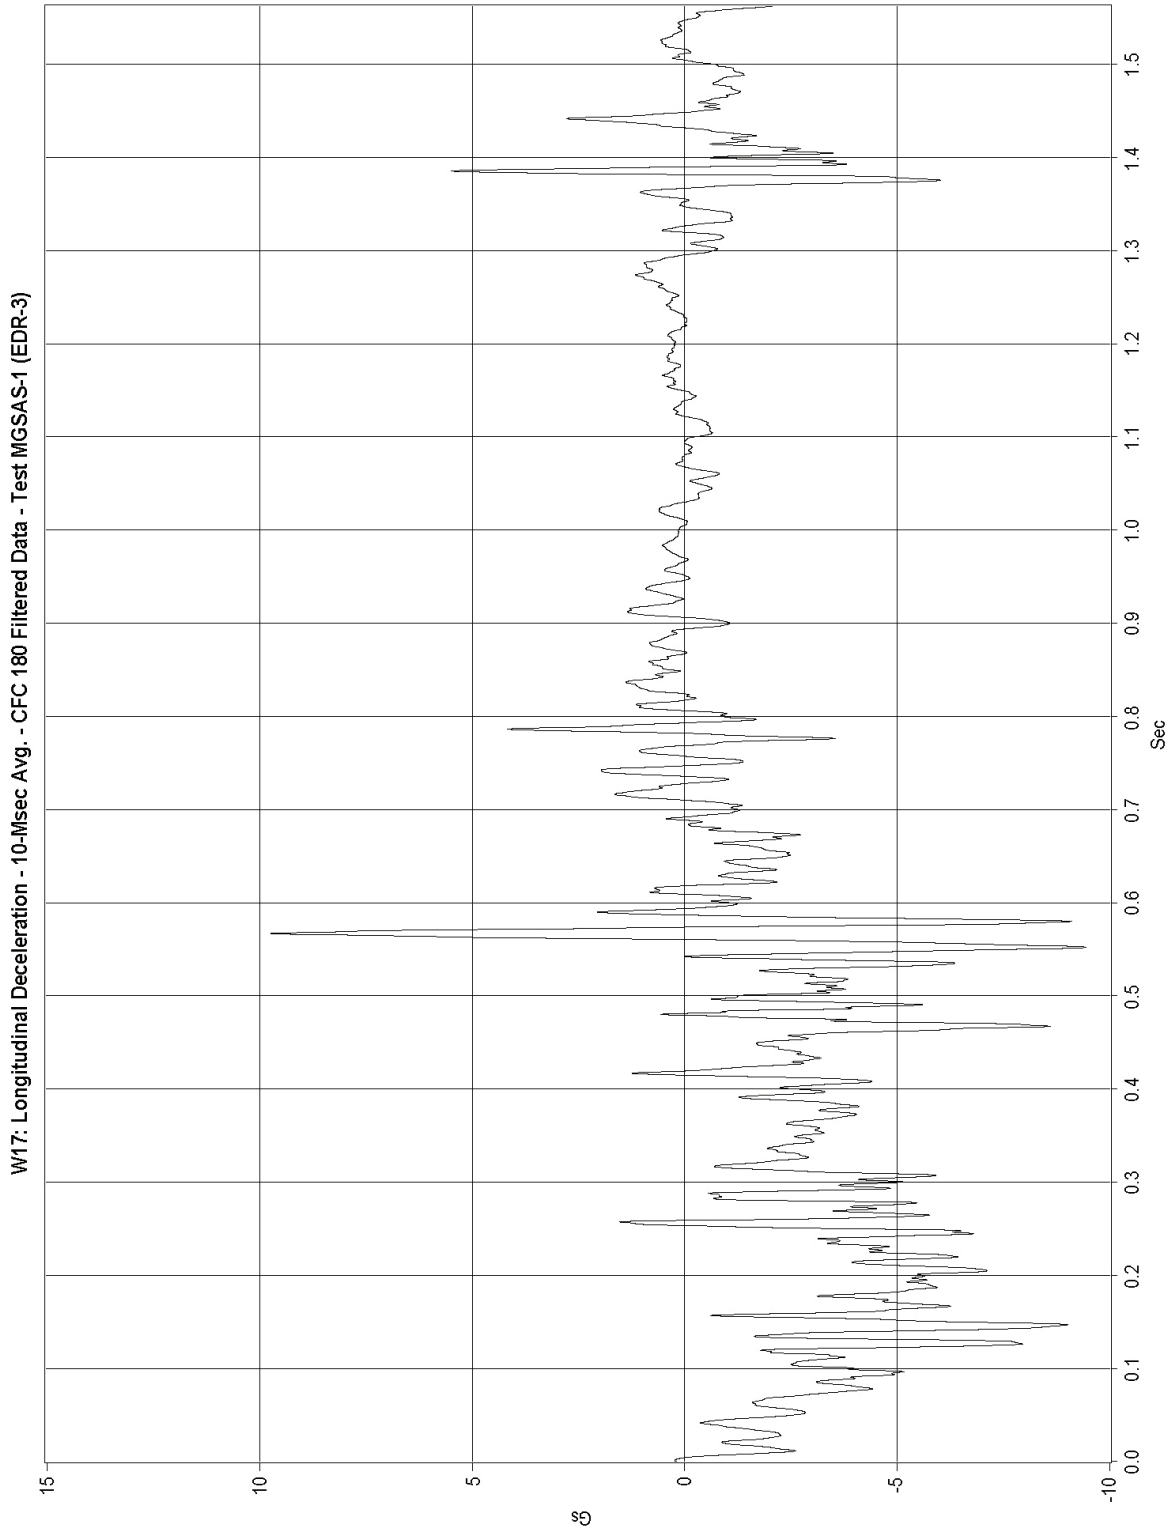
Figure D-1. Graph of Longitudinal Deceleration, Test No. MGSAS-1

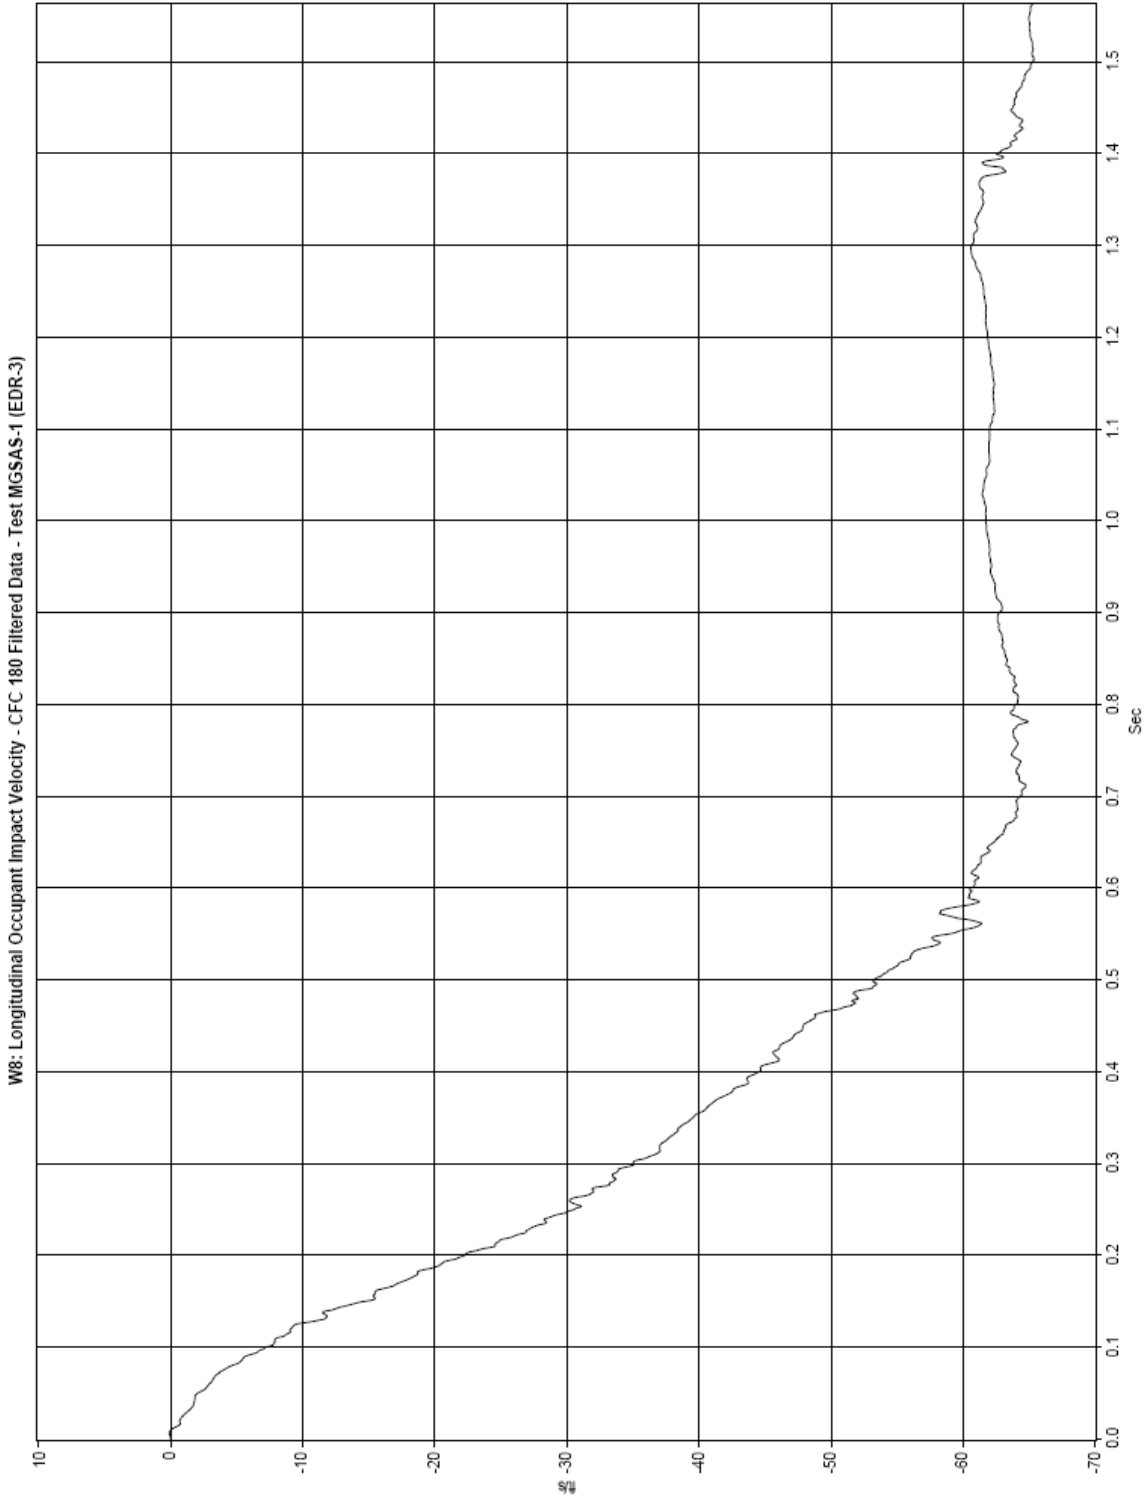
Figure D-2. Graph of Longitudinal Occupant Impact Velocity, Test No. MGSAS-1

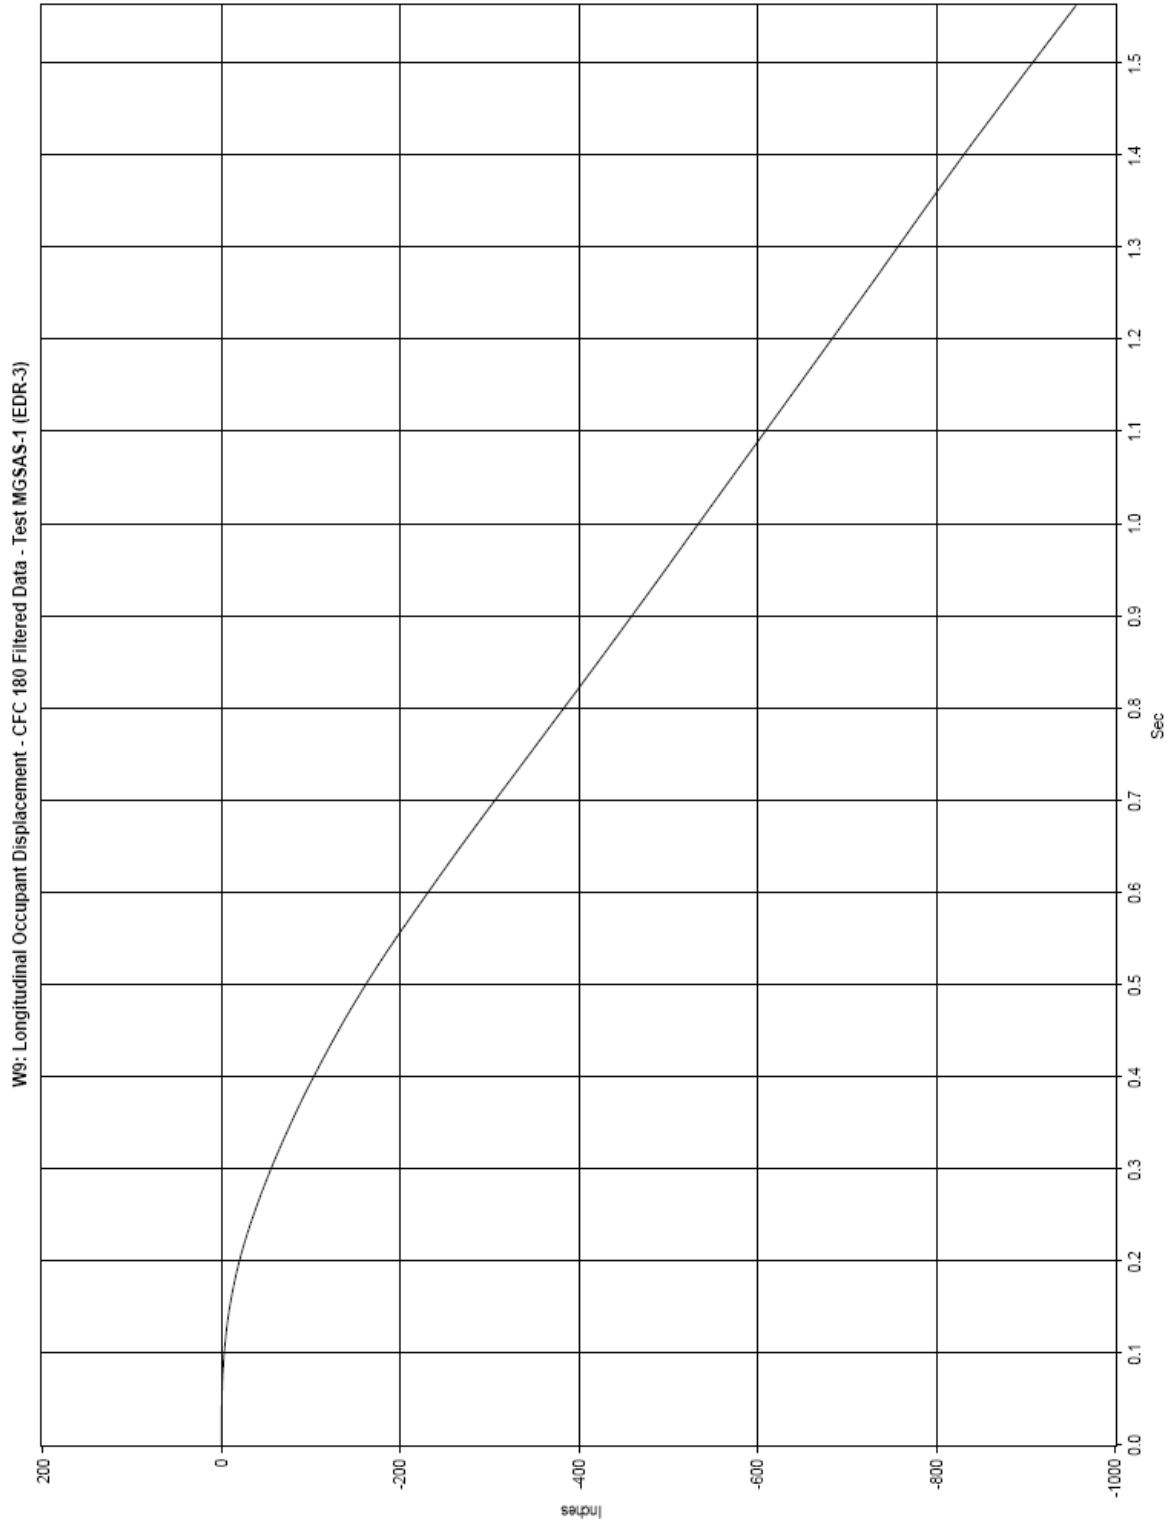
Figure D-3. Graph of Longitudinal Occupant Displacement, Test No. MGSAS-1

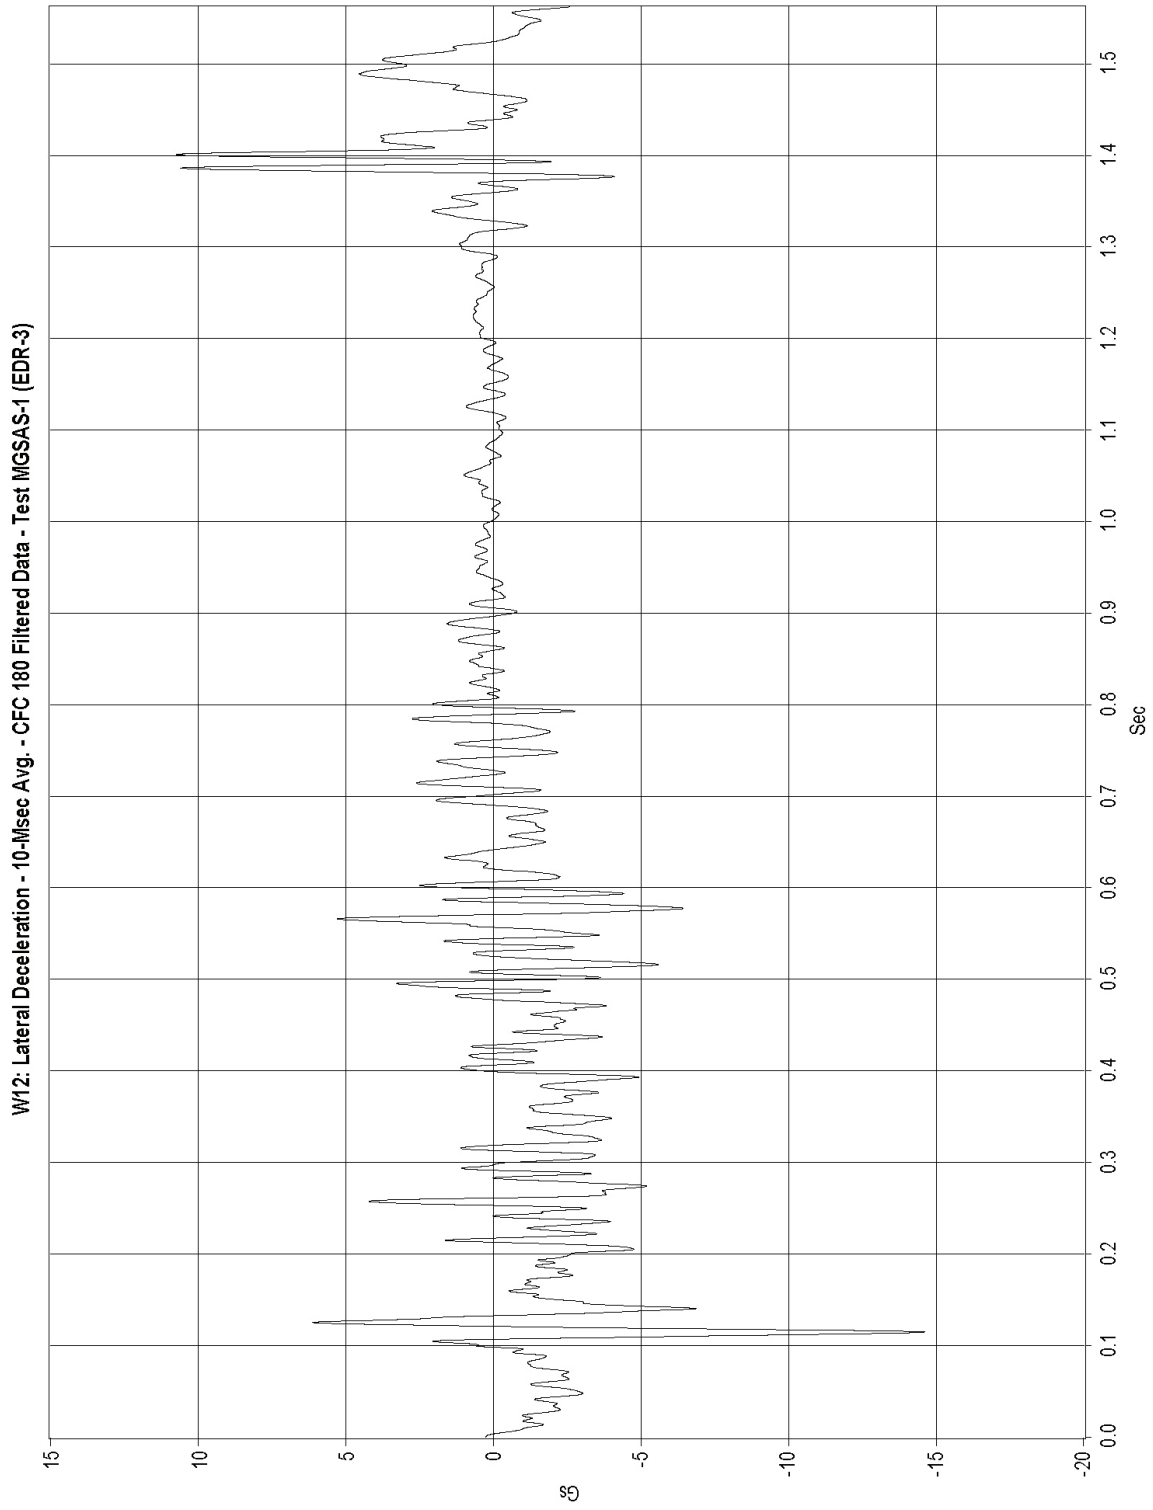
Figure D-4. Graph of Lateral Deceleration, Test No. MGSAS-1

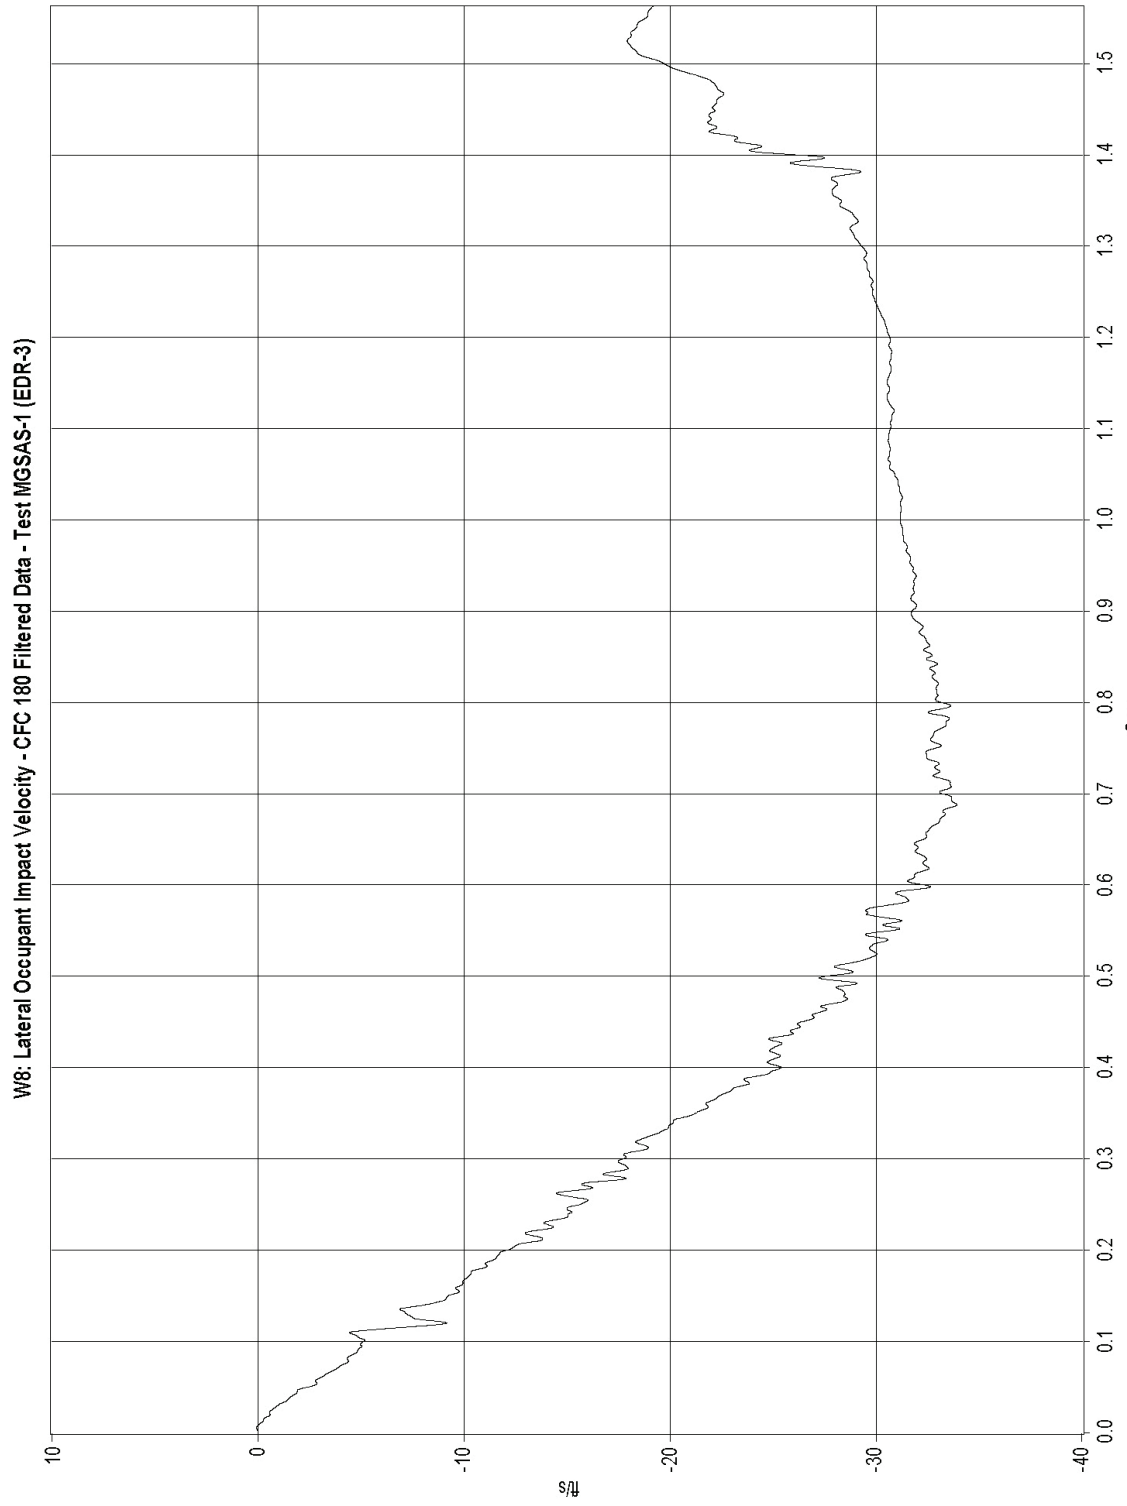
Figure D-5. Graph of Lateral Occupant Impact Velocity, Test No. MGSAS-1

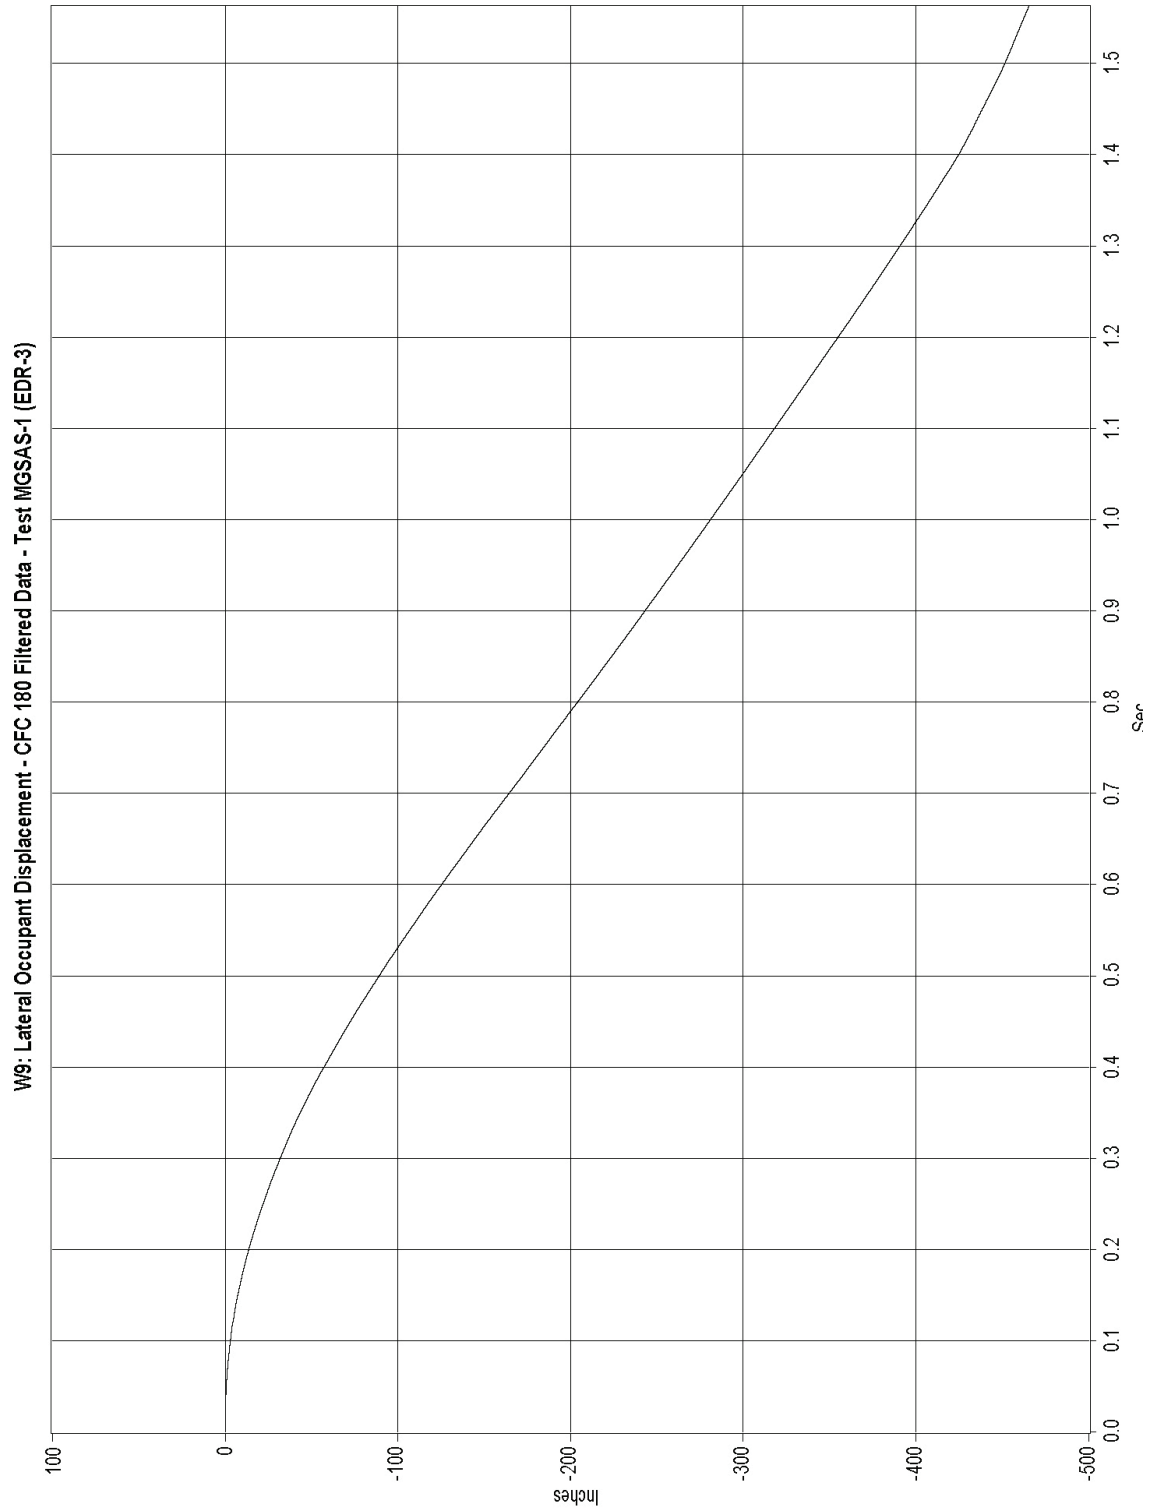
Figure D-6. Graph of Lateral Occupant Displacement, Test No. MGSAS-1

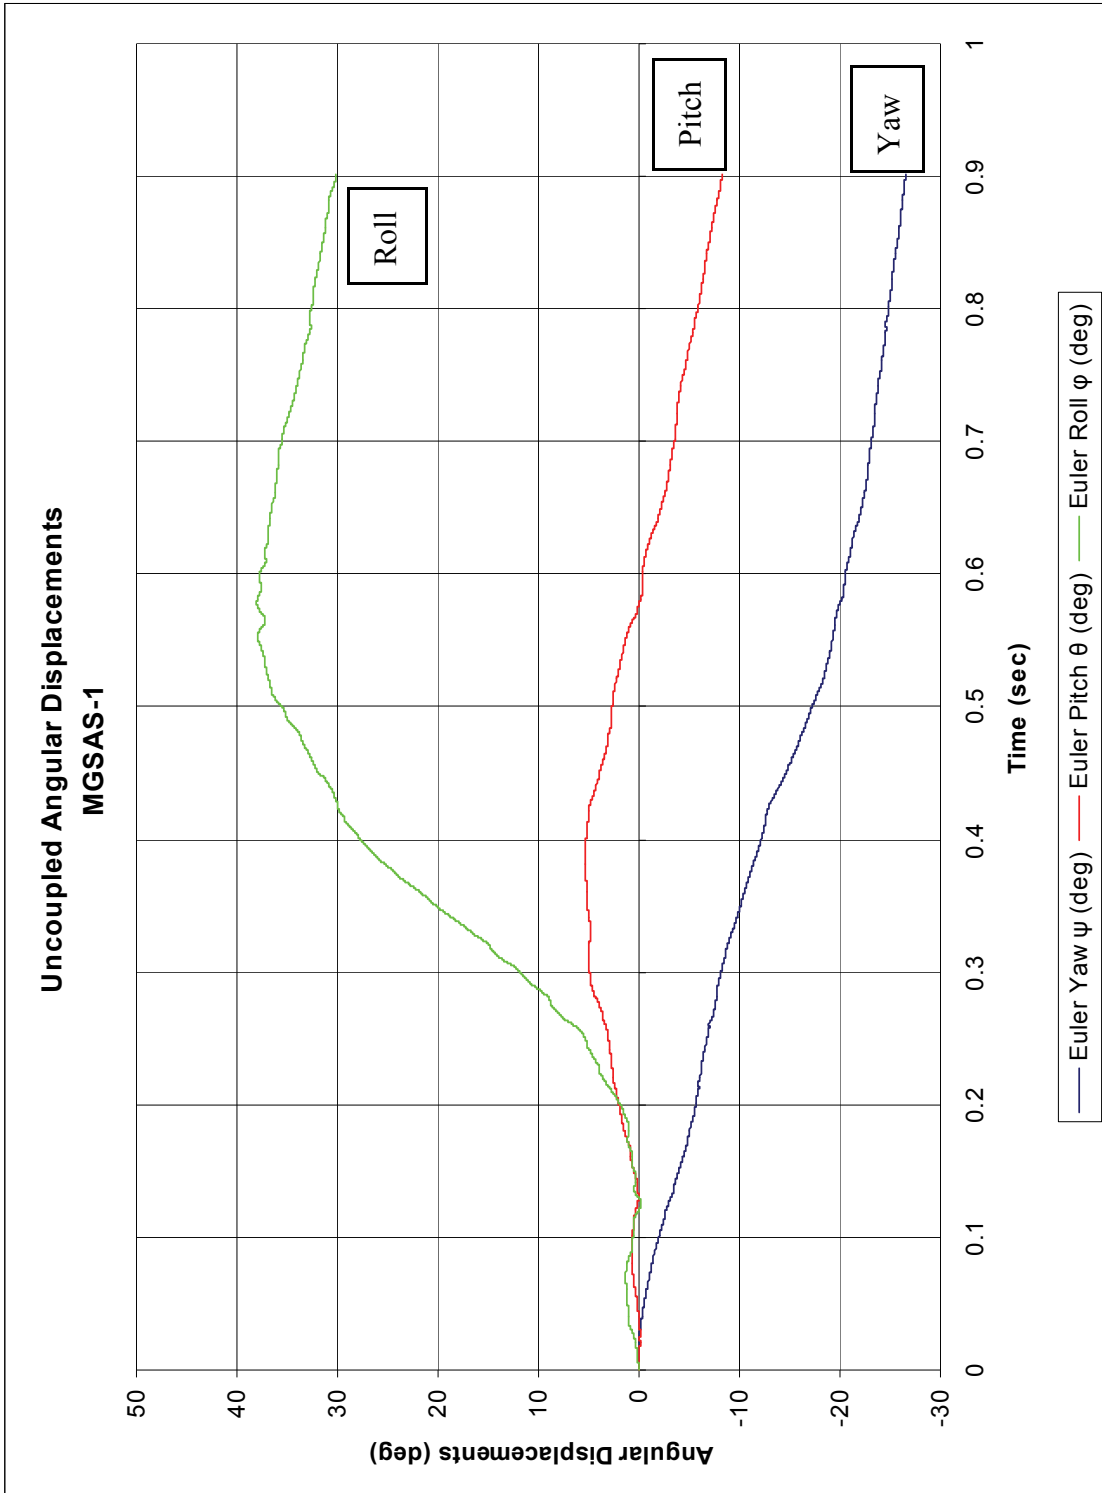
Figure D-7. Graph of Roll, Pitch, and Yaw Angular Displacements, Test No. MGSAS-1
