Approach Slope for Midwest Guardrail System

Erin A. Johnson
University of Nebraska - Lincoln

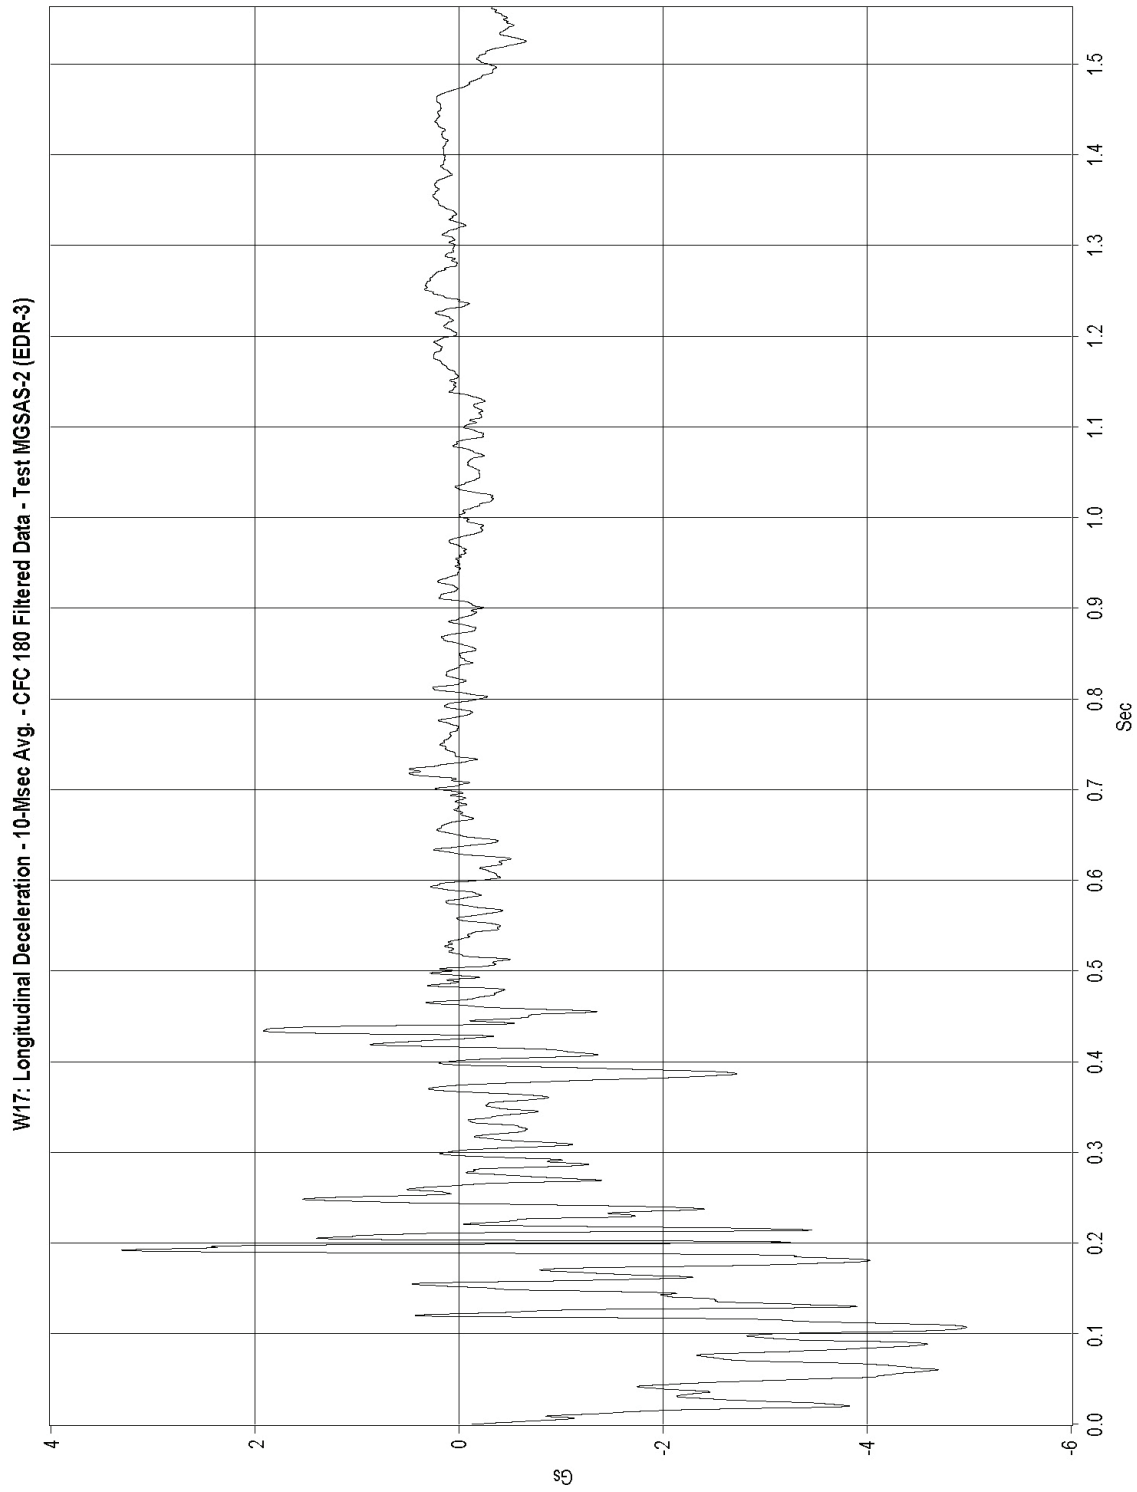
Figure F-1. Graph of Longitudinal Deceleration, Test No. MGSAS-2

The longitudinal and lateral occupant impact velocities were determined to be -3.75 m/s (-12.30 ft/s) and -5.31 m/s (-17.41 m/s), respectively. The maximum 0.010-sec average occupant ridedown decelerations in the longitudinal and lateral directions were -4.03 g's and -9.65 g's, respectively. It is noted that the occupant impact velocities (OIVs) and occupant ridedown decelerations (ORDs) were within the suggested limits provided in NCHRP Report No. 350. The THIV and PHD values were determined to be 5.93 m/s (19.46 ft/s) and 9.68 g's, respectively. The results of the occupant risk, as determined from the accelerometer data, are summarized in Figure

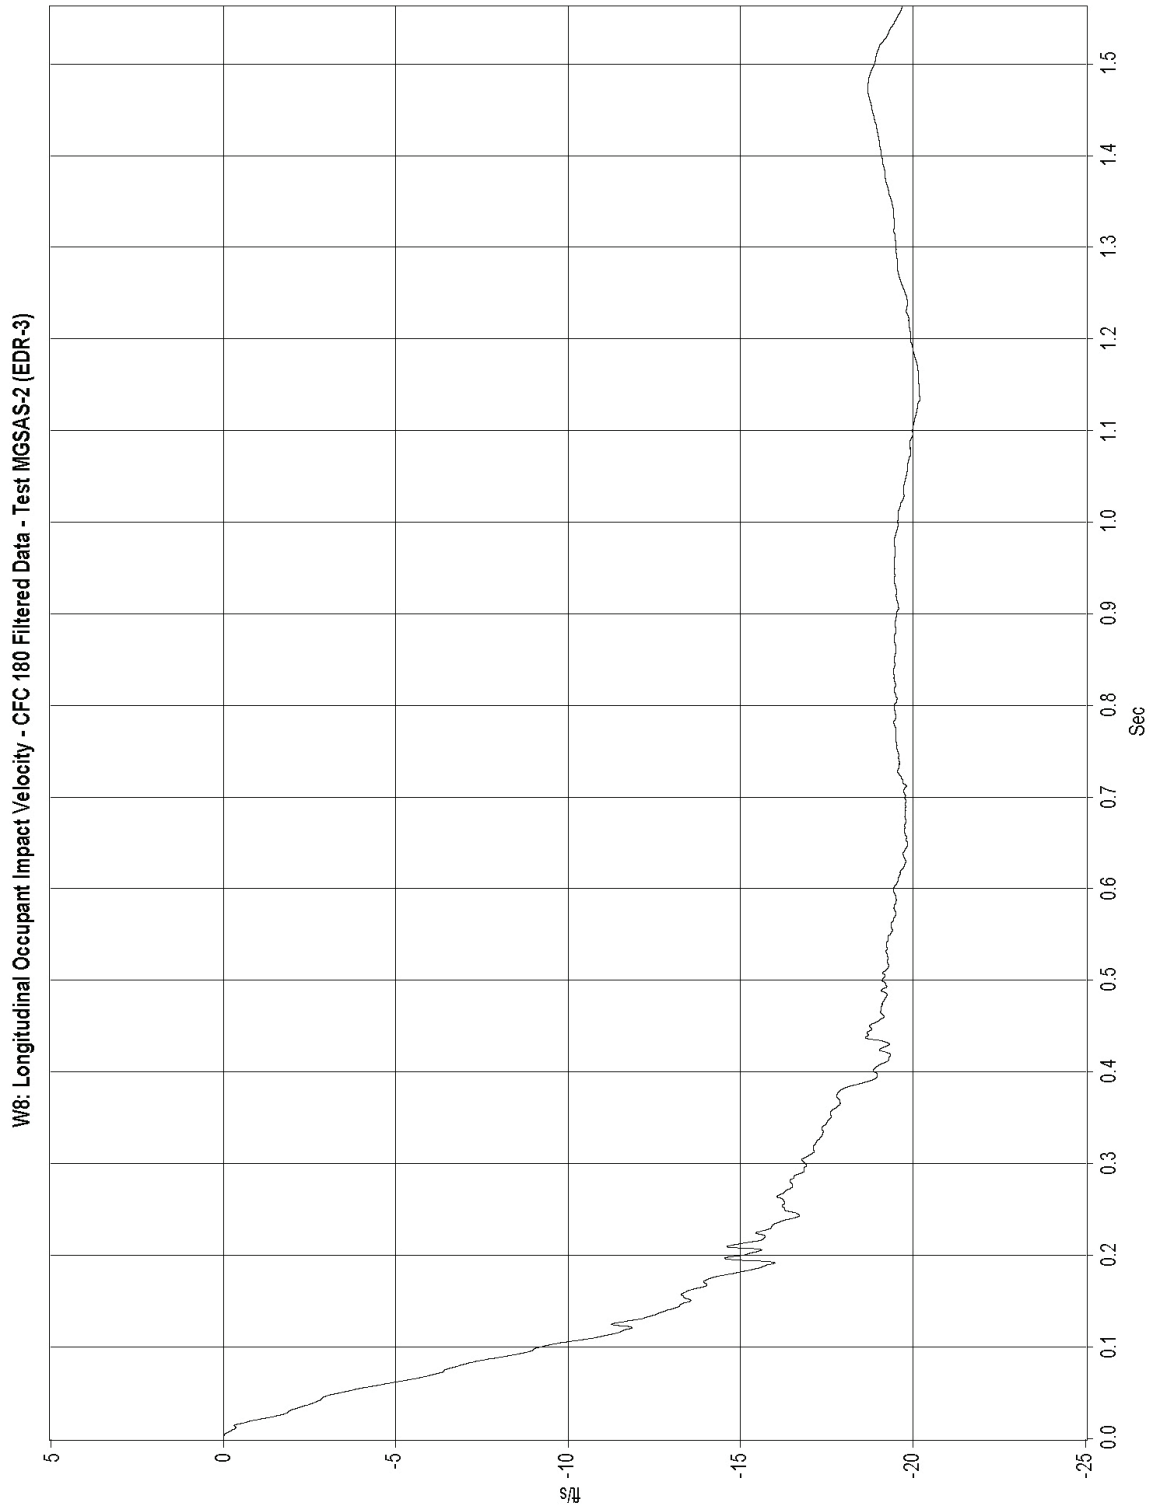
Figure F-2. Graph of Longitudinal Occupant Impact Velocity, Test No. MGSAS-2

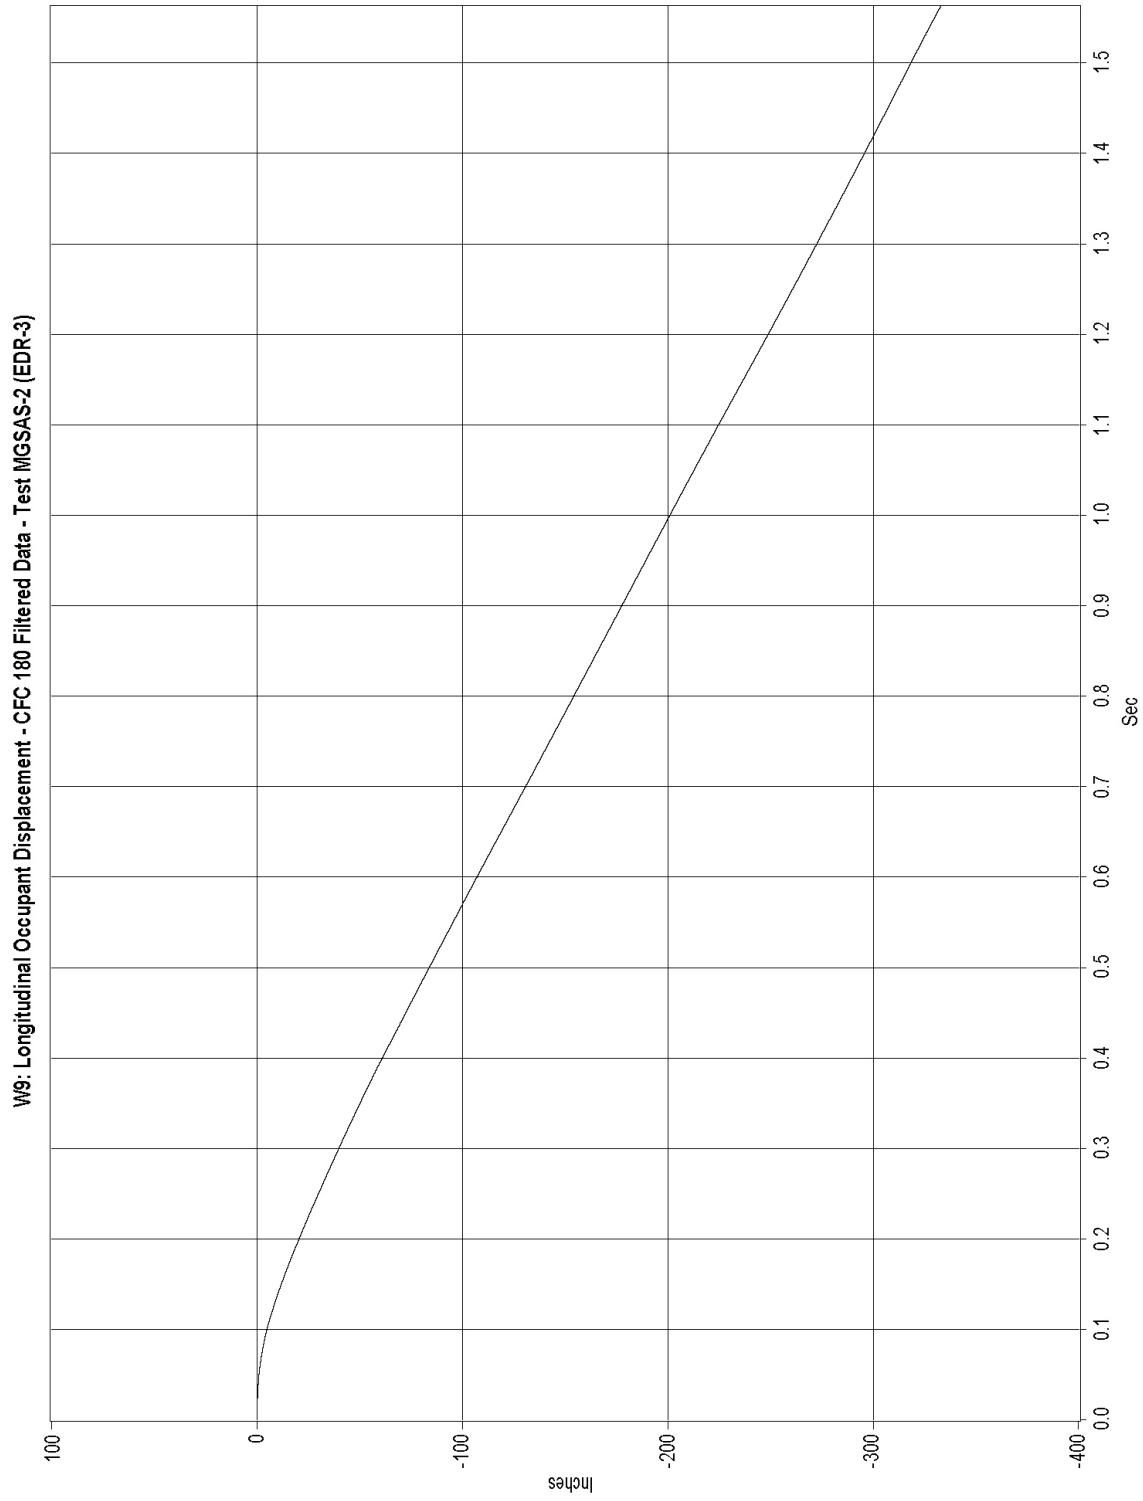
Figure F-3. Graph of Longitudinal Occupant Displacement, Test No. MGSAS-2

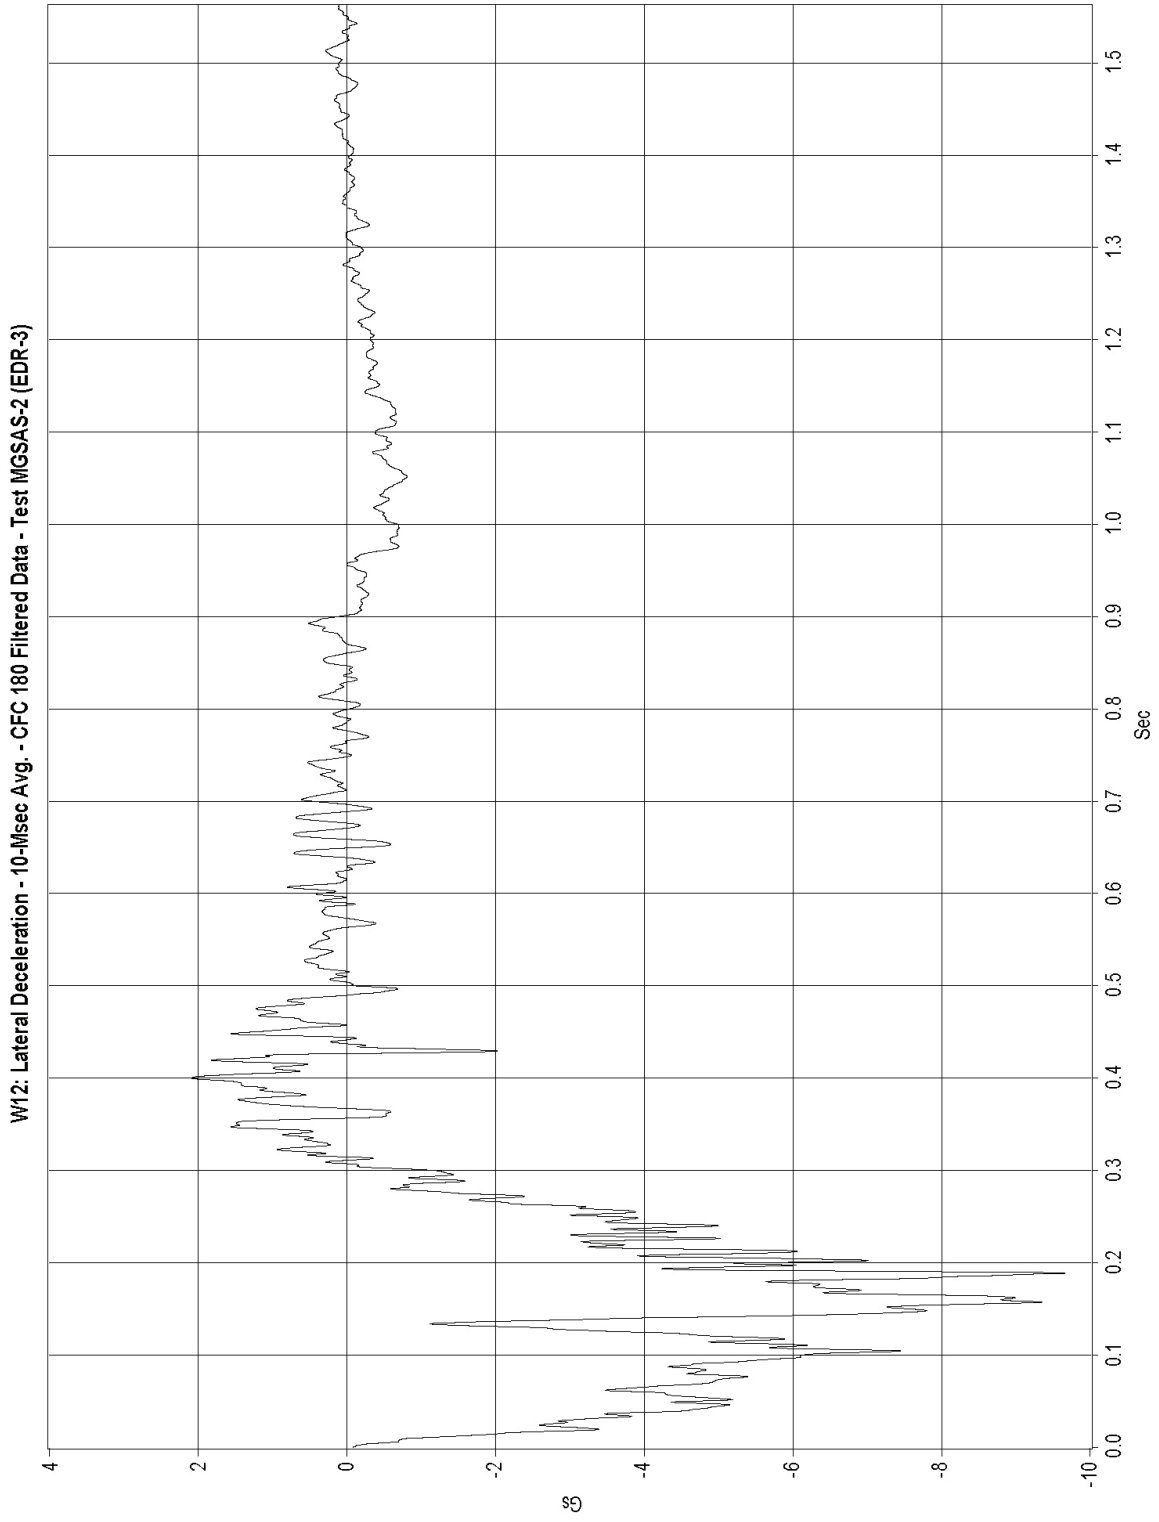
Figure F-4. Graph of Lateral Deceleration, Test No. MGSAS-2

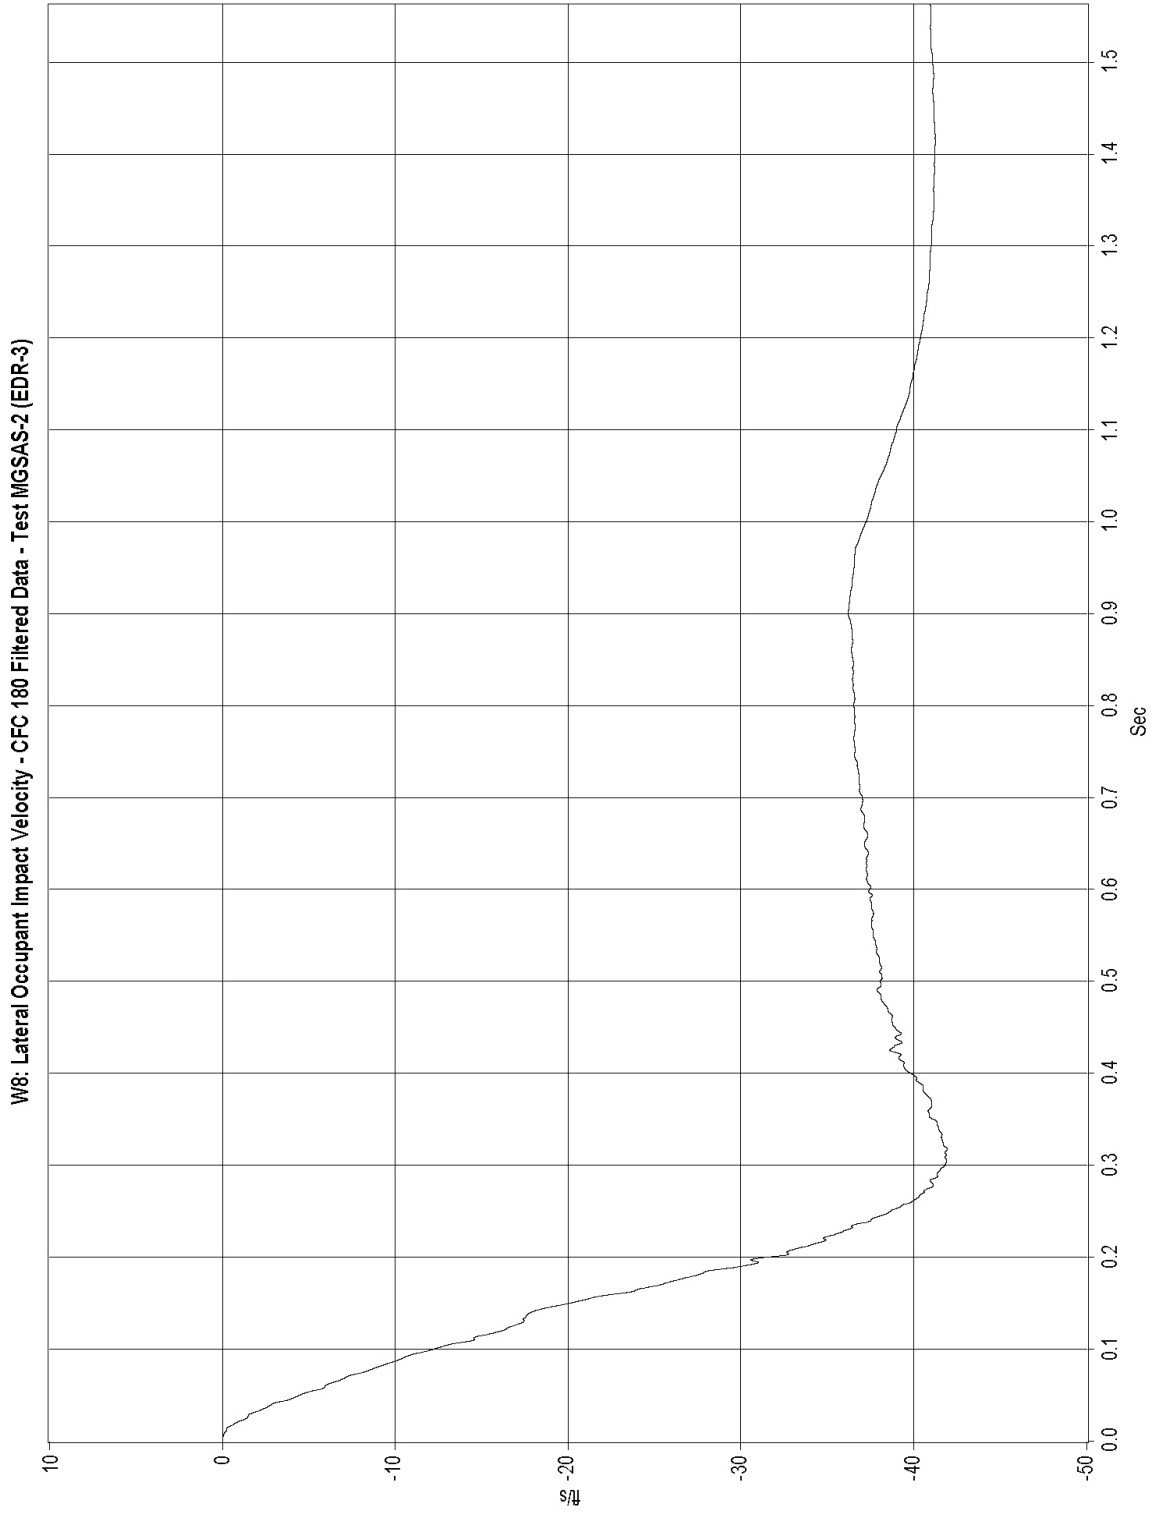
Figure F-5. Graph of Lateral Occupant Impact Velocity, Test No. MGSAS-2

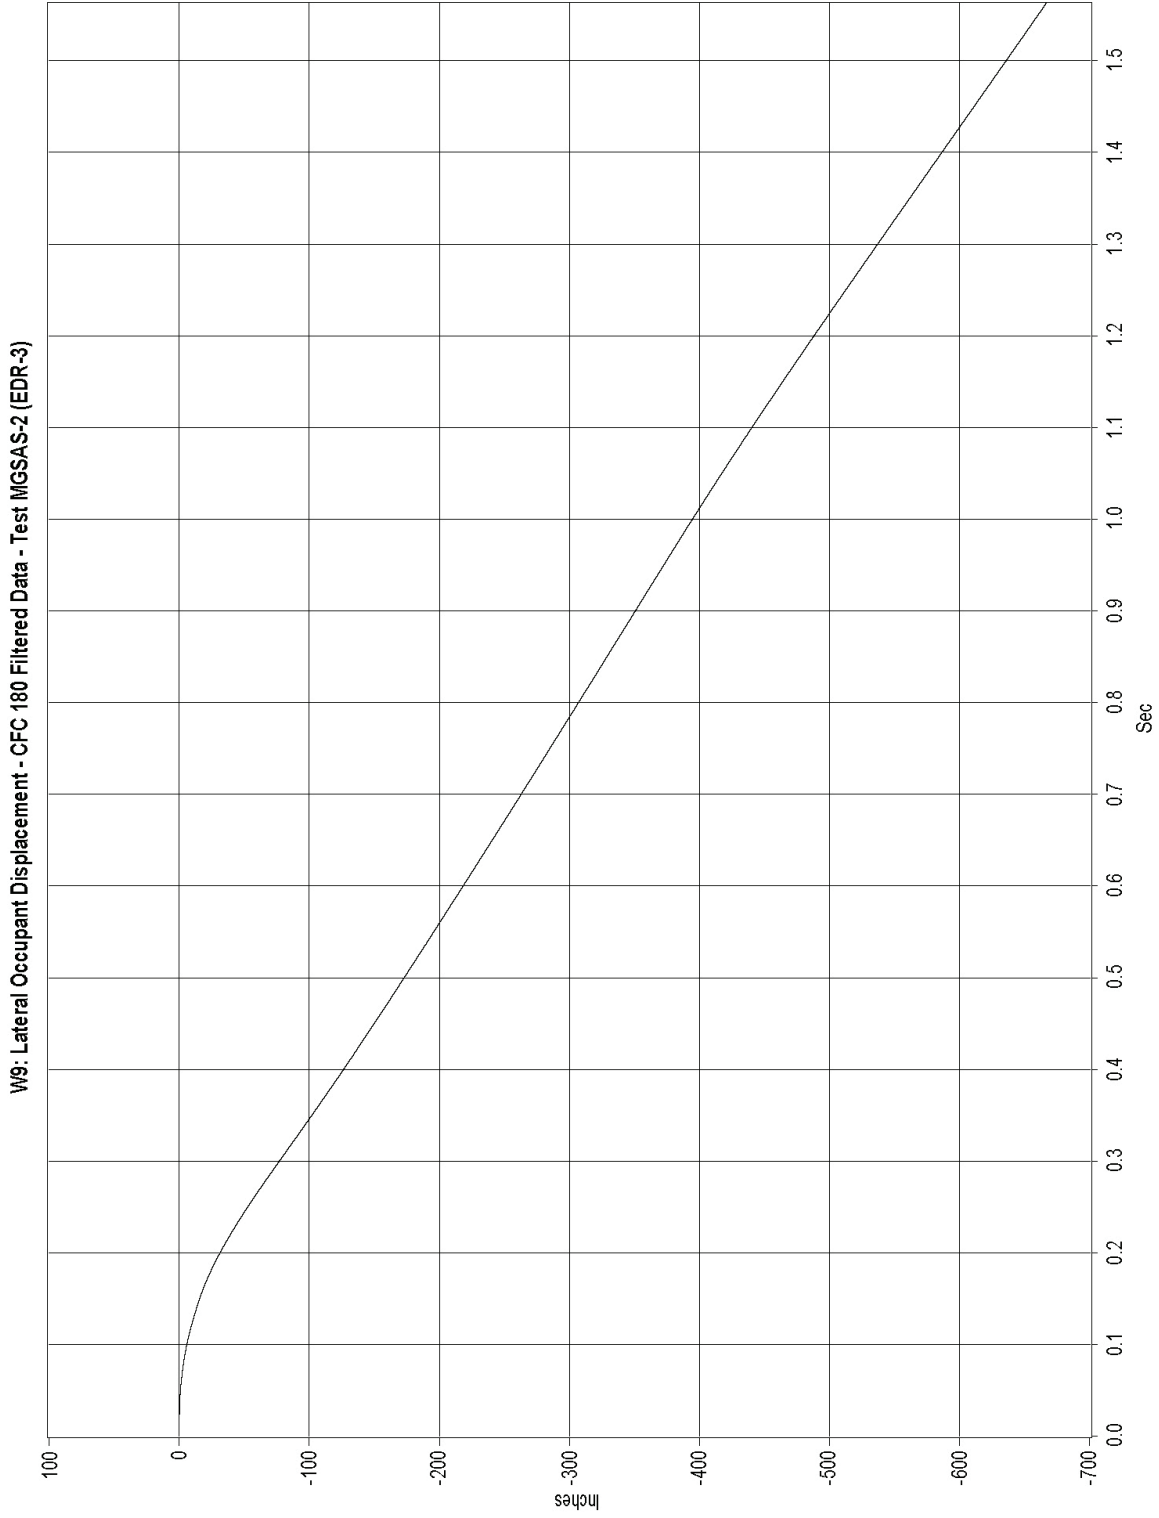
Figure F-6. Graph of Lateral Occupant Displacement, Test No. MGSAS-2

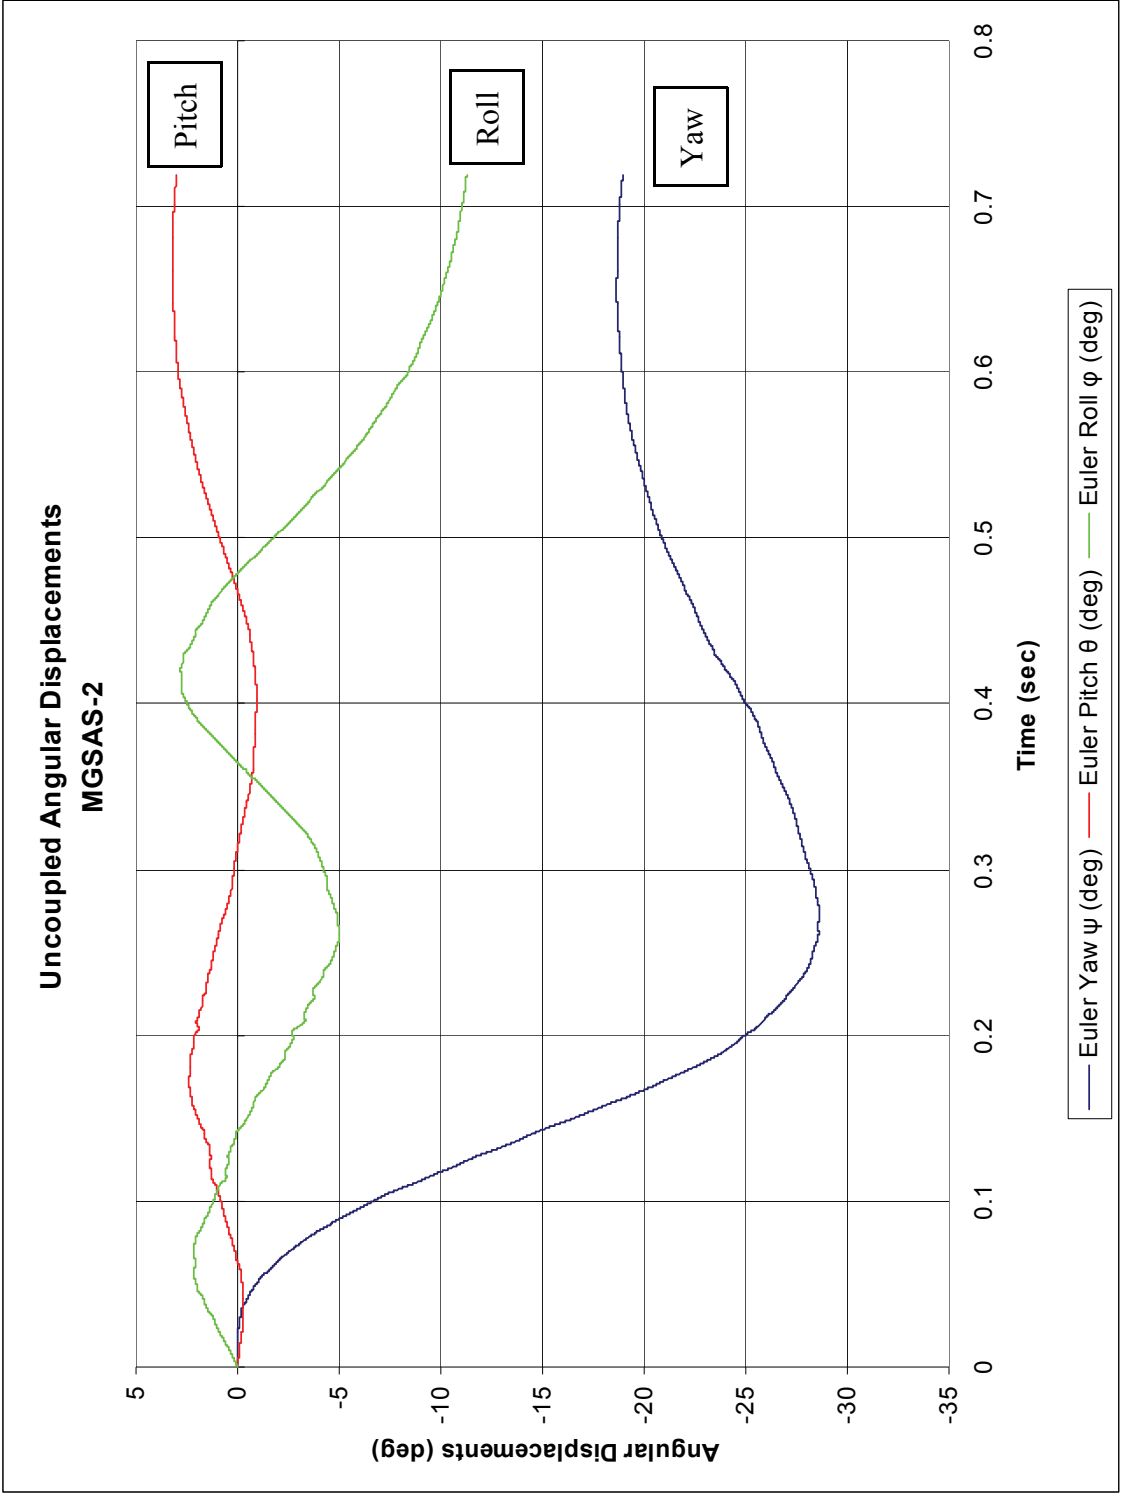
Figure F-7. Graph of Roll, Pitch, and Yaw Angular Displacements, Test No. MGSAS-2
