Evaluation of a Modified Three Cable Guardrail Adjacent to Steep Slope

EVALUATION OF A MODIFIED THREE CABLE GUARDRAIL ADJACENT TO STEEP SLOPE

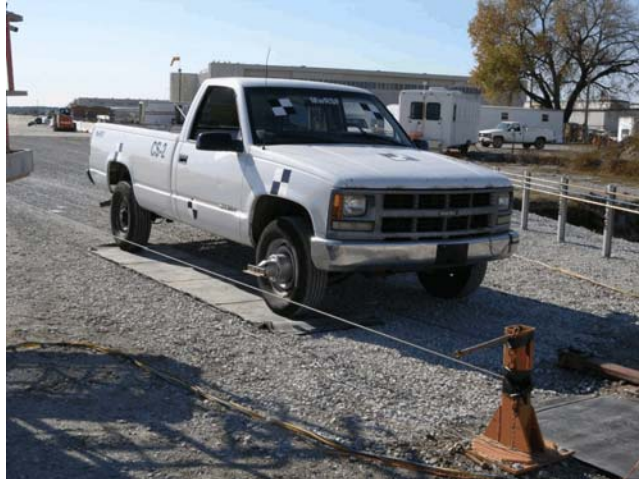
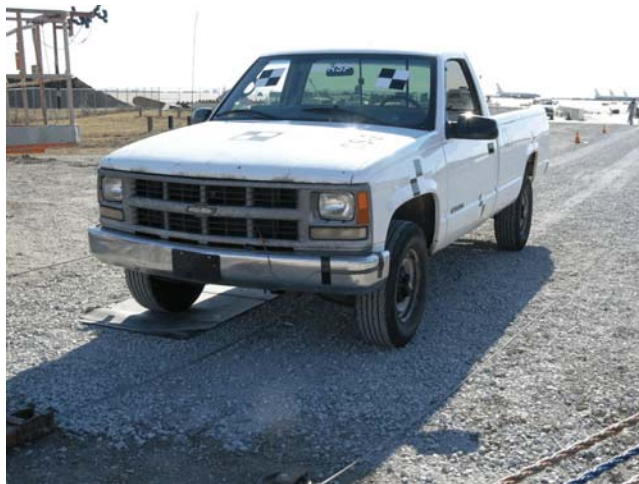
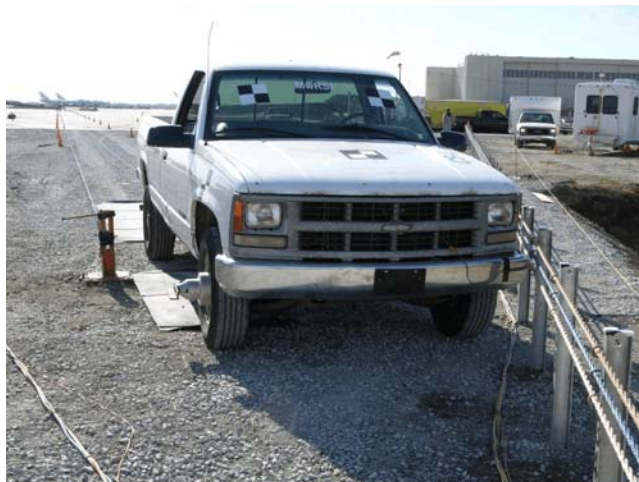
Figure 1. Test Vehicle, Test CS-2

For test CS-2, a 1999 Chevy C2500 ¾-ton pickup truck was used as the test vehicle. The test inertial and gross static weights were 2,033 kg (4,481 lbs). The test vehicle is shown in Figure 1, and vehicle dimensions are shown in Figure 2.

The longitudinal component of the center of gravity was determined using the measured axle weights. The location of the final center of gravity is shown in Figures 1 and 2.

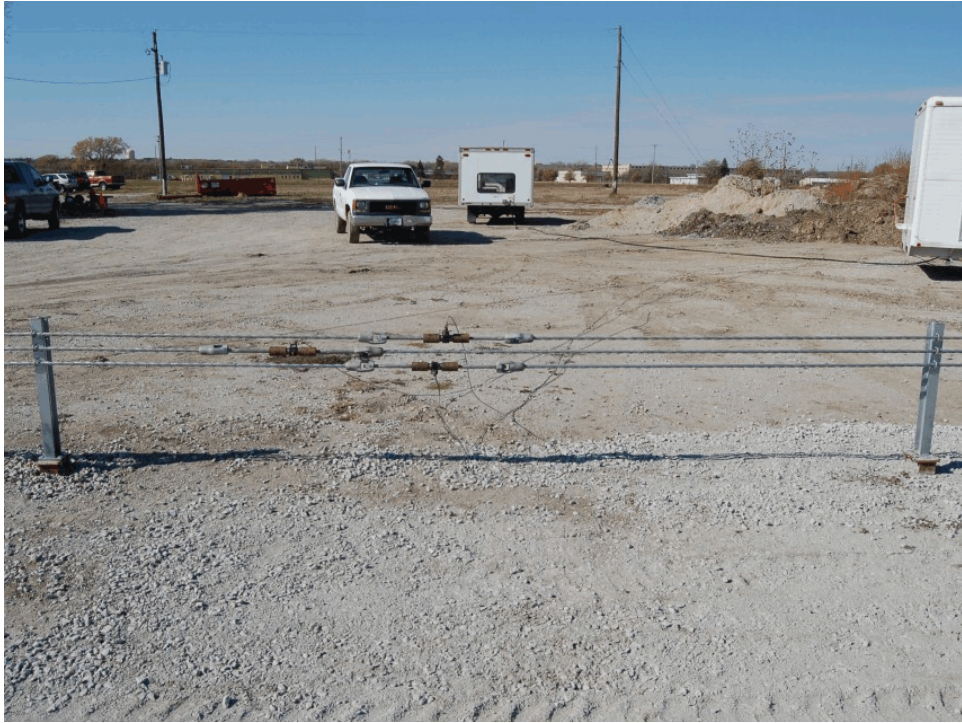
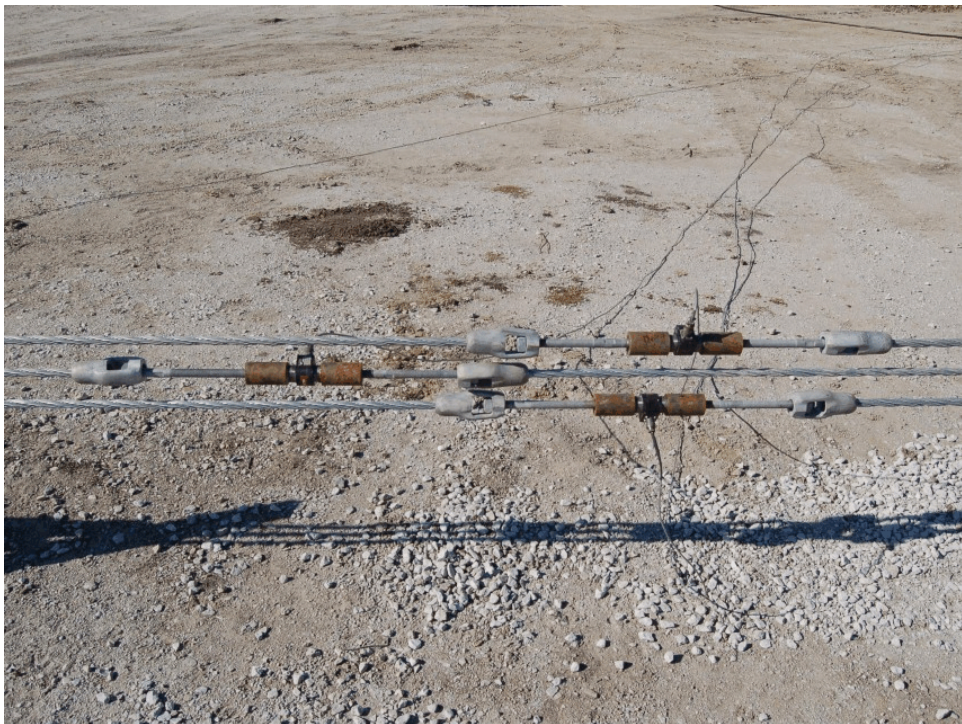
Figure 5. Upstream End Load Cell Positioning

Six load cells were installed along the three cable guardrail system. The load cells were positioned in line and at both ends of the three individual cables to measure the forces transferred to the end terminal anchors. The three load cells on the upstream end were placed between post nos. 3 and 4, as shown in Figure 5. The three load cells on the downstream end were placed between post nos. 90 and 91, as shown in Figure 6.

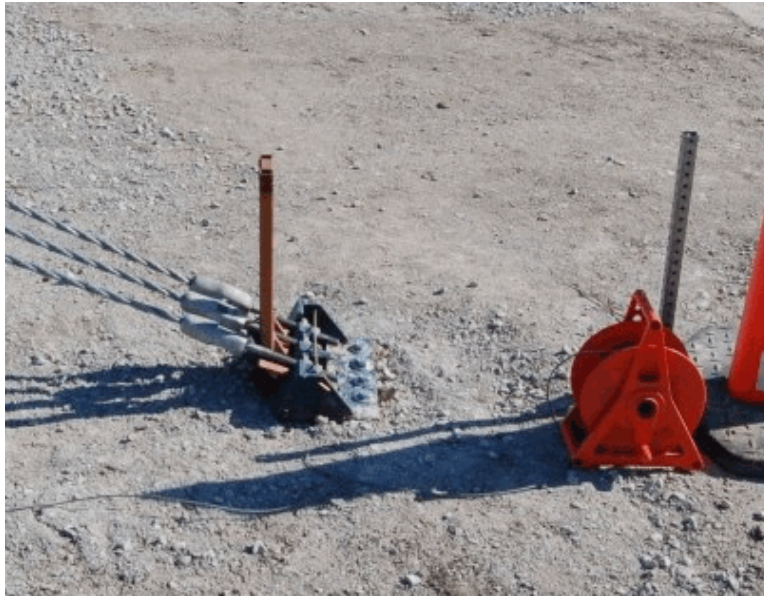
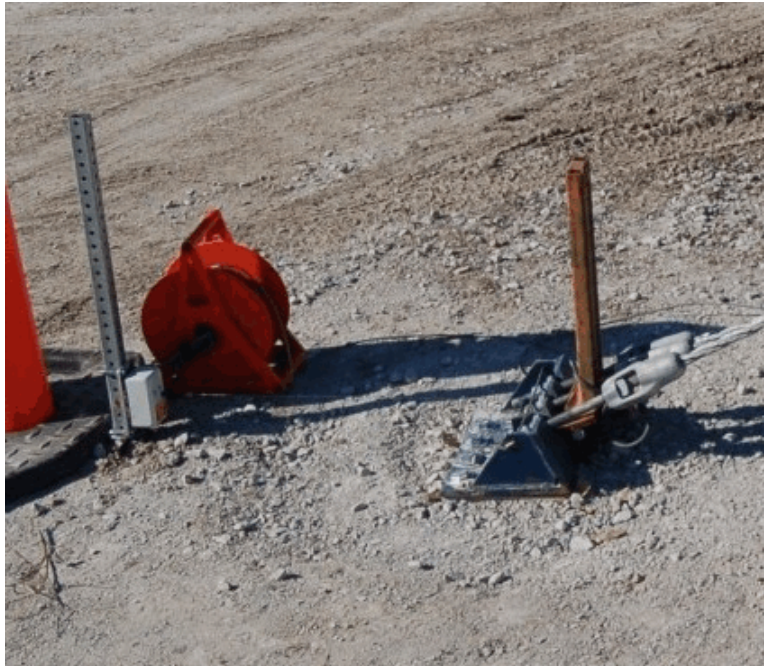
Figure 7. String Potentiometer Positioning

A string potentiometer (linear variable displacement transducer) was installed on the end terminal anchor to monitor longitudinal displacement of the anchor. The positioning of the string potentiometer on the upstream end of the terminal is shown in Figure 7.

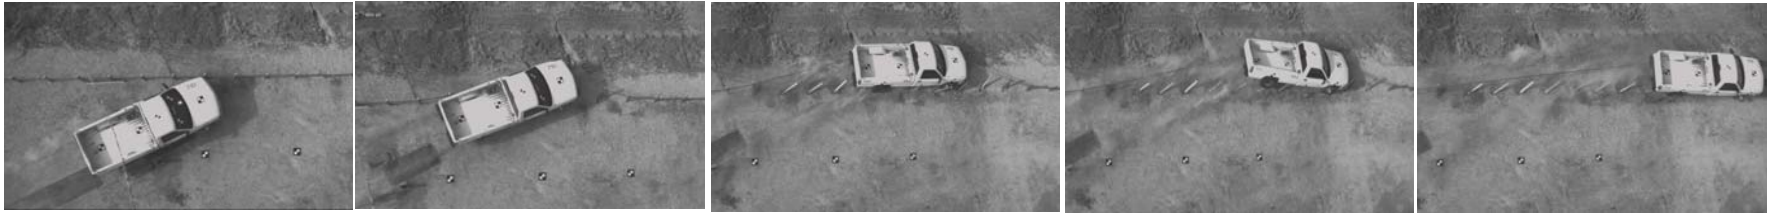
Figure 23. Summary of Test Results and Sequential Photographs, Test CS-2

- Test Agency MwRSF
- Test Number CS-2
- Date 11/1/06
- NCHRP 350 Test Designation 3-11
- Appurtenance Three Cable Guardrail Installed
Adjacent to 1.5:1 Slope
- Total Length 150.85 m
- Key Elements - Wire Rope
 - Diameter 19 mm
 - Size 7x19
 - Top Mounting Height 762 mm
 - Incremental Spacing 76 mm
- Key Elements - End Anchor Posts
 - Post Nos. 1 and 92 W152x37.2 by 2,438 mm long
 - Post Nos. 2 and 91 S76x8.5 by 838 mm long with
W152x13.4 by 1,829 mm long
- Key Elements - Slip-Base Post
 - Post Nos. 3-7 and 86-90 S76x8.5 by 838 mm long with
W152x13.4 by 1,829 mm long
 - Spacing 4,877 mm
- Key Elements - Line Posts
 - Post Nos. 8-85 S76x8.5 by 1,600-mm long
 - Spacing 1,219 mm
- Type of Soil Grading B - AASHTO M 147-65 (1990)
- Test Vehicle
 - Type/Designation 2000P
 - Make and Model 1999 Chevrolet C2500 pickup truck
 - Curb 2,182 kg
 - Test Inertial 2,033 kg
 - Gross Static 2,033kg

- Impact Conditions
 - Speed 99.1 km/h
 - Angle 23.6 deg
 - Impact Location 7.01 m downstream
centerline post no. 26
- Exit Conditions
 - Speed 52.8 km/h
 - Angle 16.3 deg
 - Exit Box Criterion Passed
- Post-Impact Trajectory
 - Vehicle Stability Satisfactory
 - Stopping Distance 42.94 m downstream
in contact with barrier
- Occupant Impact Velocity
 - Longitudinal -4.16 m/s < 12 m/s
 - Lateral (not required) 3.42 m/s
- Occupant Ridedown Deceleration (10 msec avg.)
 - Longitudinal -5.73 g's < 20 g's
 - Lateral (not required) 6.96 g's
- THIV (not required) 5.14 m/s
- PHD (not required) 8.27 g's
- Test Article Damage Moderate
- Test Article Deflections
 - Permanent Set 578 mm
 - Dynamic 3,163 mm
 - Working Width 3,317 mm
- Vehicle Damage Moderate
 - VDS¹⁰ 11-FL-2
 - CDC¹¹ 12FYES3
 - Maximum Deformation 12.7 mm at front of left-side floorpan

The 2,032-kg (4,481-lb) pickup truck impacted the three cable guardrail system at a speed of 99.1 km/h (61.6 mph) and at an angle of 23.6 degrees. A summary of the test results and the sequential photographs are shown in Figure 23. The summary of the test results and sequential photographs in English units are shown in Appendix B. Additional sequential photographs are shown in Figures 24 through 26. Documentary photographs of the crash test are shown in Figure 27.

breakpoint. At 0.764 sec, the truck continued to roll positively towards the right side. At 0.822 sec, the truck's right-front tire contacted the ground as the truck continued traveling downstream. At 0.924 sec, the truck reached its maximum positive roll of 14.7 degrees. At 0.966 sec, the truck began to exit the system. At 1.118 sec, the truck exited the system at a trajectory angle of 13.2 degrees and at a resultant velocity of 54.2 km/h (33.7 mph). At 1.184 sec, the rear of the truck yawed away from the system causing the truck to turn back toward the system. At 1.288 sec, all four tires were back in contact with the ground. At 1.890 sec, the truck redirected back into the system. At 2.652 sec, the truck came to rest 42.9 m (140.9 ft) downstream from impact with the front bumper in contact with post no. 68 and the left-front wheel on top of post no. 67. The trajectory and final position of the pickup truck are shown in Figures 23 and 29.

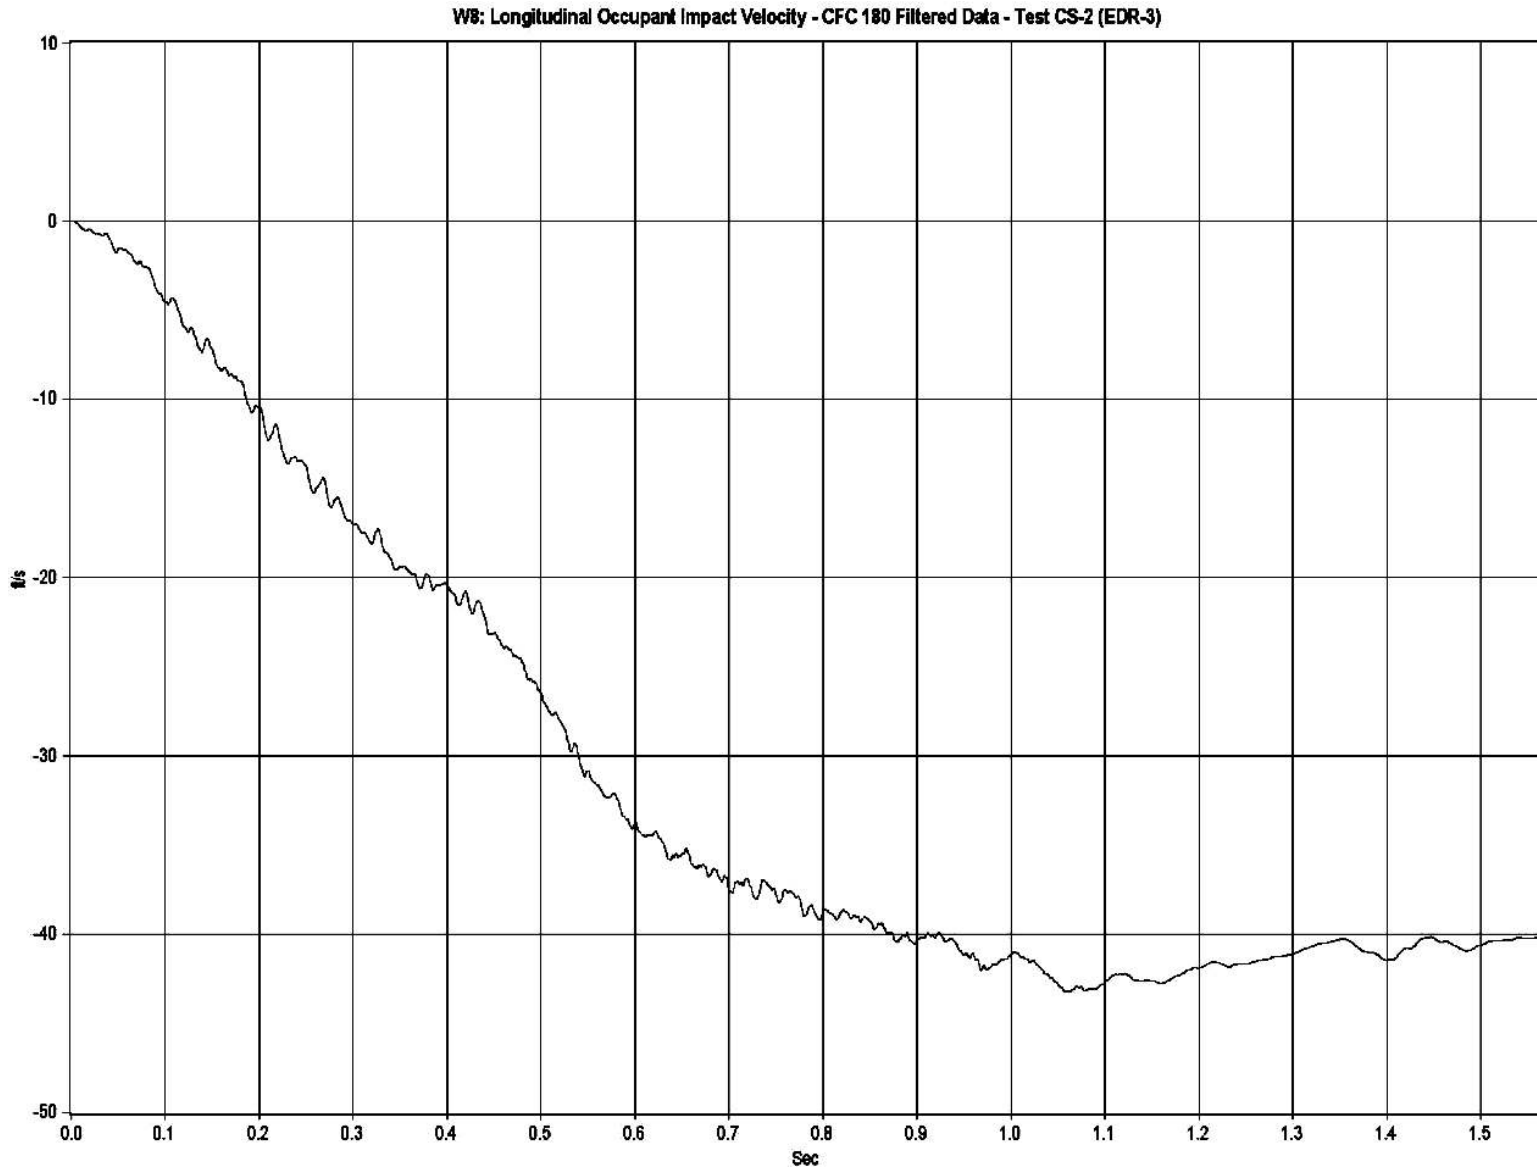
Figure D-2. Graph of Longitudinal Occupant Impact Velocity, Test CS-2

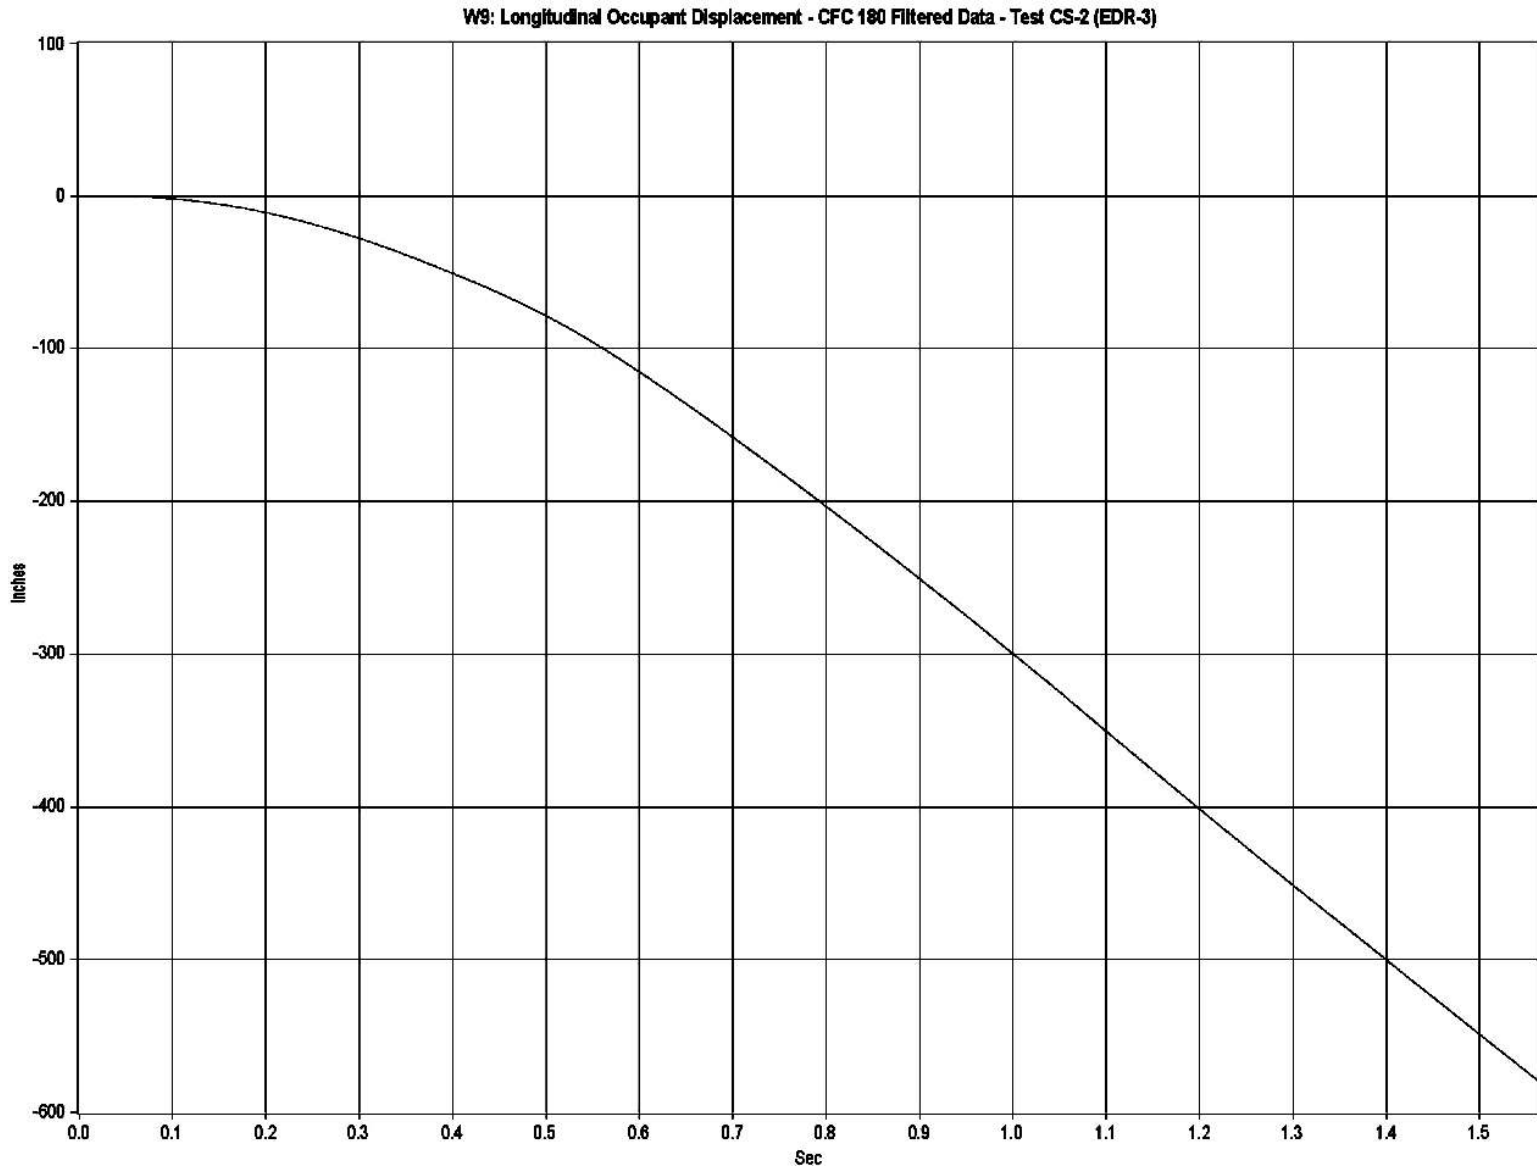
Figure D-3. Graph of Longitudinal Occupant Displacement, Test CS-2

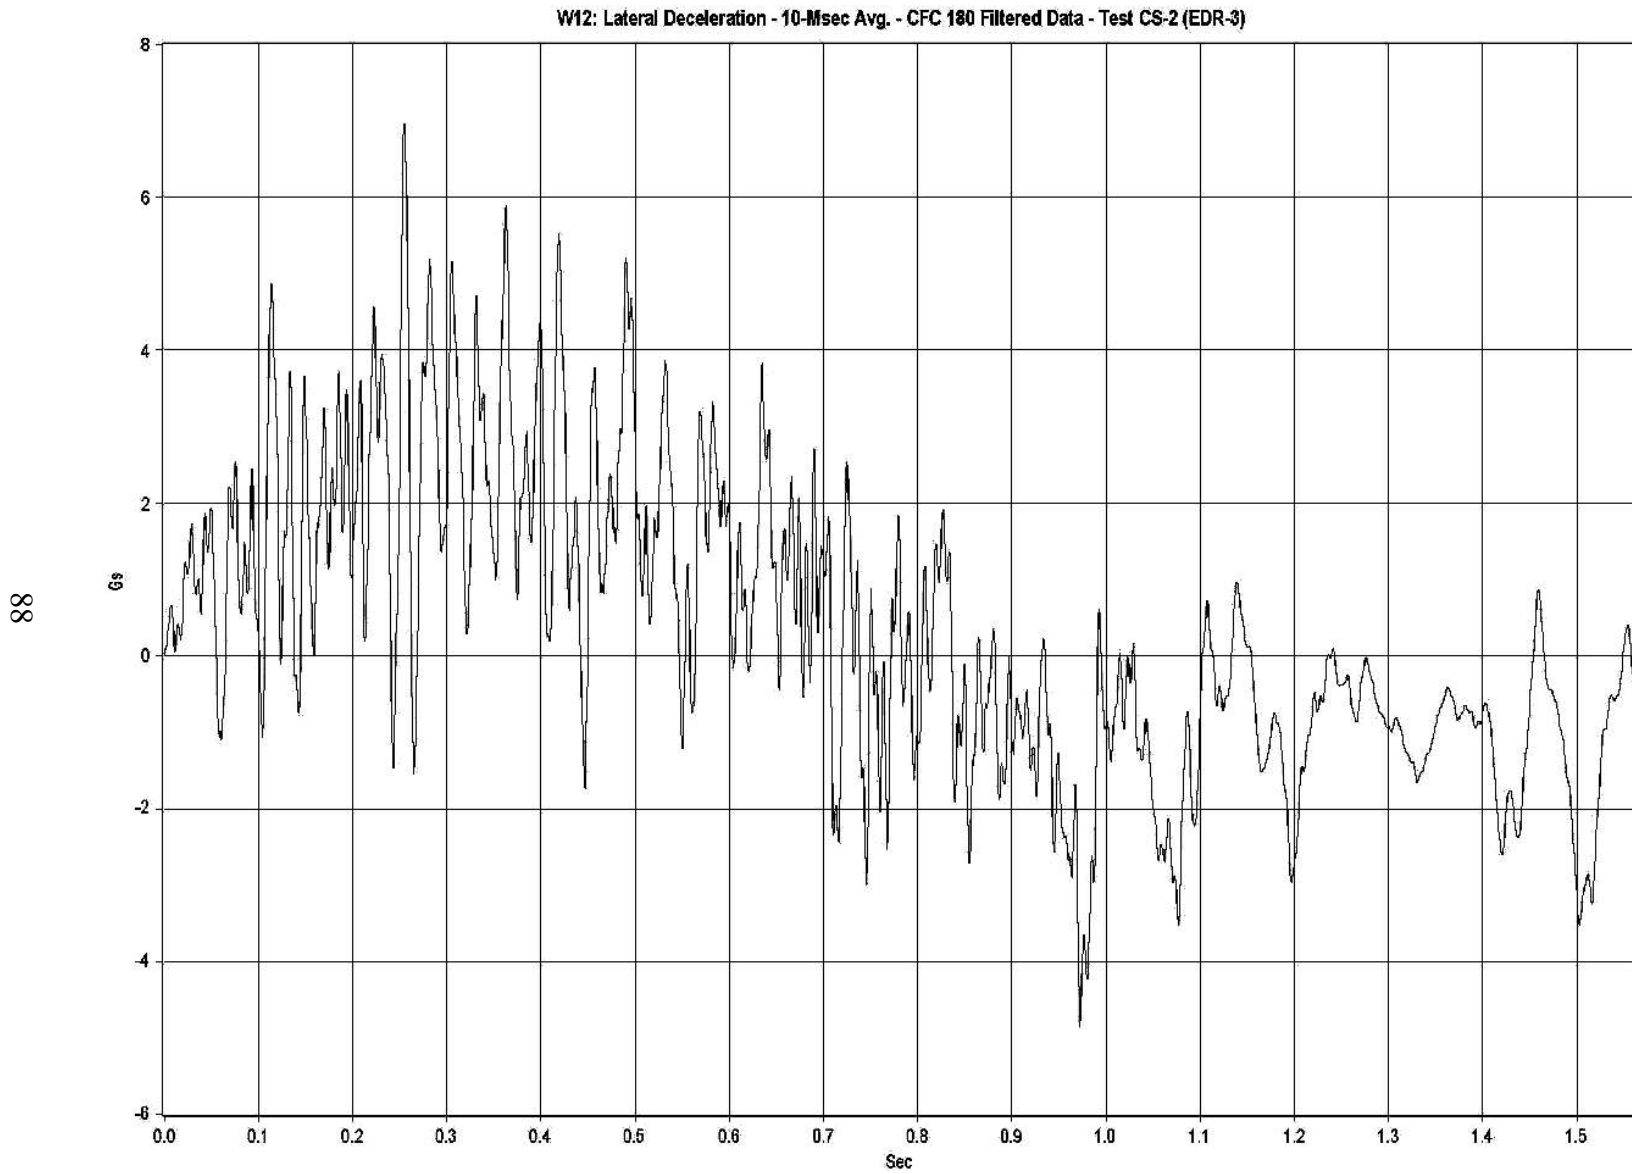
Figure D-4. Graph of Lateral Deceleration, Test CS-2

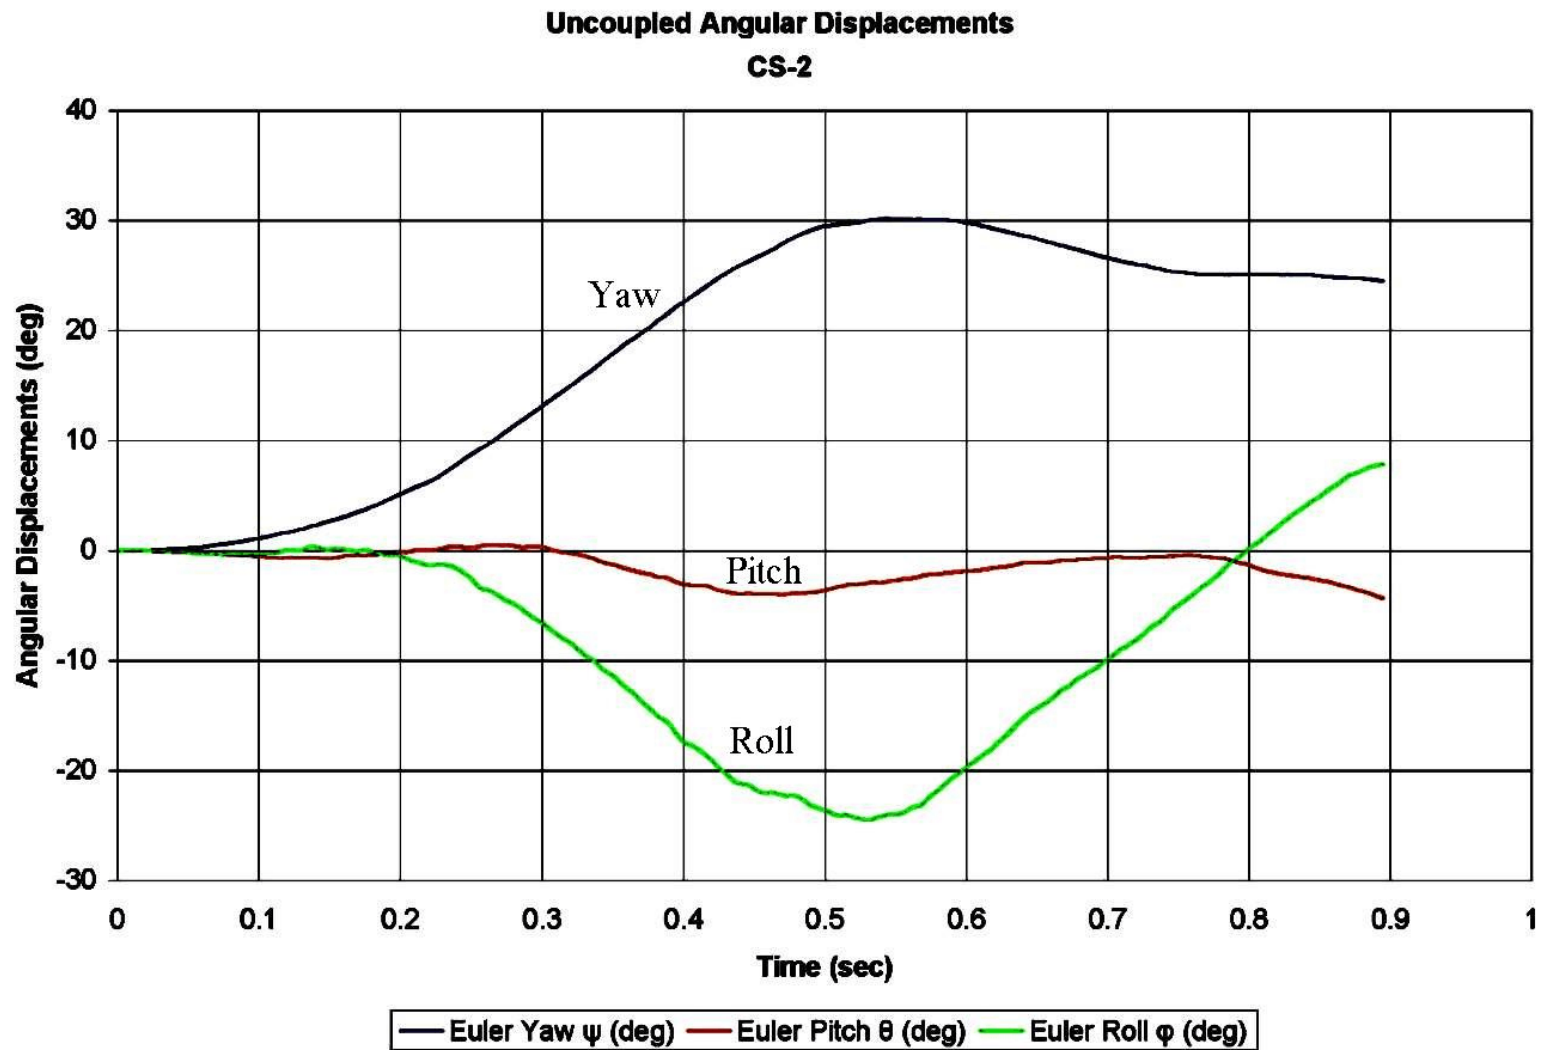
Figure D-7. Graph of Roll, Pitch, and Yaw Angular Displacements, Test CS-2
