# Assessment and Evaluation of Timber Piles Used in Nebraska for Retrofit and Rating

Sponsored By  
**Nebraska Department of Roads**

April, 2014

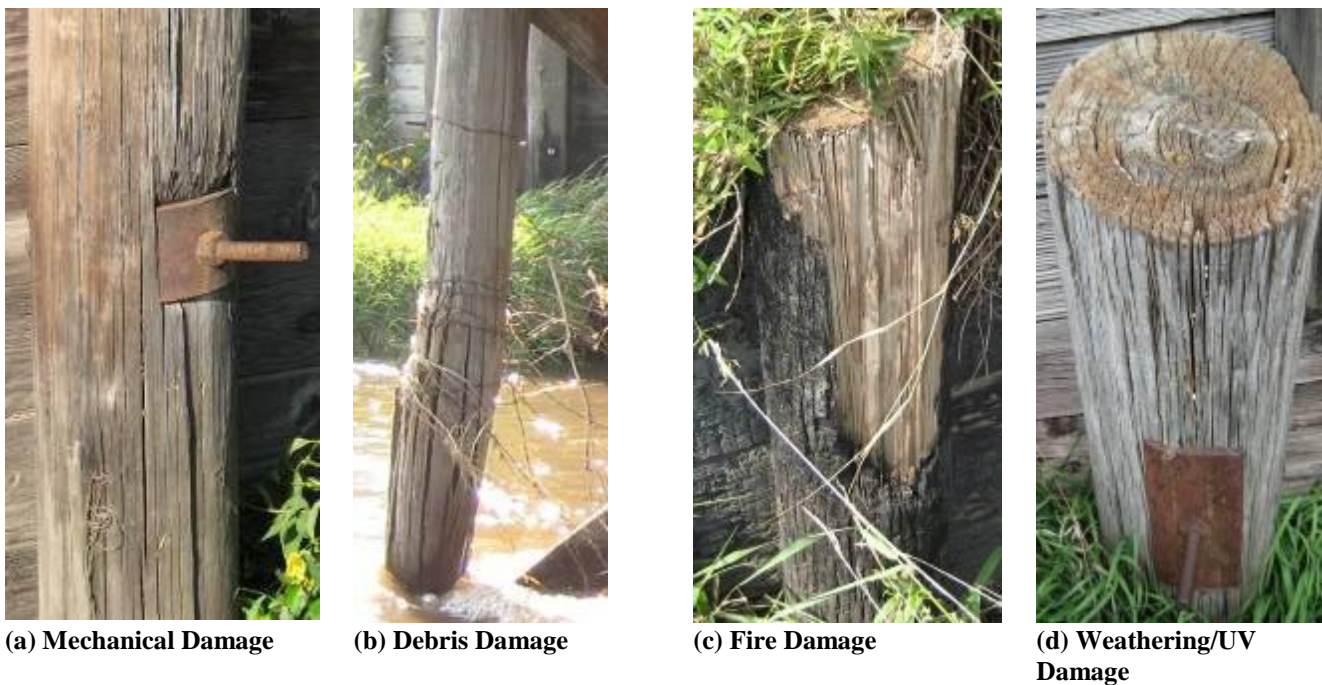
**Figure 2.1 Breaks in preservative barriers by exterior damage leads to premature decay [2]**

Physical damages are caused by different factors and cause the deterioration of exterior treated wood cover. Damage of exterior protective cover provides biological mechanism access to interior untreated wood resulting in decay of the interior wood. Different types of physical damages are shown in Figure 2.1. The most common type of physical damage is caused by impact of objects floating in water. Physical damage is also caused by overloading due to heavy loads, failure of adjacent piles, and over-tightening of the fasteners. Fire can destroy and cause failure of timber pile bridges in a matter of hours. Partially burned timber pile can carry load depending on the remaining unburned cross section of the pile.

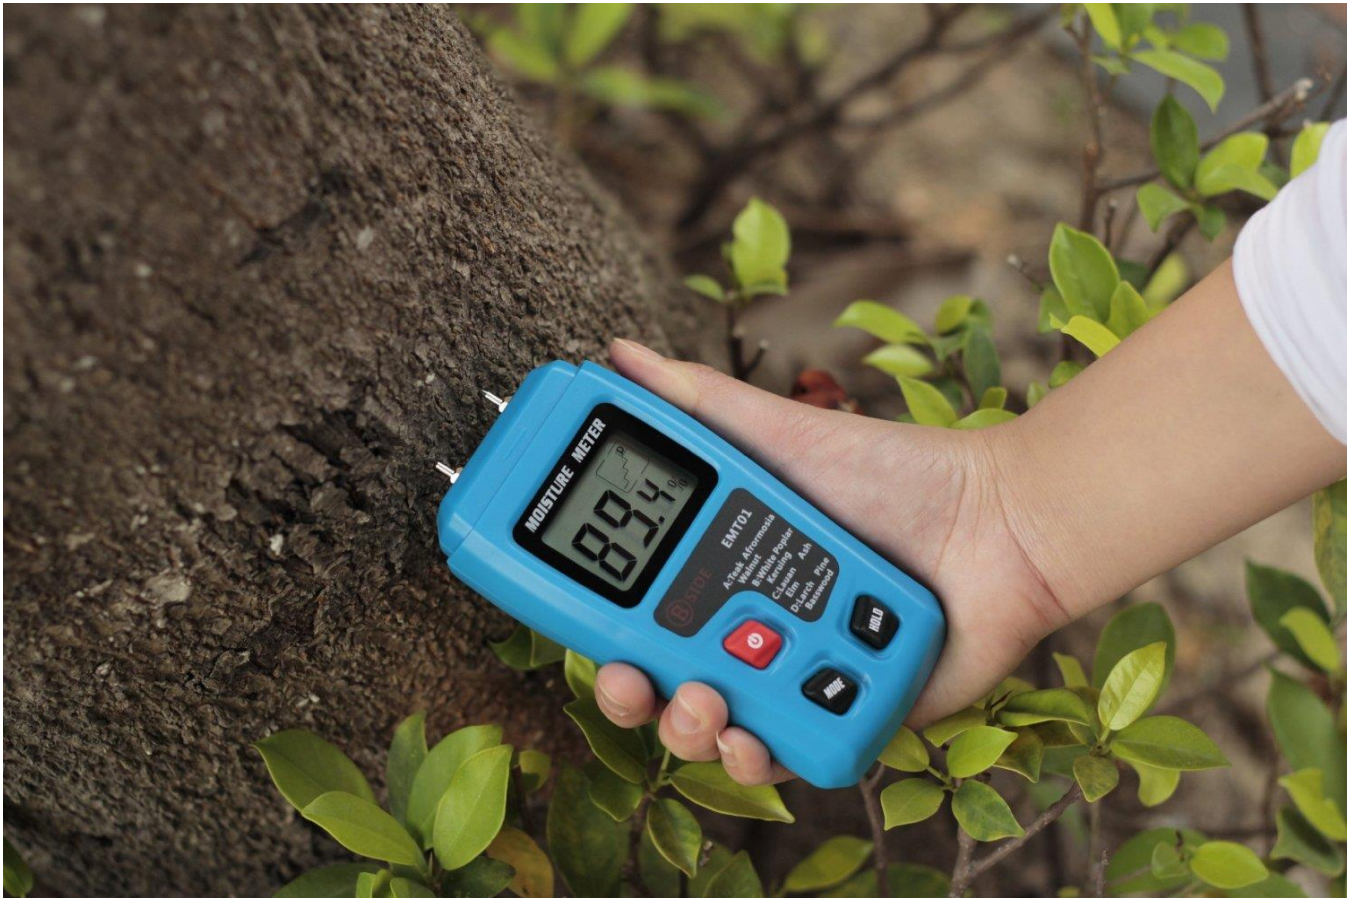
**Figure 2.2 Electronic moister meters for timber**

Excessive moisture in timber pile indicates the possibility decay. Moisture in timber pile can be measure using a moisture meter that measures the electrical resistance between two points of the timber pile. This electrical resistance is converted to equivalent moisture content using calibration charts built into the moisture meter. A moister greater than 20 percent indicates that decay is most likely to start and a thorough inspection of the pile is required.

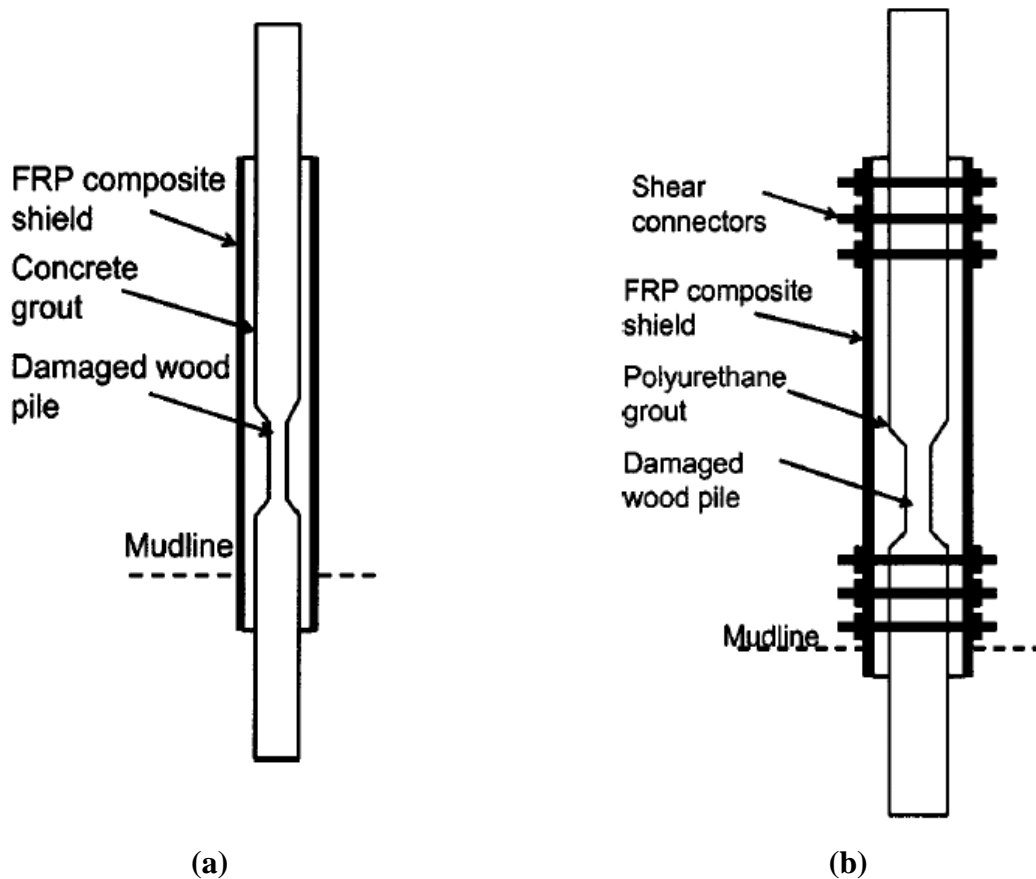
**Figure 3.6 FRP composite repair system with (a)cement-based grout (b)shear connectors and polyurethane grout [11]**

Earlier research [11] proposed a repair method for timber piles which utilizes bonded FRP composite shells that encapsulates and splices the deteriorated portion of the pile. These shells are fabricated in a quality-controlled composites manufacturing facility and have a slit or opening along their length which enables them to be opened and placed around the deteriorated pile. In this method the space between the timber pile and the FRP composite shield is filled with a grouting material that does not provide a structural bond with the wood pile, but provides interlocking between the other two components. Lopez-Anido (2005) [11] argued that their repair method has a dual function of marine borer protection and structural restoration. The repair methods used by Lopez-Anido are illustrated in Figure 3.5 and Figure 3.6.

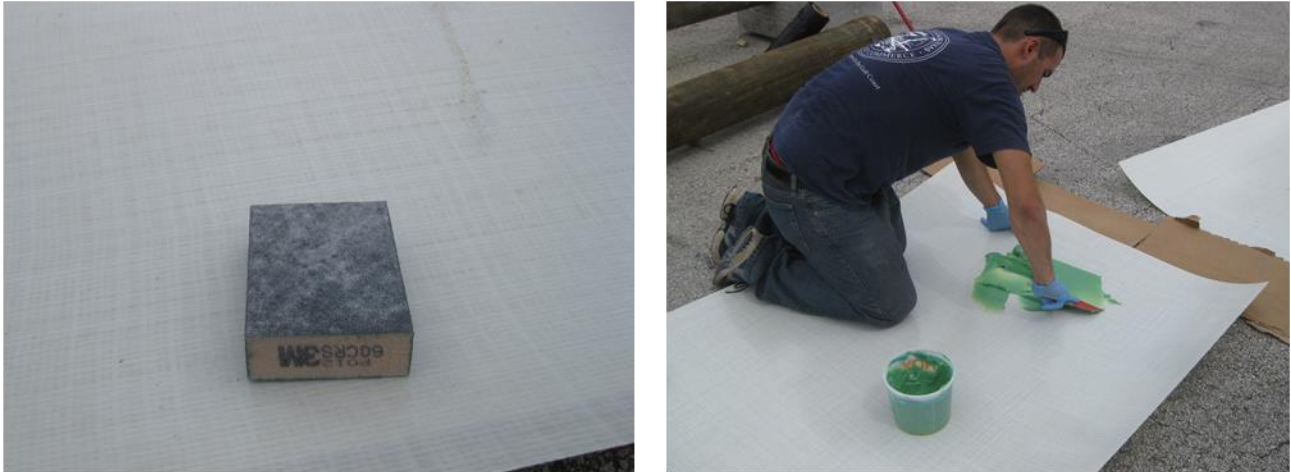
**Figure 4.2: Surface roughening and application of epoxy to GFRP sheet**

Once a piece of GFRP sheet is obtained in proper dimension, it is cleaned and its surface is made rough by a 3M sand sponge. After that, the GFRP sheet is coated with a layer of epoxy in order to affix it to

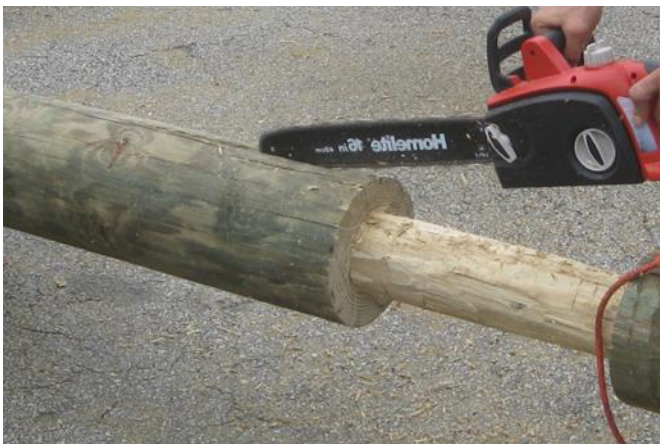
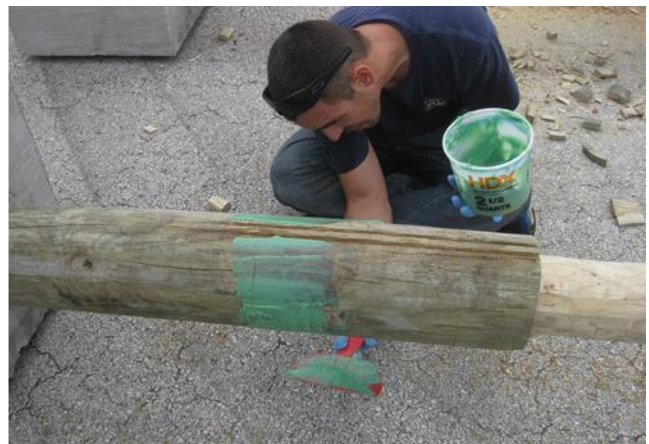
**Figure 4.3: Preparing pile for GFRP sheet**

Notches are cut in the timber piles with a chain saw to pass the grouting pipe to the damaged region of the pile. Notches should be long enough to have one end at the damaged region and other end about 3 inches outside the jacketing as shown in Figure 4.3. An approximately 8 inch wide band of epoxy coating is applied around the perimeter of the pile to establish the bond between GFRP sheet and pile. Notches can be clogged with the epoxy therefore care should be taken to avoid filling the notches with epoxy while applying epoxy coat around the perimeter of the pile.

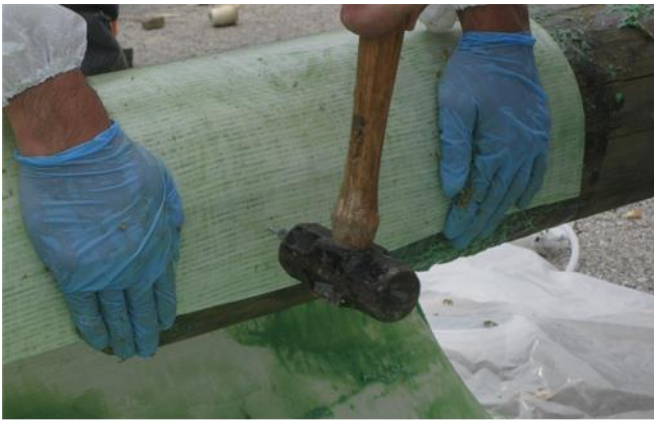
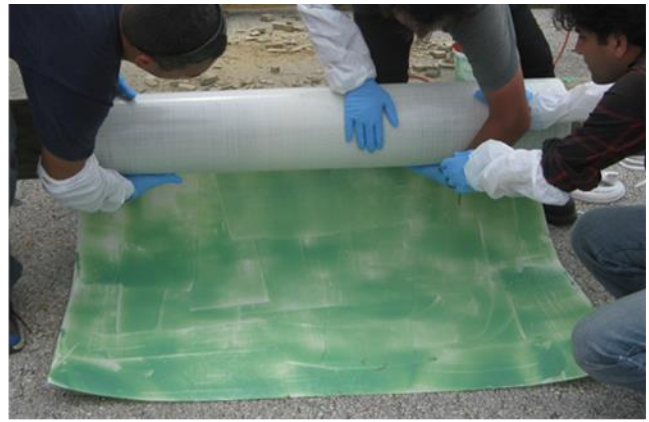
**Figure 4.4: Wrapping GFRP sheet around the pile**

In order to stretch and tighten the GFRP sheet around the timber pile, one end of the sheet may be nailed to the pile as shown in Figure 4.4. These nails might not be required for the real piles that are vertical; however, can be helpful in holding the GFRP sheet in place even in case of vertical piles.

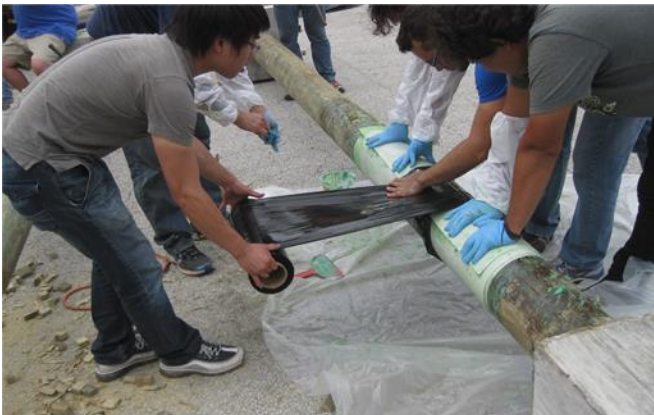
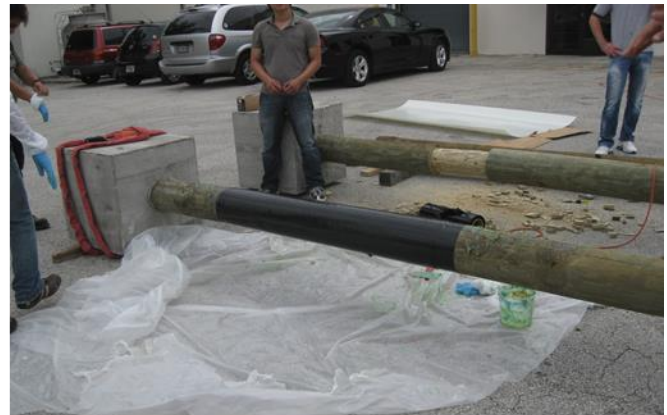
**Figure 4.5: Holding GFRP sheet around the pile by Saran<sup>TM</sup> plastic wrap**

Once GFRP sheet is wrapped around the pile, plastic wrap can be used to hold the sheet into place as shown in Figure 4.5. Complete curing of epoxy takes 24 to 72 hours. There are different stages of curing of epoxy that can be checked by followings:

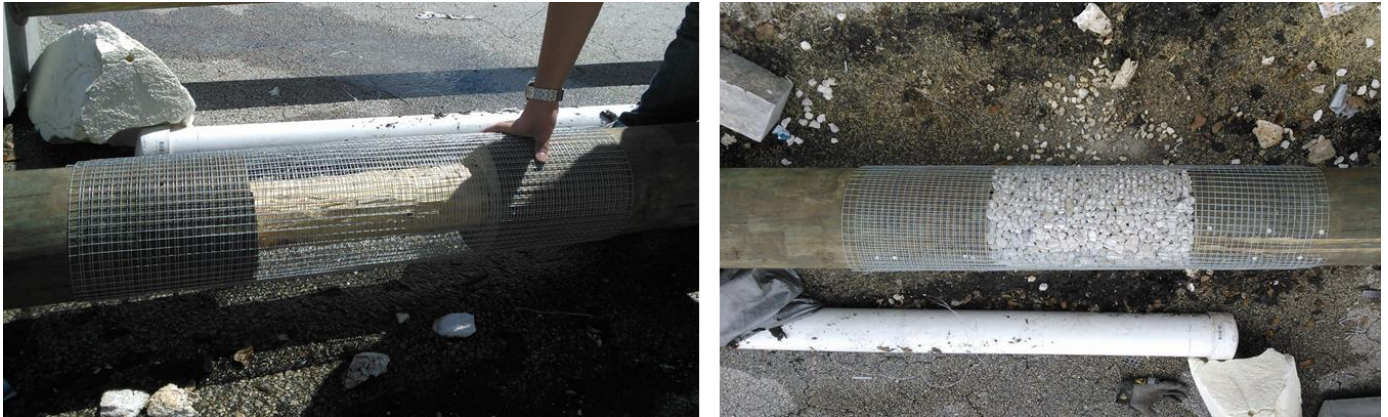
**Figure 4.6: Wire mesh for holding aggregate in damage region**

Jacketing procedure is same for different repair methods. However, for repairing the timber pile using aggregate and resin there is one extra step that is carried out before the jacketing operation. In this step, wire mesh is wrapped around the damaged region. Nails can be used to keep the mesh in place as shown in Figure 4.6. Once the mesh is wrapped around the damaged region, an access is cut in the wire to insert aggregates. An attempt was made to fill the damaged region with as much aggregates as possible in order to reduce the quantity of resin required to fill the remaining space. The jacketing operation is carried out, as described above, after filling the damaged region with aggregates.

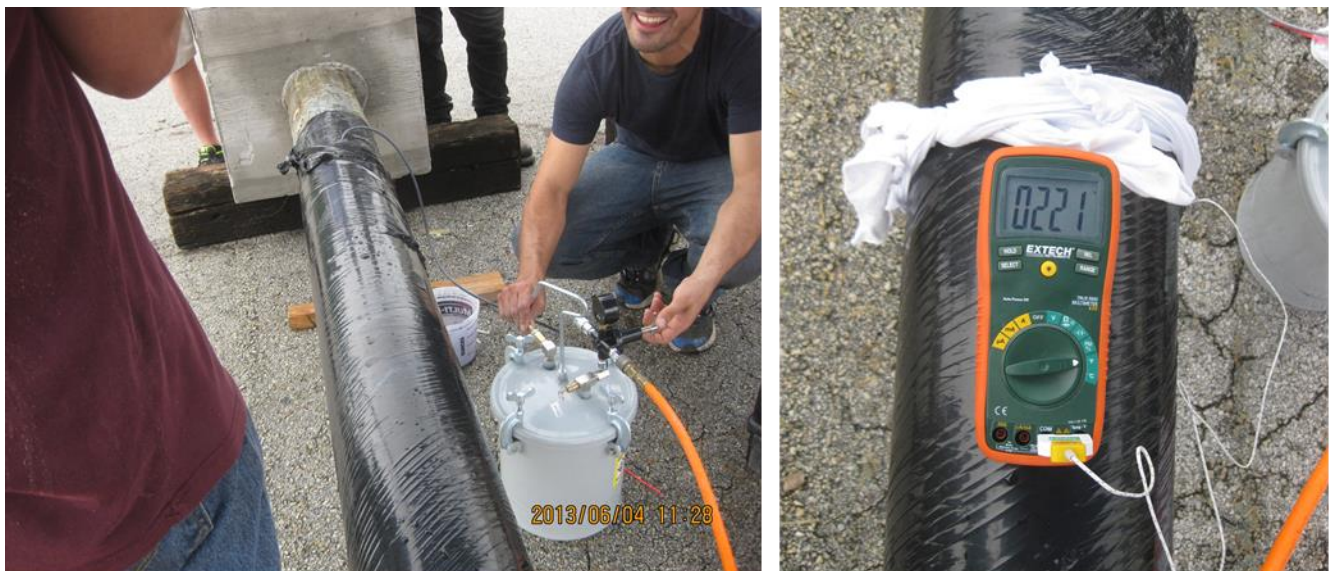
**Figure 4.7: Injection of pre-mixed resin using a pressure pot**

A pressure of 30 psi was input into the pressure pot by an external air tank. Resin is generally a low viscosity material and seeps into the cracks under low pressure. Since the piles were horizontal in this experimental set-up, one end of the pile is made higher than the other end so that air bubbles can move up out of the damaged cavity. In a real situation, the pile would be vertical and bubbles can easily move up and find their way out of the jacketing.

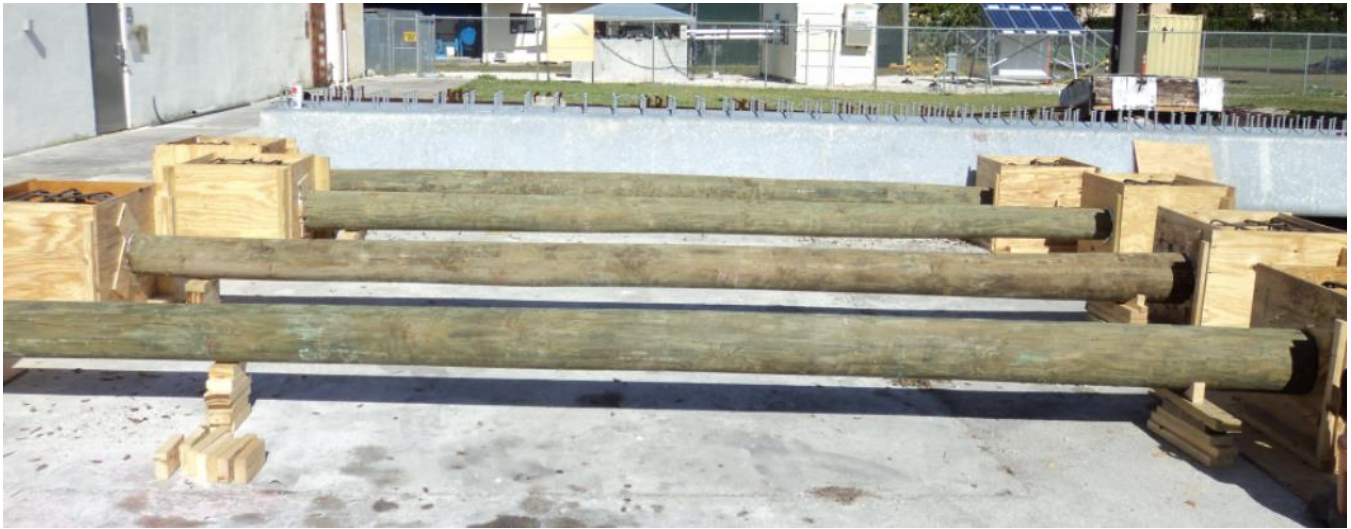
**Figure 5.1: Full Scale timber pile test specimens**

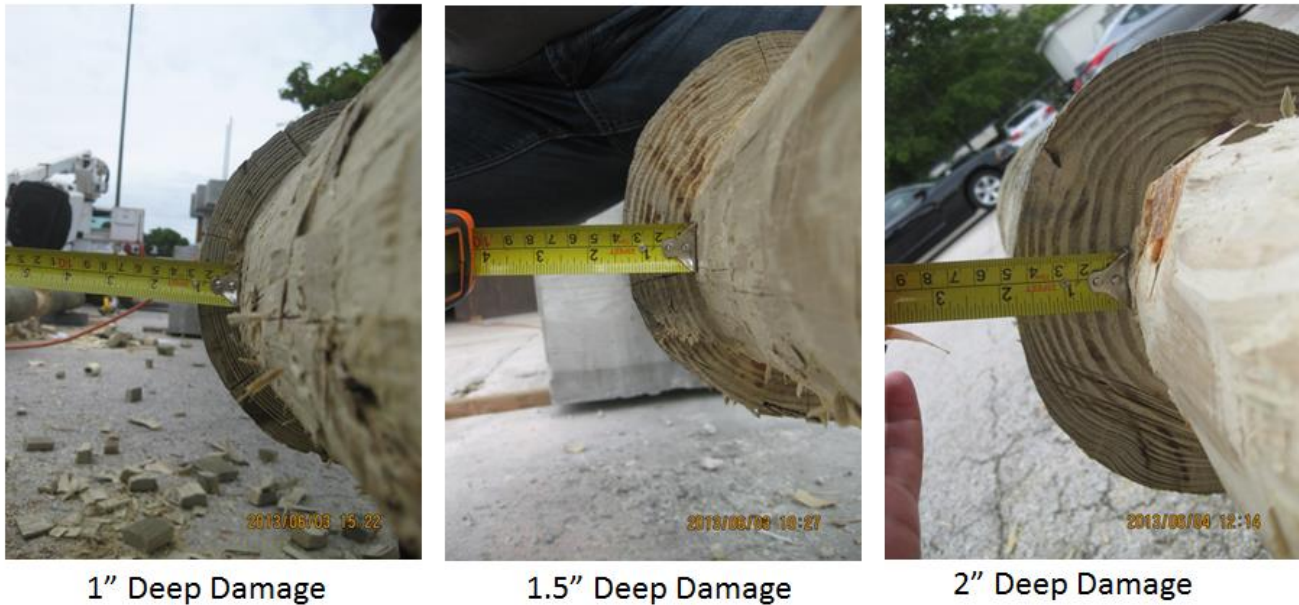
**Figure 5.3: Different levels of damage in timber pile test specimens**

Different details of the timber pile test specimens are provided in Table 5.1. The five test specimens have different levels and location of damages, and are repaired by different method as shown in Table 5.1. Three different damage levels were used in the test specimens. Specimen 2 and 3 have 1.0 inch and 1.5 inch deep damage respectively and specimen 4 through 6 have 2.0 inch deep damage. The length of damage is kept constant for all test specimens. Different levels of damage are shown in Figure 5.3.

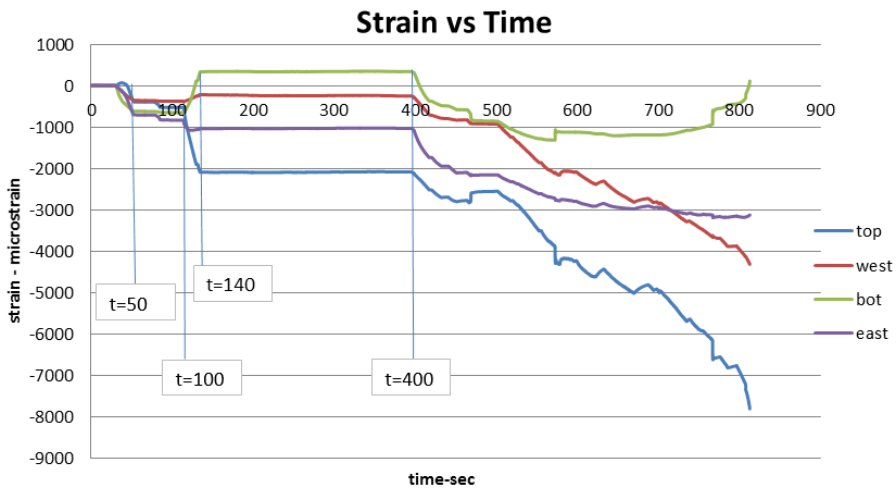
Figure C.1 Strain versus time at different stages of loading

This appendix is describing sequence of applying vertical and horizontal load on one specimen. For all the other specimens the sequence of loading is approximately the same. The initial axial load applied to the specimen from time  $t=0$  sec to  $t=50$  sec to tight timber pile with two end concrete blocks. After 50 sec the research team control vertical hydraulic jacks for applying vertical load. During  $t=100$  sec to  $t=140$  sec the vertical load applied to the specimen for making eccentricity. As it has shown in Figure C.2 and Figure C.3, after  $t=100$  sec, while just vertical load at the location of unfixed support loads applied, timber pile doesn't carry out any axial force, but the amount of moment increased significantly. During this time the vertical load keep the axial force constant but make a jump in P-Delta affect from 0.5 kip-in to 1.2 kip-in that is approximately 0.05 of the total moment at collapse level. After  $t=140$  sec until  $t=400$  sec the research team were prepared to ready for the final step of test. At the final step of loading, after the  $t=400$  sec, axial load was increased until the collapse level. For instance, Figure C.1 and Figure C.2, show during the time  $t=0$  sec to  $t=50$  sec, increasing initial axial force to 30 kips increase the strain around 500. This axial load is approximately 18 percent of collapse load. The effect of this initial load is insignificant on bending moment at the location of damage. At the next step during increasing the vertical load, the strain for east, top and west of the section decrease while the strain for bottom section increase. At the final step of loading, after  $t=400$  sec, all fibers of the section is under compression and there is more compression at the top and east than the bottom and west side of the section (these results for each specimens is different). These graphs indicate there is a moment around two major axes of the section. Furthermore, because the strain at the top of the section is maximum, therefore in this specimen the first yielding fibers occurred at the top of the section. Figure C.4 is a compression between applying force by hydraulic jack at different points of unfixed support and total horizontal and vertical loads. Figure C.5 shows the horizontal deflection at the east, west and middle of the unfixed support and middle of timber pile length.

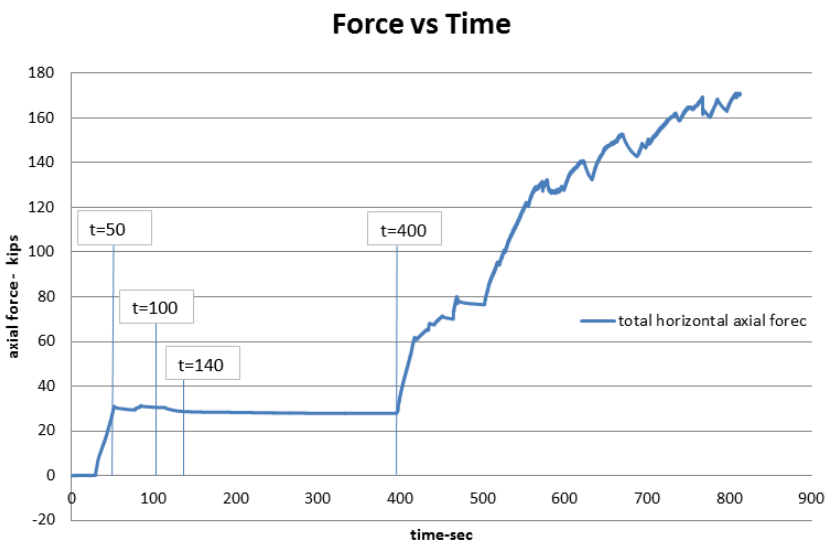
Figure C.2 Axial force versus time at different stages of loading

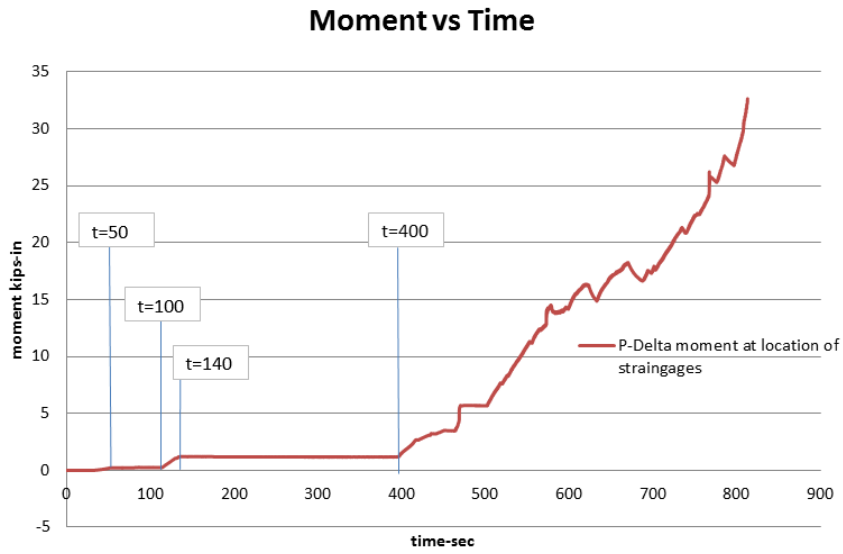
**Figure C.3 Moment versus time at different stages of loading**

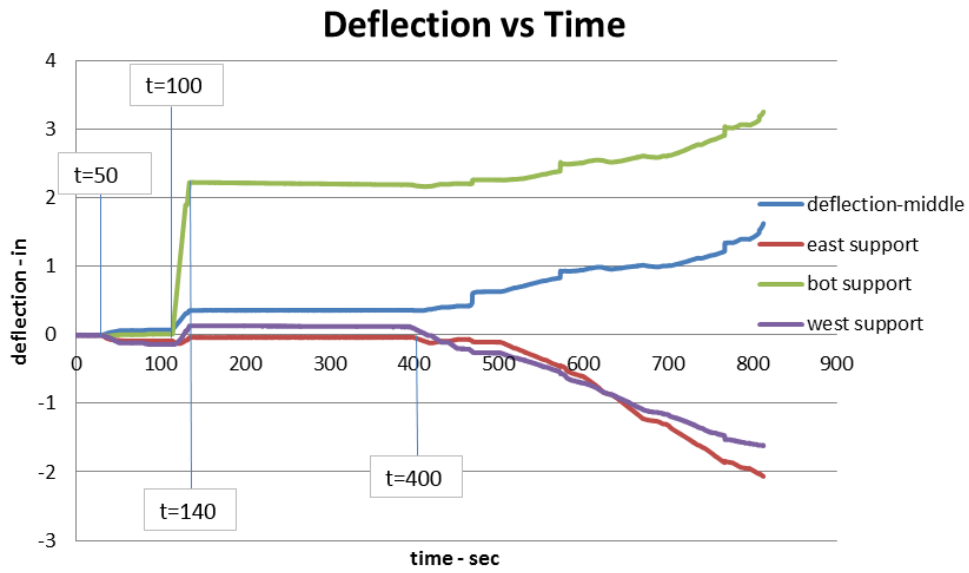
**Figure C.5 Measured deflection at different locations along the timber pile length**
