JOINT TRANSPORTATION RESEARCH PROGRAM

SPR-3507

Subsurface Condition Evaluation for Asphalt Pavement Preservation Treatments

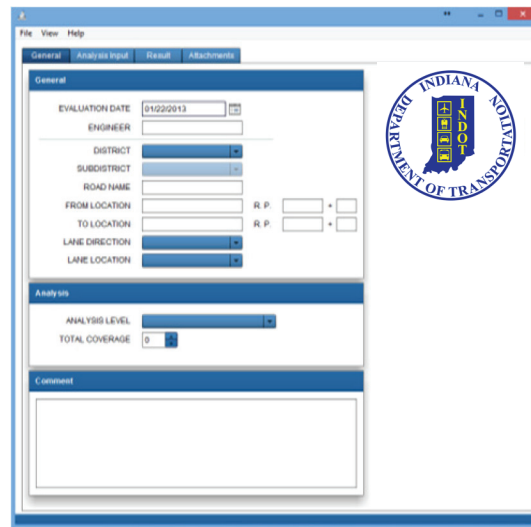
iSub: software for evaluating subsurface condition.

Guidelines for subsurface condition evaluation for pavement preservation treatment application was developed utilizing the findings from the case study. A concept of hierarchy was used in the guideline by taking project importance and available resources into consideration. A tool including guidelines, computer software (e.g., iSub and iMoisture), and its manual was also developed based on the methodology as a research product. Based on the guideline, it was concluded that the subsurface condition of the case study section on SR-70 was inadequate for the application of the pavement preservation treatments.

The evaluation tool developed in this study can help achieving a consistent and rational decision making process for project level or district level pavement preservation program. The findings, guidelines, iSub, and iMoisture will be introduced to the INDOT pavement engineers in order to assist them with district level preservation treatment practices. The details in the report and software are intended for reference only, not as specifications or design guidance. In the event that any information presented herein conflicts with the Indiana Design Manual, INDOT's Standard Specifications or

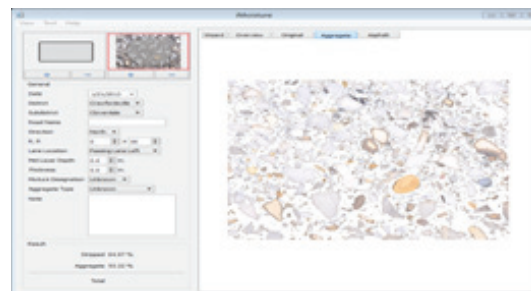
iMoisture: software for quantifying water stripping severity in asphalt mixture.
