PSFC/RR-06-1

## **Desktop Vacuum Pressure Impregnation Experiment for ITER Insulation Testing**

Mahar S., Titus P., Gung C., Hooker M., Minervini J.,  
Schultz J., Stahle P., Takayasu M.

April 2006

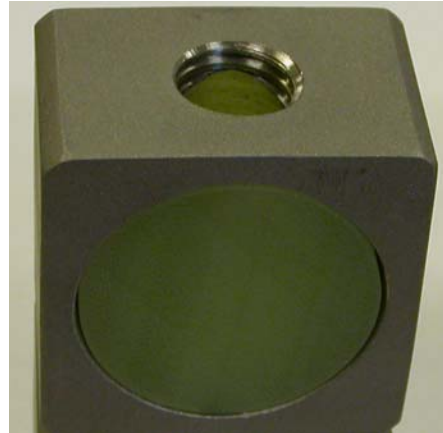
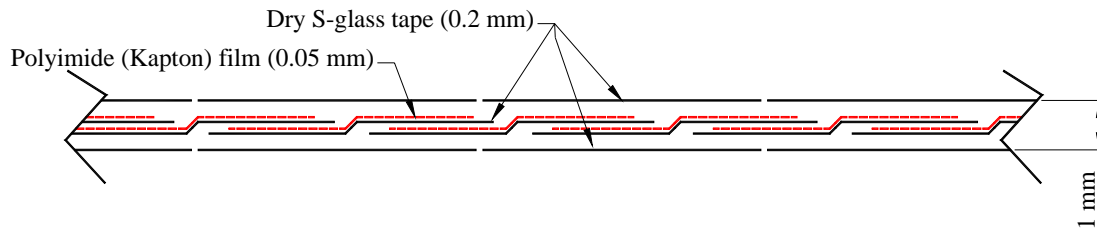
- Another G-10 piece was also machined to fit inside as well as being tapped to aid in the breaking test (although it was not used).
- According to the latest (Feb 2006) ITER Central Solenoid Specification document, the insulation will be a one step VPI system consisting of three layers:

- o Inner: dry glass, one layer, minimum gaps between tape butts, no overlap.
  - o Middle: dry glass and polyimide film tape, one pass, 45% overlap
  - o Outer: dry glass: one layer, minimum gap between tape butts, no overlap

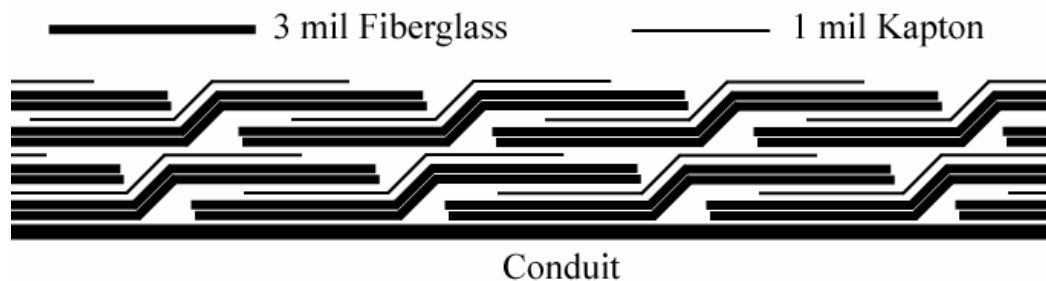
- The insulation we used in the experiment is composed of 3 mil silane treated E-glass and 1 mil Kapton tape. Instead of the desired 6 mil fiberglass, 2 layers of the 3 mil glass were used. The insulation consisted of 2 half lapped layers of 6 mil of fiberglass and 1 mil of Kapton.

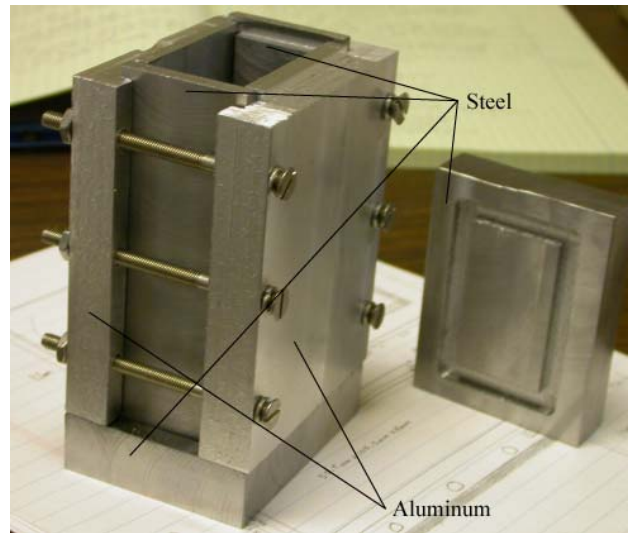
- The mold is part steel and part aluminum (for ease of machining). Before the run, it was also grit-blasted to help the RTV adhere to the metal and form a good seal. (The figure to the right is before the holes were tapped in the top and bottom for the epoxy to enter and exit the mold.)

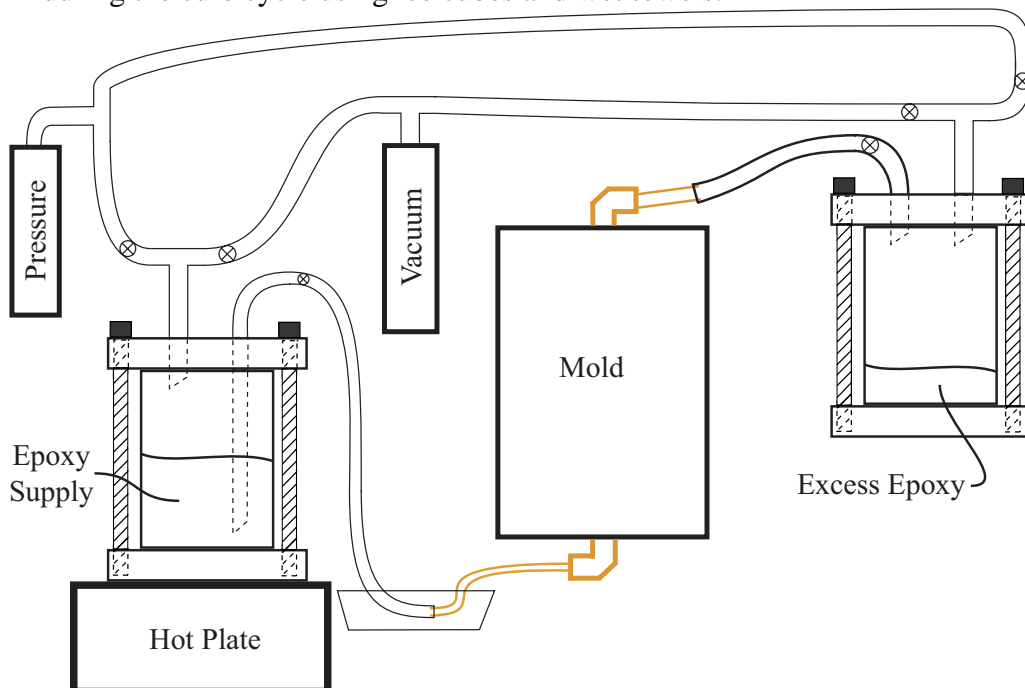
- Below is the vacuum pressure impregnation setup:  
All tubing was plastic except copper parts near the inlet and outlet, which are used to form a leak-tight seal. During the cure cycle the mold needs to be pressurized; however, the input and output tubes cannot simply be clamped shut since the change in temperature in the mold would change the pressure if it could not expand. The bottom piece of copper tubing is bent so it can sit in an ice bath (the Tygothane tubing cannot hold the pressure above ~80 C and the cure temperature is 135 C). The copper tubing on the output side is tilted up so air bubbles can escape during the impregnation; therefore, that copper tube needs to be cooled during the cure cycle using ice cubes and wet towels.

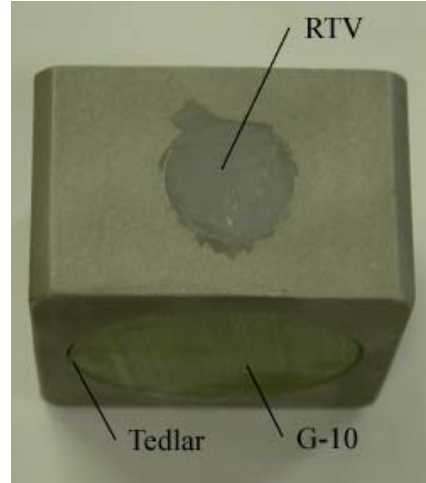
- a. The conduits were grit-blasted by hand using Rich Alum Oxide 100 grit at 110 psi. The conduits were then cleaned using ethanol and acetone.
- b. The G-10 fillers were wrapped in Tedlar around the curved circumference to allow for easy removal after impregnation.
- c. The G-10 fillers were inserted into the conduits and the threaded parts of the conduits were filled with RTV (let dry for 2-3 days).

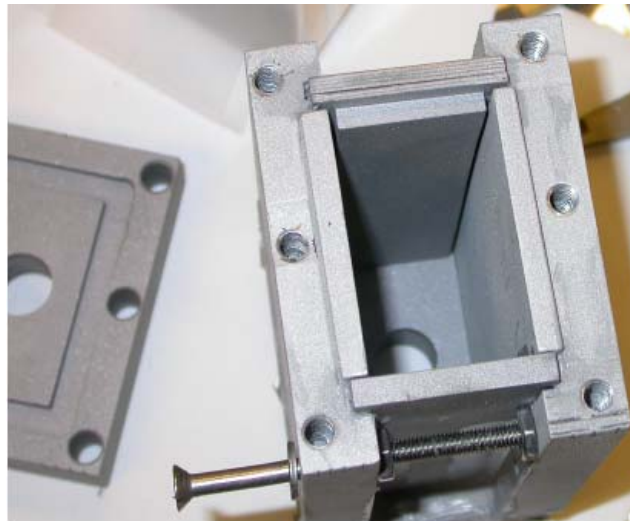
- a. The mold pieces were grit-blasted to help the RTV form a good seal.
- b. The pieces were cleaned with ethanol and acetone.
- c. A thin layer of RTV was applied to the grooves of the mold and left to dry for 24 hours.
- d. The next day another thin layer of RTV was applied on top of the dried layer. RTV was also applied to the flat parts near the grooves that would form a seal with other parts of the mold.
- e. The mold was assembled (except for the top piece).
- f. A healthy amount of RTV was spread in all corners of the mold from the outside (similar to caulking a sink) to cover all cracks.
- g. This was left to dry for 24 hours.

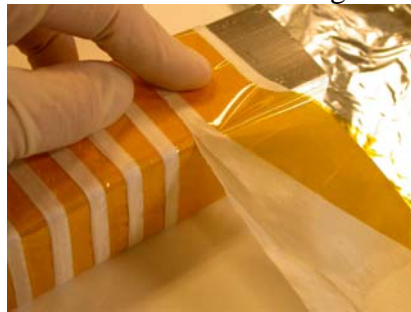
- a. It is difficult to begin a half lap on the sample itself, so two pieces that were the same dimensions were placed on either side of the two samples to be wrapped. The fiberglass and Kapton tapes were taped to one of the end pieces and the wrapping started there. Once the wrapping cleared the second sample, the Kapton glass was cut and taped to the other end piece. This process was repeated for a second lap.

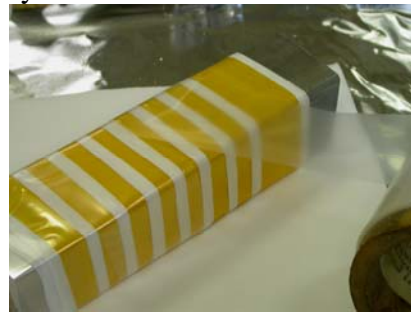
b

- b. The wrapped pieces were then wrapped in a layer of Tedlar and then in a layer of duct tape. The duct tape is used to keep pressure on the insulation so it won't unravel, and the Tedlar is used so nothing sticks to the insulation.

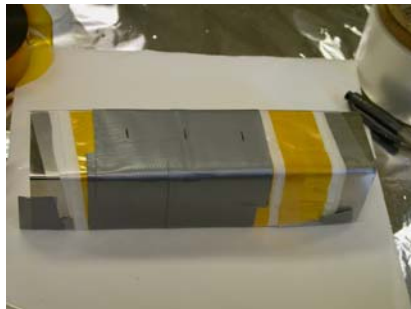
c

- c. In order to get the samples out, a razor blade is used to cut between the end pieces and samples. Slight pressure on the ends is helpful to keep the crack small where the razor blade is cutting and will help make a cleaner cut. Once the samples were cut out, scissors were used to clean up the edges.

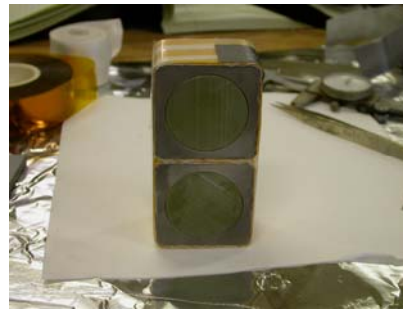
d

- d. The Tedlar and duct tape was cut off of one sample which was placed on another long piece of Tedlar with a pre-cut hole in it for the epoxy to come in through the bottom. The Tedlar and duct tape was then cut off of the other sample and it was placed on top of the first sample. The long piece of Tedlar was then wrapped around both pieces, keeping the insulation from unwinding.

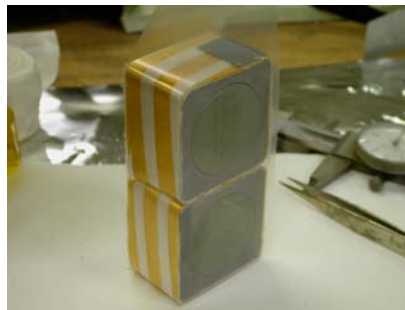
e

- e. A second long piece of Tedlar was then used to wrap the samples in the other direction, to avoid an epoxy bond between the sample and the walls. The better the sample is wrapped with Tedlar, the easier it will be to remove it from the mold after curing the epoxy.

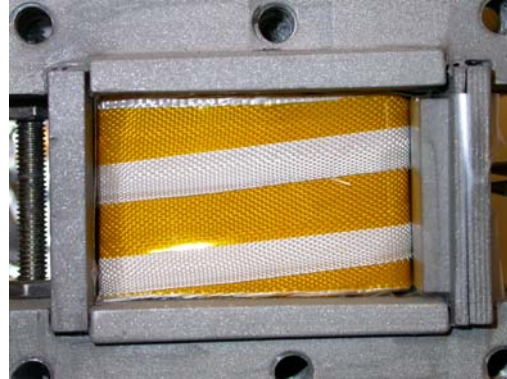
- a. The inside walls of the mold were sprayed with a Teflon spray to keep the epoxy from adhering to the mold.
- b. The samples (wrapped once in each direction with Tedlar) were inserted into the mold. They fit snugly, but if they didn't spacers would have been used to make the fit snug.
- c. A hole was cut in the top of the Tedlar for the epoxy to exit.

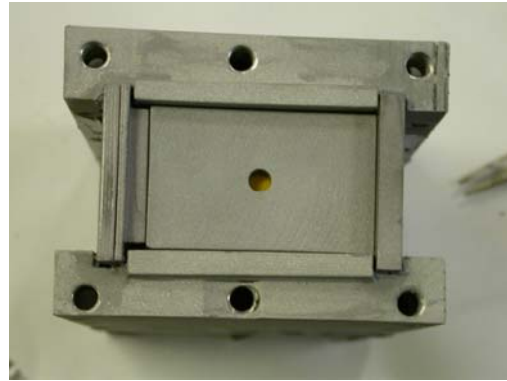
- d. A hole was cut in the top of the Tedlar and the hole in the top of the mold was inserted on the top, so that the vertical fit would be snug as well. (This was not sprayed with Teflon spray, but probably should have been since it is now epoxied to the top of the mold).

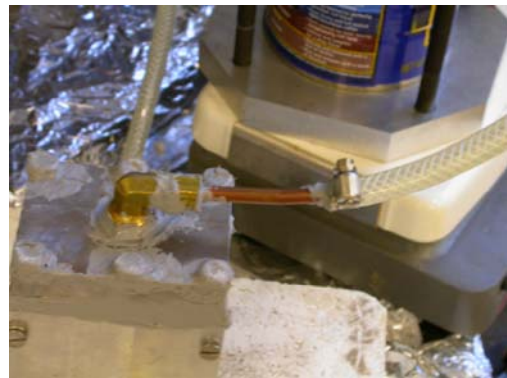
- e. A thin layer of RTV was applied to the groove in the top piece and the flat parts around that would bond to the mold.
- f. The top piece of the mold was bolted in place and the outside corners were covered in RTV to seal any cracks.
- g. The inlet and outlet pipe fittings were screwed into place and RTV was applied around the edges to seal off any cracks.
- h. This was left to dry for 3 days. (Should be left for more...maybe a week or two to make sure the RTV dries. There was still a little wet RTV when the mold was opened after the cure cycle).

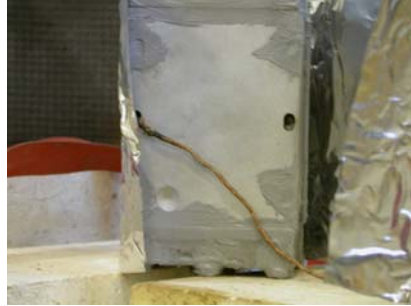
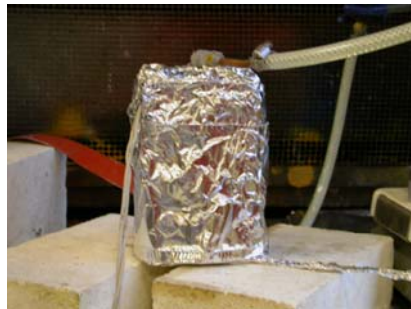
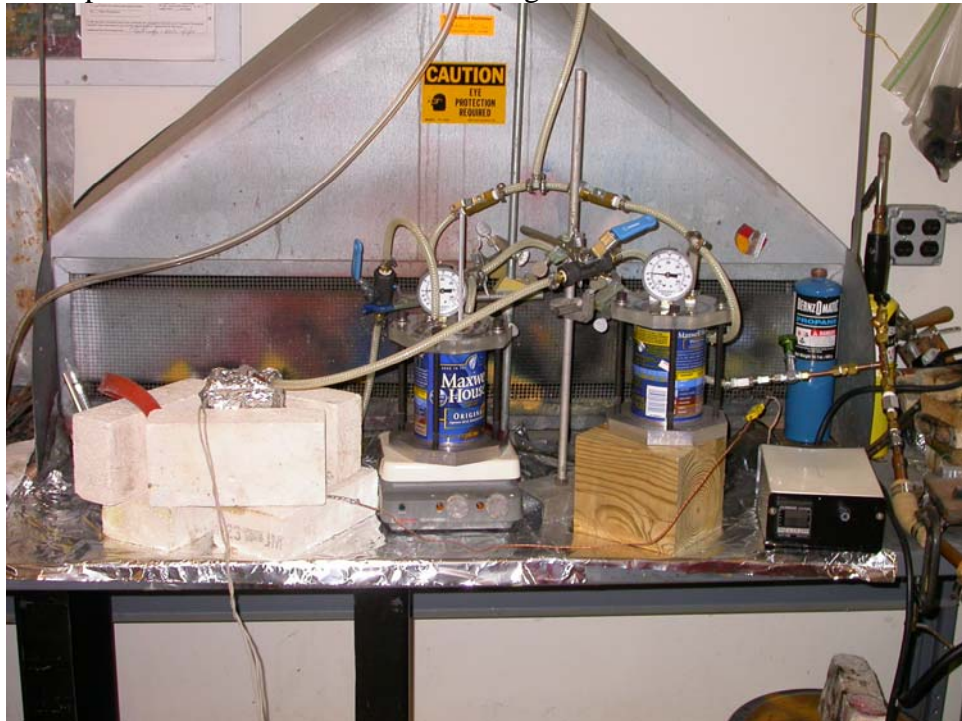
- c. The mold (with thermocouple on the wall) was first wrapped in a thin layer of Al foil to keep the heating tape from directly contacting the RTV.
- d. The heat tape was wound around the mold without overlapping so it wouldn't burn itself.

- e. More Al foil was wrapped around the heating tape and mold to keep as much heat in as possible.
- f. The mold was placed inside an "oven" of fire-bricks to keep as much of the heat in as possible. (A cardboard box was also mounted around the mold in case of epoxy leak during the pressure cycles or curing cycle).

- g. Once this is set up, the thermostat was turned on to 60 C so the mold would heat up and the heat would diffuse throughout the mold and insulation.

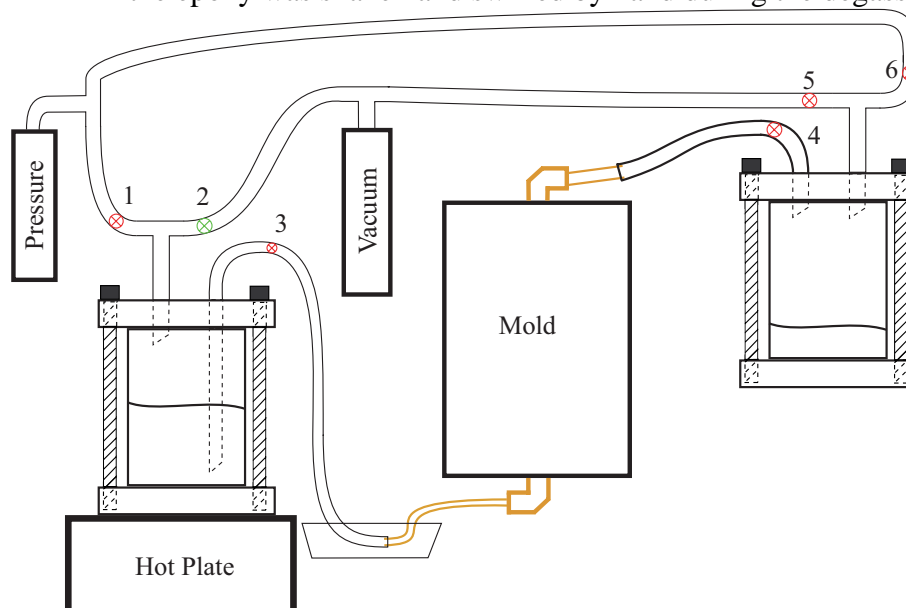
- a. According to CTD, the epoxy should be heated and stirred until it becomes a clear solution at 40-60 C. A standard thermometer was used to measure the epoxy temperature during this process.
  - i. The coffee can bottom sits on a rim of the can, so there was not good thermal conduction between the hotplate and can and it took 1.5 hours to heat the epoxy from room temperature to 55 C. (next time make that a better conduction path.)
- b. Valve 2 was opened and the epoxy was degassed at ~55 C and ~27 in Hg for about 50 min (CTD specs say 20-40 min or until bubbles stop evolving).
  - i. Since the stirrer was not mechanically stirring the epoxy, the can with the epoxy was shaken and swirled by hand during the degassing.

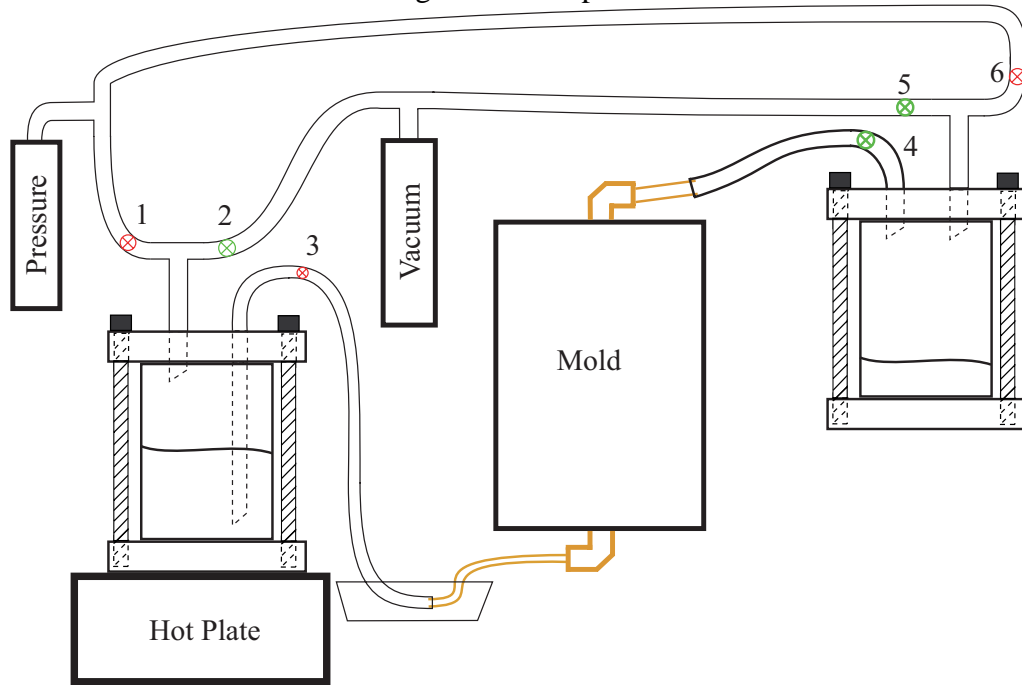
- a. For the last 10 minutes of the degassing, valves 4 and 5 were opened to get the mold and the rest of the tubing to vacuum pressure.

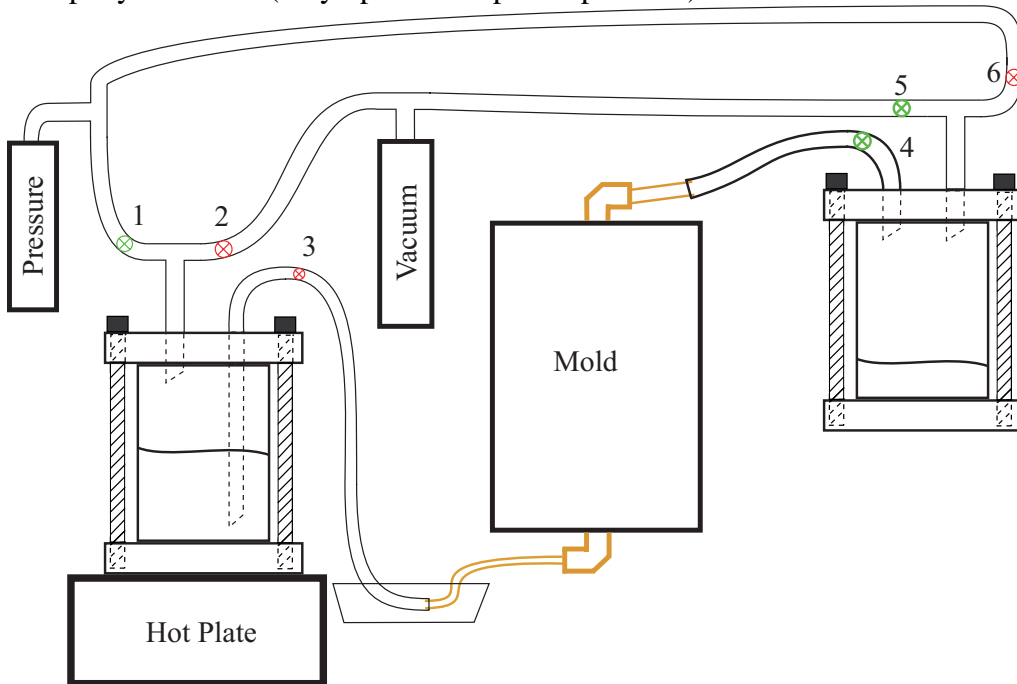
- b. Valve 2 was closed and then valve 1 was opened to allow nitrogen to fill the epoxy container (only up to atmospheric pressure).

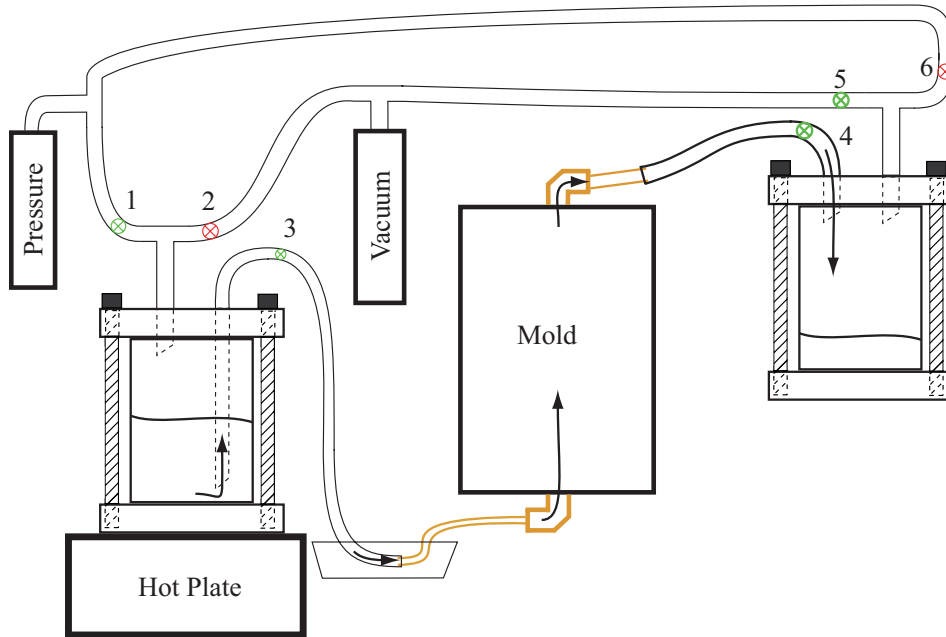
- c. With the mold at vacuum and the primary epoxy container at atmospheric pressure, valve 3 was opened and the epoxy began to flow through the tubing and into the mold.

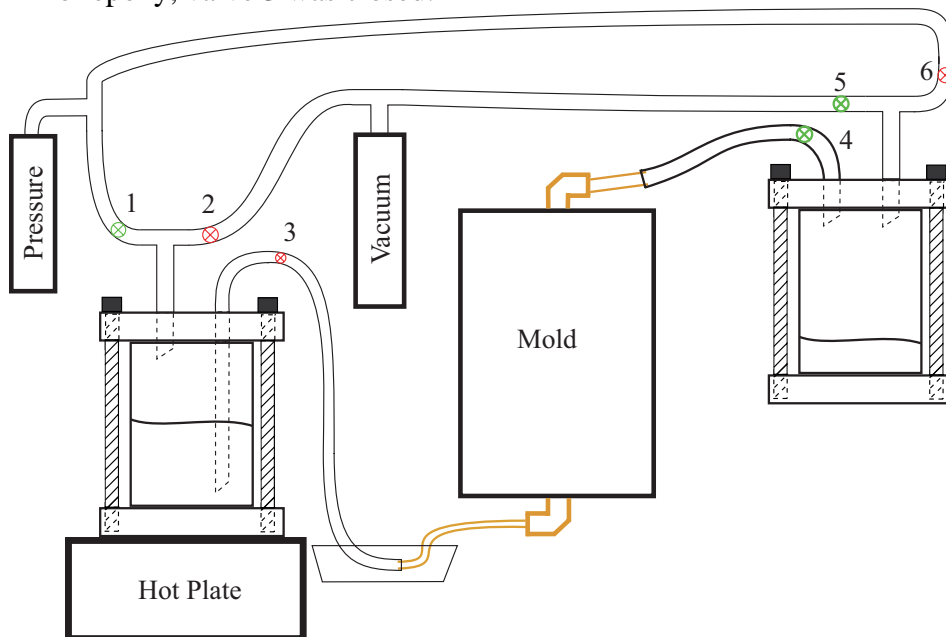
- d. After about a minute epoxy could be seen entering the secondary epoxy container. (Should take more time...maybe only open valve 3 a little so epoxy seeps up through mold slower).
- e. Some bubbles were seen in tubing, so the valves were left open for about 1 minute until the bubbles in the tubing became less frequent. To stop the flow of epoxy, valve 3 was closed.

f. The vacuum pressure in the secondary container continued to pull some epoxy through for a few seconds after valve 3 was closed.

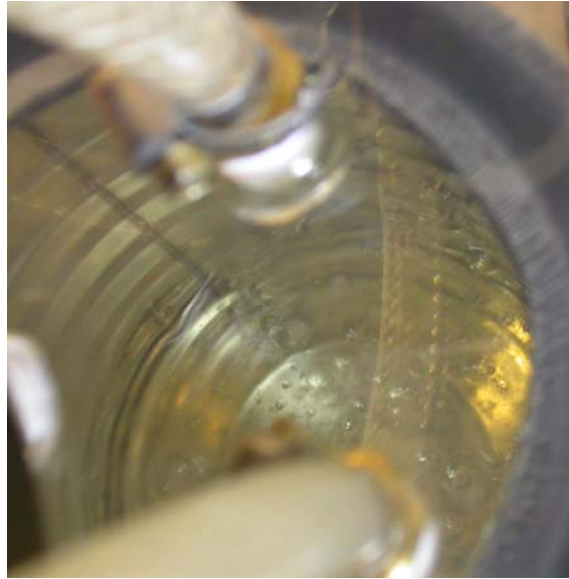
- i. The secondary epoxy container was not heated, but we saw the epoxy “boiling” in it. The can was not hot, and the epoxy was not above 60 C. Possibly the epoxy picked up bubbles while moving through the insulation, and also while entering the secondary container. (It was not a laminar flow out of the tubing...the epoxy would form bubble drops at the end of the tubing and then fall into the can. Similar to squeezing honey out of a bottle that is running out of honey. The bubbles were being pulled out through the tubing and forming bubbles before falling into the container.)

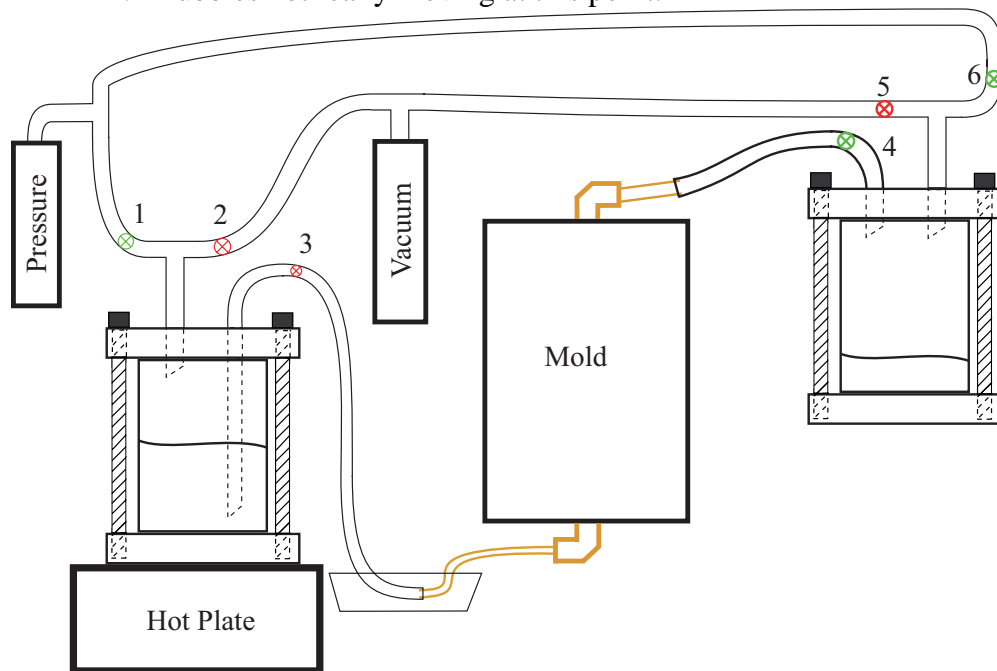
- g. When the epoxy stopped flowing into the container, bubbles continued moving up the tubing (which was at an upward angle so the bubbles would rise out away from the mold).
- h. After ~15 min with the vacuum pulling, valve 5 was closed and 6 opened with the pressure set to ~14 psi.
  - i. Bubbles not really moving at this point.

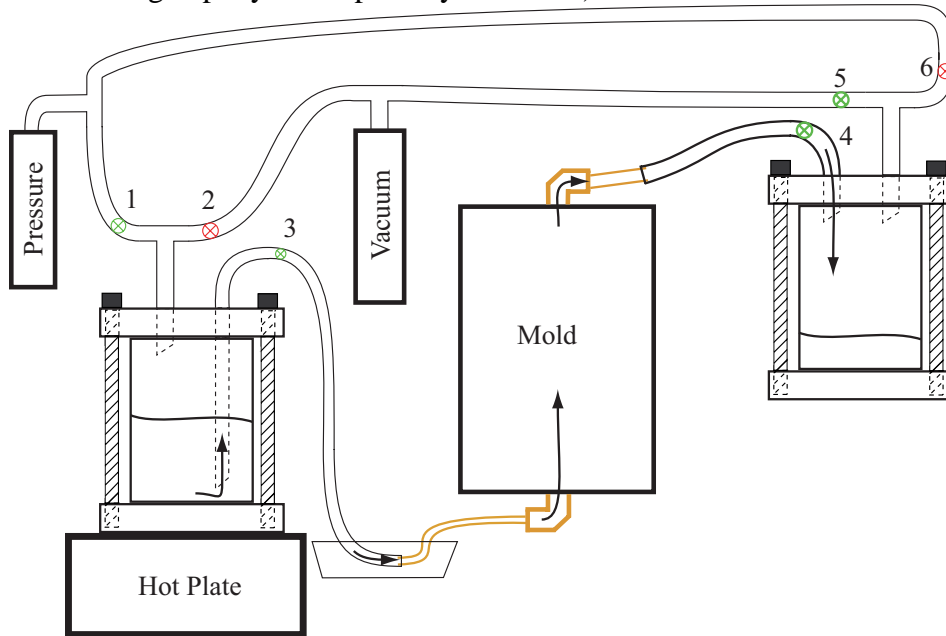
- i. After ~5 min, the valves were switched back to pull vacuum on the secondary epoxy container. (Valve 6 closed, and valve 5 opened).
- j. Valve 3 was also opened again to push more epoxy through (make sure there is enough epoxy in the primary container).

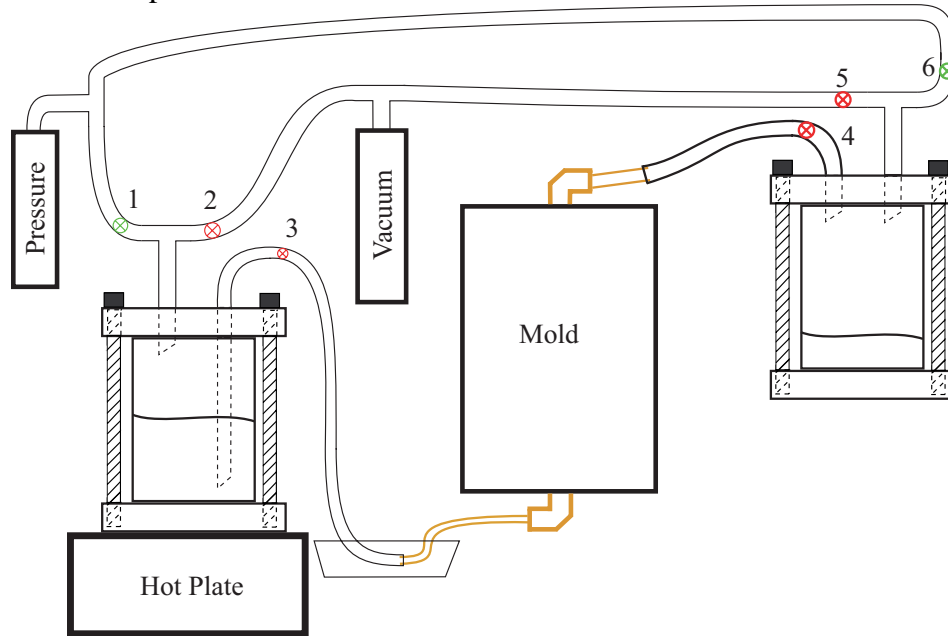
- a. All valves were closed.
- b. Valves 1 and 6 were opened to bring the pressure in both epoxy containers up to ~10 psi.

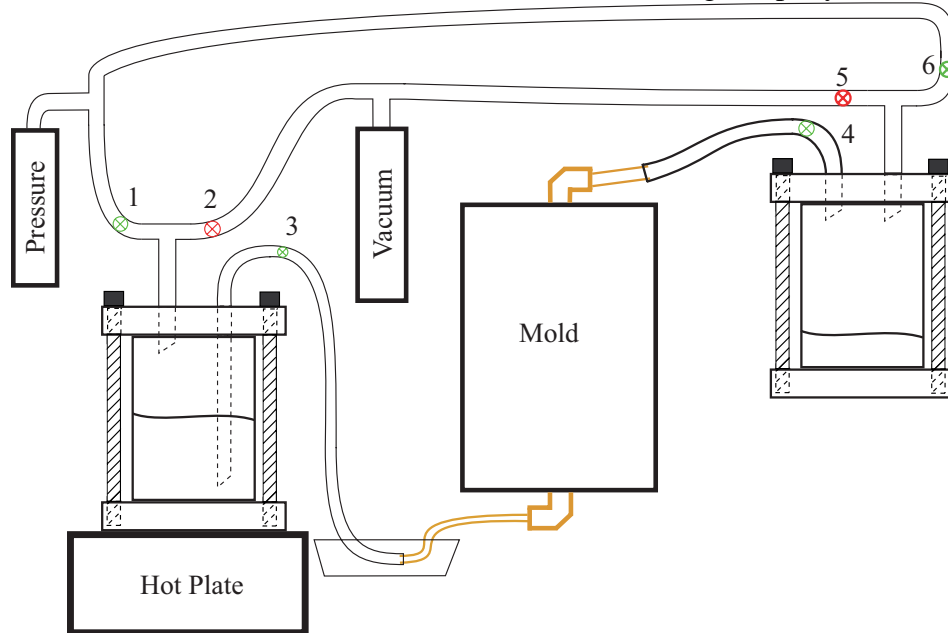
- c. Once both epoxy containers were at 10 psi, valves 3 and 4 were opened to put that pressure on the mold.
- d. The pressure was carefully increased up to 30 psi (to make any remaining bubbles in the mold as small as possible).
  - i. Checked to make sure there was not leaking of epoxy or air.

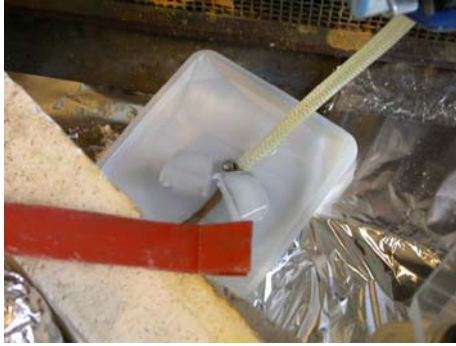
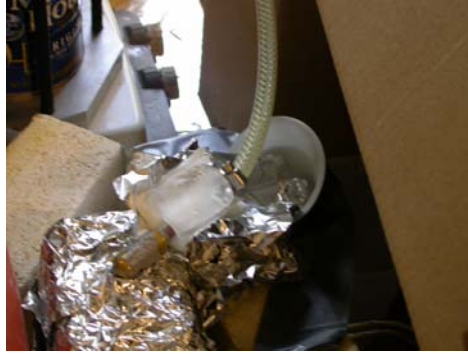
- e. Thermostat for heat tape was increased to 135 C.
- f. Tygothane tubing is only good up to 80 C and other side of copper tubing needs to be at 135 C, so ice water is used to keep the copper/Tygothane connection at less than 80 C.
  - i. Dish with input copper tubing connection was filled with ice water.
  - ii. Ice cube and wet towels placed on copper tubing on top of mold.
    - 1. Made foil funnel system to keep water off mold.

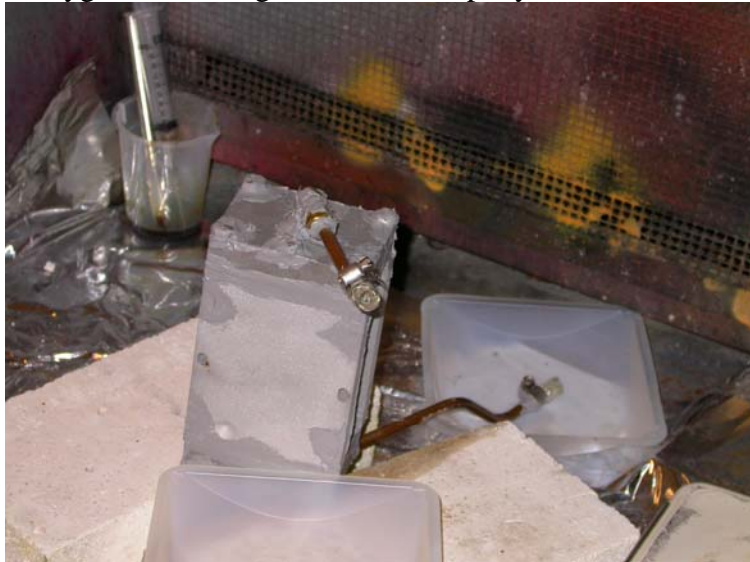
- a. After 1.5 hours at 135 C the Al foil and heat tape was removed.
- b. Vacuum pressure was applied to both ends of the mold.
- c. The Tygothane tubing was cut near the copper tubing.
  - i. Dishes were placed under the position where the cuts were made.
  - ii. The vacuum pulled all of the remaining uncured epoxy left in the Tygothane tubing back into the epoxy containers.

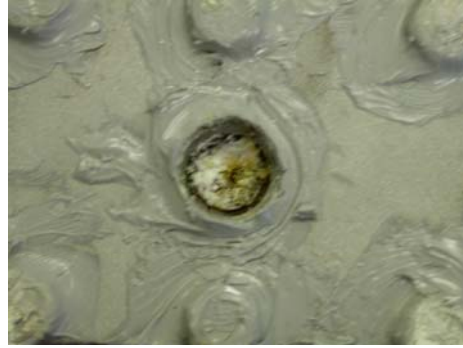
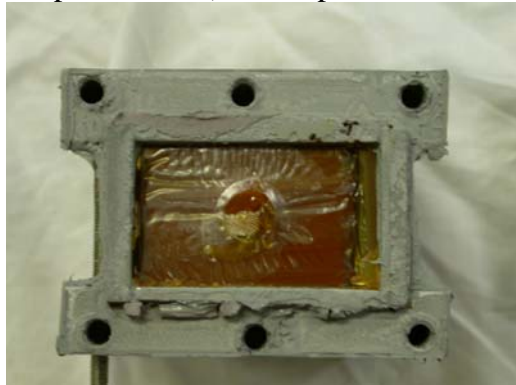
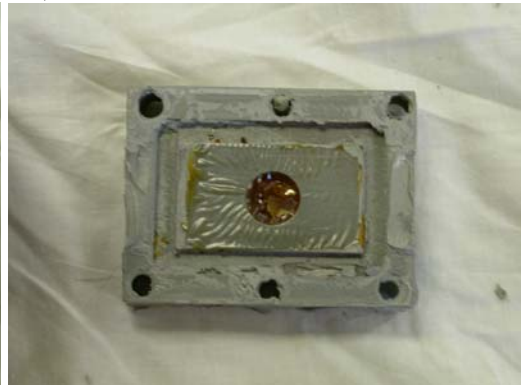
1. Visually checked to make sure that no epoxy leaks were seen.
2. Unscrewed the brass inlet and outlet elbows from the top and bottom
  - a. Took some force. The epoxy had cured from the layers of insulation, through the brass elbows, and into the copper tubing, so unscrewing these pieces broke epoxy.
3. Removed the RTV from the bolts enough to be able to use a wrench on them, and then removed all bolts.
4. The RTV is strong enough that the top and bottom cannot be pried off, so a vice had to be used. (Also epoxy filled and cured from the insulation to the threading for the top and bottom elbows, so the top and bottom pieces of the mold cannot be removed without breaking that epoxy too).
  - a. The vice was positioned on the inside of the top and bottom pieces of the mold and slowly cranked open until either the top or bottom piece could be pulled off. (Bottom piece shown below):

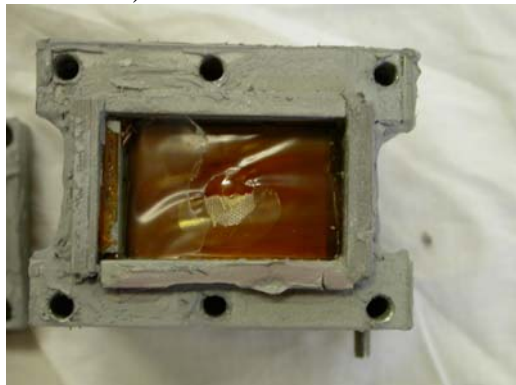
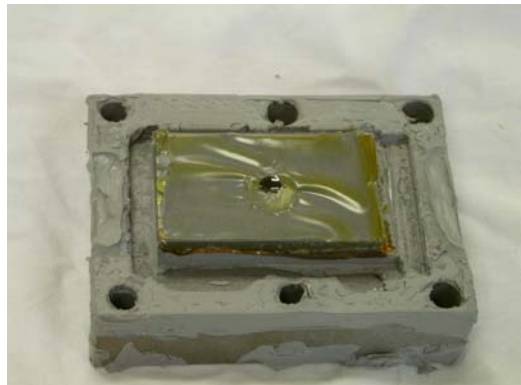
- b. A bolt was then inserted in the side holes and the vice was positioned between the bolt and the remaining top or bottom piece. The vice was cranked open until that piece could be pulled off as well. (Top piece with spacer shown below):

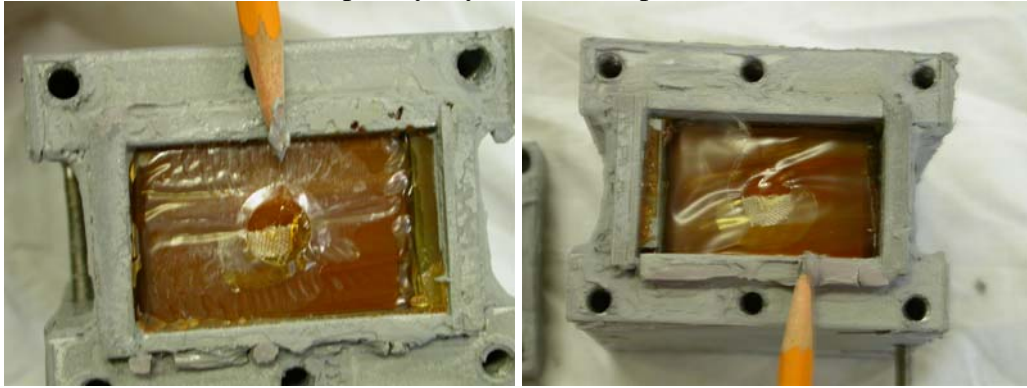
c. The RTV was not completely dry when these pieces were removed:

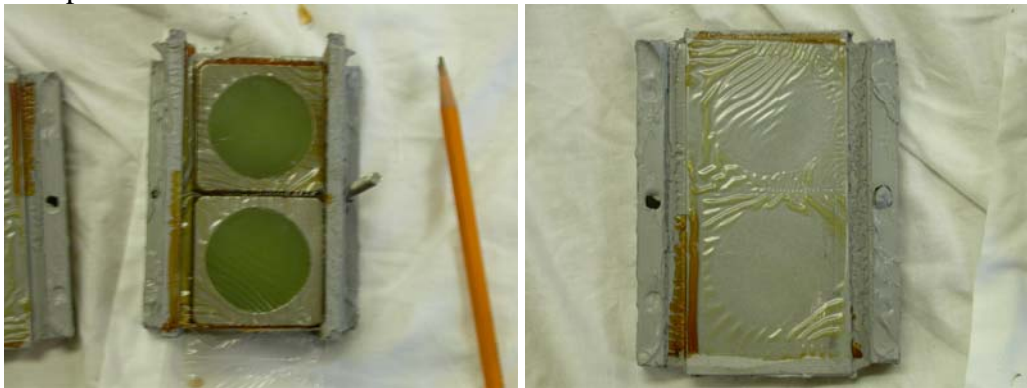
5. The vice was used to separate one of the sides from the mold.
- The space available between the side pieces was not enough to get the vice tips in, so 2 bolts were screwed back into each side and these were far enough apart that the vice would fit between them.

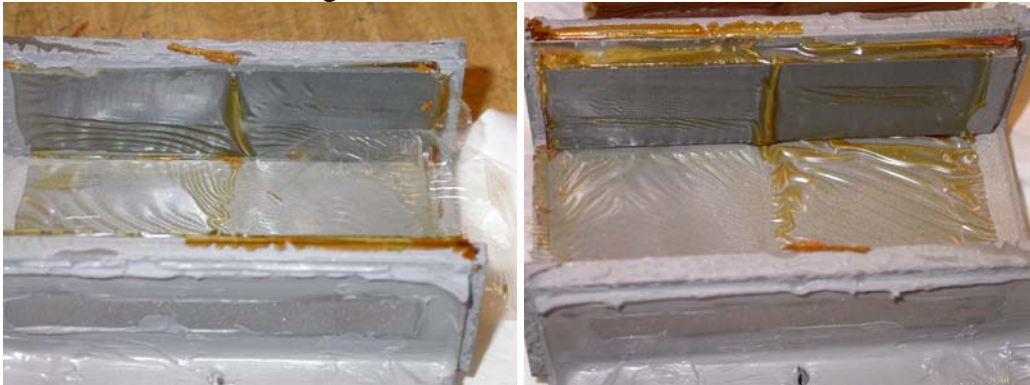
6. The Tedlar and Silicone spray did a very good job keeping the epoxy from bonding to the mold. The other side piece did not have to be separated. The samples were easily lifted out of the remaining mold without much force.

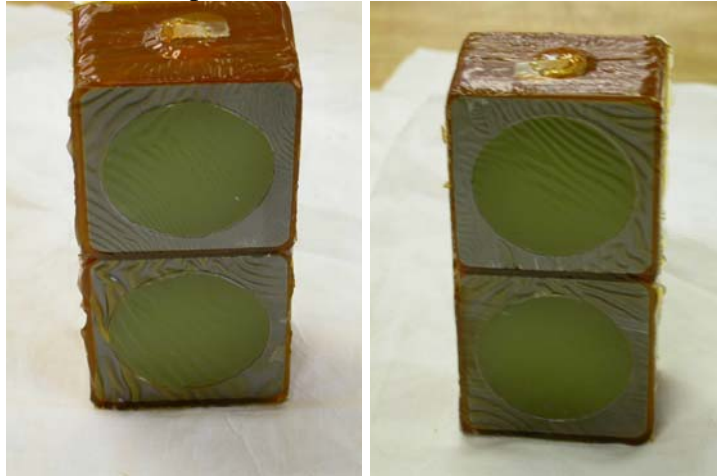
7. General pictures of the sample were taken:

8. During the removal of the sample from the mold there were a few areas where the epoxy/insulation broke.

- b. There was one region on the side where the epoxy seeped between the Tedlar sheets and attached to the mold (top right of first picture). When the side was pried off using the vice, this also caused some delamination in one area of the side of the sample.

c. The sample was looked over for bubbles, and only one was found.

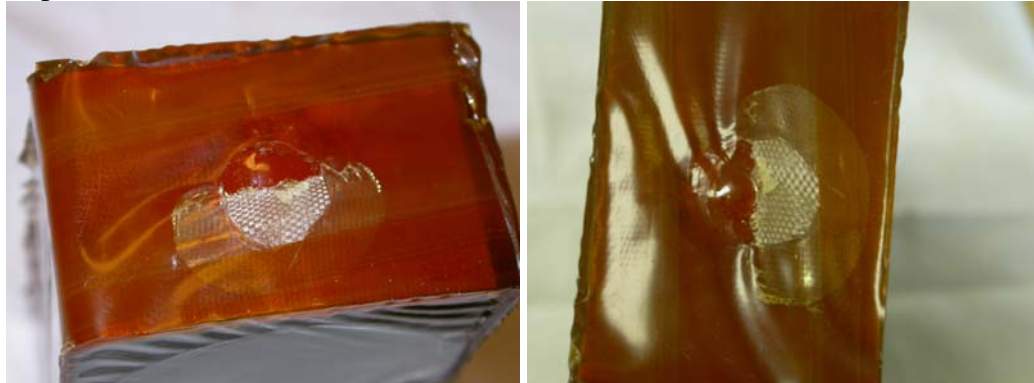
Top:

- a. At the top and bottom, the epoxy cured in the insulation had to be broken from the epoxy cured in the entering and exiting elbows.
  - i. This was done when the top and bottom pieces were pried off.

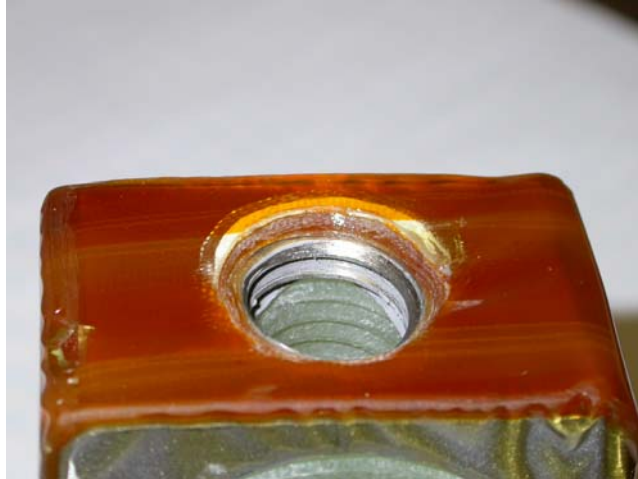
- ii. It was not clear at this time how deep these delaminations went (if they delaminated between the insulation and the jacket, or if they delaminated between layers of insulation). After dremmeling out the threaded holes, it was clear that these delaminations were between layers of insulation.

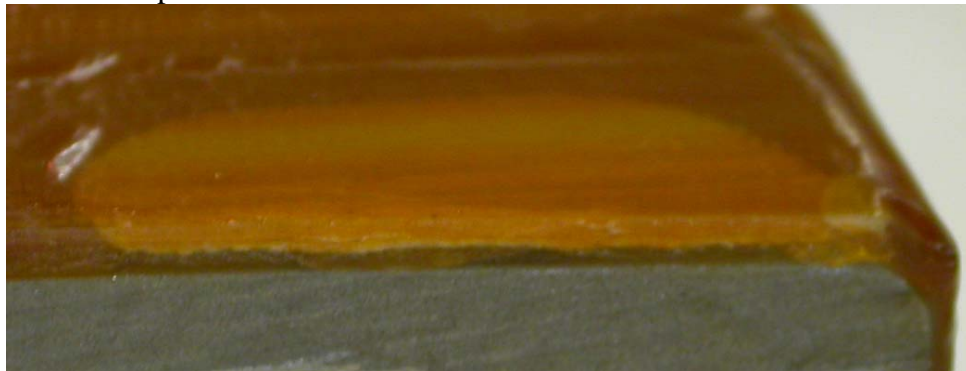
- i. Similar to the delaminations on the top and bottom of the sample, it was not clear how deep the delamination went. After smoothing down the sides with a file, it was clear that the delamination was again between the insulation layers, not between the insulation and the sample.

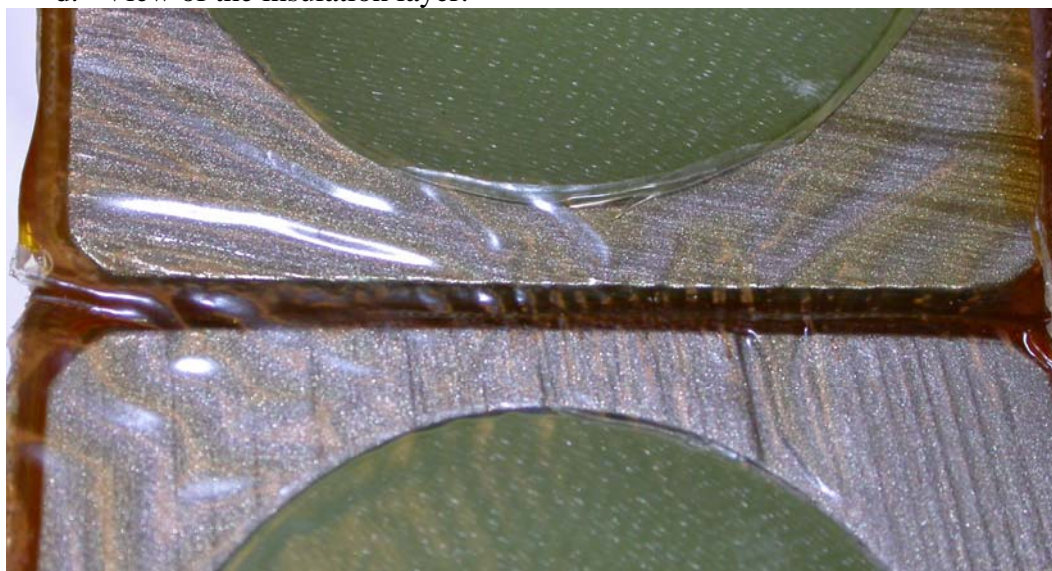
d. View of the insulation layer:

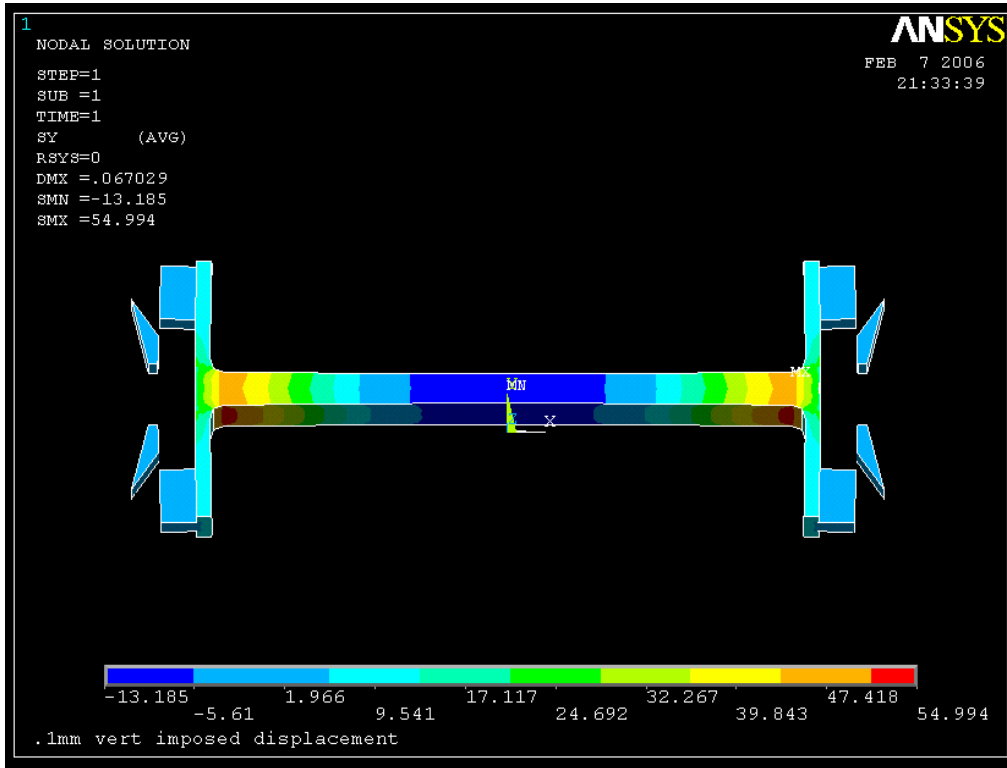
Under the same load, the expected vertical stresses (MPa) in the insulation are shown below:

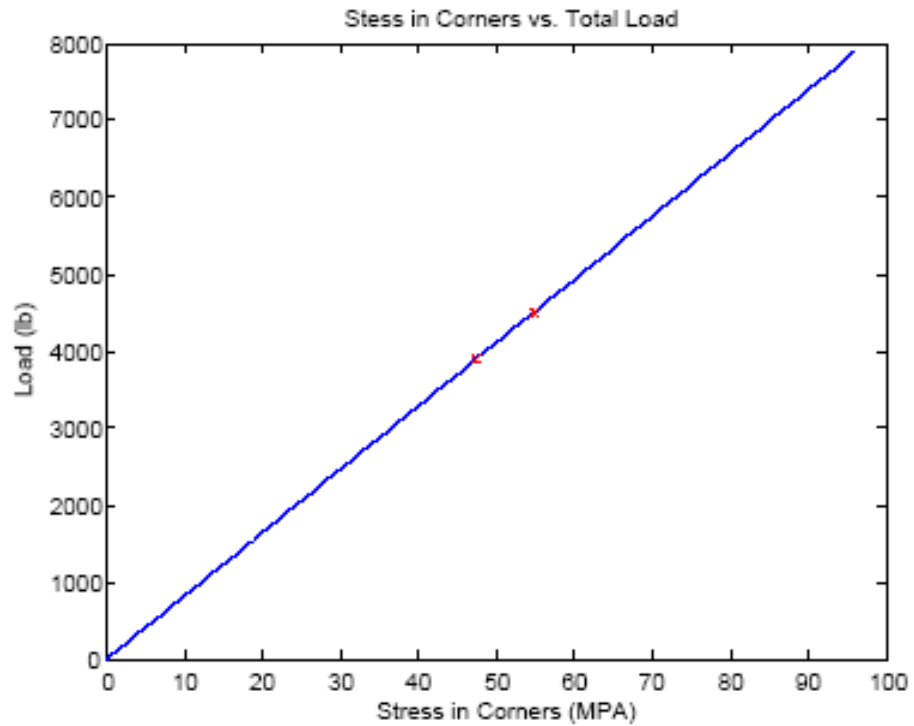
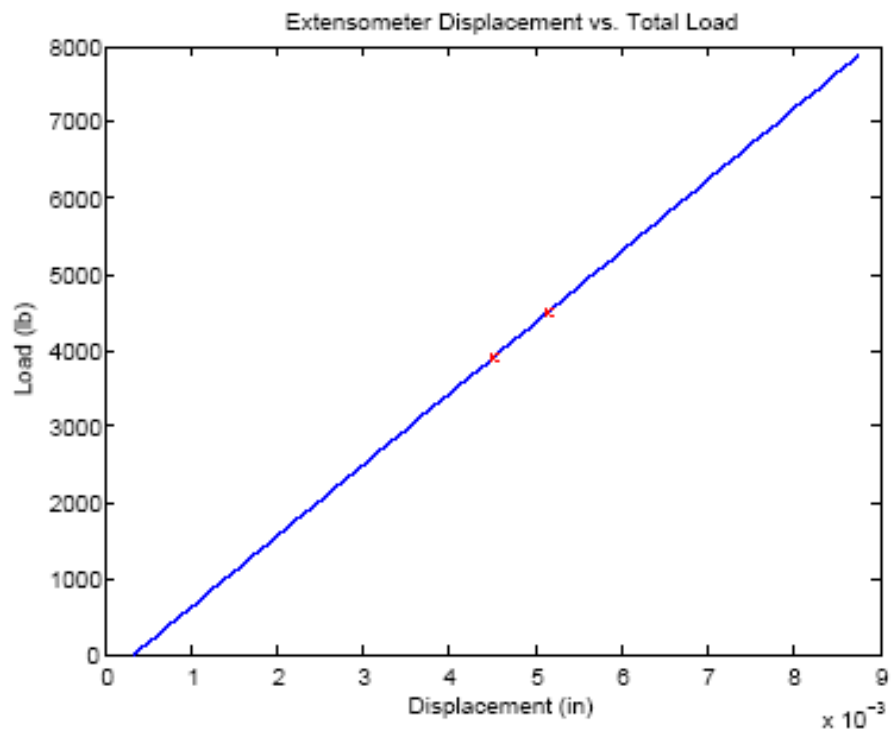
Using two sets of data from two different loads, (17367 N and 20067 N), calibration curves were generated to show estimates of the expected vertical stress in the corner and displacement of the extensometer versus the applied load as shown below.

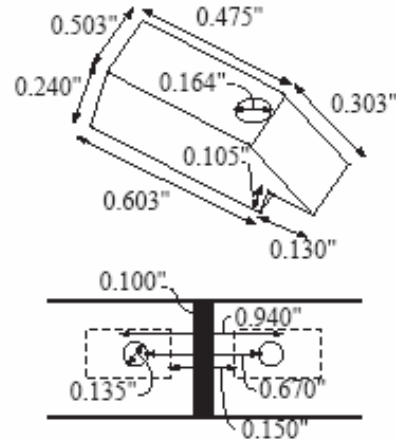
1. G-10 mounts were made to hold the extensometer on the sample. The G-10 was mounted onto the jacket, near the insulation layer between the two samples via tapped holes and bolts (see figure below).

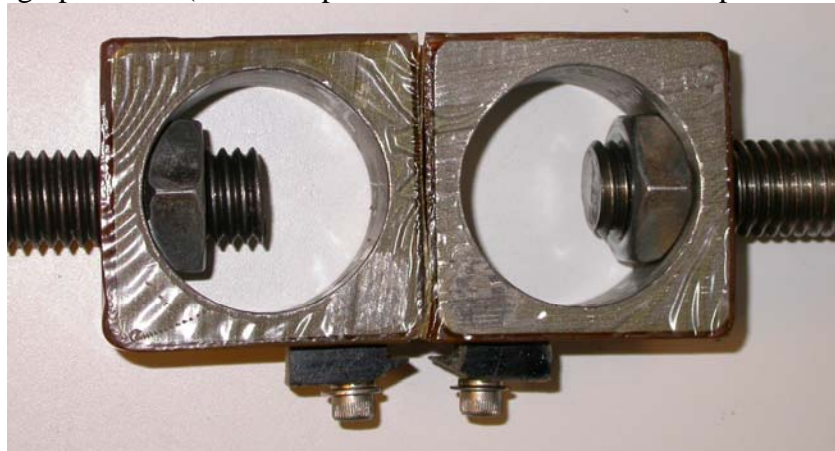
3. Our solution was to drill out the threaded part of the sample and have two nuts machined with the curvature of the inside of the sample to hold the sample as seen in the photograph below (note: this picture was taken after the sample was broken).

- a. In order to have the tapped holes aligned perfectly for the tensile test, there are a few options:
  - i. Don't tap the holes in the jacket. Leave a through hole and use nuts that have been radiused to match the shape inside.

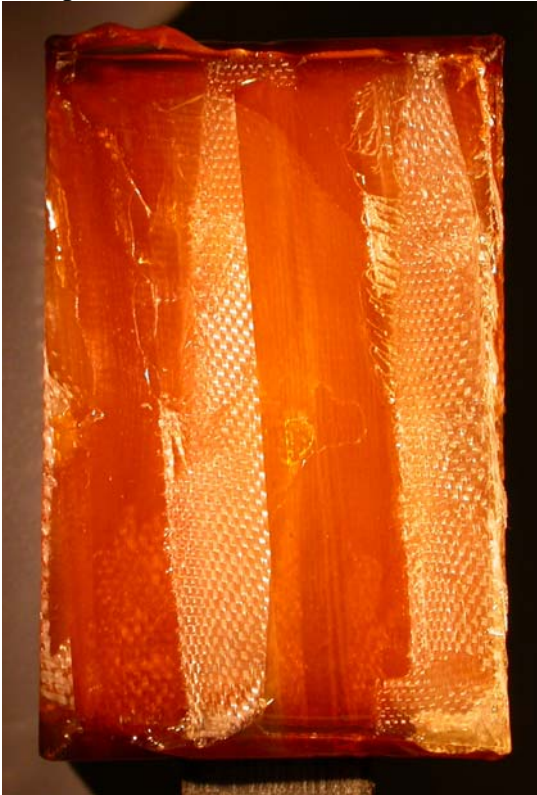
One piece:

4. The sample was loaded into the Instron and the calibrated extensometer was attached to the clips.
5. The plan was to load the sample with about 100 pounds of force at room temperature to see the extensometer response before cooling to liquid nitrogen.
6. When the sample was being loaded it broke at approximately 60 pounds of force.
  - a. This was only a fraction of the expected 4354 pounds.
7. The sample was removed from the Instron and examined.
