PSFC/RR-06-1

## **Desktop Vacuum Pressure Impregnation Experiment for ITER Insulation Testing**

Mahar S., Titus P., Gung C., Hooker M., Minervini J.,  
Schultz J., Stahle P., Takayasu M.

April 2006

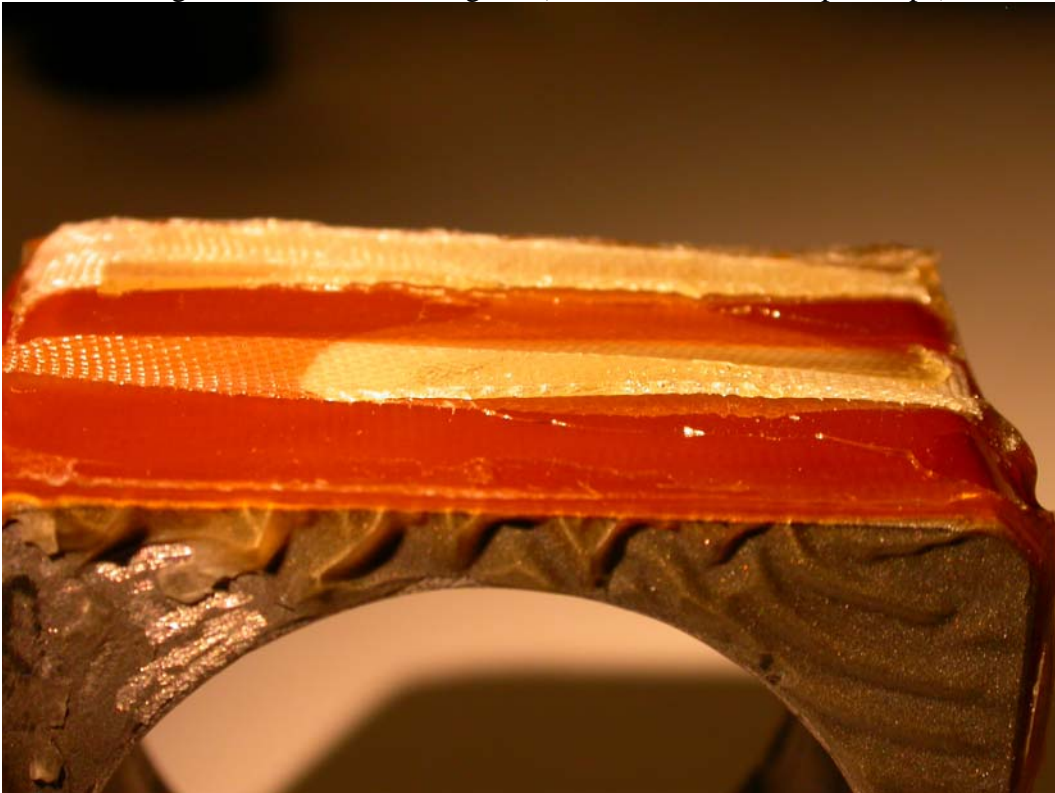
View showing delamination of fiberglass (with reflection on Kapton tape):

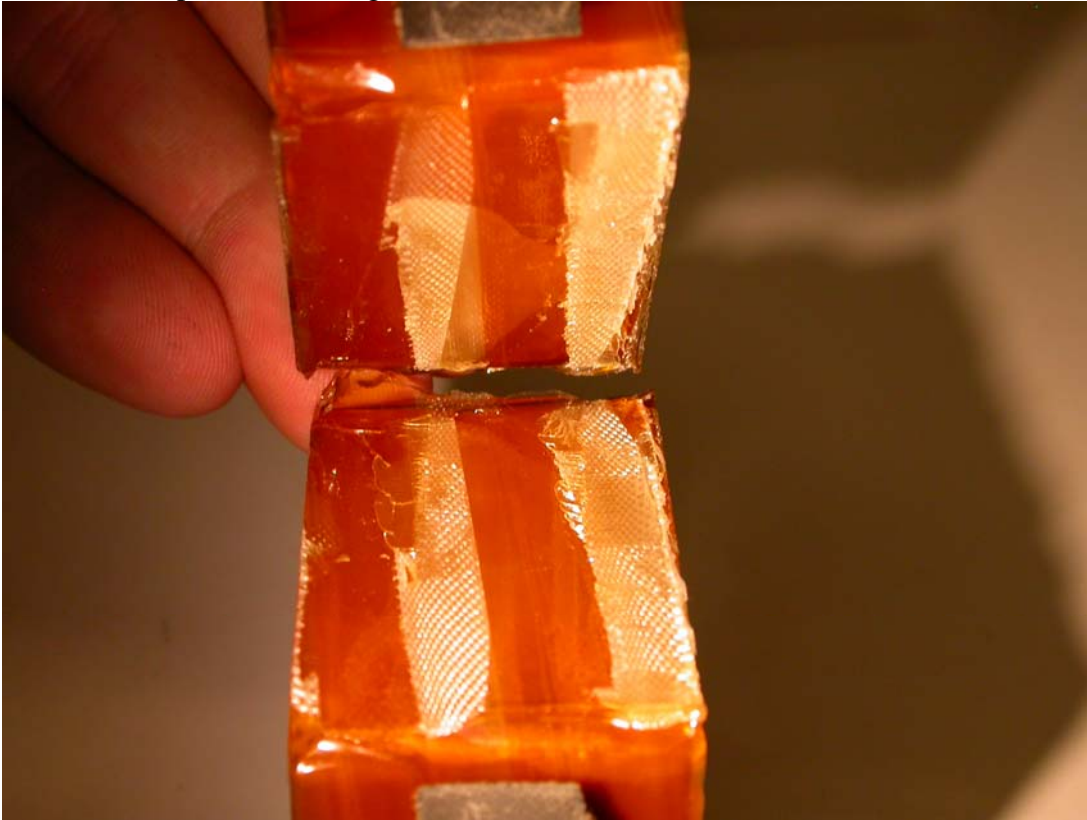
View of how pieces were aligned (cross-hatched):

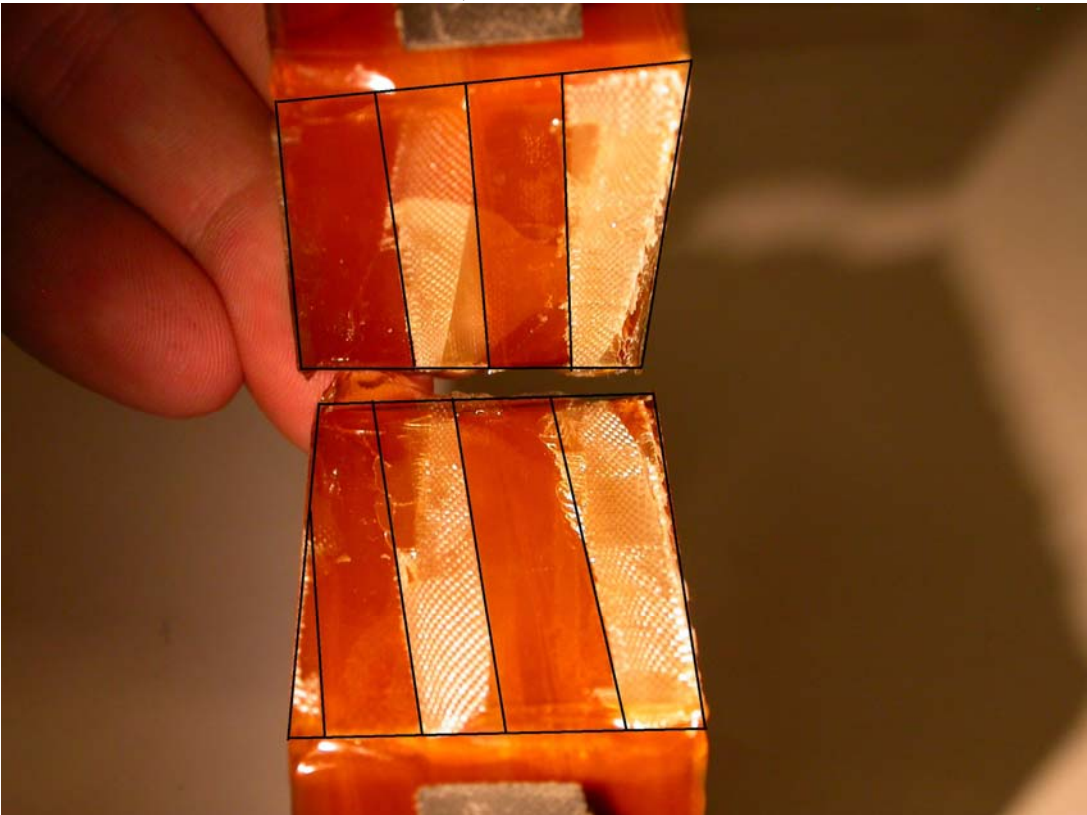
Drawn in lines...when folded down, the lines cross-hatch each other.

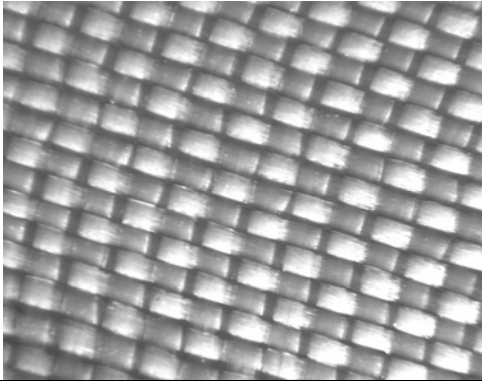
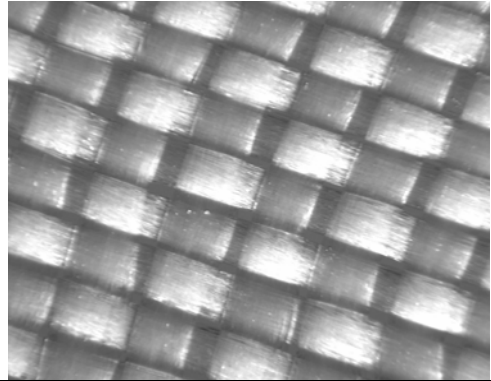
<b>Clean Fiberglass</b>	
<b>Magnified (# 41)</b>	<b>Higher Magnification (# 42)</b>

The samples were viewed under a microscope to determine if the epoxy had impregnated the fiberglass, and it was concluded that the epoxy did impregnate the fiberglass (see Appendix B for an index of where each photo number is located on the sample).

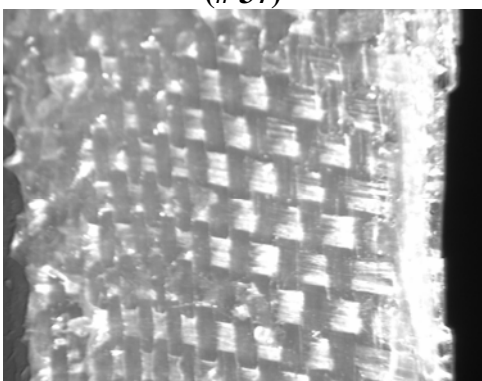
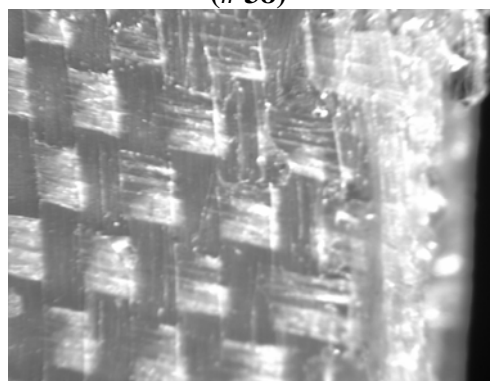
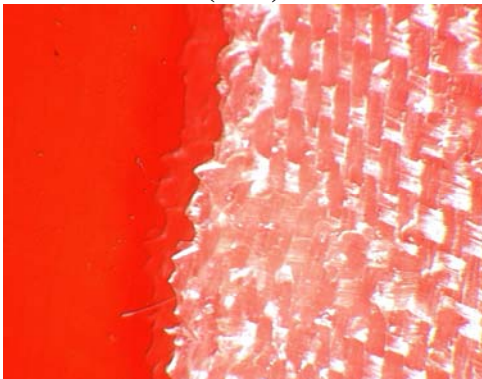
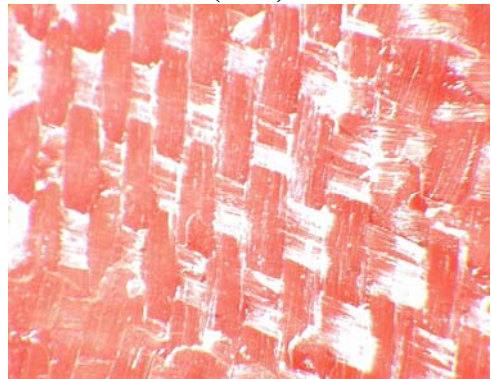
<b>Impregnated Fiberglass on Sample</b>	
<b>Magnified (# 37)</b>	<b>Higher Magnification (# 38)</b>

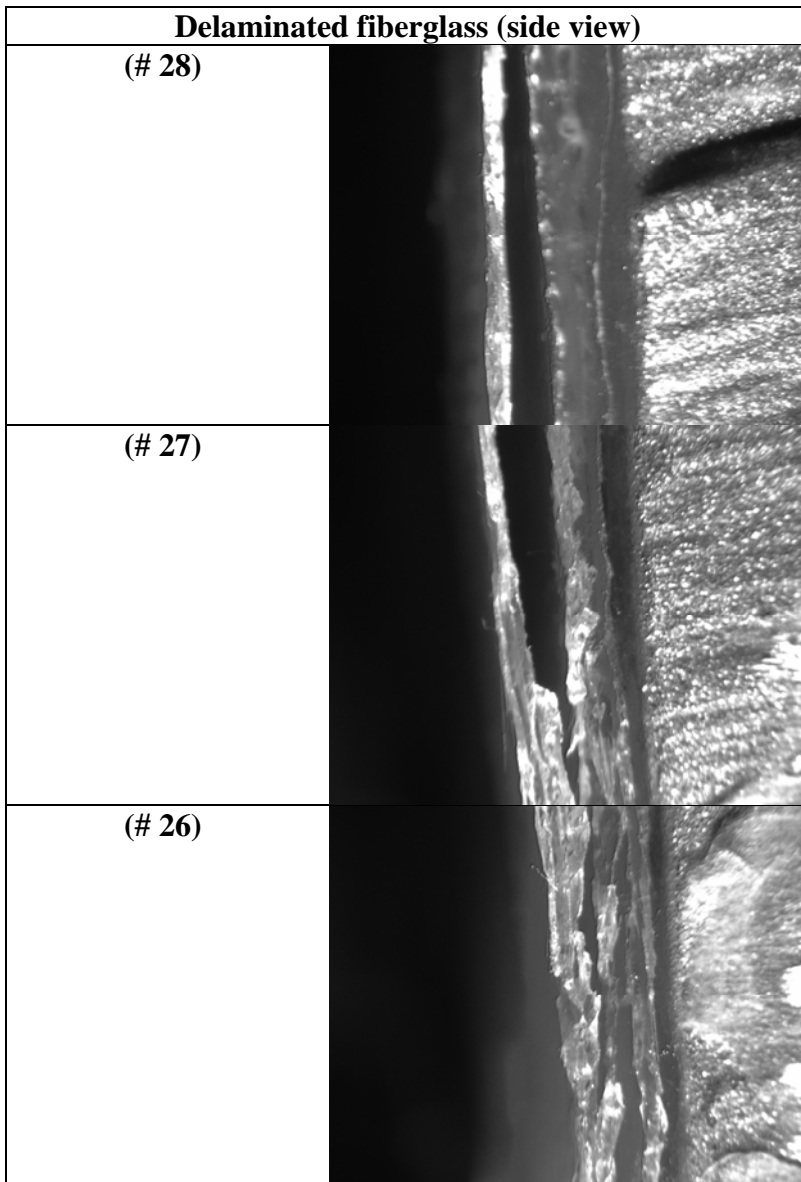
The break occurred between the two initial samples and was relatively clean. However, there was one piece of fiberglass that was originally on the bottom sample that broke and ended up epoxied to the top sample. This piece of fiberglass is seen from the side view in photos # 26 and # 27. The fiberglass delaminated from both samples, but it was still attached near the corners of the sample that it was not originally wrapped around. Other than this piece, the insulation remained wrapped around the sample it was originally wrapped around.

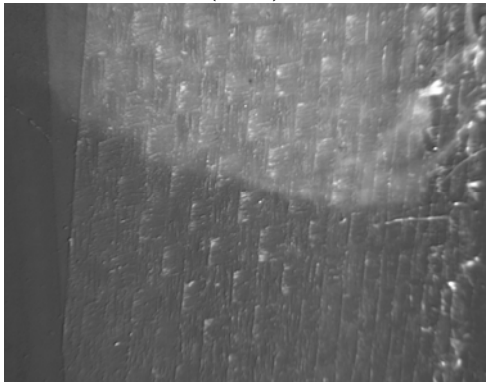
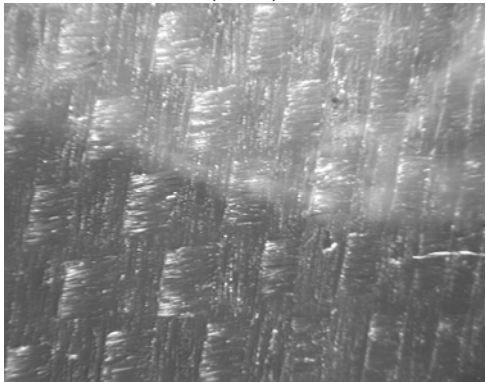
There was a noticeable region of delamination in the middle of one of the samples, and part of this region is shown in photos # 39 and # 40. The delamination was under the shown layer of fiberglass, most likely at the fiberglass-Kapton plane.

<b>Region of central delamination</b>	
<b>Magnified</b>	<b>Higher Magnification</b>
(# 39)	(# 40)

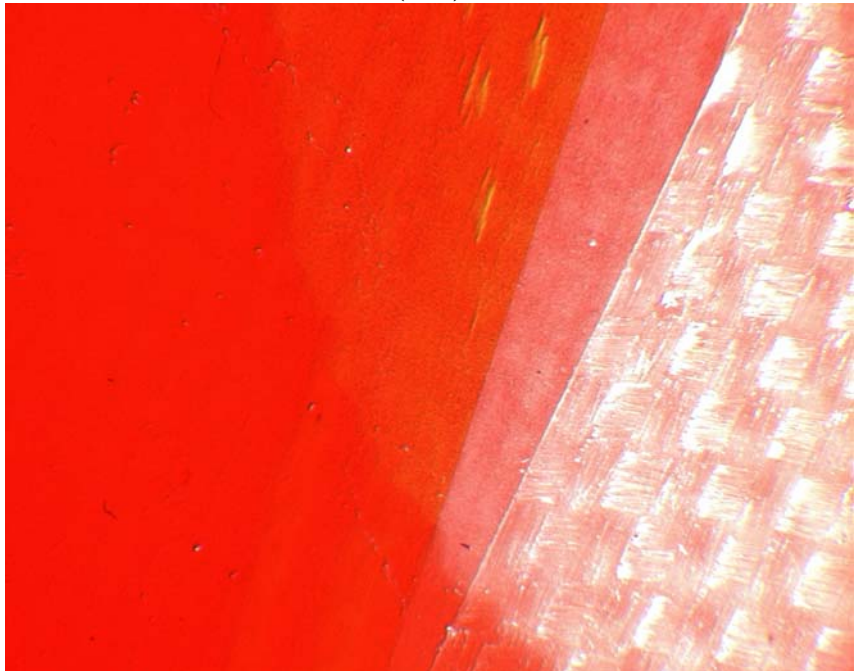
Photo # 43 shows a zoomed in view in color of the top left portion of photo # 39. This region is very interesting, since there are three distinct textures visible. The solid red-orange on the left is Kapton tape. The lighter red-orange strip near the middle is a layer of epoxy on top of the fiberglass. This is flat because the Kapton tape that was there peeled away and is still attached to the other sample (This is a good example of the breaking plane that Kapton provides). The right side of the photo is impregnated fiberglass. The interesting part is that the middle strip is very smooth, which shows that the epoxy and Kapton tape form a very good breaking plane.

<b>Region of delamination showing Kapton surfaces</b>	
(#43)

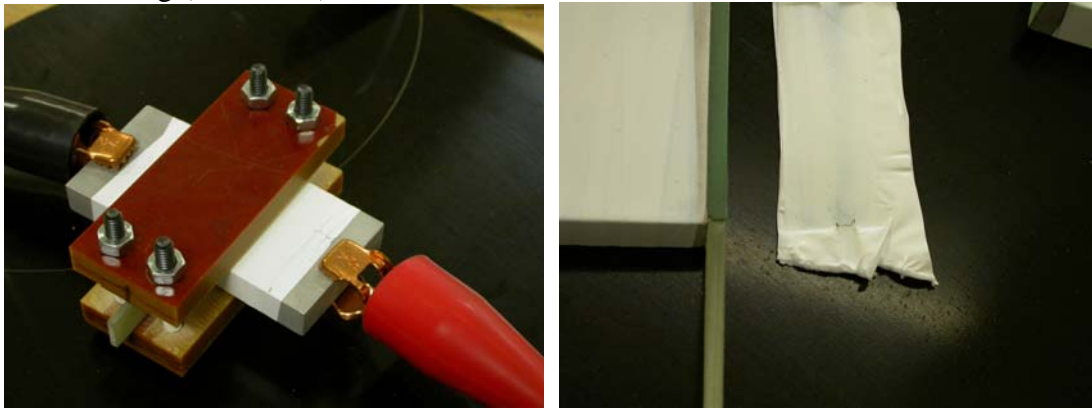
Using a model of the sample, several attempts were made to try to eliminate this arcing path, such as taping the corners of the sample with electrical and/or Kapton tape, clamping down Teflon and/or rubber to try to block the arc path. These methods did help to increase the voltage before an arc occurred, but only up to a maximum of ~10 kV before arcing (see below).

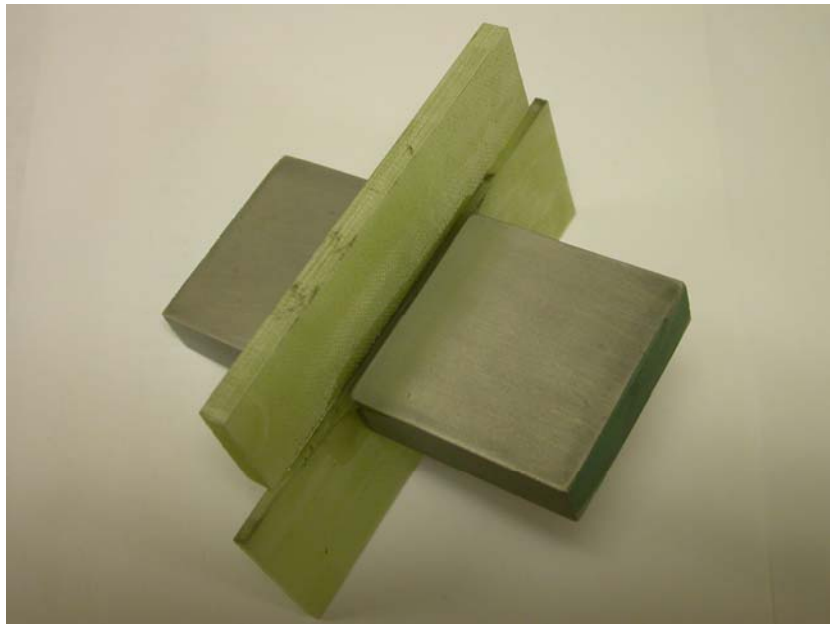
The only method that was able to hold a voltage of 21 kV (it held up to over 25kV without arcing) was to epoxy a piece of G-10 to one of the samples. This way, the path required for an arc from face-to-face of the samples was increased to over an inch (see below).

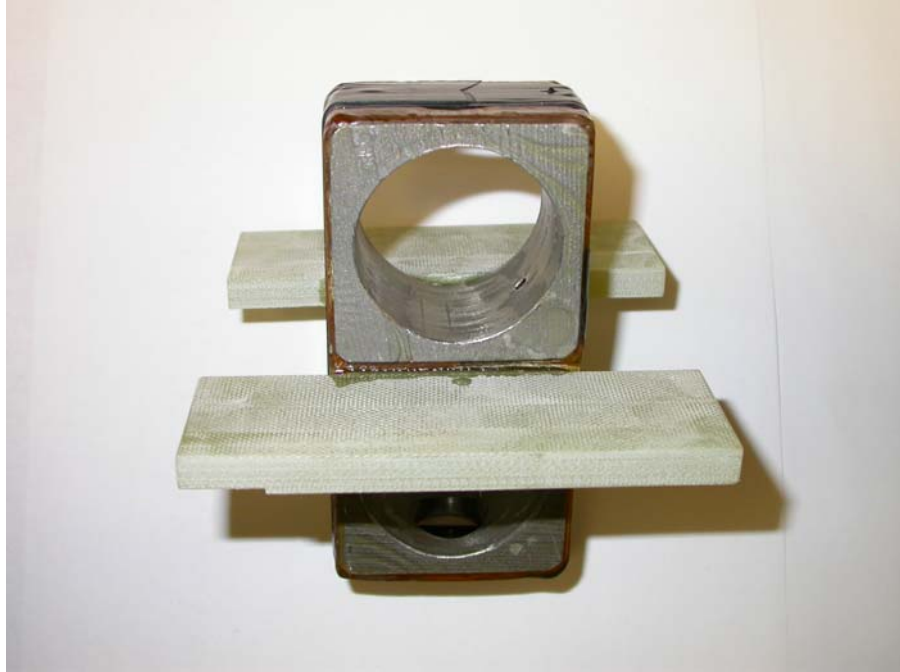
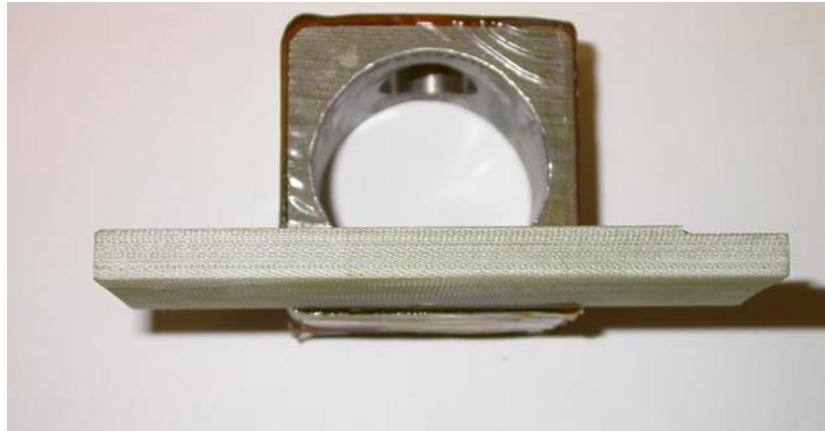
1. In order to simulate the experiment above, once the piece was cracked; it was removed from the Instron. A G-10 piece was epoxied on the faces of the samples, one on each side. This will simulate the above setup, which will prevent an arc from face-to-face of the sample.

2. Once these G-10 pieces were epoxied on, the sample was Meggar tested
  - a. At around 18 kV, there was a visible arc around the side of the G-10 blocker.
    - i. At the present time, this is an acceptable result. The insulation can hold off a voltage of at least 18 kV after cracking.
  - b. In order to bring the voltage up to 21 kV, some of the epoxy used to epoxy on the G-10 can be applied to the exposed jacket metal on the back-side of the G-10. This will extend the distance needed to arc, and should prove that the insulation is good up past 21 kV.

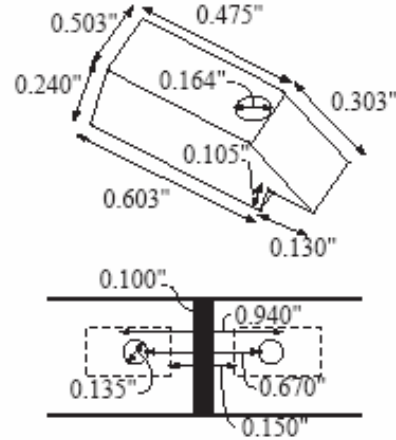
1. G-10 mounts were made to hold the extensometer on the sample. The G-10 was mounted onto the jacket, near the insulation layer between the two samples (see figure below).
