COMPOSITE STRUCTURES, 2017
**ON THE USAF ‘RISK OF FAILURE’ APPROACH AND ITS APPLICABILITY TO
COMPOSITE REPAIRS TO METAL AIRFRAMES**

W. Hu¹, S. Barter², J. Wang², R. Jones¹ and A. J. Kinloch³

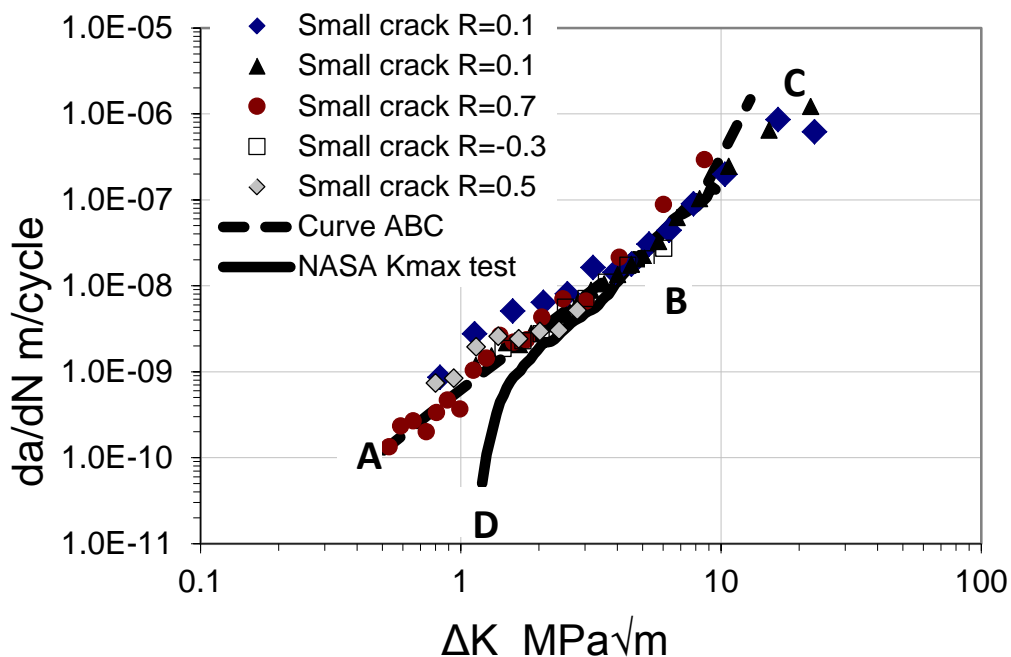
Figure 1 Comparison of da/dN versus ΔK curves associated with naturally-occurring cracks and ASTM K_{max} test cracks for 7050-T7451, from [3].

In this context, it should be noted that to date the vast majority of studies into the effect of composite repairs to cracked structures have used ASTM E647-13a like specimens where prior to patching the crack was grown from large artificial notches [7, 8]. However, as explained in ASTM E647-13a, and discussed above, such specimens do not reflect how a crack in an operational structure will grow. This is because the fatigue threshold associated with such ASTM E647-13a specimens is much greater than that seen by cracks that have grown from small naturally-occurring material discontinuities typical of those found in operational aircraft [3]. This is aptly illustrated in Figure 1 which presents the da/dN versus ΔK curves associated with the growth of small cracks in 7050-T7451 and also a corresponding da/dN versus ΔK curve that was determined using the ASTM E647-13a K_{max} test procedure where the crack was grown from a large artificial notch. Here we see that, in contrast, to the sigmoidal shape seen for da/dN versus ΔK curves determined in accordance with the fatigue test standard ASTM E647-13a, i.e. the curve DBC, the da/dN versus ΔK curves associated with naturally-occurring cracks, i.e. curve ABC, has a much lower threshold. Further, curve ABC more closely follows a Paris-like equation to this apparent threshold which, in the mid- ΔK and below region, has little (if any) R-ratio dependency. A good example of the need use the curve ABC, rather than the curve DBC, is given in [9] which discusses how to assess the operational life of critical locations in the Lockheed Martin F-22.

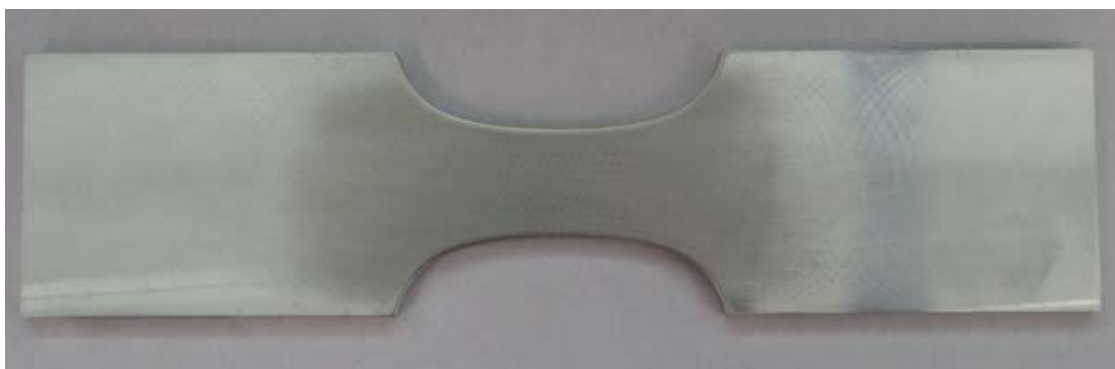
Figure 2 (a) Photograph and (b) sketch of the geometry of the metal test coupon.

Cracks in operational aircraft generally initiate and subsequently grow from small material discontinuities. Consequently, to investigate the effect of a composite repair to cracks that have initiated and subsequently grown from a small material discontinuity a number of tests were performed on 6.35 mm thick 7050-T7451 aluminium alloy dog-bone test coupons, see Figure 2. The metal coupons were cut from the 7050-T7451 plate so that the long axis of the coupons was transverse to the rolling plane and the plane of the coupons was in the rolling plane. These coupons had a working area that was 25 mm wide and 74 mm long. Both sides of the coupons contained 29 rows (in the length direction) of small laser induced notches. The number of notches in any given row alternated between 5 and 6. In each row the notches were 4 mm apart and the distance between each row was 1 mm. This array of notches was located in the centre of the working section, see Figure 3. To minimize any interaction of any resultant delaminations/disbonds the array was staggered as per Figure 3. Each laser induced notch has a typical dimension of 0.2-0.3 mm deep and 0.04-0.07 mm wide. A view of a typical laser notch is shown in Figure 4.

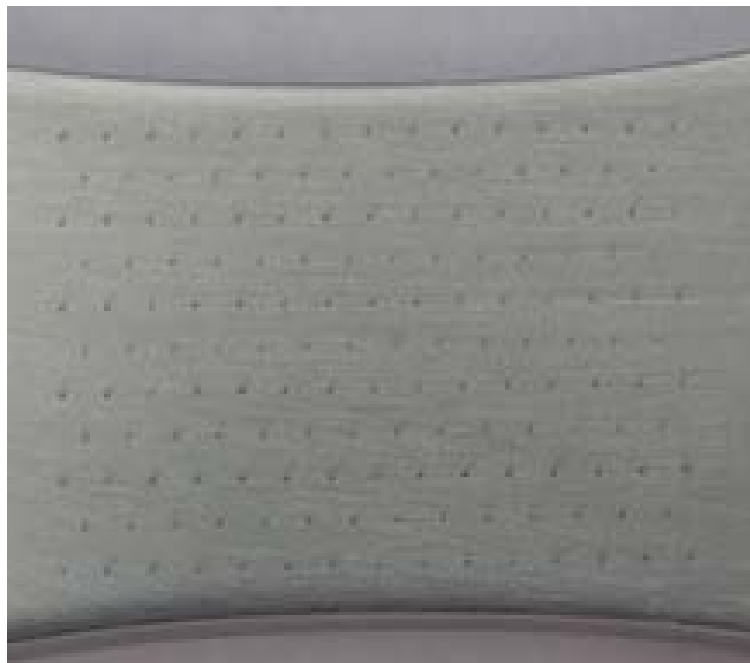
Figure 3 The staggered nature of the array of the laser induced notches which can initiate fatigue crack(s).

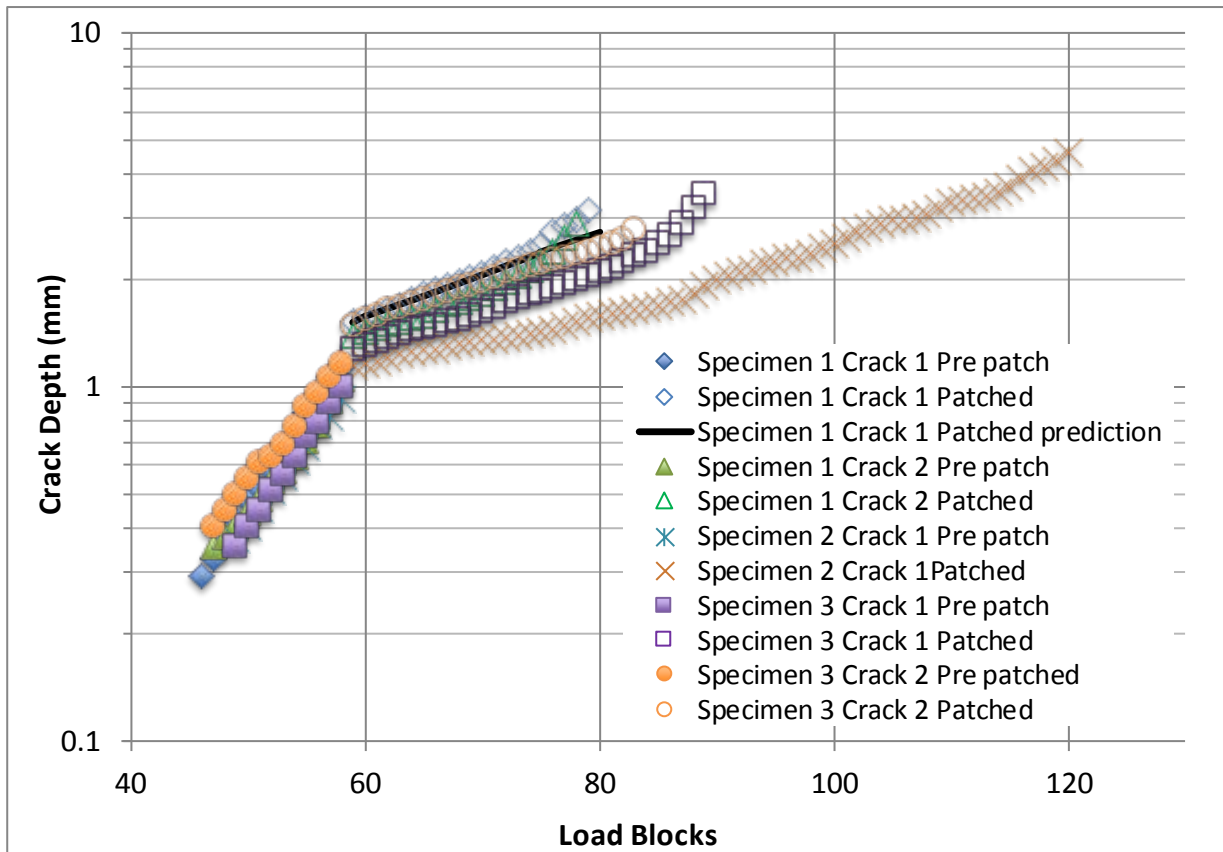
Figure 10 Crack growth histories for dogbone specimens. (After 120 blocks the marker bands associated with Specimen 2 were difficult to read as the crack was growing very fast. At this stage the crack depth has almost cross the entire thickness which is 6.35 mm.)

The resultant crack depth histories obtained in these tests are shown in Figure 10. The first thing to notice is the dramatic reduction in the crack growth rate due to patching. We also see

where, for each case, the value of $\omega_{\text{unpatched}}$ is determined from the experimental data shown in Figure 10. The mechanical properties of AA7050-T7451 and the unidirectional boron/epoxy 5521/4 prepreg that are necessary to calculate the change in the stress due to the patch applied are presented in Table 1.

which, as can be seen in Figure 10, is in good agreement with the experimental data. A comparison between the predicted and measured values of ω_{patched} is presented in Table 2 for each crack. This Table reveals that the cubic rule, i.e. equation (2), predicts values of ω_{patched} that are a reasonably good first approximation.

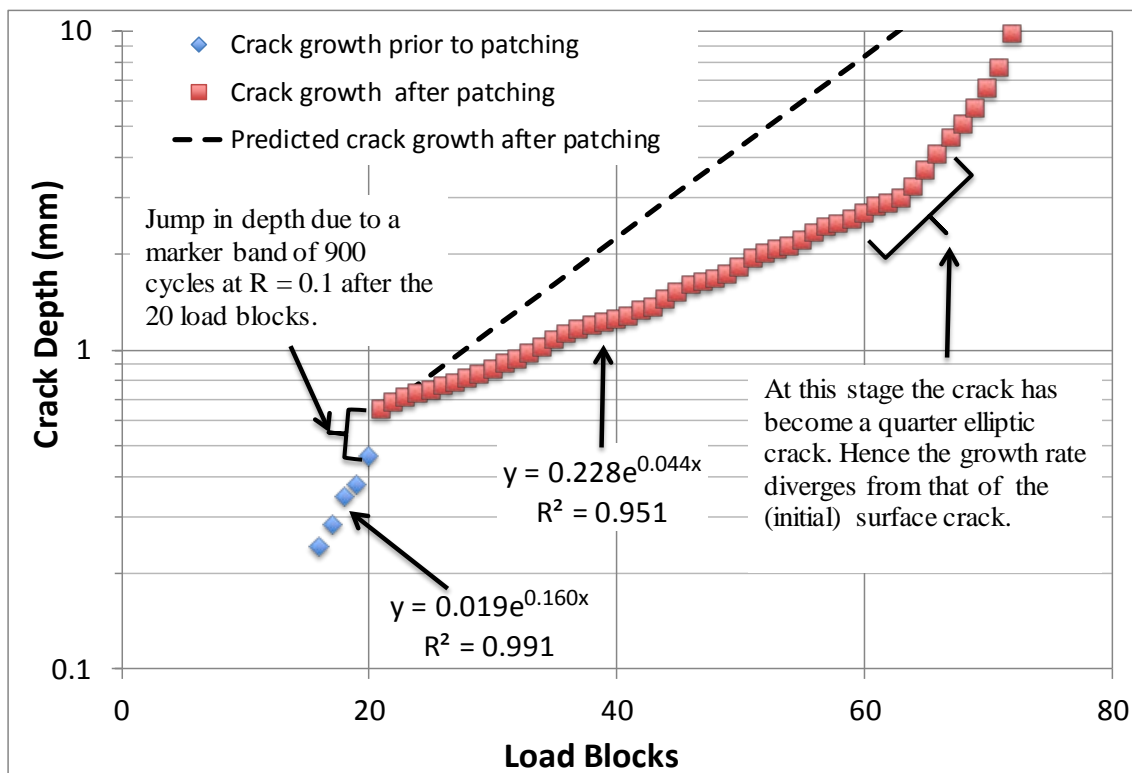
Figure 14 Crack growth histories for corrosion-pitted specimen: unrepaired and repaired patch specimens.

The crack growth histories both pre- and post-patching are shown in Figure 14 where we also see a dramatic reduction in the crack growth rate due to patching. From Figure 14 we see that prior to patching crack growth is essentially exponential with a slope of $\omega = 0.160$. For this specimen configuration, the ratio $\Delta\sigma_{\text{patched}}/\Delta\sigma_{\text{unpatched}}$ is approximately 0.743. This yields a predicted (exponential) slope after patching of:

The predicted and measured crack depth histories are shown in Figure 14 where, given the complex nature of the shape of the crack which changes (as the crack grows) from a near semi-circular surface crack to a corner crack, we see reasonably good agreement with the predicted growth history. Further, since we predict a greater value of ω than observed experimentally, the prediction is conservative.
