## Power transformer failure management on the Eskom distribution network in Limpopo

MM Sako\*, A Wessels\*\* and JHC Pretorius\*\*\*

**Abstract**—Power transformers are the crucial part of the power system network because they regulate the voltage either up or down on the electrical network for safe use by the consumers. Their reliable operation on the network is very critical because it directly impacts that of the entire electrical network connected to it. One of the major challenges power utilities face is the failure of power transformers on the distribution network. In this research, the dominating causes of transformer failures on the Eskom distribution Limpopo network were identified. Different power transformer failure management strategies are discussed. The current methodologies used in Eskom distribution to prevent power transformer failures are evaluated. Different solutions to improve the current transformer failure management strategies are proposed. The defined methods are based on literature and existing research on power transformer failure management strategies.

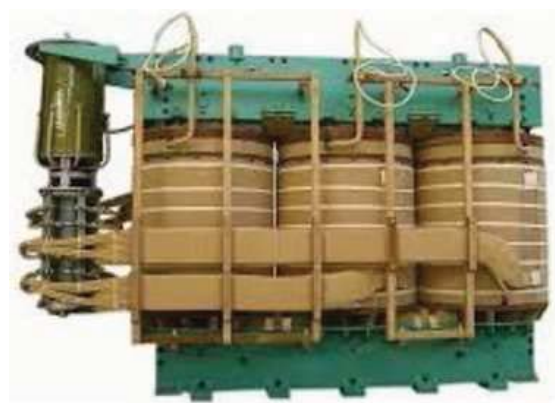
The following figure below shows the active part of a power transformer, consisting of the windings covered in cellulose insulation.

Figure 3: Active part of a power transformer [2]
