Experimental investigation on the surface and subsurface damages characteristics and formation mechanisms in ultra-precision grinding of SiC

Zhipeng Li^{1,2} · Feihu Zhang¹ · Yong Zhang¹ · Xichun Luo²

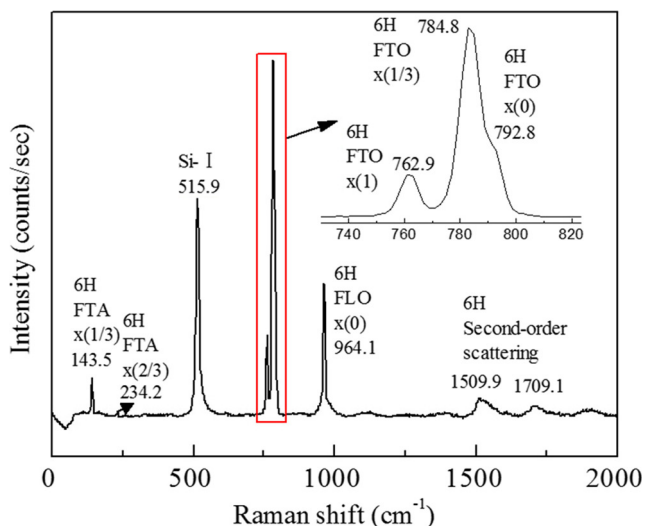
Fig. 6 The whole Raman spectra of RB-SiC before grinding

Figure 6 shows the whole Raman spectrum of RB-SiC obtained before grinding in the range of 0–2000 cm^{-1} . The weak bands at the points of 143.5 and 234.2 cm^{-1} corresponding to the folded modes of transverse acoustic (FTA) of 6H-SiC at $q/q_0 = 1/3$ and $q/q_0 = 2/3$ (q is wave vector),

respectively. According to the literature [31], the folded modes of transverse optic (FTO) of 6H-SiC Raman peaks were at 762.9 and 784.8 cm^{-1} , and longitudinal optic (LO) mode peak was at 964.1 cm^{-1} . While, FTO(0) ($q = 0$) at 792.8 cm^{-1} Raman shift should be ascribed to the stacking faults (SFs), which is associated with both 3C-SiC and 4H-SiC polytypes.

In the high-frequency region, the Raman shift features at about 1509.9 and 1709.1 cm^{-1} shift are attributed to the second-order Raman scattering band of 6H-SiC. Another sharp Raman line observed at the point of 515.9 cm^{-1} is ascribed to the crystalline Si, arising from the substrate of the bulk crystalline region [32]. We should note that compared with the stress free 6H-SiC and Si, both their transverse optic (TO) modes have a lower frequency shifts of -5 cm^{-1} , indicating tensile residual stress existed in the pristine material.

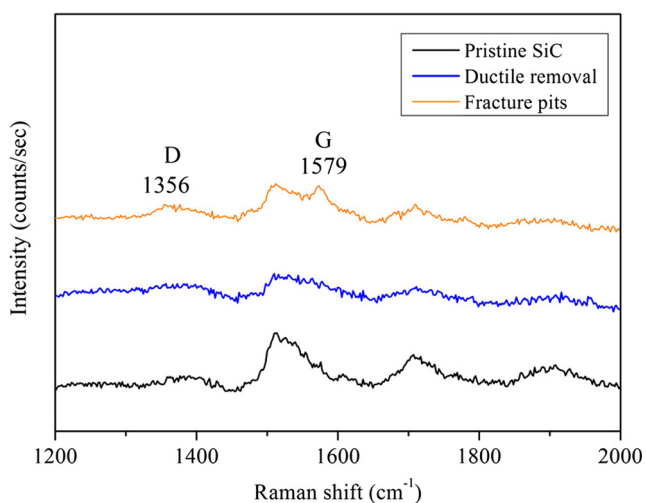
Fig. 8 Raman spectrum of graphite contained in RB-SiC

In the high-frequency region, however, the additional broad bands center at 1356 and 1579 cm^{-1} always appeared in Raman spectrum which was taken from the surface fracture points (shown in Fig. 8). As testified in Ness JN and Page TF [36], the graphite was trapped by the growing grains before its reaction with liquid silicon during RB-SiC fabrication. Therefore, those two peaks should be caused by the D peak (disorder-induced A_{1g} mode) and G peak (E_{2g} mode) of graphite, respectively [37]. Hence, it implied that graphite impurities play an important role on material fracture behavior. They can offer a potential fracture point for crack nucleation.

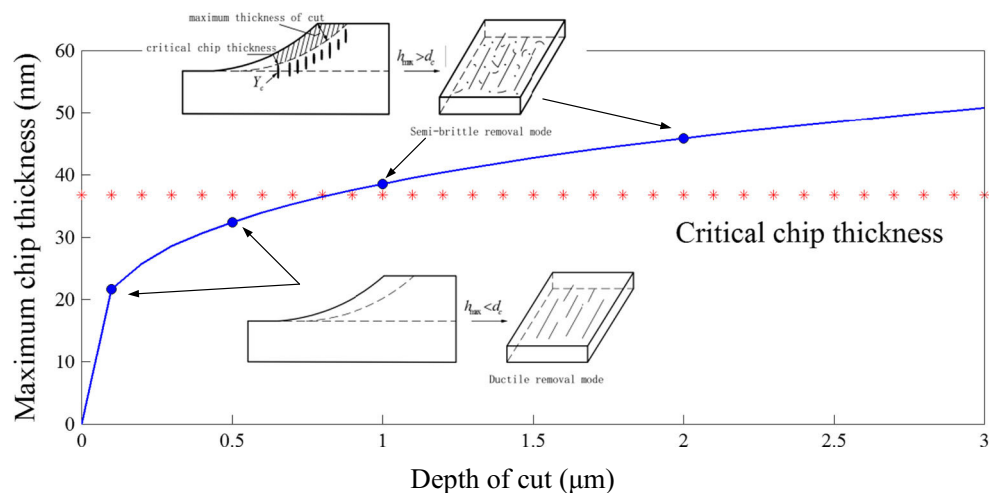
Fig. 12 Estimated undeformed maximum chip thickness and the corresponding removal mechanism

relationship between the abrasive and the workpiece in horizontal surface grinding (shown in Fig. 12), the maximum undeformed chip thickness h_{\max} can be expressed as [45]:
