Gamma radiation damage study of 0.18 m process CMOS image sensors

Gamma Radiation Damage Study of 0.18 μm Process CMOS Image Sensors

Ben Dryer^{*a}; Andrew Holland^a; N.J.Murray^a; Paul Jerram^b; Mark Robbins^b; David Burt^b;

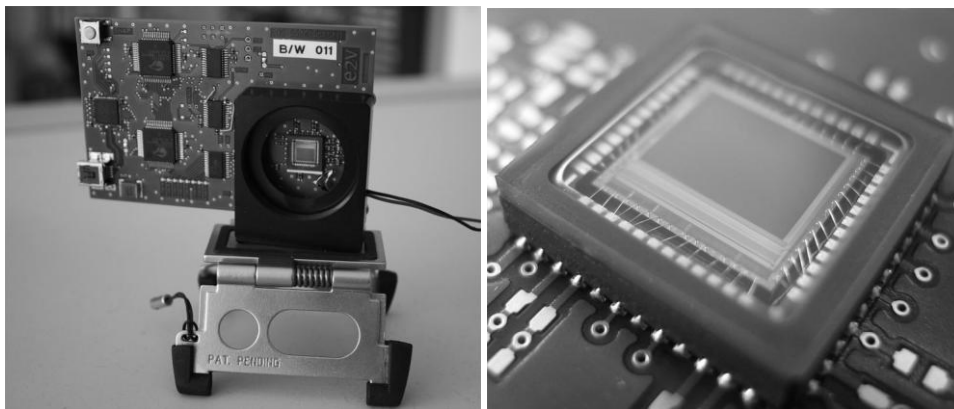
Figure 1. Photographs showing the CMOS chip on demonstration board (left), and close-up of the chip (right)

The imagers used for this study are 0.5 Mpixel arrays of $5T\ 6 \times 6\ \mu\text{m}$ pixels, manufactured using a $0.18\ \mu\text{m}$ process, and were provided by e2v technologies plc. based in Chelmsford, UK. Examples of the chip and readout boards are shown in Figure 1. The pixels have no advanced structures designed to mitigate radiation damage, so the results of this study will show a baseline of radiation hardness for the design and process used.

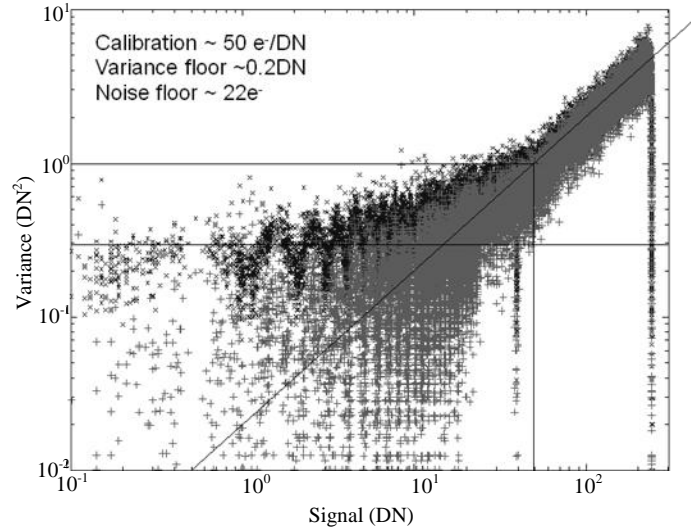
Figure 2. Typical photon transfer curve for these devices, showing full PTC (black), and PTC with read noise subtracted (grey)

Figure 2 shows a typical photon transfer plot for this range of sensors. It was obtained using a low level light source and increasing integration time. Points are plotted for each pixel. The curve indicates a calibration of $50 \text{ e}^- \cdot \text{ADU}^{-1}$, sensor noise of 22 e^- r.m.s. and a full well capacity of $\sim 13 \text{ ke}^-$. The spread in variance at low signal levels is due to noise quantization, because of the low number of (and hence large) ADC bins.

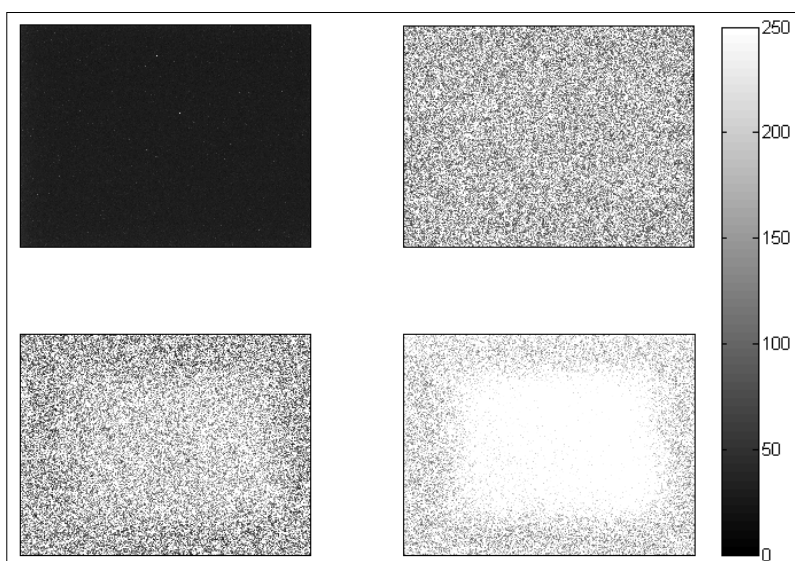
Figure 3. Still frames obtained during Co^{60} irradiation of chip BW 206 at 0 krad(Si) (no gamma flux), 0 krad(Si) (gamma flux incident), 30 krad(Si) (gamma flux incident), and 80 krad(Si) (gamma flux incident). (Top left, top right, bottom left, bottom right, respectively).

Figure 3 shows several images captured during the irradiation of chip BW 206. The gamma flux is apparent as a uniform noise across the whole sensor. As the irradiation progresses, it becomes apparent that the signal in the centre of the imaging area is increasing at a greater rate than that in the border of the imaging area, as the uniform gamma flux becomes more and more non-uniform, a similar effect is seen in some STAR-250 irradiations^[8]. As the dose approaches 120 krad(Si), the device becomes completely saturated over the whole device. At this point in the irradiation, communication with the device were lost, either due to a failure of the chip, or due to failure in the un-shielded area of the readout board.

The quickly growing non-uniformity in the gamma flux observed in these images could be as a result of three separate effects: a non-uniform increase in dark current, a non-uniform increase in responsivity, or a non-uniform increase in signal due to the irradiation of the unshielded area of the readout board. As the device is no longer responsive, it's very difficult to decouple these separate effects, to determine which may be the more significant cause, and to compare to other work.

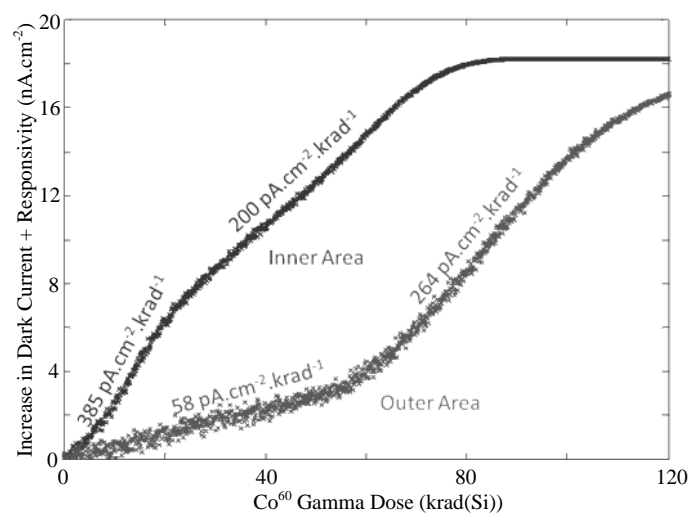
Figure 4. Measurements of the dark current for inner bright area, and outer area, during irradiation.

Figure 4 shows measurements taken at intervals of 0.1 krad(Si) during the irradiation, and plotted as an average over the inner and outer areas of the device. The inner area of the device shows a much higher increase in non-uniformity of the signal than the outer area, especially for the first 25 krad(Si). The outer area, in contrast, shows a high degree of radiation hardness up to 60 krad(Si), then begins to become damaged more quickly, equalling

or exceeding the rate of damage experienced by the inner area. The device becomes fully saturated at around 80 krad(Si) in the inner area, hence the slope returning to 0 at that point.

Figure 6 shows the dark current measured at different stages during the irradiation of chip BW 204. It can be seen that much lower dark current figures are measured than were seen in Figure 4, which suggests that much of the increase in non-uniformity is due to an increase in either responsivity to the gamma radiation, or damage to the readout board. However it's also clear that the non-uniform increase in dark current is still a factor, as the inner area of the image area increases in dark current more quickly than the outer area (and shows a very large jump between 15 and 20 krad(Si)). This plot also shows the radiation hardness of CMOS technology, with even the inner area showing an increase in dark current of only $2 \text{ pA.cm}^{-2}.\text{krad}(\text{Si})^{-1}$. We can compare this to a similar CCD not optimized for radiation hardness such as the e2v CCD57-10, which in partially inverted mode showed an increase in dark current of $30 \text{ pA.cm}^{-2}.\text{krad}(\text{Si})^{-1}$ [9]. The outer area shows an even lower measurement of $1.5 \text{ pA.cm}^{-2}.\text{krad}(\text{Si})^{-1}$ with no sudden jump after 15 krad(Si).

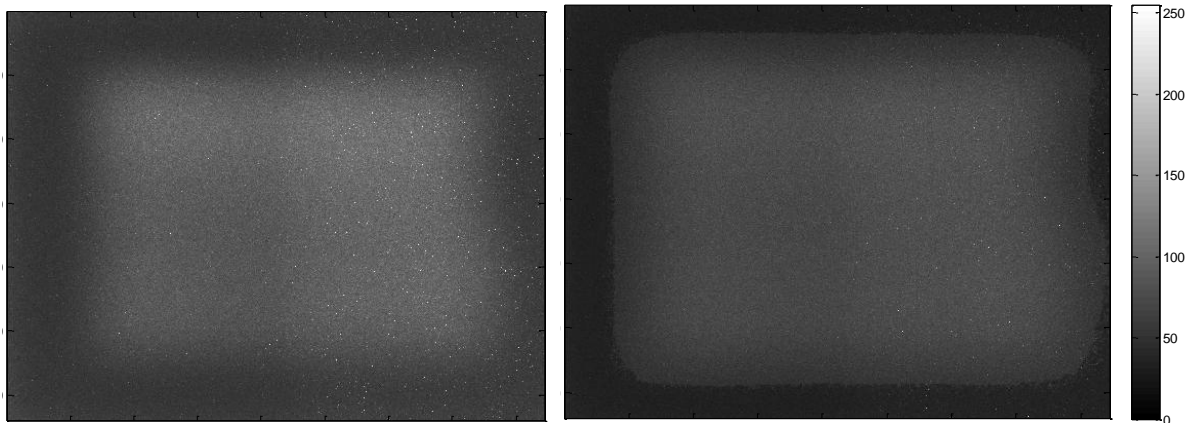
Figure 5. Dark image of chip BW 204 showing dark current non-uniformity immediately after 20 krad(Si) of irradiation (left), and after a further 6 months of annealing at room temperature (right).

Figure 5 shows the dark current pattern on a chip irradiated to 20 krad(Si) before and after 6 months of annealing at room temperature. The non-uniformity is very similar to that shown in the previous test to 120 krad(Si), and the bleeding on the right hand side of the images can be explained by prior irradiation by protons on the right hand side of the chip. It can be seen that after anneal, the dark current pattern becomes much less diffuse, and resembles glue or some similar material providing dose enhancement effects.

However, the device has been analysed for any non-uniformity of dose over the device due to underlying structure or shielding effects. No match has been found between the positioning of this dark current non-uniformity and any structural feature on the chip. As the dark current non-uniformity is central to the uniformity, and the position of the imaging area is not central to the chip (see figure 1), this suggests that the pattern of radiation damage is central to the manufacture of the imaging area, and not due to any shielding or enhancing effects. The actual reason for the enhanced dark current in the centre of the device is not understood – and is suspected to be due to the manufacture of the imaging area at the foundry level.

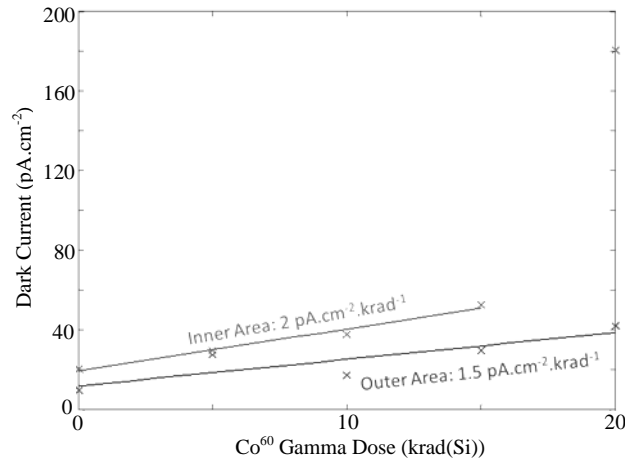
Figure 6. Plot showing average dark current with increasing radiation dose over the inner area (grey), and outer area (black)

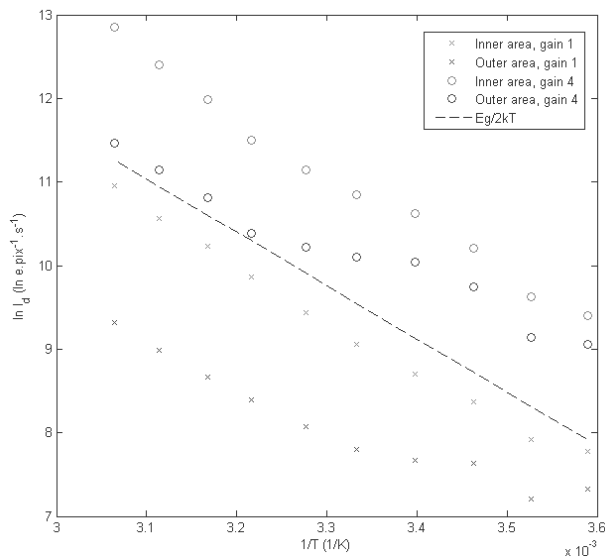
Figure 7. Shows behaviour of $\ln I_d$ against $1/T$ for inner and outer areas (circle and cross markers) at gains of 1 and 4 (black and grey)

Figure 7 shows that, in both regions of the imaging areas, the dark current follows the relationship:
