A New Method for Monitoring Gears Surface Failures Using Enhanced Image Registration Approach

Onsy, Ahmed, Fouad, Mohamed, Shaw, Brian and Dansereau, Richard M. (2014) A New Method for Monitoring Gears Surface Failures Using Enhanced Image Registration Approach. SAE International Journal of Aerospace, 7 (1). pp. 182-189.

Ahmed Onsy and Mohamed Fouad
MTC

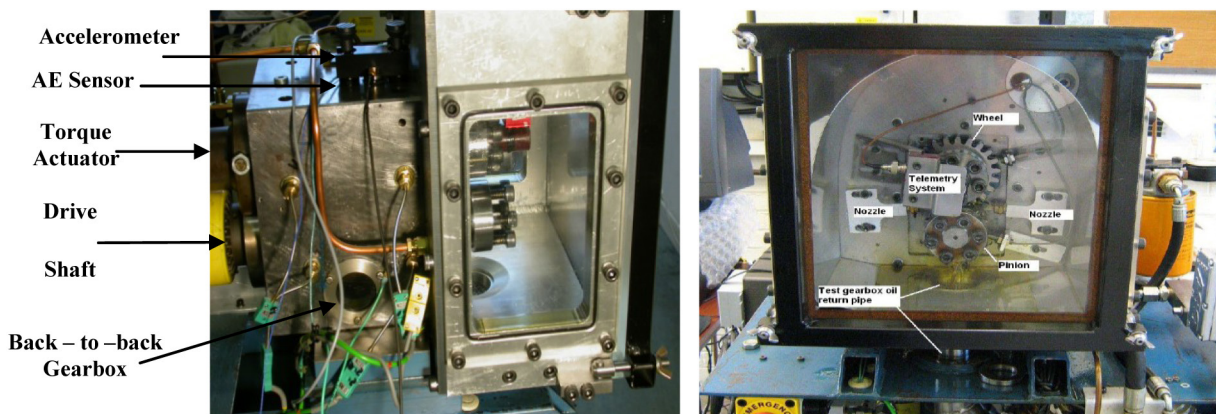
Figure 1. Newcastle University 75 mm centre distance back-to-back gear test rig

A back-to-back gear test rig developed at Newcastle University was used for this research. The rig comprises a 75 mm centre distance back-to-back test gearbox connected to a slave gearbox. The test gears, consisting of a pinion and a wheel, are lubricated by a pressurized spray of oil pumped. The system is driven by a 5.5kW variable speed electric motor controlled by an inverter to provide a speed variation of 0-6000 rpm. Testing torque is generated through a hydraulic mechanism and a slave gearbox is used to apply the load. The rig can generate a load torque on the test gears in the range of 0-600 Nm. The torque is measured using calibrated strain

gauges installed on the wheel shaft and the measured torque values are transmitted to the control program by telemetry in order to provide closed loop torque control of the actual load on the gear itself. The test rig, as shown in Figure 1, is controlled using National Instruments (NI) LabVIEW which consists of a PCI-MIO-16E-4 E series data acquisition card (NI) and 250kps sampling rate. Temperature is monitored using a USB-9211A temperature data acquisition card (NI). Three oil heaters and a water cooler are used to ensure that the running oil is maintained at a constant temperature during the tests. Temperatures were measured at three locations: rig oil tank, test gear bearing and slave gear bearing. Oil pressure and flow rates were also measured. A gear tooth trigger sensor was installed adjacent to the pinion test gear to ensure that tooth failure could be recorded. The input shaft speed and motor current were also monitored as a precaution. The test rig software provided the flexibility to change the control algorithm of the parameters measured according to the test conditions using LabVIEW's scalable architecture features. The test rig sensor-actuation system layout is shown in Figure 2. A pair of

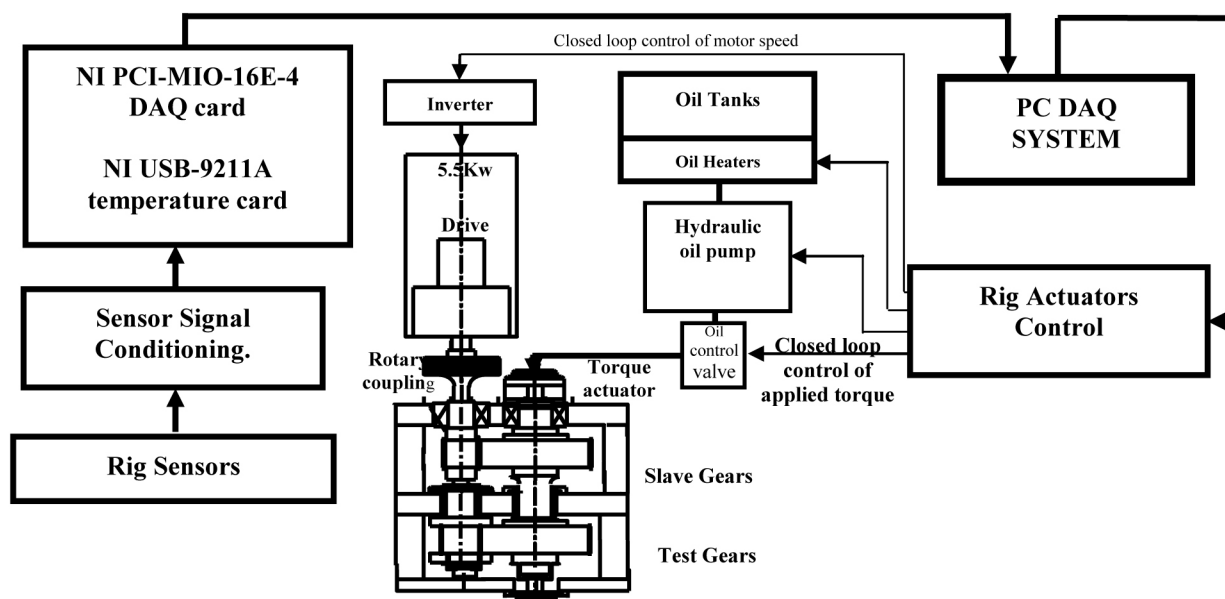
Figure 2. 75 mm test rig sensor-actuation system layout.

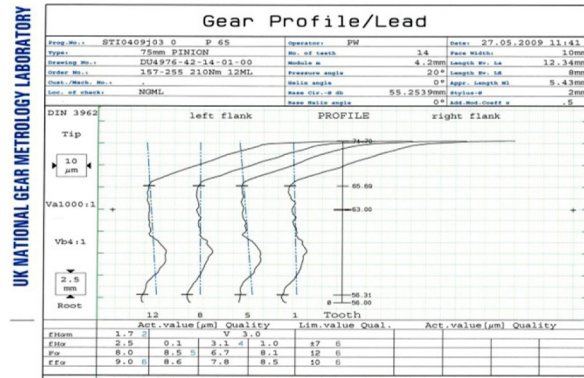
Figure 6(a). Pinion profiles of 4 teeth after test day 3. The maximum profile deviation caused by micro-pitting is evaluated as around 10 µm.

A Matlab algorithm has been developed to apply the image registration approach used in this paper and to then compute the FI, shown in (2), using an array of images as shown in Figures 4 and 5. The algorithm computed the FI at 13.7×10^6 cycles for the pinion gear of 0.08 while for the wheel gear of 0.16, which is higher than the pinion FI value. Also, at 75.78×10^6 cycles the FI value for the pinion is 0.25 while for the wheel is 0.35, which is again higher than the pinion FI value. Figure 5 illustrates the FI versus number of cycles, showing that the micro-pitting progressed gradually during the testing period using the proposed approach is more closer to the vibration and oil debris analysis results, compared to that of the BMASLIV approach [11] that uses the IR approach in [7]. The FI results are confirmed by the gear metrology results as shown in Figures 6 and 7.

It is evident that the flanks of the test gears scuffed significantly as a result of surface fatigue during continuous running at relatively high torque/contact stress. To quantify the damage on the gear flanks, profile deviation was measured on 4 teeth per gear using a gear measuring machine. The records of gear profile measurements at the end of stage 1 of the test and at the end of stage 3 respectively are shown in Figures 6 and 7. The gear involute measurements confirm the results of the IR approach.

'failure index', FI - is defined to describe the development of micro-pitting in gears. This method is indeed cheap and capable of application. The FI results are confirmed by the gear involute measurements showed in Figures 6 and 7.

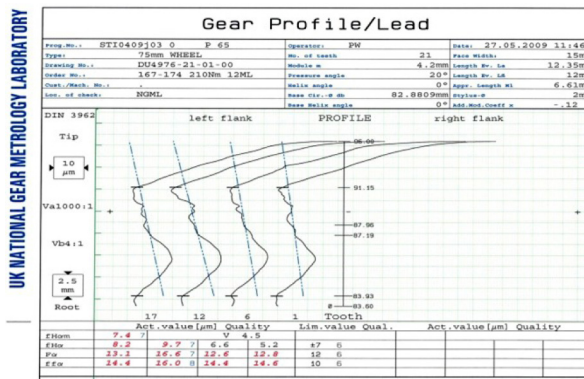
Figure 6(b). Wheel profiles of 4 teeth after test day 3. The maximum profile deviation caused by micro-pitting is evaluated as around 15 µm.

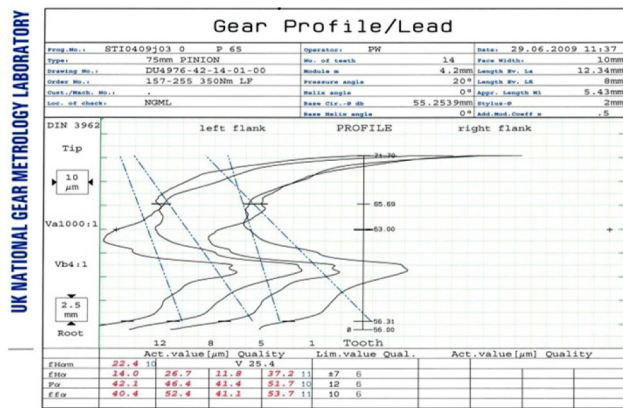
Figure 7(a). Pinion profiles of 4 teeth after test day 18. The maximum profile deviation caused by micro-pitting and macro pitting is evaluated as around 50 µm.

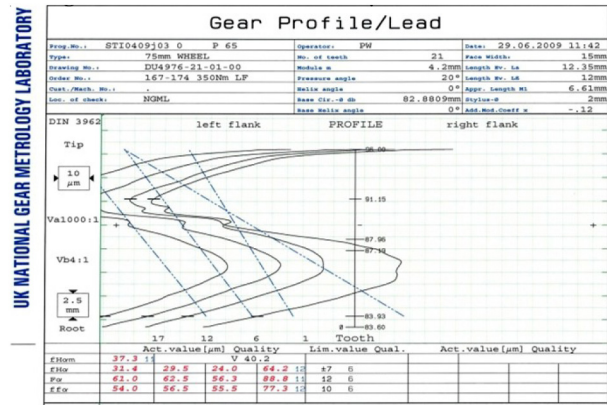
Figure 7(b). Wheel profiles of 4 teeth after test day 18. The maximum profile deviation caused by micro-pitting and macro pitting is evaluated as around 70 µm.
