3D X-ray CT of fatigue damage in fibre composites

Kristine M. Jespersen^{1*}, Jens Zangenberg², Tristan Lowe³, Philip J. Withers³, and Lars P. Mikkelsen¹

A uni-directional (UD) glass fibre composite made from a non-crimp fabric (NCF) was investigated by 3D X-ray computed tomography (CT) to study the fatigue damage at different stages of the fatigue life. The damage was found to appear as local UD fibre fracture regions close to the so-called supporting backing layer, which seemed to have an important role in the location of the damage initiation. Furthermore, the damage appeared as 3D regions containing both clusters and chains of fibre fractures, and it was concluded that considering this problem in 3D seemed to be important in order to obtain realistic results.

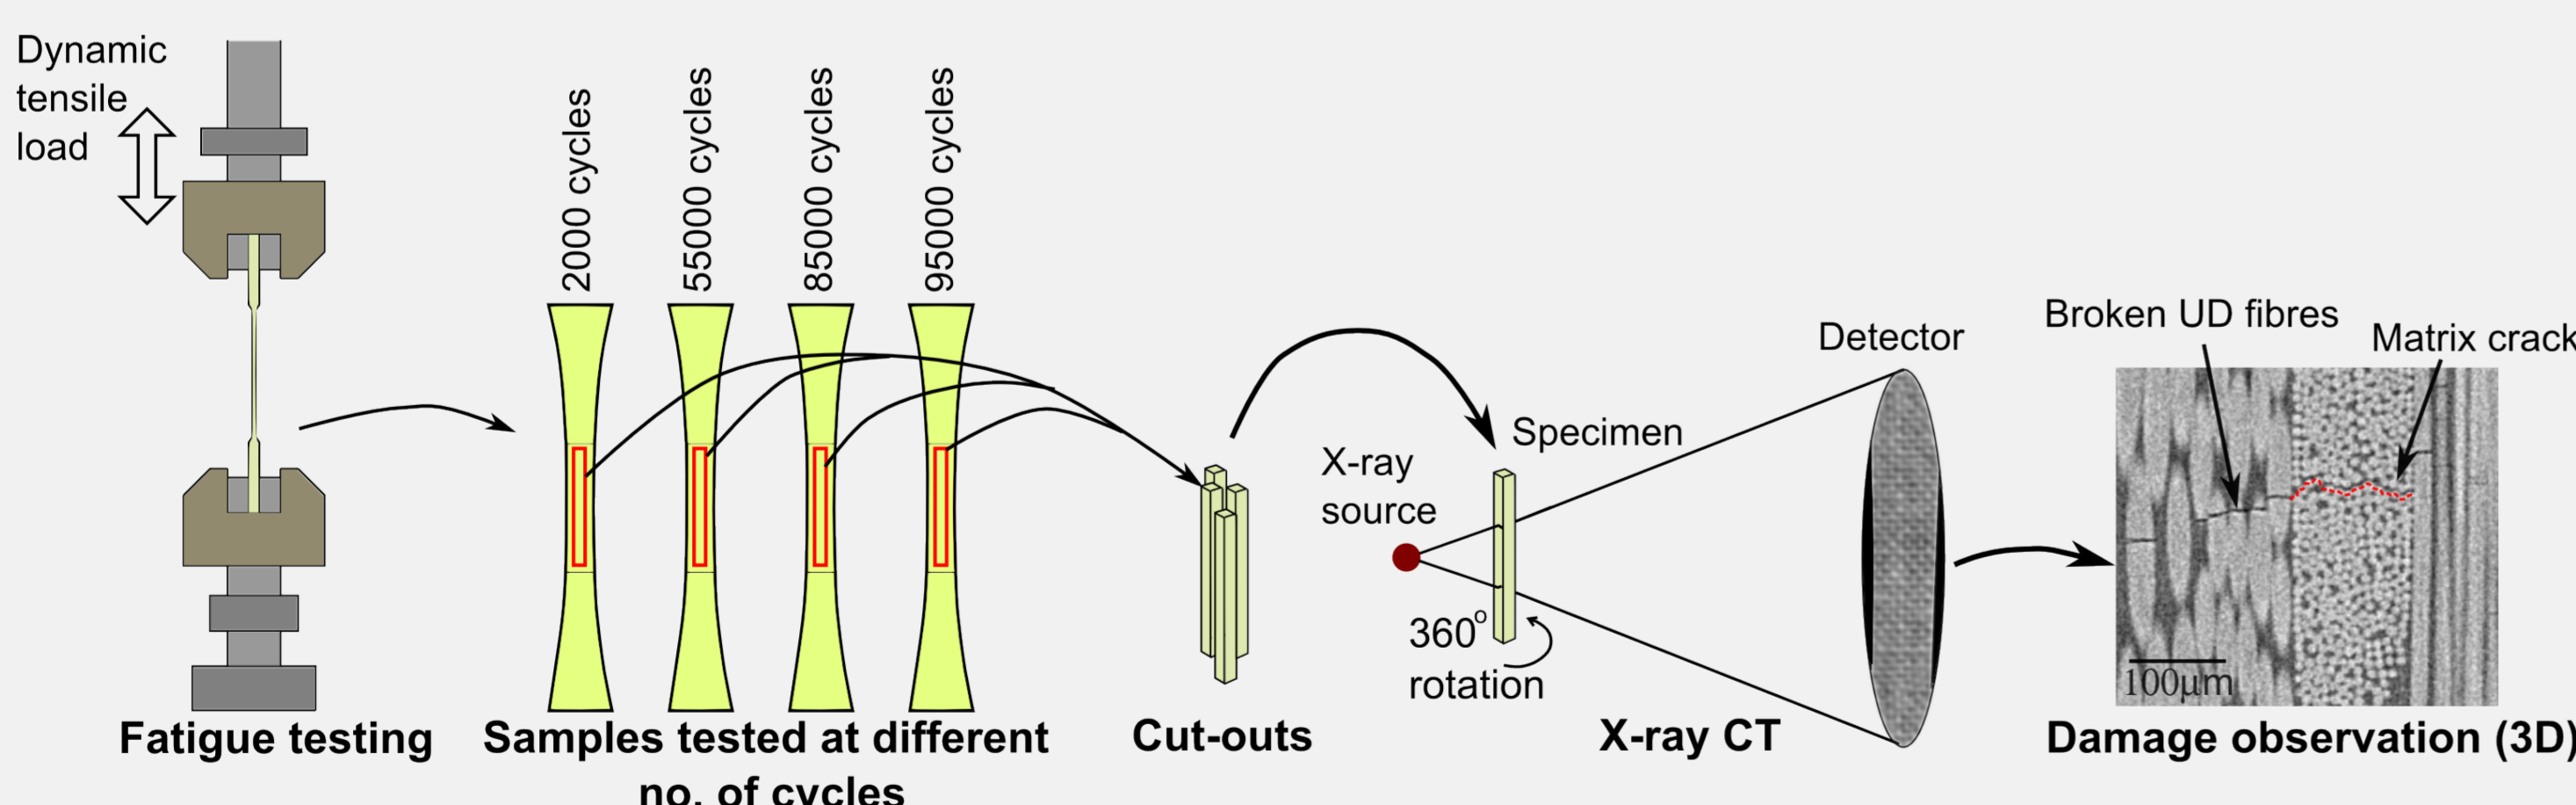
Fatigue tests ($R=0.1$) were carried out on four 410mm long butterfly shaped specimens and stopped at different number of cycles. X-ray CT experiments were performed on a Zeiss X-radia Versa 520. As the image resolution in X-ray CT scans is decreasing for increasingly large cross-sections, cut-outs are considered to obtain high resolution ($1.2 \mu\text{m}$ voxel resolution). This results in a small field of view (2.4mm), however high resolution is necessary to see individual UD fibre fractures.
