Midwest Guardrail System (MGS) with an Omitted Post

TESTING CERT # 2937.01

MIDWEST GUARDRAIL SYSTEM (MGS) WITH AN OMITTED POST

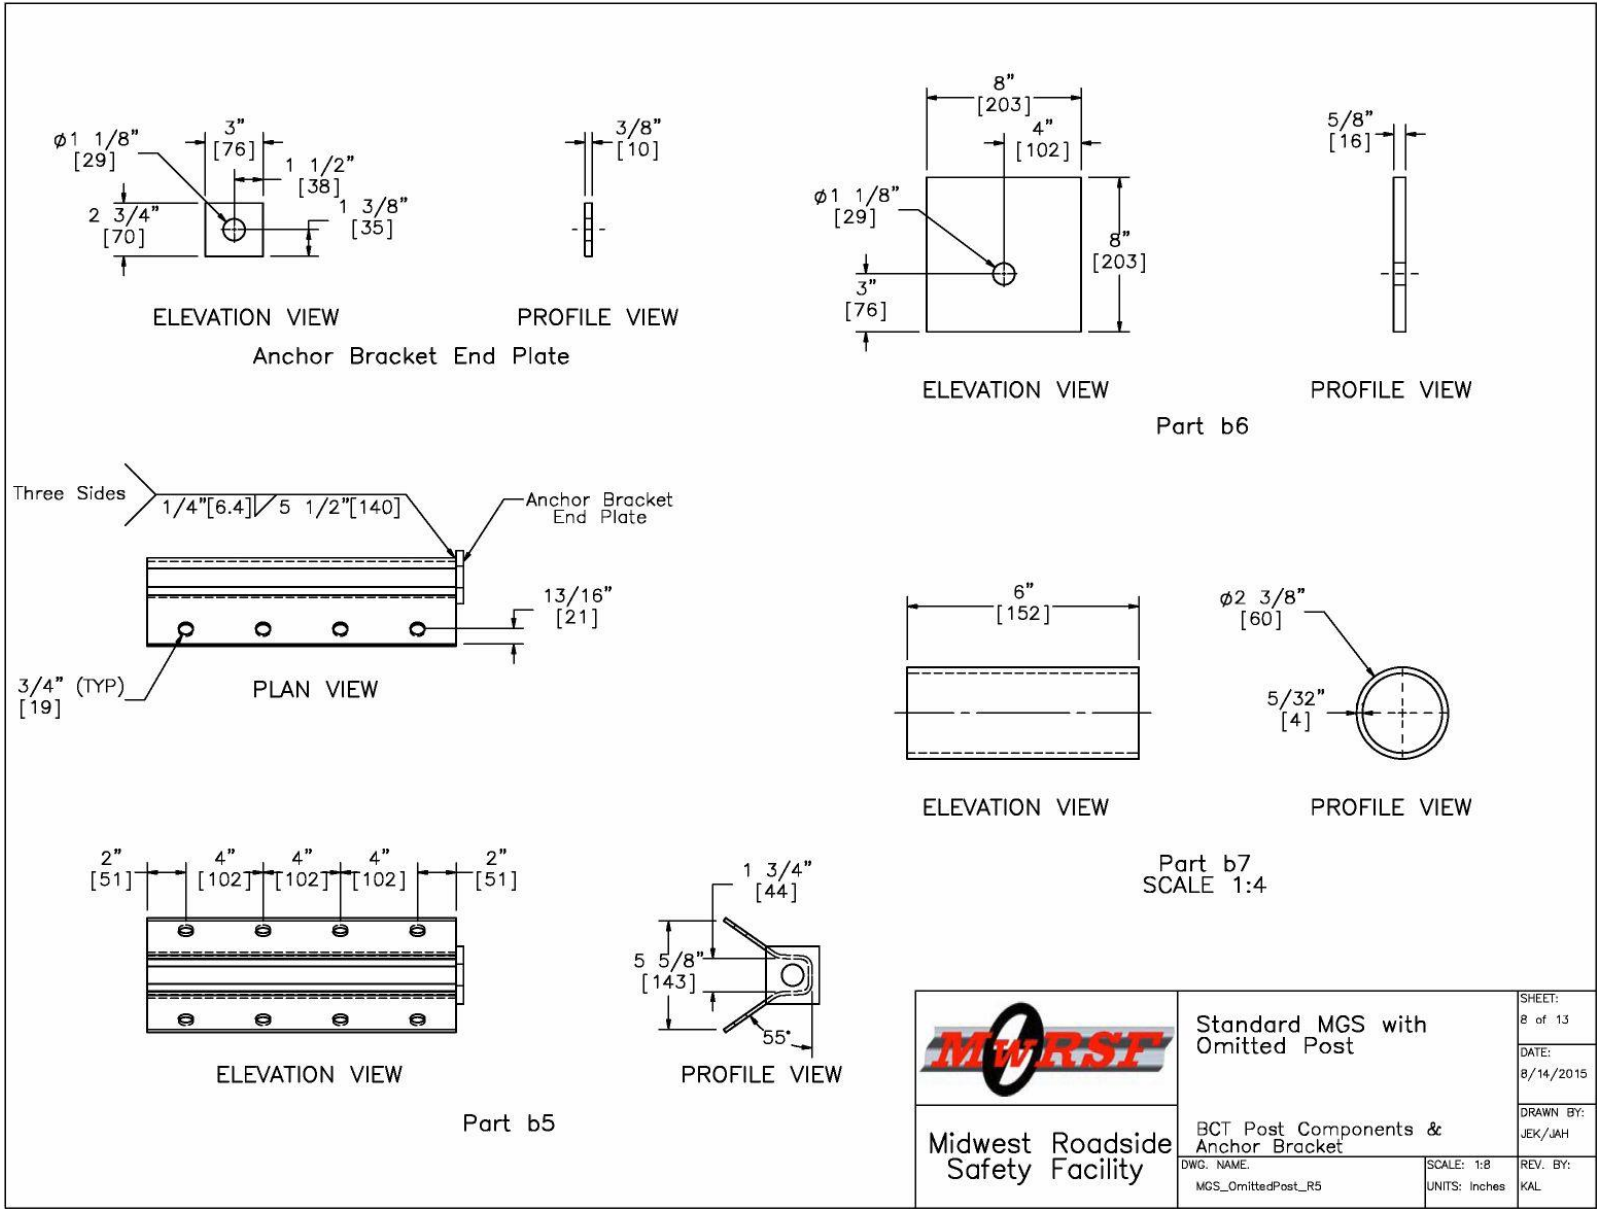
Figure 8. BCT Post Components and Anchor Bracket, Test No. MGSMP-1

Standard MGS with Omitted Post	SHEET: 8 of 13
	BCT Post Components & Anchor Bracket DWG. NAME: MGS_OmittedPost_R5	DATE: 8/14/2015
DRAWN BY: JEK/JAH		
REV. BY: KAL		
Midwest Roadside Safety Facility	SCALE: 1:8 UNITS: Inches

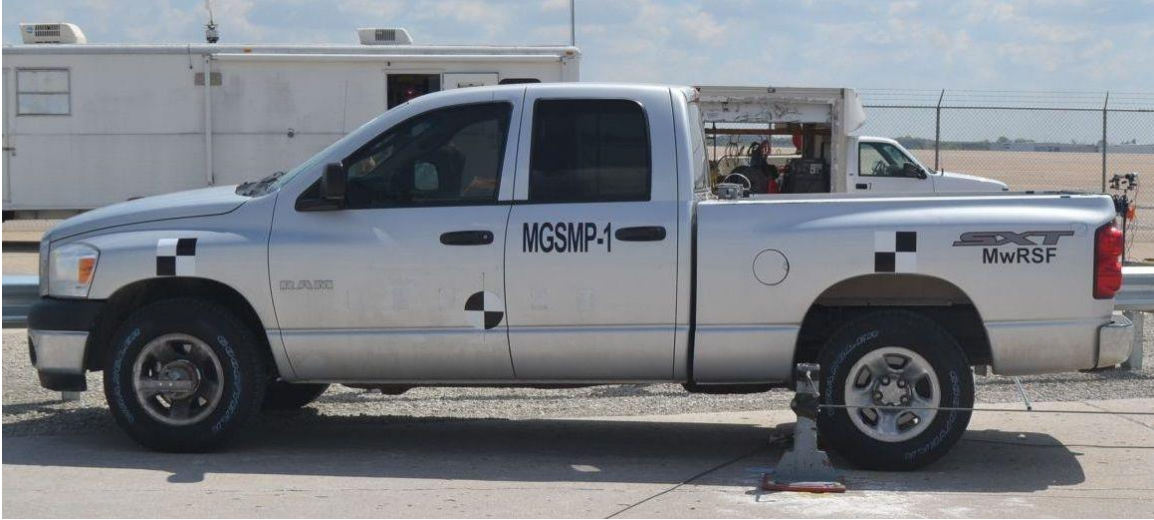
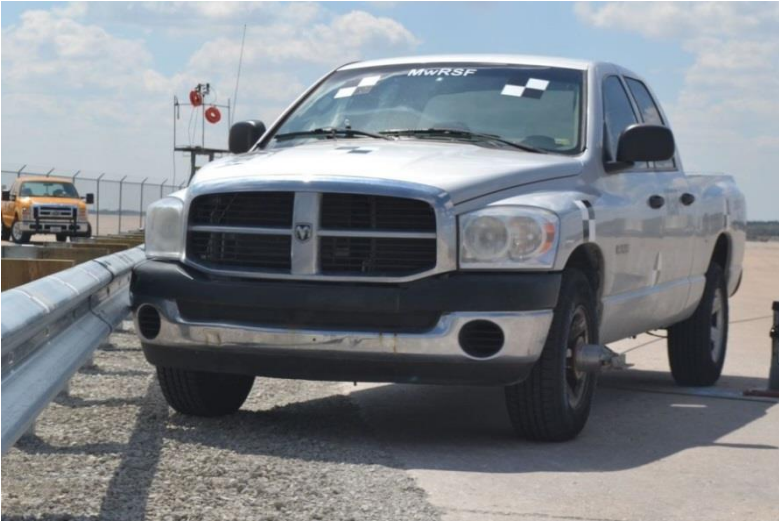
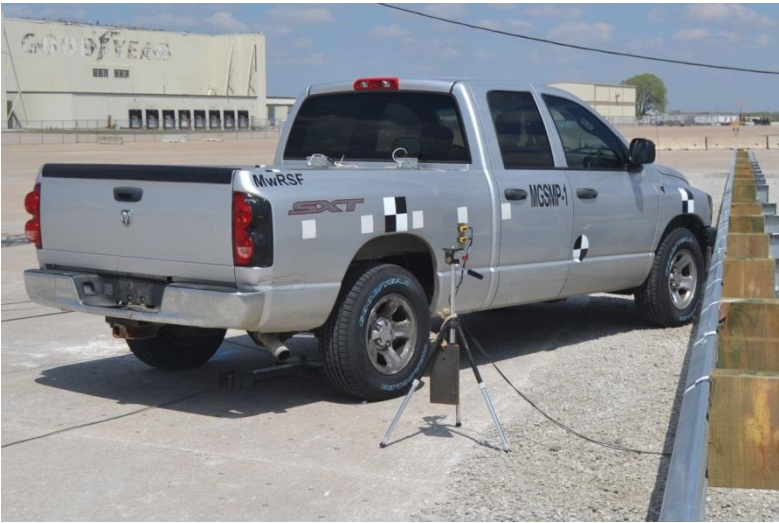
Figure 15. Test Vehicle, Test No. MGSMP-1

For test no. MGSMP-1, a 2008 Dodge Ram 1500 pickup truck was used as the test vehicle. The curb, test inertial, and gross static vehicle weights were 5,057 lb (2,294 kg), 4,934 lb (2,238 kg), and 5,099 lb (2,313 kg), respectively. The test vehicle is shown in Figure 15, and vehicle dimensions are shown in Figure 16.

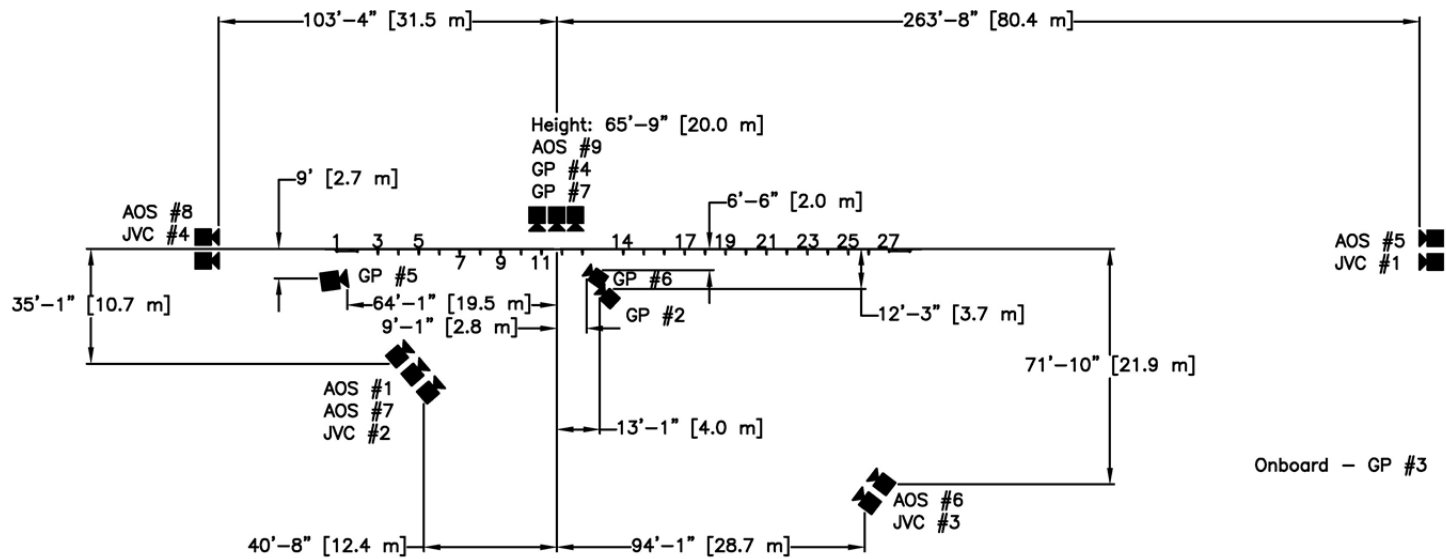
Figure 18. Camera Locations, Speeds, and Lens Settings, Test No. MGSMP-1

No.	Type	Operating Speed (frames/sec)	Lens	Lens Setting
AOS-1	AOS Vitcam CTM	500	Sigma 50 mm Fixed	-
AOS-5	AOS X-PRI	500	Vivitar 135 mm Fixed	-
AOS-6	AOS X-PRI	500	Sigma 28-70	50
AOS-7	AOS X-PRI	500	Sigma 28-70 DG	70
AOS-8	AOS S-VIT 1531	500	Fujinon 50 mm Fixed	-
AOS-9	AOS TRI-VIT 2236	500	Kowa 8 mm Fixed	-
GP-2	GoPro Hero 3	120		
GP-3	GoPro Hero 3+	120		
GP-4	GoPro Hero 3+	120		
GP-5	GoPro Hero 3+	120		
GP-6	GoPro Hero 3+	120		
GP-7	GoPro Hero 4	120		
JVC-1	JVC - GZ-MC500 (Everio)	29.97		
JVC-2	JVC - GZ-MG27u (Everio)	29.97		
JVC-3	JVC - GZ-MG27u (Everio)	29.97		
JVC-4	JVC - GZ-MG27u (Everio)	29.97

Six AOS high-speed digital video cameras, six GoPro digital video cameras, and four JVC digital video cameras were utilized to film test no. MGSMP-1. Camera details, camera operating speeds, lens information, and a schematic of the camera locations relative to the system are shown in Figure 18.

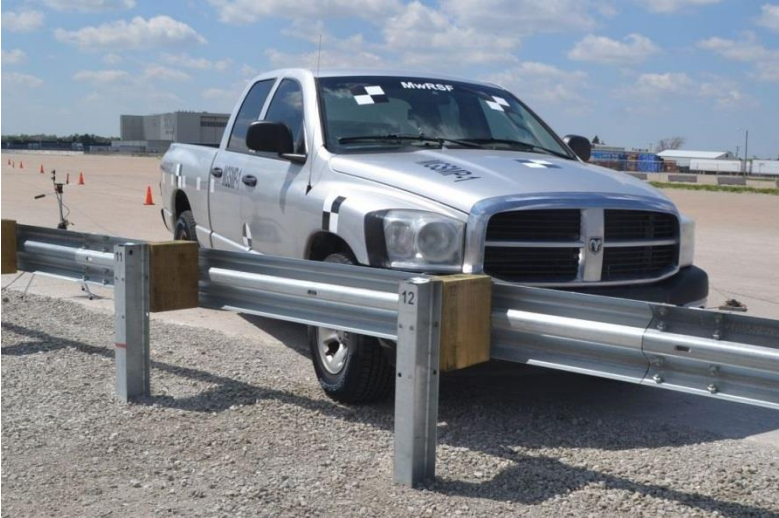
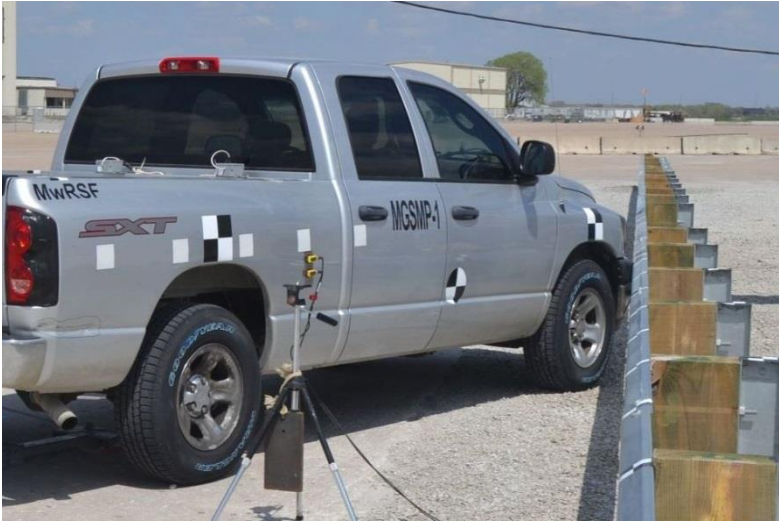
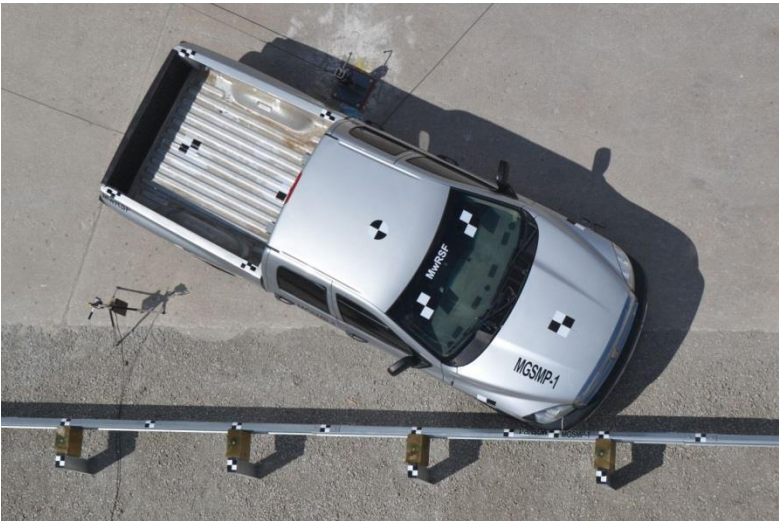
Figure 22. Impact Location, Test No. MGSMP-1

Initial vehicle impact was to occur 206¼ in. (5,239 mm) upstream from the centerline of the splice between post nos. 13 and 14, or 168¾ in. (4,286 mm) upstream from the location of the omitted post, as shown in Figure 22. The actual point of impact was ½ in. (13 mm) downstream from the targeted impact point. A sequential description of the impact events is contained in Table 5. The vehicle came to rest 108 ft – 11 in. (33.2 m) downstream from the point of impact and 45 ft – 9 in. (13.9 m) laterally behind the barrier system. The vehicle trajectory and final position are shown in Figures 19 and 23.

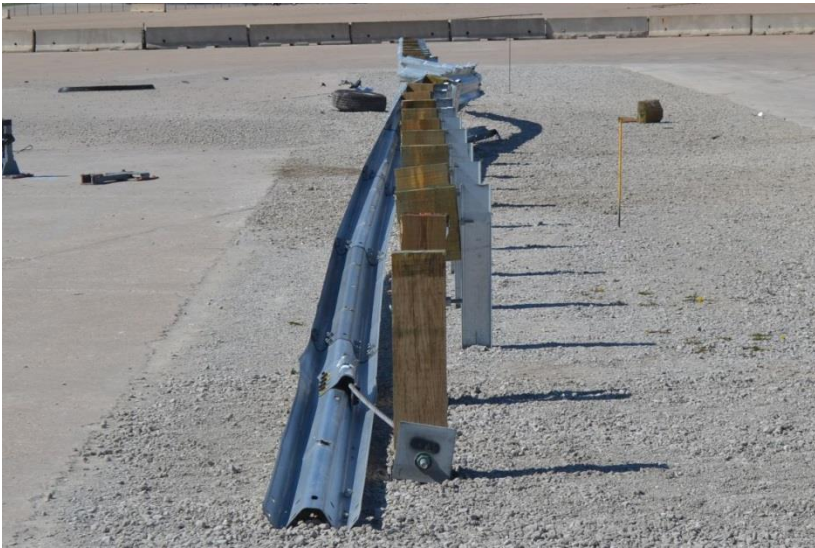
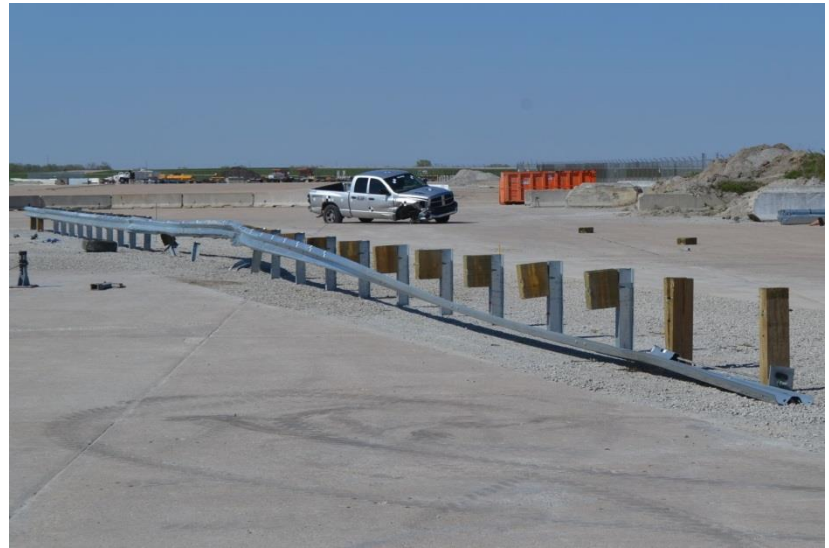
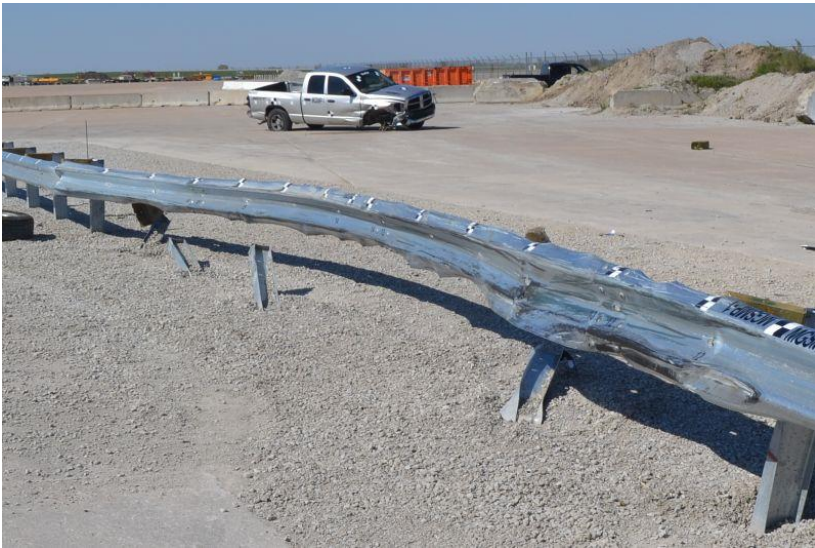
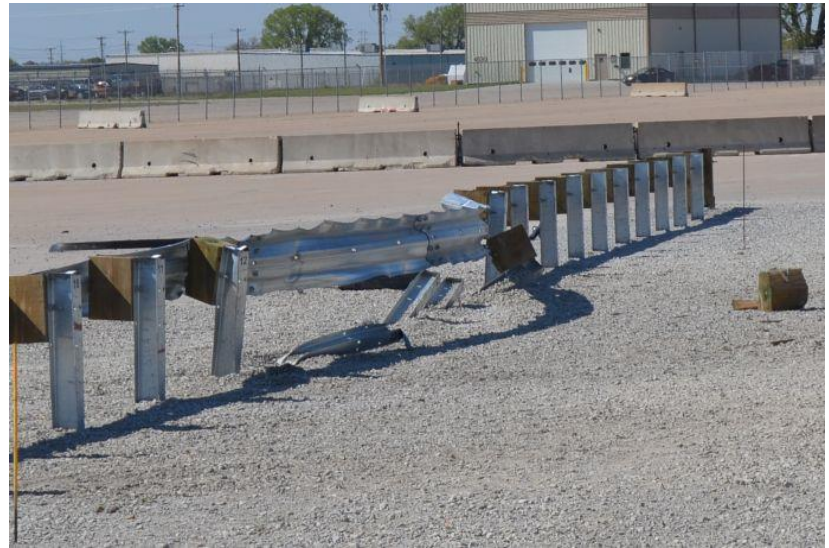
Figure 24. System Damage, Test No. MGSMP-1

Damage to the barrier was moderate, as shown in Figures 24 through 28. Barrier damage consisted of rail deformation, disengagement of the W-beam rail from the posts, bending of the steel posts, and fracture of wooded posts. The length of vehicle contact along the barrier was approximately 39 ft – 9¼ in. (12.1 m), which spanned from 18¼ in. (464 mm) upstream from the centerline of post no. 12 through 9 in. (229 mm) downstream from post no. 17.

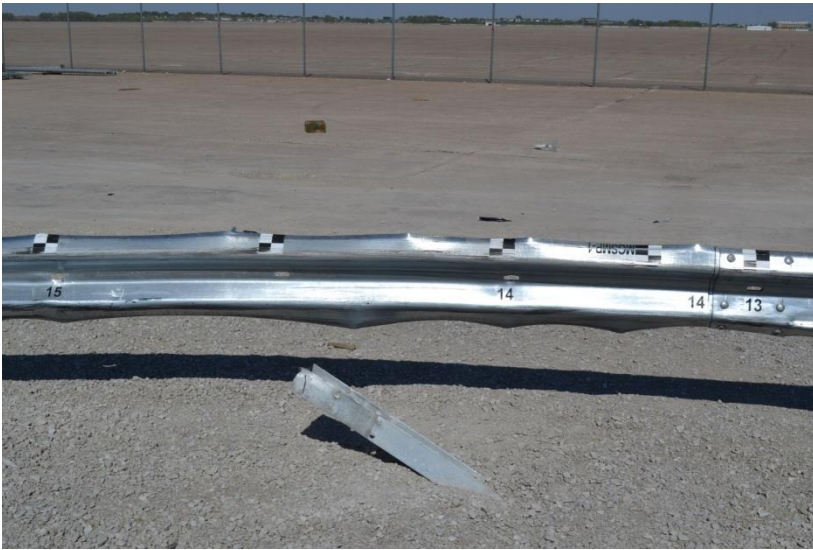
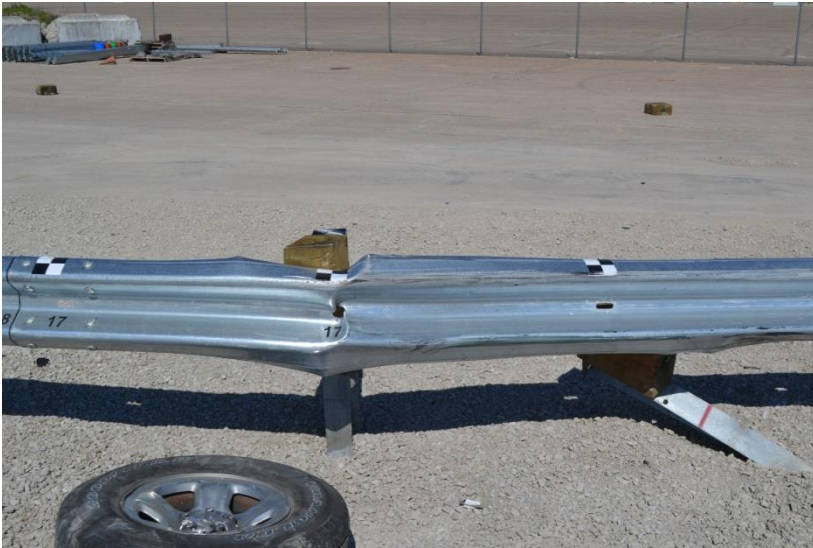
Figure 25. Rail Damage Between Post Nos. 12 and 17, Test No. MGSMP-1

bent at ground line due to the vehicle running over them, as shown in Figure 25. Blockouts were disengaged from post nos. 13 through 15.

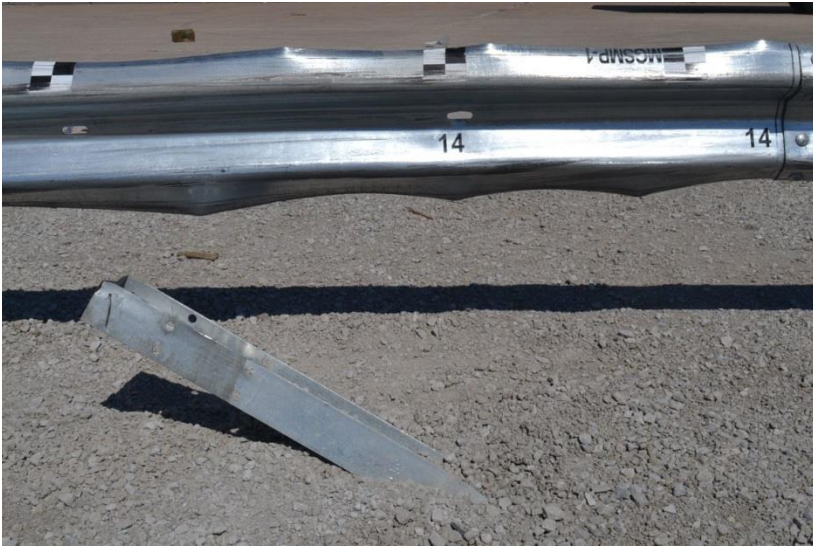
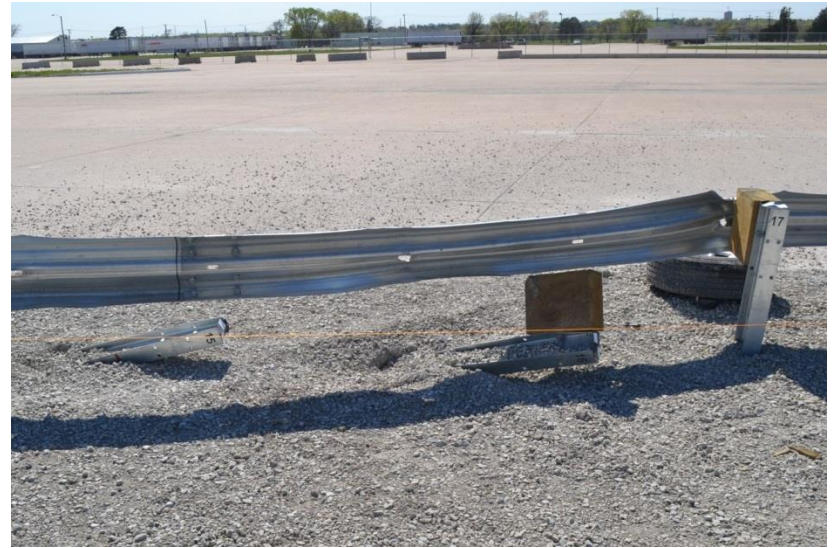
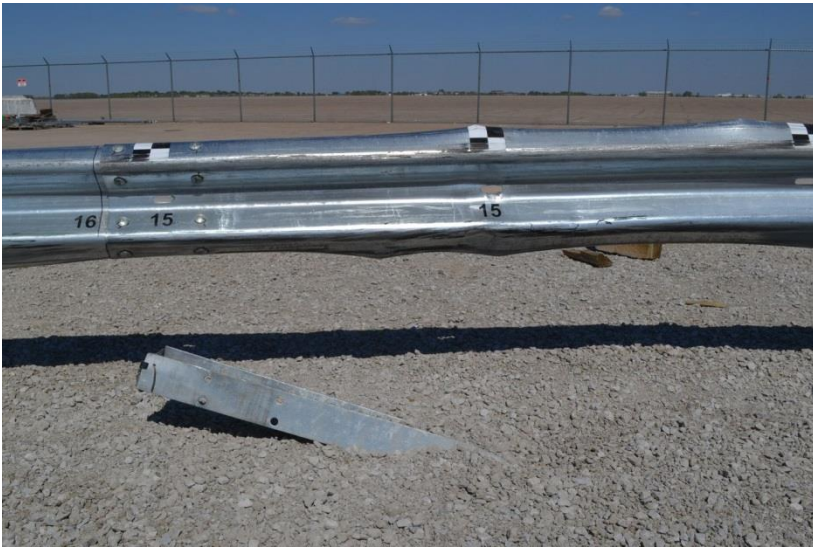
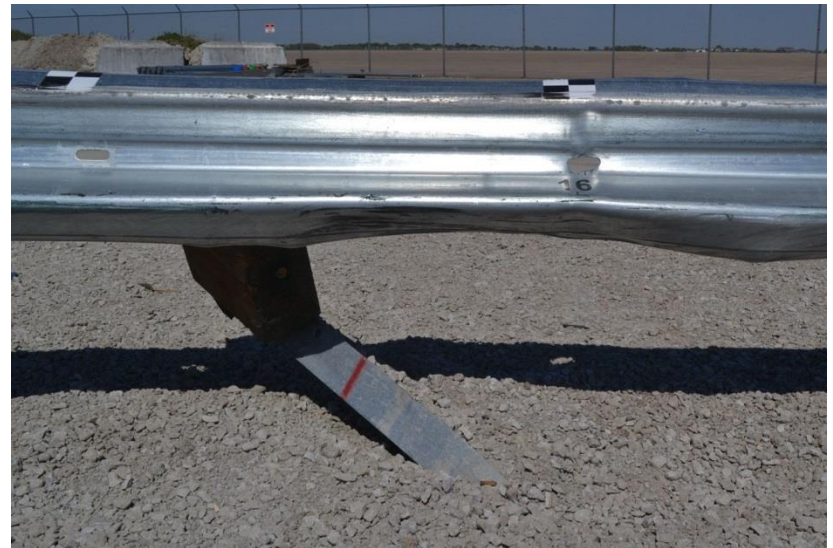
Figure 27. Post nos. 14 through 17 Damage, Test No. MGSMP-1

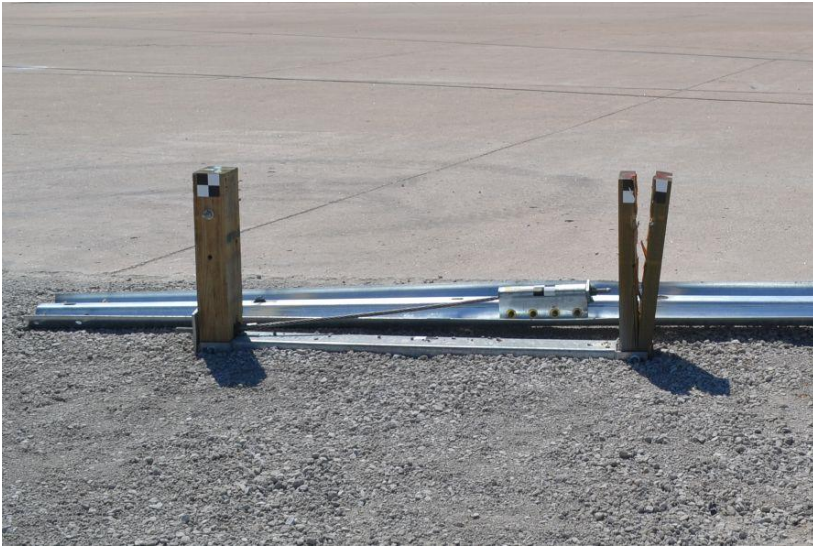
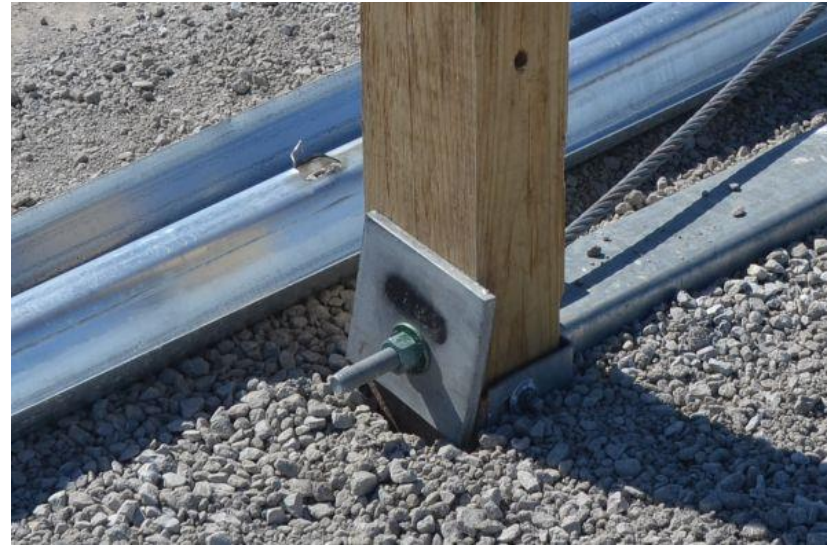
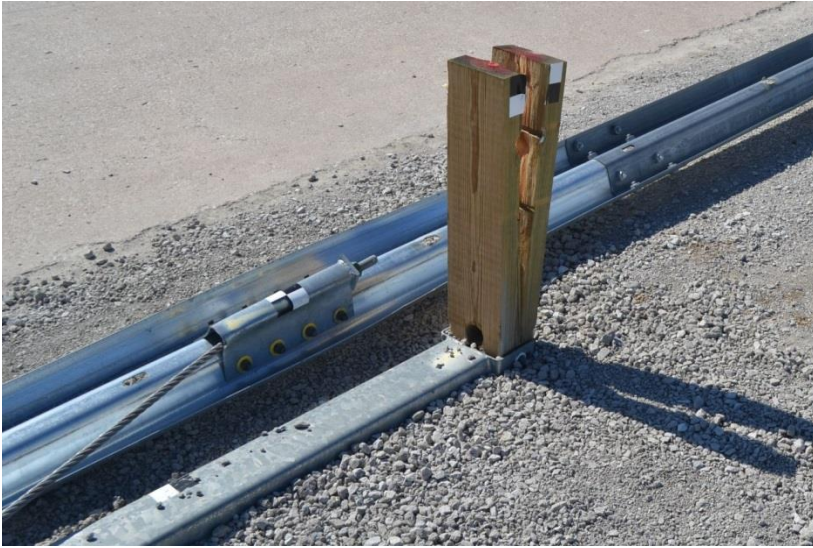
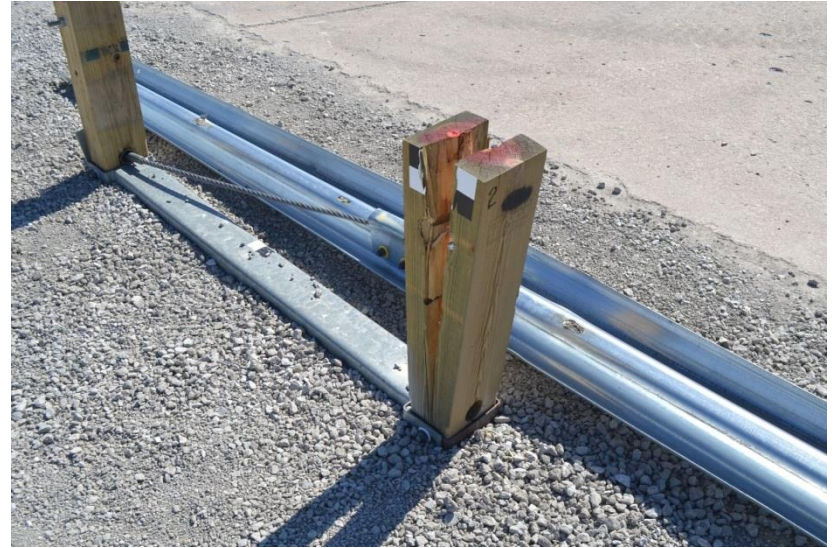
Figure 28. Upstream Anchor Damage, Test No. MGSMP-1

Although the post bolts pulled through the rail at the upstream anchor, the cable anchor remained intact between the rail and the bottom of post no. 1, as shown in Figure 28. Two tears, ¾ in. (19 mm) and ½ in. (13 mm) long, occurred in the rail at the bolt location of post no. 1. Post no. 2 was split down the center through the bolt hole. A 1-in. (25-mm) soil gap was found on the upstream side of post no. 1. The downstream anchorage was undamaged, except for a 1/16-in. (2-mm) soil gap found on the downstream side of the foundation tubes.

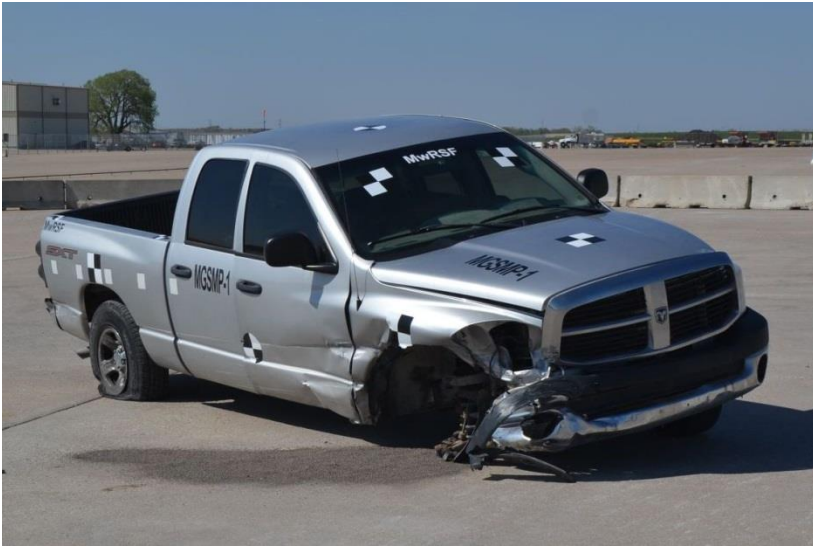
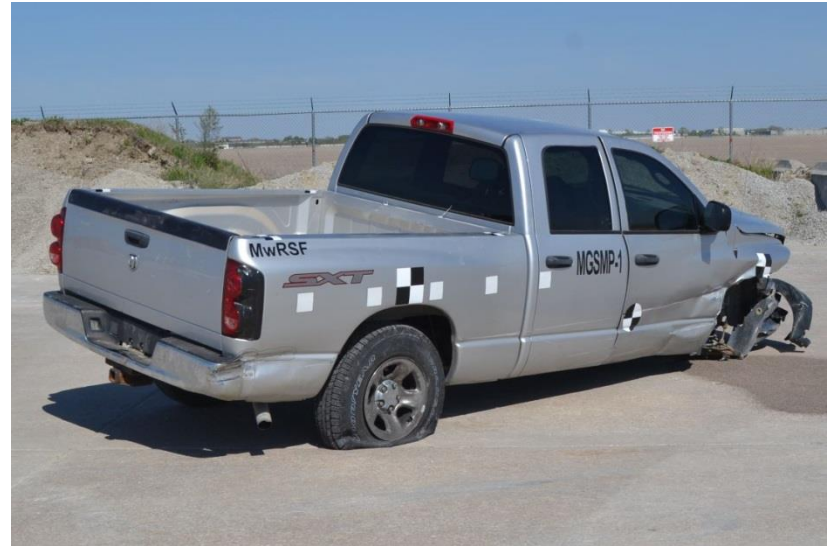
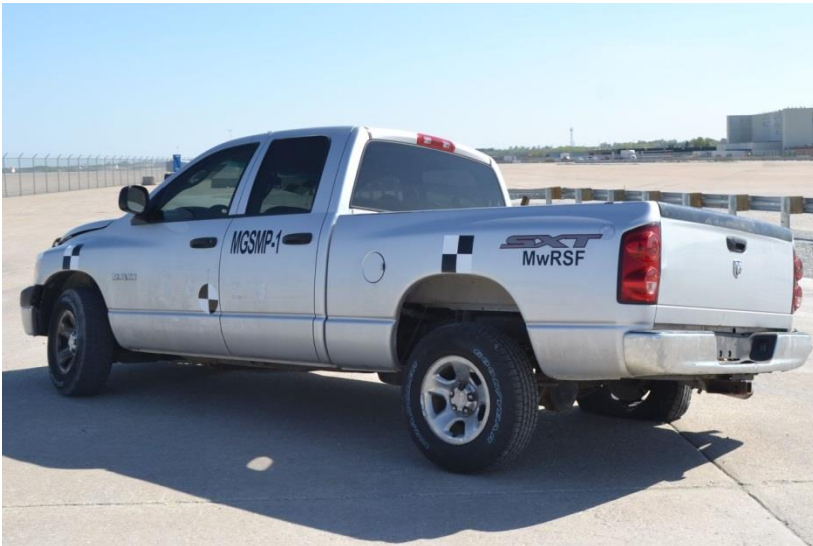
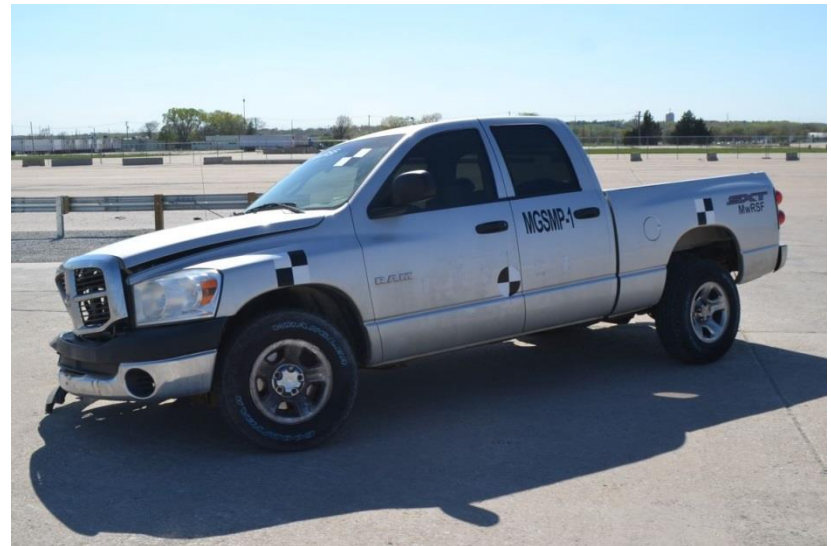
Figure 29. Vehicle Damage, Test No. MGSMP-1

The damage to the vehicle was moderate, as shown in Figures 29 and 30. The maximum occupant compartment deformations are listed in Table 6 along with the deformation limits established in MASH for various areas of the occupant compartment. Note that none of the MASH-established deformation limits were violated. Complete occupant compartment and vehicle deformations and the corresponding locations are provided in Appendix D.

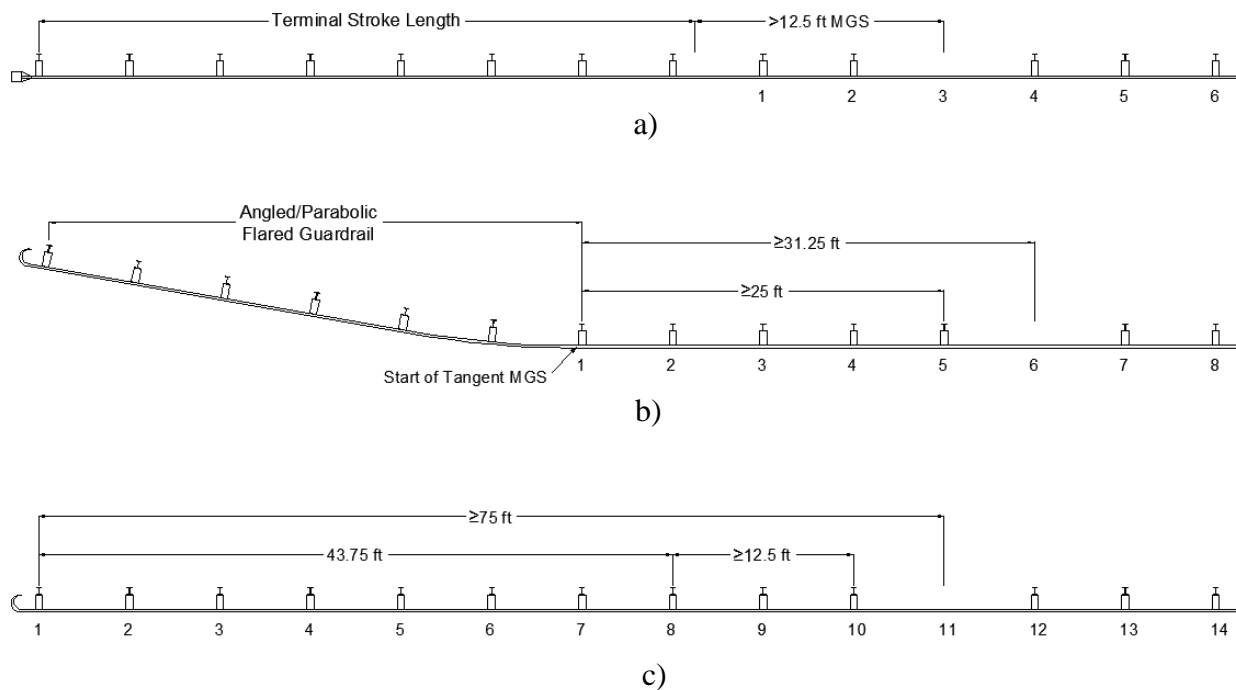
Figure 32. Recommended Distance Between Omitted Posts and a) Energy-Absorbing Terminals, b) Flared Terminals, and c) Trailing-End Guardrail Anchorages

identified by system stroke length, and the omitted post. In other words, the first post eligible for omission is the third guardrail post from the inner end of the terminal, or end of stroke length, as shown in Figure 32.

Non-energy absorbing terminals typically flare away from the roadway utilizing either an angled or parabolic geometry. Both geometric layouts result in increased effective impact angles, which result in increased system deflections for impacts on or near the flared terminal. Due to the increase in system deflections associated with guardrail flares, at least 25 ft (7.6 m) of tangent MGS should be used to separate a flared guardrail terminal and the enlarged span length, making the sixth post on the tangent length of MGS eligible for omission, as shown in Figure 32.

performance, rendering these recommendations erroneous. From the noted study, impacts beyond 43.75 ft (13.3 m) from the end post resulted in consistent redirection and working width. It is recommended that no omitted posts be located within this outer 43.75 ft (13.3 m) or the adjacent 12.5 ft (3.8 m) of MGS. Thus, the location of the first allowable omitted post would be 75 ft (22.9 m) from the anchorage post, or the 11th post of the installation, as shown previously in Figure 32.

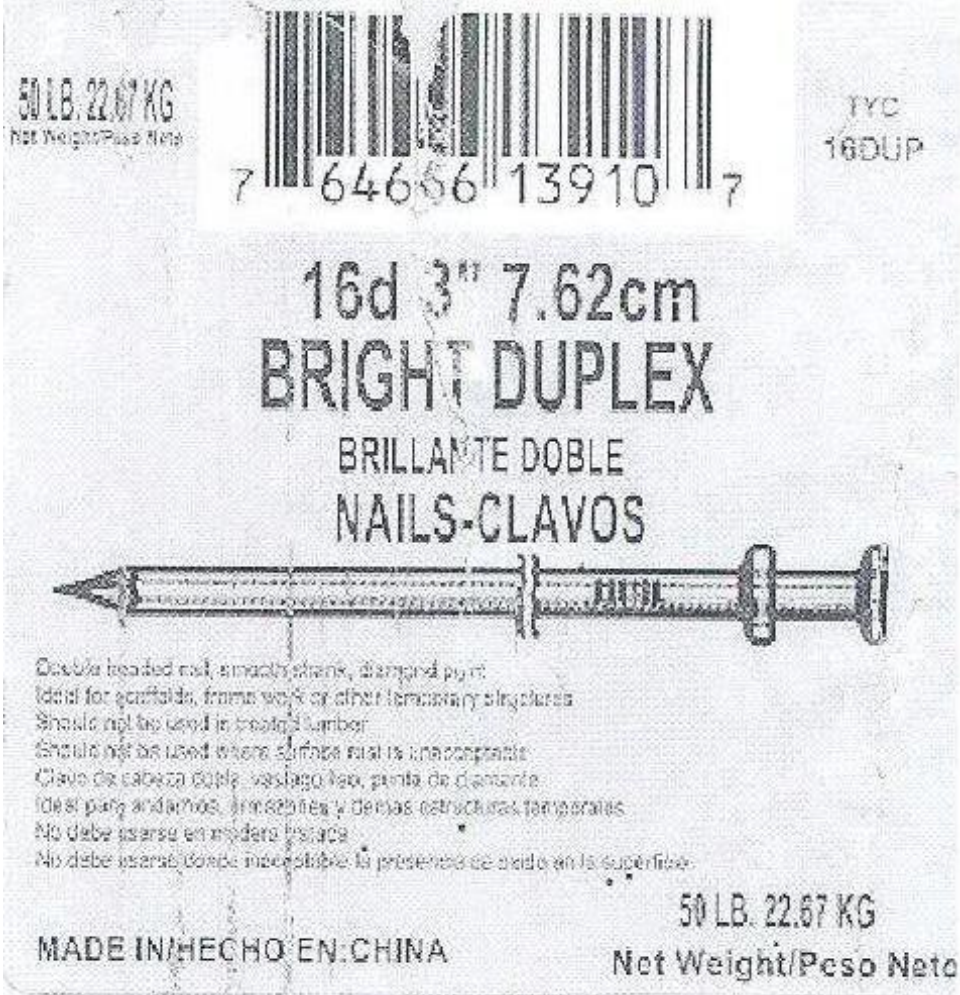
Figure A-5. 16D Double Head Nail, Test No. MGSMP-1

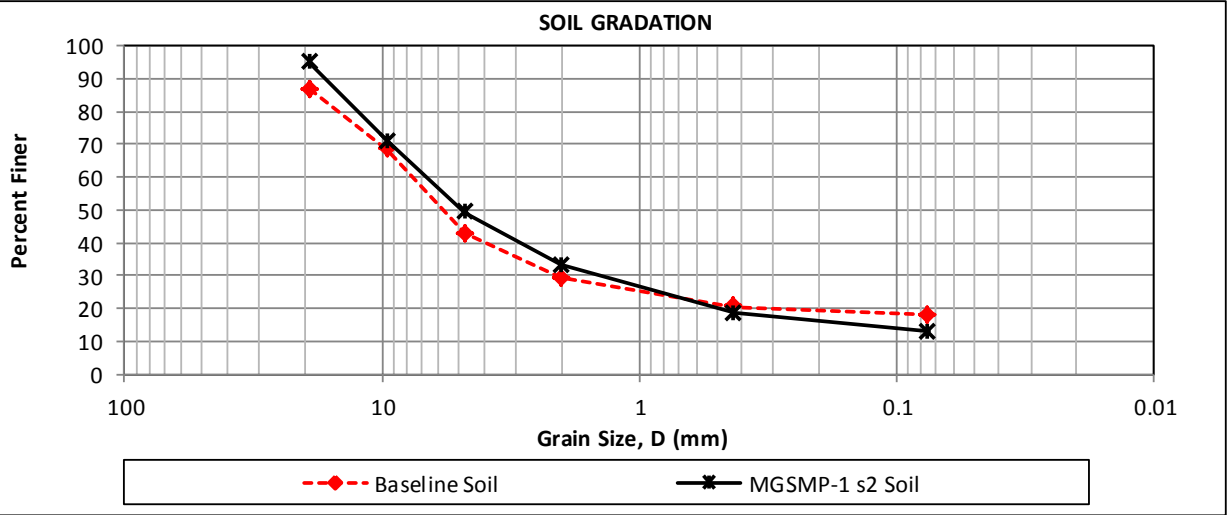
Date.....	4/29/2015
Test Facility & Site Location.....	Midwest Roadside Safety Facility
In situ soil description (ASTM D2487).....	Well Graded Gravel (GW)
Fill material description (ASTM D2487).....	Well Graded Gravel (GW) (see sieve analyses above)
Description of fill placement procedure.....	8-inch lifts tamped with a pneumatic compactor

Figure C-2. Static Soil Test S2, Test No. MGSMP-1

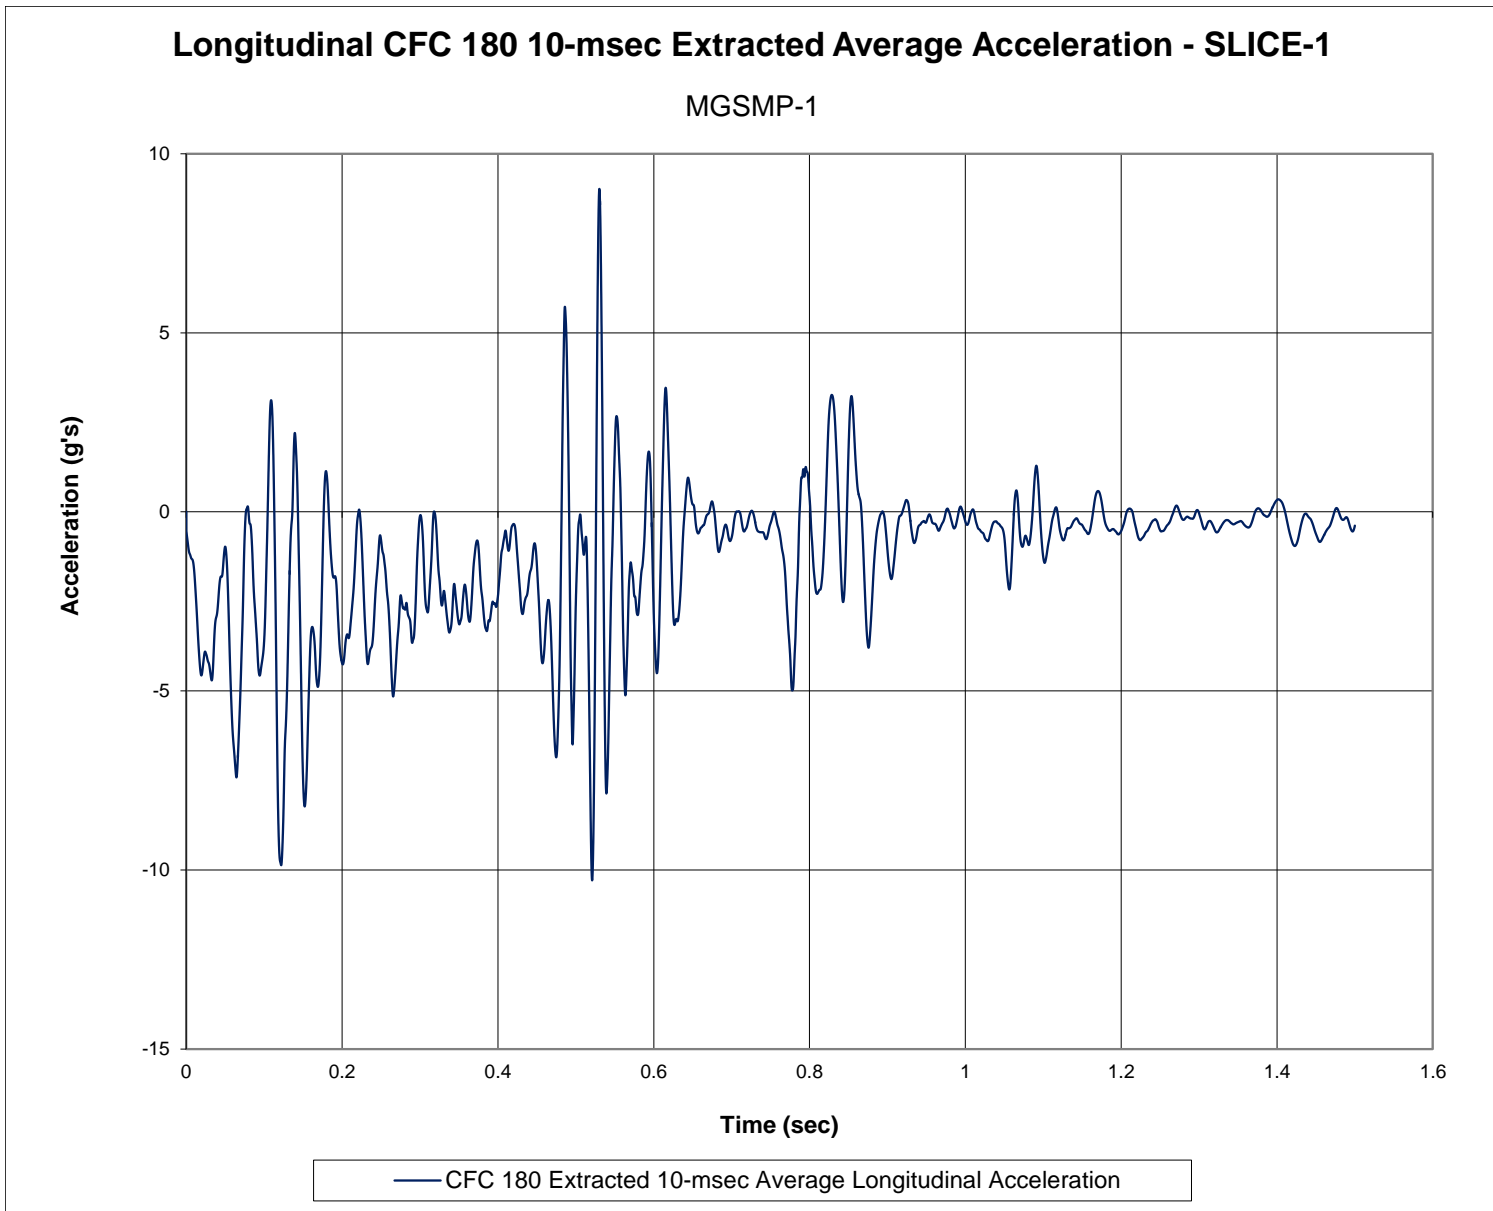
Figure E-1. 10-ms Average Longitudinal Deceleration (SLICE-1), Test No. MGSMP-1

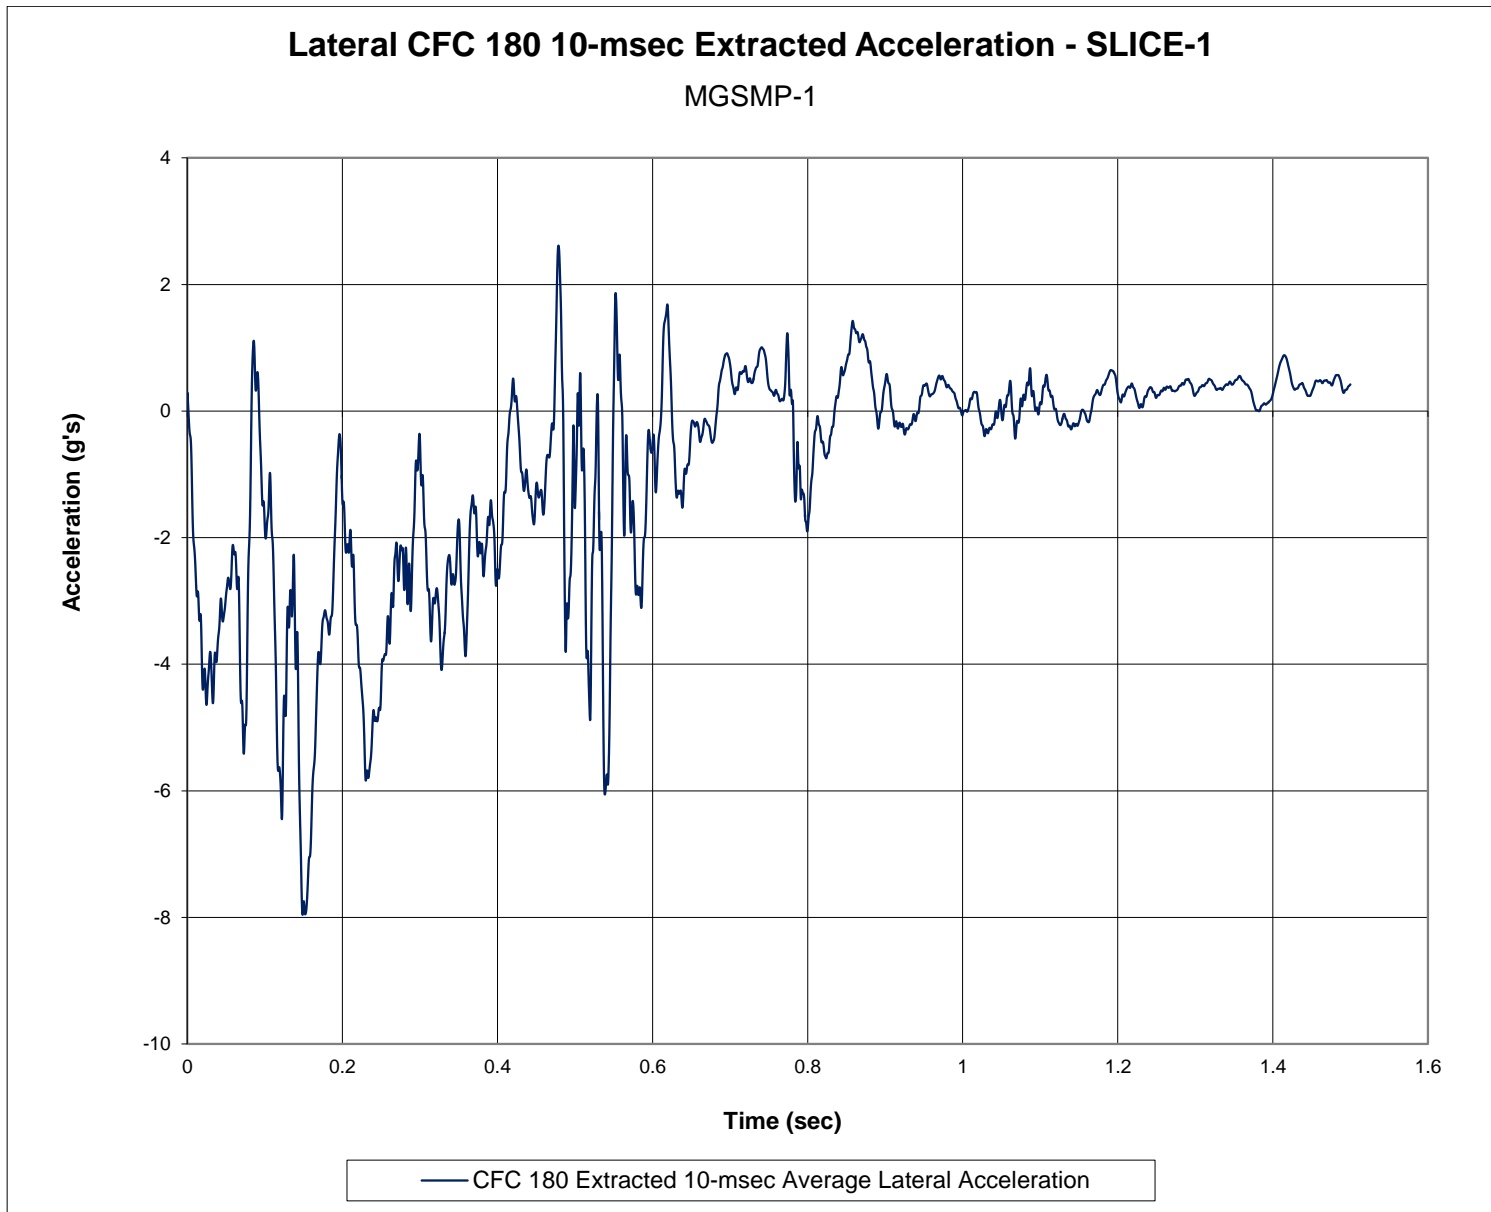
Figure E-4. 10-ms Average Lateral Deceleration (SLICE-1), Test No. MGSMP-1

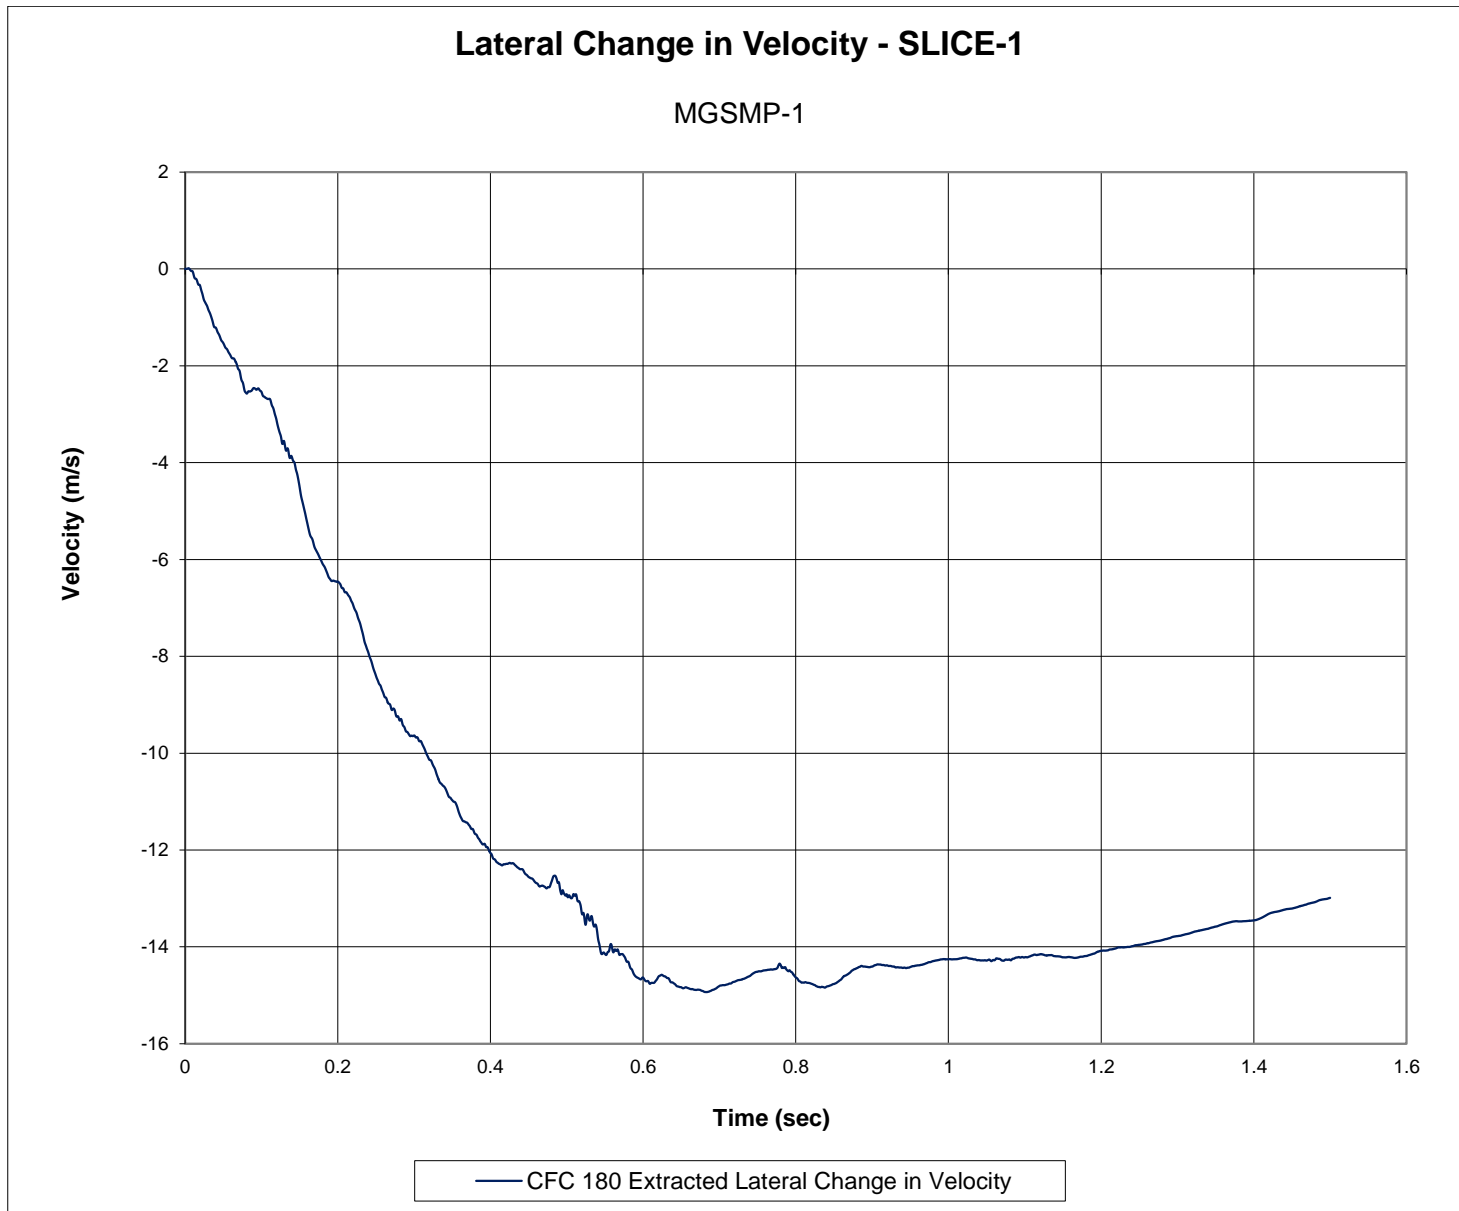
Figure E-5. Lateral Change in Velocity (SLICE-1), Test No. MGSMP-1
