Midwest Guardrail System (MGS) with an Omitted Post

TESTING CERT # 2937.01

MIDWEST GUARDRAIL SYSTEM (MGS) WITH AN OMITTED POST

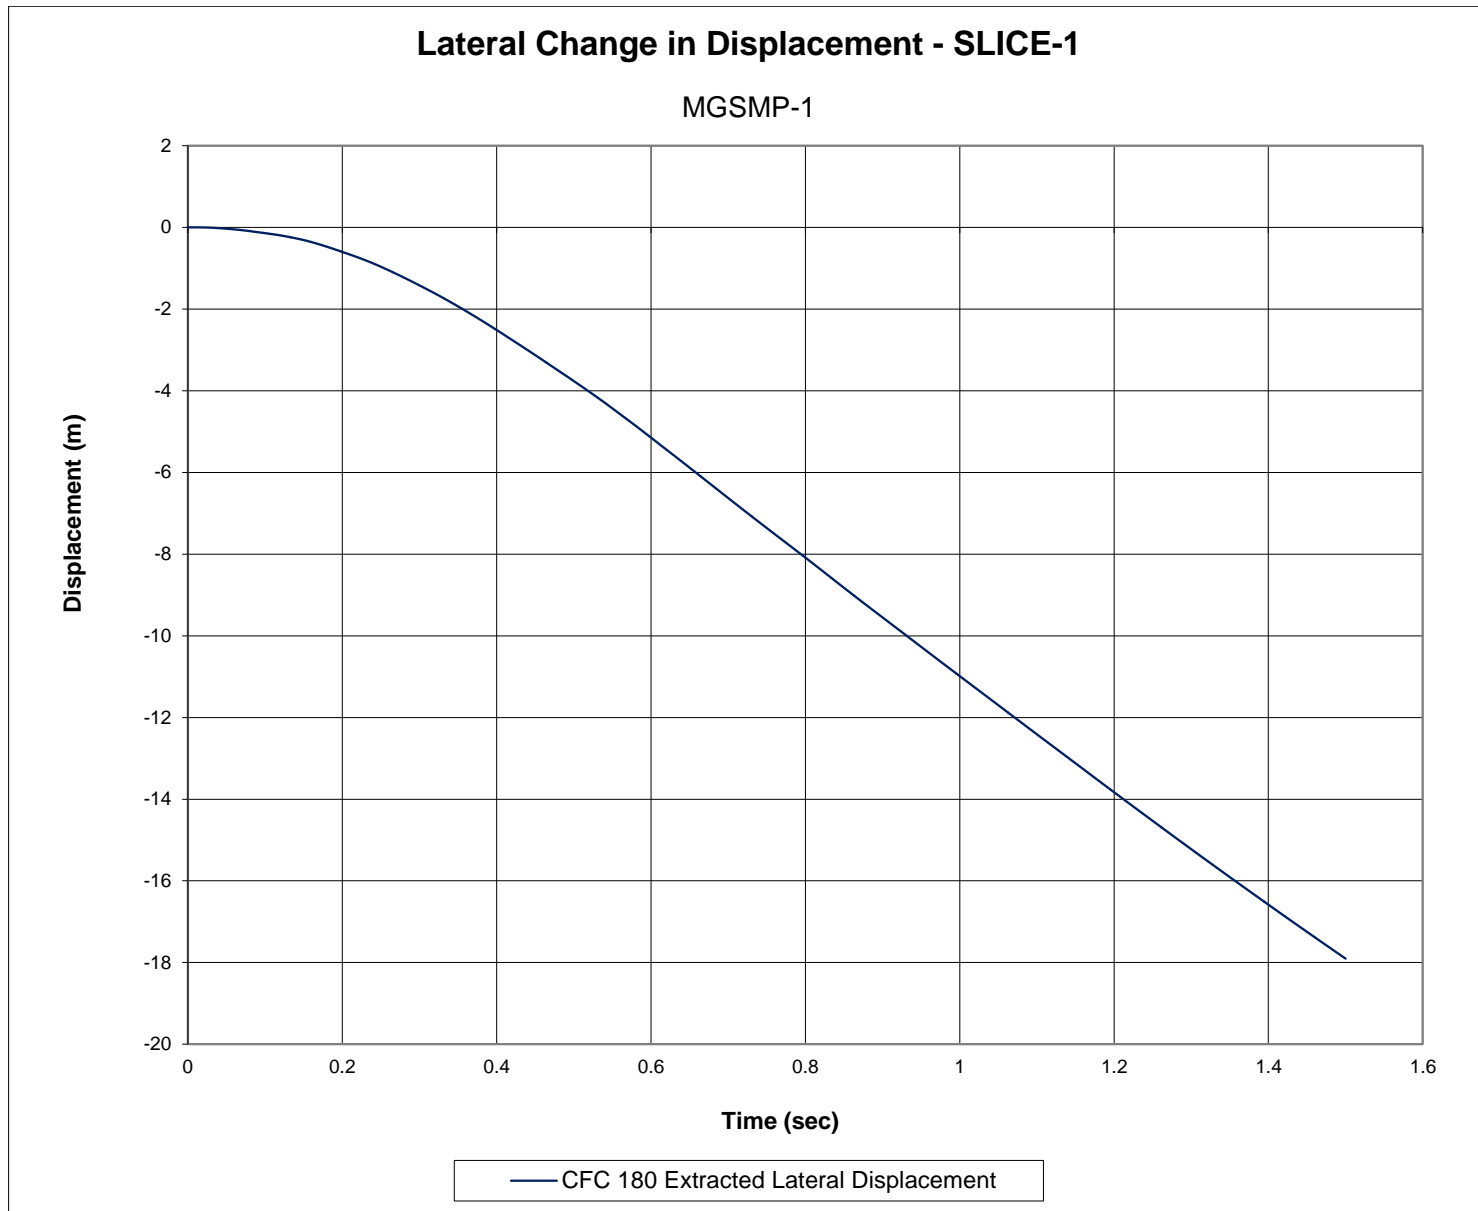
Figure E-6. Lateral Occupant Displacement (SLICE-1), Test No. MGSMP-1

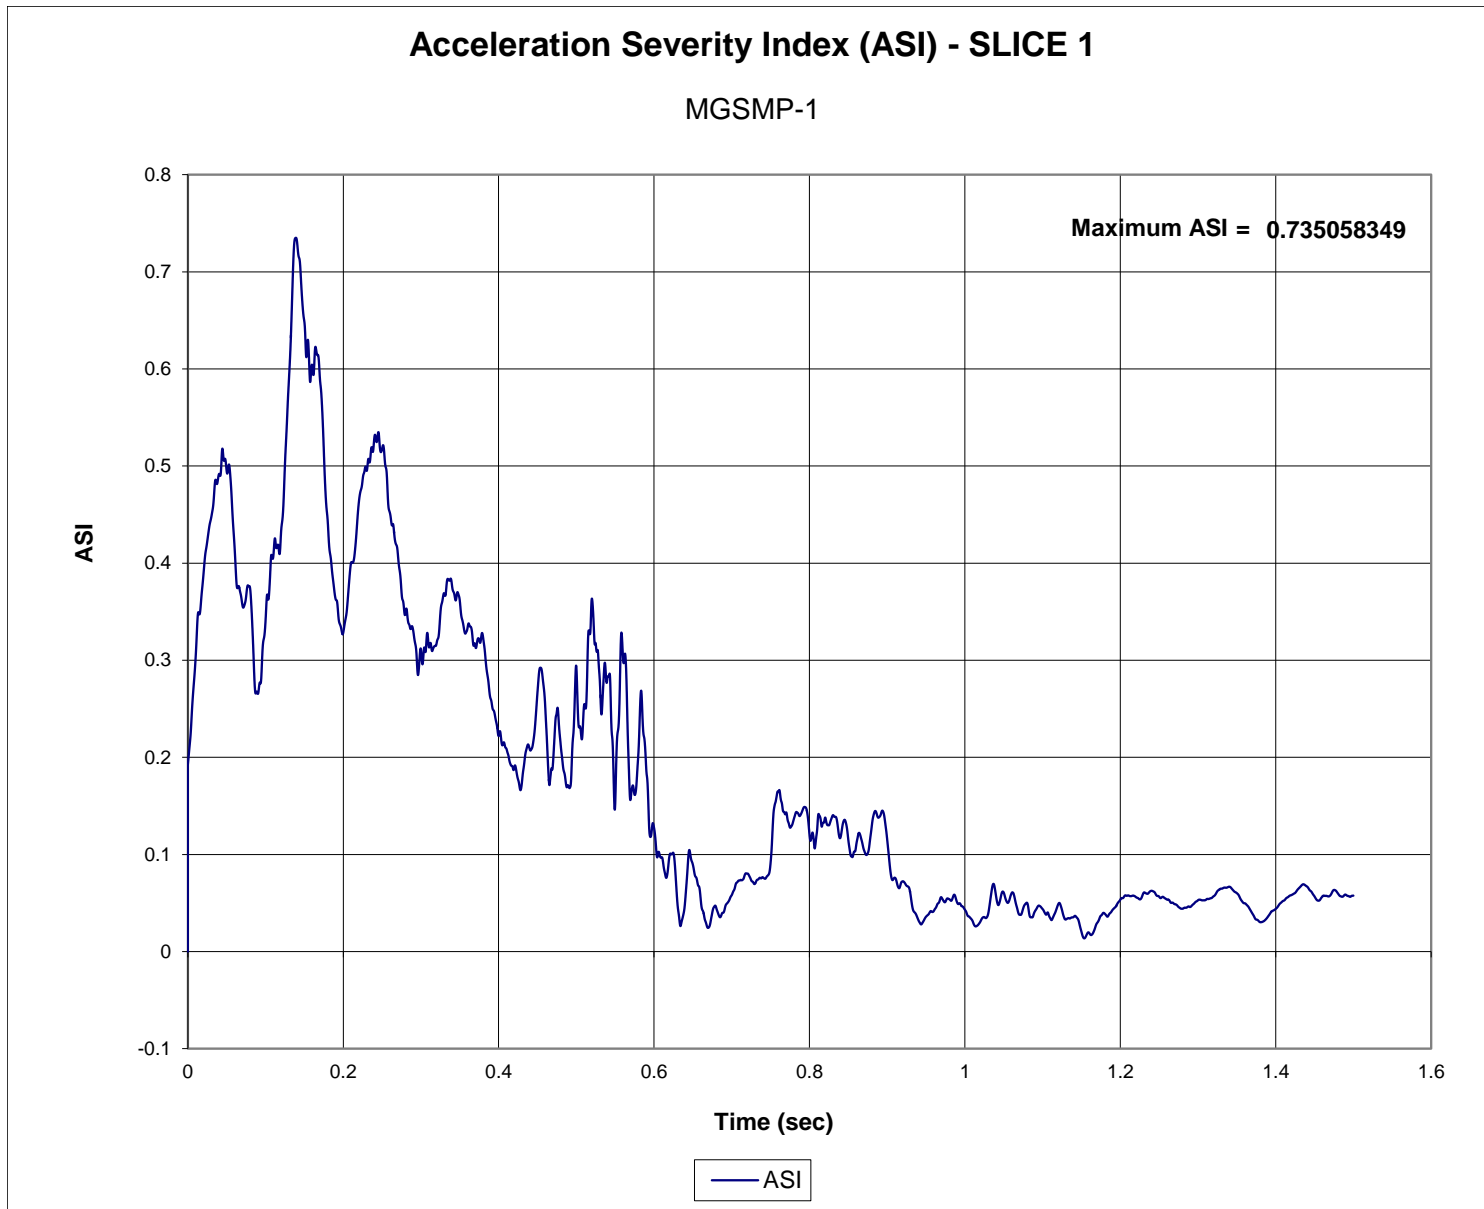
Figure E-8. Acceleration Severity Index (SLICE-1), Test No. MGSMP-1

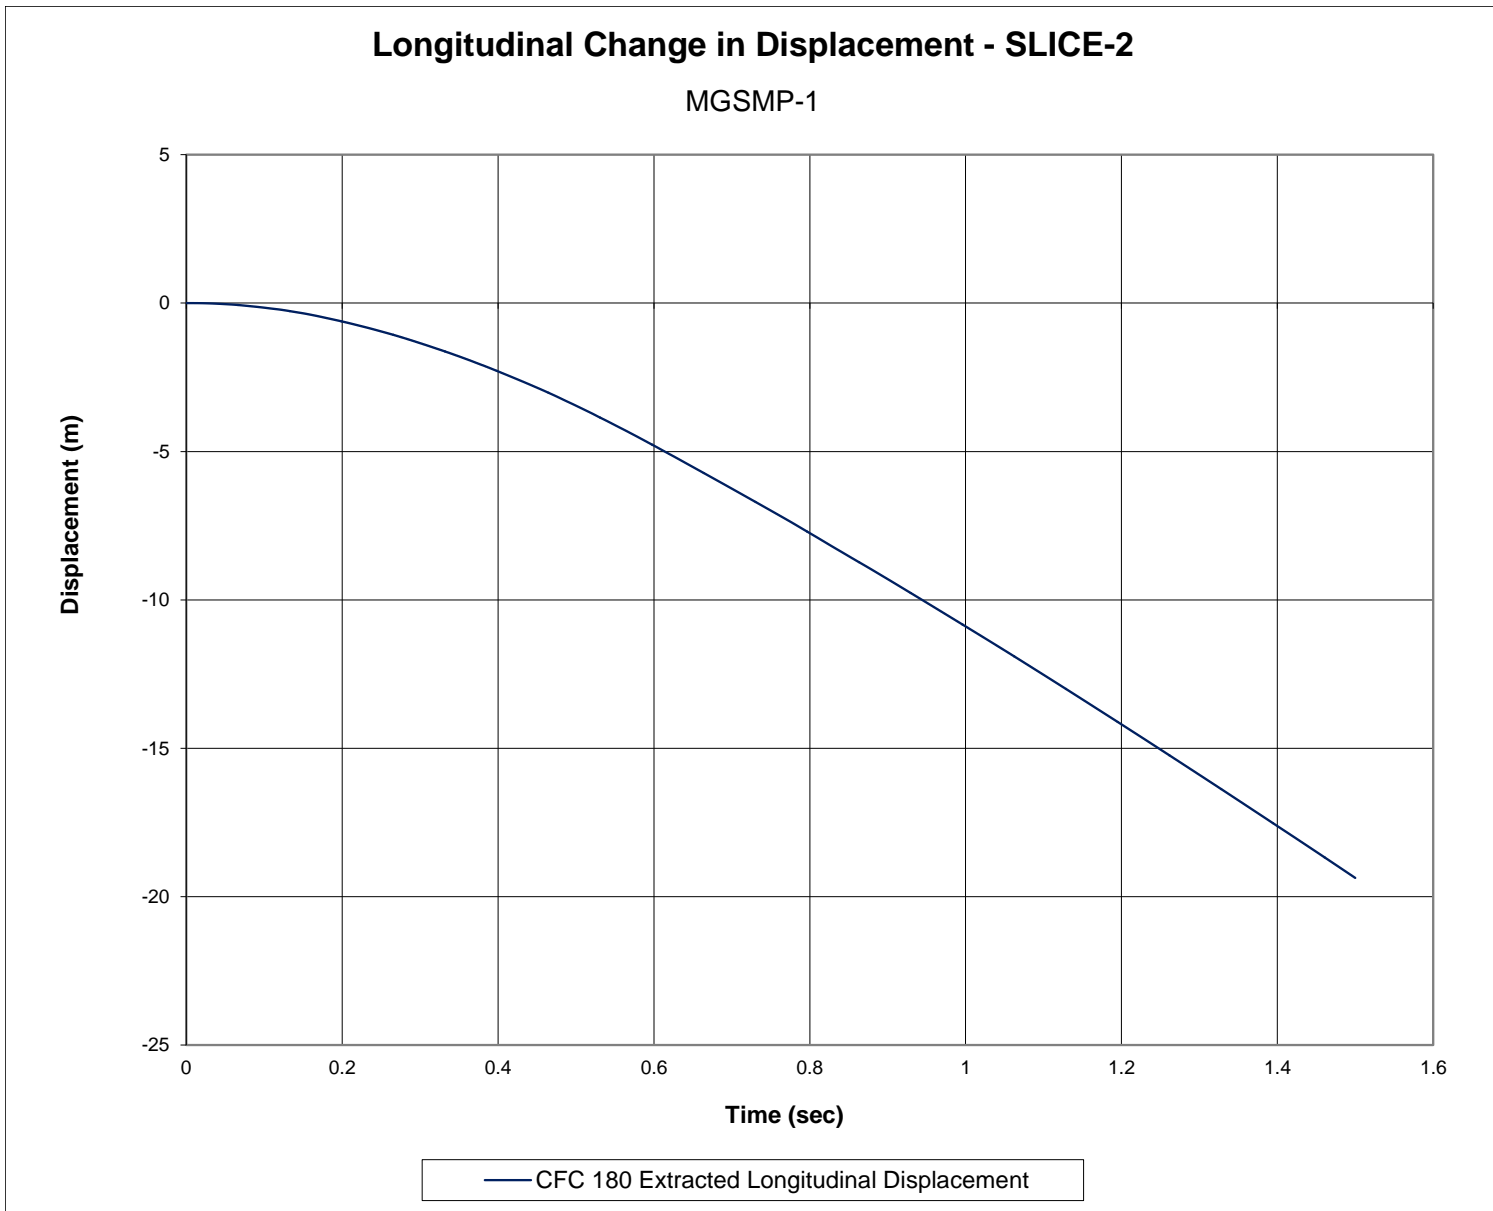
Figure E-11. Longitudinal Occupant Displacement (SLICE-2), Test No. MGSM-1
