Post-earthquake fire resistance of steel buildings

Jelinek, T. ; Zania, V.; Giuliani, Luisa

Published in:
Journal of Constructional Steel Research

In press in: Journal of Constructional Steel Research 138C (2017) pp. 774-782

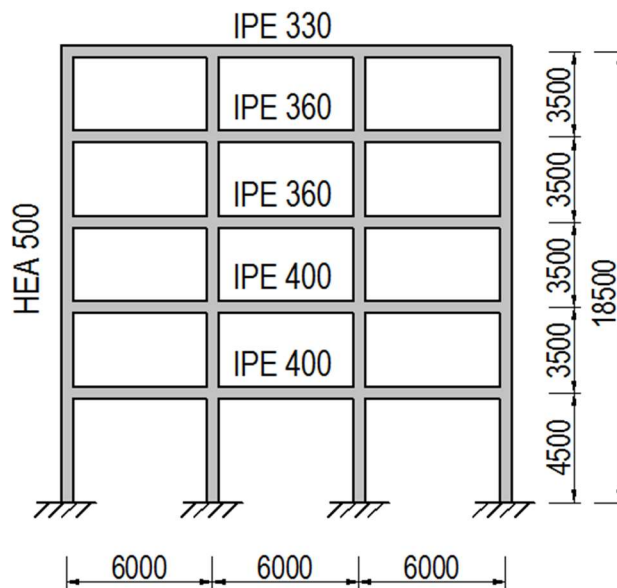
The structure chosen as case study is shown in Figure 1. The building represents the main frame of a residential steel building already studied in literature [15]. The load-bearing structure consists of an unprotected steel moment-resisting frame. The elements are made of S235 steel and all beam-column joints are assumed rigid. The frame is not insulated against fire, but is designed to withstand gravity and seismic load according to EN 1998-1 (following the concept of strong column-weak beam). In particular, the design peak ground acceleration (PGA) is 0.32 g and the damping ratio of the structure is assumed equal to 1% (modeled here as Rayleigh damping). The design vertical loads are:

Figure 1: Case study building geometry with dimensions in mm and section profiles

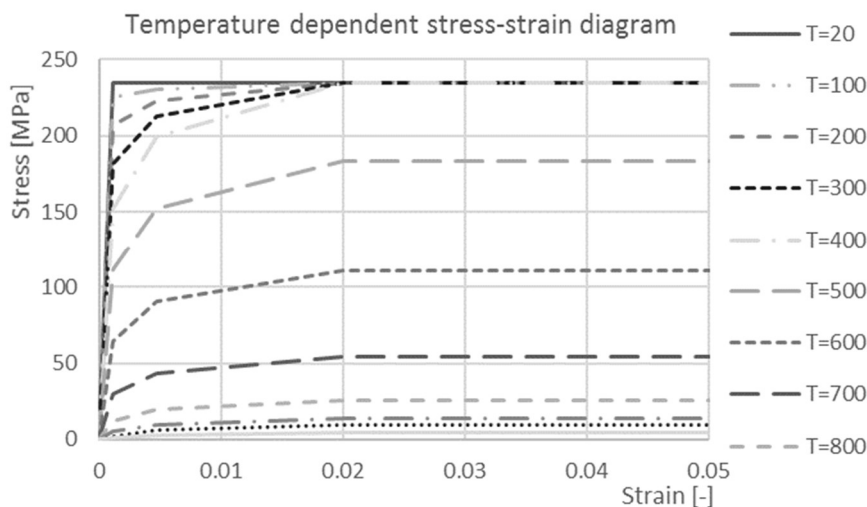
The thermo-plastic stress-strain relation used at different temperatures is shown in Figure 2. In particular, a multi-linear diagram is used, where the yielding curve between the elastic range and the plastic plateau is defined by three points: the first point indicated the end of the elastic branch and is assumed at the 0.2% proof strength of the steel (i.e. the strength that corresponds to the 0.2% residual strain after having unloaded the specimen); the third point indicates the beginning of the horizontal plateau and is defined by the ultimate steel strength and a corresponding deformation of 2%; the second point is defined in-between the previous two, with the purpose of giving a proper representation of the yielding curve.

Figure 2: Quadrilinear stress-strain diagram for steel at elevated temperatures

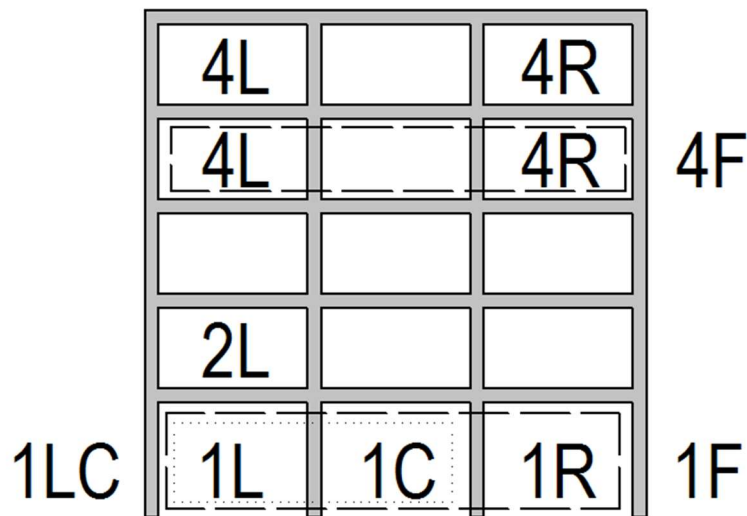
were then considered in the investigation of the building response to direct fire (DF) and PEF. All investigated scenarios are shown in Figure 4 and identified with a number indicating the floor number (1 to 4) and a letter indicating the position of the fire in the frame (R for right bay, C for center bay, L for left bay, and F for fire on the whole floor). In each fire scenario, all beams and columns pertinent to the bay or to the floor on fire were considered to be exposed to the fire and therefore subjected to the heating pertinent to each profile section.

Figure 4: Investigated fire scenarios and abbreviations used in the paper to indicate them

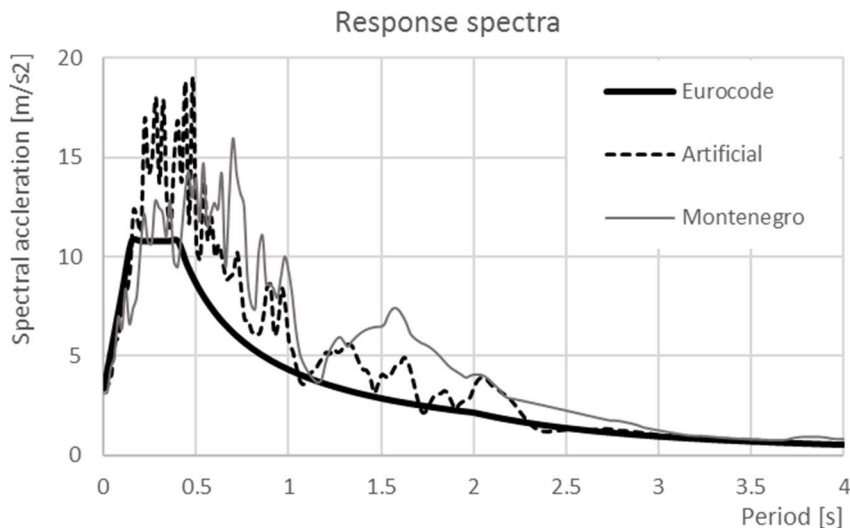
A seismic response analysis was carried out for all 7 earthquake events. Then the Artificial and the Montenegro earthquakes were selected for the investigation of the consequent fire response analysis (Figure 5). The Artificial earthquake was chosen due to its relatively good fit to the Eurocode response spectrum (EN 1998-1, 2004) which was used to design the building. In contrast, the spectrum of the Montenegro earthquake is higher than the Eurocode spectrum particularly for the first (swaying) mode (1Hz). As a result, larger floor drifts than the ones considered in design are expected, especially at the top floors (see also Table 2).

Figure 5: Response spectra of 2 accelerograms and the elastic response spectrum according to EN1998-1 [1].

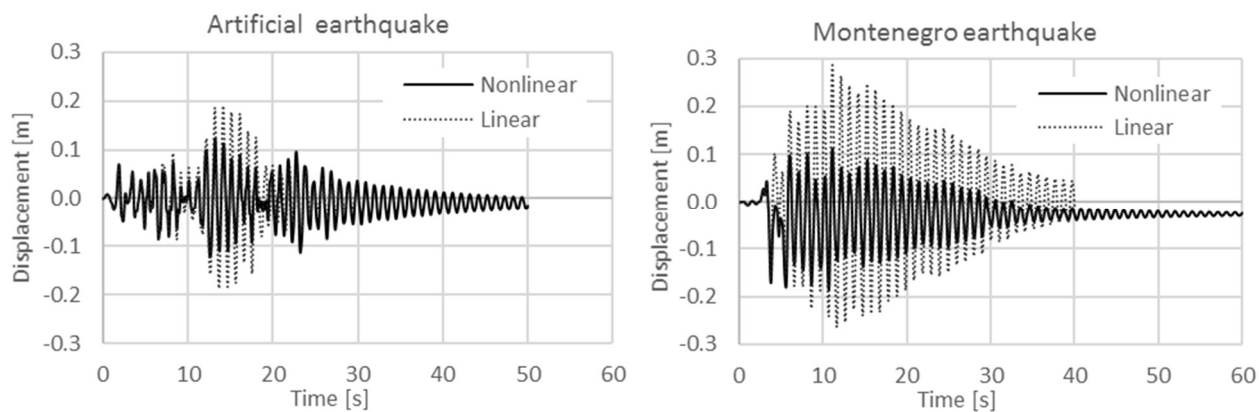
The results of the seismic analysis are shown in Figure 6 in terms of time history displacement of the roof for the Artificial earthquake (left chart) and the Montenegro earthquake (right chart). In both charts, the time history obtained from the nonlinear analysis is compared with the one obtained from a linear analysis, in order to highlight the time when the energy of earthquake is dissipated by the development of plastic hinges. It is noted that additional 20 seconds of free vibration are added to the accelerograms during the nonlinear analysis, in order to dissipate all dynamic effects before starting the subsequent analysis step.

Figure 6: Comparison of displacement response histories of elastic and inelastic systems for Artificial (left) and Montenegro (right) earthquake

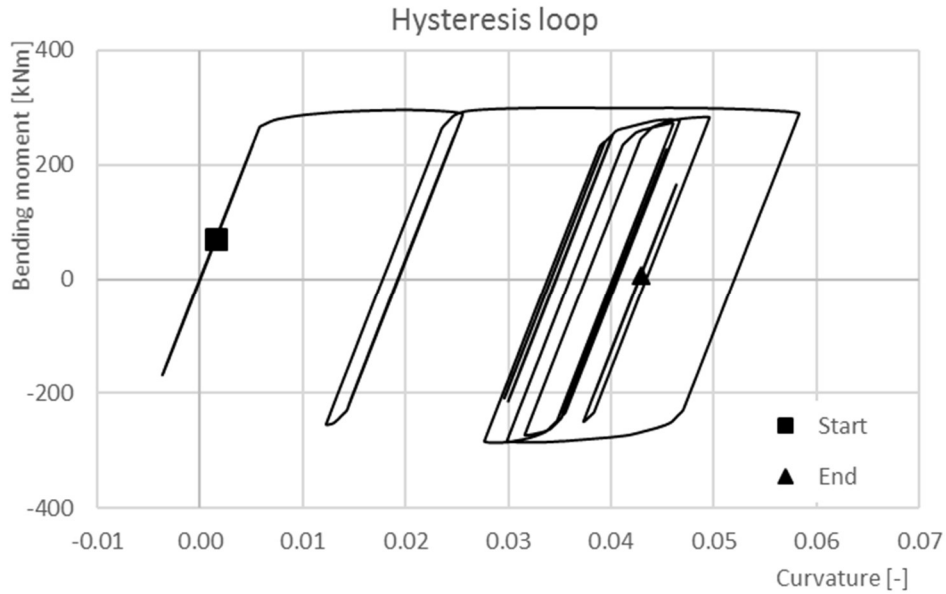
In Figure 7, the moment-curvature diagram of a plastic hinge formed during the Artificial earthquake is shown (left end of the beam in 1st level and left bay). The hysteresis loops indicate how much energy dissipates in that particular hinge. The start and the end states are indicated in the chart with two markers (square and triangular, respectively) in order to follow the evolution of the moment-curvature relation. It is worth noting that the section becomes fully plastic at an early stage during the earthquake. However, after several loading and unloading cycles, it ends up to be almost unloaded in its final status. The initial and final moments, even though very close to each other, are not the same,

presumably due to geometric nonlinearities. The initial and final curvature instead differ significantly from one another, due to the residual plastic deformations.

Figure 7: Full hysteresis loops in the joint (left end of the beam at ground floor, left bay)

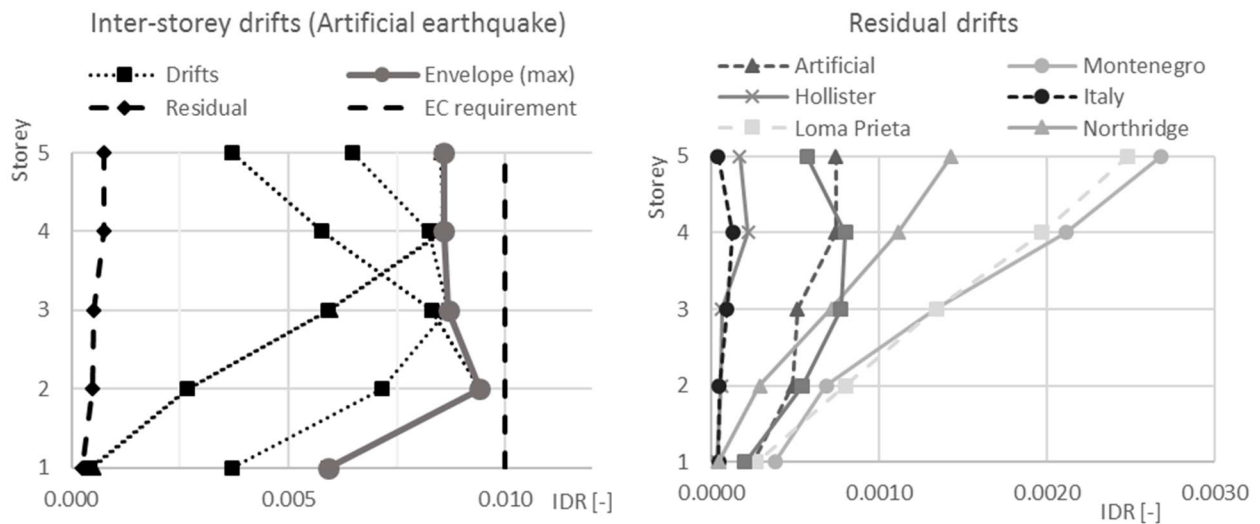
Figure 8 illustrates the results of the frame deformations in terms of inter-story drift ratios (IDRs) for individual levels. The IDR is defined in the following equation, where δ_i is the displacements at top of the i -th story and h_i is the story height:

The left chart in Figure 8 shows the maximum IDRs for the Artificial earthquake and their envelope (continuous line) along with the residual drift at the end of the seismic motion. It can be observed that the damage limitation prescribed by EN 1998-1 [1] is not exceeded, even though a seismic action meeting the damage limitation requirement would have a larger probability of occurrence than the design seismic action. The right chart shows a comparison of the residual drifts (permanent deformations) caused by each of the 7 earthquakes considered in the analyses. It can be seen that Montenegro and Loma Prieta earthquakes result in the largest IDRs amongst the selected time histories, while the values are still less than half of the required ones [1].

Figure 8: Inter-story drifts for the Artificial earthquake (left) and residual inter-story drifts for all analyzed earthquakes (right).

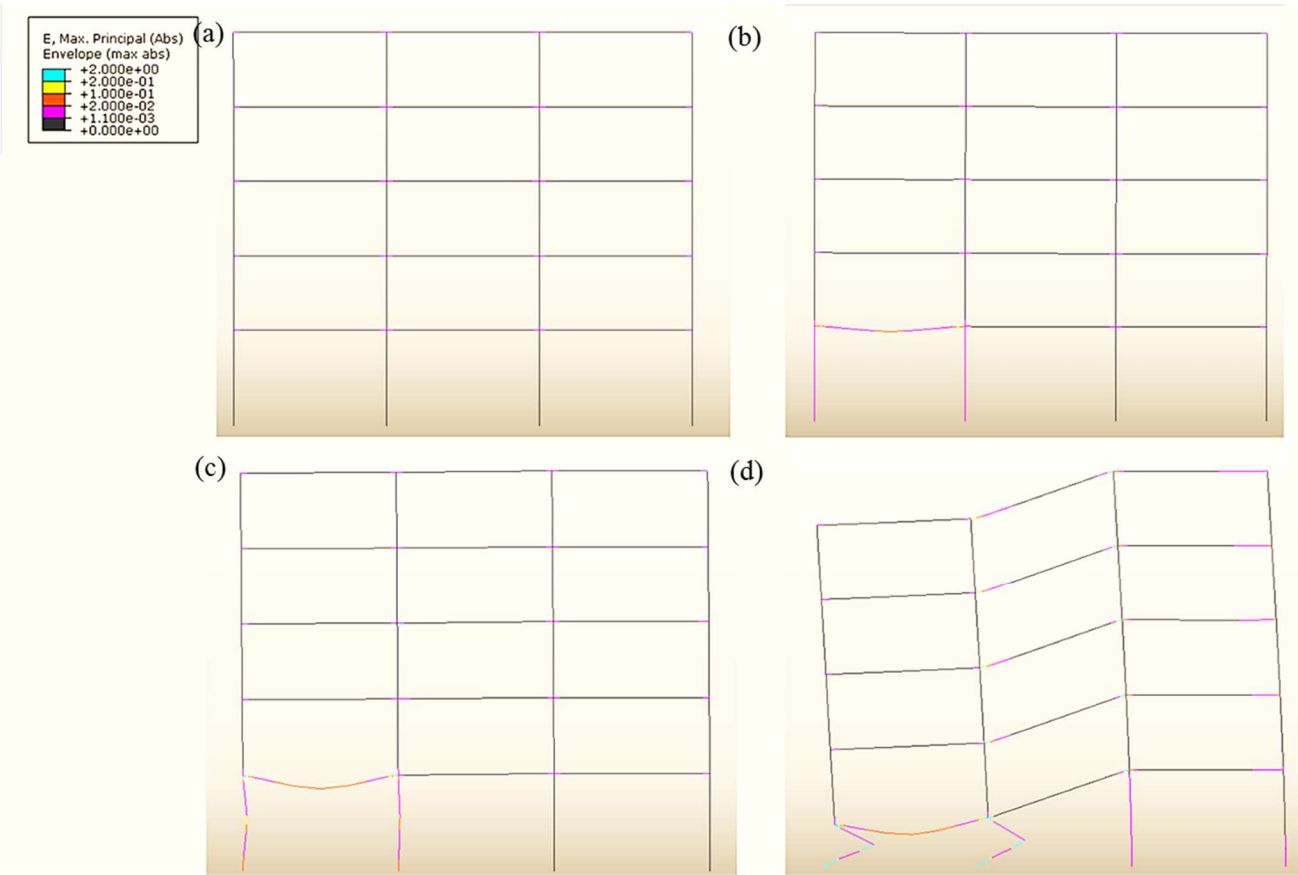
Figure 9 shows the deformation of the frame at 4 times in the analysis, specifically at 0 min (initial state), 20.1 min (triggering of catenary effect on the beam) and at 27.8 min (failure of both columns leading to global collapse immediately after). The failure mode of the frame can be followed by looking at the progression of the element plasticization (colored part of the frame). The failure starts in the beam and then progresses to the outer column, eventually involving the inner column as well. This failure corresponds to the global collapse of the frame, which occurs after ca. 28 min, clearly visible in the bottom right picture of Figure 9.

Figure 9: Global collapse mechanism (Scenario A-1L): initial state at 0 min (a), catenary effect at 20.1 min (b), failure of columns at 27.8 min (c) and global collapse 2 seconds later (d).

- The formation of the beam mechanism is closely followed by the failure of the left column first and of the right column shortly after. At this point, the frame remains unsupported for 2/3 of its width, which causes the structure to bend down, presumably leading to the failure of the two cold columns and resulting in a global collapse of the whole frame.

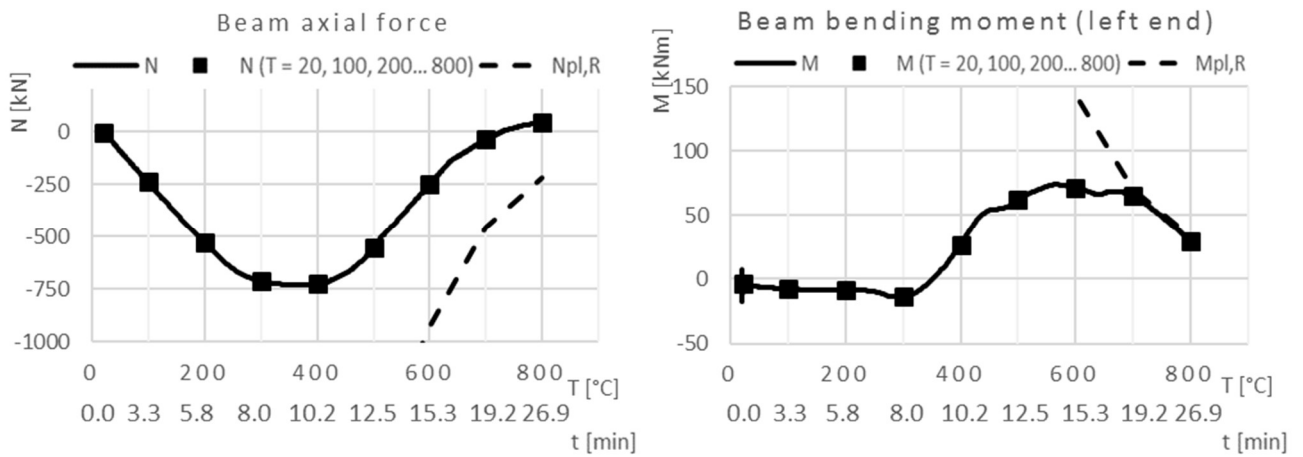
The behavior of structural elements during the collapse mechanism can be better understood by looking at the section forces of the beam and left column reported in Figure 10 and Figure 11 respectively with respect to the element temperature (upper charts) and time of fire exposure (bottom charts):

- At the beginning of the fire, all heated elements expand in the longitudinal direction. While the expansion of the columns is quite limited, due to the restraint offered by the upper part of the frame, the expansion of the beam (left chart of Figure 10) is more significant and causes the left outer column outwards movement. This, in turn, causes an increment in the bending moment of the left column, as the flexural stiffness of the column opposes to the outer displacement of the beam (right chart of Figure 11).

- As the steel heating progresses, the steel mechanical properties degrade and the load bearing capacity of both beams and columns decrease (indicated with a dotted line in the charts of Figure 10 and Figure 11). Plastic hinges develop first at the beam-ends, inducing higher deflection and moment at the beam mid-span (right chart of Figure 10). Soon after, a third plastic hinge forms at mid-span of the beam, when it becomes a mechanism and loses its ability to carry the load.

- After the formation of the mechanism, the beam deflection increases rapidly, while the axial stresses in the beam begin to decrease (left chart of Figure 10) and the left column is called back inward. This behaviour, caused by the nonlinear effect of the beam elongation, is often responsible for triggering a catenary in the beam, as described in Aiuti et al. [33]. In this case, the value of the

Figure 10: Axial force in the beam (left charts) and moment at the beam left end (right charts) in the A-1L scenario, plotted against the beam temperature (upper axis) and the time of fire exposure (bottom axis). The dotted lines in the left and right charts represent the axial and bending resistance, respectively.

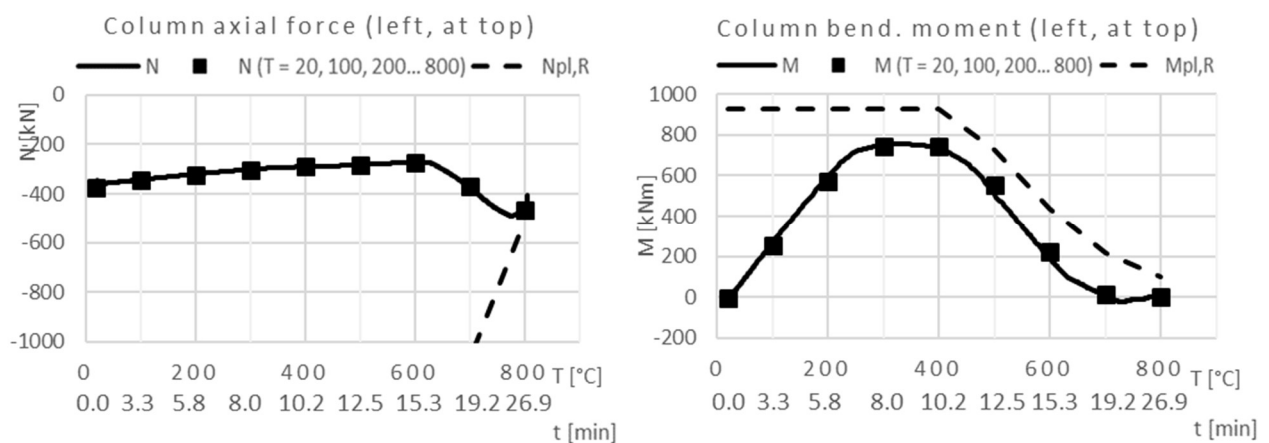
Figure 11: Axial force in the column (left charts) and moment at the top of the left column (right chart) in the A-1L scenario, plotted against the beam temperature (upper axis) and the time of fire exposure (bottom axis). The dotted lines in the left and right charts represent the axial and bending resistance, respectively.

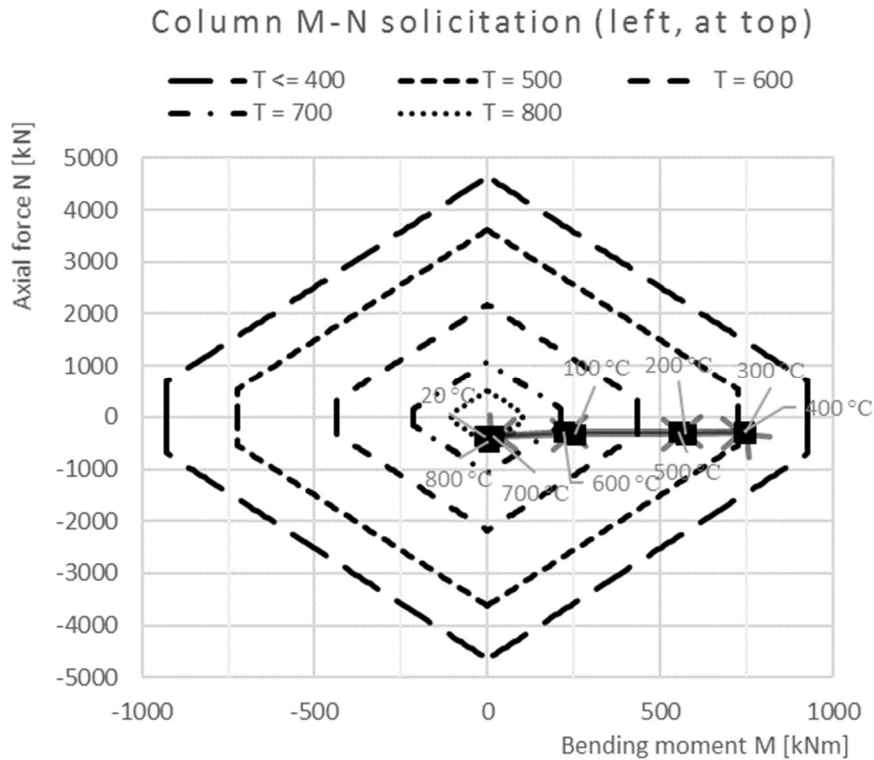
Figure 12: Interaction diagram of axial force and bending moment at top of the left column with resistance envelope shrinking with elevated temperature

Both the time of global collapse and the failure progression induced by the post-earthquake fire (PEF) is almost identical to what obtained by investigating the response of the undamaged frame to direct fire (DF), i.e. without the consideration of a prior earthquake. In particular, in the PEF case, the beam failure occurs ca. 10 s earlier than it would in case of DF. This is visible in Figure 13, where the moment distribution on the heated beam are reported for both PEF and DF analyses and the different sectional failures are highlighted. It can be seen that, despite the different initial value of the moment,

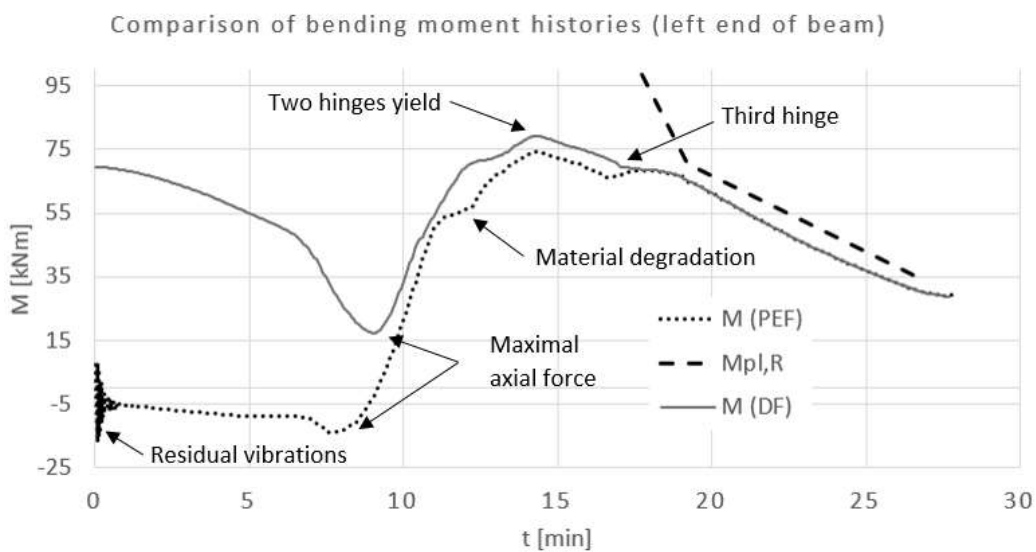
the development of the moment becomes almost the same after ca. 500 s of analysis, when the compressive force in the beam starts to decrease. The negligible time difference in the beam failure reflects on the time of global collapse of the frame, which is delayed by ca. 13 seconds in the PEF case.

Figure 13: Comparison of bending moment histories in case of DF and PEF for A-1L scenario (left end of the heated beam)
