The detection of hydrogen induced cracking in welded and seamless steel pipes using acoustic emission and ultrasonic techniques

THE DETECTION OF HYDROGEN INDUCED CRACKING
IN WELDED AND SEAMLESS STEEL PIPES USING
ACOUSTIC EMISSION AND ULTRASONIC TECHNIQUES

G A Raine, F.Inst. NDT.TEng (CEI)

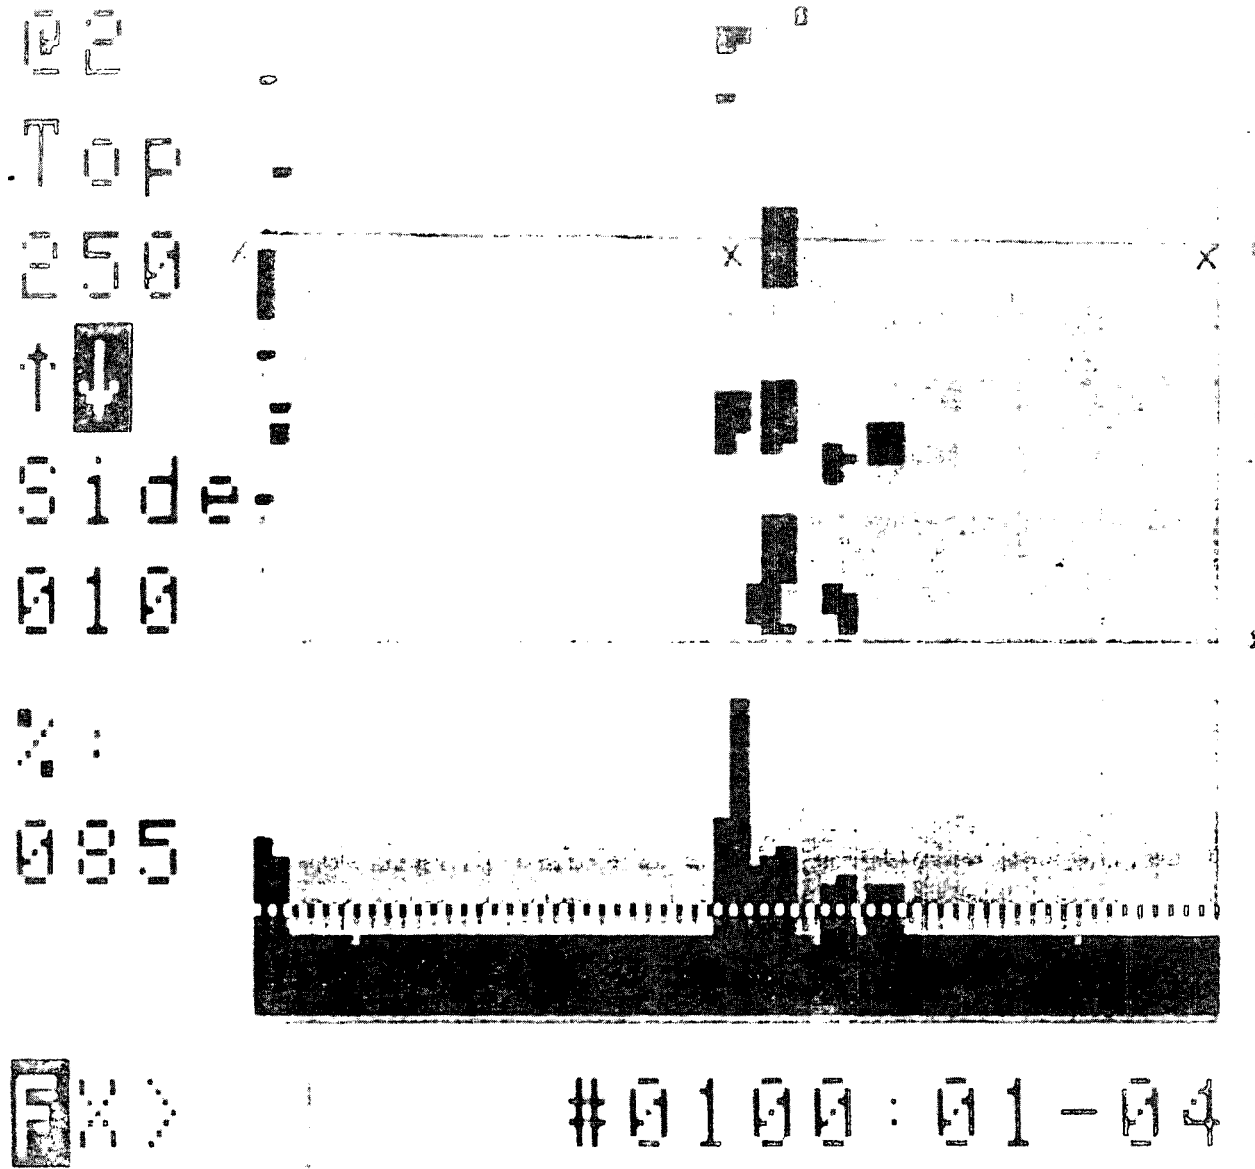
Figure 102 Ultrasonic scan of top area of pipe section 3

The mechanised ultrasonic scanner was used to examine the pipe and produced indications in the same area as the acoustic emission events, Figure 102. Metallographic sections were removed in an attempt to validate the ultrasonic and acoustic emission indications.

The results from the automatic welded pipe 3 were again different from those of the two previous pipes. Only two regions of activity were noted during the whole test. As before, because the acoustic activity produced was small the test was extended, monitoring on a limited basis. The same two regions remained active, Figures 99-101. The pipe had been fully examined using a mechanised ultrasonic scanner prior to the test and no defects had been detected. Post test examination of the pipe revealed an area of cracking in the same area as the acoustic emission system had predicted, Figure 102. Metallographic sections were removed from the pipe in the area

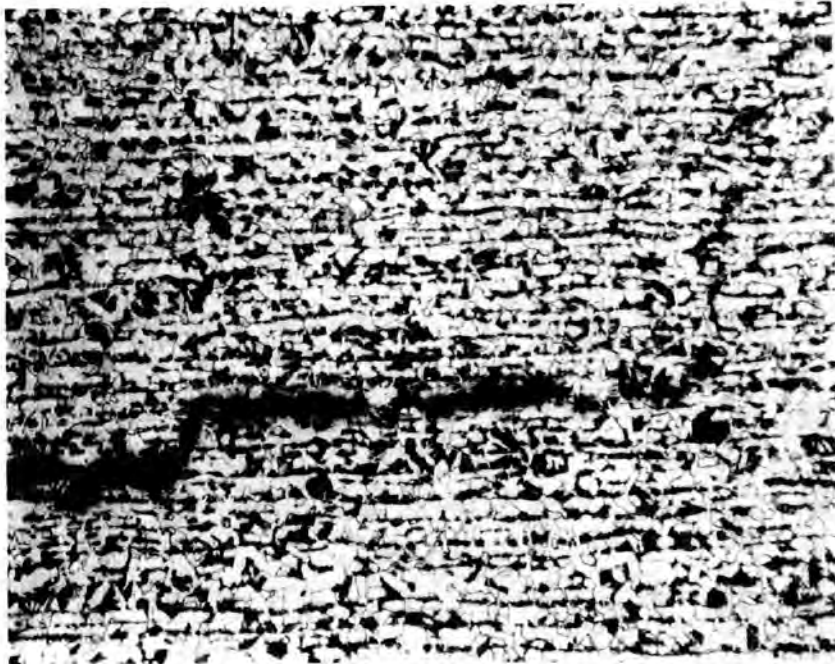
Figure 107
Metallographic section of pipe section 3 showing
the extent of the banding x 100
